**NYC Department of Education**  
**Building Condition Assessment Survey 2023 - 2024**

Architectural Inspection

**Asset: P.S. 18 - BROOKLYN, 101 MAUJER STREET, New York, 11206**

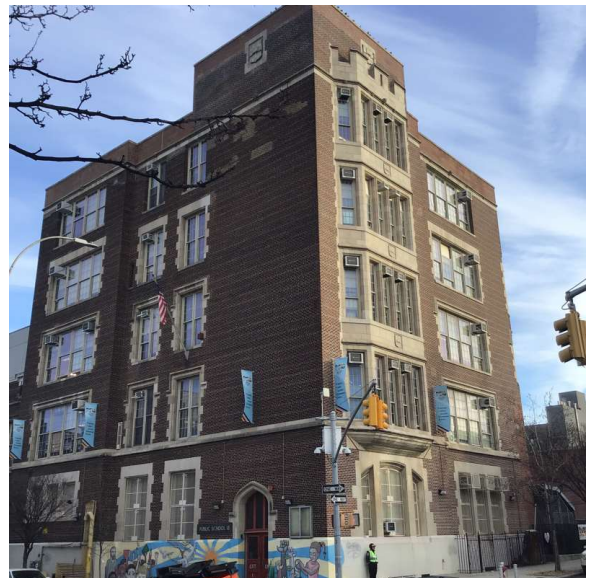
Corner Leonard Street and Maujer Street - Northeast View

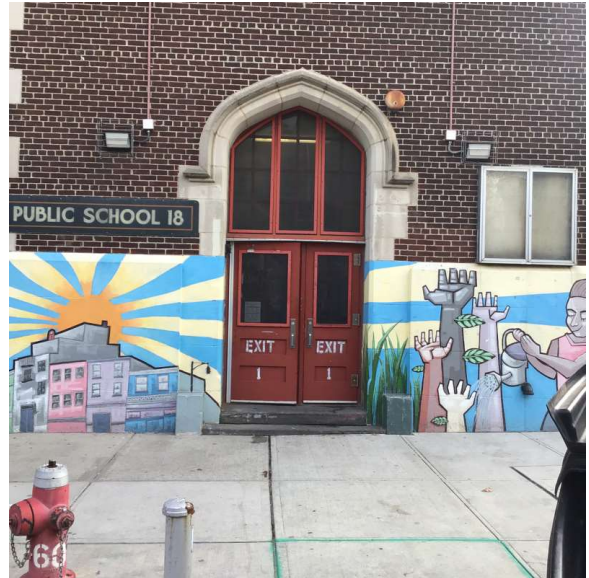
Facade A - Leonard Street

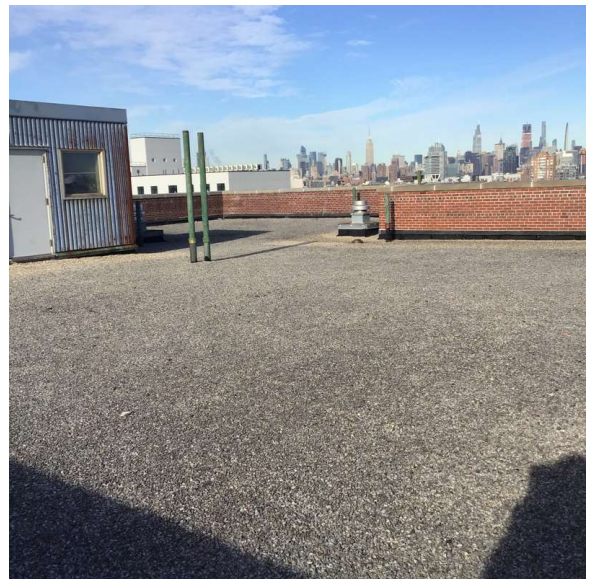
Roof 1 - West View

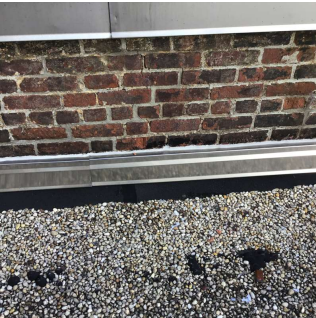
Question	Response
<b>EXTERIOR</b>	
<b>PARAPETS</b>	
Instance Condition	3 - Fair
Instance Quantity	3,000
Instance Quantity Uom	C.F.
Deficiency	BRICK: MINOR CRACKS, SPALLING
Roof Plan reference	<p>K018</p>

Deficiency Quantity	20
Quantity Uom	S.F.
Potential Action	REPAIR
Urgency of Action	PRIORITY 3
Purpose of Action	LEVEL 2
Deficiency Photo1

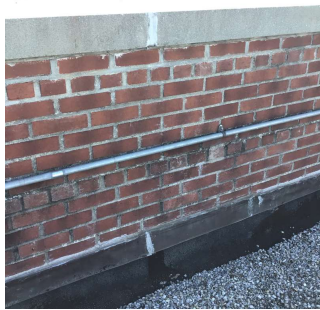
Violations	Roof 2 No violations recorded.
Deficiency	BRICK: DETERIORATED JOINTS
Roof Plan reference	<p>K018</p>  
Deficiency Quantity	150
Quantity Uom	S.F.
Potential Action	REPOINT
Urgency of Action	PRIORITY 3
Purpose of Action	LEVEL 2

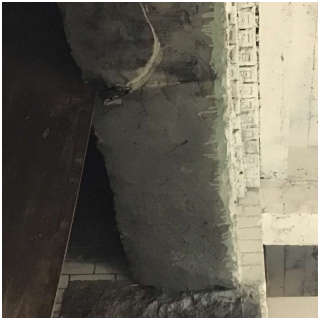
<b>Question</b>	<b>Response</b>
<b>EXTERIOR</b>	
<b>WINDOWS</b>	
<b>LINTELS</b>	Inspected
	Facade B
Violations	No violations recorded.
<b>WINDOWS</b>	
Material Type(s)	Inspected
	Aluminum
Instance on Aluminum - Double Hung: All Facades	Inspected
Instance Condition	2 - Between Good and Fair
Instance Quantity	5,000
Instance Quantity Uom	S.F.
Are these windows insulated	Yes
Installation Year	2015
Source of Installation	Custodial Staff
Deficiency	No deficiencies recorded
<b>INTERIOR</b>	
	Inspected
<b>POOLS</b>	
	Does not Exist
<b>STRUCTURAL</b>	
	Inspected
<b>COLUMNS/BEAMS/BEARING WALLS</b>	
Condition	Inspected
	3 - Fair
Deficiency	CONCRETE COLUMNS/BEAMS: CRACKED/SPALLED/REINFORCEMENT EXPOSED
Deficiency Location/Instance	Basement
Deficiency Quantity	150
Quantity Uom	S.F.
Potential Action	REPAIR
Urgency of Action	PRIORITY 3
Purpose of Action	LEVEL 5
Deficiency Photo1

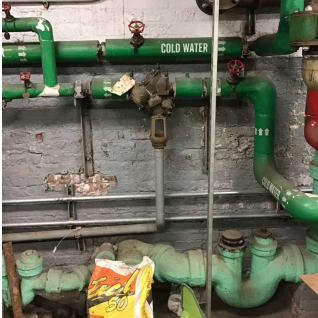
Question	Response
<b>INTERIOR</b>	
<b>STRUCTURAL</b>	
<b>FLOOR STRUCTURE</b>	Inspected
Violations	No violations recorded.
<b>FOUNDATION WALLS</b>	Inspected
Material Type(s)	Masonry
Condition	4 - Between Fair and Poor
Deficiency	BRICK: WATER INFILTRATION IN NON- INSTRUCTIONAL SPACE
Deficiency Location/Instance	Basement at Pneumatic Control Area, Areaway 1 and 3
Deficiency Quantity	400
Quantity Uom	S.F.
Potential Action	INSTALL WATERPROOFING
Urgency of Action	PRIORITY 5
Purpose of Action	LEVEL 5
Deficiency Photo1

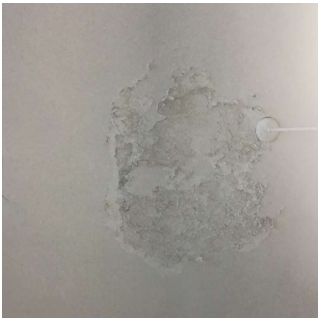
Violations	Basement No violations recorded.
<b>ROOF STRUCTURE</b>	Inspected
Condition	3 - Fair
Deficiency	CONCRETE: CRACKED/SPALLED/REINFORCEMENT EXPOSED
Deficiency Location/Instance	Stair B/2
Deficiency Quantity	100
Quantity Uom	S.F.
Potential Action	REPAIR
Urgency of Action	PRIORITY 3
Purpose of Action	LEVEL 5
Deficiency Photo1

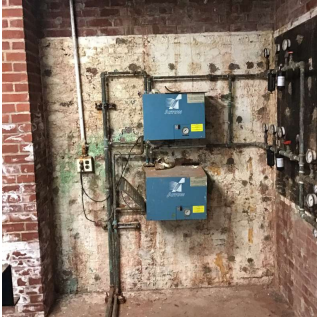
Question	Response
<b>INTERIOR</b>	
<b>STRUCTURAL</b>	
<b>VAULTS-BUNKERS</b>	
<b>Foundation Walls</b>	
Deficiency	WATER INFILTRATION IN NON- INSTRUCTIONAL SPACE
Deficiency Location/Instance	Vault 1, 2
Deficiency Quantity	100
Quantity Uom	S.F.
Potential Action	INSTALL WATERPROOFING
Urgency of Action	PRIORITY 5
Purpose of Action	LEVEL 5
Deficiency Photo1

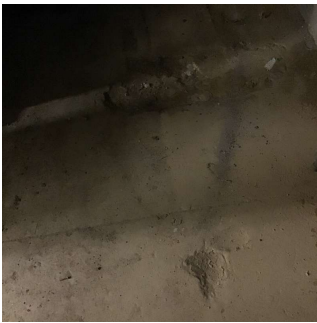
Violations	Basement below Facade C No violations recorded.
<b>Slab Structure</b>	
Condition	Inspected 3 - Fair
Deficiency	CONCRETE: CRACKS/SPALLED/REINFORCEMENT EXPOSED
Deficiency Location/Instance	Vault 1
Deficiency Quantity	50
Quantity Uom	S.F.
Potential Action	REPAIR
Urgency of Action	PRIORITY 3
Purpose of Action	LEVEL 5
Deficiency Photo1

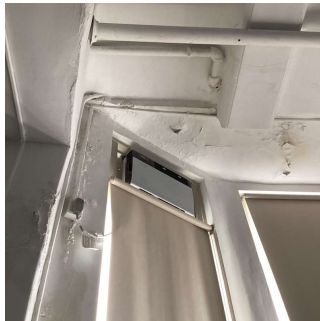
Question	Response
<b>INTERIOR</b>	
<b>CLASSROOMS/CORRIDORS/ADMIN SPACES</b>	
<b>Ceiling</b>	
Deficiency Photo1

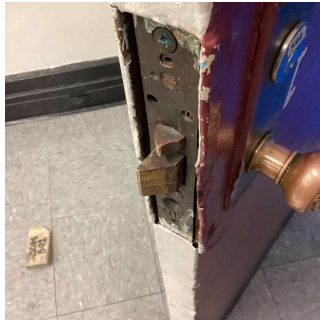
Violations	Room 501 No violations recorded.
<b>Door(s)</b>	
Condition	Inspected 5 - Poor
Deficiency	METAL CLAD WOOD: DETERIORATED DOOR
Deficiency Location/Instance	Rooms 503, 504
Deficiency Quantity	2
Quantity Uom	EACH
Potential Action	MAINTENANCE
Urgency of Action	PRIORITY 3
Purpose of Action	LEVEL 2
Deficiency Photo1

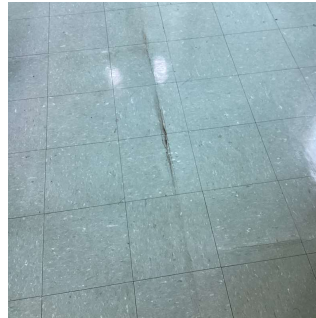
Room 402

VINYL TILES: DETERIORATED SUBSTRATE

REPLACE

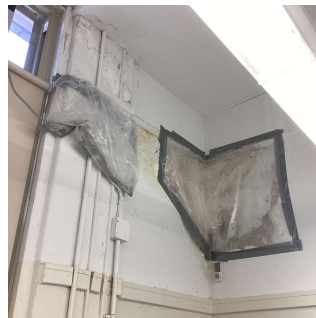
PLASTER: CRACKS/SPALLING - ACTIVE LEAK

REPLACE

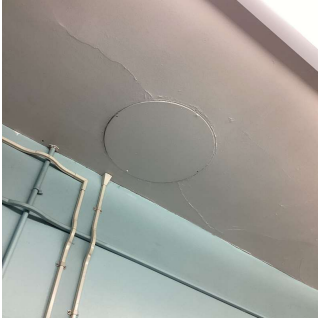
Violations	Storage Room No violations recorded.
Deficiency	METAL PAN: DAMAGED/MISSING
Deficiency Location/Instance	Near Entrance, Near Rear Window

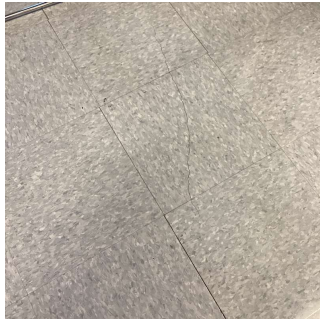
Question	Response
<b>INTERIOR</b>	
<b>LIBRARY</b>	
<b>Ceiling</b>	
Deficiency	No deficiencies recorded
<b>Door(s)</b>	
Instance on Room 204	Inspected
Condition	1 - Good
Deficiency	No deficiencies recorded
<b>Floor Finish</b>	
Instance on Room 204	Inspected
Condition	2 - Between Good and Fair
Deficiency	VINYL TILES: DETERIORATED SUBSTRATE
Deficiency Location/Instance	Center
Deficiency Quantity	10
Quantity Uom	S.F.
Potential Action	REPLACE
Urgency of Action	PRIORITY 3
Purpose of Action	LEVEL 2
Deficiency Photo1

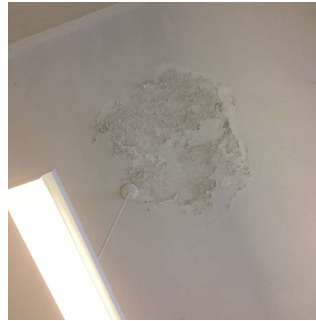
<b>Ceiling</b>	
Condition	2 - Between Good and Fair
Deficiency	PLASTER: CRACKS/SPALLING - ACTIVE LEAK
Deficiency Location/Instance	Stair B/2
Deficiency Quantity	20
Quantity Uom	S.F.
Potential Action	REPLACE
Urgency of Action	PRIORITY 5
Purpose of Action	LEVEL 2

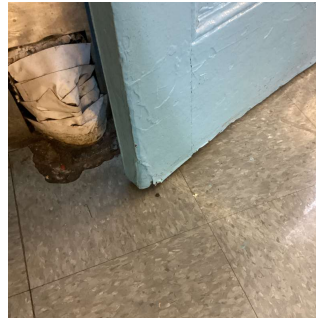
Stair A/1

METAL CLAD WOOD: DETERIORATED DOOR

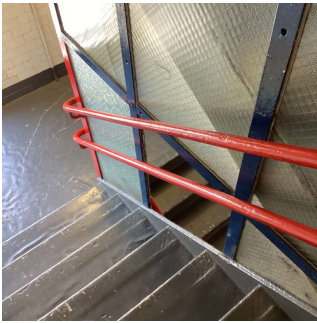
GLASS PANEL: DAMAGED/DETERIORATED

REPLACE

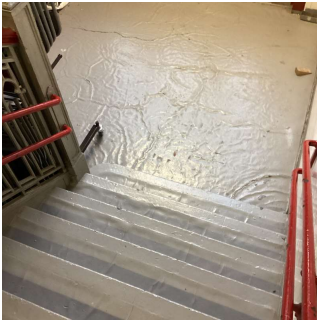
Violations	Stair A/4 No violations recorded.
<b>Railings</b>	Inspected
Condition	2 - Between Good and Fair
Deficiency	No deficiencies recorded
<b>Stairs and Landings</b>	Inspected
Condition	5 - Poor
Deficiency	ROLLED ASPHALT: CRACKS
Deficiency Location/Instance	Stairs A/1-5,Bulkhead, B/1,2,Bulkhead
Deficiency Quantity	1,200
Quantity Uom	S.F.
Potential Action	REPLACE
Urgency of Action	PRIORITY 3
Purpose of Action	LEVEL 2
Deficiency Photo1

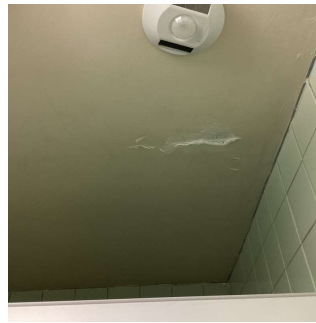
5th Floor Men

Violations	Stair B/1 No violations recorded.
<b>Walls</b>	Inspected
Condition	2 - Between Good and Fair
Deficiency	No deficiencies recorded
<b>TOILET ROOMS - STAFF</b>	Inspected
<b>Ceiling</b>	Inspected
Condition	4 - Between Fair and Poor
Deficiency	PLASTER: CRACKS/SPALLING
Deficiency Location/Instance	5th Floor Men, In Room 452
Deficiency Quantity	10
Quantity Uom	S.F.
Potential Action	REPLACE

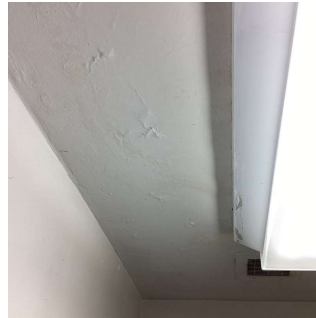
5th Floor Women

PLASTER: CRACKS/SPALLING - ACTIVE LEAK

REPLACE

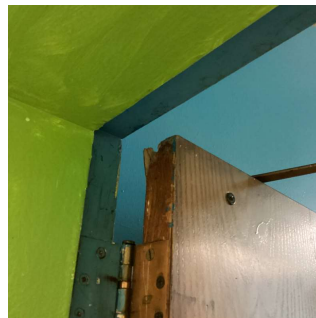
WOOD: DETERIORATED DOOR

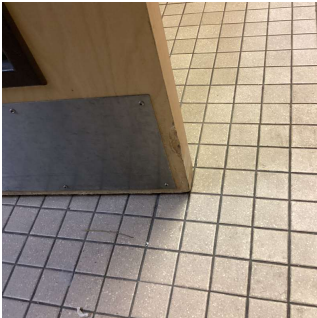
Question	Response
<b>INTERIOR</b>	
<b>TOILET ROOMS - STAFF</b>	
<b>Walls</b>	
Deficiency Quantity	20
Quantity Uom	S.F.
Potential Action	REPLACE
Urgency of Action	PRIORITY 3
Purpose of Action	LEVEL 2
Deficiency Photo1	 
Violations	5th Floor Women No violations recorded.
<b>TOILET ROOMS - STUDENTS</b>	
<b>Ceiling</b>	Inspected
Condition	2 - Between Good and Fair
Deficiency	No deficiencies recorded
<b>Door(s)</b>	Inspected
Condition	5 - Poor
Deficiency	WOOD: DETERIORATED DOOR
Deficiency Location/Instance	4th Floor Girls
Deficiency Quantity	1
Quantity Uom	EACH
Potential Action	MAINTENANCE
Urgency of Action	PRIORITY 3
Purpose of Action	LEVEL 2
Deficiency Photo1

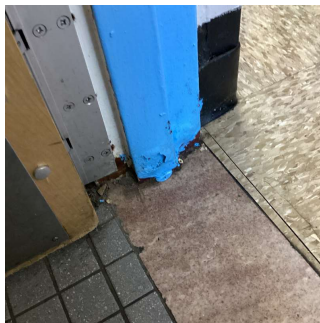
Violations	4th Floor Girls No violations recorded.
Deficiency	METAL: DETERIORATED DOOR AND FRAME
Deficiency Location/Instance	4th Floor Boys
Deficiency Quantity	1
Quantity Uom	EACH
Potential Action	MAINTENANCE
Urgency of Action	PRIORITY 3
Purpose of Action	LEVEL 2

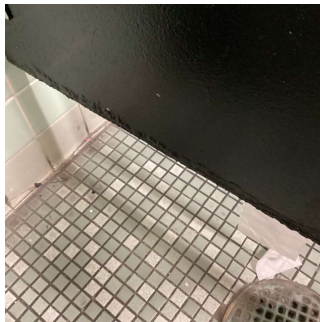
Violations	4th Floor Boys No violations recorded.
<b>Floor Finish</b>	Inspected
Condition	2 - Between Good and Fair
Deficiency	No deficiencies recorded
<b>Stalls</b>	Inspected
Condition	3 - Fair
Deficiency	RUST - MAJOR
Deficiency Location/Instance	In Room 203
Deficiency Quantity	1
Quantity Uom	EACH
Potential Action	REPLACE
Urgency of Action	PRIORITY 3
Purpose of Action	LEVEL 2
Deficiency Photo1

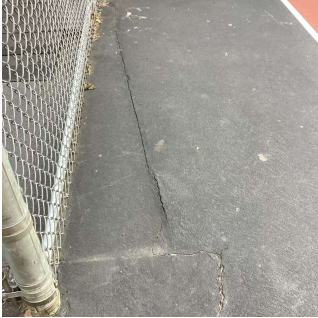
<b>Question</b>	<b>Response</b>
<b>SITE</b>	
<b>PAVING</b>	
<b>Student Non-Use</b>	Inspected
<b>Pavers</b>	Does not Exist
<b>Student Use</b>	Inspected
Gravel Exists?	No
<b>Asphalt</b>	Inspected
Condition	2 - Between Good and Fair
Deficiency	CRACKS - MAJOR
Deficiency Location/Instance	Schoolyard
Deficiency Quantity	20
Quantity Uom	S.F.
Potential Action	REPLACE
Urgency of Action	PRIORITY 3
Purpose of Action	LEVEL 2
Deficiency Photo1

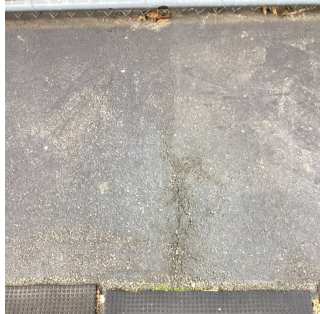
Question	Response
<b>SITE</b>	
<b>PAVING</b>	
<b>DOT Sidewalk</b>	
<b>Concrete</b>	
Deficiency Photo1	 
Violations	Leonard Street No violations recorded.
Deficiency	DAMAGED/DETERIORATED/MISSING SECTIONS
Deficiency Location/Instance	Maujer Street, Leonard Street
Deficiency Quantity	200
Quantity Uom	S.F.
Potential Action	REPLACE
Urgency of Action	PRIORITY 3
Purpose of Action	LEVEL 2
Deficiency Photo1	 
Violations	Maujer Street No violations recorded.
<b>Pavers</b>	Does not Exist
<b>PLAYGROUNDS</b>	Inspected
Instance on Schoolyard	Inspected
<b>Benches</b>	
Instance on Schoolyard	Does not Exist
<b>Fence</b>	
Instance on Schoolyard	Inspected
Condition	2 - Between Good and Fair
Deficiency	No deficiencies recorded
<b>Pavement</b>	
Instance on Schoolyard	Inspected
Condition	2 - Between Good and Fair
Deficiency	ASPHALT: CRACKS - MAJOR
Deficiency Location/Instance	Near Entrance Gate
Deficiency Quantity	10
Quantity Uom	S.F.
Potential Action	REPLACE

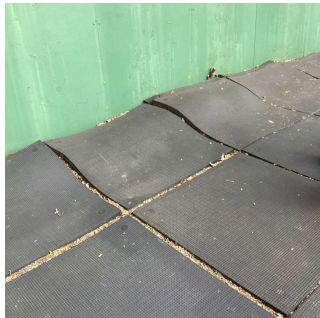
Near Entrance Gate
Violations	No violations recorded.
<b>Play Equipment</b>	
Instance on Schoolyard	Inspected
Condition	2 - Between Good and Fair
Deficiency	No deficiencies recorded
<b>Safety Surfacing</b>	
Instance on Schoolyard	Inspected
Condition	5 - Poor
Deficiency	DETERIORATED/MISSING
Deficiency Location/Instance	Schoolyard
Deficiency Quantity	500
Quantity Uom	S.F.
Potential Action	REPLACE
Urgency of Action	PRIORITY 5
Purpose of Action	LEVEL 6
Deficiency Photo1

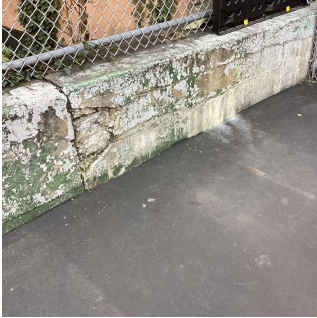
Schoolyard
Violations	35657637L
<b>Unpaved Area</b>	
Instance on Schoolyard	Does not Exist
<b>PLAYING SURFACE</b>	
	Does not Exist
<b>RETAINING WALLS</b>	
Are there any Retaining Walls 6' OR higher facing public street/sidewalk?	No
Condition	3 - Fair
Deficiency	CAST IN PLACE CONCRETE: CRACKS/SPALLING - MAJOR
Deficiency Location/Instance	Schoolyard

<b>Question</b>	<b>Response</b>
<b>SITE</b>	
<b>RETAINING WALLS</b>	
Quantity Uom	S.F.
Potential Action	REPLACE
Urgency of Action	PRIORITY 3
Purpose of Action	LEVEL 2
Deficiency Photo1
