NYC Department of Education
Building Condition Assessment Survey 2023 - 2024

Architectural Inspection

K020

Asset: P.S. 20 - BROOKLYN, 225 ADELPHI STREET, New York, 11205

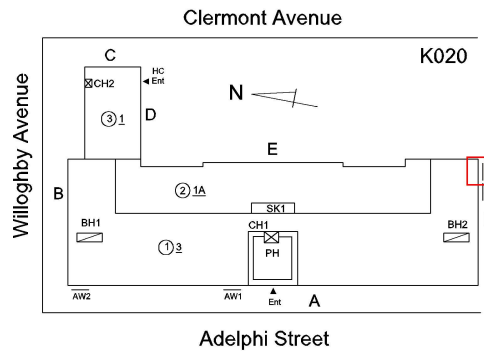
Roof Plan reference

AREAWAY STAIRS: DETERIORATED RAILINGS

REPLACE

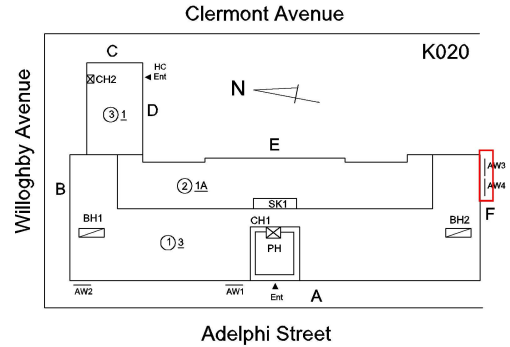
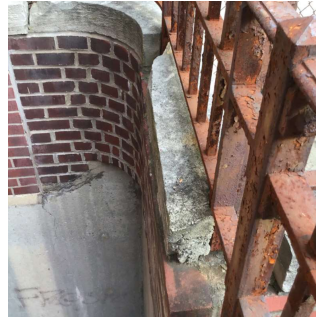
AW3

AREAWAY WALLS: DETERIORATED COPING STONE

REPLACE

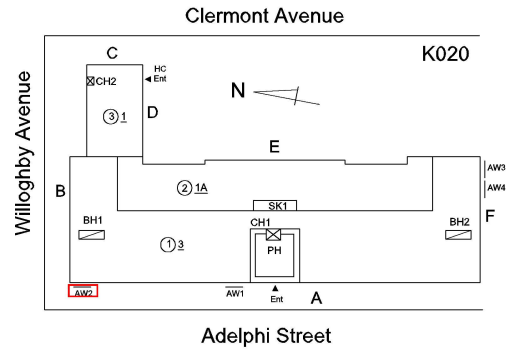
Roof Plan reference

AREAWAY SLAB: CRACKS AND SPALLING

30
S.F.
REPLACE
PRIORITY 4
LEVEL 2

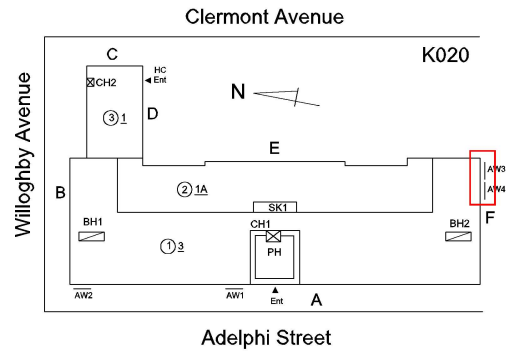
Roof Plan reference

AREAWAY WALLS: DETERIORATED JOINTS

200
S.F.
REPAIR
PRIORITY 3
LEVEL 2

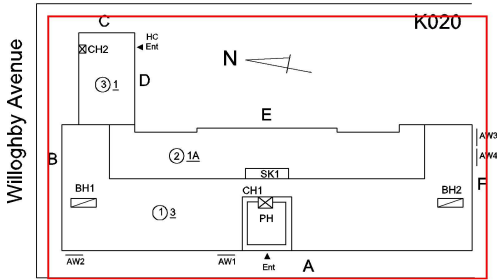
Violations	AW3 No violations recorded.
AWNINGS AND CANOPIES	
	Does not Exist
CHIMNEY	
Material Type(s)	Inspected Masonry
Condition	2 - Between Good and Fair
Deficiency	No deficiencies recorded
COPING	
Condition	Inspected 4 - Between Fair and Poor
Deficiency	CAST STONE: DISINTEGRATING / FREEZE THAW
Roof Plan reference	<p align="center">Clermont Avenue</p>

<p align="center">Adelphi Street</p>
Deficiency Quantity	200
Quantity Uom	L.F.
Potential Action	REPLACE-IN-KIND
Urgency of Action	PRIORITY 4
Purpose of Action	LEVEL 2
Deficiency Photo1

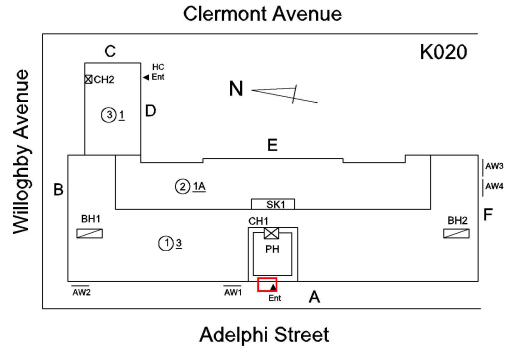
Question	Response
EXTERIOR	
DOORS	
DOORS AND FRAMES	
Condition	5 - Poor
Deficiency	METAL: DETERIORATED DOOR AND FRAME - MAJOR DETERIORATION
Roof Plan reference

<p align="center">Clermont Avenue K020 Willoghby Avenue Adelphi Street</p>
Deficiency Quantity	3
Quantity Uom	EACH
Potential Action	REPLACE
Urgency of Action	PRIORITY 4
Purpose of Action	LEVEL 2
Deficiency Photo1

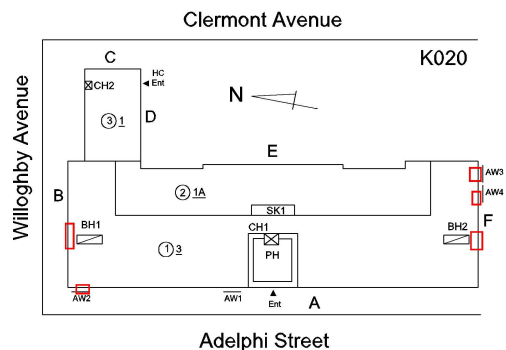
<p align="center">Facade A</p>
Violations	No violations recorded.
Deficiency	METAL CLAD: DETERIORATED DOOR AND FRAME - MAJOR DETERIORATION
Roof Plan reference

<p align="center">Clermont Avenue K020 Willoghby Avenue Adelphi Street</p>
Deficiency Quantity	8
Quantity Uom	EACH
Potential Action	REPLACE
Urgency of Action	PRIORITY 4
Purpose of Action	LEVEL 2

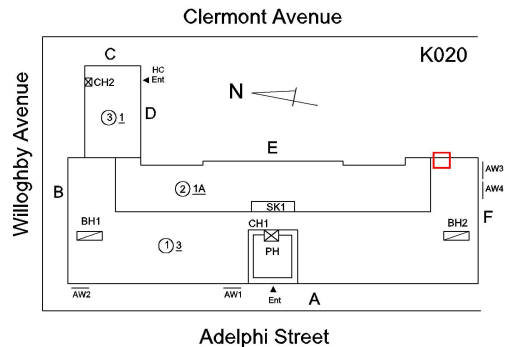
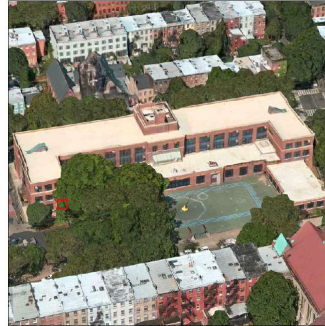
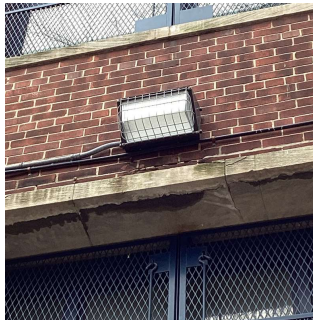
Facade E

BRICK: MAJOR / THRU CRACKS

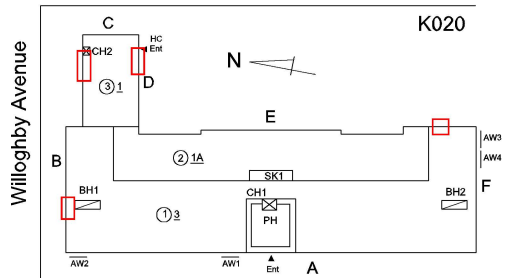
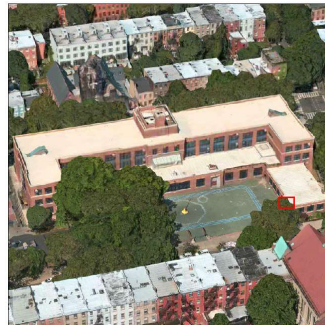
STONE: CHIPPED/SPALLED/BROKEN PIECES - MAJOR

REPLACE

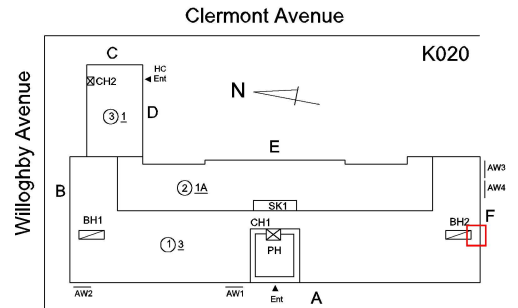
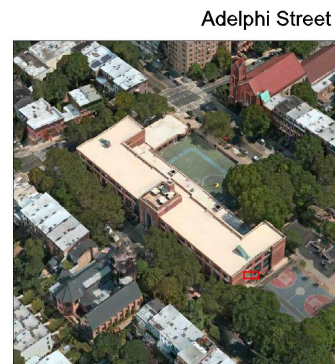
GLASS BLOCK: CHIPPED/ BROKEN PIECES

REPLACE-IN-KIND

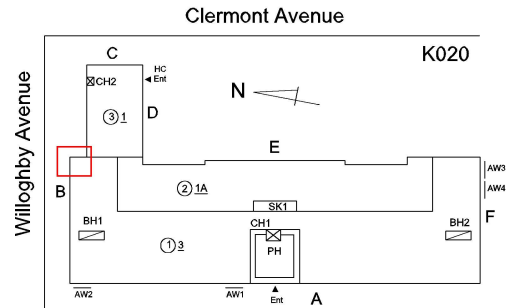
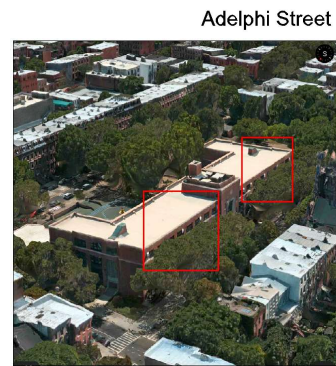
BRICK: EFFLORESCENCE

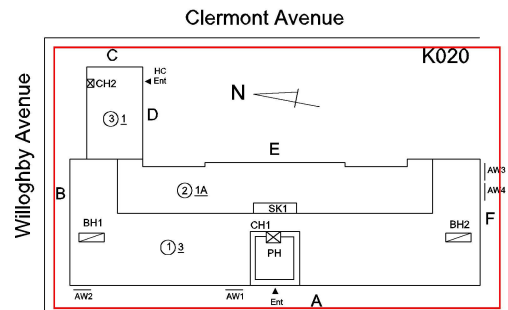
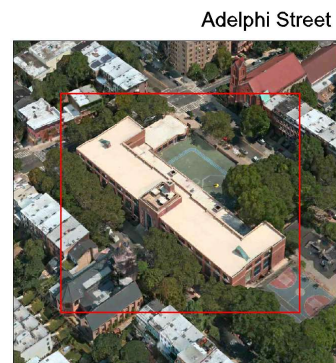
BRICK: DETERIORATED JOINTS

Question	Response
EXTERIOR	
EXTERIOR WALLS	
Deficiency Quantity	5,000
Quantity Uom	S.F.
Potential Action	REPOINT
Urgency of Action	PRIORITY 3
Purpose of Action	LEVEL 2
Deficiency Photo1

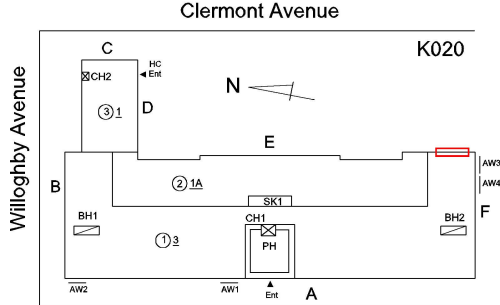
Violations	Facade B No violations recorded.
EXTERIOR SOFFITS	Does not Exist
LOADING DOCK	Does not Exist
LOUVER	Inspected
Condition	2 - Between Good and Fair
Deficiency	No deficiencies recorded
PARAPETS	Inspected
Material Type(s)	Masonry
Replacement Quantity	8,000
Replacement Uom	C.F.
Instance on All Facades	Inspected
Instance Condition	3 - Fair
Instance Quantity	8,000
Instance Quantity Uom	C.F.
Deficiency	BRICK: DETERIORATED JOINTS
Roof Plan reference

Deficiency Quantity	30
Quantity Uom	S.F.
Potential Action	REPOINT
Urgency of Action	PRIORITY 4
Purpose of Action	LEVEL 2

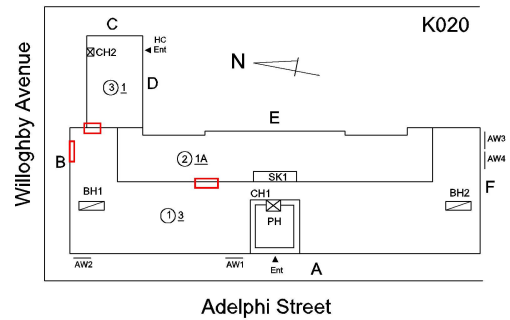
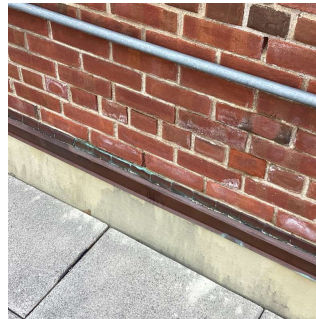
Roof 1

BRICK: DETERIORATED JOINTS
Clermont Avenue

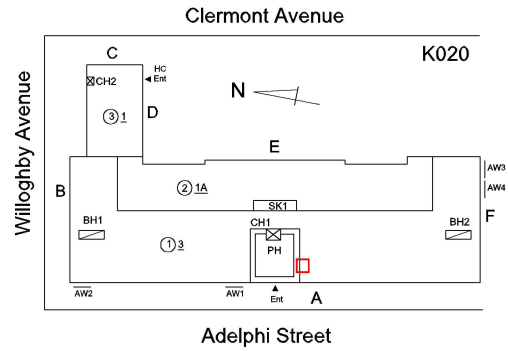
STONE: MAJOR DETERIORATION/CRACKS

10
S.F.
REMOVE AND REBUILD
PRIORITY 4
LEVEL 2

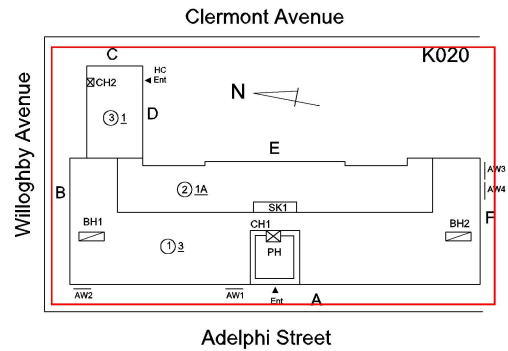
BRICK: EFFLORESCENCE

1,000
S.F.
MAINTENANCE
PRIORITY 1
LEVEL 1

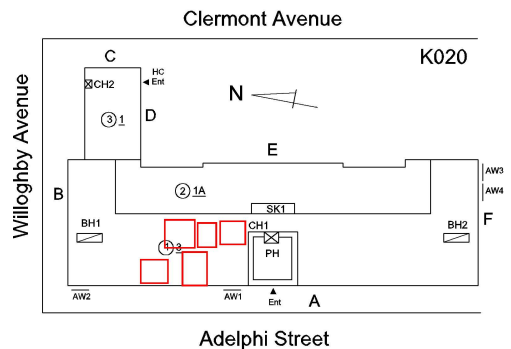
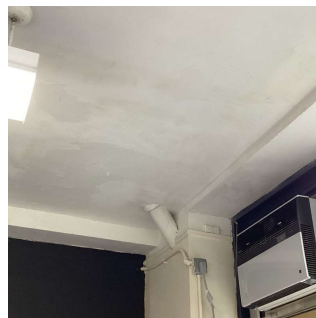
IRMA: ROOFING: MAJOR ACTIVE ROOF LEAKS IN INSTRUCTIONAL SPACE

Question	Response
EXTERIOR	
ROOF	
Roofing	
ROOFING	Inspected
	Roof 1 - Room 318 (shown), Rooms 313, 315, 316, 317
Violations	No violations recorded.
Instance on Modified Bitumen: Roofs 2, 3	Inspected
Instance Condition	5 - Poor
Instance Photo

REPLACE ROOFING WITHOUT MAJOR EQUIPMENT REMOVAL

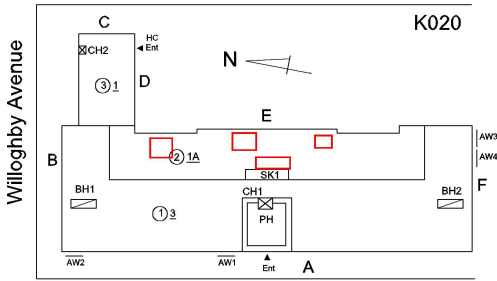
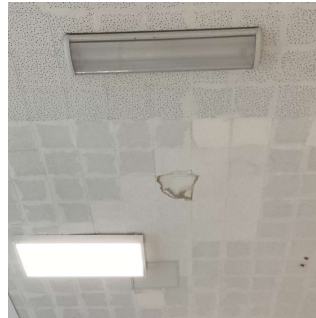
Roof 3
Instance Quantity	12,000
Instance Quantity Uom	S.F.
Does the roof have major mechanical equipment sitting on Dunnage Steel less than 18" above the Roofing?	No
Does this roof instance have a Sustainable Roof System?	Yes
Sustainable Roof Type	White Roof
Sustainable Roof Location (Roof Number)	Roofs 2, 3
Do solar panels exist on these roofs?	No
Is/Are the roof(s) suitable for Solar Panel installation?	Yes
Installation Year	2013
Source of Installation	Custodial Staff
Deficiency	MODIFIED BITUMEN: ROOFING: MAJOR ACTIVE ROOF LEAKS IN INSTRUCTIONAL SPACE
Roof Plan reference	<p align="center">Clermont Avenue</p>

Roof 2 - Cafeteria (shown), Auditorium, 1st Floor near Exit 5
No violations recorded.

Quantity Uom	S.F.
Potential Action	REPLACE ROOFING WITHOUT MAJOR EQUIPMENT REMOVAL
Urgency of Action	PRIORITY 5
Purpose of Action	LEVEL 2

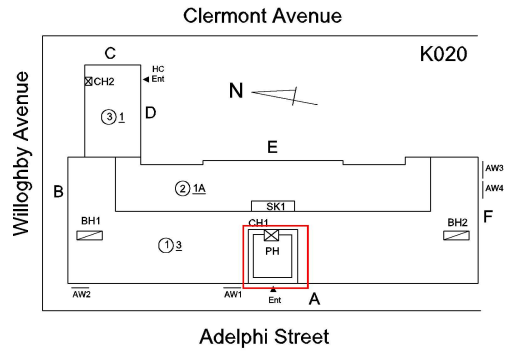
BULKHEAD/PENTHOUSE

50
S.F.
MAINTENANCE
PRIORITY 1
LEVEL 1

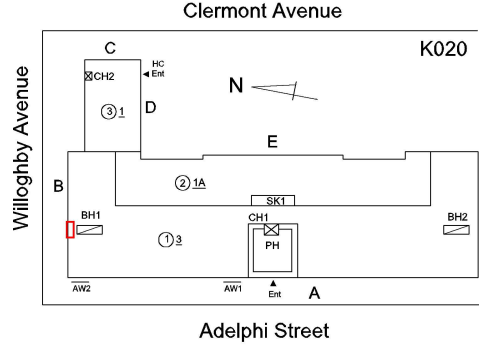
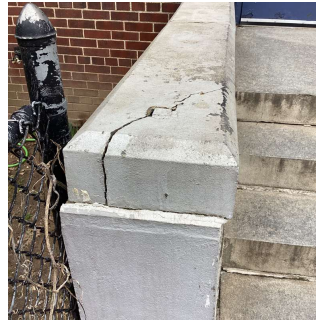
Facade B

STONE: DETERIORATED COPING STONE

REPLACE

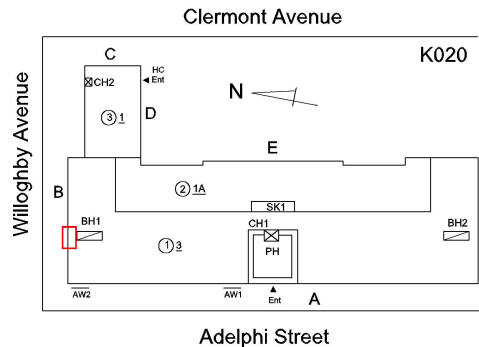
STONE: BULGING/DISPLACED

REPLACE

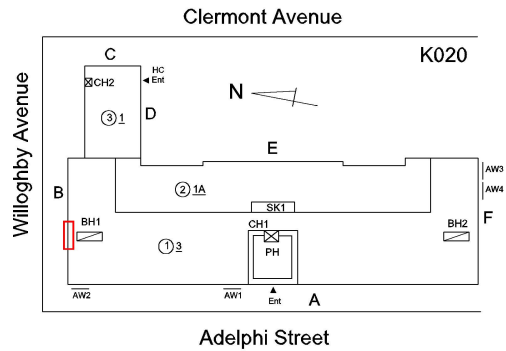
MISSING RAILING

REPLACE

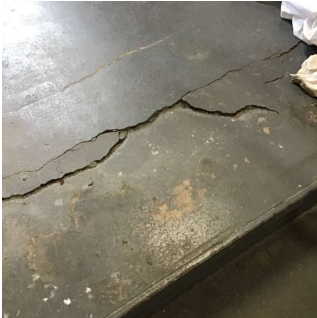
Question	Response
EXTERIOR	
WINDOWS	
WINDOWS	
Instance Quantity	200
Instance Quantity Uom	S.F.
Are these windows insulated	Yes
Installation Year	2023
Source of Installation	Custodial Staff
Deficiency	No deficiencies recorded
INTERIOR	Inspected
POOLS	Does not Exist
STRUCTURAL	Inspected
COLUMNS/BEAMS/BEARING WALLS	
Condition	2 - Between Good and Fair
Deficiency	No deficiencies recorded
FLOOR STRUCTURE	
Condition	2 - Between Good and Fair
Deficiency	CONCRETE: CRACKS/SPALLED/REINFORCEMENT EXPOSED
Deficiency Location/Instance	PH
Deficiency Quantity	20
Quantity Uom	S.F.
Potential Action	REPAIR
Urgency of Action	PRIORITY 3
Purpose of Action	LEVEL 5
Deficiency Photo1

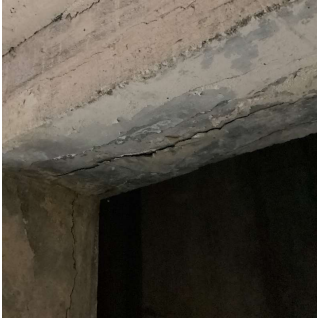
Question	Response
INTERIOR	
STRUCTURAL	
VAULTS-BUNKERS	
Foundation Walls	Inspected
Violations	No violations recorded.
Slab Structure	Inspected
Condition	4 - Between Fair and Poor
Deficiency	STEEL COLUMNS/BEAMS: DETERIORATED CONCRETE FIREPROOFING
Deficiency Location/Instance	Basement - Vault
Deficiency Quantity	20
Quantity Uom	S.F.
Potential Action	REPAIR
Urgency of Action	PRIORITY 4
Purpose of Action	LEVEL 5
Deficiency Photo1

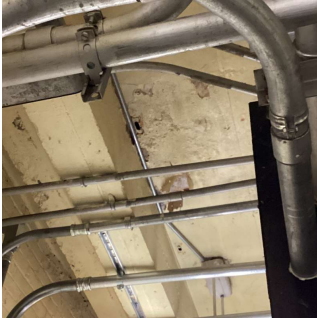
Violations	No violations recorded.
Deficiency	CONCRETE: WATER INFILTRATION IN ELECTRICAL PANEL ROOM
Deficiency Location/Instance	Basement - Electrical Panel Room
Deficiency Quantity	100
Quantity Uom	S.F.
Potential Action	INSTALL WATERPROOFING
Urgency of Action	PRIORITY 5
Purpose of Action	LEVEL 6
Deficiency Photo1

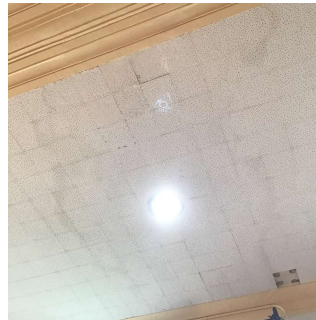
Left Side

ACOUSTIC TILES ON PLASTER: DAMAGED/MISSING - ACTIVE LEAK

REPLACE

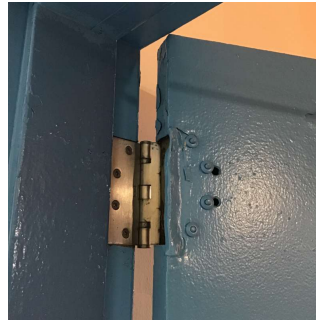
Stage Entrance from Corridor

METAL: DETERIORATED DOOR

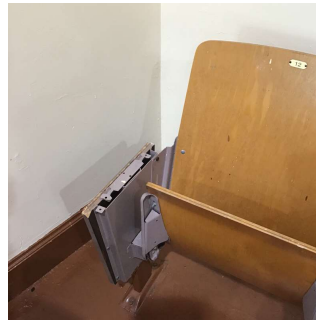
Seat P/12

DAMAGED/BROKEN/INOPERABLE

REPLACE

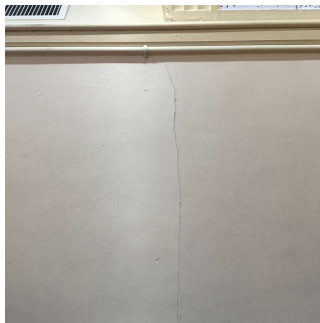
Question	Response
INTERIOR	
AUDITORIUM	
Fixed Seating	
Deficiency Photo1	 
	Seat C/1
Violations	No violations recorded.
Floor Finish	
Instance on 1st Floor (406 Seats)	Inspected
Condition	2 - Between Good and Fair
Deficiency	No deficiencies recorded
Sliding-folding Partition	
Instance on 1st Floor (406 Seats)	Does not Exist
Stage	
Instance on 1st Floor (406 Seats)	Inspected
Stage	
Instance on 1st Floor (406 Seats)	Inspected
Condition	2 - Between Good and Fair
Deficiency	No deficiencies recorded
Stage Curtain Rigging	
Instance on 1st Floor (406 Seats)	Inspected
Condition	2 - Between Good and Fair
Deficiency	No deficiencies recorded
Stage Curtains	
Instance on 1st Floor (406 Seats)	Inspected
Condition	2 - Between Good and Fair
Deficiency	No deficiencies recorded
Walls	
Instance on 1st Floor (406 Seats)	Inspected
Condition	2 - Between Good and Fair
Deficiency	PLASTER: CRACKS/SPALLING
Deficiency Location/Instance	Left Side

Left Side
Violations	No violations recorded.
Window Curtains/Shades/Blinds	
Instance on 1st Floor (406 Seats)	Inspected
Condition	2 - Between Good and Fair
Deficiency	No deficiencies recorded
CAFETERIA	
Instance on 1st Floor	Inspected
Ceiling	
Instance on 1st Floor	Inspected
Condition	2 - Between Good and Fair
Deficiency	ACOUSTIC TILES ON PLASTER: DAMAGED/MISSING
Deficiency Location/Instance	Near Mens Staff Toilet
Deficiency Quantity	10
Quantity Uom	S.F.
Potential Action	REPLACE
Urgency of Action	PRIORITY 3
Purpose of Action	LEVEL 2
Deficiency Photo1

Deficiency Quantity	10
Quantity Uom	S.F.
Potential Action	REPLACE
Urgency of Action	PRIORITY 3
Purpose of Action	LEVEL 2

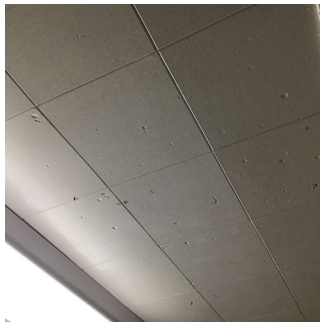
Near Mens Staff Toilet
Violations	No violations recorded.
Deficiency	ACOUSTIC TILES ON PLASTER: DAMAGED/MISSING - ACTIVE LEAK
Deficiency Location/Instance	Center, Near Kitchen
Deficiency Quantity	25
Quantity Uom	S.F.
Potential Action	REPLACE
Urgency of Action	PRIORITY 5
Purpose of Action	LEVEL 2

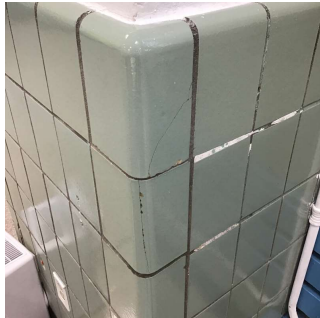
Violations	Right Side No violations recorded.
Sliding-folding Partition	
Instance on 1st Floor	Does not Exist
Stage	
Instance on 1st Floor	Does not Exist
Walls	
Instance on 1st Floor	Inspected
Condition	2 - Between Good and Fair
Deficiency	GLAZED BLOCK: CRACKS/SPALLING
Deficiency Location/Instance	Near Windows

Question	Response
INTERIOR	
CAFETERIA	
Walls	
Deficiency Quantity	15
Quantity Uom	S.F.
Potential Action	REPLACE
Urgency of Action	PRIORITY 3
Purpose of Action	LEVEL 2
Deficiency Photo1

Violations	Near Windows No violations recorded.
Deficiency	PLASTER: CRACKS/SPALLING
Deficiency Location/Instance	Near Exit 6, Serving Area
Deficiency Quantity	20
Quantity Uom	S.F.
Potential Action	REPLACE
Urgency of Action	PRIORITY 3
Purpose of Action	LEVEL 2
Deficiency Photo1

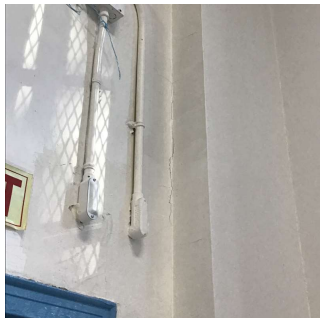
Violations	Near Exit 6 No violations recorded.
Window Curtains/Shades/Blinds	
Instance on 1st Floor	Does not Exist
CLASSROOMS/CORRIDORS/ADMIN SPACES	
Ceiling	Inspected
Condition	2 - Between Good and Fair
Deficiency	ACOUSTIC TILES: DAMAGED/MISSING
Deficiency Location/Instance	Room B6.1
Deficiency Quantity	25
Quantity Uom	S.F.
Potential Action	REPLACE
Urgency of Action	PRIORITY 3
Purpose of Action	LEVEL 2

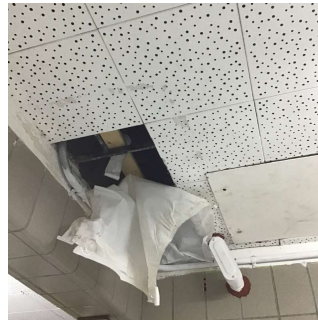
Corridor near 1st Floor Boys Toilet

ACOUSTIC TILES ON PLASTER: DAMAGED/MISSING

REPLACE

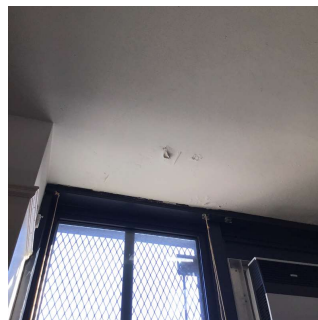
Room 313

PLASTER: CRACKS/SPALLING - ACTIVE LEAK

REPLACE

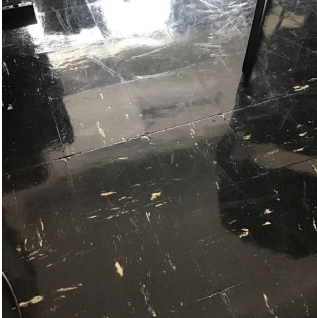
Question	Response
INTERIOR	
CLASSROOMS/CORRIDORS/ADMIN SPACES	
Ceiling	Inspected
Violations	No violations recorded.
Door(s)	Inspected
Condition	5 - Poor
Deficiency	WOOD: DETERIORATED DOOR
Deficiency Location/Instance	Rooms 118, 218, 224, 302, 315, and others
Deficiency Quantity	13
Quantity Uom	EACH
Potential Action	MAINTENANCE
Urgency of Action	PRIORITY 3
Purpose of Action	LEVEL 2
Deficiency Photo1	 
Violations	Room 315 No violations recorded.
Floor Finish	Inspected
Condition	2 - Between Good and Fair
Deficiency	VINYL TILES: DETERIORATED SUBSTRATE
Deficiency Location/Instance	Corridor near 1st Floor Girls Toilet, Corridor near Rooms 126, 209, Room B4.2
Deficiency Quantity	50
Quantity Uom	S.F.
Potential Action	REPLACE
Urgency of Action	PRIORITY 3
Purpose of Action	LEVEL 2
Deficiency Photo1	 
Violations	Corridor near 1st Floor Girls No violations recorded.
Deficiency	VINYL TILES: BROKEN/DETERIORATED/MISSING TILES
Deficiency Location/Instance	Rooms 101, 118, 219

Question	Response
INTERIOR	
CLASSROOMS/CORRIDORS/ADMIN SPACES	
Floor Finish	
Urgency of Action	PRIORITY 3
Purpose of Action	LEVEL 2
Deficiency Photo1

Room 219
Violations	No violations recorded.
Walls	
Condition	Inspected
	2 - Between Good and Fair
Deficiency	PLASTER: CRACKS/SPALLING
Deficiency Location/Instance	Rooms 118, 202, 215, 220, Corridor near Room 104, Corridor near Exit 4
Deficiency Quantity	60
Quantity Uom	S.F.
Potential Action	REPLACE
Urgency of Action	PRIORITY 3
Purpose of Action	LEVEL 2
Deficiency Photo1

Deficiency Quantity	900
Quantity Uom	S.F.
Potential Action	REPLACE

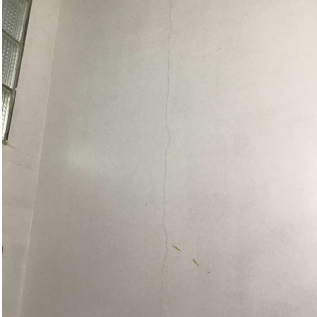
Corridor near Exit 4
Violations	No violations recorded.
Deficiency	GLAZED BLOCK: CRACKS/SPALLING
Deficiency Location/Instance	Corridor near Room 324
Deficiency Quantity	10
Quantity Uom	S.F.
Potential Action	REPLACE
Urgency of Action	PRIORITY 3
Purpose of Action	LEVEL 2

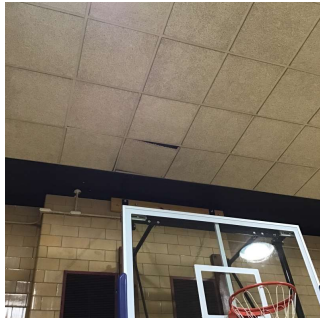
Question	Response
INTERIOR	
CLASSROOMS/CORRIDORS/ADMIN SPACES	
Walls	
Deficiency Photo1	 
Violations	Corridor near Room 324 No violations recorded.
Specialties	Inspected
Classroom Locker(s)	Inspected
Condition	2 - Between Good and Fair
Deficiency	No deficiencies recorded
Fixed Seating	Does not Exist
GYMNASIUM	Inspected
Instance on 1st Floor	Inspected
Ceiling	
Instance on 1st Floor	Inspected
Condition	2 - Between Good and Fair
Deficiency	TECTUM: DAMAGED/MISSING
Deficiency Location/Instance	Right Side
Deficiency Quantity	10
Quantity Uom	S.F.
Potential Action	REPLACE
Urgency of Action	PRIORITY 5
Purpose of Action	LEVEL 6
Deficiency Photo1

Violations	Right Side No violations recorded.
Door(s)	
Instance on 1st Floor	Inspected
Condition	3 - Fair
Deficiency	WOOD: DETERIORATED DOOR
Deficiency Location/Instance	Office
Deficiency Quantity	1
Quantity Uom	EACH
Potential Action	MAINTENANCE

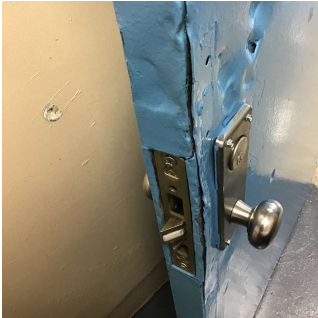
Question	Response
INTERIOR	
GYMNASIUM	
Walls	
Deficiency Photo1	 
Violations	Near Windows No violations recorded.
Window Curtains/Shades/Blinds	
Instance on 1st Floor	Does not Exist
INTERIOR DOOR HARDWARE	
Condition	Inspected 3 - Fair
Deficiency	No deficiencies recorded
INTERIOR GUARDS	
Condition	Inspected 2 - Between Good and Fair
Deficiency	No deficiencies recorded
KITCHEN	
Instance on 1st Floor	Inspected
Ceiling	
Instance on 1st Floor	Inspected
Condition	2 - Between Good and Fair
Deficiency	METAL PAN: DAMAGED/MISSING
Deficiency Location/Instance	Left Side
Deficiency Quantity	15
Quantity Uom	S.F.
Potential Action	REPLACE
Urgency of Action	PRIORITY 3
Purpose of Action	LEVEL 2
Deficiency Photo1	 
Violations	Left Side No violations recorded.
Door(s)	
Instance on 1st Floor	Inspected
Condition	5 - Poor
Deficiency	METAL: DETERIORATED DOOR
Deficiency Location/Instance	Kitchen Office Adjacent to Kitchen, Store Room

Question	Response
INTERIOR	
KITCHEN	
Door(s)	
Deficiency Quantity	2
Quantity Uom	EACH
Potential Action	MAINTENANCE
Urgency of Action	PRIORITY 3
Purpose of Action	LEVEL 2
Deficiency Photo1

Violations	Kitchen Office Adjacent to Kitchen No violations recorded.
Deficiency	WOOD: DETERIORATED DOOR
Deficiency Location/Instance	Entrance
Deficiency Quantity	1
Quantity Uom	EACH
Potential Action	MAINTENANCE
Urgency of Action	PRIORITY 3
Purpose of Action	LEVEL 2
Deficiency Photo1

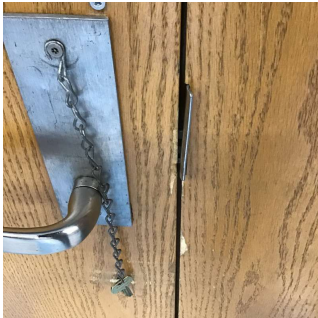
Question	Response
INTERIOR	
KITCHEN	
Floor Finish	
Deficiency Photo1	 
	Near Storage Room
Violations	No violations recorded.
Walls	
Instance on 1st Floor	Inspected
Condition	2 - Between Good and Fair
Deficiency	CERAMIC TILE: BROKEN/ MISSING
Deficiency Location/Instance	Center
Deficiency Quantity	10
Quantity Uom	S.F.
Potential Action	REPLACE
Urgency of Action	PRIORITY 3
Purpose of Action	LEVEL 2
Deficiency Photo1	 
	Center
Violations	No violations recorded.
LIBRARY	
Instance on Room 108	Inspected
Built-in Furnishing	
Instance on Room 108	Inspected
Condition	2 - Between Good and Fair
Deficiency	No deficiencies recorded
Ceiling	
Instance on Room 108	Inspected
Condition	2 - Between Good and Fair
Deficiency	No deficiencies recorded
Door(s)	
Instance on Room 108	Inspected
Condition	3 - Fair
Deficiency	WOOD: DETERIORATED DOOR
Deficiency Location/Instance	Entrance

Question	Response
INTERIOR	
LIBRARY	
Door(s)	
Deficiency Quantity	1
Quantity Uom	EACH
Potential Action	MAINTENANCE
Urgency of Action	PRIORITY 3
Purpose of Action	LEVEL 2
Deficiency Photo1

Entrance
Violations	No violations recorded.
Floor Finish	
Instance on Room 108	Inspected
Condition	2 - Between Good and Fair
Deficiency	VINYL TILES: BROKEN/DETERIORATED/MISSING TILES
Deficiency Location/Instance	Right Side
Deficiency Quantity	10
Quantity Uom	S.F.
Potential Action	REPLACE
Urgency of Action	PRIORITY 3
Purpose of Action	LEVEL 2
Deficiency Photo1

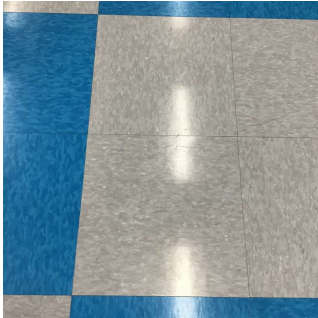
Right Side
Violations	No violations recorded.
Walls	
Instance on Room 108	Inspected
Condition	2 - Between Good and Fair
Deficiency	No deficiencies recorded
LOCKER ROOM	Does not Exist
MULTI-PURPOSE ROOM	Does not Exist
SCIENCE DEMO ROOM	Does not Exist
SCIENCE LAB	Inspected
Instance on Room 301	Inspected
Alternative use	No

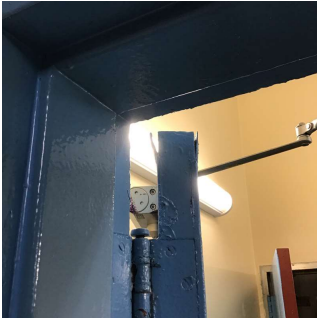
Question	Response
INTERIOR	
SCIENCE LAB	
Fixed Equipment	
Instance on Room 301	Inspected
Condition	2 - Between Good and Fair
Deficiency	No deficiencies recorded
SCIENCE PREP ROOM	
	Does not Exist
SHOWER ROOM	
	Does not Exist
STAIRS/RAMPS: INTERIOR	
Do Letter Stair Signs Exist?	Inspected
	Yes
Ceiling	
Condition	Inspected
	2 - Between Good and Fair
Deficiency	No deficiencies recorded
Door(s)	
Condition	Inspected
	2 - Between Good and Fair
Deficiency	METAL: DETERIORATED DOOR
Deficiency Location/Instance	Stair A/3
Deficiency Quantity	1
Quantity Uom	EACH
Potential Action	MAINTENANCE
Urgency of Action	PRIORITY 3
Purpose of Action	LEVEL 2
Deficiency Photo1

Stair A/3
Violations	No violations recorded.
Partition	
	Does not Exist
Railings	
Condition	Inspected
	2 - Between Good and Fair
Deficiency	No deficiencies recorded
Stairs and Landings	
Condition	Inspected
	3 - Fair
Deficiency	METAL: RUST - MAJOR
Deficiency Location/Instance	Stair C/1

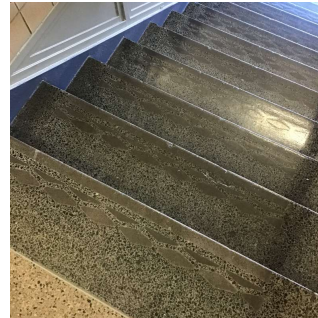
Stair A/3

TERRAZZO: CRACKS

REPLACE

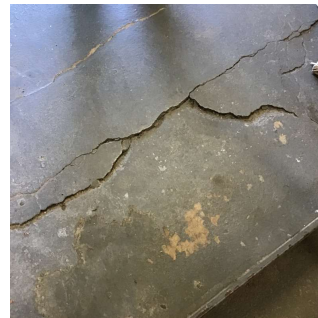
Stair A/Bulkhead

CONCRETE: CRACKS/SPALLING - MAJOR

REPLACE

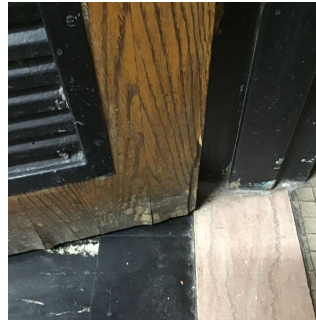
Gymnasium Office

Question	Response
INTERIOR	
STAIRS/RAMPS: INTERIOR	
Walls	
Deficiency Photo1	 
Violations	Stair A/3 No violations recorded.
TOILET ROOMS - STAFF	Inspected
Ceiling	Inspected
Condition	2 - Between Good and Fair
Deficiency	PLASTER: CRACKS/SPALLING
Deficiency Location/Instance	1st Floor Women
Deficiency Quantity	10
Quantity Uom	S.F.
Potential Action	REPLACE
Urgency of Action	PRIORITY 3
Purpose of Action	LEVEL 2
Deficiency Photo1	 
Violations	1st Floor Women No violations recorded.
Door(s)	Inspected
Condition	5 - Poor
Deficiency	WOOD: DETERIORATED DOOR
Deficiency Location/Instance	Gymnasium Office, 2nd Floor Staff, 3rd Floor Staff, In Rooms B24,101, and others
Deficiency Quantity	9
Quantity Uom	EACH
Potential Action	MAINTENANCE
Urgency of Action	PRIORITY 3
Purpose of Action	LEVEL 2

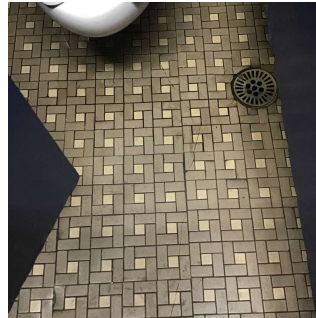
1st Floor Women

CERAMIC TILE: BROKEN/MISSING TILES

REPLACE

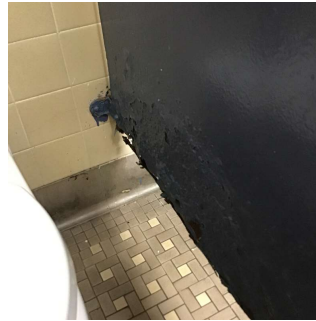
1st Floor Women

RUST - MAJOR

REPLACE

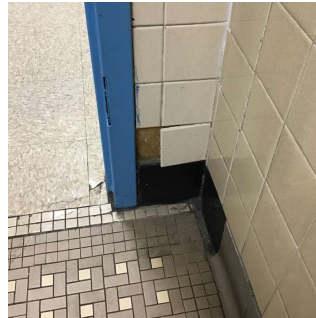
1st Floor Men

CERAMIC TILE: BROKEN/ MISSING

REPLACE

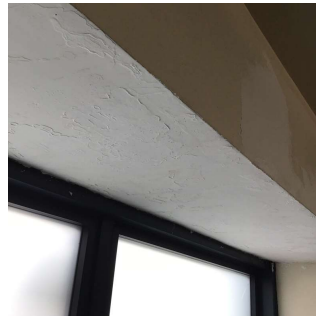
PLASTER: CRACKS/SPALLING

Question	Response
INTERIOR	
TOILET ROOMS - STAFF	Inspected
Walls	Inspected
Violations	2nd Floor Staff No violations recorded.
TOILET ROOMS - STUDENTS	Inspected
Ceiling	Inspected
Condition	2 - Between Good and Fair
Deficiency	No deficiencies recorded
Door(s)	Inspected
Condition	5 - Poor
Deficiency	WOOD: DETERIORATED DOOR
Deficiency Location/Instance	Rooms 312, 314
Deficiency Quantity	2
Quantity Uom	EACH
Potential Action	MAINTENANCE
Urgency of Action	PRIORITY 3
Purpose of Action	LEVEL 2
Deficiency Photo1	 
Violations	Room 312 No violations recorded.
Floor Finish	Inspected
Condition	2 - Between Good and Fair
Deficiency	CERAMIC TILE: BROKEN/MISSING TILES
Deficiency Location/Instance	Rooms 312, 314
Deficiency Quantity	25
Quantity Uom	S.F.
Potential Action	REPLACE
Urgency of Action	PRIORITY 3
Purpose of Action	LEVEL 2
Deficiency Photo1	 
Violations	Room 312 No violations recorded.
Stalls	Inspected

REPLACE

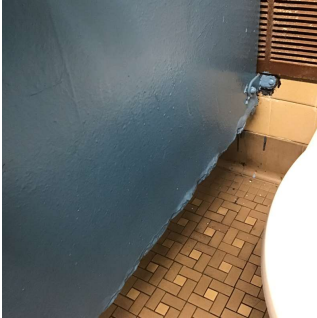
Question	Response
INTERIOR	
TOILET ROOMS - STUDENTS	Inspected
Stalls	
Condition	5 - Poor
Deficiency	RUST - MAJOR
Deficiency Location/Instance	Room 312
Deficiency Quantity	4
Quantity Uom	EACH
Potential Action	REPLACE
Urgency of Action	PRIORITY 3
Purpose of Action	LEVEL 2
Deficiency Photo1

Violations	Room 312 No violations recorded.
Walls	Inspected
Condition	2 - Between Good and Fair
Deficiency	CERAMIC TILE: BROKEN/ MISSING
Deficiency Location/Instance	Rooms 312, 314
Deficiency Quantity	30
Quantity Uom	S.F.
Potential Action	REPLACE
Urgency of Action	PRIORITY 3
Purpose of Action	LEVEL 2
Deficiency Photo1

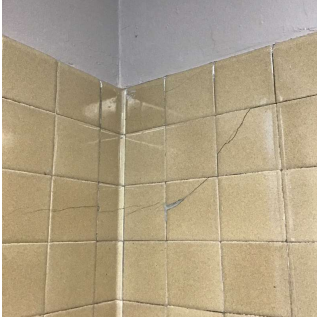
Violations	Room 312 No violations recorded.
Deficiency	PLASTER: CRACKS/SPALLING
Deficiency Location/Instance	Room 314
Deficiency Quantity	10
Quantity Uom	S.F.
Potential Action	REPLACE
Urgency of Action	PRIORITY 3
Purpose of Action	LEVEL 2

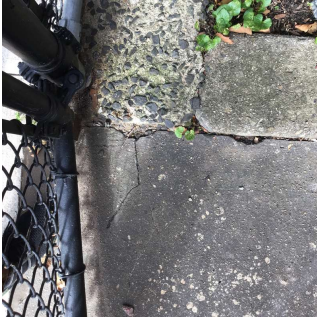
Question	Response
SITE	
IRRIGATION SYSTEM	Does not Exist
PAVING	Inspected
Student Non-Use	Inspected
Gravel Exists?	No
Asphalt	Does not Exist
Concrete	Inspected
Condition	2 - Between Good and Fair
Deficiency	CRACKS - MAJOR
Deficiency Location/Instance	Adelphi Street
Deficiency Quantity	25
Quantity Uom	S.F.
Potential Action	REPLACE
Urgency of Action	PRIORITY 3
Purpose of Action	LEVEL 2
Deficiency Photo1

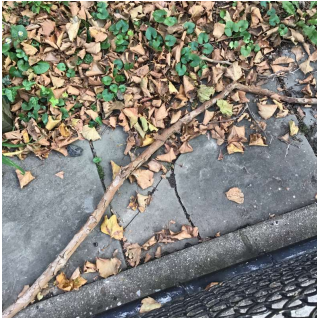
Adelphi Street	
Violations	No violations recorded.
Student Use	Inspected
Gravel Exists?	No
Asphalt	Inspected
Condition	4 - Between Fair and Poor

Adelphi Street	
Violations	No violations recorded.
Pavers	Inspected
Condition	2 - Between Good and Fair
Deficiency	DAMAGED/MISSING
Deficiency Location/Instance	Adelphi Street
Deficiency Quantity	30
Quantity Uom	S.F.
Potential Action	REPLACE
Urgency of Action	PRIORITY 3
Purpose of Action	LEVEL 2
Deficiency Photo1

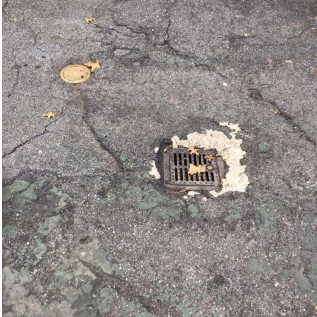
Violations	Schoolyard No violations recorded.
Deficiency	POTHoles
Deficiency Location/Instance	Schoolyard Near Exit 5
Deficiency Quantity	50
Quantity Uom	S.F.
Potential Action	REPAIR
Urgency of Action	PRIORITY 3
Purpose of Action	LEVEL 2

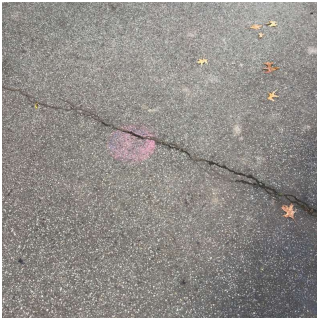
Schoolyard Near Exit 5
Violations	No violations recorded.
Concrete	Does not Exist
Pavers	Does not Exist
Site Sidewalks & Walkways	Inspected
Asphalt	Inspected
Condition	3 - Fair
Deficiency	CRACKS - MAJOR
Deficiency Location/Instance	Near Schoolyard
Deficiency Quantity	50
Quantity Uom	S.F.
Potential Action	REPLACE
Urgency of Action	PRIORITY 3
Purpose of Action	LEVEL 2
Deficiency Photo1

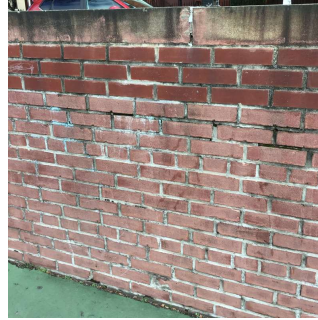
Schoolyard

BRICK: DETERIORATED JOINT AT COPING STONE
