NYC Department of Education
Building Condition Assessment Survey 2023 - 2024

Architectural Inspection

K022

Asset: P.S. 22 - BROOKLYN, 443 ST. MARKS AVENUE, New York, 11226

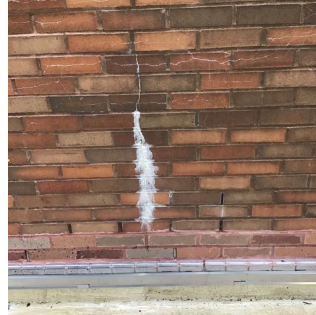
Facade J

BULKHEAD/PENTHOUSE WALLS/EXTERIOR: WATER INFILTRATION

100
S.F.
REPAIR
PRIORITY 5
LEVEL 2

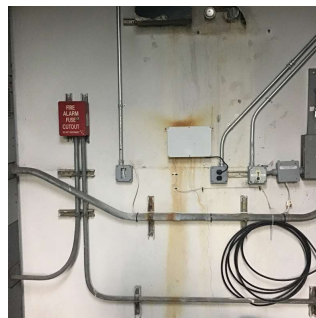
Basement - Electrical Room C18

CONCRETE: WATER INFILTRATION IN ELECTRICAL PANEL ROOM

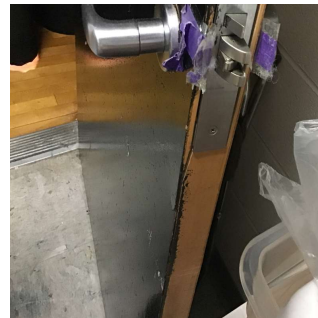
WOOD: DETERIORATED DOOR

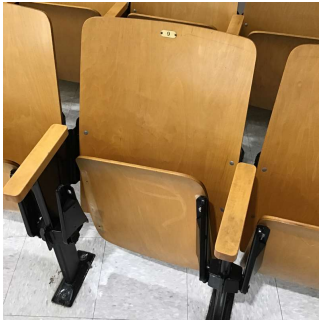
Question	Response
INTERIOR	
AUDITORIUM	
Door(s)	
Violations	Stage storage No violations recorded.
Fixed H/C Lift	
Instance on 2nd Floor (302 seats)	Inspected
Condition	2 - Between Good and Fair
Deficiency	No deficiencies recorded
Fixed Seating	
Instance on 2nd Floor (302 seats)	Inspected
Condition	3 - Fair
Deficiency	DAMAGED/BROKEN/INOPERABLE
Deficiency Location/Instance	Seat K/9
Deficiency Quantity	1
Quantity Uom	EACH
Potential Action	REPLACE
Urgency of Action	PRIORITY 5
Purpose of Action	LEVEL 6
Deficiency Photo1

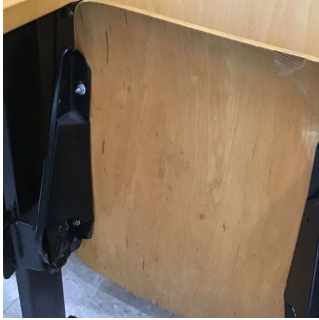
Violations	Seat K/9 No violations recorded.
Deficiency	DAMAGED/BROKEN/INOPERABLE
Deficiency Location/Instance	Seats L/1,8,16, K/2,3, and others
Deficiency Quantity	13
Quantity Uom	EACH
Potential Action	REPLACE
Urgency of Action	PRIORITY 3
Purpose of Action	LEVEL 2
Deficiency Photo1

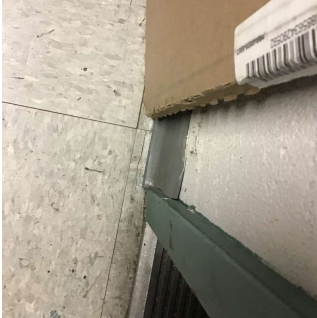
Question	Response
INTERIOR	
AUDITORIUM	
Floor Finish	
Condition	2 - Between Good and Fair
Deficiency	VINYL TILES: BROKEN/DETERIORATED/MISSING TILES
Deficiency Location/Instance	Stage storage, Entrance, near seat D/1
Deficiency Quantity	20
Quantity Uom	S.F.
Potential Action	REPLACE
Urgency of Action	PRIORITY 3
Purpose of Action	LEVEL 2
Deficiency Photo1

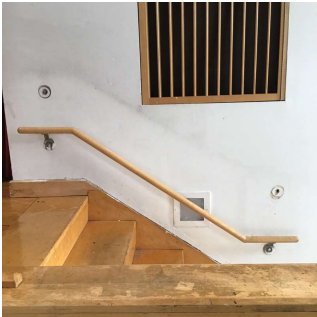
Violations	Stage storage No violations recorded.
Sliding-folding Partition	
Instance on 2nd Floor (302 seats)	Does not Exist
Stage	
Instance on 2nd Floor (302 seats)	Inspected
Stage	
Instance on 2nd Floor (302 seats)	Inspected
Condition	3 - Fair
Deficiency	RAILINGS/MISSING
Deficiency Location/Instance	Left side, right side
Deficiency Quantity	16
Quantity Uom	L.F.
Potential Action	REPLACE
Urgency of Action	PRIORITY 5
Purpose of Action	LEVEL 6
Deficiency Photo1

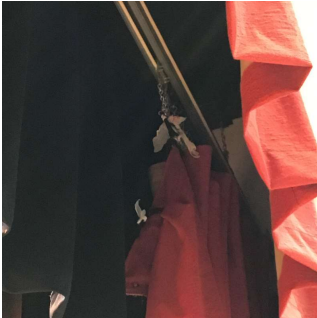
Question	Response
INTERIOR	
AUDITORIUM	
Stage	
Stage	
Quantity Uom	S.F.
Potential Action	REPLACE
Urgency of Action	PRIORITY 3
Purpose of Action	LEVEL 2
Deficiency Photo1	 
	Near center
Violations	No violations recorded.
Stage Curtain Rigging	Inspected
Instance on 2nd Floor (302 seats)	Inspected
Condition	3 - Fair
Deficiency	DAMAGED/DETERIORATED
Deficiency Location/Instance	Left side
Deficiency Quantity	1
Quantity Uom	EACH
Potential Action	REPLACE
Urgency of Action	PRIORITY 3
Purpose of Action	LEVEL 2
Deficiency Photo1

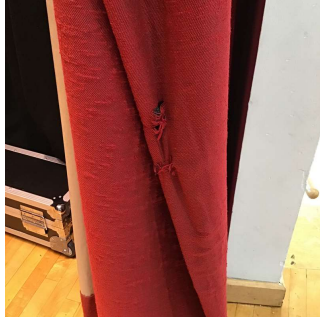
Left side
Violations	No violations recorded.
Stage Curtains	Inspected
Instance on 2nd Floor (302 seats)	Inspected
Condition	4 - Between Fair and Poor
Deficiency	WORN/DETERIORATED
Deficiency Location/Instance	Left side, right side
Deficiency Quantity	800
Quantity Uom	S.F.
Potential Action	REPLACE
Urgency of Action	PRIORITY 3
Purpose of Action	LEVEL 2

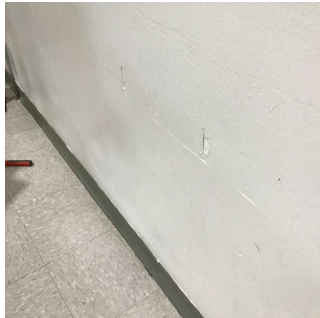
Left side
Violations	No violations recorded.
Walls	
Instance on 2nd Floor (302 seats)	Inspected
Condition	2 - Between Good and Fair
Deficiency	GYPSUM BOARD: DETERIORATED
Deficiency Location/Instance	Near stage, left side of stage, right side of stage
Deficiency Quantity	30
Quantity Uom	S.F.
Potential Action	REPLACE
Urgency of Action	PRIORITY 3
Purpose of Action	LEVEL 2
Deficiency Photo1

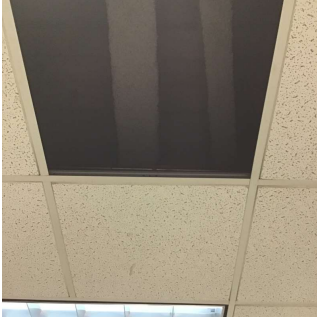
Near stage
Violations	No violations recorded.
Window Curtains/Shades/Blinds	
Instance on 2nd Floor (302 seats)	Inspected
Condition	2 - Between Good and Fair
Deficiency	No deficiencies recorded
CAFETERIA	
Instance on 1st Floor - staff	Inspected
Instance on 1st Floor - student	Inspected
Ceiling	
Instance on 1st Floor - staff	Inspected
Condition	2 - Between Good and Fair
Deficiency	ACOUSTIC TILES: DAMAGED/MISSING
Deficiency Location/Instance	Near Servery

Question	Response
INTERIOR	
CAFETERIA	
Ceiling	
Potential Action	REPLACE
Urgency of Action	PRIORITY 3
Purpose of Action	LEVEL 2
Deficiency Photo1

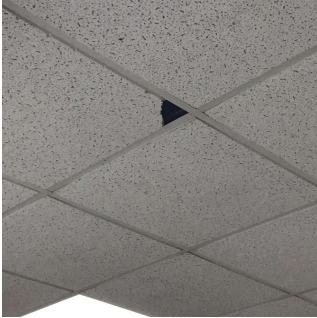
Near Servery
Violations	No violations recorded.
Instance on 1st Floor - student	Inspected
Condition	2 - Between Good and Fair
Deficiency	ACOUSTIC TILES: DAMAGED/MISSING
Deficiency Location/Instance	Near water fountain, exit
Deficiency Quantity	10
Quantity Uom	S.F.
Potential Action	REPLACE
Urgency of Action	PRIORITY 3
Purpose of Action	LEVEL 2
Deficiency Photo1

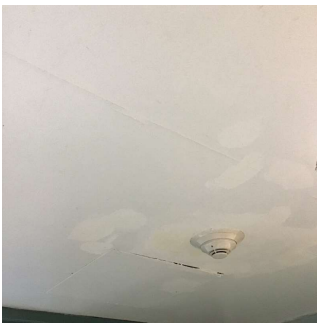
Near water fountain
Violations	No violations recorded.
Deficiency	GYPSUM BOARD: DAMAGED/DETERIORATED
Deficiency Location/Instance	Near Entrance, center, windows, Servery
Deficiency Quantity	50
Quantity Uom	S.F.
Potential Action	REPLACE
Urgency of Action	PRIORITY 3
Purpose of Action	LEVEL 2

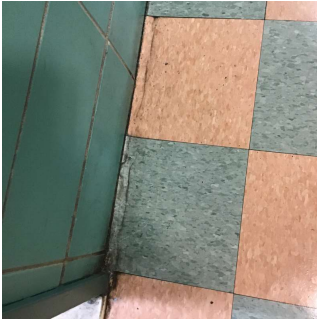
Near Entrance
Violations	No violations recorded.
Door(s)	
Instance on 1st Floor - staff	Inspected
Condition	2 - Between Good and Fair
Deficiency	No deficiencies recorded
Instance on 1st Floor - student	Inspected
Condition	2 - Between Good and Fair
Deficiency	No deficiencies recorded
Fixed Equipment	
Instance on 1st Floor - staff	Does not Exist
Instance on 1st Floor - student	Does not Exist
Floor Finish	
Instance on 1st Floor - student	Inspected
Condition	2 - Between Good and Fair
Deficiency	VINYL TILES: BROKEN/DETERIORATED/MISSING TILES
Deficiency Location/Instance	Near Entrance, water fountains, windows, center, exit 3, and others
Deficiency Quantity	100
Quantity Uom	S.F.
Potential Action	REPLACE
Urgency of Action	PRIORITY 3
Purpose of Action	LEVEL 2
Deficiency Photo1

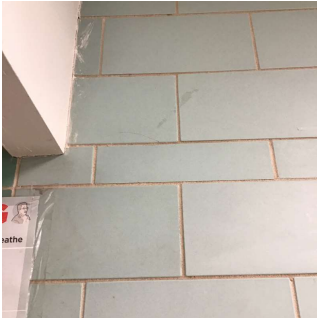
Question	Response
INTERIOR	
CAFETERIA	
Stage	
Instance on 1st Floor - student	Does not Exist
Walls	
Instance on 1st Floor - student	Inspected
Condition	2 - Between Good and Fair
Deficiency	GLAZED BLOCK: CRACKS/SPALLING
Deficiency Location/Instance	Near water fountain, kitchen
Deficiency Quantity	10
Quantity Uom	S.F.
Potential Action	REPLACE
Urgency of Action	PRIORITY 3
Purpose of Action	LEVEL 2
Deficiency Photo1

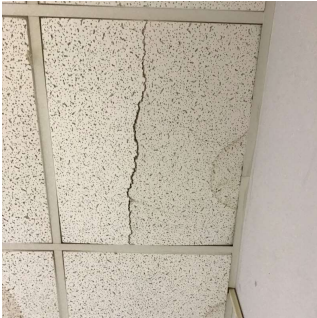
Room 236

Near water fountain
Violations	No violations recorded.
Window Curtains/Shades/Blinds	
Instance on 1st Floor - staff	Does not Exist
Instance on 1st Floor - student	Does not Exist
CLASSROOMS/CORRIDORS/ADMIN SPACES	
Ceiling	Inspected
Condition	2 - Between Good and Fair
Deficiency	ACOUSTIC TILES: DAMAGED/MISSING
Deficiency Location/Instance	Rooms 236,148,140A
Deficiency Quantity	20
Quantity Uom	S.F.
Potential Action	REPLACE
Urgency of Action	PRIORITY 3
Purpose of Action	LEVEL 2
Deficiency Photo1

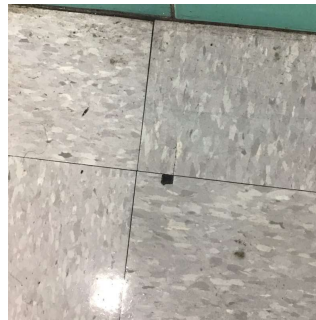
Corridor near Room 448

VINYL TILES: BROKEN/DETERIORATED/MISSING TILES

REPLACE

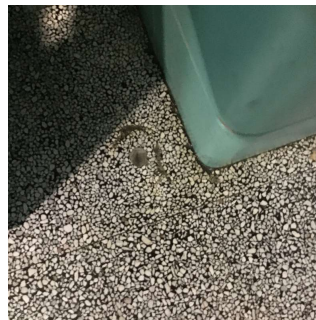
CERAMIC TILE: BROKEN/MISSING TILES

REPLACE

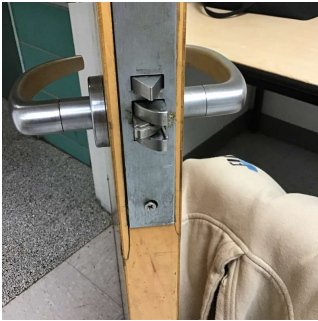
Question	Response
INTERIOR	
GYMNASIUM	
Door(s)	
Deficiency Photo1

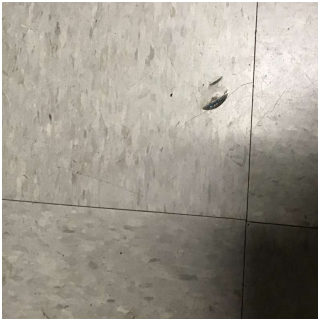
Room 111B
Violations	No violations recorded.
Fixed Equipment	
Instance on 1st Floor	Inspected
Condition	2 - Between Good and Fair
Deficiency	No deficiencies recorded
Floor Finish	
Instance on 1st Floor	Inspected
Condition	2 - Between Good and Fair
Deficiency	VINYL TILES: BROKEN/DETERIORATED/MISSING TILES
Deficiency Location/Instance	Storage
Deficiency Quantity	10
Quantity Uom	S.F.
Potential Action	REPLACE
Urgency of Action	PRIORITY 3
Purpose of Action	LEVEL 2
Deficiency Photo1

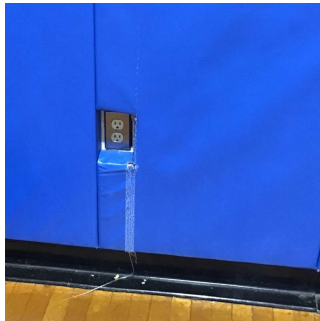
Question	Response
INTERIOR	
GYMNASIUM	
Walls	
Deficiency Photo1

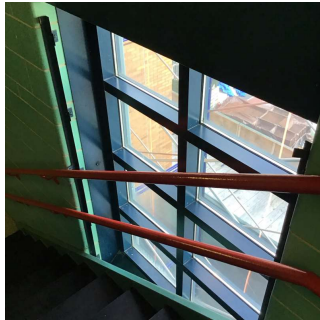
Violations	Near Windows No violations recorded.
Window Curtains/Shades/Blinds	
Instance on 1st Floor	Does not Exist
INTERIOR DOOR HARDWARE	
Condition	Inspected 3 - Fair
Deficiency	No deficiencies recorded
INTERIOR GUARDS	
Condition	Inspected 4 - Between Fair and Poor
Deficiency	DETERIORATED/TORN-OUT/MISSING
Deficiency Location/Instance	Stairs C/2,3, D/2,3, E/2, and others
Deficiency Quantity	300
Quantity Uom	S.F.
Potential Action	REPLACE
Urgency of Action	PRIORITY 3
Purpose of Action	LEVEL 2
Deficiency Photo1

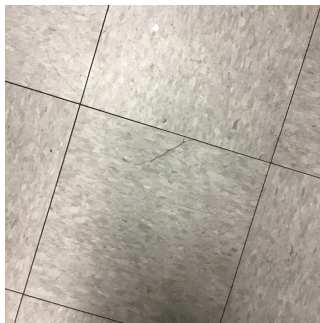
Question	Response
INTERIOR	
KITCHEN	
Floor Finish	
Deficiency Photo1

Violations	Room 101B No violations recorded.
Walls	
Instance on 1st Floor	Inspected
Condition	2 - Between Good and Fair
Deficiency	CERAMIC TILE: BROKEN/ MISSING
Deficiency Location/Instance	Near Windows
Deficiency Quantity	10
Quantity Uom	S.F.
Potential Action	REPLACE
Urgency of Action	PRIORITY 3
Purpose of Action	LEVEL 2
Deficiency Photo1

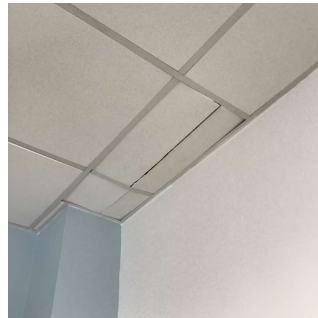
Deficiency	ACOUSTIC TILES: DAMAGED/MISSING
Deficiency Location/Instance	Near bookshelves
Deficiency Quantity	10
Quantity Uom	S.F.
Potential Action	REPLACE
Urgency of Action	PRIORITY 3
Purpose of Action	LEVEL 2
Deficiency Photo1

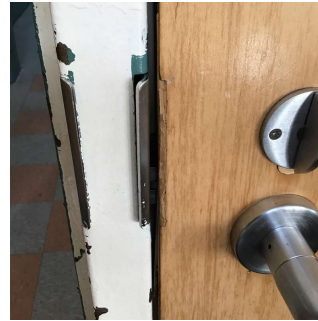
Instance on Room 424	Inspected
Condition	3 - Fair
Deficiency	WOOD: DETERIORATED DOOR
Deficiency Location/Instance	Entrance
Deficiency Quantity	1
Quantity Uom	EACH
Potential Action	MAINTENANCE
Urgency of Action	PRIORITY 3
Purpose of Action	LEVEL 2

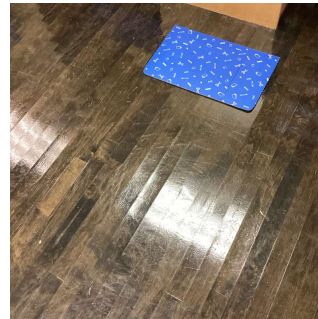
Left Side

WOOD: DAMAGED/DETERIORATED

REPLACE

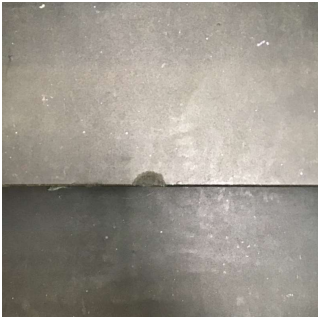
Question	Response
INTERIOR	
STAIRS/RAMPS: INTERIOR	
Door(s)	Inspected
Condition	2 - Between Good and Fair
Deficiency	No deficiencies recorded
Partition	Does not Exist
Railings	Inspected
Condition	2 - Between Good and Fair
Deficiency	No deficiencies recorded
Stairs and Landings	Inspected
Condition	2 - Between Good and Fair
Deficiency	CERAMIC TILE: BROKEN/MISSING
Deficiency Location/Instance	Stair B/1
Deficiency Quantity	10
Quantity Uom	S.F.
Potential Action	REPLACE
Urgency of Action	PRIORITY 3
Purpose of Action	LEVEL 2
Deficiency Photo1	 
Violations	Stair B/1 No violations recorded.
Deficiency	CONCRETE: CRACKS/SPALLING - MAJOR
Deficiency Location/Instance	Stair A/2, D/2
Deficiency Quantity	10
Quantity Uom	S.F.
Potential Action	REPLACE
Urgency of Action	PRIORITY 3
Purpose of Action	LEVEL 2
Deficiency Photo1

Violations	Stair A/2 No violations recorded.
Walls	Inspected
Condition	2 - Between Good and Fair
Deficiency	GLAZED BLOCK: CRACKS/SPALLING

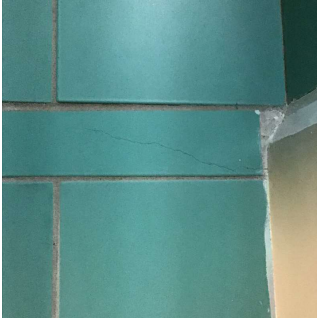
Question	Response
INTERIOR	
STAIRS/RAMPS: INTERIOR	
Walls	
Deficiency Location/Instance	Stair E/1,3
Deficiency Quantity	10
Quantity Uom	S.F.
Potential Action	REPLACE
Urgency of Action	PRIORITY 3
Purpose of Action	LEVEL 2
Deficiency Photo1

Stair E/1
Violations	No violations recorded.
TOILET ROOMS - STAFF	
	Inspected
Ceiling	
	Inspected
Condition	2 - Between Good and Fair
Deficiency	No deficiencies recorded
Door(s)	
	Inspected
Condition	4 - Between Fair and Poor
Deficiency	WOOD: DETERIORATED DOOR
Deficiency Location/Instance	Room 430
Deficiency Quantity	1
Quantity Uom	EACH
Potential Action	MAINTENANCE
Urgency of Action	PRIORITY 3
Purpose of Action	LEVEL 2
Deficiency Photo1

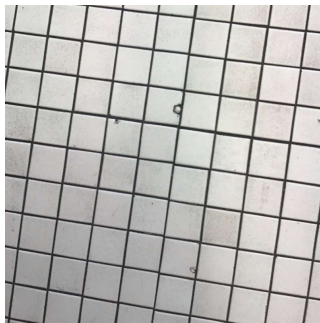
Violations	Room 420 No violations recorded.
Floor Finish	
Condition	Inspected 2 - Between Good and Fair
Deficiency	CERAMIC TILE: BROKEN/MISSING TILES
Deficiency Location/Instance	Rooms 420,410,320,310,213, and others
Deficiency Quantity	50
Quantity Uom	S.F.
Potential Action	REPLACE
Urgency of Action	PRIORITY 3
Purpose of Action	LEVEL 2

Violations	Room 420 No violations recorded.
Stalls	Inspected
Condition	2 - Between Good and Fair
Deficiency	No deficiencies recorded
Walls	Inspected
Condition	2 - Between Good and Fair
Deficiency	CERAMIC TILE: BROKEN/ MISSING
Deficiency Location/Instance	Rooms 420,410,346,248A
Deficiency Quantity	20
Quantity Uom	S.F.
Potential Action	REPLACE
Urgency of Action	PRIORITY 3
Purpose of Action	LEVEL 2
Deficiency Photo1

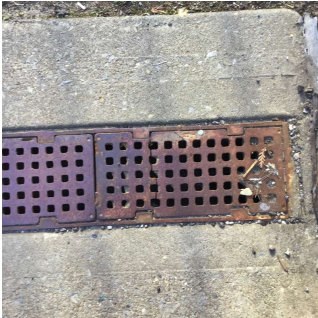
Violations	containerization area No violations recorded.
Drainage System for Asphalt	Inspected
Catch Basins/Manhole - Surrounded by asphalt	Inspected
Condition	2 - Between Good and Fair
Deficiency	No deficiencies recorded
Culverts - Asphalt Covering	Does not Exist
Drainage System for Concrete	Inspected
Catch Basins/Manhole - Surrounded by concrete	Inspected
Condition	3 - Fair
Deficiency	DAMAGED COVER
Deficiency Location/Instance	Ramp near Schoolyard
Deficiency Quantity	1
Quantity Uom	EACH
Potential Action	REPLACE
Urgency of Action	PRIORITY 3
Purpose of Action	LEVEL 2
Deficiency Photo1

Violations	Ramp near Schoolyard No violations recorded.

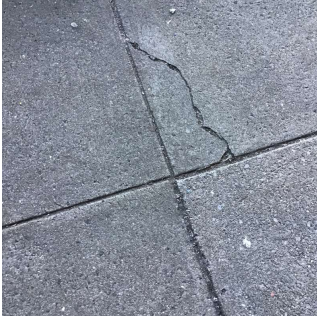
Question	Response
SITE	
PAVING	
Student Non-Use	
Concrete	
Deficiency Photo1	 
Violations	Near containerization area No violations recorded.
Pavers	Does not Exist
Student Use	Inspected
Gravel Exists?	No
Asphalt	Inspected
Condition	3 - Fair
Deficiency	CRACKS - MAJOR
Deficiency Location/Instance	Schoolyard
Deficiency Quantity	50
Quantity Uom	S.F.
Potential Action	REPLACE
Urgency of Action	PRIORITY 3
Purpose of Action	LEVEL 2
Deficiency Photo1	 
Violations	Schoolyard No violations recorded.
Concrete	Inaccessible
Pavers	Does not Exist
Site Sidewalks & Walkways	Inspected
Asphalt	Does not Exist
Concrete	Inspected
Condition	3 - Fair
Deficiency	DAMAGED/DETERIORATED/MISSING SECTIONS
Deficiency Location/Instance	Near exit 7, exit 8, exit 9, exit 10
Deficiency Quantity	350
Quantity Uom	S.F.
Potential Action	REPLACE

Near exit 9
Violations	No violations recorded.
Pavers	Does not Exist
DOT Sidewalk	Inspected
Asphalt	Does not Exist
Concrete	Inspected
Condition	4 - Between Fair and Poor
Deficiency	DAMAGED/DETERIORATED/MISSING SECTIONS
Deficiency Location/Instance	Along Classon Avenue, St Marks Avenue
Deficiency Quantity	725
Quantity Uom	S.F.
Potential Action	REPLACE
Urgency of Action	PRIORITY 3
Purpose of Action	LEVEL 2
Deficiency Photo1

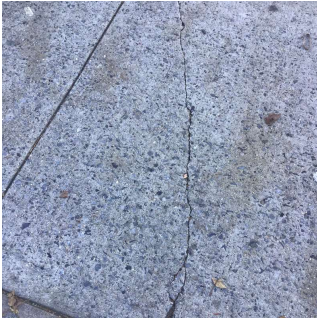
Along Classon Avenue
Violations	No violations recorded.
Deficiency	DAMAGED CURBS
Deficiency Location/Instance	Along Classon Avenue, St Marks Avenue
Deficiency Quantity	40
Quantity Uom	L.F.
Potential Action	REPLACE
Urgency of Action	PRIORITY 3
Purpose of Action	LEVEL 2

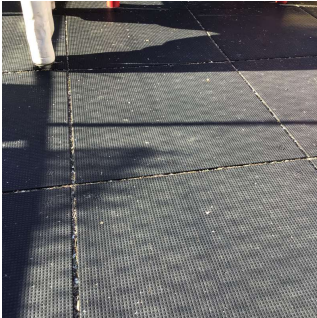
Question	Response
SITE	
PLAYGROUNDS	
Safety Surfacing	
Deficiency	DETERIORATED/MISSING
Deficiency Location/Instance	Schoolyard
Deficiency Quantity	200
Quantity Uom	S.F.
Potential Action	MAINTENANCE
Urgency of Action	PRIORITY 3
Purpose of Action	LEVEL 2
Deficiency Photo1

Violations	Schoolyard No violations recorded.
Unpaved Area	
Instance on West Schoolyard	Does not Exist
PLAYING SURFACE	
	Does not Exist
RETAINING WALLS	
Are there any Retaining Walls 6' OR higher facing public street/sidewalk?	Inspected No
Condition	3 - Fair
Deficiency	CAST IN PLACE CONCRETE: CRACKS/SPALLING - MAJOR
Deficiency Location/Instance	Schoolyard
Deficiency Quantity	50
Quantity Uom	S.F.
Potential Action	REPLACE
Urgency of Action	PRIORITY 3
Purpose of Action	LEVEL 2
Deficiency Photo1

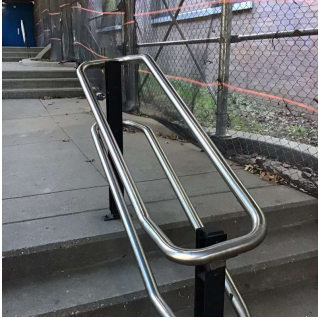
Question	Response
SITE	
SEATING	Inspected
Benches	Inspected
Metal/Wood/Plastic	
Condition	2 - Between Good and Fair
Deficiency	No deficiencies recorded
Bleachers	Does not Exist
SITE WALLS (NOT RETAINING WALLS)	Inspected
Condition	3 - Fair
Deficiency	BRICK: BULGING/DISPLACED
Deficiency Location/Instance	Along St Marks Avenue, Classon Avenue
Deficiency Quantity	50
Quantity Uom	S.F.
Potential Action	REPLACE
Urgency of Action	PRIORITY 3
Purpose of Action	LEVEL 2
Deficiency Photo1	 
Violations	Along St Marks Avenue No violations recorded.
STAIRS/RAMPS: EXTERIOR	Inspected
Railings	Inspected
Condition	3 - Fair
Deficiency	DAMAGED
Deficiency Location/Instance	Near exit 10
Deficiency Quantity	10
Quantity Uom	L.F.
Potential Action	REPLACE
Urgency of Action	PRIORITY 3
Purpose of Action	LEVEL 2
Deficiency Photo1

Violations	Near exit 10 No violations recorded.
Site Cheek/flank Walls	Inspected
Condition	2 - Between Good and Fair
