NYC Department of Education
Building Condition Assessment Survey 2023 - 2024

Architectural Inspection

Asset: P.S. 23 - BROOKLYN, 545 WILLOUGHBY AVENUE, New York, 11206

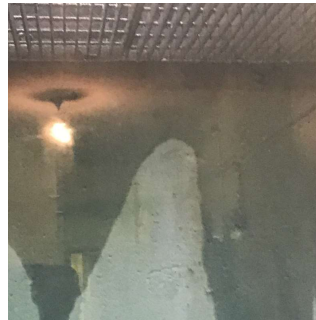
AW2
No violations recorded.

**AREAWAY GRATINGS: MAJOR RUSTING AND / OR BROKEN
SUPPORTS**

20
L.F.
REPLACE
PRIORITY 4
LEVEL 2

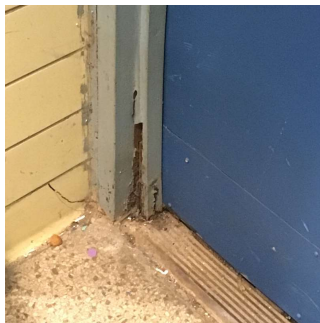
METAL CLAD: DETERIORATED DOOR AND FRAME - MAJOR DETERIORATION

Violations	Facade G No violations recorded.
DOOR HARDWARE	Inspected
Condition	3 - Fair
Deficiency	No deficiencies recorded
LINTELS	Inspected
Condition	2 - Between Good and Fair
Deficiency	No deficiencies recorded
TRANSOM/SIDE LIGHT	Inspected
Condition	2 - Between Good and Fair
Deficiency	No deficiencies recorded
EXTERIOR WALLS	Inspected
Material Type(s)	Concrete, Masonry
Replacement Quantity	26,000
Replacement Uom	S.F.
Instance on All Facades	Under Construction
Instance Quantity	26,000
Instance Quantity Uom	S.F.
EXTERIOR SOFFITS	Inspected
Condition	3 - Fair
Deficiency	STUCCO/PLASTER: MINOR CRACKS/SPALLING
Roof Plan reference

5
EACH
REPLACE
PRIORITY 4
LEVEL 2

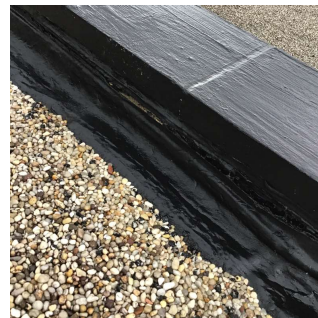
BUILT-UP: FLASHING: BASE FLASHING DETERIORATED

REMOVE AND REPLACE

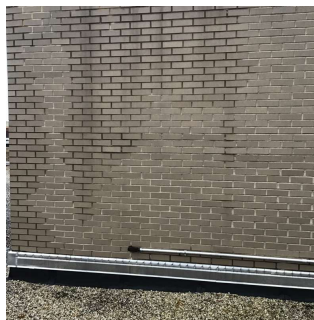
Bulk Head 1
No violations recorded.

BULKHEAD/PENTHOUSE WALLS/EXTERIOR: DETERIORATED JOINTS

100
S.F.
REPOINT
PRIORITY 3
LEVEL 2

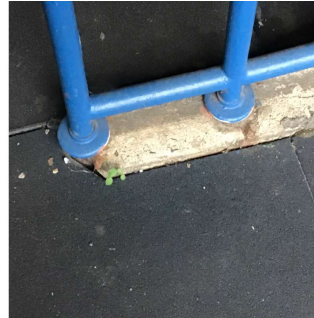
Facade F - Exterior Ramp

CAST IN PLACE CONCRETE: CRACKS/SPALLING - MAJOR

S.F.
REPLACE
PRIORITY 4
LEVEL 2

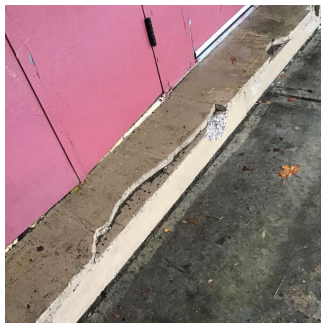
STONE: CRACKS/SPALLING - MAJOR

Violations	Exit 3 facing schoolyard 35671949L
WINDOWS	Inspected
Replacement Quantity	12,000
Replacement Uom	S.F.
EXTERIOR GUARDS	Inspected
Condition	2 - Between Good and Fair
Deficiency	No deficiencies recorded
LINTELS	Inspected
Condition	2 - Between Good and Fair
Deficiency	No deficiencies recorded
WINDOWS	Inspected
Material Type(s)	Aluminum
Instance on Aluminum - Double Hung: All Facades	Inspected
Instance Condition	3 - Fair
Instance Quantity	12,000
Instance Quantity Uom	S.F.
Are these windows insulated	Yes
Installation Year	2006
Source of Installation	Custodial Staff
Deficiency	No deficiencies recorded
INTERIOR	Inspected
POOLS	Does not Exist
STRUCTURAL	Inspected
COLUMNS/BEAMS/BEARING WALLS	Inspected
Condition	3 - Fair
Deficiency	CONCRETE COLUMNS/BEAMS: CRACKED/SPALLED/REINFORCEMENT EXPOSED
Deficiency Location/Instance	Basement - Room B18 and B20, Boiler Room

10
S.F.
REPLACE
PRIORITY 5
LEVEL 6

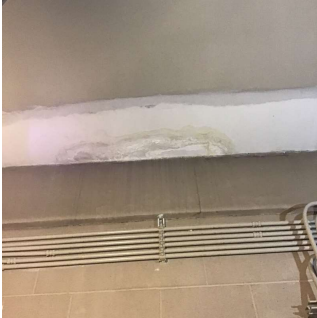
Question	Response
INTERIOR	
AUDITORIUM	
Ceiling	
Quantity Uom	S.F.
Potential Action	REPLACE
Urgency of Action	PRIORITY 3
Purpose of Action	LEVEL 2
Deficiency Photo1

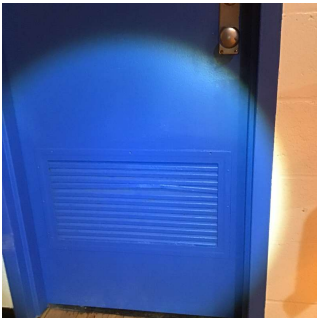
Storage Room
Violations	No violations recorded.
Door(s)	
Instance on 1st Floor (208 Seats)	Inspected
Condition	3 - Fair
Deficiency	METAL: DAMAGED LOUVER
Deficiency Location/Instance	Storage Room
Deficiency Quantity	1
Quantity Uom	EACH
Potential Action	MAINTENANCE
Urgency of Action	PRIORITY 3
Purpose of Action	LEVEL 2
Deficiency Photo1

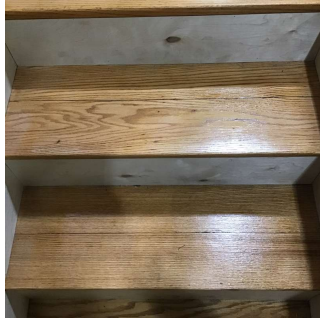
Question	Response
INTERIOR	
AUDITORIUM	
Sliding-folding Partition	
Instance on 1st Floor (208 Seats)	Not Required
Stage	
Instance on 1st Floor (208 Seats)	Inspected
Stage	Inspected
Instance on 1st Floor (208 Seats)	Inspected
Condition	2 - Between Good and Fair
Deficiency	DAMAGED FLOOR
Deficiency Location/Instance	Right and Left Side
Deficiency Quantity	20
Quantity Uom	S.F.
Potential Action	REPLACE
Urgency of Action	PRIORITY 3
Purpose of Action	LEVEL 2
Deficiency Photo1

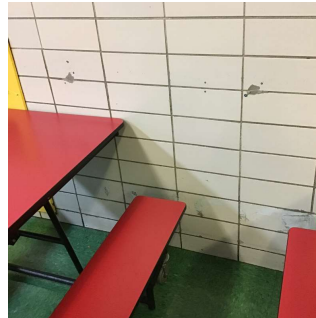
Rear Near Windows

SALT GLAZED BRICK: CRACKS/SPALLING

REPLACE

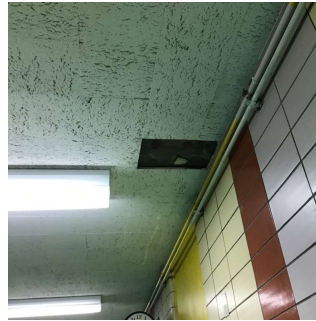
Corridor near Room 104

ACOUSTIC TILES ON PLASTER: DAMAGED/MISSING

REPLACE

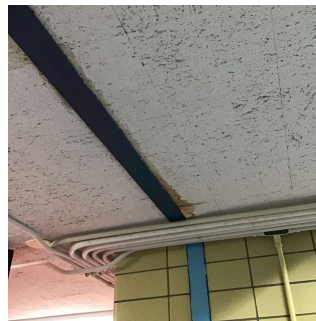
Corridor near Room 228

ACOUSTIC TILES: DAMAGED/MISSING - ACTIVE LEAK

REPLACE

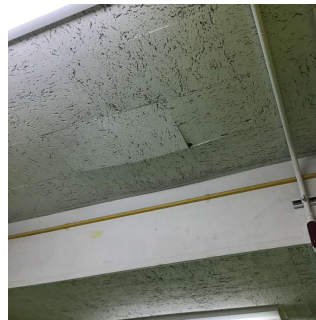
Corridor near Room 118

ACOUSTIC TILES: DAMAGED/MISSING

REPLACE

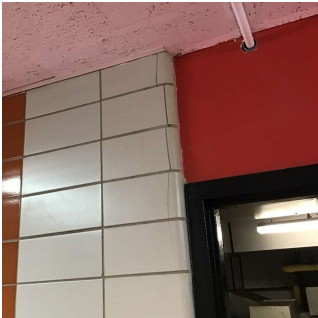
Question	Response
INTERIOR	
CLASSROOMS/CORRIDORS/ADMIN SPACES	
Walls	
Violations	Room 232 No violations recorded.
Deficiency	GLAZED BLOCK: CRACKS/SPALLING
Deficiency Location/Instance	Corridor near Rooms 237, 235, 230, 120, 117 and others
Deficiency Quantity	100
Quantity Uom	S.F.
Potential Action	REPLACE
Urgency of Action	PRIORITY 3
Purpose of Action	LEVEL 2
Deficiency Photo1

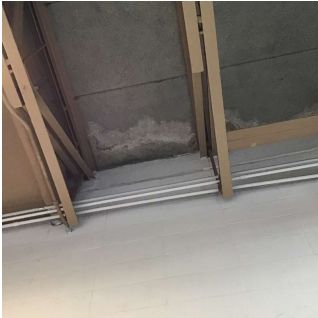
Violations	Corridor near Room 235 No violations recorded.
Specialties	Does not Exist
GYMNASIUM	
Instance on 1st Floor	Inspected
Ceiling	Inspected
Instance on 1st Floor	Inspected
Condition	3 - Fair
Deficiency	TECTUM: DAMAGED/MISSING - ACTIVE LEAK
Deficiency Location/Instance	Near Entrance, Near Windows, Center, Left And Right side
Deficiency Quantity	200
Quantity Uom	S.F.
Potential Action	REPLACE
Urgency of Action	PRIORITY 5
Purpose of Action	LEVEL 2
Deficiency Photo1

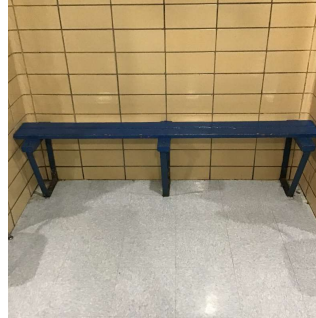
Deficiency	DAMAGED FIXED SEATING
Deficiency Location/Instance	Near Entrance
Deficiency Quantity	1
Quantity Uom	EACH
Potential Action	REPLACE
Urgency of Action	PRIORITY 3
Purpose of Action	LEVEL 2
Deficiency Photo1

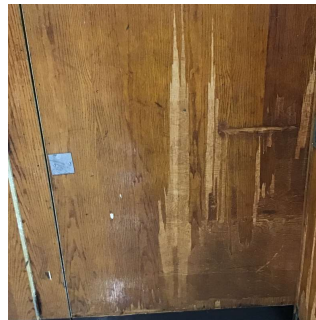
Instance on 1st Floor	Inspected
Condition	3 - Fair
Deficiency	MOVABLE PANELS: DAMAGED
Deficiency Location/Instance	Main Entrance
Deficiency Quantity	40
Quantity Uom	S.F.
Potential Action	REPLACE
Urgency of Action	PRIORITY 3
Purpose of Action	LEVEL 2
Deficiency Photo1

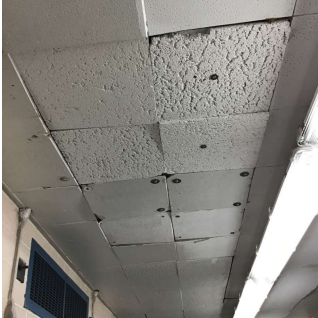
Question	Response
INTERIOR	
GYMNASIUM	
Walls	
Quantity Uom	S.F.
Potential Action	REPLACE
Urgency of Action	PRIORITY 3
Purpose of Action	LEVEL 2
Deficiency Photo1	 
Violations	Near Windows No violations recorded.
Window Curtains/Shades/Blinds	
Instance on 1st Floor	Does not Exist
INTERIOR DOOR HARDWARE	
Condition	Inspected
Deficiency	3 - Fair
Deficiency	No deficiencies recorded
INTERIOR GUARDS	
Condition	Inspected
Deficiency	2 - Between Good and Fair
Deficiency	No deficiencies recorded
KITCHEN	
Instance on 1st Floor	Inspected
Ceiling	
Instance on 1st Floor	Inspected
Condition	4 - Between Fair and Poor
Deficiency	ACOUSTIC TILES ON PLASTER: DAMAGED/MISSING
Deficiency Location/Instance	Near Windows
Deficiency Quantity	20
Quantity Uom	S.F.
Potential Action	REPLACE
Urgency of Action	PRIORITY 5
Purpose of Action	LEVEL 6
Deficiency Photo1	 
Violations	Near Windows No violations recorded.
Deficiency	ACOUSTIC TILES ON PLASTER: DAMAGED/MISSING

Question	Response
INTERIOR	
KITCHEN	
Ceiling	
Deficiency Location/Instance	Main Entrance, Rear, Prep area, Right and Left Side
Deficiency Quantity	60
Quantity Uom	S.F.
Potential Action	REPLACE
Urgency of Action	PRIORITY 3
Purpose of Action	LEVEL 2
Deficiency Photo1

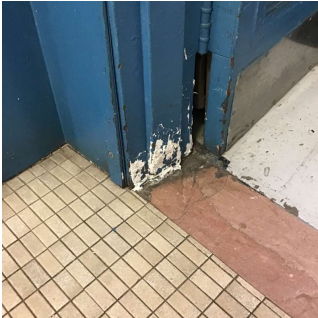
Violations	Main Entrance No violations recorded.
Door(s)	
Instance on 1st Floor	Inspected
Condition	5 - Poor
Deficiency	METAL: DETERIORATED DOOR AND FRAME
Deficiency Location/Instance	Vestibule Exit 12, Storage Room, mop Room
Deficiency Quantity	3
Quantity Uom	EACH
Potential Action	MAINTENANCE
Urgency of Action	PRIORITY 3
Purpose of Action	LEVEL 2
Deficiency Photo1

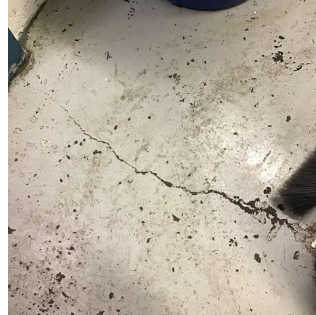
Mop Room

Violations	Vestibule Exit 12 No violations recorded.
Floor Finish	
Instance on 1st Floor	Inspected
Condition	3 - Fair
Deficiency	CONCRETE: CRACKS
Deficiency Location/Instance	Mop Room, Storage Room
Deficiency Quantity	20
Quantity Uom	S.F.
Potential Action	REPLACE
Urgency of Action	PRIORITY 3

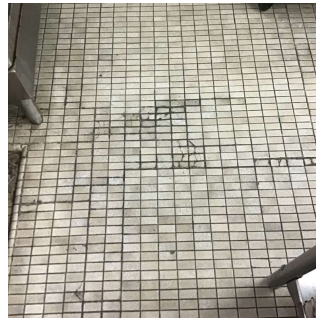
Rear

Deficiency	CERAMIC TILE: BROKEN/MISSING TILES
Deficiency Location/Instance	Prep area, Rear, Left Side
Deficiency Quantity	20
Quantity Uom	S.F.
Potential Action	REPLACE
Urgency of Action	PRIORITY 3
Purpose of Action	LEVEL 2
Deficiency Photo1

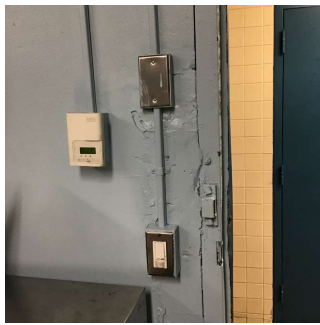
Instance on 1st Floor	Inspected
Condition	2 - Between Good and Fair
Deficiency	PLASTER: CRACKS/SPALLING
Deficiency Location/Instance	Storage Room
Deficiency Quantity	10
Quantity Uom	S.F.
Potential Action	REPLACE
Urgency of Action	PRIORITY 3
Purpose of Action	LEVEL 2

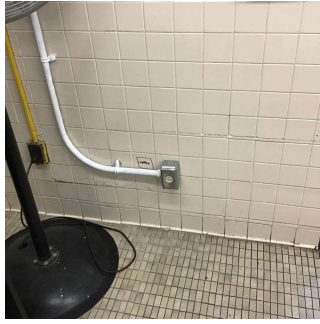
Storage Room
Violations	No violations recorded.
Deficiency	CERAMIC TILE: BROKEN/ MISSING
Deficiency Location/Instance	Main Entrance
Deficiency Quantity	10
Quantity Uom	S.F.
Potential Action	REPLACE
Urgency of Action	PRIORITY 3
Purpose of Action	LEVEL 2
Deficiency Photo1

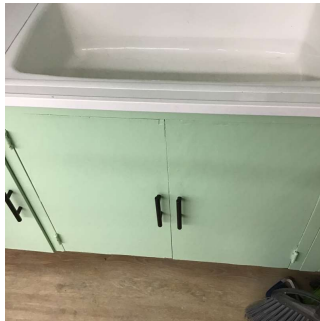
Main Entrance
Violations	No violations recorded.
LIBRARY	Inspected
Instance on Room 207	Inspected
Built-in Furnishing	
Instance on Room 207	Inspected
Condition	2 - Between Good and Fair
Deficiency	SINK/STORAGE CABINET - DAMAGED/DETERIORATED
Deficiency Location/Instance	Left Side
Deficiency Quantity	10
Quantity Uom	L.F.
Potential Action	REPLACE
Urgency of Action	PRIORITY 3
Purpose of Action	LEVEL 2

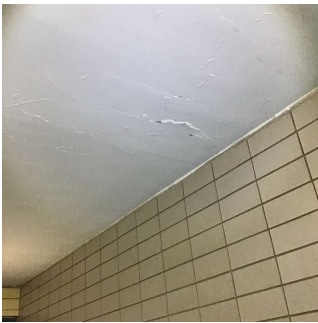
Question	Response
INTERIOR	
SCIENCE LAB	Does not Exist
SCIENCE PREP ROOM	Does not Exist
SHOWER ROOM	Does not Exist
STAIRS/RAMPS: INTERIOR	Inspected
Do Letter Stair Signs Exist?	Yes
Ceiling	Inspected
Condition	2 - Between Good and Fair
Deficiency	PLASTER: CRACKS/SPALLING
Deficiency Location/Instance	Stairs A/3, B/3
Deficiency Quantity	20
Quantity Uom	S.F.
Potential Action	REPLACE
Urgency of Action	PRIORITY 3
Purpose of Action	LEVEL 2
Deficiency Photo1

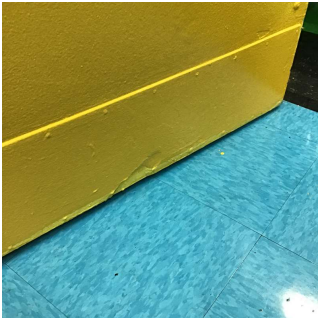
Violations	Stair A/3 No violations recorded.
Door(s)	Inspected
Condition	3 - Fair
Deficiency	METAL: DETERIORATED DOOR
Deficiency Location/Instance	Stairs C/1, D/1
Deficiency Quantity	2
Quantity Uom	EACH
Potential Action	MAINTENANCE
Urgency of Action	PRIORITY 3
Purpose of Action	LEVEL 2
Deficiency Photo1

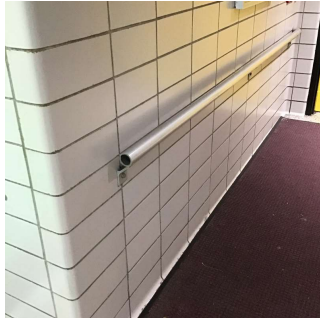
Question	Response
INTERIOR	
STAIRS/RAMPS: INTERIOR	
Railings	
Deficiency	METAL: DAMAGED
Deficiency Location/Instance	Corridor near Exit 2, Corridor near 108
Deficiency Quantity	20
Quantity Uom	L.F.
Potential Action	REPLACE
Urgency of Action	PRIORITY 5
Purpose of Action	LEVEL 6
Deficiency Photo1

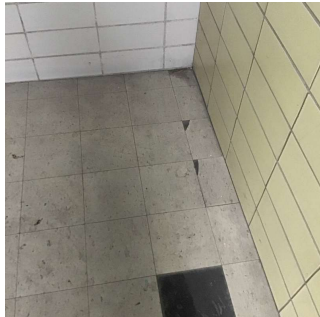
Violations	Corridor near Exit 2 No violations recorded.
Stairs and Landings	Inspected
Condition	2 - Between Good and Fair
Deficiency	VINYL TILES: BROKEN/DETERIORATED/MISSING TILES
Deficiency Location/Instance	Stairs C/Bulkhead, 3, 2, D/Bulkhead
Deficiency Quantity	40
Quantity Uom	S.F.
Potential Action	REPLACE
Urgency of Action	PRIORITY 3
Purpose of Action	LEVEL 2
Deficiency Photo1

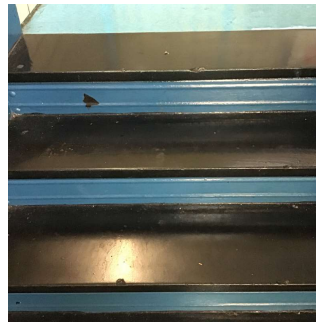
Stair B/3

Violations	Stair C/Bulkhead No violations recorded.
Deficiency	STONE: BROKEN/MISSING
Deficiency Location/Instance	Stairs A/2, 1, B/3, 2, 1 and others
Deficiency Quantity	60
Quantity Uom	S.F.
Potential Action	REPLACE
Urgency of Action	PRIORITY 3

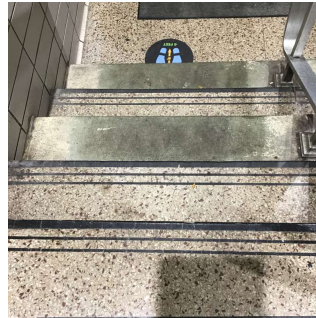
Vestibule Exit 2

TERRAZZO: CRACKS

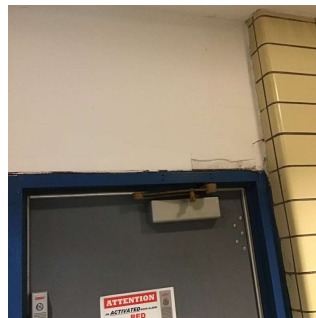
PLASTER: CRACKS/SPALLING

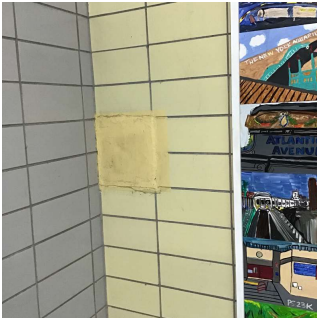
Question	Response
INTERIOR	
STAIRS/RAMPS: INTERIOR	
Walls	
Violations	Stair C/1 Vestibule No violations recorded.
Deficiency	GLAZED BLOCK: CRACKS/SPALLING
Deficiency Location/Instance	Stairs A/1, B/2, C/1, D/3
Deficiency Quantity	40
Quantity Uom	S.F.
Potential Action	REPLACE
Urgency of Action	PRIORITY 3
Purpose of Action	LEVEL 2
Deficiency Photo1

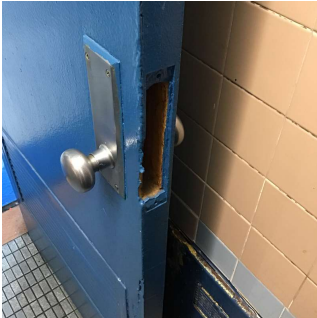
Violations	Stair B/2 No violations recorded.
TOILET ROOMS - STAFF	
Ceiling	Inspected
Condition	2 - Between Good and Fair
Deficiency	No deficiencies recorded
Door(s)	Inspected
Condition	5 - Poor
Deficiency	WOOD: DETERIORATED DOOR
Deficiency Location/Instance	Rooms 323, 321, 221, 127, 123
Deficiency Quantity	5
Quantity Uom	EACH
Potential Action	MAINTENANCE
Urgency of Action	PRIORITY 3
Purpose of Action	LEVEL 2
Deficiency Photo1

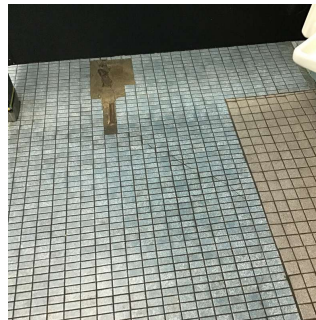
Room 115

CERAMIC TILE: DETERIORATED SUBSTRATE

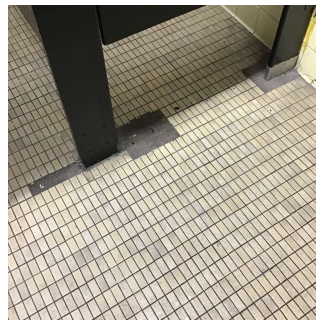
CERAMIC TILE: BROKEN/MISSING TILES

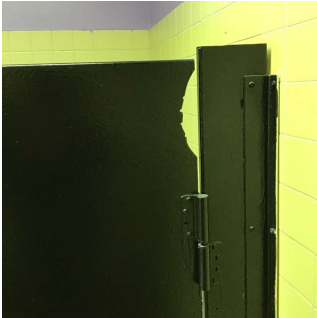
Question	Response
INTERIOR	
TOILET ROOMS - STUDENTS	
Floor Finish	Inspected
	Room 117
Violations	No violations recorded.
Stalls	Inspected
Condition	5 - Poor
Deficiency	BROKEN/MISSING
Deficiency Location/Instance	Room 117
Deficiency Quantity	1
Quantity Uom	EACH
Potential Action	REPLACE
Urgency of Action	PRIORITY 3
Purpose of Action	LEVEL 2
Deficiency Photo1

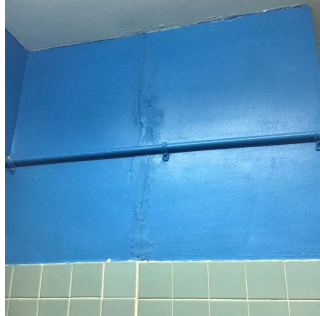
Room 117
Violations	No violations recorded.
Walls	Inspected
Condition	2 - Between Good and Fair
Deficiency	PLASTER: CRACKS/SPALLING
Deficiency Location/Instance	Room 211
Deficiency Quantity	10
Quantity Uom	S.F.
Potential Action	REPLACE

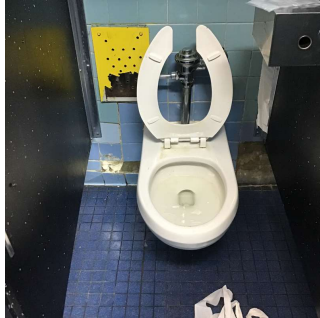
Room 211
Violations	No violations recorded.
Deficiency	CERAMIC TILE: BROKEN/ MISSING
Deficiency Location/Instance	Rooms 217, 211, 117, 115
Deficiency Quantity	40
Quantity Uom	S.F.
Potential Action	REPLACE
Urgency of Action	PRIORITY 3
Purpose of Action	LEVEL 2
Deficiency Photo1

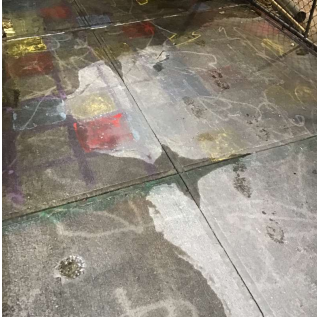
Question	Response
SITE	
Drainage System for Concrete	
Catch Basins/Manhole - Surrounded by concrete	Inspected
Purpose of Action	LEVEL 2
Deficiency Photo1	No photo recorded
Violations	No violations recorded.
Culverts - Concrete Covering	Does not Exist
Drainage System for Soil	Does not Exist
DRINKING FOUNTAINS	Does not Exist
FENCES	Inaccessible
IRRIGATION SYSTEM	Does not Exist
PAVING	Inspected
Student Non-Use	Inspected
Gravel Exists?	No
Asphalt	Does not Exist
Concrete	Inspected
Condition	3 - Fair
Deficiency	CRACKS - MAJOR
Deficiency Location/Instance	Vernon Avenue
Deficiency Quantity	50
Quantity Uom	S.F.
Potential Action	REPLACE
Urgency of Action	PRIORITY 3
Purpose of Action	LEVEL 2
Deficiency Photo1	 
Violations	Vernon Avenue No violations recorded.
Pavers	Does not Exist
Student Use	Inspected
Gravel Exists?	No
Asphalt	Does not Exist
Concrete	Inspected
Condition	3 - Fair
Deficiency	DAMAGED/DETERIORATED/MISSING SECTIONS
Deficiency Location/Instance	Courtyard, West Side of the Building

Deficiency Quantity	200
Quantity Uom	S.F.
Potential Action	REPLACE
Urgency of Action	PRIORITY 3
Purpose of Action	LEVEL 2

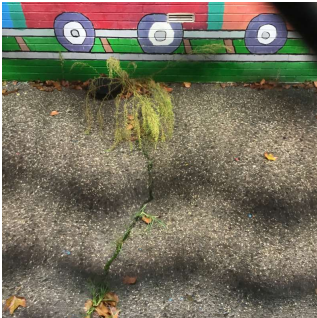
Violations	Courtyard No violations recorded.
Pavers	Does not Exist
Site Sidewalks & Walkways	Inspected
Asphalt	Does not Exist
Concrete	Inspected
Condition	3 - Fair
Deficiency	CRACKS - MAJOR
Deficiency Location/Instance	Willoughby Avenue
Deficiency Quantity	50
Quantity Uom	S.F.
Potential Action	REPLACE
Urgency of Action	PRIORITY 3
Purpose of Action	LEVEL 2
Deficiency Photo1

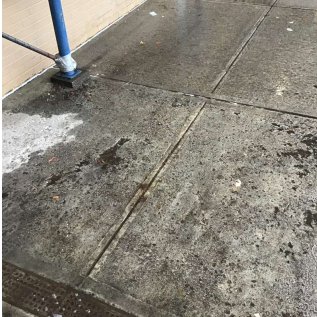
Violations	Willoughby Avenue No violations recorded.
Deficiency	DAMAGED/DETERIORATED/MISSING SECTIONS
Deficiency Location/Instance	Near Exit 3, Main Entrance
Deficiency Quantity	150
Quantity Uom	S.F.
Potential Action	REPLACE
Urgency of Action	PRIORITY 3
Purpose of Action	LEVEL 2

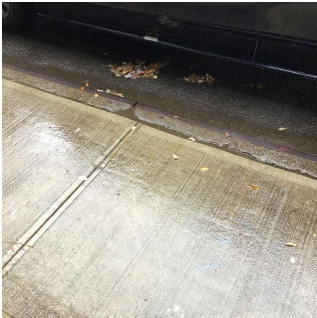
Near Exit 3
Violations	No violations recorded.
Pavers	Does not Exist
DOT Sidewalk	Inspected
Asphalt	Does not Exist
Concrete	Inspected
Condition	3 - Fair
Deficiency	DAMAGED CURBS
Deficiency Location/Instance	Vernon Avenue, Willoughby Avenue
Deficiency Quantity	20
Quantity Uom	L.F.
Potential Action	REPLACE
Urgency of Action	PRIORITY 3
Purpose of Action	LEVEL 2
Deficiency Photo1

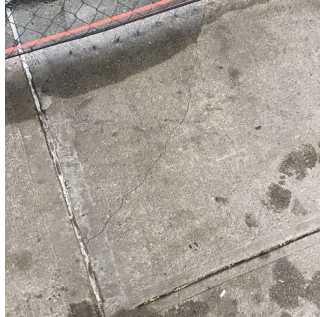
Vernon Avenue
Violations	No violations recorded.
Deficiency	DAMAGED/DETERIORATED/MISSING SECTIONS
Deficiency Location/Instance	Vernon Avenue, Willoughby Avenue
Deficiency Quantity	125
Quantity Uom	S.F.
Potential Action	REPLACE
Urgency of Action	PRIORITY 3
Purpose of Action	LEVEL 2
