NYC Department of Education
Building Condition Assessment Survey 2023 - 2024

Architectural Inspection

Asset: P.S. 24 - BROOKLYN, 427 38TH STREET, New York, 11232

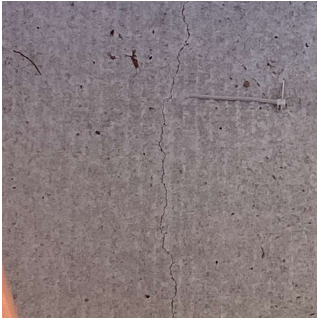
AREAWAY SLAB: CRACKS AND SPALLING

REPLACE

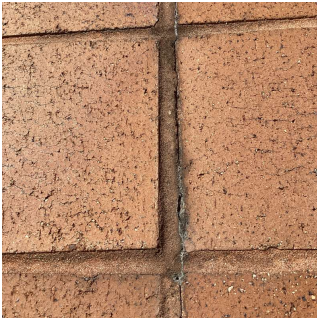
Violations	AW3 No violations recorded.
AWNINGS AND CANOPIES	
	Does not Exist
CHIMNEY	
Material Type(s)	Inspected Masonry
Condition	3 - Fair
Deficiency	BRICK: DETERIORATED JOINTS
Roof Plan reference	K024 37th Street
Deficiency Quantity	50
Quantity Uom	S.F.
Potential Action	REPOINT
Urgency of Action	PRIORITY 3
Purpose of Action	LEVEL 2
Deficiency Photo1

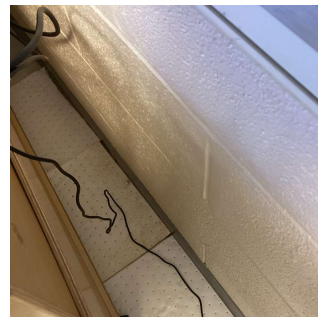
Facade E - Room 420

BRICK: WATER INFILTRATION IN INSTRUCTIONAL SPACE

100
S.F.
REPAIR
PRIORITY 5
LEVEL 2

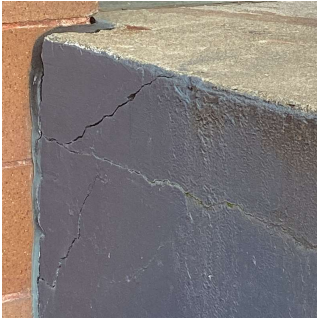
CHEEK WALL/CRACKS, SPALLING - MAJOR

10
 S.F.
 REPLACE
 PRIORITY 4
 LEVEL 2

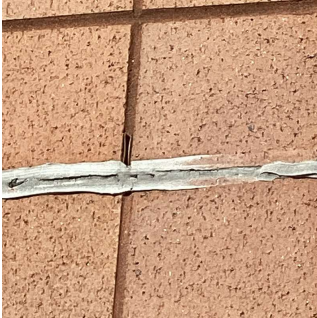
Violations	Facade B No violations recorded.
LOUVER	Inspected
Condition	2 - Between Good and Fair
Deficiency	No deficiencies recorded
PARAPETS	Inspected
Material Type(s)	Concrete, Masonry
Replacement Quantity	10,000
Replacement Uom	C.F.
Instance on All Facades	Inspected
Instance Condition	3 - Fair
Instance Quantity	10,000
Instance Quantity Uom	C.F.
Deficiency	STONE: DETERIORATED JOINTS
Roof Plan reference	K024 37th Street

Deficiency Quantity	20
Quantity Uom	S.F.
Potential Action	REPOINT
Urgency of Action	PRIORITY 3
Purpose of Action	LEVEL 2
Deficiency Photo1

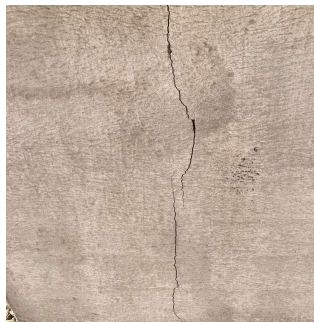
Roof 1
No violations recorded.

Violations	Roof 3 No violations recorded.
Deficiency	CONCRETE: MAJOR DETERIORATION/CRACKS

30
S.F.
REMOVE AND REBUILD
PRIORITY 4
LEVEL 2

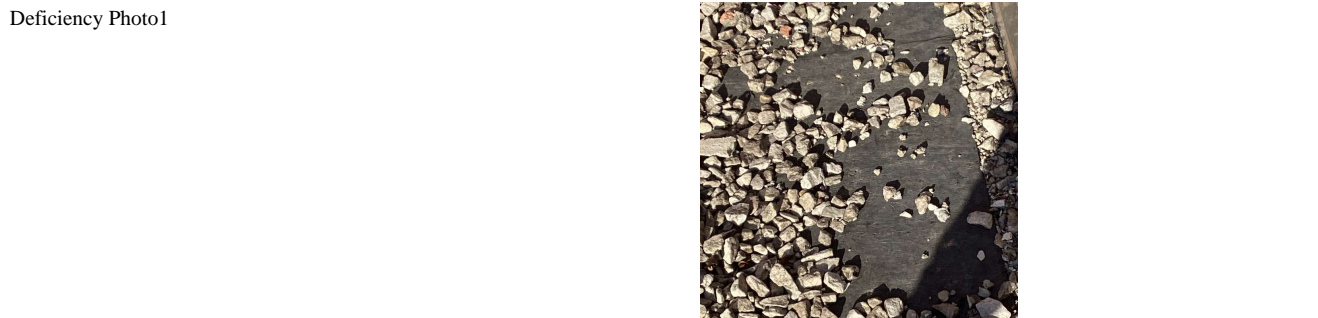
Roof 4

Deficiency	IRMA: ROOFING: LOSS OF GRAVEL
------------	-------------------------------

Urgency of Action	PRIORITY 3
-------------------	------------

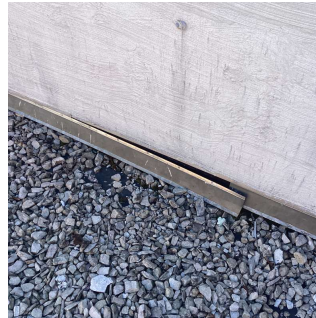
Roof 3

Deficiency	IRMA: FLASHING: BASE FLASHING DETERIORATED
------------	--

Deficiency Quantity	20
---------------------	----

Potential Action	REPLACE
------------------	---------

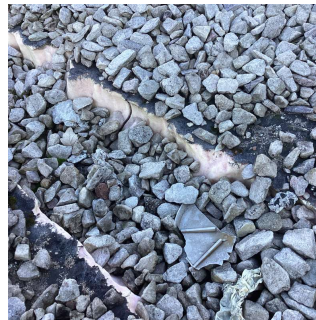
Roof 1

IRMA: ROOFING: DETERIORATED PAVERS WITH INTEGRAL INSULATION

REPLACE

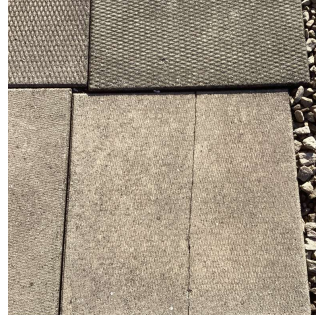
Roof 1

DETERIORATED

REPLACE

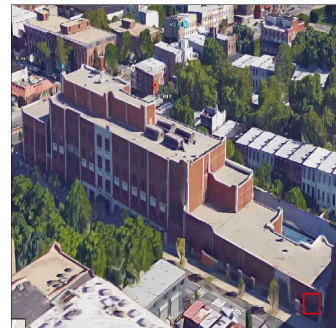
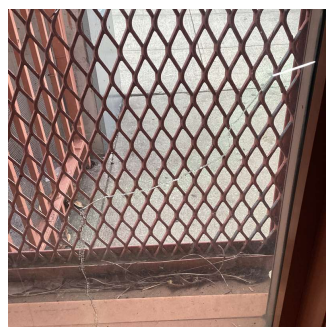
Question	Response
EXTERIOR	
WINDOWS	
Replacement Uom	S.F.
EXTERIOR GUARDS	
Condition	Inspected
Deficiency	2 - Between Good and Fair
Deficiency	No deficiencies recorded
LINTELS	
Condition	Inspected
Deficiency	2 - Between Good and Fair
Deficiency	No deficiencies recorded
WINDOWS	
Material Type(s)	Inspected
Material Type(s)	Aluminum
Instance on Aluminum - Double Hung: All Facades	Inspected
Instance Condition	3 - Fair
Instance Quantity	7,300
Instance Quantity Uom	S.F.
Are these windows insulated	No
Installation Year	1997
Source of Installation	Custodial Staff
Deficiency	ALUMINUM - DOUBLE HUNG: BROKEN PANE
Roof Plan reference	K024 37th Street
Elevation

Deficiency Quantity	30
Quantity Uom	S.F.
Potential Action	MAINTENANCE
Urgency of Action	PRIORITY 3
Purpose of Action	LEVEL 2
Deficiency Photo1

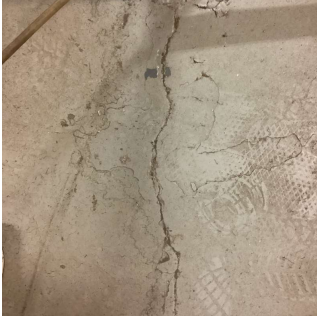
Question	Response
EXTERIOR	
WINDOWS	
WINDOWS	
Instance on Aluminum - Other: Facade A	Inspected
Instance Condition	3 - Fair
Instance Quantity	200
Instance Quantity Uom	S.F.
Are these windows insulated	No
Installation Year	1997
Source of Installation	Custodial Staff
Deficiency	No deficiencies recorded
INTERIOR	Inspected
POOLS	Does not Exist
STRUCTURAL	Inspected
COLUMNS/BEAMS/BEARING WALLS	Inspected
Condition	2 - Between Good and Fair
Deficiency	No deficiencies recorded
FLOOR STRUCTURE	Inspected
Condition	4 - Between Fair and Poor
Deficiency	CONCRETE SLAB ON GRADE: THRU CRACKS
Deficiency Location/Instance	Basement - Boiler Room, Rooms 006, 016, 016A, 018, 001, 003, Pipe Space, Corridor near Boiler Room
Deficiency Quantity	180
Quantity Uom	S.F.
Potential Action	REPLACE
Urgency of Action	PRIORITY 4
Purpose of Action	LEVEL 5
Deficiency Photo1

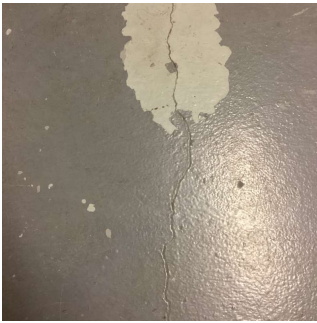
Basement - Boiler Room
Violations	No violations recorded.
Deficiency	CONCRETE: CRACKS/SPALLED/REINFORCEMENT EXPOSED

Deficiency Location/Instance	PH
Deficiency Quantity	50
Quantity Uom	S.F.
Potential Action	REPAIR
Urgency of Action	PRIORITY 4
Purpose of Action	LEVEL 5

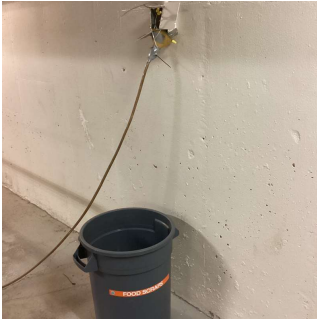
Violations	PH No violations recorded.
FOUNDATION WALLS	
Material Type(s)	Inspected Concrete
Condition	4 - Between Fair and Poor
Deficiency	CONCRETE: WATER INFILTRATION IN NON- INSTRUCTIONAL SPACE
Deficiency Location/Instance	Basement - Boiler Room
Deficiency Quantity	100
Quantity Uom	S.F.
Potential Action	INSTALL WATERPROOFING
Urgency of Action	PRIORITY 5
Purpose of Action	LEVEL 5
Deficiency Photo1

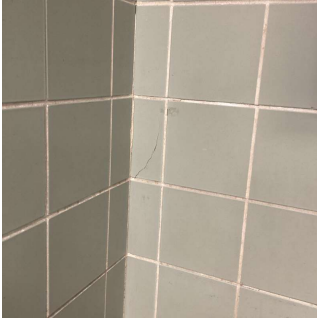
Question	Response
INTERIOR	
CAFETERIA	
Sliding-folding Partition	
Instance on 1st Floor	Does not Exist
Stage	
Instance on 1st Floor	Does not Exist
Walls	
Instance on 1st Floor	Inspected
Condition	2 - Between Good and Fair
Deficiency	GLAZED BLOCK: CRACKS/SPALLING
Deficiency Location/Instance	Near Windows
Deficiency Quantity	10
Quantity Uom	S.F.
Potential Action	REPLACE
Urgency of Action	PRIORITY 3
Purpose of Action	LEVEL 2
Deficiency Photo1

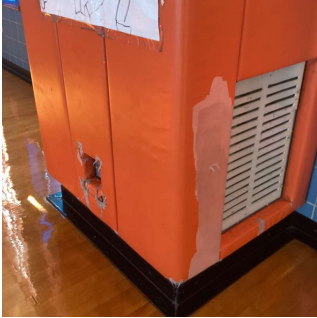
Question	Response
INTERIOR	
GYMNASIUM	
Walls	
Instance on 2nd Floor	Inspected
Condition	2 - Between Good and Fair
Deficiency	WALL PADDING: DETERIORATED
Deficiency Location/Instance	Right and Left Side, Rear Wall
Deficiency Quantity	120
Quantity Uom	S.F.
Potential Action	REPLACE
Urgency of Action	PRIORITY 3
Purpose of Action	LEVEL 2
Deficiency Photo1

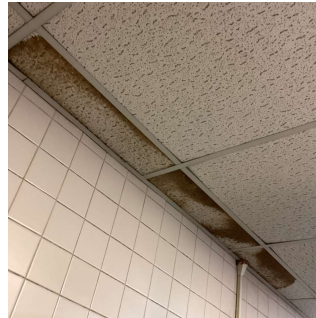
Deficiency	ACOUSTIC TILES: DAMAGED/MISSING
Deficiency Location/Instance	Servery, Small Servery
Deficiency Quantity	50
Quantity Uom	S.F.
Potential Action	REPLACE
Urgency of Action	PRIORITY 3
Purpose of Action	LEVEL 2
Deficiency Photo1

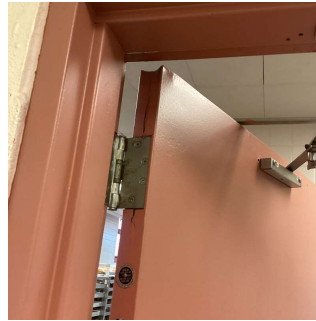
Instance on 1st Floor	Inspected
Condition	3 - Fair
Deficiency	METAL: DETERIORATED DOOR
Deficiency Location/Instance	Office Room
Deficiency Quantity	1
Quantity Uom	EACH
Potential Action	MAINTENANCE
Urgency of Action	PRIORITY 3
Purpose of Action	LEVEL 2

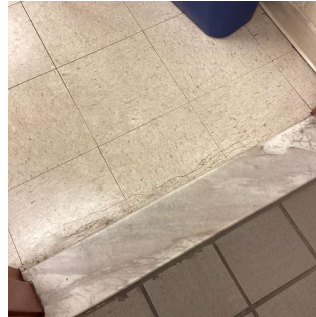
Deficiency VINYL TILES: BROKEN/DETERIORATED/MISSING TILES

Deficiency Location/Instance Office Room

Deficiency Quantity 10

Potential Action REPLACE

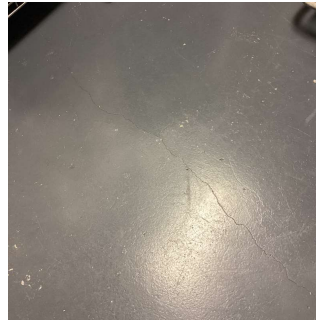
Deficiency CONCRETE: CRACKS

Deficiency Location/Instance Room 103B

Deficiency Quantity 10

Potential Action REPLACE

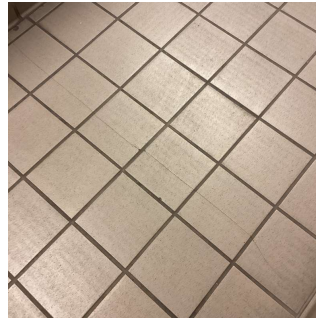
Servery

CERAMIC TILE: BROKEN/MISSING TILES

REPLACE

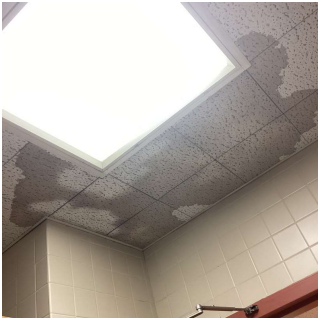
Violations	Stair A/1 No violations recorded.
TOILET ROOMS - STAFF	
Ceiling	Inspected
Condition	4 - Between Fair and Poor
Deficiency	ACOUSTIC TILES ON PLASTER: DAMAGED/MISSING
Deficiency Location/Instance	Women Toilet Room - 1st Floor, Men Toilet Room - 1st Floor
Deficiency Quantity	60
Quantity Uom	S.F.
Potential Action	REPLACE
Urgency of Action	PRIORITY 3
Purpose of Action	LEVEL 2
Deficiency Photo1

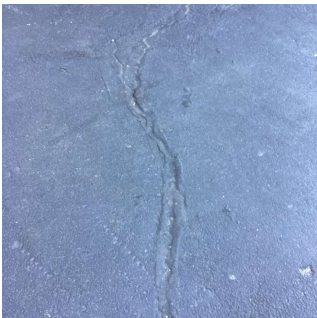
Violations	Schoolyard No violations recorded.
Concrete	Does not Exist
Pavers	Does not Exist
Site Sidewalks & Walkways	Inspected
Asphalt	Inspected
Condition	3 - Fair
Deficiency	CRACKS - MAJOR
Deficiency Location/Instance	Schoolyard
Deficiency Quantity	150
Quantity Uom	S.F.
Potential Action	REPLACE
Urgency of Action	PRIORITY 3
Purpose of Action	LEVEL 2
Deficiency Photo1

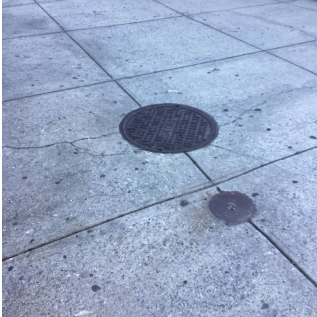
Violations	Schoolyard No violations recorded.
Concrete	Inspected
Condition	3 - Fair
Deficiency	DAMAGED/DETERIORATED/MISSING SECTIONS
Deficiency Location/Instance	38th Street
Deficiency Quantity	275
Quantity Uom	S.F.
Potential Action	REPLACE
Urgency of Action	PRIORITY 3
Purpose of Action	LEVEL 2

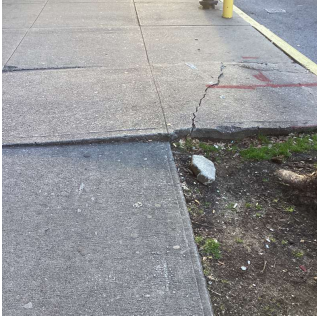
Violations	38th Street No violations recorded.
Pavers	Inspected
Condition	2 - Between Good and Fair
Deficiency	No deficiencies recorded
DOT Sidewalk	Inspected
Asphalt	Does not Exist
Concrete	Inspected
Condition	4 - Between Fair and Poor
Deficiency	HEAVING
Deficiency Location/Instance	38th Street
Deficiency Quantity	50
Quantity Uom	S.F.
Potential Action	REPLACE
Urgency of Action	PRIORITY 5
Purpose of Action	LEVEL 6
Deficiency Photo1

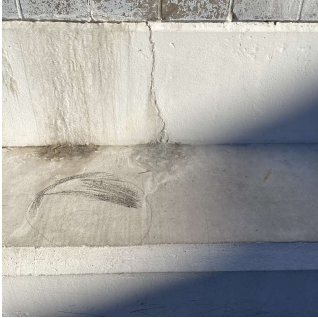
Question	Response
SITE	
PAVING	Inspected
DOT Sidewalk	
Concrete	Inspected
Violations	No violations recorded.
Pavers	Does not Exist
PLAYGROUNDS	Inspected
Instance on Upper Rear Yard	Inspected
Benches	
Instance on Upper Rear Yard	Inspected
Condition	3 - Fair
Deficiency	DAMAGED/DETERIORATED
Deficiency Location/Instance	Near Wall
Deficiency Quantity	1
Quantity Uom	EACH
Potential Action	REPLACE
Urgency of Action	PRIORITY 3
Purpose of Action	LEVEL 2
Deficiency Photo1

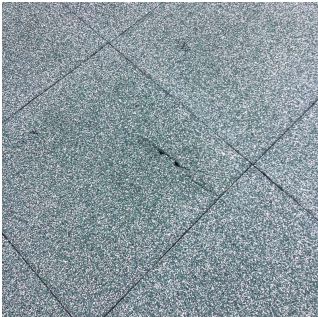
Deficiency	DETERIORATED/MISSING
Deficiency Location/Instance	Near Slide
Deficiency Quantity	20
Quantity Uom	S.F.
Potential Action	REPLACE
Urgency of Action	PRIORITY 3

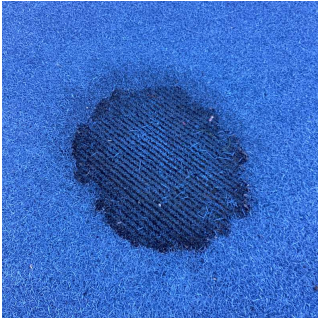
Near Slide
Violations	No violations recorded.
Unpaved Area	
Instance on Upper Rear Yard	Does not Exist
PLAYING SURFACE	Inspected
Playing Field	Inspected
Instance on Schoolyard	Inspected
Instance Condition	3 - Fair
Deficiency	ARTIFICIAL TURF: DAMAGED/WORN OUT
Deficiency Location/Instance	Schoolyard
Deficiency Quantity	50
Quantity Uom	S.F.
Potential Action	REPLACE
Urgency of Action	PRIORITY 3
Purpose of Action	LEVEL 2
Deficiency Photo1

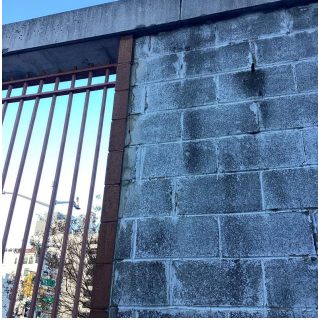
Question	Response
SITE	
RETAINING WALLS	
Purpose of Action	LEVEL 2
Deficiency Photo1	 
Violations	4th Avenue No violations recorded.
SEATING	
Benches	Inspected
Concrete	Inspected
Condition	2 - Between Good and Fair
Deficiency	No deficiencies recorded
Metal/Wood/Plastic	Does not Exist
Bleachers	Does not Exist
SITE WALLS (NOT RETAINING WALLS)	
Condition	3 - Fair
Deficiency	CAST IN PLACE CONCRETE: CRACKS/SPALLING - MAJOR
Deficiency Location/Instance	38th Street
Deficiency Quantity	10
Quantity Uom	S.F.
Potential Action	REPLACE
Urgency of Action	PRIORITY 3
Purpose of Action	LEVEL 2
Deficiency Photo1	 
Violations	38th Street No violations recorded.
Deficiency	MASONRY UNIT: CRACKS/SPALLING - MAJOR
Deficiency Location/Instance	38th Street
Deficiency Quantity	20
Quantity Uom	S.F.
Potential Action	REPLACE
Urgency of Action	PRIORITY 3
Purpose of Action	LEVEL 2

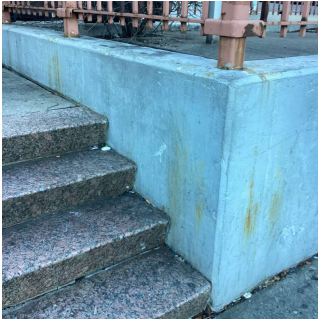
Violations	38th Street No violations recorded.
STAIRS/RAMPS: EXTERIOR	
Railings	Inspected
Condition	4 - Between Fair and Poor
Deficiency	MISSING
Deficiency Location/Instance	4th Avenue
Deficiency Quantity	20
Quantity Uom	L.F.
Potential Action	REPLACE
Urgency of Action	PRIORITY 5
Purpose of Action	LEVEL 6
Deficiency Photo1
