**NYC Department of Education**  
**Building Condition Assessment Survey 2023 - 2024**

Architectural Inspection

**Asset:** P.S. 32 ADDITION - BROOKLYN, 317 HOYT STREET, New York, 11231

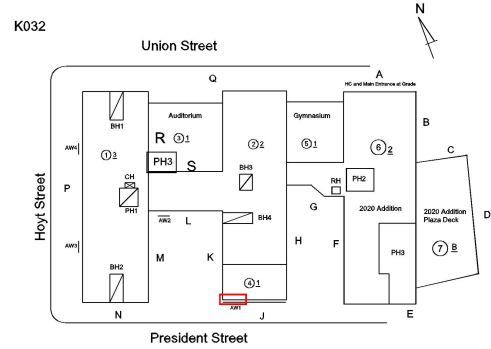
AW1  
No violations recorded.

Question	Response
<b>Architectural</b>	
<b>EXTERIOR</b>	Inspected
<b>AREAWAY</b>	Inspected
Instance on AW1-AW4	Inspected
Instance Condition	5 - Poor
Instance Quantity	4
Instance Quantity Uom	EACH
Deficiency	AREAWAY STAIRS: DETERIORATED TREADS/RISERS/NOSINGS

60  
S.F.  
REPAIR  
PRIORITY 3  
LEVEL 2

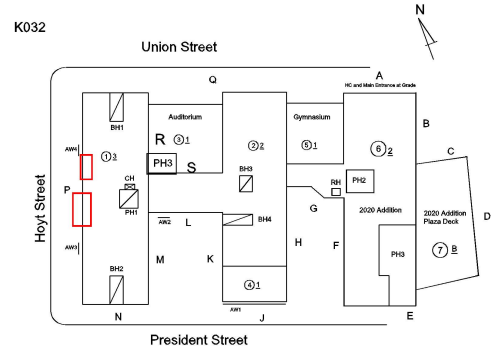
AREAWAY WALLS: DETERIORATED COPING STONE

20  
S.F.  
REPAIR  
PRIORITY 3  
LEVEL 2

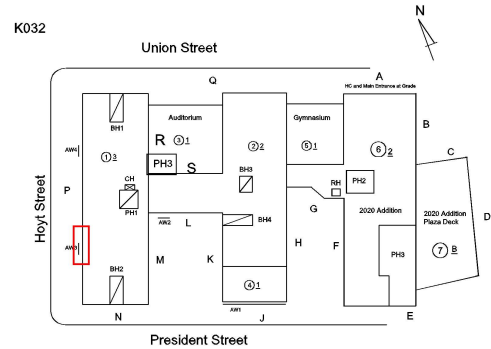
AREAWAY LADDER: DETERIORATED

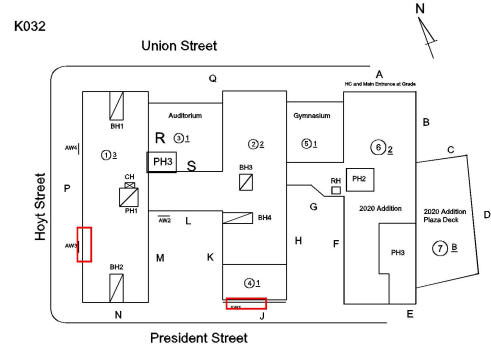
AW3  
No violations recorded.

AREAWAY WALLS: CRACKS AND SPALLING

100  
S.F.  
REPAIR  
PRIORITY 3  
LEVEL 2

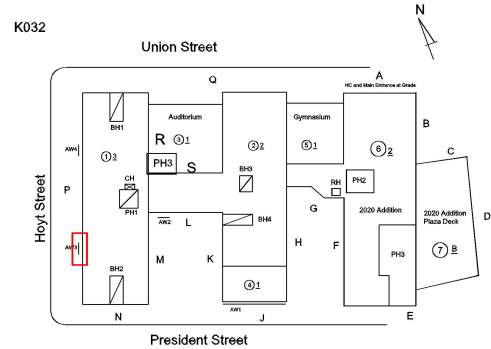
AREAWAY DRAINS: CLOGGED

3  
EACH  
MAINTENANCE  
PRIORITY 5  
LEVEL 2

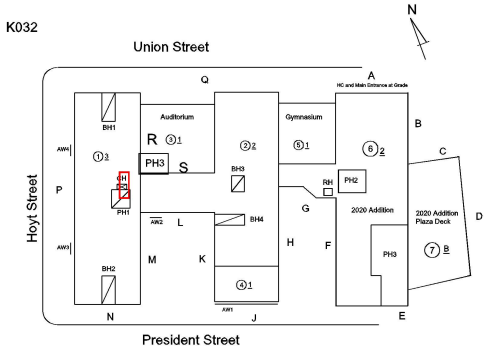
AW2 (x2), AW3
Violations	No violations recorded.
<b>AWNINGS AND CANOPIES</b>	
Condition	Inspected
Deficiency	2 - Between Good and Fair
	No deficiencies recorded
<b>CHIMNEY</b>	
Material Type(s)	Inspected
Condition	Masonry
Deficiency	3 - Fair
Roof Plan reference	BRICK: DETERIORATED JOINTS

Deficiency Quantity	25
Quantity Uom	S.F.
Potential Action	REPOINT
Urgency of Action	PRIORITY 3
Purpose of Action	LEVEL 2
Deficiency Photo1

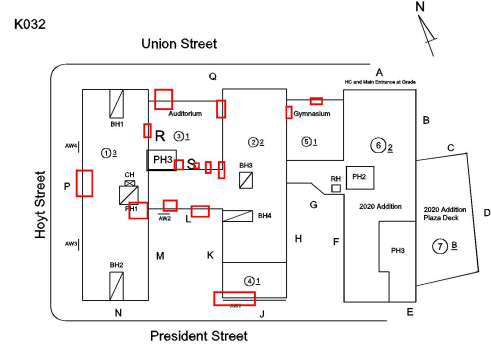
Violations	Roof 1 No violations recorded.
<b>COPING</b>	
Condition	Inspected
Deficiency	3 - Fair
	CAST STONE: CRACKED/BROKEN PIECES

14

REPLACE-IN-KIND

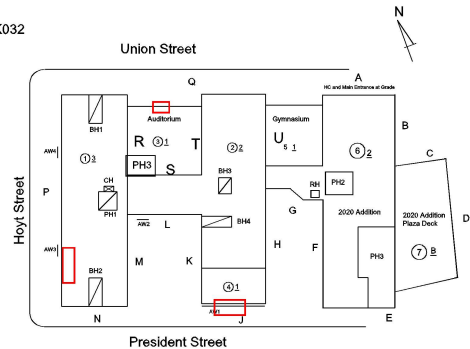
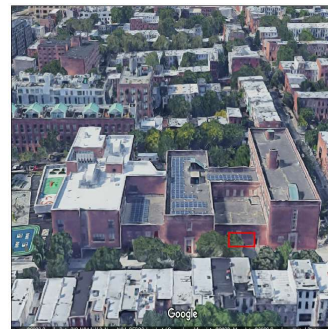
BRICK: DETERIORATED MASONRY SILLS - MINOR

10

REPAIR

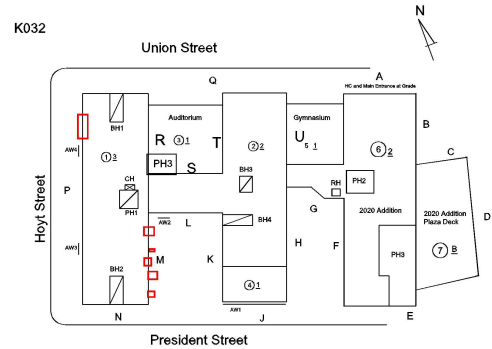
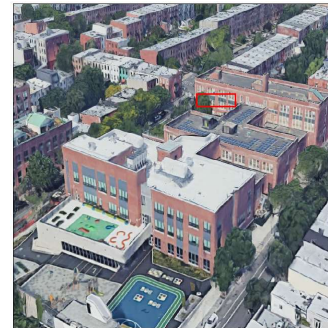
STONE: CHIPPED/SPALLED/BROKEN PIECES - MINOR

50

REPAIR

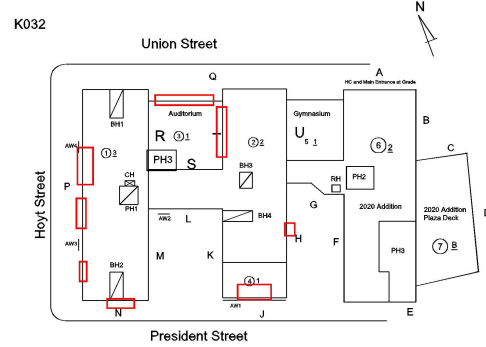
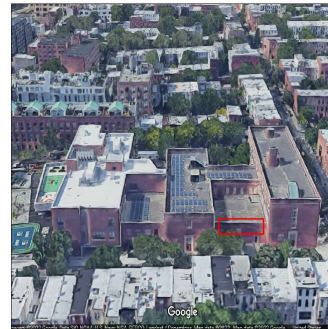
Facade Q at Auditorium  
No violations recorded.

BRICK: DETERIORATED JOINTS

300  
S.F.  
REPOINT  
PRIORITY 3  
LEVEL 2

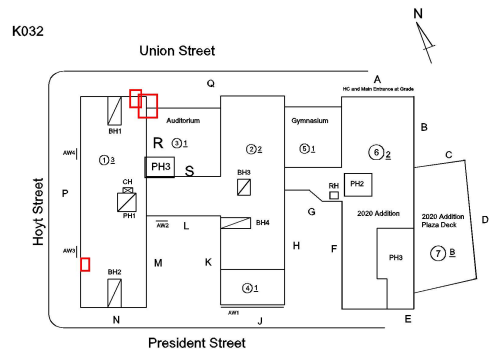
Instance Quantity	1,500
Instance Quantity Uom	C.F.
Deficiency	No deficiencies recorded
Instance on Facades H-Q, T-W Original Building)	Inspected
Instance Condition	3 - Fair
Instance Quantity	8,000
Instance Quantity Uom	C.F.
Deficiency	<b>BRICK: MAJOR DETERIORATION/CRACKS</b>

15  
S.F.  
REMOVE AND REBUILD  
PRIORITY 4  
LEVEL 2

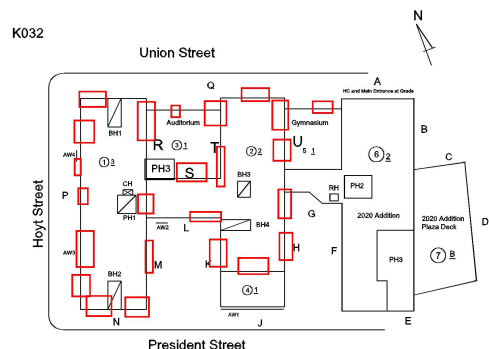
Deficiency	<b>BRICK: DETERIORATED JOINTS</b>
Roof Plan reference

4,000  
S.F.  
REPOINT

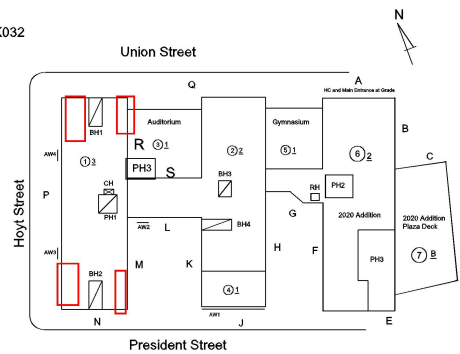
Deficiency	IRMA: ROOFING: MAJOR ACTIVE ROOF LEAKS IN INSTRUCTIONAL SPACE
------------	---------------------------------------------------------------

Deficiency Quantity	600
---------------------	-----

Potential Action	REPLACE ROOFING WITHOUT MAJOR EQUIPMENT REMOVAL
------------------	-------------------------------------------------

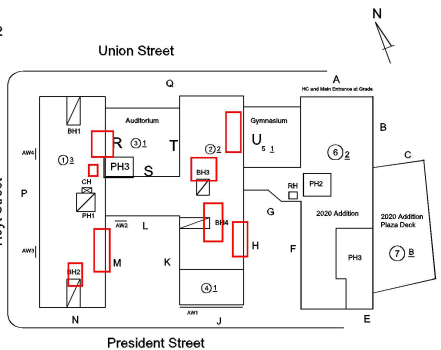
Violations	Roof 1 - Rooms 300, 301, 307, 314, 315, 316 No violations recorded.
Deficiency	IRMA: ROOFING: DAMAGED INSULATION
Roof Plan reference	K032

Deficiency Quantity	600
Quantity Uom	S.F.
Potential Action	REPLACE
Urgency of Action	PRIORITY 4
Purpose of Action	LEVEL 2
Deficiency Photo1

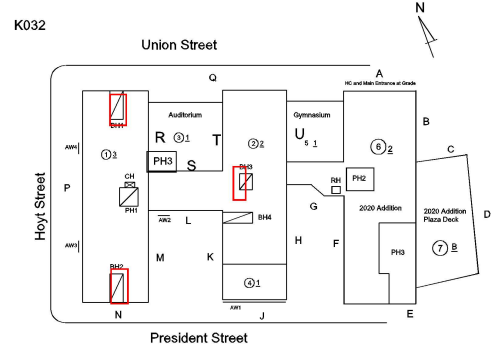
BH2  
No violations recorded.

Violations	Roof 1 No violations recorded.
<b>ROOFING DRAINS</b>	Inspected
Condition	2 - Between Good and Fair
Deficiency	No deficiencies recorded
<b>Specialties</b>	Inspected
<b>BULKHEAD/PENTHOUSE</b>	Inspected
Condition	3 - Fair
Deficiency	BULKHEAD/PENTHOUSE WALLS/EXTERIOR: DETERIORATED JOINTS

150  
S.F.  
REPOINT  
PRIORITY 3  
LEVEL 2

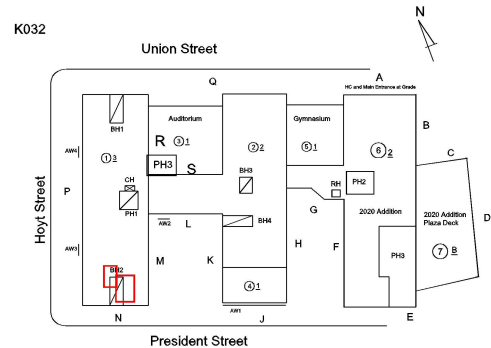
**BULKHEAD/PENTHOUSE WALLS/EXTERIOR:  
CRACKS/SPALLING - MAJOR**

15  
S.F.  
REPLACE  
PRIORITY 4  
LEVEL 2

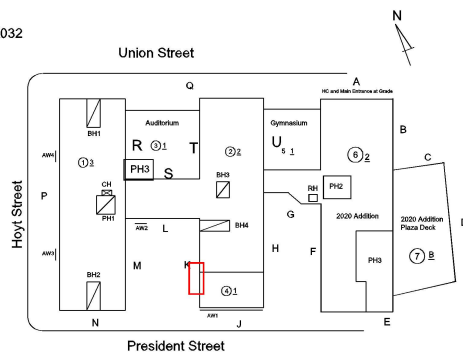
STONE: WORN-OUT TREAD/RISER/NOSING

60

REPLACE

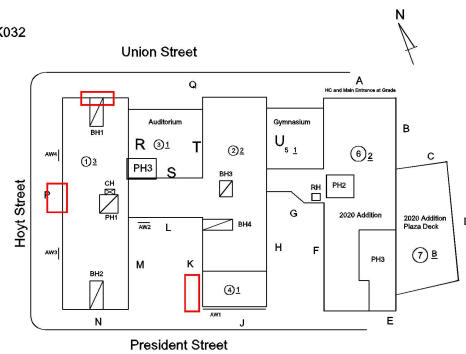
**STONE: DETERIORATED JOINTS**

150

L.F.

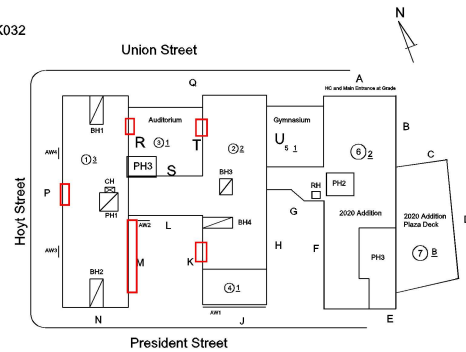
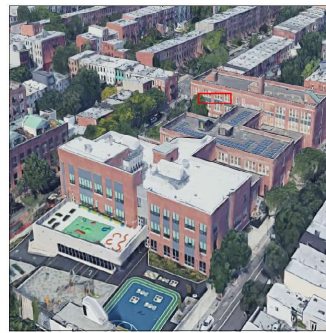
Facade M  
No violations recorded.

STEEL: MAJOR RUSTING

75  
L.F.  
REPLACE  
PRIORITY 4  
LEVEL 2

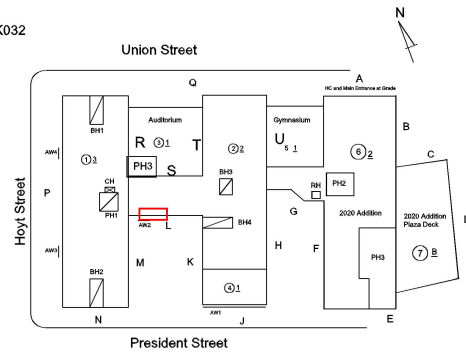
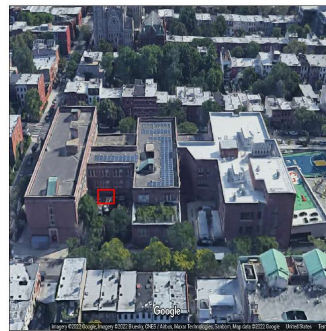
Basement Custodial Locker Room  
No violations recorded.

ALUMINUM - DOUBLE HUNG: DETERIORATED

30  
S.F.  
**REPLACE WINDOW**  
**PRIORITY 4**  
**LEVEL 2**

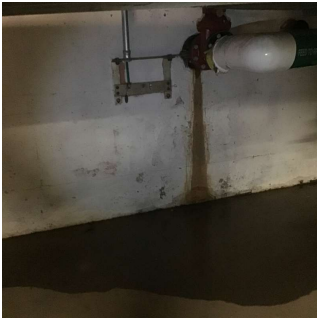
Question	Response
<b>INTERIOR</b>	
<b>STRUCTURAL</b>	
<b>FLOOR STRUCTURE</b>	Inspected
	Rooms B17, B4, B128
Violations	No violations recorded.
<b>FOUNDATION WALLS</b>	Inspected
Material Type(s)	Concrete, Masonry
Condition	4 - Between Fair and Poor
Deficiency	BRICK: CRACKED/SPALLED
Deficiency Location/Instance	Basement Storage Room B130
Deficiency Quantity	75
Quantity Uom	S.F.
Potential Action	RESTITCH
Urgency of Action	PRIORITY 3
Purpose of Action	LEVEL 5
Deficiency Photo1	 
Violations	Basement Storage Room B130 No violations recorded.
Deficiency	CONCRETE: WATER INFILTRATION IN NON- INSTRUCTIONAL SPACE
Deficiency Location/Instance	Auditorium and Gym Fan Room B11, Crawl Space near Electric Panel Room
Deficiency Quantity	100
Quantity Uom	S.F.
Potential Action	INSTALL WATERPROOFING
Urgency of Action	PRIORITY 5
Purpose of Action	LEVEL 5
Deficiency Photo1

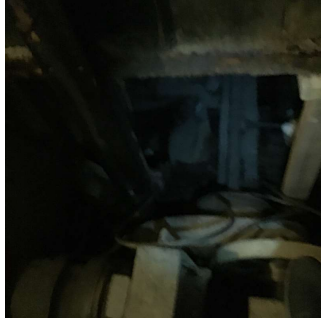
<b>Question</b>	<b>Response</b>
<b>INTERIOR</b>	
<b>STRUCTURAL</b>	
<b>VAULTS-BUNKERS</b>	
<b>Foundation Walls</b>	Inspected
Condition	3 - Fair
Deficiency	CRACKS, SPALLING
Deficiency Location/Instance	Vault
Deficiency Quantity	50
Quantity Uom	S.F.
Potential Action	REPAIR
Urgency of Action	PRIORITY 3
Purpose of Action	LEVEL 5
Deficiency Photo1	 
Violations	Vault No violations recorded.
<b>Slab Structure</b>	Inspected
Condition	3 - Fair
Deficiency	CONCRETE: CRACKS/SPALLED/REINFORCEMENT EXPOSED
Deficiency Location/Instance	Vault
Deficiency Quantity	80
Quantity Uom	S.F.
Potential Action	REPAIR
Urgency of Action	PRIORITY 3
Purpose of Action	LEVEL 5
Deficiency Photo1

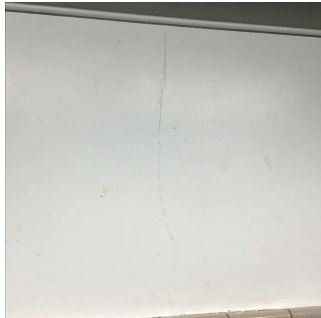
Question	Response
<b>INTERIOR</b>	
<b>CLASSROOMS/CORRIDORS/ADMIN SPACES</b>	
<b>Walls</b>	
Violations	Corridor near Room 105 No violations recorded.
Deficiency	PLASTER: CRACKS/SPALLING
Deficiency Location/Instance	Corridor near Rooms B130, 122, 200, 206, 225, and others
Deficiency Quantity	120
Quantity Uom	S.F.
Potential Action	REPLACE
Urgency of Action	PRIORITY 3
Purpose of Action	LEVEL 2
Deficiency Photo1

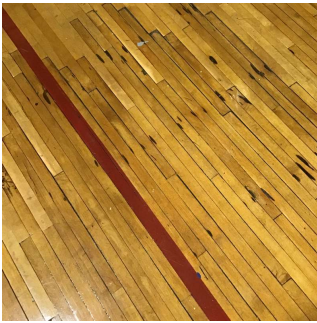
Question	Response
<b>INTERIOR</b>	
<b>GYMNASIUM</b>	
<b>Floor Finish</b>	
Deficiency Photo1

Violations	Near Drinking Fountain No violations recorded.
<b>Seating</b>	
Instance on 1st Floor	Inspected
Condition	3 - Fair
Deficiency	DAMAGED FIXED SEATING
Deficiency Location/Instance	Near Windows
Deficiency Quantity	1
Quantity Uom	EACH
Potential Action	REPLACE
Urgency of Action	PRIORITY 3
Purpose of Action	LEVEL 2
Deficiency Photo1

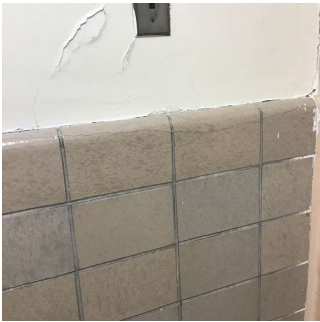
<b>Question</b>	<b>Response</b>
<b>INTERIOR</b>	
<b>STAIRS/RAMPS: INTERIOR</b>	
<b>Stairs and Landings</b>	Inspected
Violations	No violations recorded.
<b>Walls</b>	Inspected
Condition	2 - Between Good and Fair
Deficiency	GLAZED BLOCK: CRACKS/SPALLING
Deficiency Location/Instance	Stair D/1 Vestibule, 2, E/2, F/1 Vestibule
Deficiency Quantity	35
Quantity Uom	S.F.
Potential Action	REPLACE
Urgency of Action	PRIORITY 3
Purpose of Action	LEVEL 2
Deficiency Photo1

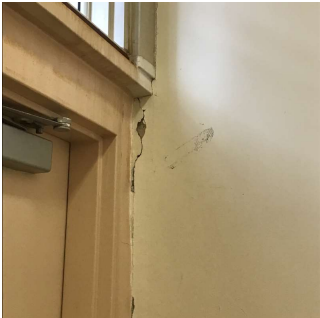
Violations	Stair D/1 Vestibule No violations recorded.
Deficiency	PLASTER: CRACKS/SPALLING
Deficiency Location/Instance	Stairs D/1 Vestibule, E/1 Vestibule, F/1 Vestibule, G/1 Vestibule
Deficiency Quantity	50
Quantity Uom	S.F.
Potential Action	REPLACE
Urgency of Action	PRIORITY 3
Purpose of Action	LEVEL 2
Deficiency Photo1

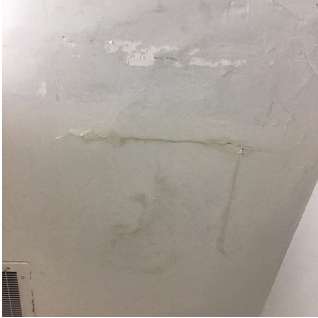
Deficiency	PLASTER: CRACKS/SPALLING
Deficiency Location/Instance	Room 121
Deficiency Quantity	10
Quantity Uom	S.F.

Question	Response
<b>INTERIOR</b>	
<b>TOILET ROOMS - STAFF</b>	
<b>Ceiling</b>	
Potential Action	REPLACE
Urgency of Action	PRIORITY 3
Purpose of Action	LEVEL 2
Deficiency Photo1

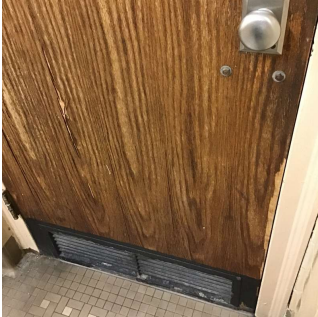
Room 121
Violations	No violations recorded.
<b>Door(s)</b>	Inspected
Condition	5 - Poor
Deficiency	WOOD: DETERIORATED DOOR
Deficiency Location/Instance	Rooms 121, 127
Deficiency Quantity	2
Quantity Uom	EACH
Potential Action	MAINTENANCE
Urgency of Action	PRIORITY 3
Purpose of Action	LEVEL 2
Deficiency Photo1

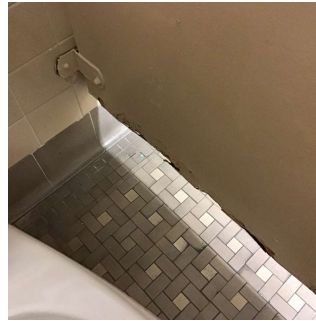
Room 121
Violations	No violations recorded.
<b>Floor Finish</b>	Inspected
Condition	2 - Between Good and Fair
Deficiency	No deficiencies recorded
<b>Stalls</b>	Inspected
Condition	5 - Poor
Deficiency	RUST - MAJOR
Deficiency Location/Instance	Rooms 121, 127
Deficiency Quantity	2
Quantity Uom	EACH
Potential Action	REPLACE
Urgency of Action	PRIORITY 3
Purpose of Action	LEVEL 2

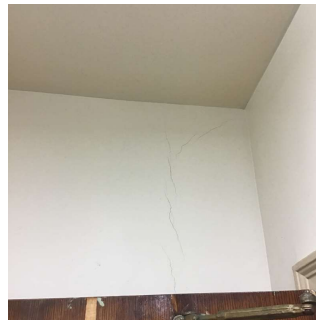
Room 127

PLASTER: CRACKS/SPALLING

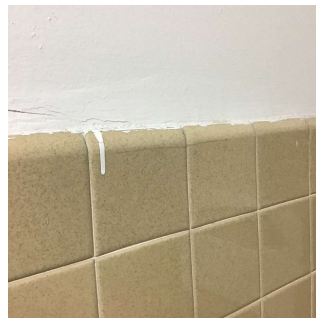
CERAMIC TILE: BROKEN/ MISSING

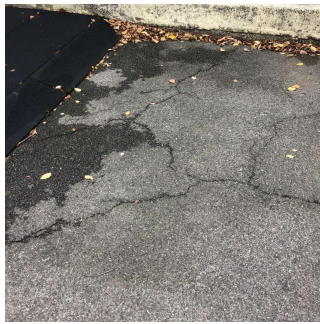
Violations	Left Side No violations recorded.
<b>Fence</b>	
Instance on Schoolyard	Does not Exist
Instance on Near President Street	Inspected
Condition	2 - Between Good and Fair
Deficiency	No deficiencies recorded
Instance on 1st Floor Rooftop	Does not Exist
<b>Pavement</b>	
Instance on Near President Street	Inspected
Condition	3 - Fair
Deficiency	ASPHALT: CRACKS - MAJOR
Deficiency Location/Instance	Right Side
Deficiency Quantity	50
Quantity Uom	S.F.
Potential Action	REPLACE
Urgency of Action	PRIORITY 3
Purpose of Action	LEVEL 2
Deficiency Photo1

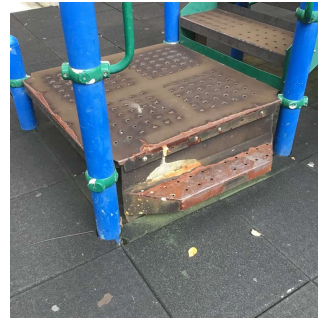
Violations	Right Side No violations recorded.
<b>Play Equipment</b>	
Instance on Near President Street	Inspected
Condition	5 - Poor
Deficiency	BROKEN/DETERIORATED/MISSING
Deficiency Location/Instance	Right Side
Deficiency Quantity	1
Quantity Uom	EACH
Potential Action	REPLACE
Urgency of Action	PRIORITY 3

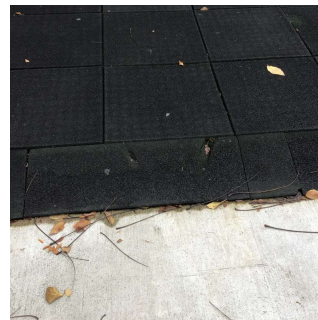
Instance on Near President Street	Inspected
Condition	2 - Between Good and Fair
Deficiency	DETERIORATED/MISSING
Deficiency Location/Instance	Left Side
Deficiency Quantity	10
Quantity Uom	S.F.
Potential Action	REPLACE
Urgency of Action	PRIORITY 3
Purpose of Action	LEVEL 2
Deficiency Photo1
