NYC Department of Education
Building Condition Assessment Survey 2023 - 2024

Architectural Inspection

Asset: I.S. 33 - BROOKLYN, 70 TOMPKINS AVENUE, New York, 11206

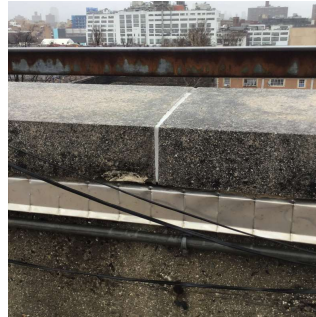
Facade H

CAST STONE: CRACKED/BROKEN PIECES

REPLACE-IN-KIND

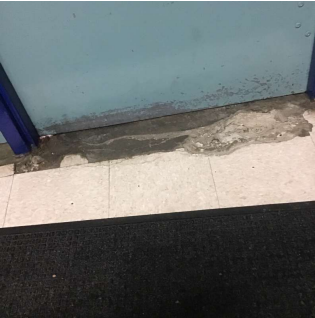
METAL CLAD: DETERIORATED DOOR AND FRAME - MAJOR DETERIORATION

Deficiency Quantity	8
Quantity Uom	EACH
Potential Action	REPLACE
Urgency of Action	PRIORITY 4
Purpose of Action	LEVEL 2
Deficiency Photo1

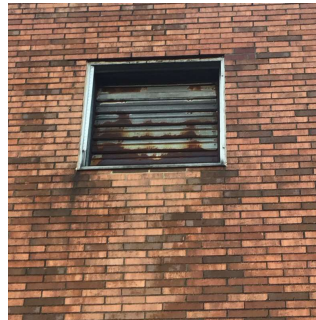
Facade A

MAJOR RUSTING

REPLACE

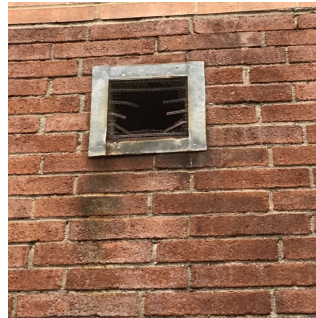
Facade F

MISSING/DAMAGED SCREEN

REPLACE

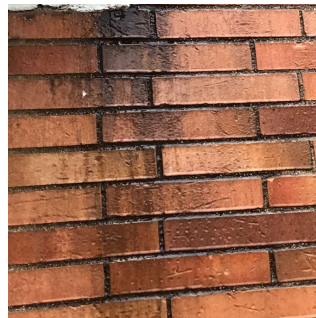
Facade E

BRICK: DETERIORATED JOINTS

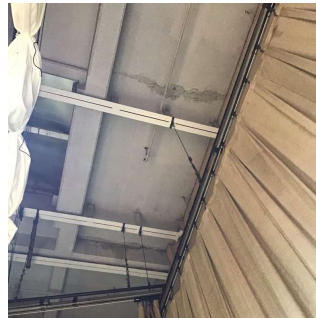
Roof 3 - Auditorium Stage (shown), Gymnasium, Roof 1 - Room 431, Stairs A/4, B/4

BUILT-UP: ROOFING: MAJOR ACTIVE ROOF LEAKS IN INSTRUCTIONAL SPACE

REPLACE ROOFING WITHOUT MAJOR EQUIPMENT REMOVAL

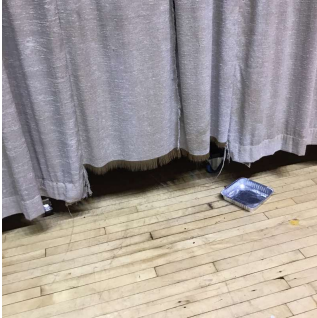
Question	Response
INTERIOR	
AUDITORIUM	
Stage	
Stage Curtains	
Deficiency Quantity	500
Quantity Uom	S.F.
Potential Action	REPLACE
Urgency of Action	PRIORITY 3
Purpose of Action	LEVEL 2
Deficiency Photo1

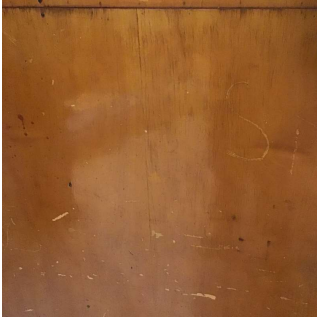
Violations	Center No violations recorded.
Walls	
Instance on 1st Floor (506 seats)	Inspected
Condition	2 - Between Good and Fair
Deficiency	WOOD PANELING: DETERIORATED
Deficiency Location/Instance	Near stage
Deficiency Quantity	20
Quantity Uom	S.F.
Potential Action	REPLACE
Urgency of Action	PRIORITY 3
Purpose of Action	LEVEL 2
Deficiency Photo1

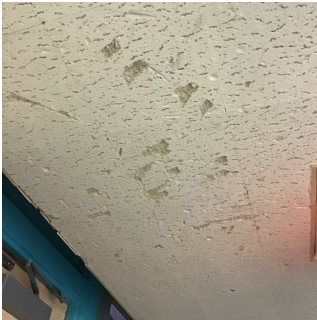
Center	Center
Violations	No violations recorded.
Instance on Sub - Basement - Staff (800 SF)	Inspected
Condition	2 - Between Good and Fair
Deficiency	ACOUSTIC TILES ON PLASTER: DAMAGED/MISSING
Deficiency Location/Instance	Near exit, Servery
Deficiency Quantity	10
Quantity Uom	S.F.
Potential Action	REPLACE
Urgency of Action	PRIORITY 3
Purpose of Action	LEVEL 2
Deficiency Photo1

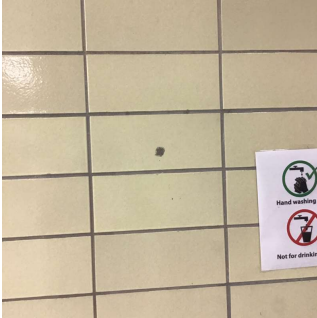
Question	Response
INTERIOR	
CAFETERIA	
Walls	
Quantity Uom	S.F.
Potential Action	REPLACE
Urgency of Action	PRIORITY 3
Purpose of Action	LEVEL 2
Deficiency Photo1

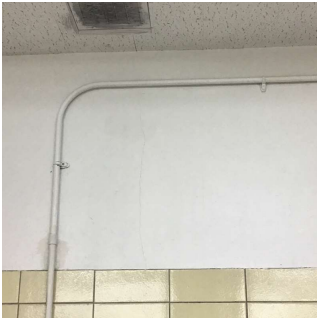
Violations	Near drinking fountains No violations recorded.
Deficiency	PLASTER: CRACKS/SPALLING
Deficiency Location/Instance	Near drinking fountains
Deficiency Quantity	10
Quantity Uom	S.F.
Potential Action	REPLACE
Urgency of Action	PRIORITY 3
Purpose of Action	LEVEL 2
Deficiency Photo1

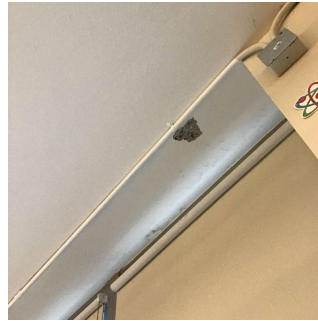
Room 310

PLASTER: CRACKS/SPALLING - ACTIVE LEAK

REPLACE

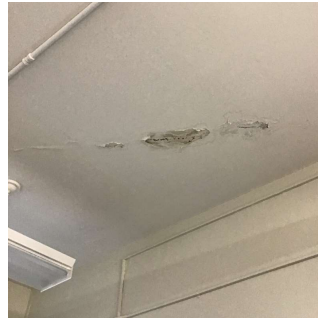
Room 431

ACOUSTIC TILES ON PLASTER: DAMAGED/MISSING

REPLACE

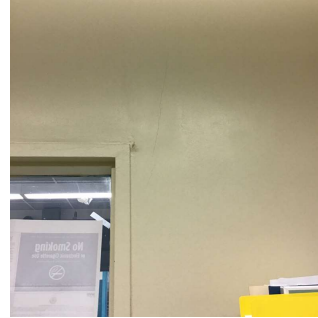
Office

GLAZED BLOCK: CRACKS/SPALLING
Near slop area
10
S.F.
REPLACE
PRIORITY 3
LEVEL 2

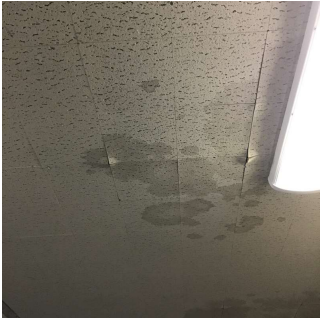
Question	Response
INTERIOR	
KITCHEN	Inspected
Walls	
Violations	Exit 13 No violations recorded.
LIBRARY	Does not Exist
LOCKER ROOM	Inspected
Instance on 1st Floor - Boys (256 Lockers)	Inspected
Alternative use	No
Instance on 1st Floor - Girls (330 Lockers)	Inspected
Alternative use	No
Ceiling	
Instance on 1st Floor - Girls (330 Lockers)	Inspected
Condition	2 - Between Good and Fair
Deficiency	ACOUSTIC TILES ON PLASTER: DAMAGED/MISSING
Deficiency Location/Instance	Near skylights
Deficiency Quantity	20
Quantity Uom	S.F.
Potential Action	REPLACE
Urgency of Action	PRIORITY 3
Purpose of Action	LEVEL 2
Deficiency Photo1

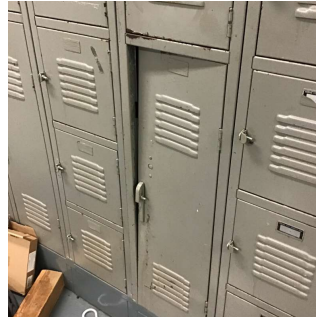
Locker 4

Deficiency DAMAGED UNITS

Deficiency Location/Instance Locker 803,623, 596,594,272, and others

Potential Action REPLACE

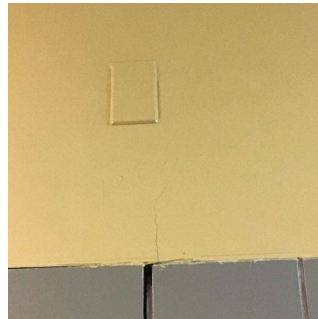
Near Entrance

Instance on 1st Floor - Girls (330 Lockers)	Inspected
Condition	2 - Between Good and Fair
Deficiency	PLASTER: CRACKS/SPALLING
Deficiency Location/Instance	Near Entrance, center
Deficiency Quantity	20
Quantity Uom	S.F.
Potential Action	REPLACE
Urgency of Action	PRIORITY 3
Purpose of Action	LEVEL 2
Deficiency Photo1

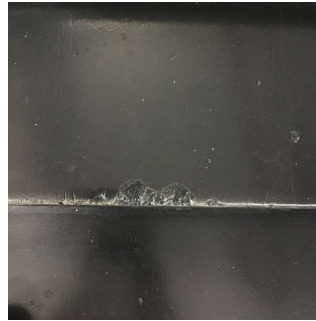
Stair B/1

VINYL TILES: DETERIORATED SUBSTRATE

REPLACE

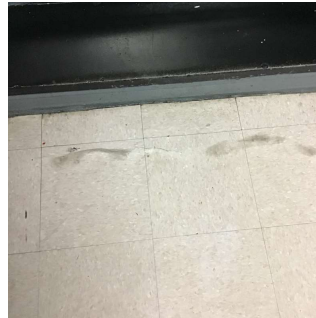
Stair B/1

TERRAZZO: CRACKS

REPLACE

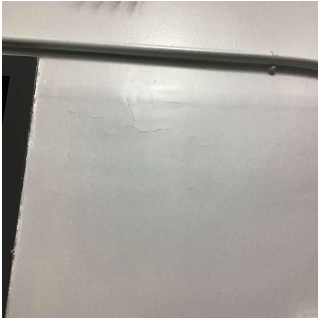
Question	Response
INTERIOR	
TOILET ROOMS - STAFF	
Stalls	Inspected
Condition	2 - Between Good and Fair
Deficiency	No deficiencies recorded
Walls	Inspected
Condition	2 - Between Good and Fair
Deficiency	PLASTER: CRACKS/SPALLING
Deficiency Location/Instance	Room 423A
Deficiency Quantity	10
Quantity Uom	S.F.
Potential Action	REPLACE
Urgency of Action	PRIORITY 3
Purpose of Action	LEVEL 2
Deficiency Photo1

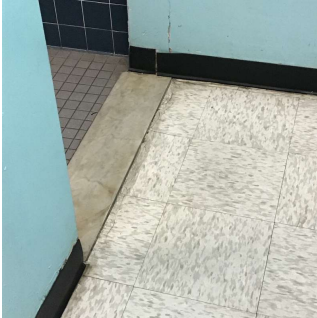
Question	Response
INTERIOR	
TOILET ROOMS - STUDENTS	
Floor Finish	
Condition	2 - Between Good and Fair
Deficiency	VINYL TILES: BROKEN/DETERIORATED/MISSING TILES
Deficiency Location/Instance	Room B32
Deficiency Quantity	10
Quantity Uom	S.F.
Potential Action	REPLACE
Urgency of Action	PRIORITY 3
Purpose of Action	LEVEL 2
Deficiency Photo1

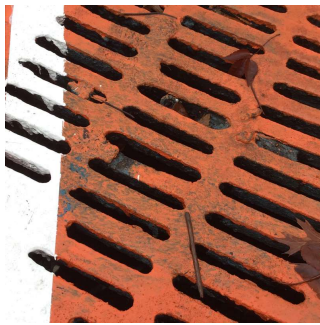
Condition	3 - Fair
Deficiency	DAMAGED COVER
Deficiency Location/Instance	Schoolyard
Deficiency Quantity	1
Quantity Uom	EACH
Potential Action	REPLACE
Urgency of Action	PRIORITY 3
Purpose of Action	LEVEL 2

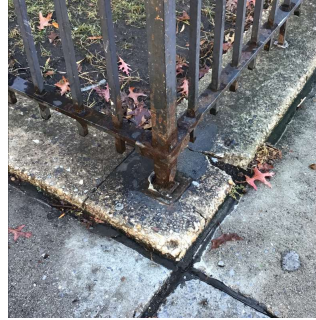
Along Martin Luther King Jr. Place
No violations recorded.

CONCRETE CURB: DAMAGED/DETERIORATED

REPLACE

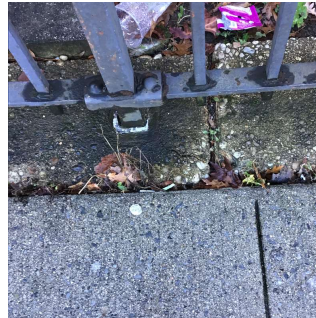
Along Martin Luther King Jr. Place
No violations recorded.

CHAIN LINK: DAMAGED/DETERIORATED

REPLACE

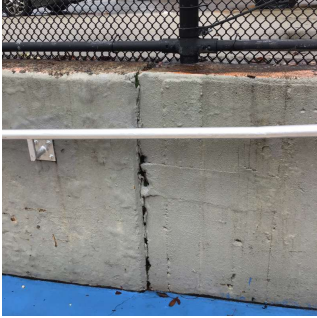
Schoolyard
Violations	No violations recorded.
RETAINING WALLS	Inspected
Are there any Retaining Walls 6' OR higher facing public street/sidewalk?	Yes
Condition	3 - Fair
Deficiency	CAST IN PLACE CONCRETE: DETERIORATED CONTROL/EXPANSION JOINT
Deficiency Location/Instance	Schoolyard

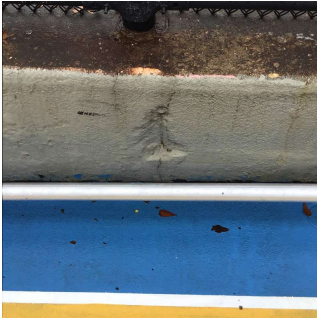
Violations	Along Martin Luther King Jr. Place No violations recorded.
Deficiency	CAST IN PLACE CONCRETE: CRACKS/SPALLING - MAJOR
Deficiency Location/Instance	Schoolyard
Deficiency Quantity	50
Quantity Uom	S.F.
Potential Action	REPLACE
Urgency of Action	PRIORITY 3
Purpose of Action	LEVEL 2
Deficiency Photo1

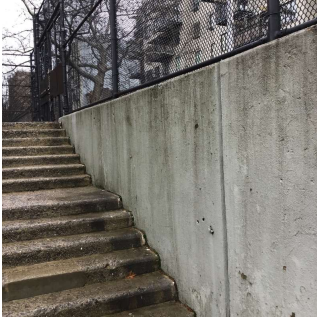
Question	Response
SITE	
STAIRS/RAMPS: EXTERIOR	
Railings	Inspected
Condition	5 - Poor
Deficiency	MISSING
Deficiency Location/Instance	Along Stockton Street
Deficiency Quantity	30
Quantity Uom	L.F.
Potential Action	REPLACE
Urgency of Action	PRIORITY 5
Purpose of Action	LEVEL 6
Deficiency Photo1

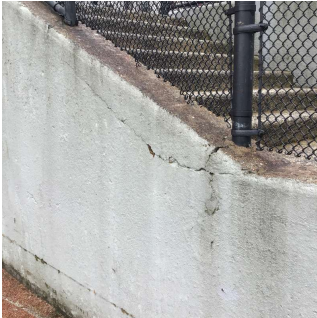
Violations	Along Stockton Street No violations recorded.
Site Cheek/flank Walls	Inspected
Condition	2 - Between Good and Fair
Deficiency	CAST IN PLACE CONCRETE: CRACKS/SPALLING - MAJOR
Deficiency Location/Instance	Schoolyard
Deficiency Quantity	20
Quantity Uom	S.F.
Potential Action	REPLACE
Urgency of Action	PRIORITY 3
Purpose of Action	LEVEL 2
Deficiency Photo1

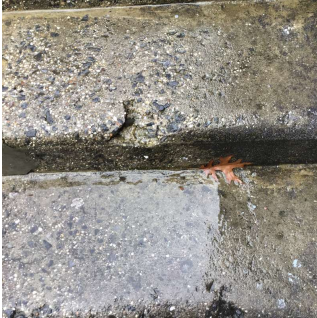
Violations	Schoolyard No violations recorded.
Stairs/ramps	Inspected
Condition	3 - Fair
Deficiency	CAST IN PLACE CONCRETE: WORN-OUT TREAD/RISER/NOSERS
Deficiency Location/Instance	Along Stockton Street
Deficiency Quantity	10
Quantity Uom	S.F.
Potential Action	REPLACE

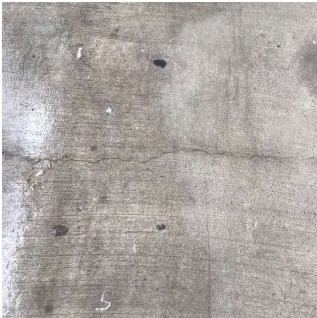
Near exit 9
Violations	No violations recorded.
ARTWORK	Inspected
Instance	Exterior - Building Facade - 11666
Instance Photo

Along Stockton Street
Violations	No violations recorded.
Deficiency	CAST IN PLACE CONCRETE: CRACKS/SPALLING - MAJOR
Deficiency Location/Instance	Near exit 9, Schoolyard
Deficiency Quantity	50
Quantity Uom	S.F.
Potential Action	REPLACE
Urgency of Action	PRIORITY 3
Purpose of Action	LEVEL 2
Deficiency Photo1
