NYC Department of Education
Building Condition Assessment Survey 2023 - 2024

Architectural Inspection

Asset: P.S. 34 - BROOKLYN, 131 NORMAN AVENUE, New York, 11222

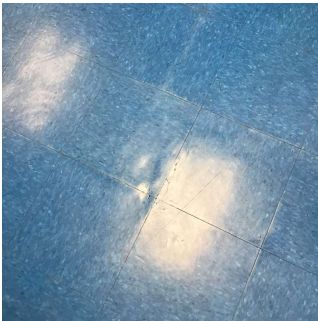
Violations	Roof Structure at Roof 4 No violations recorded.
VAULTS-BUNKERS	Does not Exist
AUDITORIUM	Does not Exist
CAFETERIA	Inspected
Instance on Basement - East	Inspected
Instance on Basement - West (300 SF)	Inspected
Ceiling	
Instance on Basement - East	Inspected
Condition	2 - Between Good and Fair
Deficiency	No deficiencies recorded
Instance on Basement - West (300 SF)	Inspected
Condition	2 - Between Good and Fair
Deficiency	No deficiencies recorded
Door(s)	
Instance on Basement - East	Not Required
Instance on Basement - West (300 SF)	Not Required
Fixed Equipment	
Instance on Basement - East	Does not Exist
Instance on Basement - West (300 SF)	Does not Exist
Floor Finish	
Instance on Basement - West (300 SF)	Inspected
Condition	4 - Between Fair and Poor
Deficiency	VINYL TILES: DETERIORATED SUBSTRATE
Deficiency Location/Instance	Center, Near Stair E

Deficiency Quantity	25
Quantity Uom	S.F.
Potential Action	REPLACE
Urgency of Action	PRIORITY 3
Purpose of Action	LEVEL 2

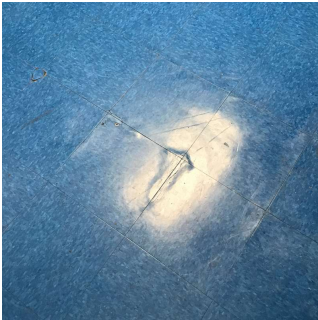
Center
Violations	No violations recorded.
Instance on Basement - East	Inspected
Condition	2 - Between Good and Fair
Deficiency	VINYL TILES: DETERIORATED SUBSTRATE
Deficiency Location/Instance	Near Girls Toilet Room, Near Exit 11, East Side, West Side
Deficiency Quantity	80
Quantity Uom	S.F.
Potential Action	REPLACE
Urgency of Action	PRIORITY 3
Purpose of Action	LEVEL 2
Deficiency Photo1

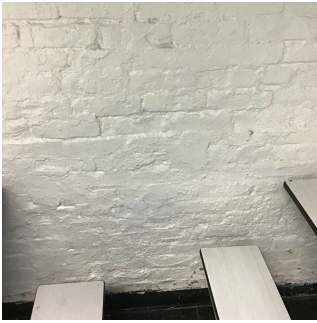
Near Girls Toilet Room
Violations	No violations recorded.
Sliding-folding Partition	
Instance on Basement - East	Does not Exist
Instance on Basement - West (300 SF)	Does not Exist
Stage	
Instance on Basement - East	Does not Exist
Instance on Basement - West (300 SF)	Does not Exist
Walls	
Instance on Basement - East	Inspected
Condition	2 - Between Good and Fair
Deficiency	BRICK: CRACKS/SPALLING - ACTIVE LEAK
Deficiency Location/Instance	Near Stair E, Near Stair F

Deficiency Quantity	80
Quantity Uom	S.F.
Potential Action	REPLACE
Urgency of Action	PRIORITY 5
Purpose of Action	LEVEL 2

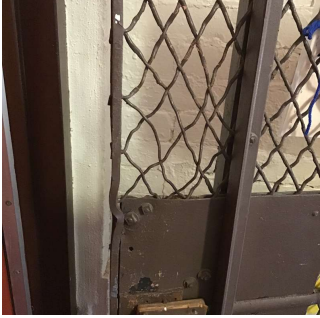
Question	Response
INTERIOR	
CLASSROOMS/CORRIDORS/ADMIN SPACES	Inspected
Walls	Inspected
Violations	Basement Staff Lounge No violations recorded.
Specialties	Does not Exist
GYMNASIUM	Does not Exist
INTERIOR DOOR HARDWARE	Inspected
Condition	3 - Fair
Deficiency	No deficiencies recorded
INTERIOR GUARDS	Inspected
Condition	2 - Between Good and Fair
Deficiency	DETERIORATED/TORN-OUT/MISSING
Deficiency Location/Instance	Stair A/1
Deficiency Quantity	20
Quantity Uom	S.F.
Potential Action	REPLACE
Urgency of Action	PRIORITY 3
Purpose of Action	LEVEL 2
Deficiency Photo1

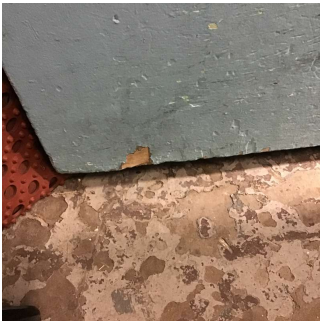
Violations	Stair A/1 No violations recorded.
KITCHEN	Inspected
Instance on Basement	Inspected
Ceiling	
Instance on Basement	Inspected
Condition	2 - Between Good and Fair
Deficiency	No deficiencies recorded
Door(s)	
Instance on Basement	Inspected
Condition	3 - Fair
Deficiency	WOOD: DETERIORATED DOOR
Deficiency Location/Instance	Exit 14 Vestibule
Deficiency Quantity	1

Quantity Uom	EACH
Potential Action	MAINTENANCE
Urgency of Action	PRIORITY 3
Purpose of Action	LEVEL 2

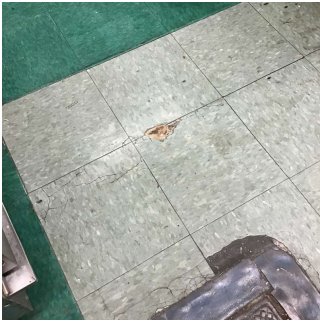
Violations	Exit 14 Vestibule No violations recorded.
Floor Finish	
Instance on Basement	Inspected
Condition	2 - Between Good and Fair
Deficiency	VINYL TILES: DETERIORATED SUBSTRATE
Deficiency Location/Instance	Near Exit 14
Deficiency Quantity	20
Quantity Uom	S.F.
Potential Action	REPLACE
Urgency of Action	PRIORITY 3
Purpose of Action	LEVEL 2
Deficiency Photo1

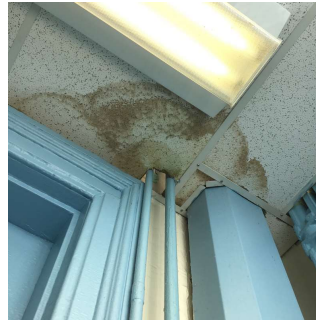
1st Floor Staff At Stair A

Ceiling

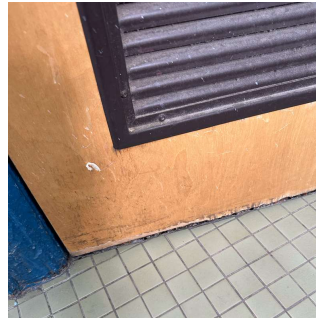
1st Floor Staff at Stair B

WOOD: DETERIORATED DOOR

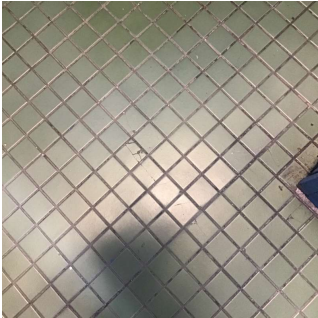
Question	Response
INTERIOR	
TOILET ROOMS - STAFF	
Door(s)	Inspected 2nd Floor Staff
Violations	No violations recorded.
Floor Finish	Inspected
Condition	3 - Fair
Deficiency	CERAMIC TILE: BROKEN/MISSING TILES
Deficiency Location/Instance	2nd Floor Staff
Deficiency Quantity	10
Quantity Uom	S.F.
Potential Action	REPLACE
Urgency of Action	PRIORITY 3
Purpose of Action	LEVEL 2
Deficiency Photo1

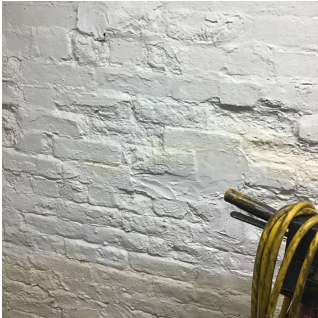
Violations	2nd Floor Staff No violations recorded.
Stalls	Does not Exist
Walls	Inspected
Condition	2 - Between Good and Fair
Deficiency	BRICK: CRACKS/SPALLING
Deficiency Location/Instance	Basement Staff
Deficiency Quantity	10
Quantity Uom	S.F.
Potential Action	REPLACE
Urgency of Action	PRIORITY 3
Purpose of Action	LEVEL 2
Deficiency Photo1

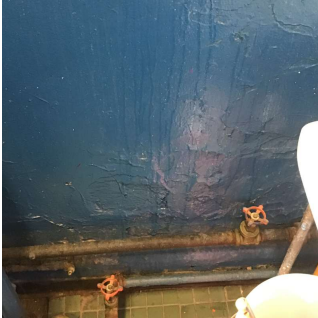
Violations	Basement Staff No violations recorded.
Deficiency	PLASTER: CRACKS/SPALLING
Deficiency Location/Instance	2nd Floor Staff
Deficiency Quantity	10

Question	Response
INTERIOR	
TOILET ROOMS - STAFF	
Walls	
Quantity Uom	S.F.
Potential Action	REPLACE
Urgency of Action	PRIORITY 3
Purpose of Action	LEVEL 2
Deficiency Photo1

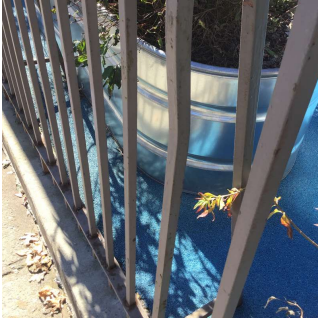
Question	Response
SITE	
FENCES	
Purpose of Action	LEVEL 2
Deficiency Photo1	 
Violations	McGuinness Boulevard No violations recorded.
Deficiency	WROUGHT IRON: DAMAGED/DETERIORATED
Deficiency Location/Instance	McGuinness Boulevard, Norman Avenue, Eckford Street
Deficiency Quantity	200
Quantity Uom	S.F.
Potential Action	REPLACE
Urgency of Action	PRIORITY 3
Purpose of Action	LEVEL 2
Deficiency Photo1

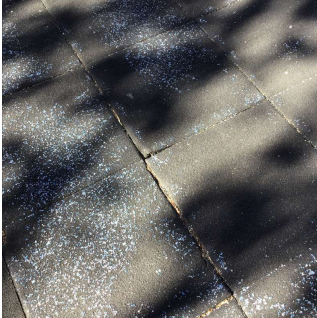
Question	Response
SITE	
PLAYGROUNDS	
Play Equipment	
Instance on McGuinness Boulevard Schoolyard	Does not Exist
Safety Surfacing	
Instance on Eckford Street Schoolyard	Inspected
Condition	2 - Between Good and Fair
Deficiency	DETERIORATED/MISSING
Deficiency Location/Instance	Center
Deficiency Quantity	15
Quantity Uom	S.F.
Potential Action	REPLACE
Urgency of Action	PRIORITY 3
Purpose of Action	LEVEL 2
Deficiency Photo1

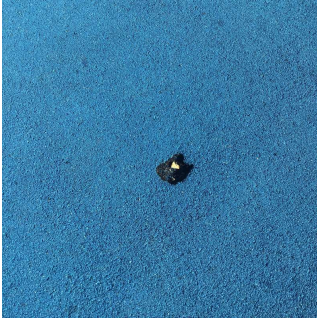
Center
Violations	No violations recorded.
Unpaved Area	
Instance on McGuinness Boulevard Schoolyard	Does not Exist
Instance on Eckford Street Schoolyard	Does not Exist

Center
Violations	No violations recorded.
Instance on McGuinness Boulevard Schoolyard	Inspected
Condition	2 - Between Good and Fair
Deficiency	DETERIORATED/MISSING
Deficiency Location/Instance	Center
Deficiency Quantity	10
Quantity Uom	S.F.
Potential Action	REPLACE
Urgency of Action	PRIORITY 3
Purpose of Action	LEVEL 2
Deficiency Photo1
