NYC Department of Education
Building Condition Assessment Survey 2023 - 2024

Architectural Inspection

Asset: P.S. 39 - BROOKLYN, 417 6TH AVENUE, New York, 11215

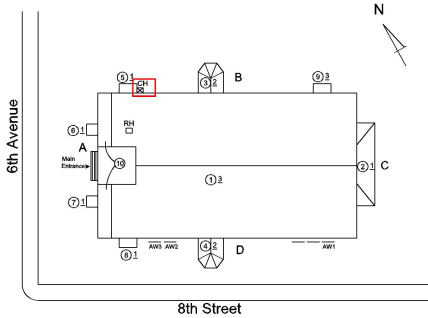
Violations	Facade D - AW2 No violations recorded.
AWNINGS AND CANOPIES	
	Does not Exist
CHIMNEY	
Material Type(s)	Inspected Masonry
Condition	2 - Between Good and Fair
Deficiency	BRICK: MINOR CRACKS AND SPALLING
Roof Plan reference	K039

Deficiency Quantity	10
Quantity Uom	S.F.
Potential Action	RESTITCH
Urgency of Action	PRIORITY 3
Purpose of Action	LEVEL 2
Deficiency Photo1

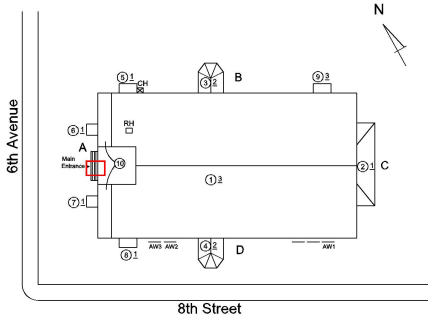
Question	Response
EXTERIOR	
DOORS	Inspected
DOORS AND FRAMES	Inspected
Condition	5 - Poor
Deficiency	WOOD: DETERIORATED DOOR AND FRAME - MAJOR DETERIORATION
Roof Plan reference	K039

Deficiency Quantity	2
Quantity Uom	EACH
Potential Action	REPLACE
Urgency of Action	PRIORITY 4
Purpose of Action	LEVEL 2
Deficiency Photo1

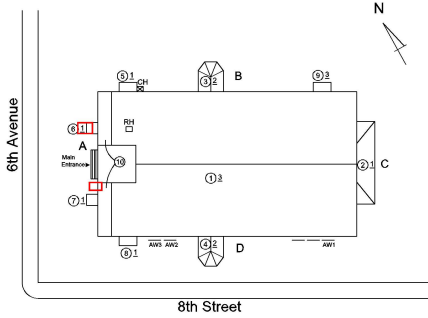
Violations	Facade A - Main Entrance No violations recorded.
Deficiency	METAL CLAD: DETERIORATED DOOR AND FRAME - MAJOR DETERIORATION
Roof Plan reference	K039

Deficiency Quantity	2
Quantity Uom	EACH
Potential Action	REPLACE
Urgency of Action	PRIORITY 4
Purpose of Action	LEVEL 2

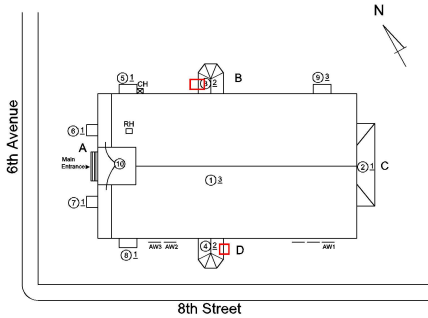
Violations	Facade A - Exit 2 No violations recorded.
Deficiency	METAL CLAD: DETERIORATED DOOR - MAJOR DETERIORATION
Roof Plan reference	K039

Deficiency Quantity	2
Quantity Uom	EACH
Potential Action	REPLACE
Urgency of Action	PRIORITY 4
Purpose of Action	LEVEL 2
Deficiency Photo1

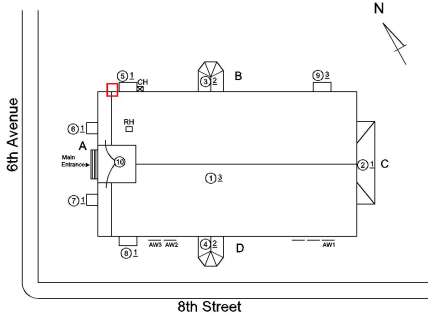
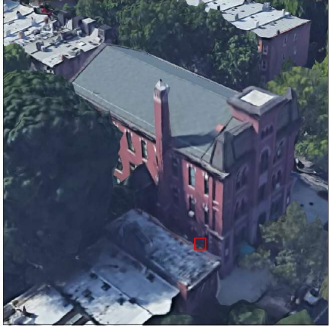
Question	Response
EXTERIOR	
EXTERIOR WALLS	Inspected
Material Type(s)	Masonry, Steel
Replacement Quantity	15,000
Replacement Uom	S.F.
Instance on All Facades	Inspected
Instance Condition	3 - Fair
Instance Quantity	15,000
Instance Quantity Uom	S.F.
Deficiency	BRICK: DETERIORATED MASONRY SILLS - MINOR
Roof Plan reference	K039

Deficiency Quantity	10
Quantity Uom	L.F.
Potential Action	REPAIR
Urgency of Action	PRIORITY 3
Purpose of Action	LEVEL 2
Deficiency Photo1

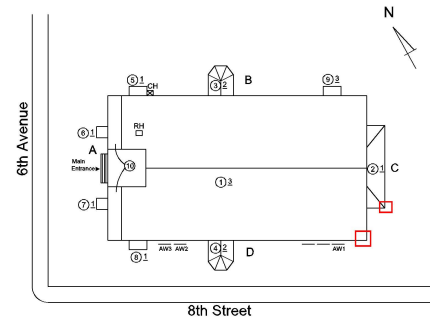
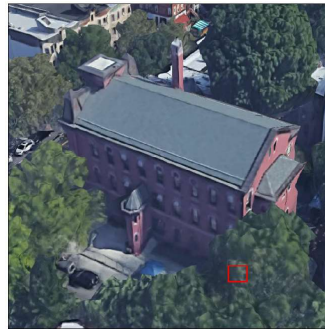
Violations	Facade B No violations recorded.
Deficiency	BRICK: CRACKS/DISPLACED/SPALLED BRICK AT BUILDING CORNERS

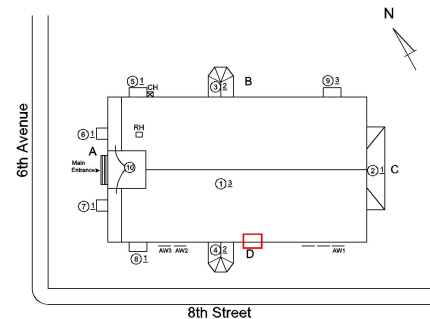
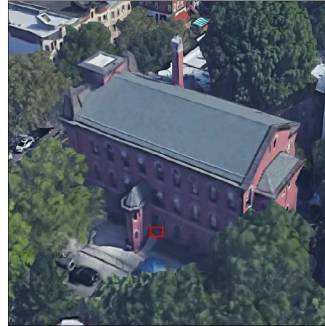
BRICK: DETERIORATED MASONRY SILLS - MAJOR

REMOVE AND REPLACE

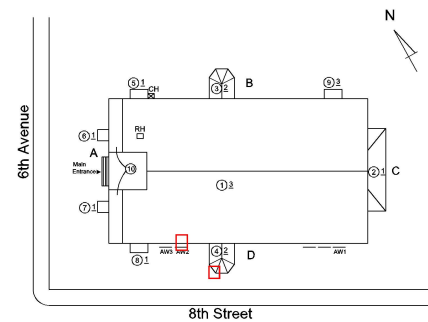
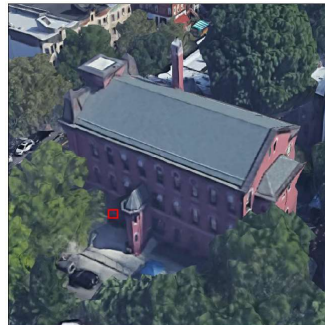
BRICK: MINOR CRACKS AND SPALLING

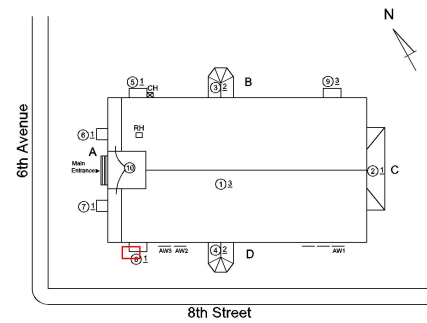
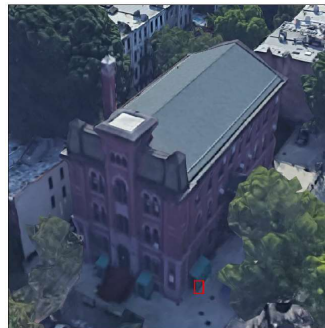
METAL PANEL: DAMAGED TRIM

REPLACE

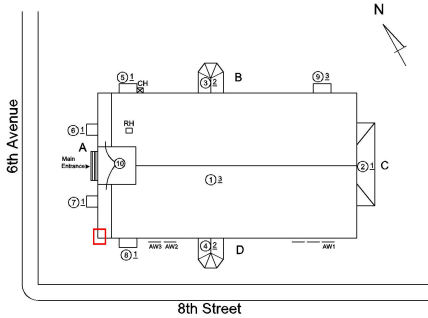
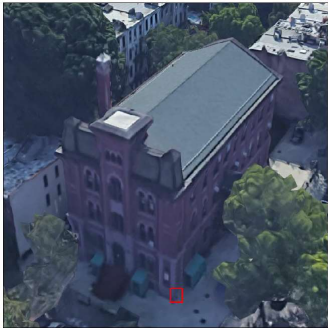
Question	Response
EXTERIOR	
EXTERIOR WALLS	
Violations	No violations recorded.
Deficiency	STONE: CRACKS AT BUILDING CORNERS
Roof Plan reference	K039

Deficiency Quantity	10
Quantity Uom	S.F.
Potential Action	REPLACE
Urgency of Action	PRIORITY 4
Purpose of Action	LEVEL 2
Deficiency Photo1

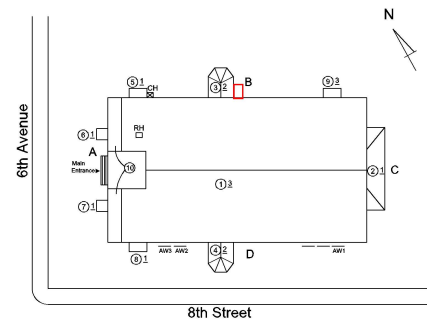
Condition	3 - Fair
Deficiency	CAST IN PLACE CONCRETE: CRACKS/SPALLING - MAJOR
Roof Plan reference	K039

Deficiency Quantity	10
Quantity Uom	S.F.
Potential Action	REPLACE
Urgency of Action	PRIORITY 4
Purpose of Action	LEVEL 2

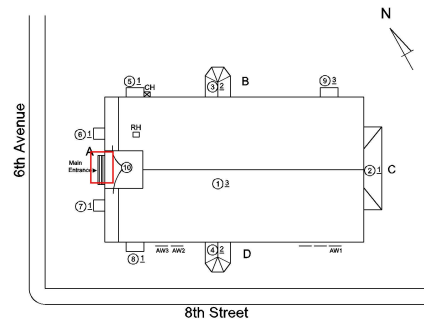
RUST - MAJOR

REPLACE

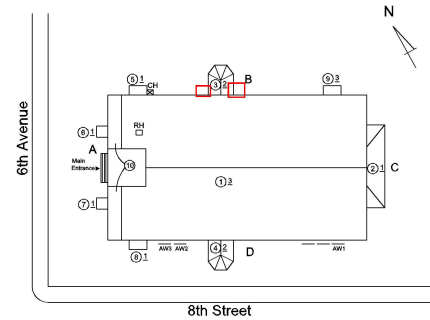
STONE: WORN-OUT TREAD/RISER/NOSING

40
S.F.
REPLACE
PRIORITY 4
LEVEL 2

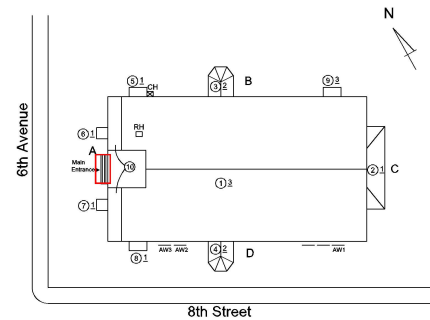
CONCRETE: CRACKS/SPALLING - MAJOR

20
S.F.
REPLACE
PRIORITY 4
LEVEL 2
