NYC Department of Education
Building Condition Assessment Survey 2023 - 2024

Architectural Inspection

Asset: P.S. 40 - BROOKLYN, 265 RALPH AVENUE, New York, 11221

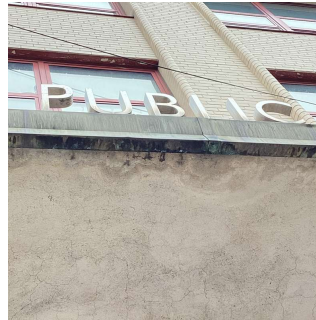
Facade A

CONCRETE: WATER PENETRATION

50
S.F.
REPAIR
PRIORITY 5
LEVEL 2

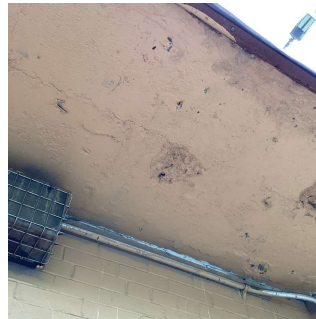
Facade G

CONCRETE: MAJOR CRACKS/SPALLING

REPAIR

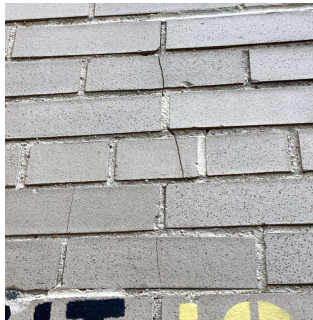
Question	Response
EXTERIOR	
DOORS	
DOORS AND FRAMES	
Violations	No violations recorded.
Deficiency	METAL: DETERIORATED DOOR AND FRAME - MAJOR DETERIORATION
Roof Plan reference	
Deficiency Quantity	9
Quantity Uom	EACH
Potential Action	REPLACE
Urgency of Action	PRIORITY 4
Purpose of Action	LEVEL 2
Deficiency Photo1	
Violations	Facade C No violations recorded.
DOOR HARDWARE	Inspected
Condition	3 - Fair
Deficiency	No deficiencies recorded
LINTELS	Inspected
Condition	2 - Between Good and Fair
Deficiency	No deficiencies recorded
TRANSOM/SIDE LIGHT	Inspected
Condition	2 - Between Good and Fair
Deficiency	No deficiencies recorded
EXTERIOR WALLS	Inspected
Material Type(s)	Masonry
Replacement Quantity	25,000
Replacement Uom	S.F.
Instance on All Facades	Inspected
Instance Condition	4 - Between Fair and Poor
Instance Quantity	25,000
Instance Quantity Uom	S.F.
Deficiency	BRICK: MINOR CRACKS AND SPALLING

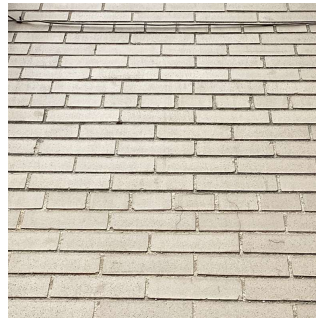
Facade C

BRICK: DETERIORATED JOINTS

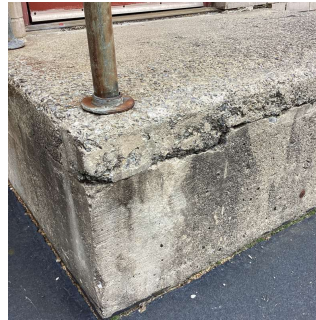
Facade K

Deficiency	CAST IN PLACE CONCRETE: CRACKS/SPALLING - MAJOR
------------	---

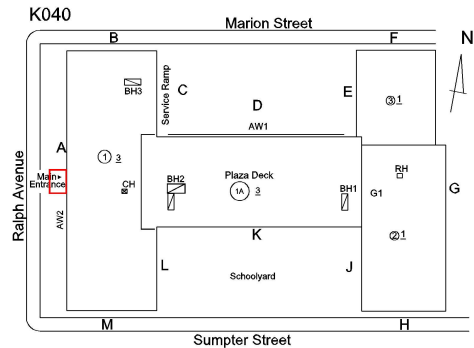
Roof Plan reference

Deficiency	CONCRETE: CRACKS/SPALLING - MINOR
------------	-----------------------------------

Deficiency Quantity

20

REPAIR

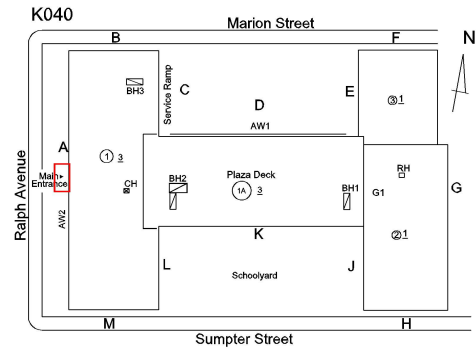
Roof Plan reference

CONCRETE: WORN-OUT TREAD/RISER/NOSING

10

S.F.

REPLACE

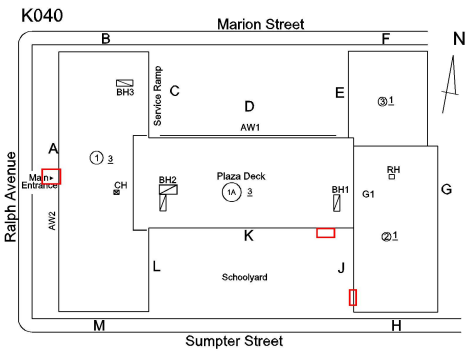
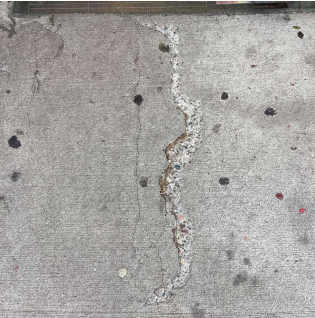
Question	Response
EXTERIOR	
STAIRS/RAMPS: EXTERIOR	
STAIRS/RAMPS	
Rooftop reference

CONCRETE: CRACKS/SPALLING - MAJOR

Deficiency Quantity	20
Quantity Uom	S.F.
Potential Action	REPLACE
Urgency of Action	PRIORITY 4
Purpose of Action	LEVEL 2
Deficiency Photo1

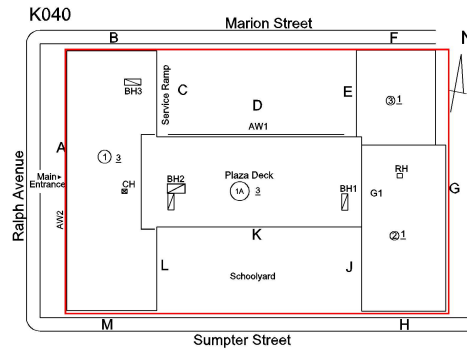
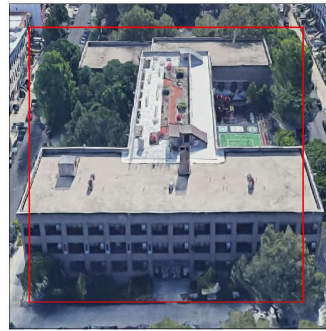
Roof Plan reference

Violations	Facade A No violations recorded.
WINDOWS	Inspected
Replacement Quantity	12,000
Replacement Uom	S.F.
EXTERIOR GUARDS	
Condition	2 - Between Good and Fair
Deficiency	No deficiencies recorded
LINTELS	
Condition	2 - Between Good and Fair
Deficiency	No deficiencies recorded
WINDOWS	
Material Type(s)	Aluminum
Instance on Aluminum - Other: All Facades except Gymnasium Facades	Inspected
Instance Condition	5 - Poor
Instance Quantity	11,500
Instance Quantity Uom	S.F.
Are these windows insulated	Yes
Installation Year	2008
Source of Installation	Custodial Staff
Deficiency	ALUMINUM - OTHER: DETERIORATED

6,000

REPLACE WINDOW

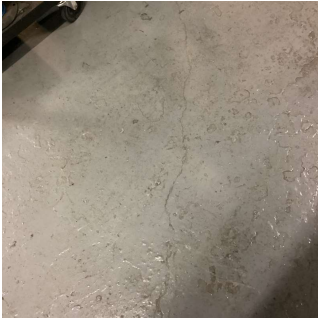
Question	Response
INTERIOR	
STRUCTURAL	
COLUMNS/BEAMS/BEARING WALLS	Inspected
Condition	2 - Between Good and Fair
Deficiency	No deficiencies recorded
FLOOR STRUCTURE	Inspected
Condition	3 - Fair
Deficiency	CONCRETE SLAB ON GRADE: THRU CRACKS
Deficiency Location/Instance	Boiler Room, Electrical Panel Room, Paint Storage Room
Deficiency Quantity	40
Quantity Uom	S.F.
Potential Action	REPAIR
Urgency of Action	PRIORITY 3
Purpose of Action	LEVEL 5
Deficiency Photo1

Boiler Room
Violations	No violations recorded.
FOUNDATION WALLS	Inspected
Material Type(s)	Concrete
Condition	2 - Between Good and Fair
Deficiency	No deficiencies recorded
ROOF STRUCTURE	Inspected
Condition	3 - Fair
Deficiency	CONCRETE COLUMNS AND BEAMS: CRACKED/SPALLED/REINFORCEMENT EXPOSED
Deficiency Location/Instance	BH3
Deficiency Quantity	10
Quantity Uom	S.F.
Potential Action	REPLACE
Urgency of Action	PRIORITY 4
Purpose of Action	LEVEL 5
Deficiency Photo1

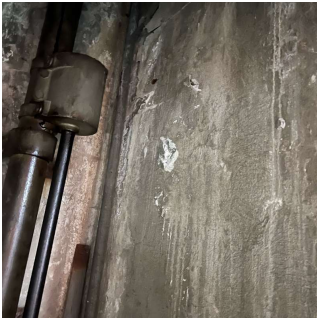
Question	Response
INTERIOR	
STRUCTURAL	
VAULTS-BUNKERS	Inspected
Foundation Walls	Inspected
Condition	3 - Fair
Deficiency	CRACKS, SPALLING
Deficiency Location/Instance	Ash Hoist Vault
Deficiency Quantity	10
Quantity Uom	S.F.
Potential Action	REPAIR
Urgency of Action	PRIORITY 4
Purpose of Action	LEVEL 5
Deficiency Photo1

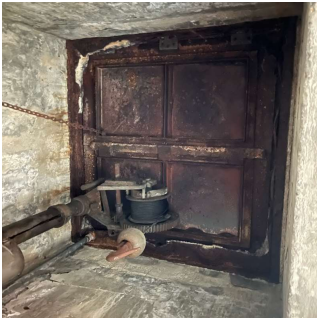
Violations	Ash Hoist Vault No violations recorded.
Slab Structure	Inspected
Condition	2 - Between Good and Fair
Deficiency	No deficiencies recorded
Vault/Ash Hoist Doors and Framing	Inspected
Condition	5 - Poor
Deficiency	DETERIORATED/DAMAGED VAULT/ASH HOIST DOORS AND FRAMING
Deficiency Location/Instance	Ash Hoist Vault
Deficiency Quantity	2
Quantity Uom	EACH
Potential Action	REPLACE
Urgency of Action	PRIORITY 4
Purpose of Action	LEVEL 2
Deficiency Photo1

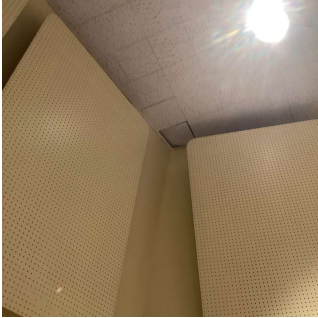
Rear Left
No violations recorded.

Instance on 1st Floor (470 Seats)	Inspected
Condition	2 - Between Good and Fair
Deficiency	ACOUSTIC TILES ON PLASTER: DAMAGED/MISSING
Deficiency Location/Instance	Rear Left
Deficiency Quantity	10
Quantity Uom	S.F.
Potential Action	REPLACE
Urgency of Action	PRIORITY 3
Purpose of Action	LEVEL 2
Deficiency Photo1

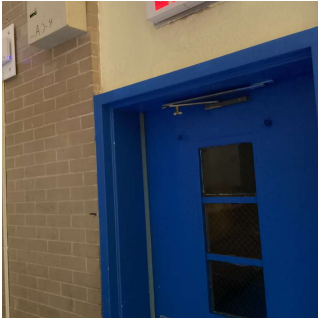
Left of Stage
35671849Y

Instance on 1st Floor (470 Seats)	Inspected
Condition	3 - Fair
Deficiency	METAL: DETERIORATED DOOR AND FRAME
Deficiency Location/Instance	Left of Stage
Deficiency Quantity	1
Quantity Uom	EACH
Potential Action	MAINTENANCE
Urgency of Action	PRIORITY 4
Purpose of Action	LEVEL 4
Deficiency Photo1

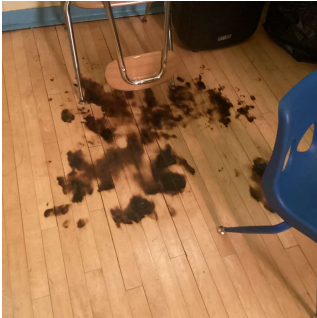
Question	Response
INTERIOR	
AUDITORIUM	
Stage	
Stage	
Deficiency Location/Instance	Left Stage
Deficiency Quantity	10
Quantity Uom	S.F.
Potential Action	REPLACE
Urgency of Action	PRIORITY 3
Purpose of Action	LEVEL 2
Deficiency Photo1

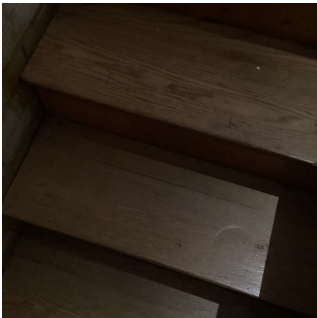
Violations	Left Stage No violations recorded.
Deficiency	DAMAGED STEPS
Deficiency Location/Instance	Right Side
Deficiency Quantity	10
Quantity Uom	S.F.
Potential Action	REPLACE
Urgency of Action	PRIORITY 3
Purpose of Action	LEVEL 2
Deficiency Photo1

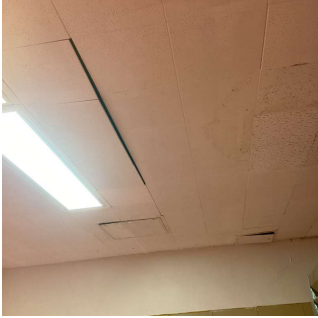
Rear
No violations recorded.

Question	Response
INTERIOR	
AUDITORIUM	
Stage	
Stage Curtains	
Potential Action	REPLACE
Urgency of Action	PRIORITY 3
Purpose of Action	LEVEL 2
Deficiency Photo1	 
	Left Rear
Violations	No violations recorded.
Walls	
Instance on 1st Floor (470 Seats)	Inspected
Condition	2 - Between Good and Fair
Deficiency	PLASTER: CRACKS/SPALLING
Deficiency Location/Instance	Rear Left Side
Deficiency Quantity	30
Quantity Uom	S.F.
Potential Action	REPLACE
Urgency of Action	PRIORITY 3
Purpose of Action	LEVEL 2
Deficiency Photo1	 
	Rear Left Side
Violations	No violations recorded.
Window Curtains/Shades/Blinds	
Instance on 1st Floor (470 Seats)	Does not Exist
CAFETERIA	
Instance on Basement	Inspected
Instance on Basement	Inspected
Ceiling	
Instance on Basement	Inspected
Condition	2 - Between Good and Fair
Deficiency	ACOUSTIC TILES: DAMAGED/MISSING
Deficiency Location/Instance	Rear, Center, Along Windows
Deficiency Quantity	30
Quantity Uom	S.F.

Potential Action	REPLACE
Urgency of Action	PRIORITY 3
Purpose of Action	LEVEL 2
Deficiency Photo1

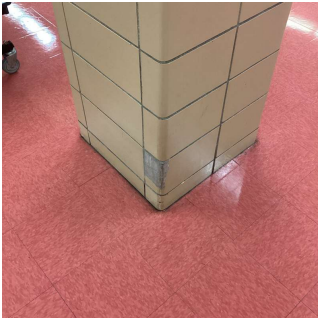
Instance on Basement	Inspected
Condition	2 - Between Good and Fair
Deficiency	GLAZED BLOCK: CRACKS/SPALLING
Deficiency Location/Instance	Rear Column
Deficiency Quantity	10
Quantity Uom	S.F.
Potential Action	REPLACE
Urgency of Action	PRIORITY 3
Purpose of Action	LEVEL 2
Deficiency Photo1

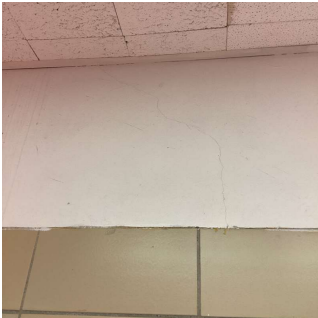
Question	Response
INTERIOR	
CAFETERIA	
Walls	
Violations	Rear Column No violations recorded.
Deficiency	PLASTER: CRACKS/SPALLING
Deficiency Location/Instance	Near Exit, Rear, Along Windows
Deficiency Quantity	30
Quantity Uom	S.F.
Potential Action	REPLACE
Urgency of Action	PRIORITY 3
Purpose of Action	LEVEL 2
Deficiency Photo1

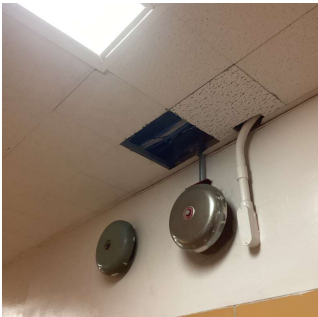
Violations	Near Exit No violations recorded.
Window Curtains/Shades/Blinds	
Instance on Basement	Does not Exist
CLASSROOMS/CORRIDORS/ADMIN SPACES	
Ceiling	
Condition	Inspected
Condition	2 - Between Good and Fair
Deficiency	ACOUSTIC TILES: DAMAGED/MISSING
Deficiency Location/Instance	Corridor near Rooms B23, B25, 116, 119, Corridor near Stair A/Basement and others
Deficiency Quantity	80
Quantity Uom	S.F.
Potential Action	REPLACE
Urgency of Action	PRIORITY 3
Purpose of Action	LEVEL 2
Deficiency Photo1

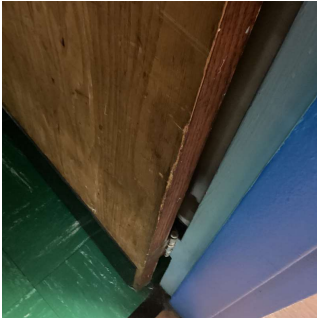
Question	Response
INTERIOR	
CLASSROOMS/CORRIDORS/ADMIN SPACES	
Door(s)	
Deficiency Location/Instance	Room 216
Deficiency Quantity	1
Quantity Uom	EACH
Potential Action	MAINTENANCE
Urgency of Action	PRIORITY 4
Purpose of Action	LEVEL 4
Deficiency Photo1	 
	Room 216
Violations	35671848M
Deficiency	WOOD: DETERIORATED DOOR
Deficiency Location/Instance	Rooms 136, 138, 147, 148, 149 and others
Deficiency Quantity	25
Quantity Uom	EACH
Potential Action	MAINTENANCE
Urgency of Action	PRIORITY 3
Purpose of Action	LEVEL 2
Deficiency Photo1

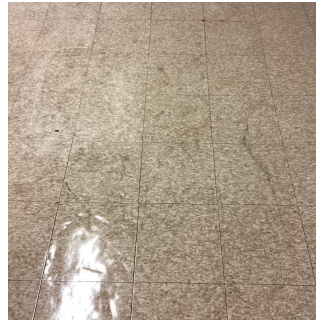
Room 148
Violations	No violations recorded.
Floor Finish	Inspected
Condition	2 - Between Good and Fair
Deficiency	VINYL TILES: DETERIORATED SUBSTRATE
Deficiency Location/Instance	Corridor near room B25
Deficiency Quantity	40
Quantity Uom	S.F.
Potential Action	REPLACE
Urgency of Action	PRIORITY 3
Purpose of Action	LEVEL 2

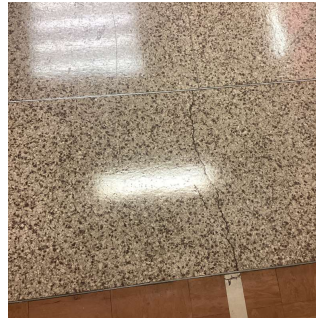
Lobby

TERRAZZO: CRACKS

REPLACE

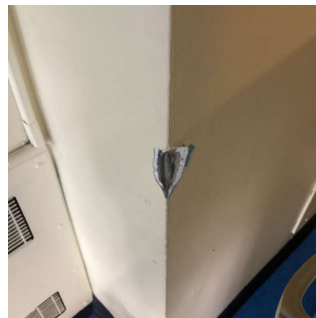
PLASTER: CRACKS/SPALLING

REPLACE

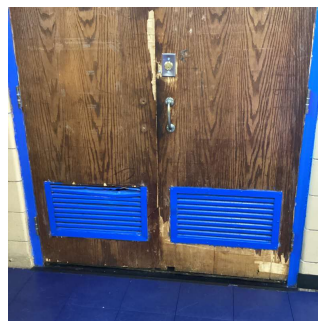
Condition	4 - Between Fair and Poor
-----------	---------------------------

Deficiency	WOOD: DETERIORATED DOOR
------------	-------------------------

Deficiency Location/Instance	Storage Room
------------------------------	--------------

Deficiency Quantity	2
---------------------	---

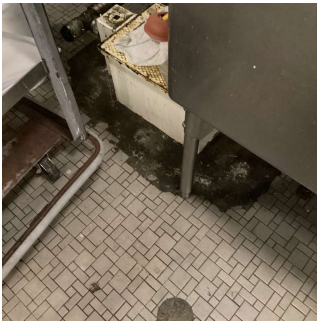
Question	Response
INTERIOR	
KITCHEN	
Floor Finish	
Deficiency Photo1

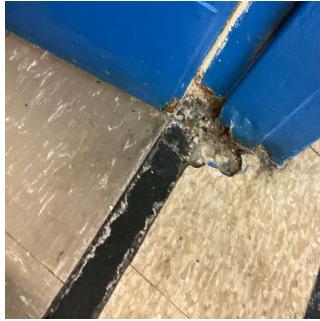
Stair B/3
Violations	No violations recorded.
Door(s)	Inspected
Condition	3 - Fair
Deficiency	METAL: DETERIORATED DOOR AND FRAME
Deficiency Location/Instance	Stair A/Basement (2 Doors)
Deficiency Quantity	2
Quantity Uom	EACH
Potential Action	MAINTENANCE
Urgency of Action	PRIORITY 3
Purpose of Action	LEVEL 2
Deficiency Photo1

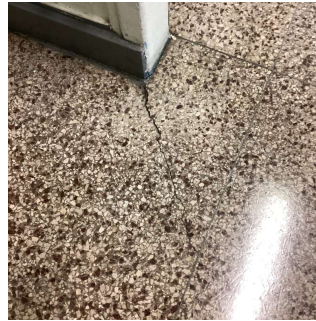
Stair B/Basement

Stair A/Basement
Violations	No violations recorded.
Partition	Does not Exist
Railings	Inspected
Condition	2 - Between Good and Fair
Deficiency	No deficiencies recorded
Stairs and Landings	Inspected
Condition	3 - Fair
Deficiency	TERRAZZO: CRACKS
Deficiency Location/Instance	Stair B/Basement,Main Entrance
Deficiency Quantity	30
Quantity Uom	S.F.
Potential Action	REPLACE
Urgency of Action	PRIORITY 3
Purpose of Action	LEVEL 2

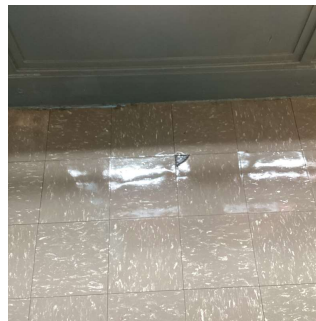
Stair B/2

VINYL TILES: BROKEN/DETERIORATED/MISSING TILES

REPLACE

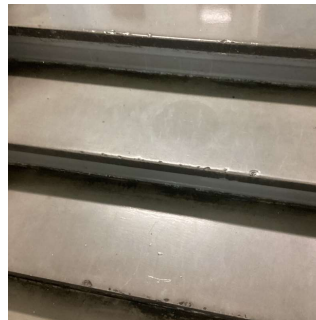
Stair B/Basement

STONE: BROKEN/MISSING

REPLACE

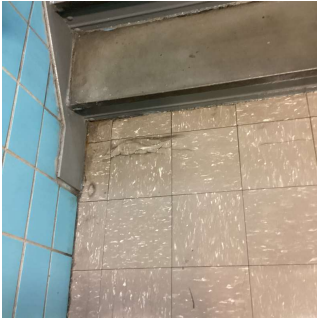
Question	Response
INTERIOR	
STAIRS/RAMPS: INTERIOR	
Stairs and Landings	
Deficiency	VINYL TILES: DETERIORATED SUBSTRATE
Deficiency Location/Instance	Stair B/2
Deficiency Quantity	15
Quantity Uom	S.F.
Potential Action	REPLACE
Urgency of Action	PRIORITY 3
Purpose of Action	LEVEL 2
Deficiency Photo1

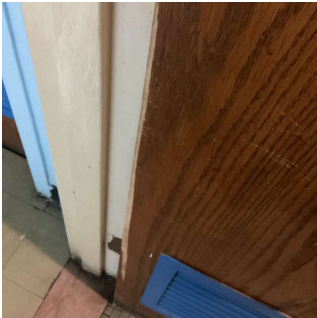
Violations	Stair B/2 No violations recorded.
Walls	Inspected
Condition	2 - Between Good and Fair
Deficiency	No deficiencies recorded
TOILET ROOMS - STAFF	
Ceiling	Inspected
Condition	2 - Between Good and Fair
Deficiency	No deficiencies recorded
Door(s)	Inspected
Condition	5 - Poor
Deficiency	WOOD: DETERIORATED DOOR
Deficiency Location/Instance	Nurse's, Rooms 134, 234, 333, 334 and others
Deficiency Quantity	7
Quantity Uom	EACH
Potential Action	MAINTENANCE
Urgency of Action	PRIORITY 3
Purpose of Action	LEVEL 2
Deficiency Photo1

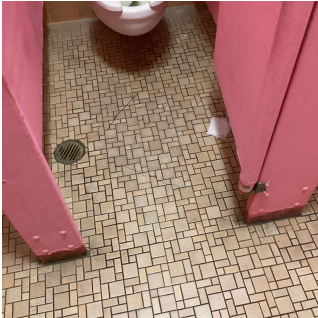
Question	Response
INTERIOR	
TOILET ROOMS - STAFF	
Floor Finish	
Deficiency	CERAMIC TILE: DETERIORATED SUBSTRATE
Deficiency Location/Instance	Room 134
Deficiency Quantity	15
Quantity Uom	S.F.
Potential Action	REPLACE
Urgency of Action	PRIORITY 3
Purpose of Action	LEVEL 2
Deficiency Photo1

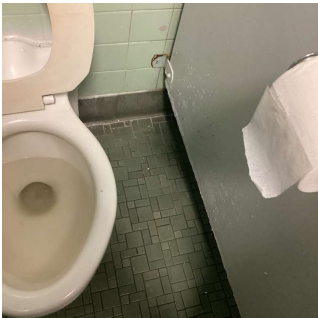
Room 134
Violations	No violations recorded.
Stalls	Inspected
Condition	5 - Poor
Deficiency	RUST - MAJOR
Deficiency Location/Instance	Rooms 100, 102, 333, 334,
Deficiency Quantity	4
Quantity Uom	EACH
Potential Action	REPLACE
Urgency of Action	PRIORITY 3
Purpose of Action	LEVEL 2
Deficiency Photo1

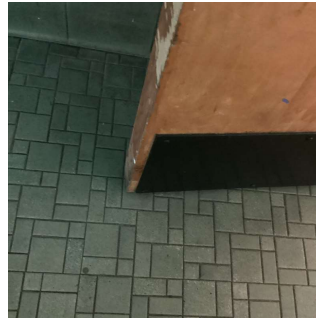
Room 328

WOOD: DETERIORATED DOOR

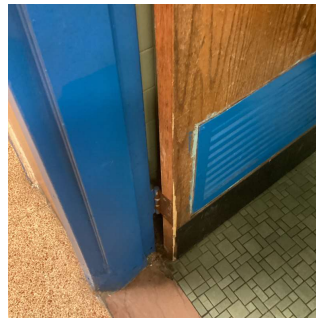
Room 108

WOOD: DETERIORATED DOOR AND FRAME

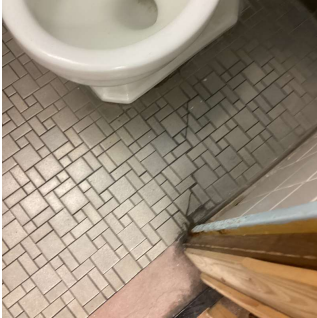
Question	Response
INTERIOR	
TOILET ROOMS - STUDENTS	
Floor Finish	Inspected
Condition	2 - Between Good and Fair
Deficiency	CERAMIC TILE: BROKEN/MISSING TILES
Deficiency Location/Instance	Rooms B25, 121, 228
Deficiency Quantity	15
Quantity Uom	S.F.
Potential Action	REPLACE
Urgency of Action	PRIORITY 3
Purpose of Action	LEVEL 2
Deficiency Photo1

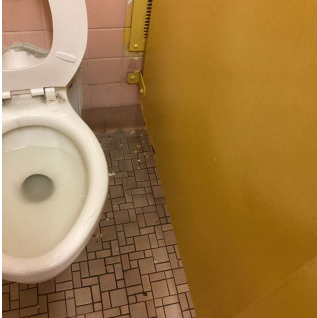
Room 121
Violations	No violations recorded.
Stalls	Inspected
Condition	5 - Poor
Deficiency	RUST - MAJOR
Deficiency Location/Instance	Rooms 322, 228, 224
Deficiency Quantity	16
Quantity Uom	EACH
Potential Action	REPLACE
Urgency of Action	PRIORITY 3
Purpose of Action	LEVEL 2
Deficiency Photo1

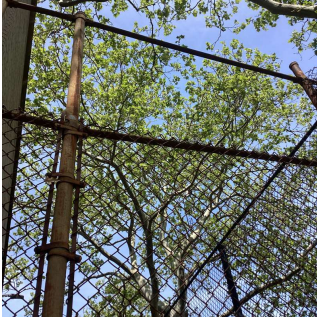
Question	Response
SITE	
Drainage System for Soil	Inspected
Catch Basins/Manhole - Surrounded by Soil	Inspected
Condition	2 - Between Good and Fair
Deficiency	No deficiencies recorded
Culverts - Soil Covering	Does not Exist
DRINKING FOUNTAINS	Does not Exist
FENCES	Inspected
Condition	4 - Between Fair and Poor
Deficiency	WROUGHT IRON: DAMAGED/DETERIORATED
Deficiency Location/Instance	Near Exit 11, Marion Street
Deficiency Quantity	80
Quantity Uom	S.F.
Potential Action	REPLACE
Urgency of Action	PRIORITY 3
Purpose of Action	LEVEL 2
Deficiency Photo1	No photo recorded
Violations	No violations recorded.
Deficiency	CHAIN LINK: MISSING SECTIONS
Deficiency Location/Instance	Sumpter Street
Deficiency Quantity	50
Quantity Uom	S.F.
Potential Action	REPLACE
Urgency of Action	PRIORITY 3
Purpose of Action	LEVEL 2
Deficiency Photo1

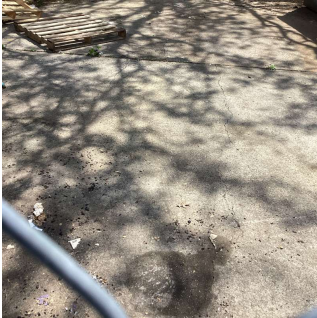
Question	Response
SITE	
PAVING	
Student Non-Use	
Concrete	
Deficiency Photo1

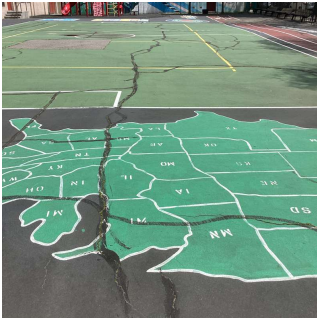
Violations	Marion Street No violations recorded.
Pavers	Does not Exist
Student Use	Inspected
Gravel Exists?	No
Asphalt	Inspected
Condition	4 - Between Fair and Poor
Deficiency	CRACKS - MAJOR
Deficiency Location/Instance	Playground
Deficiency Quantity	1,200
Quantity Uom	S.F.
Potential Action	REPLACE
Urgency of Action	PRIORITY 3
Purpose of Action	LEVEL 2
Deficiency Photo1

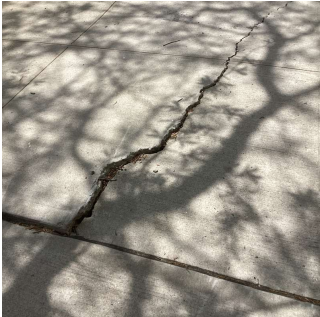
Violations	Sumpter Street No violations recorded.
Deficiency	HEAVING
Deficiency Location/Instance	Sumpter Street
Deficiency Quantity	50
Quantity Uom	S.F.
Potential Action	REPLACE
Urgency of Action	PRIORITY 5
Purpose of Action	LEVEL 6
Deficiency Photo1

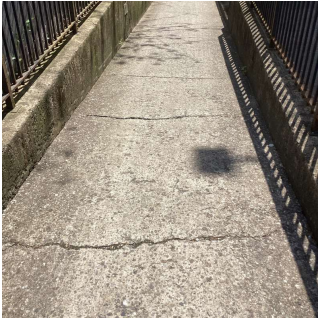
Near Exit 11
Violations	No violations recorded.
ARTWORK	Does not Exist

Question	Response
SITE	
SEATING	Inspected
Bleachers	Does not Exist
SITE WALLS (NOT RETAINING WALLS)	Does not Exist
STAIRS/RAMPS: EXTERIOR	Inspected
Railings	Inspected
Condition	2 - Between Good and Fair
Deficiency	No deficiencies recorded
Site Cheek/flank Walls	Inspected
Condition	2 - Between Good and Fair
Deficiency	No deficiencies recorded
Stairs/ramps	Inspected
Condition	3 - Fair
Deficiency	CAST IN PLACE CONCRETE: CRACKS/SPALLING - MAJOR
Deficiency Location/Instance	Near Exit 11
Deficiency Quantity	200
Quantity Uom	S.F.
Potential Action	REPLACE
Urgency of Action	PRIORITY 3
Purpose of Action	LEVEL 2
Deficiency Photo1
