**NYC Department of Education**  
**Building Condition Assessment Survey 2023 - 2024**

Architectural Inspection

**Asset: P.S. 41 - BROOKLYN, 411 THATFORD AVENUE, New York, 11212**

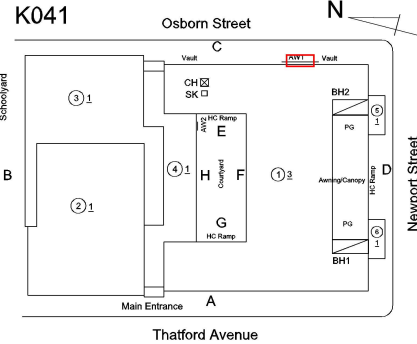
Roof Plan reference

AREAWAY WALLS: CRACKS AND SPALLING

REPAIR

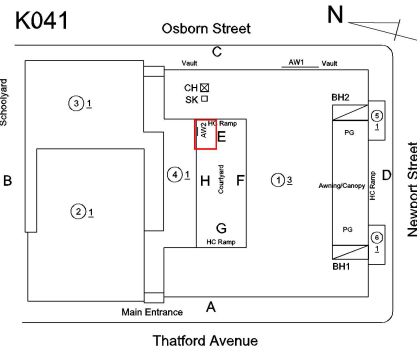
Roof Plan reference

AREAWAY DRAINS: CLOGGED

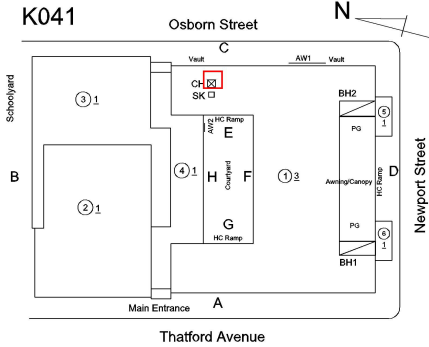
Question	Response
<b>EXTERIOR</b>	
<b>AREAWAY</b>	
Deficiency Photo1	 
Violations	AW2 No violations recorded.
<b>AWNINGS AND CANOPIES</b>	
Condition	Inspected 2 - Between Good and Fair
Deficiency	No deficiencies recorded
<b>CHIMNEY</b>	
Material Type(s)	Inspected Masonry
Condition	3 - Fair
Deficiency	BRICK: DETERIORATED CAP
Rooftop Reference

Deficiency Quantity	10
Quantity Uom	L.F.
Potential Action	REPLACE
Urgency of Action	PRIORITY 4
Purpose of Action	LEVEL 2
Deficiency Photo1	 
Violations	Chimney No violations recorded.
Deficiency	BRICK: DETERIORATED LADDER

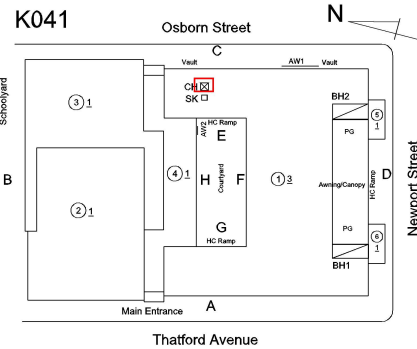
Roof Plan reference

**BRICK: MAJOR / THRU CRACKS**

40  
S.F.  
REMOVE AND REBUILD  
PRIORITY 4  
LEVEL 2

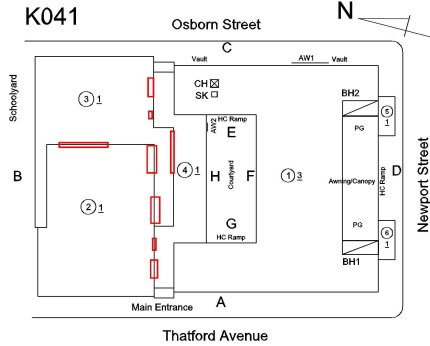
Violations	Chimney No violations recorded.
<b>COPING</b>	
Condition	Inspected 3 - Fair
Deficiency	CAST STONE: DETERIORATED BED JOINT
Roof Plan reference

Deficiency Quantity	85
Quantity Uom	L.F.
Potential Action	REPOINT
Urgency of Action	PRIORITY 3
Purpose of Action	LEVEL 2
Deficiency Photo1

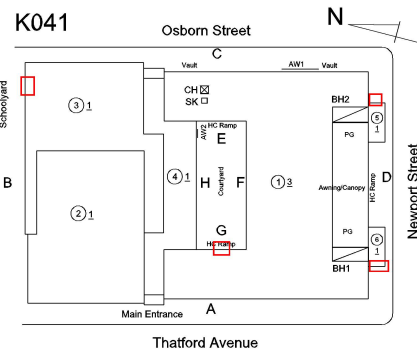
Roof Plan reference

Violations	Roof 3 No violations recorded.
<b>CORNICE</b>	
	Does not Exist
<b>DOORS</b>	
	Inspected
<b>DOORS AND FRAMES</b>	
Condition	Inspected 5 - Poor
Deficiency	METAL: DETERIORATED DOOR AND FRAME - MAJOR DETERIORATION

5  
EACH  
REPLACE  
PRIORITY 4  
LEVEL 2

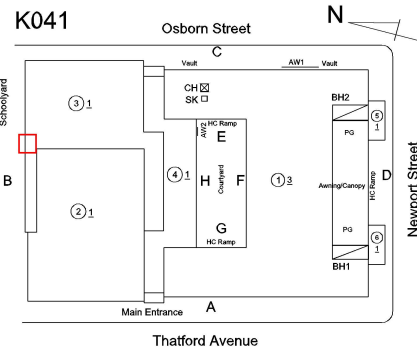
Roof Plan reference

**METAL: DETERIORATED DOOR AND FRAME - MINOR DETERIORATION**

2  
EACH  
MAINTENANCE  
PRIORITY 3  
LEVEL 2

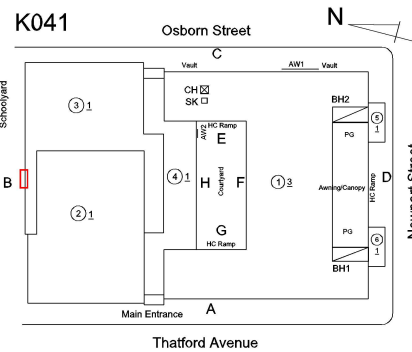
Roof Plan reference

**METAL: DETERIORATED DOOR - MAJOR DETERIORATION**

REPLACE

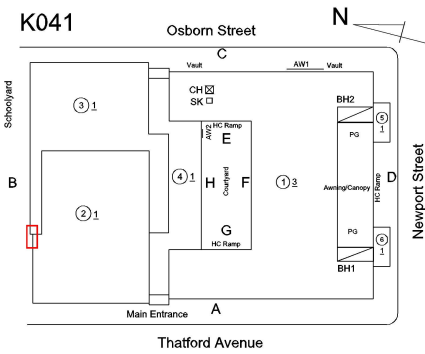
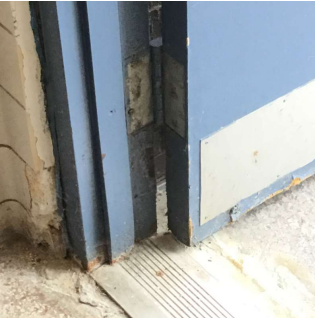
**METAL CLAD: DETERIORATED DOOR AND FRAME - MAJOR DETERIORATION**

Deficiency Quantity	2
Quantity Uom	EACH
Potential Action	REPLACE
Urgency of Action	PRIORITY 4
Purpose of Action	LEVEL 2
Deficiency Photo1

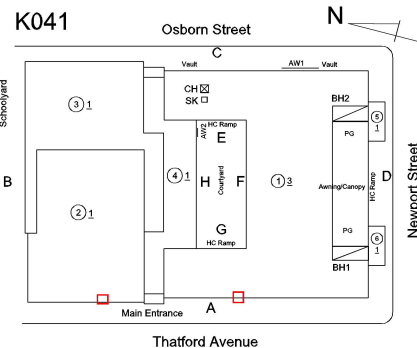
Roof Plan reference

**BRICK: MINOR CRACKS AND SPALLING**

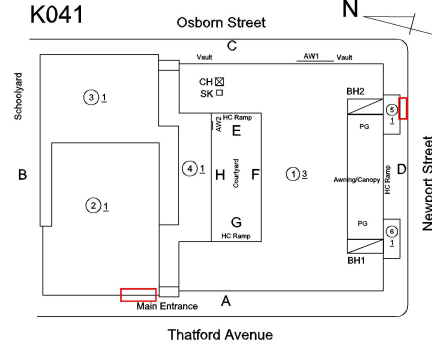
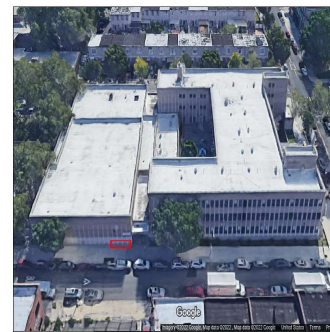
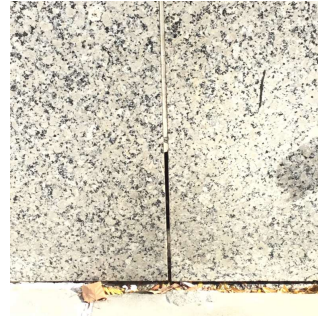
Facade A

STONE: DETERIORATED JOINTS

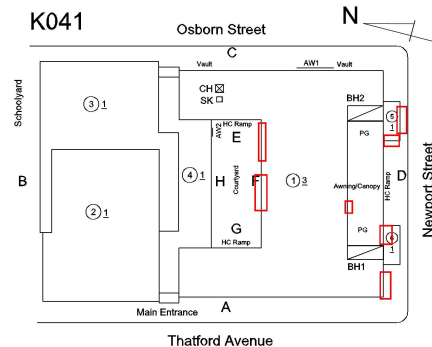
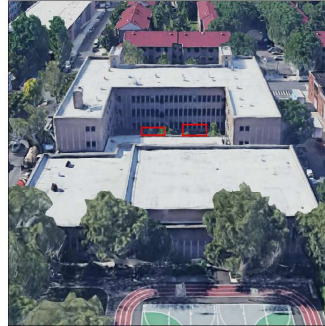
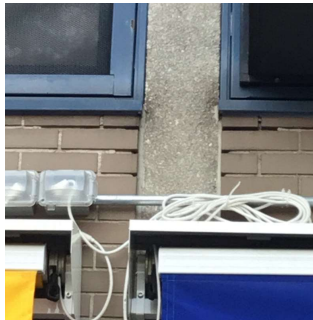
Facade F

BRICK: DETERIORATED JOINTS

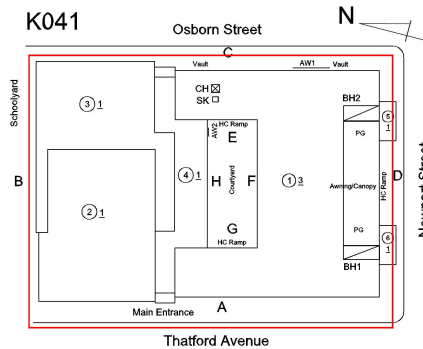
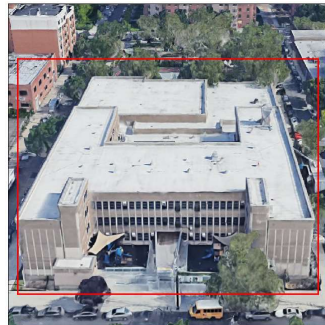
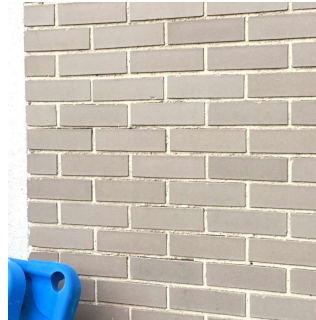
Courtyard  
No violations recorded.

BRICK: DETERIORATED JOINTS

PRIORITY 3  
LEVEL 2

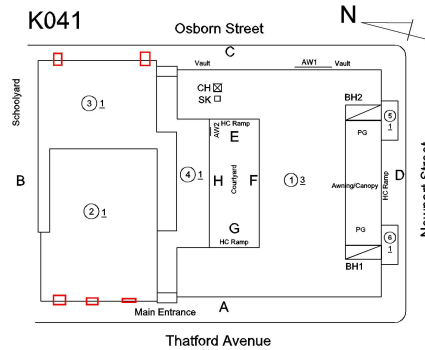
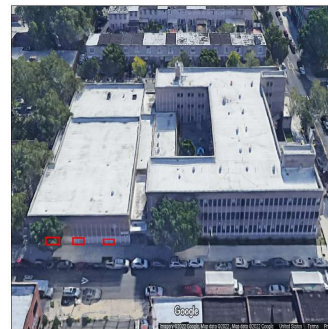
Roof Plan reference

BROKEN/ DENTED BLADES

20  
S.F.  
REPLACE  
PRIORITY 4  
LEVEL 2

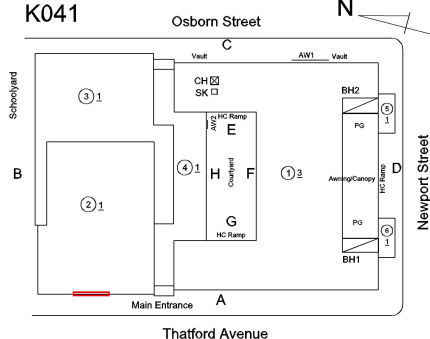
Violations	Facade A No violations recorded.
<b>PARAPETS</b>	Inspected
Material Type(s)	Masonry
Replacement Quantity	12,000
Replacement Uom	C.F.
Instance on All Roofs	Inspected
Instance Condition	3 - Fair
Instance Quantity	12,000
Instance Quantity Uom	C.F.
Deficiency	<b>BRICK: DETERIORATED JOINTS</b>
Roof Plan reference

Deficiency Quantity	20
Quantity Uom	S.F.
Potential Action	REPOINT
Urgency of Action	PRIORITY 3
Purpose of Action	LEVEL 2
Deficiency Photo1

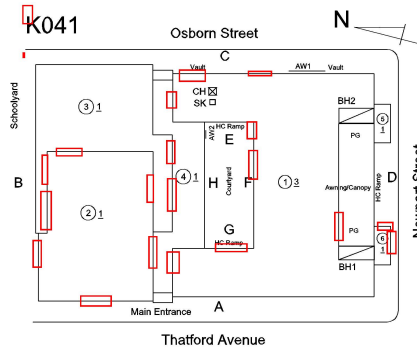
Roof Plan reference

Violations	Roof 2 No violations recorded.
Deficiency	<b>BRICK: EFFLORESCENCE</b>

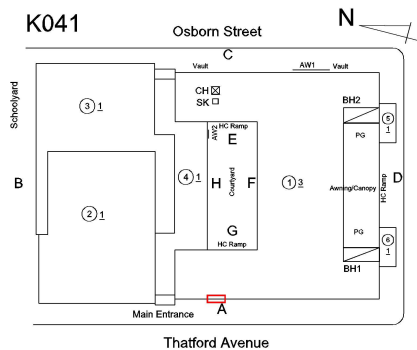
Roof Plan reference

RAILINGS/PANELS: DETERIORATED, MAJOR RUSTING

Question	Response
<b>EXTERIOR</b>	
<b>ROOF</b>	
<b>Roofing</b>	
<b>ROOF BARRIER/FENCE</b>	
Deficiency Quantity	25
Quantity Uom	S.F.
Potential Action	REPLACE
Urgency of Action	PRIORITY 4
Purpose of Action	LEVEL 2
Deficiency Photo1	 
	Roof 1
Violations	No violations recorded.
<b>ROOF CAGE</b>	Does not Exist
<b>ROOFING</b>	Inspected
Instance on Modified Bitumen: All Roofs	Inspected
Instance Condition	2 - Between Good and Fair
Instance Photo	 
	Roof 1
Instance Quantity	50,000
Instance Quantity Uom	S.F.
Does the roof have major mechanical equipment sitting on Dunnage Steel less than 18" above the Roofing?	No
Does this roof instance have a Sustainable Roof System?	Yes
Sustainable Roof Type	White Roof
Sustainable Roof Location (Roof Number)	All Roofs
Do solar panels exist on these roofs?	Yes
Solar Panel Location (Roof Number)	Roofs 1-4
Is/Are the roof(s) suitable for Solar Panel installation?	Yes
Installation Year	2014
Source of Installation	Custodial Staff

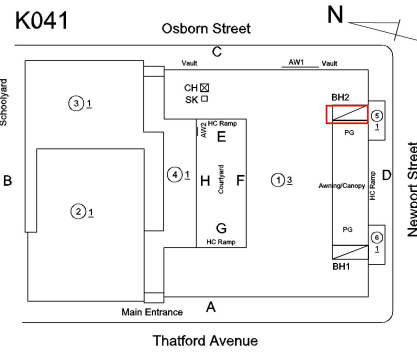
Roof Plan reference

Deficiency	No deficiencies recorded
<b>ROOFING DRAINS</b>	Inspected
Condition	2 - Between Good and Fair
Deficiency	No deficiencies recorded
<b>Specialties</b>	Inspected
<b>BULKHEAD/PENTHOUSE</b>	Inspected
Condition	3 - Fair
Deficiency	BULKHEAD/PENTHOUSE WALLS/EXTERIOR: DETERIORATED JOINTS

15  
 S.F.  
 REPOINT  
 PRIORITY 4  
 LEVEL 2

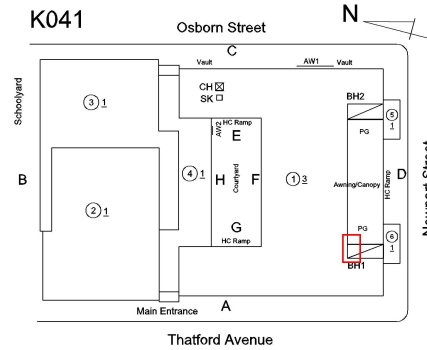
Roof Plan reference

**BULKHEAD/PENTHOUSE WALLS/INTERIOR: CMU  
CRACKS/SPALLING**

REPLACE

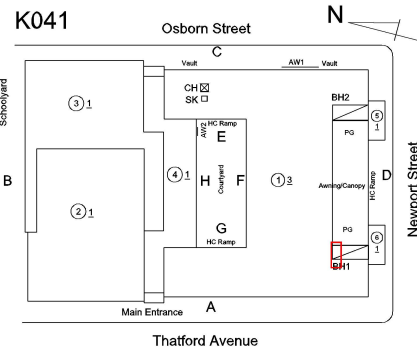
BH1  
No violations recorded.

**BULKHEAD/PENTHOUSE WALLS/EXTERIOR: WATER  
INFILTRATION**

50  
S.F.  
REPAIR  
PRIORITY 5  
LEVEL 2

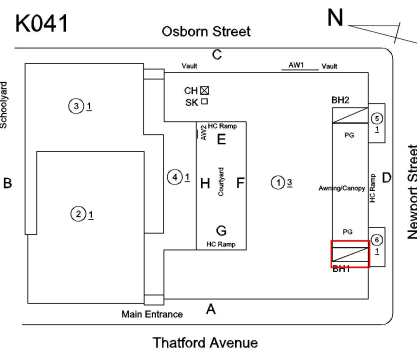
Roof Plan reference

**BULKHEAD/PENTHOUSE WALLS/EXTERIOR:  
EFFLORESCENCE**

50  
S.F.  
MAINTENANCE  
PRIORITY 3  
LEVEL 2

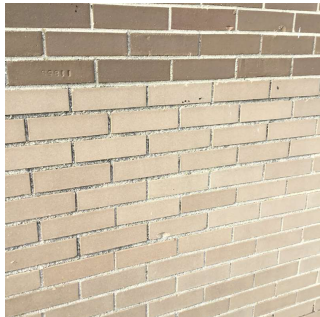
Violations	BH2 No violations recorded.
Deficiency	BULKHEAD/PENTHOUSE WALLS/EXTERIOR: DETERIORATED JOINTS
Roof Plan reference

Deficiency Quantity	80
Quantity Uom	S.F.
Potential Action	REPOINT
Urgency of Action	PRIORITY 3
Purpose of Action	LEVEL 2
Deficiency Photo1

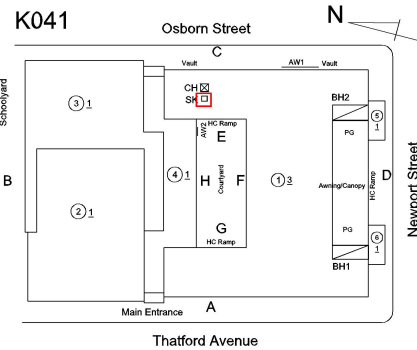
Violations	BH2 No violations recorded.
<b>CUPOLA/ SPIRES/ TOWERS</b>	Does not Exist
<b>DORMER</b>	Does not Exist
<b>DUNNAGE STEEL</b>	Does not Exist
<b>SKYLIGHT/ROOF VENT</b>	Inspected
Material Type(s)	Glass
Condition	3 - Fair
Deficiency	SHAFT VENTS DAMAGED

1  
EACH  
MAINTENANCE  
PRIORITY 3  
LEVEL 2

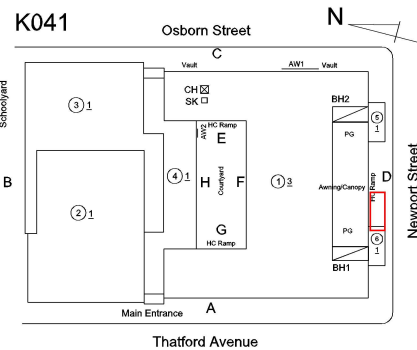
CAST IN PLACE CONCRETE: CRACKS/SPALLING - MAJOR

40  
S.F.  
REPLACE  
PRIORITY 4  
LEVEL 2

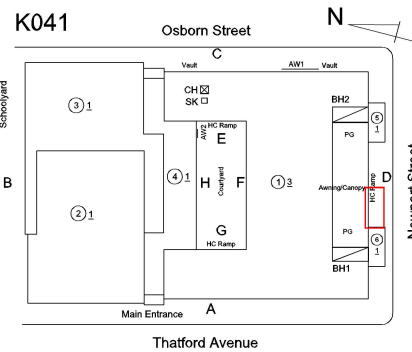
**CAST IN PLACE CONCRETE: CRACKS/SPALLING - MINOR**

REPAIR

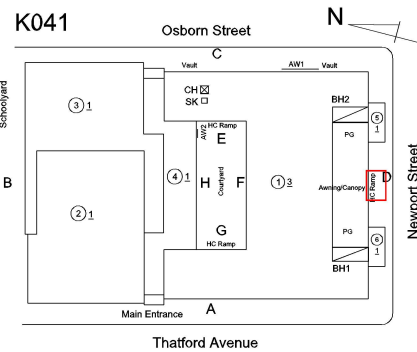
BROKEN BRACKET

2  
 EACH  
 REPLACE  
 PRIORITY 4  
 LEVEL 2

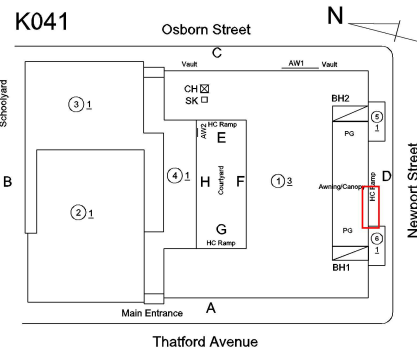
CONCRETE: CRACKS/SPALLING - MINOR

25  
 S.F.  
 REPAIR  
 PRIORITY 3  
 LEVEL 2

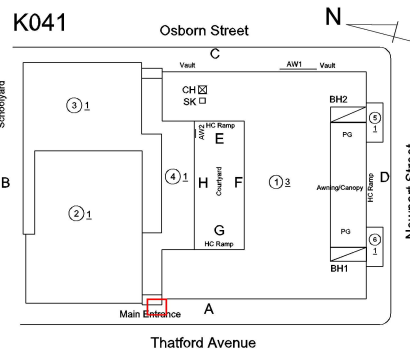
**STONE: CRACKS/SPALLING - MINOR**

REPAIR

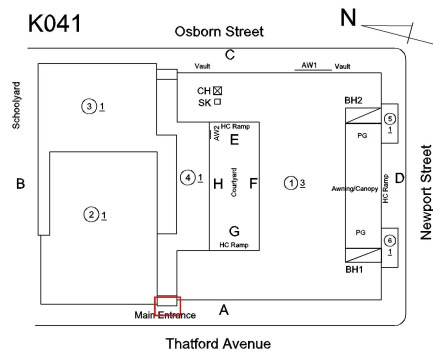
**STONE: DETERIORATED JOINTS**

Deficiency Quantity	20
Quantity Uom	L.F.
Potential Action	REPOINT
Urgency of Action	PRIORITY 4
Purpose of Action	LEVEL 2
Deficiency Photo1

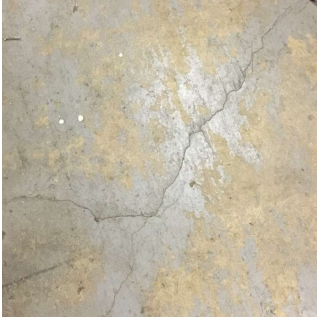
Boiler Room
Violations	No violations recorded.
Deficiency	CONCRETE SLAB ON GRADE: THRU CRACKS
Deficiency Location/Instance	Basement
Deficiency Quantity	140
Quantity Uom	S.F.
Potential Action	REPAIR
Urgency of Action	PRIORITY 3
Purpose of Action	LEVEL 5
Deficiency Photo1

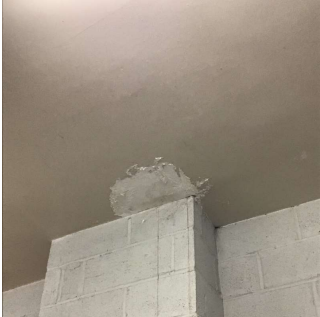
<b>Question</b>	<b>Response</b>
<b>INTERIOR</b>	
<b>AUDITORIUM</b>	
Instance on 1st Floor (413 seats)	Inspected
<b>Ceiling</b>	
Instance on 1st Floor (413 seats)	Inspected
Condition	2 - Between Good and Fair
Deficiency	PLASTER: CRACKS/SPALLING
Deficiency Location/Instance	Storage
Deficiency Quantity	10
Quantity Uom	S.F.
Potential Action	REPLACE
Urgency of Action	PRIORITY 3
Purpose of Action	LEVEL 2
Deficiency Photo1

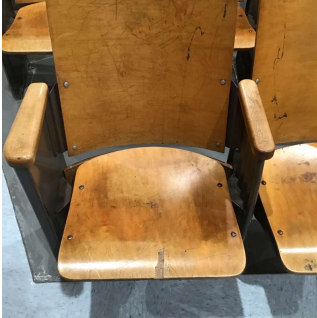
Question	Response
<b>INTERIOR</b>	
<b>AUDITORIUM</b>	
<b>Fixed Seating</b>	
Condition	4 - Between Fair and Poor
Deficiency	DAMAGED/BROKEN/INOPERABLE
Deficiency Location/Instance	Seats A/8,102,103,107,107, and others
Deficiency Quantity	43
Quantity Uom	EACH
Potential Action	REPLACE
Urgency of Action	PRIORITY 3
Purpose of Action	LEVEL 2
Deficiency Photo1

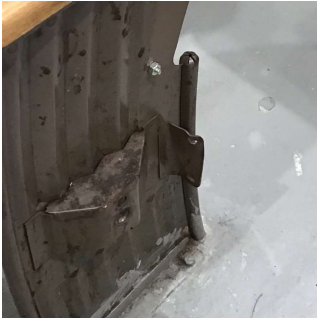
Violations	Seat A/8 No violations recorded.
Deficiency	DAMAGED/BROKEN/INOPERABLE
Deficiency Location/Instance	Seat D/114, O/113
Deficiency Quantity	2
Quantity Uom	EACH
Potential Action	REPLACE
Urgency of Action	PRIORITY 5
Purpose of Action	LEVEL 6
Deficiency Photo1

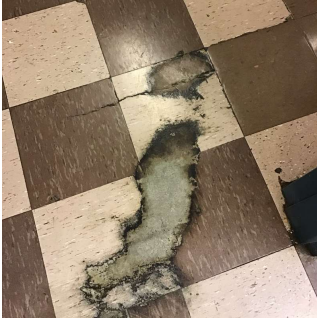
Question	Response
<b>INTERIOR</b>	
<b>CAFETERIA</b>	
<b>Floor Finish</b>	
Condition	2 - Between Good and Fair
Deficiency	VINYL TILES: WORN-OUT TILES
Deficiency Location/Instance	Exit 9 Vestibule
Deficiency Quantity	10
Quantity Uom	S.F.
Potential Action	REPLACE
Urgency of Action	PRIORITY 3
Purpose of Action	LEVEL 2
Deficiency Photo1

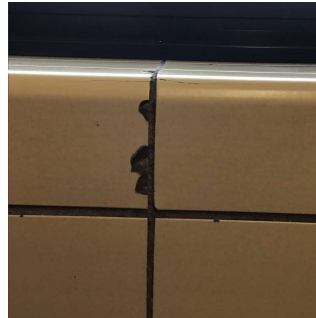
Corridor near Room 330

GLAZED BLOCK: CRACKS/SPALLING

REPLACE

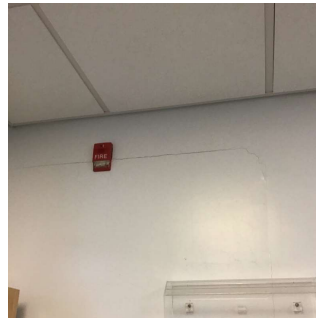
GYPSON BOARD: DETERIORATED

REPLACE

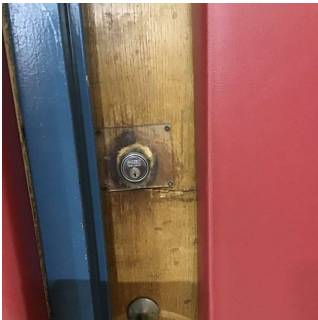
Violations	Near room 145A No violations recorded.
<b>Door(s)</b>	
Instance on 1st Floor	Inspected
Condition	4 - Between Fair and Poor
Deficiency	WOOD: DETERIORATED DOOR
Deficiency Location/Instance	Room 145A, Entrance
Deficiency Quantity	2
Quantity Uom	EACH
Potential Action	MAINTENANCE
Urgency of Action	PRIORITY 3
Purpose of Action	LEVEL 2
Deficiency Photo1

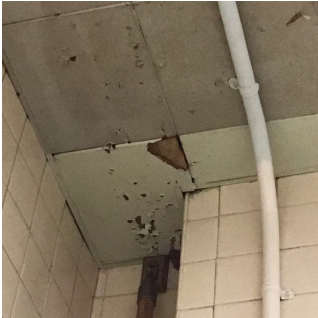
Question	Response
<b>INTERIOR</b>	
<b>KITCHEN</b>	
<b>Ceiling</b>	
Deficiency	ACOUSTIC TILES ON PLASTER: DAMAGED/MISSING
Deficiency Location/Instance	Near Windows, Entrance, Center
Deficiency Quantity	10
Quantity Uom	S.F.
Potential Action	REPLACE
Urgency of Action	PRIORITY 3
Purpose of Action	LEVEL 2
Deficiency Photo1

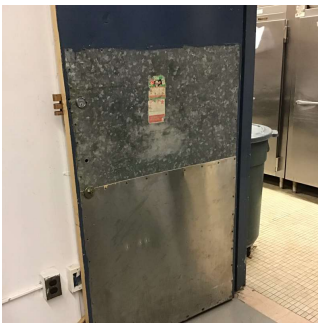
Violations	Near Entrance, center, entrance No violations recorded.
<b>Door(s)</b>	
Instance on 1st Floor	Inspected
Condition	3 - Fair
Deficiency	METAL: DETERIORATED DOOR
Deficiency Location/Instance	Storage
Deficiency Quantity	1
Quantity Uom	EACH
Potential Action	MAINTENANCE
Urgency of Action	PRIORITY 3
Purpose of Action	LEVEL 2
Deficiency Photo1

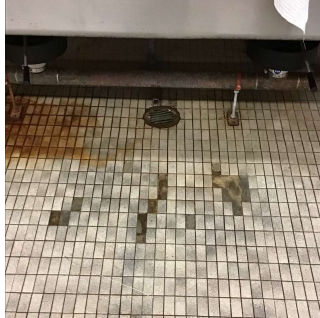
Violations	Storage No violations recorded.
<b>Floor Finish</b>	
Instance on 1st Floor	Inspected
Condition	3 - Fair
Deficiency	CERAMIC TILE: BROKEN/MISSING TILES
Deficiency Location/Instance	Near Windows, center, storage
Deficiency Quantity	40
Quantity Uom	S.F.

Potential Action	REPLACE

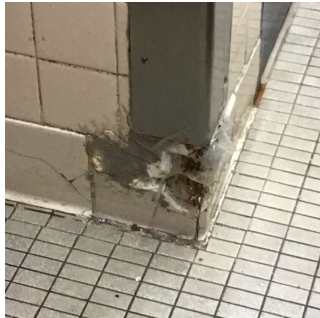
Violations	Near Windows No violations recorded.
<b>Walls</b>	
Instance on 1st Floor	Inspected
Condition	2 - Between Good and Fair
Deficiency	CERAMIC TILE: BROKEN/ MISSING
Deficiency Location/Instance	Near Windows, sinks, entrance
Deficiency Quantity	20
Quantity Uom	S.F.
Potential Action	REPLACE
Urgency of Action	PRIORITY 3
Purpose of Action	LEVEL 2
Deficiency Photo1

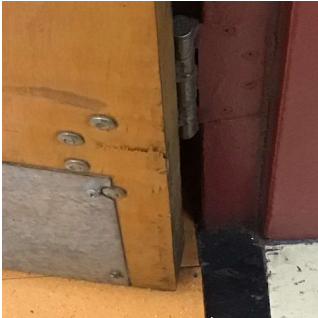
Question	Response
<b>INTERIOR</b>	
<b>LIBRARY</b>	
<b>Door(s)</b>	
Deficiency	WOOD: DETERIORATED DOOR
Deficiency Location/Instance	Entrance
Deficiency Quantity	1
Quantity Uom	EACH
Potential Action	MAINTENANCE
Urgency of Action	PRIORITY 3
Purpose of Action	LEVEL 2
Deficiency Photo1

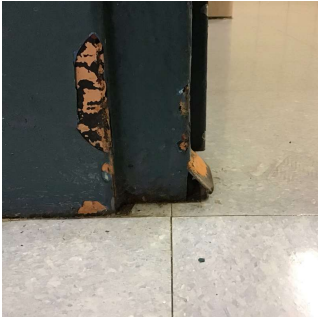
<b>SHOWER ROOM</b>	Does not Exist
<b>STAIRS/RAMPS: INTERIOR</b>	Inspected
Do Letter Stair Signs Exist?	Yes
<b>Ceiling</b>	Inspected
Condition	2 - Between Good and Fair
Deficiency	No deficiencies recorded
<b>Door(s)</b>	Inspected
Condition	3 - Fair
Deficiency	METAL: DETERIORATED DOOR AND FRAME
Deficiency Location/Instance	Stair AB/1

Question	Response
<b>INTERIOR</b>	
<b>STAIRS/RAMPS: INTERIOR</b>	
<b>Door(s)</b>	
Deficiency Quantity	2
Quantity Uom	EACH
Potential Action	MAINTENANCE
Urgency of Action	PRIORITY 3
Purpose of Action	LEVEL 2
Deficiency Photo1

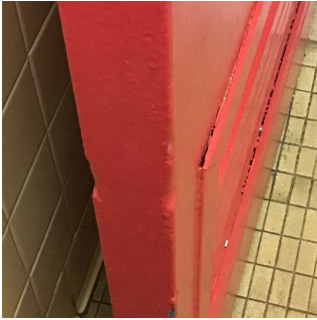
Question	Response
<b>INTERIOR</b>	
<b>TOILET ROOMS - STAFF</b>	
<b>Walls</b>	
Deficiency Photo1	 
Violations	Room 113B No violations recorded.
<b>TOILET ROOMS - STUDENTS</b>	
<b>Ceiling</b>	Inspected
Condition	2 - Between Good and Fair
Deficiency	No deficiencies recorded
<b>Door(s)</b>	Inspected
Condition	5 - Poor
Deficiency	WOOD: DETERIORATED DOOR
Deficiency Location/Instance	Rooms 327,323,227
Deficiency Quantity	3
Quantity Uom	EACH
Potential Action	MAINTENANCE
Urgency of Action	PRIORITY 3
Purpose of Action	LEVEL 2
Deficiency Photo1

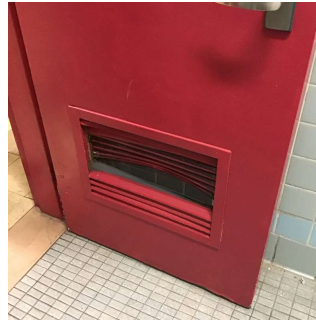
Room 333

Violations	Room 323 No violations recorded.
Deficiency	WOOD: DAMAGED LOUVER
Deficiency Location/Instance	Rooms 333,229
Deficiency Quantity	2
Quantity Uom	EACH
Potential Action	MAINTENANCE
Urgency of Action	PRIORITY 3
Purpose of Action	LEVEL 2

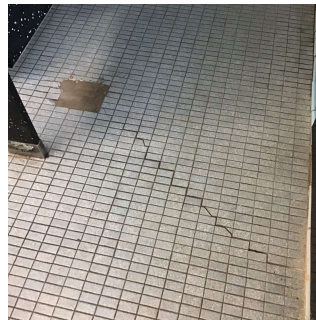
Room 327

CERAMIC TILE: DETERIORATED SUBSTRATE

REPLACE

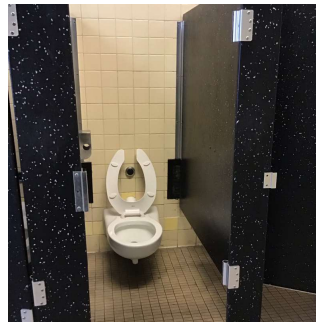
Room 227

BROKEN/MISSING

REPLACE

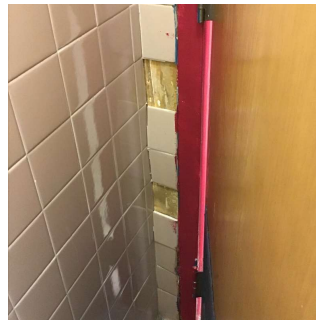
Room 227

CERAMIC TILE: BROKEN/ MISSING

REPLACE

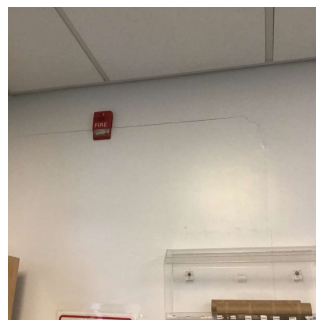
GYPSON BOARD: DETERIORATED

REPLACE

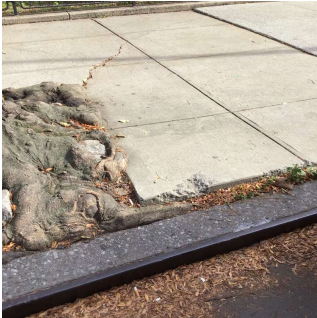
Near exit 10
Violations	No violations recorded.
<b>Pavers</b>	Does not Exist
<b>DOT Sidewalk</b>	Inspected
<b>Asphalt</b>	Does not Exist
<b>Concrete</b>	Inspected
Condition	4 - Between Fair and Poor
Deficiency	HEAVING
Deficiency Location/Instance	Along Thatford Avenue, Osborn Street
Deficiency Quantity	100
Quantity Uom	S.F.
Potential Action	REPLACE
Urgency of Action	PRIORITY 3
Purpose of Action	LEVEL 2
Deficiency Photo1

Along Thatford Avenue
Violations	No violations recorded.
Deficiency	DAMAGED/DETERIORATED/MISSING SECTIONS
Deficiency Location/Instance	Along Thatford Avenue, Newport Street, Osborn Street
Deficiency Quantity	1,200
Quantity Uom	S.F.
Potential Action	REPLACE

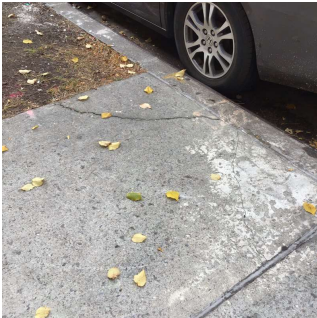
Violations	Along Thatford Avenue No violations recorded.
Deficiency	<b>DAMAGED CURBS</b>
Deficiency Location/Instance	Along Thatford Avenue, Newport Street, Osborn Street
Deficiency Quantity	140
Quantity Uom	L.F.
Potential Action	<b>REPLACE</b>
Urgency of Action	<b>PRIORITY 3</b>
Purpose of Action	<b>LEVEL 2</b>
Deficiency Photo1

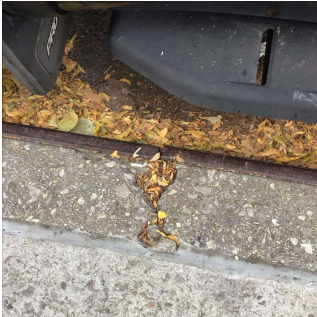
Violations	Along Thatford Avenue No violations recorded.
<b>Pavers</b>	Does not Exist
<b>PLAYGROUNDS</b>	Inspected
Instance on Courtyard	Inspected
Instance on Newport Street - East	Inspected
Instance on Newport Street - West	Inspected
<b>Benches</b>	
Instance on Courtyard	Inspected
Condition	2 - Between Good and Fair
Deficiency	No deficiencies recorded
Instance on Newport Street - East	Does not Exist
Instance on Newport Street - West	Does not Exist
<b>Fence</b>	
Instance on Courtyard	Does not Exist
