**NYC Department of Education**  
**Building Condition Assessment Survey 2023 - 2024**

Architectural Inspection

**Asset: I.S. 98 - BROOKLYN, 1401 EMMONS AVENUE, New York, 11235**

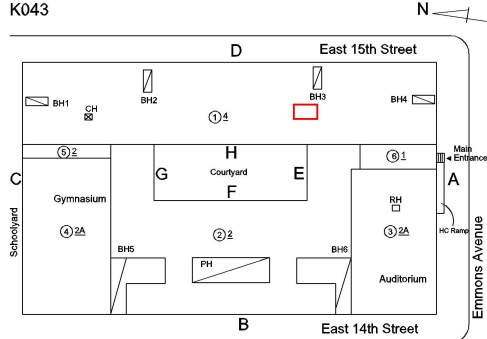
Do solar panels exist on these roofs?	Yes
Solar Panel Location (Roof Number)	Roofs 1 - 4
Installation Year	2011
Source of Installation	Custodial Staff
Deficiency	MODIFIED BITUMEN: ROOFING: MAJOR ACTIVE ROOF LEAKS IN INSTRUCTIONAL SPACE
Roof Plan reference	K043

Deficiency Quantity	400
Quantity Uom	S.F.

Question	Response
<b>EXTERIOR</b>	
<b>ROOF</b>	
<b>Roofing</b>	
<b>ROOFING</b>	
Potential Action	REPLACE ROOFING WITHOUT MAJOR EQUIPMENT REMOVAL
Urgency of Action	PRIORITY 5
Purpose of Action	LEVEL 2
Deficiency Photo1

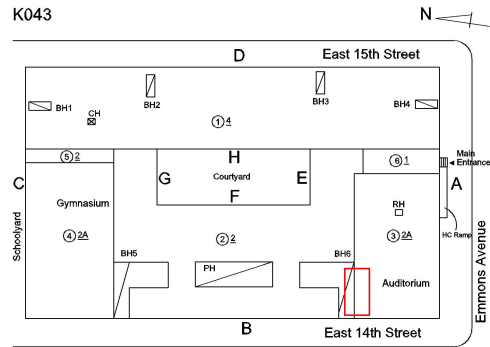
Deficiency BULKHEAD/PENTHOUSE WALLS/EXTERIOR: DETERIORATED JOINTS

Deficiency Quantity 30  
 Quantity Uom S.F.  
 Potential Action REPOINT  
 Urgency of Action PRIORITY 4  
 Purpose of Action LEVEL 2  
 Deficiency Photo1

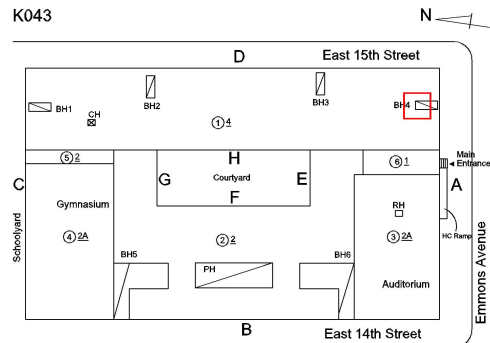
Deficiency BULKHEAD/PENTHOUSE CEILING: PLASTER DAMAGED/DETERIORATED

Deficiency Quantity 10  
 Quantity Uom S.F.  
 Potential Action REPLACE  
 Urgency of Action PRIORITY 4  
 Purpose of Action LEVEL 2

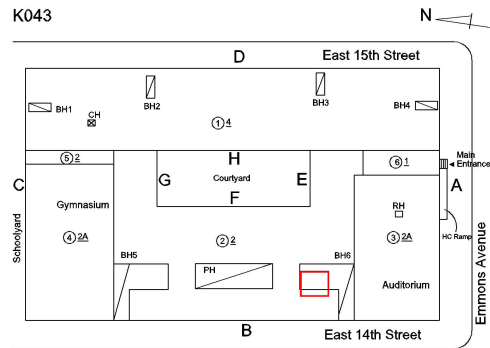
**BULKHEAD/PENTHOUSE WALLS/INTERIOR: CMU  
CRACKS/SPALLING**

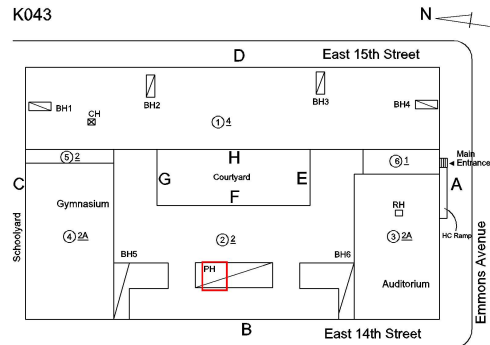
PH  
 No violations recorded.

**BULKHEAD/PENTHOUSE WALLS/INTERIOR: CMU  
DETERIORATED JOINTS**

10  
 S.F.  
 REPOINT  
 PRIORITY 3  
 LEVEL 2

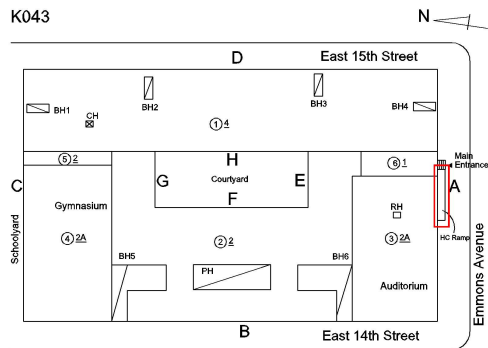
Facade A  
No violations recorded.

<b>CUPOLA/ SPIRES/ TOWERS</b>	Does not Exist
<b>DORMER</b>	Does not Exist
<b>DUNNAGE STEEL</b>	Inspected
Condition	2 - Between Good and Fair
Deficiency	No deficiencies recorded
<b>SKYLIGHT/ROOF VENT</b>	Does not Exist
<b>ROOF/GRAVITY TANK</b>	Does not Exist
<b>STAIRS/RAMPS: EXTERIOR</b>	Inspected
<b>BUILDING CHEEK/FLANK WALLS</b>	Inspected
Condition	2 - Between Good and Fair
Deficiency	No deficiencies recorded
<b>RAILINGS</b>	Inspected
Condition	5 - Poor
Deficiency	RUST - MAJOR

30  
L.F.  
REPLACE  
PRIORITY 4  
LEVEL 2

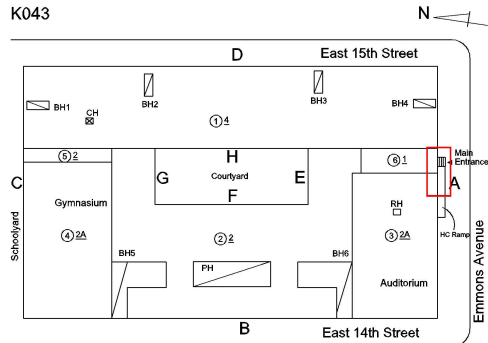
STONE: DETERIORATED SUBSTRATE

10  
S.F.  
REPLACE SUBSTRATE AND RESET  
PRIORITY 4  
LEVEL 2

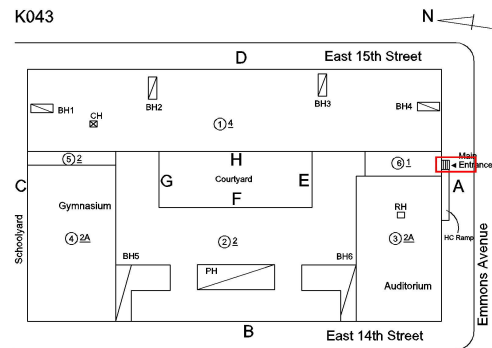
**STONE: CRACKS/SPALLING - MAJOR**

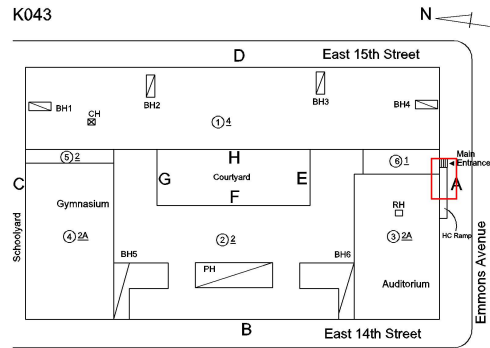
**CONCRETE: CRACKS/SPALLING - MINOR**

10  
 S.F.  
 REPAIR  
 PRIORITY 3  
 LEVEL 2

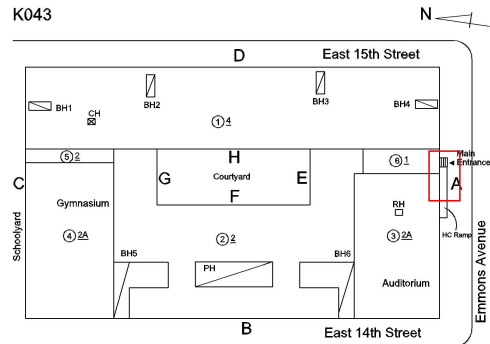
**CONCRETE: CRACKS/SPALLING - MAJOR**

20  
 S.F.  
 REPLACE  
 PRIORITY 4  
 LEVEL 2

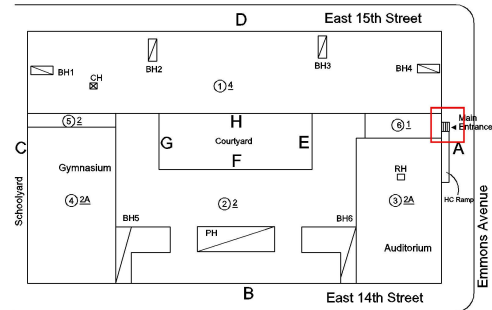
**STONE: WORN-OUT TREAD/RISER/NOSING**

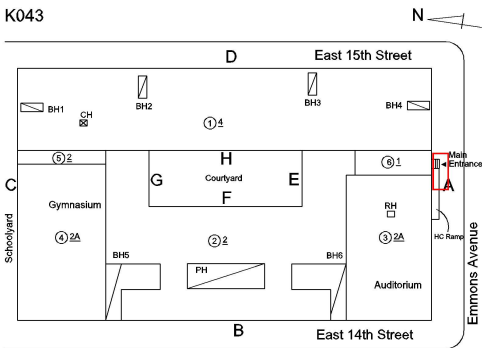
**STONE: CRACKS/SPALLING - MINOR**

Deficiency Quantity	10
Quantity Uom	S.F.
Potential Action	REPAIR
Urgency of Action	PRIORITY 3
Purpose of Action	LEVEL 2
Deficiency Photo1

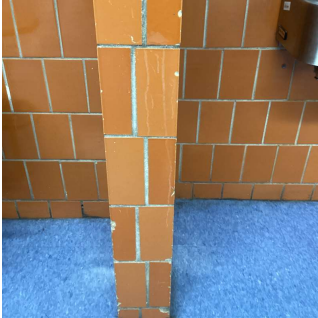
Question	Response
<b>INTERIOR</b>	
<b>CAFETERIA</b>	
<b>Sliding-folding Partition</b>	
Instance on 1st Floor	Does not Exist
<b>Stage</b>	
Instance on 1st Floor	Does not Exist
<b>Walls</b>	
Instance on 1st Floor	Inspected
Condition	2 - Between Good and Fair
Deficiency	GLAZED BLOCK: CRACKS/SPALLING
Deficiency Location/Instance	Near Right and Left Side Drinking Fountain, by Servery
Deficiency Quantity	30
Quantity Uom	S.F.
Potential Action	REPLACE
Urgency of Action	PRIORITY 3
Purpose of Action	LEVEL 2
Deficiency Photo1

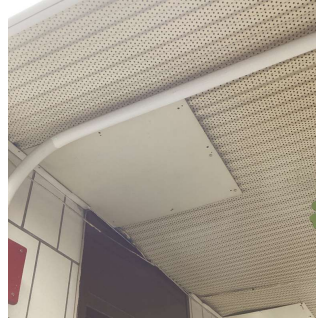
Corridor near Room 408

Deficiency	METAL PAN: DAMAGED/MISSING
Deficiency Location/Instance	Corridor near Rooms 118, 401, 403, 408, by Stair E/4 and others
Deficiency Quantity	1,250
Quantity Uom	S.F.
Potential Action	REPLACE
Urgency of Action	PRIORITY 3
Purpose of Action	LEVEL 2
Deficiency Photo1

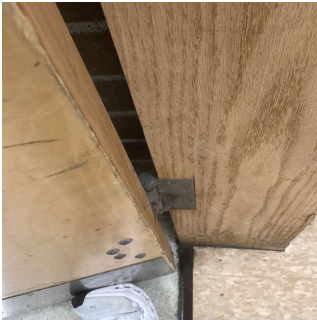
Violations	Corridor near Room 249B No violations recorded.
<b>Door(s)</b>	Inspected
Condition	5 - Poor
Deficiency	WOOD: DETERIORATED DOOR
Deficiency Location/Instance	Rooms 416, 424, 432, Corridor near Cafeteria, by Room 405 and others
Deficiency Quantity	13
Quantity Uom	EACH
Potential Action	MAINTENANCE
Urgency of Action	PRIORITY 3
Purpose of Action	LEVEL 2
Deficiency Photo1

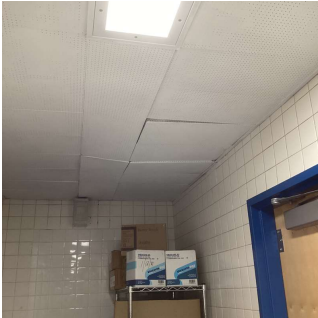
No	Potential Falling Debris	Loose Metal Pan tiles is a potential falling debris condition.	INTERIOR   KITCHEN   Ceiling	Near Storage Room	Miguel Arzuaga	Fireman
----	--------------------------	--	------------------------------	-------------------	----------------	---------

<b>Question</b>	<b>Response</b>
<b>INTERIOR</b>	
<b>INTERIOR DOOR HARDWARE</b>	Inspected
Condition	3 - Fair
Deficiency	No deficiencies recorded
<b>INTERIOR GUARDS</b>	Inspected
Condition	2 - Between Good and Fair
Deficiency	No deficiencies recorded
<b>KITCHEN</b>	Inspected
Instance on 1st Floor	Inspected
<b>Ceiling</b>	
Instance on 1st Floor	Inspected
Condition	3 - Fair
Deficiency	METAL PAN: DAMAGED/MISSING
Deficiency Location/Instance	Near Storage Room, by Fridges
Deficiency Quantity	20
Quantity Uom	S.F.
Potential Action	REPLACE
Urgency of Action	PRIORITY 5
Purpose of Action	LEVEL 6
Deficiency Photo1

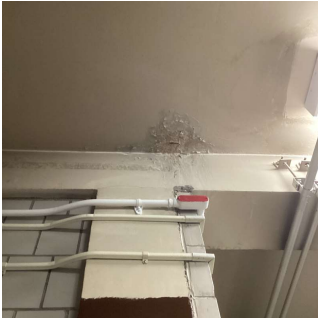
<b>Question</b>	<b>Response</b>
<b>INTERIOR</b>	
<b>SCIENCE PREP ROOM</b>	Inspected
<b>Fixed Equipment</b>	
Condition	2 - Between Good and Fair
Deficiency	No deficiencies recorded
<b>SHOWER ROOM</b>	Inspected
Instance on 2nd Floor - Boys	Inaccessible
Instance on 2nd Floor - Girls	Inaccessible
<b>STAIRS/RAMPS: INTERIOR</b>	Inspected
Do Letter Stair Signs Exist?	Yes
<b>Ceiling</b>	Inspected
Condition	2 - Between Good and Fair
Deficiency	PLASTER: CRACKS/SPALLING
Deficiency Location/Instance	Stairs E/4, F/2
Deficiency Quantity	30
Quantity Uom	S.F.
Potential Action	REPLACE
Urgency of Action	PRIORITY 3
Purpose of Action	LEVEL 2
Deficiency Photo1

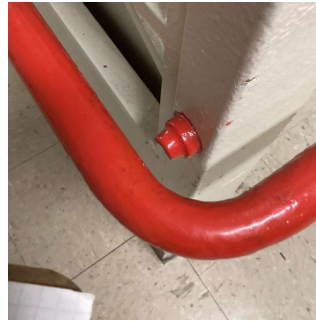
Violations	Stair F/2 No violations recorded.
<b>Door(s)</b>	Inspected
Condition	2 - Between Good and Fair
Deficiency	No deficiencies recorded
<b>Partition</b>	Does not Exist
<b>Railings</b>	Inspected
Condition	3 - Fair
Deficiency	METAL: BROKEN BRACKET
Deficiency Location/Instance	Stair B/2

Deficiency Quantity	5
Quantity Uom	EACH
Potential Action	REPLACE
Urgency of Action	PRIORITY 3
Purpose of Action	LEVEL 2

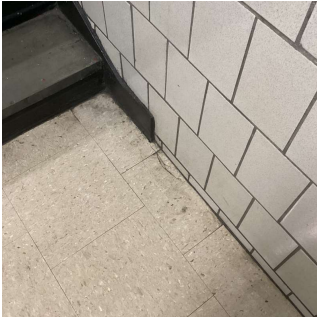
Question	Response
<b>INTERIOR</b>	
<b>STAIRS/RAMPS: INTERIOR</b>	
<b>Stairs and Landings</b>	
Violations	Stair E/Bulkhead No violations recorded.
Deficiency	VINYL TILES: BROKEN/DETERIORATED/MISSING TILES
Deficiency Location/Instance	Stairs B/4, 3, E/3, 2
Deficiency Quantity	50
Quantity Uom	S.F.
Potential Action	REPLACE
Urgency of Action	PRIORITY 3
Purpose of Action	LEVEL 2
Deficiency Photo1

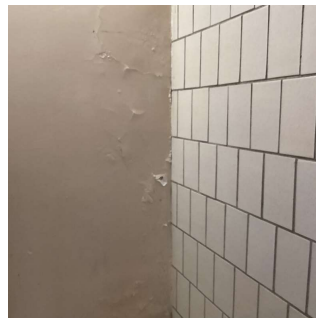
PLASTER: CRACKS/SPALLING

REPLACE

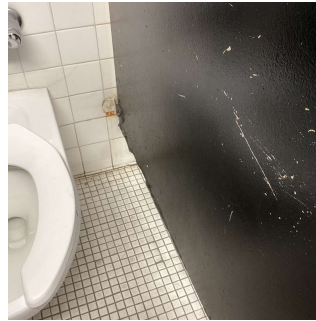
Question	Response
<b>INTERIOR</b>	
<b>TOILET ROOMS - STAFF</b>	Inspected
<b>Door(s)</b>	
Quantity Uom	EACH
Potential Action	MAINTENANCE
Urgency of Action	PRIORITY 3
Purpose of Action	LEVEL 2
Deficiency Photo1	 
	Room 224
Violations	No violations recorded.
<b>Floor Finish</b>	Inspected
Condition	2 - Between Good and Fair
Deficiency	CERAMIC TILE: DETERIORATED SUBSTRATE
Deficiency Location/Instance	Room 224
Deficiency Quantity	10
Quantity Uom	S.F.
Potential Action	REPLACE
Urgency of Action	PRIORITY 3
Purpose of Action	LEVEL 2
Deficiency Photo1	 
	Room 224
Violations	No violations recorded.
<b>Stalls</b>	Inspected
Condition	5 - Poor
Deficiency	RUST - MAJOR
Deficiency Location/Instance	In Kitchen Locker Room, Rooms 224, 228
Deficiency Quantity	3
Quantity Uom	EACH
Potential Action	REPLACE
Urgency of Action	PRIORITY 3
Purpose of Action	LEVEL 2

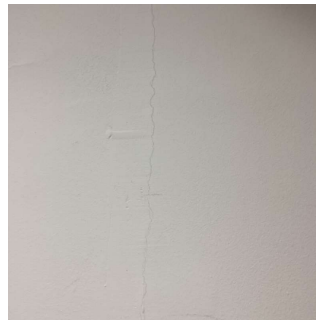
Room 228

PLASTER: CRACKS/SPALLING

REPLACE

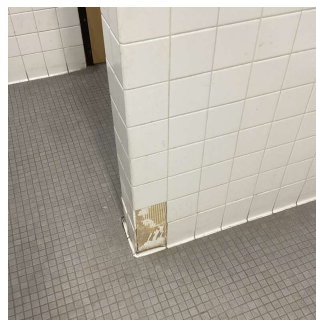
CERAMIC TILE: BROKEN/ MISSING

REPLACE

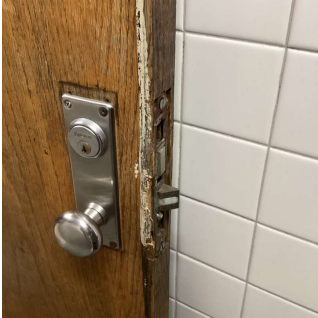
<b>Question</b>	<b>Response</b>
<b>INTERIOR</b>	
<b>TOILET ROOMS - STAFF</b>	Inspected
<b>Walls</b>	Inspected
	Room 240
Violations	No violations recorded.
<b>TOILET ROOMS - STUDENTS</b>	Inspected
<b>Ceiling</b>	Inspected
Condition	2 - Between Good and Fair
Deficiency	GYPSUM BOARD: DAMAGED/DETERIORATED
Deficiency Location/Instance	Rooms 124, 126
Deficiency Quantity	20
Quantity Uom	S.F.
Potential Action	REPLACE
Urgency of Action	PRIORITY 3
Purpose of Action	LEVEL 2
Deficiency Photo1	 
	Room 126
Violations	No violations recorded.
Deficiency	PLASTER: CRACKS/SPALLING
Deficiency Location/Instance	Room 410
Deficiency Quantity	10
Quantity Uom	S.F.
Potential Action	REPLACE
Urgency of Action	PRIORITY 3
Purpose of Action	LEVEL 2
Deficiency Photo1	 
	Room 410
Violations	No violations recorded.
<b>Door(s)</b>	Inspected
Condition	5 - Poor
Deficiency	WOOD: DETERIORATED DOOR
Deficiency Location/Instance	Rooms 404, 210, 126, 124
Deficiency Quantity	4

Question	Response
<b>INTERIOR</b>	
<b>TOILET ROOMS - STUDENTS</b>	Inspected
<b>Door(s)</b>	
Quantity Uom	EACH
Potential Action	MAINTENANCE
Urgency of Action	PRIORITY 3
Purpose of Action	LEVEL 2
Deficiency Photo1

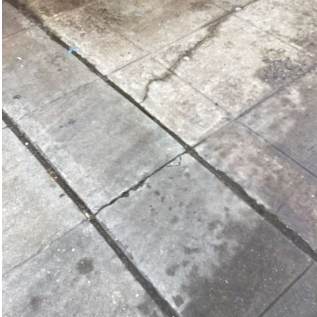
Question	Response
<b>SITE</b>	
<b>PAVING</b>	
<b>Student Non-Use</b>	
<b>Asphalt</b>	Does not Exist
<b>Concrete</b>	Inspected
Condition	3 - Fair
Deficiency	DAMAGED/DETERIORATED/MISSING SECTIONS
Deficiency Location/Instance	East 14th Street
Deficiency Quantity	50
Quantity Uom	S.F.
Potential Action	REPLACE
Urgency of Action	PRIORITY 3
Purpose of Action	LEVEL 2
Deficiency Photo1

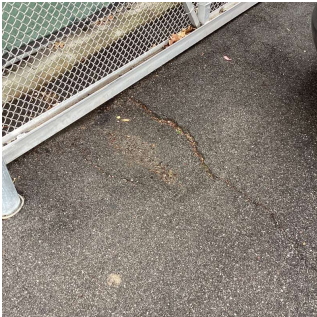
Violations	East 14th Street No violations recorded.
<b>Pavers</b>	Does not Exist
<b>Student Use</b>	Inspected
Gravel Exists?	No
<b>Asphalt</b>	Inspected
Condition	4 - Between Fair and Poor
Deficiency	POTHOLES
Deficiency Location/Instance	Near East 15th Street
Deficiency Quantity	10
Quantity Uom	S.F.
Potential Action	REPAIR
Urgency of Action	PRIORITY 3
Purpose of Action	LEVEL 2
Deficiency Photo1

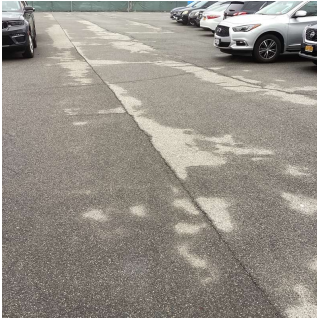
Violations	Near East 15th Street No violations recorded.
Deficiency	CRACKS - MAJOR
Deficiency Location/Instance	Schoolyard
Deficiency Quantity	1,200

Question	Response
<b>SITE</b>	
<b>PAVING</b>	
<b>Student Use</b>	
<b>Asphalt</b>	
Quantity Uom	S.F.
Potential Action	REPLACE
Urgency of Action	PRIORITY 3
Purpose of Action	LEVEL 2
Deficiency Photo1

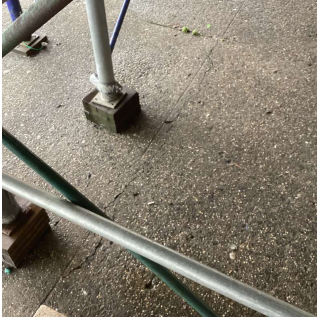
Schoolyard
Violations	No violations recorded.
<b>Concrete</b>	Does not Exist
<b>Pavers</b>	Does not Exist
<b>Site Sidewalks &amp; Walkways</b>	Inspected
<b>Asphalt</b>	Does not Exist
<b>Concrete</b>	Inspected
Condition	3 - Fair
Deficiency	DAMAGED/DETERIORATED/MISSING SECTIONS
Deficiency Location/Instance	Emmons Avenue
Deficiency Quantity	200
Quantity Uom	S.F.
Potential Action	REPLACE
Urgency of Action	PRIORITY 3
Purpose of Action	LEVEL 2
Deficiency Photo1

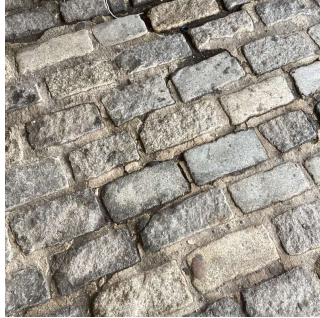
Emmons Avenue
Violations	No violations recorded.
<b>Pavers</b>	Inspected
Condition	2 - Between Good and Fair
Deficiency	DAMAGED/MISSING
Deficiency Location/Instance	Emmons Avenue
Deficiency Quantity	10
Quantity Uom	S.F.
Potential Action	REPLACE

Question	Response
<b>SITE</b>	
<b>PAVING</b>	
<b>Site Sidewalks &amp; Walkways</b>	
<b>Pavers</b>	
Urgency of Action	PRIORITY 3
Purpose of Action	LEVEL 2
Deficiency Photo1

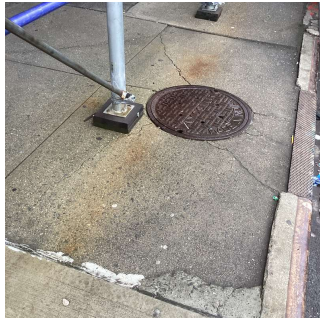
East 15th Street 56288
Violations	
Deficiency	DAMAGED/DETERIORATED/MISSING SECTIONS
Deficiency Location/Instance	East 15th Street, Emmons Avenue, East 14th Street, Shore Parkway
Deficiency Quantity	3,150
Quantity Uom	S.F.
Potential Action	REPLACE
Urgency of Action	PRIORITY 4
Purpose of Action	LEVEL 4
Deficiency Photo1

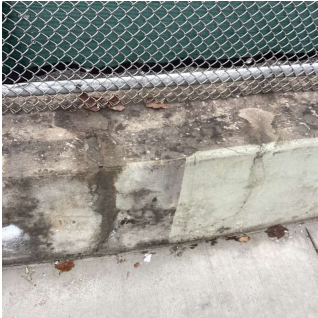
East 15th Street 56288
Violations	
<b>Pavers</b>	Does not Exist
<b>PLAYGROUNDS</b>	Does not Exist
<b>PLAYING SURFACE</b>	Does not Exist
<b>RETAINING WALLS</b>	Inspected
Are there any Retaining Walls 6' OR higher facing public street/sidewalk?	No
Condition	3 - Fair
Deficiency	CAST IN PLACE CONCRETE: CRACKS/SPALLING - MAJOR
Deficiency Location/Instance	East 14th Street
Deficiency Quantity	40
Quantity Uom	S.F.
Potential Action	REPLACE
Urgency of Action	PRIORITY 3
Purpose of Action	LEVEL 2

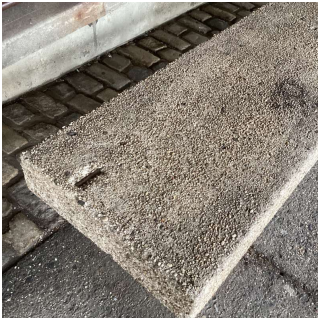
Violations	East 14th Street No violations recorded.
<b>SEATING</b>	Inspected
<b>Benches</b>	Inspected
<b>Concrete</b>	Inspected
Condition	5 - Poor
Deficiency	CRACKS/SPALLING - MAJOR
Deficiency Location/Instance	Emmons Avenue
Deficiency Quantity	3
Quantity Uom	EACH
Potential Action	REPLACE
Urgency of Action	PRIORITY 3
Purpose of Action	LEVEL 2
Deficiency Photo1
