**NYC Department of Education**  
**Building Condition Assessment Survey 2023 - 2024**

Architectural Inspection

**Asset:** P.S. 45 - BROOKLYN, 84 SCHAFFER STREET, New York, 11207

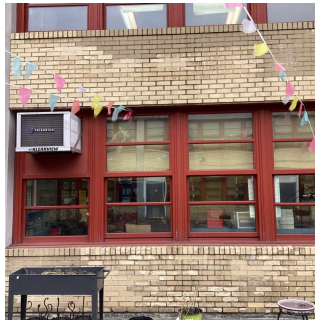
Facade G

**BRICK: MAJOR / THRU CRACKS**

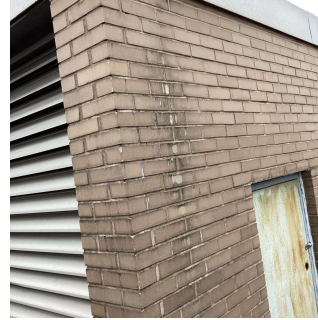
Shaft Vent Brick

Question	Response
<b>EXTERIOR</b>	
<b>ROOF</b>	
<b>Specialties</b>	
<b>BULKHEAD/PENTHOUSE</b>	
Roof Plan reference	
Deficiency Quantity	200
Quantity Uom	S.F.
Potential Action	REPOINT
Urgency of Action	PRIORITY 4
Purpose of Action	LEVEL 2
Deficiency Photo1	
Violations	Bulkhead 3 No violations recorded.
<b>CUPOLA/ SPIRES/ TOWERS</b>	Does not Exist
<b>DORMER</b>	Does not Exist
<b>DUNNAGE STEEL</b>	Does not Exist
<b>SKYLIGHT/ROOF VENT</b>	Inspected
Material Type(s)	Glass, Other
Condition	3 - Fair
Deficiency	<b>WATER INFILTRATION</b>
Roof Plan reference	
Deficiency Quantity	10
Quantity Uom	S.F.
Potential Action	MAINTENANCE

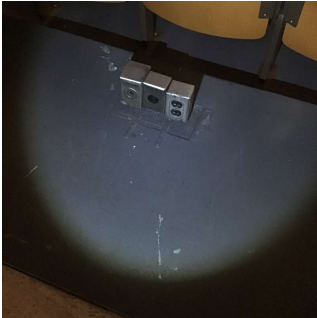
Question	Response
<b>INTERIOR</b>	
<b>AUDITORIUM</b>	
<b>Fixed Seating</b>	
Deficiency	No deficiencies recorded
<b>Floor Finish</b>	
Instance on Basement (420 seats)	Inspected
Condition	2 - Between Good and Fair
Deficiency	CONCRETE: TRIPPING HAZARD - ELECTRICAL OUTLET
Deficiency Location/Instance	Near seat N/105
Deficiency Quantity	10
Quantity Uom	S.F.
Potential Action	REMOVE
Urgency of Action	PRIORITY 5
Purpose of Action	LEVEL 6
Deficiency Photo1

Near seat N/105
Violations	No violations recorded.
Deficiency	VINYL TILES: BROKEN/DETERIORATED/MISSING TILES
Deficiency Location/Instance	Near center
Deficiency Quantity	20
Quantity Uom	S.F.
Potential Action	REPLACE
Urgency of Action	PRIORITY 3
Purpose of Action	LEVEL 2
Deficiency Photo1

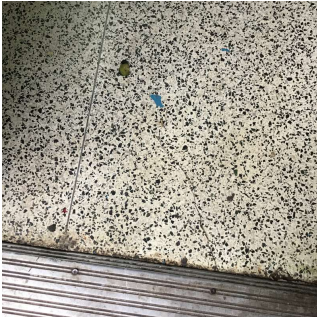
Question	Response
<b>INTERIOR</b>	
<b>CLASSROOMS/CORRIDORS/ADMIN SPACES</b>	
<b>Floor Finish</b>	Inspected
	Corridor near Room 205
Violations	No violations recorded.
Deficiency	TERRAZZO: CRACKS
Deficiency Location/Instance	Exit 3
Deficiency Quantity	10
Quantity Uom	S.F.
Potential Action	REPLACE
Urgency of Action	PRIORITY 3
Purpose of Action	LEVEL 2
Deficiency Photo1

Exit 3
Violations	No violations recorded.
Deficiency	VINYL TILES: DETERIORATED SUBSTRATE
Deficiency Location/Instance	Corridor near Room 219
Deficiency Quantity	10
Quantity Uom	S.F.
Potential Action	REPLACE
Urgency of Action	PRIORITY 5
Purpose of Action	LEVEL 6
Deficiency Photo1

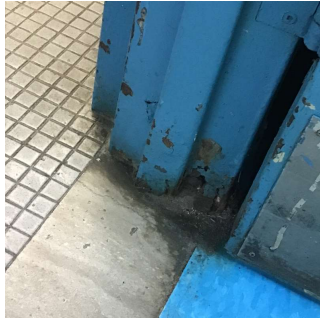
Question	Response
<b>INTERIOR</b>	
<b>KITCHEN</b>	
<b>Ceiling</b>	
Violations	No violations recorded.
<b>Door(s)</b>	
Instance on Basement	Inspected
Condition	4 - Between Fair and Poor
Deficiency	METAL: DETERIORATED DOOR AND FRAME
Deficiency Location/Instance	Entrance
Deficiency Quantity	2
Quantity Uom	EACH
Potential Action	MAINTENANCE
Urgency of Action	PRIORITY 3
Purpose of Action	LEVEL 2
Deficiency Photo1

Violations	Entrance No violations recorded.
<b>Floor Finish</b>	
Instance on Basement	Inspected
Condition	5 - Poor
Deficiency	CONCRETE: CRACKS
Deficiency Location/Instance	Office
Deficiency Quantity	10
Quantity Uom	S.F.
Potential Action	REPLACE
Urgency of Action	PRIORITY 3
Purpose of Action	LEVEL 2
Deficiency Photo1

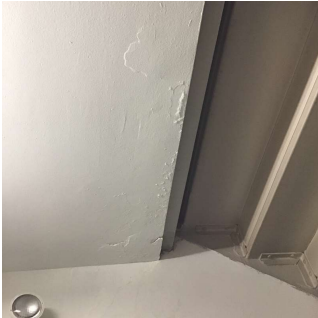
Question	Response
<b>INTERIOR</b>	
<b>LIBRARY</b>	Inspected
<b>Walls</b>	
Instance on Room 125	Inspected
Condition	2 - Between Good and Fair
Deficiency	No deficiencies recorded
<b>LOCKER ROOM</b>	Does not Exist
<b>MULTI-PURPOSE ROOM</b>	Does not Exist
<b>SCIENCE DEMO ROOM</b>	Does not Exist
<b>SCIENCE LAB</b>	Inspected
Instance on Room 337	Inspected
Alternative use	No
<b>Fixed Equipment</b>	
Instance on Room 337	Inspected
Condition	2 - Between Good and Fair
Deficiency	No deficiencies recorded
<b>SCIENCE PREP ROOM</b>	Does not Exist
<b>SHOWER ROOM</b>	Does not Exist
<b>STAIRS/RAMPS: INTERIOR</b>	Inspected
Do Letter Stair Signs Exist?	Partially
<b>Ceiling</b>	Inspected
Condition	2 - Between Good and Fair
Deficiency	PLASTER: CRACKS/SPALLING
Deficiency Location/Instance	Stair D/2
Deficiency Quantity	10
Quantity Uom	S.F.
Potential Action	REPLACE
Urgency of Action	PRIORITY 3
Purpose of Action	LEVEL 2
Deficiency Photo1

Violations	Stair D/2 No violations recorded.

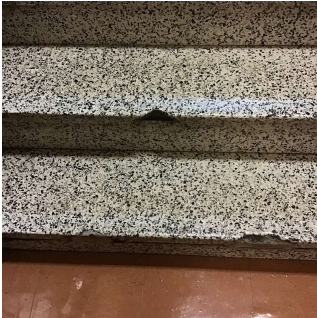
Violations	Stair B/basement No violations recorded.
Deficiency	TERRAZZO: CRACKS
Deficiency Location/Instance	Near room 133
Deficiency Quantity	10
Quantity Uom	S.F.
Potential Action	REPLACE
Urgency of Action	PRIORITY 5
Purpose of Action	LEVEL 6
Deficiency Photo1

Violations	Near Room 133 No violations recorded.
Deficiency	TERRAZZO: CRACKS
Deficiency Location/Instance	Near Room 133, Exit 1
Deficiency Quantity	50
Quantity Uom	S.F.
Potential Action	REPLACE
Urgency of Action	PRIORITY 3
Purpose of Action	LEVEL 2

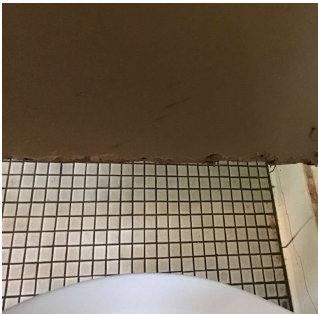
Question	Response
<b>INTERIOR</b>	
<b>STAIRS/RAMPS: INTERIOR</b>	Inspected
<b>Walls</b>	Inspected
Violations	Stair B/basement No violations recorded.
<b>TOILET ROOMS - STAFF</b>	Inspected
<b>Ceiling</b>	Inspected
Condition	2 - Between Good and Fair
Deficiency	No deficiencies recorded
<b>Door(s)</b>	Inspected
Condition	2 - Between Good and Fair
Deficiency	No deficiencies recorded
<b>Floor Finish</b>	Inspected
Condition	5 - Poor
Deficiency	CERAMIC TILE: BROKEN/MISSING TILES
Deficiency Location/Instance	Room 366,364,319,219,111, and others
Deficiency Quantity	80
Quantity Uom	S.F.
Potential Action	REPLACE
Urgency of Action	PRIORITY 3
Purpose of Action	LEVEL 2
Deficiency Photo1	 
Room 364	
Violations	No violations recorded.
<b>Stalls</b>	Inspected
Condition	5 - Poor
Deficiency	RUST - MAJOR
Deficiency Location/Instance	Room 134A,130A,111,109
Deficiency Quantity	4
Quantity Uom	EACH
Potential Action	REPLACE
Urgency of Action	PRIORITY 3

Purpose of Action	LEVEL 2
Deficiency Photo1

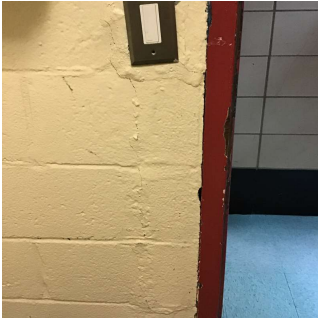
Question	Response
<b>INTERIOR</b>	
<b>TOILET ROOMS - STAFF</b>	Inspected
<b>Stalls</b>	Inspected
	Rm 109
Violations	No violations recorded.
<b>Walls</b>	Inspected
Condition	2 - Between Good and Fair
Deficiency	MASONRY: CRACKS/SPALLING
Deficiency Location/Instance	Room 319
Deficiency Quantity	10
Quantity Uom	S.F.
Potential Action	REPLACE
Urgency of Action	PRIORITY 3
Purpose of Action	LEVEL 2
Deficiency Photo1

Room 319
Violations	No violations recorded.
Deficiency	CERAMIC TILE: BROKEN/ MISSING
Deficiency Location/Instance	Room 366,364,319,219,111, and others
Deficiency Quantity	50
Quantity Uom	S.F.
Potential Action	REPLACE
Urgency of Action	PRIORITY 3
Purpose of Action	LEVEL 2
Deficiency Photo1

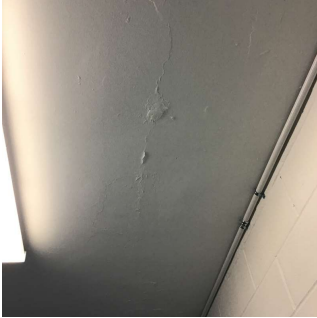
Question	Response
<b>INTERIOR</b>	
<b>TOILET ROOMS - STUDENTS</b>	
<b>Ceiling</b>	
Quantity Uom	S.F.
Potential Action	REPLACE
Urgency of Action	PRIORITY 3
Purpose of Action	LEVEL 2
Deficiency Photo1

Room 317
Violations	No violations recorded.
<b>Door(s)</b>	Inspected
Condition	5 - Poor
Deficiency	WOOD: DETERIORATED DOOR
Deficiency Location/Instance	Room 313,217,213
Deficiency Quantity	3
Quantity Uom	EACH
Potential Action	MAINTENANCE
Urgency of Action	PRIORITY 3
Purpose of Action	LEVEL 2
Deficiency Photo1

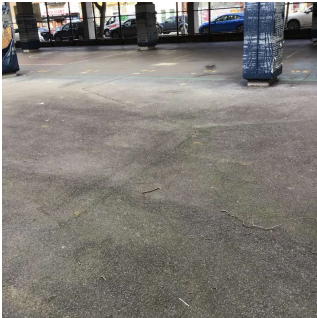
Question	Response
<b>SITE</b>	
<b>PAVING</b>	
<b>Student Non-Use</b>	Does not Exist
<b>Student Use</b>	Inspected
Gravel Exists?	No
<b>Asphalt</b>	Inspected
Condition	4 - Between Fair and Poor
Deficiency	CRACKS - MAJOR
Deficiency Location/Instance	Courtyard
Deficiency Quantity	1,000
Quantity Uom	S.F.
Potential Action	REPLACE
Urgency of Action	PRIORITY 3
Purpose of Action	LEVEL 2
Deficiency Photo1

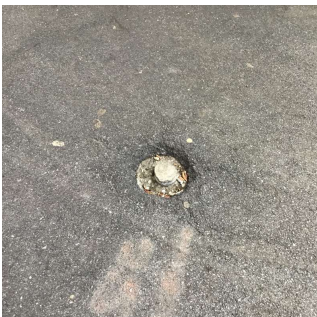
Violations	Courtyard No violations recorded.
Deficiency	POTHOLES
Deficiency Location/Instance	Courtyard
Deficiency Quantity	50
Quantity Uom	S.F.
Potential Action	REPAIR
Urgency of Action	PRIORITY 5
Purpose of Action	LEVEL 6
Deficiency Photo1

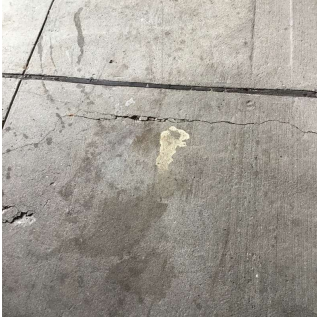
Violations	Courtyard No violations recorded.
<b>Concrete</b>	Inspected
Condition	3 - Fair
Deficiency	DAMAGED/DETERIORATED/MISSING SECTIONS
Deficiency Location/Instance	Near Schoolyard, Courtyard
Deficiency Quantity	200
Quantity Uom	S.F.
Potential Action	REPLACE

Question	Response
<b>SITE</b>	
<b>PAVING</b>	
<b>Student Use</b>	
<b>Concrete</b>	
Urgency of Action	PRIORITY 3
Purpose of Action	LEVEL 2
Deficiency Photo1

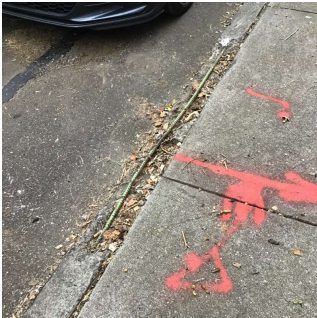
Violations	Near Schoolyard No violations recorded.
<b>Pavers</b>	Does not Exist
<b>Site Sidewalks &amp; Walkways</b>	Inspected
<b>Asphalt</b>	Does not Exist
<b>Concrete</b>	Inspected
Condition	2 - Between Good and Fair
Deficiency	No deficiencies recorded
<b>Pavers</b>	Does not Exist
<b>DOT Sidewalk</b>	Inspected
<b>Asphalt</b>	Does not Exist
<b>Concrete</b>	Inspected
Condition	4 - Between Fair and Poor
Deficiency	DAMAGED CURBS
Deficiency Location/Instance	Along Decatur Street
Deficiency Quantity	10
Quantity Uom	L.F.
Potential Action	REPLACE
Urgency of Action	PRIORITY 5
Purpose of Action	LEVEL 6
Deficiency Photo1

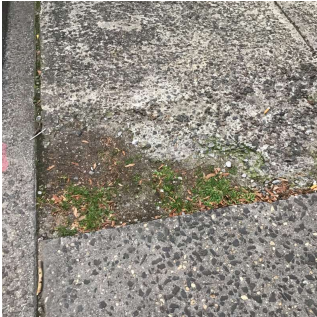
Violations	Along Decatur Street No violations recorded.
Deficiency	DAMAGED/DETERIORATED/MISSING SECTIONS
Deficiency Location/Instance	Along Schaefer Street, Decatur Street

Deficiency Quantity	175

Question	Response
<b>SITE</b>	
<b>PAVING</b>	
<b>DOT Sidewalk</b>	
<b>Concrete</b>	
Quantity Uom	S.F.
Potential Action	REPLACE
Urgency of Action	PRIORITY 5
Purpose of Action	LEVEL 6
Deficiency Photo1

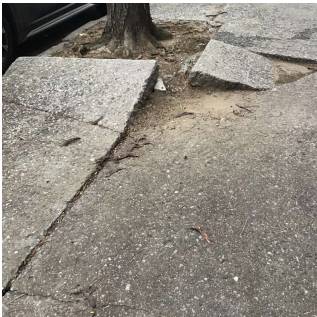
Along Schaefer Street
Violations	No violations recorded.
Deficiency	HEAVING
Deficiency Location/Instance	Along Schaefer Street, Decatur Street
Deficiency Quantity	350
Quantity Uom	S.F.
Potential Action	REPLACE
Urgency of Action	PRIORITY 5
Purpose of Action	LEVEL 6
Deficiency Photo1

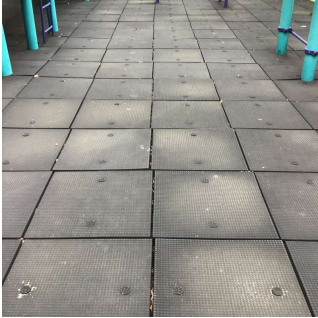
Question	Response
<b>SITE</b>	
<b>PAVING</b>	Inspected
<b>DOT Sidewalk</b>	
<b>Concrete</b>	Inspected
Violations	No violations recorded.
<b>Pavers</b>	Does not Exist
<b>PLAYGROUNDS</b>	Inspected
Instance on South side of Schoolyard	Inspected
<b>Benches</b>	
Instance on South side of Schoolyard	Does not Exist
<b>Fence</b>	
Instance on South side of Schoolyard	Does not Exist
<b>Pavement</b>	
Instance on South side of Schoolyard	Does not Exist
<b>Play Equipment</b>	
Instance on South side of Schoolyard	Inspected
Condition	2 - Between Good and Fair
Deficiency	No deficiencies recorded
<b>Safety Surfacing</b>	
Instance on South side of Schoolyard	Inspected
Condition	4 - Between Fair and Poor
Deficiency	DETERIORATED/MISSING
Deficiency Location/Instance	Schoolyard
Deficiency Quantity	300
Quantity Uom	S.F.
Potential Action	MAINTENANCE
Urgency of Action	PRIORITY 3
Purpose of Action	LEVEL 2
Deficiency Photo1

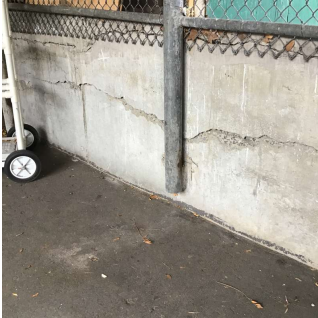
<b>Unpaved Area</b>	
Instance on South side of Schoolyard	Does not Exist
<b>PLAYING SURFACE</b>	Does not Exist
<b>RETAINING WALLS</b>	Inspected
Are there any Retaining Walls 6' OR higher facing public street/sidewalk?	Yes
Condition	3 - Fair
Deficiency	CAST IN PLACE CONCRETE: CRACKS/SPALLING - MAJOR
Deficiency Location/Instance	Courtyard
Deficiency Quantity	100
Quantity Uom	S.F.

Question	Response
<b>SITE</b>	
<b>RETAINING WALLS</b>	
Potential Action	REPLACE
Urgency of Action	PRIORITY 3
Purpose of Action	LEVEL 2
Deficiency Photo1

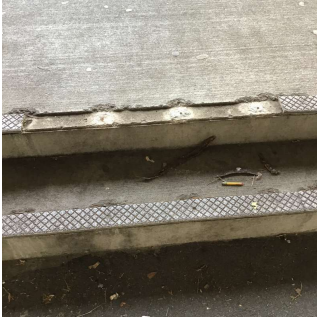
Question	Response
<b>SITE</b>	
<b>STAIRS/RAMPS: EXTERIOR</b>	
<b>Stairs/ramps</b>	
Condition	2 - Between Good and Fair
Deficiency	CAST IN PLACE CONCRETE: WORN-OUT TREAD/RISER/NOSERS
Deficiency Location/Instance	Courtyard
Deficiency Quantity	10
Quantity Uom	S.F.
Potential Action	REPLACE
Urgency of Action	PRIORITY 5
Purpose of Action	LEVEL 6
Deficiency Photo1
