NYC Department of Education
Building Condition Assessment Survey 2023 - 2024

Architectural Inspection

K051

Asset: I.S. 51 - BROOKLYN, 350 5TH AVENUE, New York, 11215

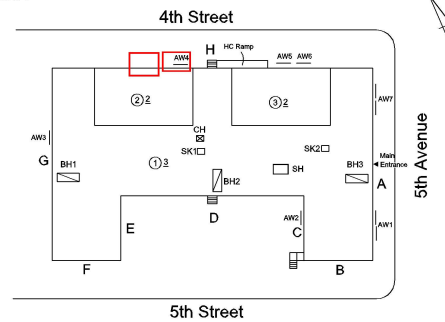
Deficiency

AREAWAY WALLS: CRACKS AND SPALLING

REPAIR

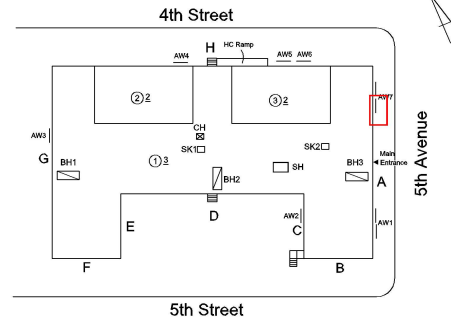
Deficiency

AREAWAY SLAB: CRACKS AND SPALLING

REPAIR

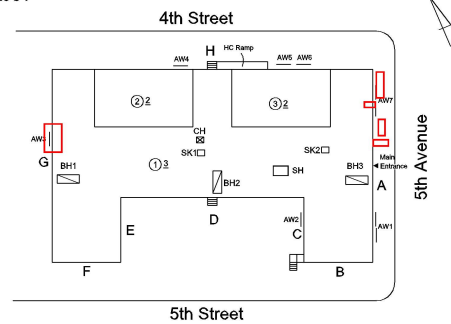
Deficiency

AREAWAY WALLS: CRACKS AND SPALLING

REPAIR

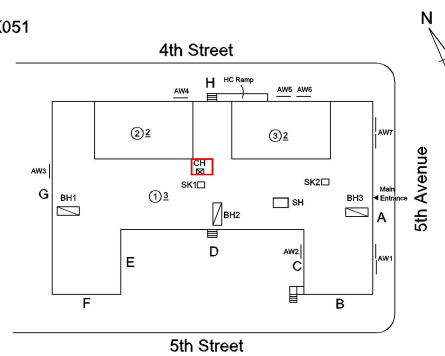
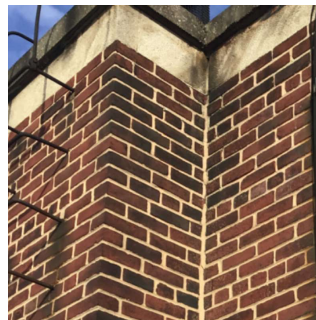
Chimney

Deficiency

BRICK: DETERIORATED CAP

REPLACE

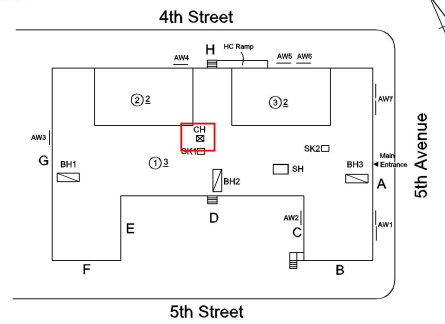
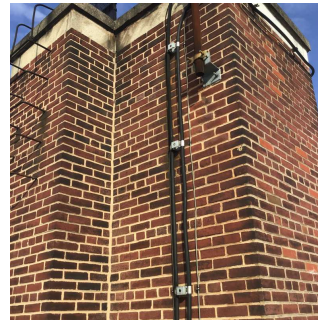
Chimney

Deficiency

BRICK: MINOR CRACKS AND SPALLING

10
S.F.
RESTITCH
PRIORITY 3
LEVEL 2

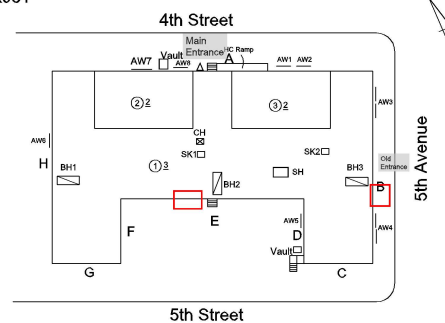
Deficiency

METAL CLAD: DETERIORATED DOOR AND FRAME - MAJOR DETERIORATION

5
EACH
REPLACE
PRIORITY 4

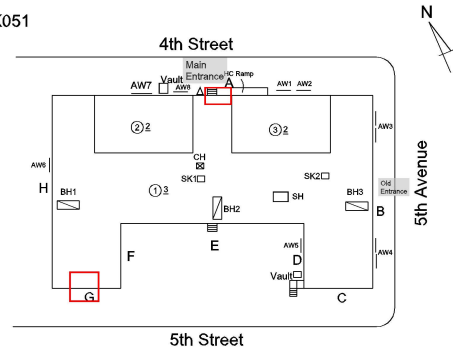
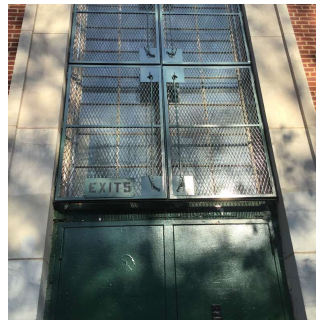
Exit 5
No violations recorded.

Deficiency
Roof Plan reference

METAL: DENTED, MAJOR RUSTING

10
S.F.
REPLACE
PRIORITY 4
LEVEL 2

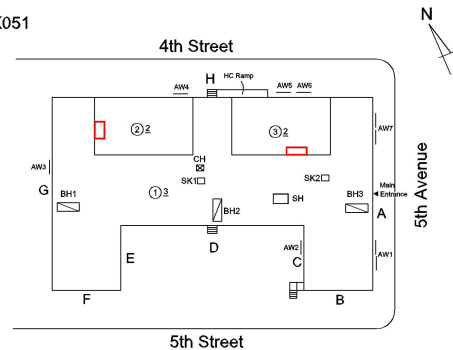
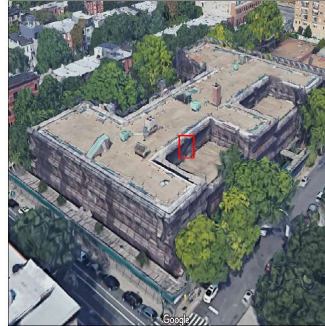
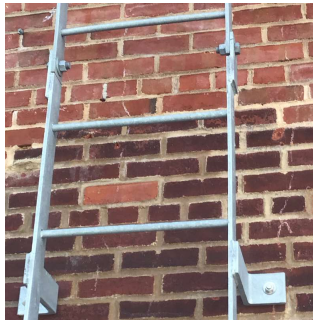
Facade A

Inspected
Masonry
36,000
S.F.
Inspected
2 - Between Good and Fair
36,000
S.F.
BRICK: MINOR CRACKS AND SPALLING

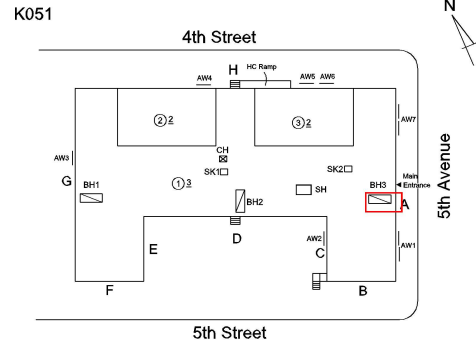
Installation Year	2022
Source of Installation	Custodial Staff
Deficiency	No deficiencies recorded
ROOFING DRAINS	Inspected
Condition	1 - Good
Deficiency	No deficiencies recorded
Specialties	Inspected
BULKHEAD/PENTHOUSE	Inspected
Condition	3 - Fair
Deficiency	BULKHEAD/PENTHOUSE WALLS/INTERIOR: PLASTER CRACKS/SPALLING

80
S.F.
REPLACE
PRIORITY 3
LEVEL 2

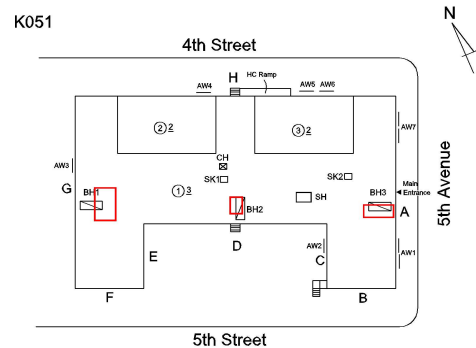
BULKHEAD/PENTHOUSE WINDOWS: DAMAGED, DETERIORATED WINDOWS

90
S.F.
REPLACE
PRIORITY 4
LEVEL 2

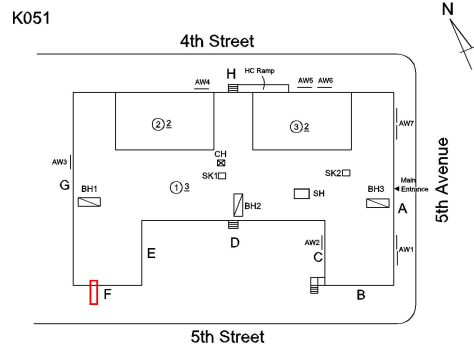
Exit 5
No violations recorded.

BUILDING CHEEK/FLANK WALLS

10
S.F.
REPAIR
PRIORITY 3
LEVEL 2

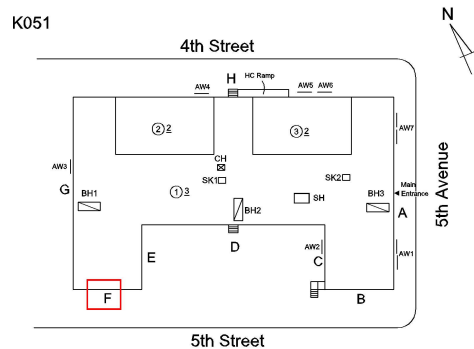
CONCRETE: WORN-OUT TREAD/RISER/NOSING

50
S.F.
REPLACE
PRIORITY 4
LEVEL 2

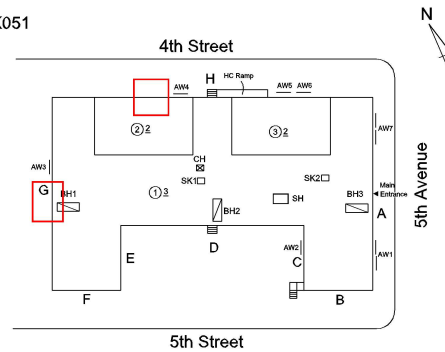
CONCRETE: CRACKS/SPALLING - MINOR

REPAIR

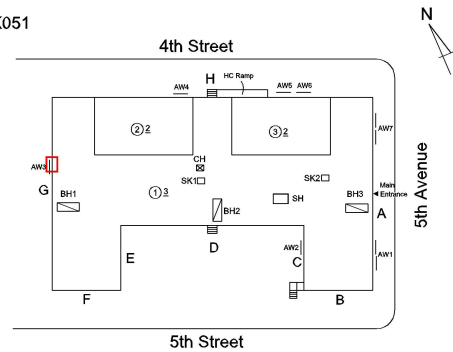
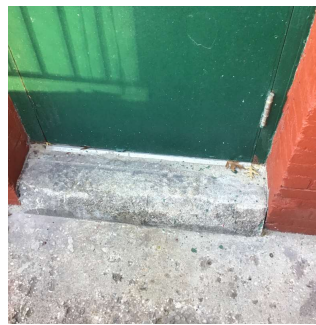
AW3 Exit 8
No violations recorded.

STONE: CRACKS/SPALLING - MAJOR

10
S.F.
REPLACE
PRIORITY 4
LEVEL 2

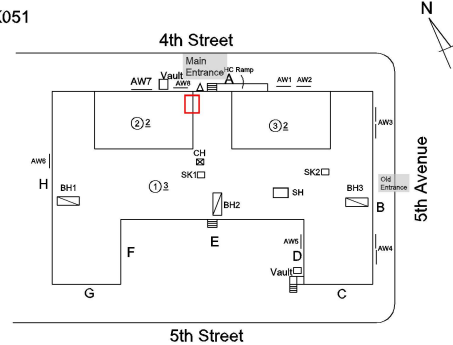
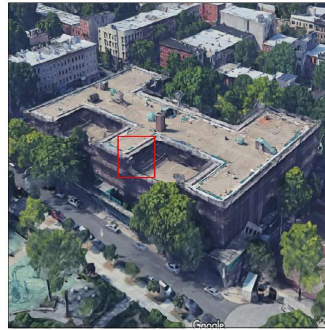
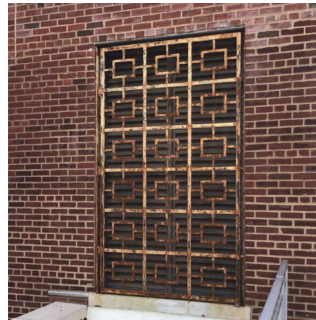
Facade A

RUST - MAJOR

30
S.F.
REPLACE
PRIORITY 4
LEVEL 2

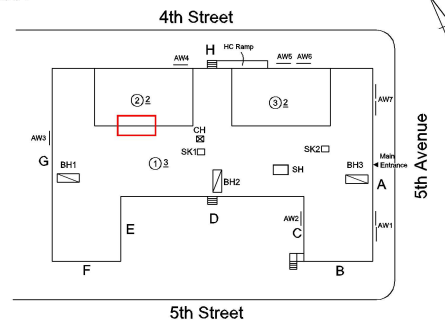
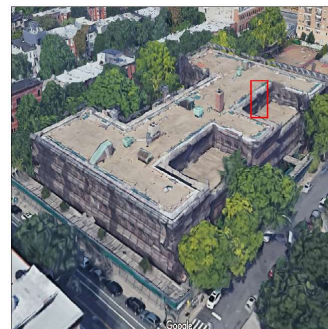
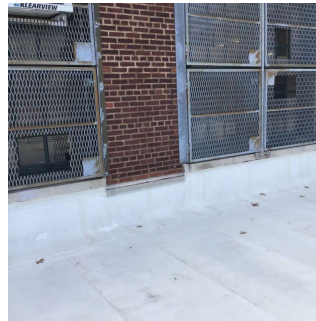
Facade A

DETERIORATED/TORN-OUT/MISSING

REPLACE
PRIORITY 4
LEVEL 2

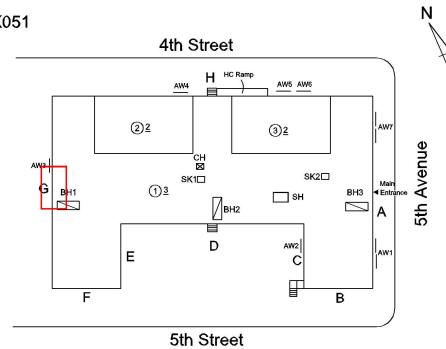
Deficiency	STEEL: BROKEN PANE
Roof Plan reference	K051

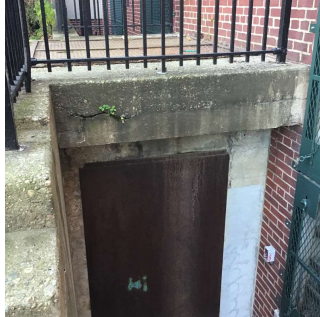
Question	Response
INTERIOR	
STRUCTURAL	
VAULTS-BUNKERS	
Foundation Walls	
Deficiency Photo1

Question	Response
INTERIOR	
STRUCTURAL	
FLOOR STRUCTURE	
Deficiency Photo1	 
Violations	Basement Mechanical Equipment Room No violations recorded.
FOUNDATION WALLS	
Material Type(s)	Inspected Concrete
Condition	3 - Fair
Deficiency	CONCRETE: WATER INFILTRATION IN NON- INSTRUCTIONAL SPACE
Deficiency Location/Instance	Basement Mechanical Room
Deficiency Quantity	80
Quantity Uom	S.F.
Potential Action	INSTALL WATERPROOFING
Urgency of Action	PRIORITY 5
Purpose of Action	LEVEL 5
Deficiency Photo1	 
Violations	Facade x No violations recorded.
ROOF STRUCTURE	
Condition	Inspected 2 - Between Good and Fair
Deficiency	No deficiencies recorded
VAULTS-BUNKERS	
Foundation Walls	
Condition	Inspected 2 - Between Good and Fair
Deficiency	CRACKS, SPALLING
Deficiency Location/Instance	AW8
Deficiency Quantity	10
Quantity Uom	S.F.
Potential Action	REPAIR
Urgency of Action	PRIORITY 3
Purpose of Action	LEVEL 5

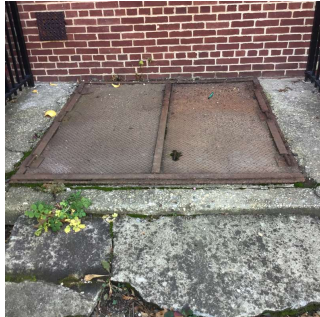
Violations	AW7 No violations recorded.
Slab Structure	Inspected
Condition	2 - Between Good and Fair
Deficiency	No deficiencies recorded
Vault/Ash Hoist Doors and Framing	Inspected
Condition	3 - Fair
Deficiency	NOT IN USE / DETERIORATED
Deficiency Location/Instance	Facade A
Deficiency Quantity	4
Quantity Uom	EACH
Potential Action	REMOVE AND SEAL
Urgency of Action	PRIORITY 3
Purpose of Action	LEVEL 2
Deficiency Photo1

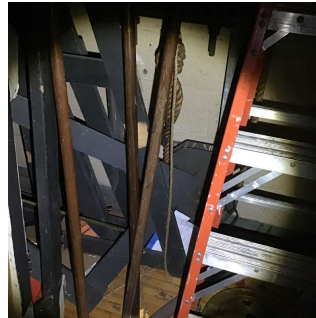
Question	Response
INTERIOR	
AUDITORIUM	
Stage	
Stage	
Deficiency Photo1	 
Violations	Right Side No violations recorded.
Deficiency	DAMAGED FLOOR
Deficiency Location/Instance	Right Side
Deficiency Quantity	10
Quantity Uom	S.F.
Potential Action	REPLACE
Urgency of Action	PRIORITY 3
Purpose of Action	LEVEL 2
Deficiency Photo1	 
Violations	Right Side No violations recorded.
Stage Curtain Rigging	Inspected
Instance on 1st Floor (470 Seats)	Inspected
Condition	3 - Fair
Deficiency	DAMAGED/DETERIORATED
Deficiency Location/Instance	Left Side
Deficiency Quantity	1
Quantity Uom	EACH
Potential Action	REPLACE
Urgency of Action	PRIORITY 3
Purpose of Action	LEVEL 2

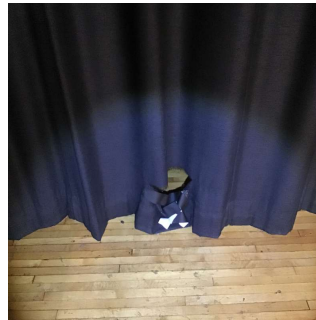
Right Side

Deficiency

WORN/DETERIORATED

REPLACE

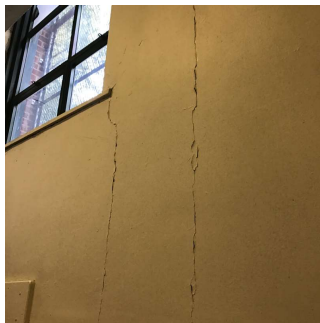
Deficiency

PLASTER: CRACKS/SPALLING

REPLACE

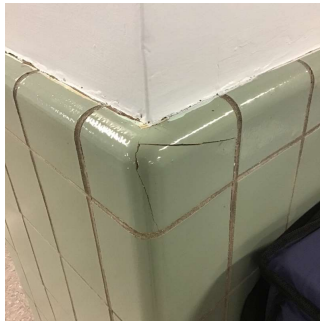
Violations	Exit 7 No violations recorded.
Window Curtains/Shades/Blinds	
Instance on 1st Floor (470 Seats)	Inspected
Condition	2 - Between Good and Fair
Deficiency	No deficiencies recorded
CAFETERIA	
Instance on Basement	Inspected
Ceiling	
Instance on Basement	Inspected
Condition	2 - Between Good and Fair
Deficiency	No deficiencies recorded
Door(s)	
Instance on Basement	Inspected
Condition	2 - Between Good and Fair
Deficiency	No deficiencies recorded
Fixed Equipment	
Instance on Basement	Does not Exist
Floor Finish	
Instance on Basement	Inspected
Condition	2 - Between Good and Fair
Deficiency	No deficiencies recorded
Sliding-folding Partition	
Instance on Basement	Does not Exist
Stage	
Instance on Basement	Does not Exist
Walls	
Instance on Basement	Inspected
Condition	2 - Between Good and Fair
Deficiency	GLAZED BLOCK: CRACKS/SPALLING
Deficiency Location/Instance	Center Columns, Near Stair K

Deficiency Quantity	20
Quantity Uom	S.F.
Potential Action	REPLACE
Urgency of Action	PRIORITY 3
Purpose of Action	LEVEL 2

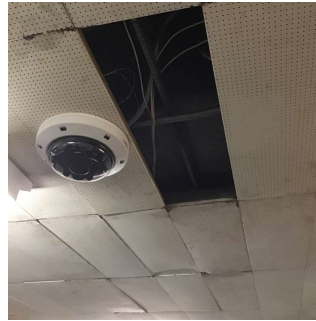
Corridor near Room 340

Violations	Corridor near Room 223 No violations recorded.
Deficiency	METAL PAN: DAMAGED/MISSING
Deficiency Location/Instance	Corridor near Rooms 103, 118, 240, 305, 340, and others
Deficiency Quantity	250
Quantity Uom	S.F.
Potential Action	REPLACE
Urgency of Action	PRIORITY 3
Purpose of Action	LEVEL 2

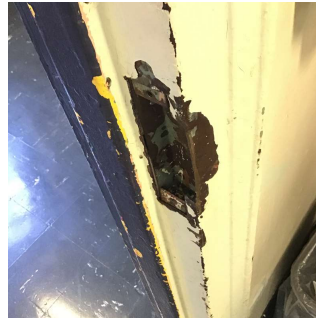
Room 344

Deficiency

METAL: DETERIORATED DOOR AND FRAME

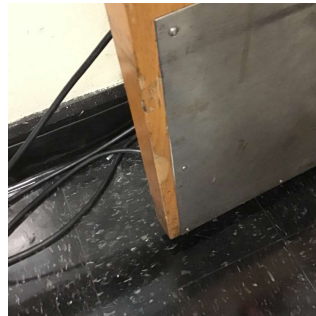
Deficiency

WOOD: DETERIORATED DOOR

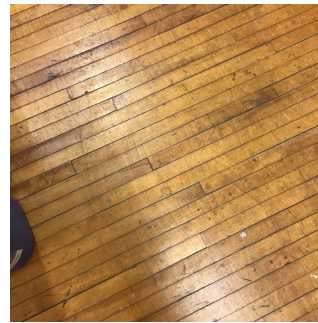
Room 323

Room 345
Violations	No violations recorded.
Deficiency	WOOD: DAMAGED/DETERIORATED
Deficiency Location/Instance	Rooms 142, 323
Deficiency Quantity	20
Quantity Uom	S.F.
Potential Action	REPLACE

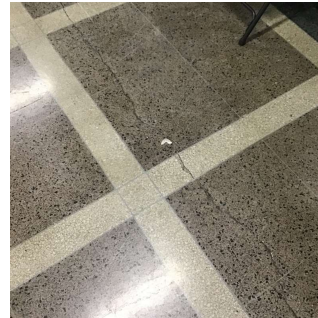
Main Entrance Lobby

Deficiency

TERRAZZO: CRACKS

REPLACE

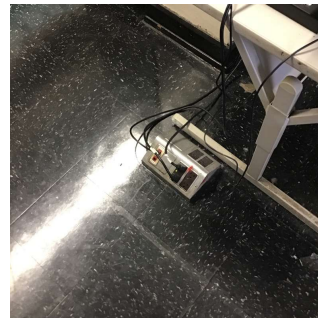
Room 201

Deficiency

VINYL TILES: TRIPPING HAZARD - ELECTRICAL OUTLET

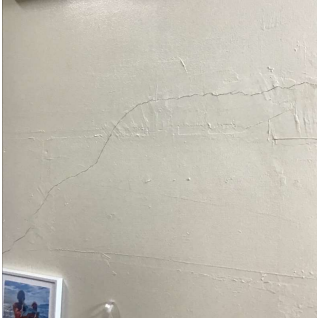
Question	Response
INTERIOR	
CLASSROOMS/CORRIDORS/ADMIN SPACES	
Walls	Inspected
Condition	2 - Between Good and Fair
Deficiency	PLASTER: CRACKS/SPALLING
Deficiency Location/Instance	Rooms 134, 234, 342, Corridor near Rooms 206, 315, and others
Deficiency Quantity	80
Quantity Uom	S.F.
Potential Action	REPLACE
Urgency of Action	PRIORITY 3
Purpose of Action	LEVEL 2
Deficiency Photo1

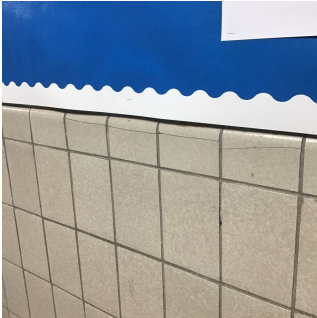
Room 342
Violations	No violations recorded.
Deficiency	GLAZED BLOCK: CRACKS/SPALLING
Deficiency Location/Instance	Corridor near Rooms B12, 209
Deficiency Quantity	20
Quantity Uom	S.F.
Potential Action	REPLACE
Urgency of Action	PRIORITY 3
Purpose of Action	LEVEL 2
Deficiency Photo1

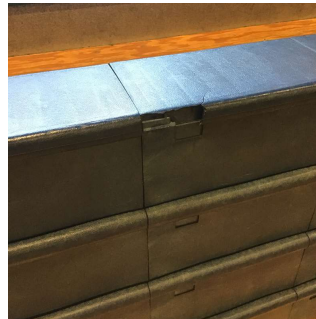
Near Locker Room

Instance on 1st Floor	Inspected
Condition	2 - Between Good and Fair
Deficiency	DAMAGED BLEACHERS
Deficiency Location/Instance	Near Locker Room, Near Main Entrance
Deficiency Quantity	20
Quantity Uom	S.F.
Potential Action	REPLACE
Urgency of Action	PRIORITY 3
Purpose of Action	LEVEL 2
Deficiency Photo1

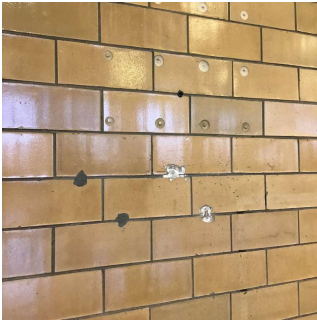
Question	Response
INTERIOR	
GYMNASIUM	
Walls	
Instance on 1st Floor	Inspected
Condition	2 - Between Good and Fair
Deficiency	GLAZED BLOCK: CRACKS/SPALLING
Deficiency Location/Instance	Near Drinking Fountain
Deficiency Quantity	10
Quantity Uom	S.F.
Potential Action	REPLACE
Urgency of Action	PRIORITY 3
Purpose of Action	LEVEL 2
Deficiency Photo1

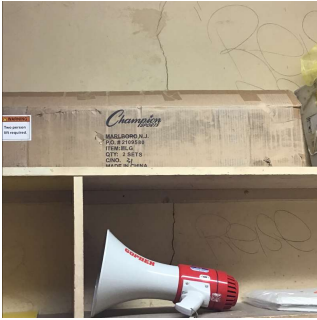
Violations	Near Drinking Fountain No violations recorded.
Deficiency	PLASTER: CRACKS/SPALLING
Deficiency Location/Instance	Storage Room, Near Windows
Deficiency Quantity	30
Quantity Uom	S.F.
Potential Action	REPLACE
Urgency of Action	PRIORITY 3
Purpose of Action	LEVEL 2
Deficiency Photo1

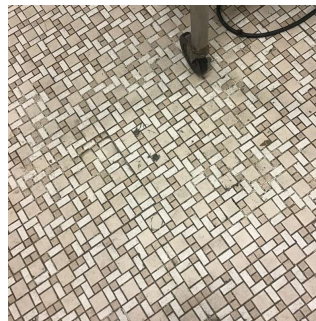
Serving Area

Deficiency	CERAMIC TILE: BROKEN/MISSING TILES
Deficiency Location/Instance	Serving Area, Center
Deficiency Quantity	20
Quantity Uom	S.F.
Potential Action	REPLACE
Urgency of Action	PRIORITY 3
Purpose of Action	LEVEL 2
Deficiency Photo1

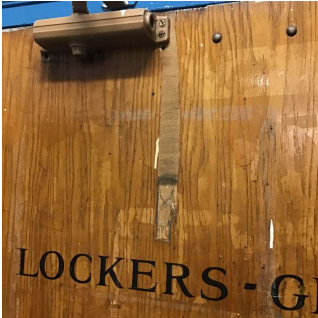
Question	Response
INTERIOR	
LOCKER ROOM	
Ceiling	
Deficiency	No deficiencies recorded
Door(s)	
Instance on 1st Floor (180 Lockers)	Inspected
Condition	3 - Fair
Deficiency	WOOD: DETERIORATED DOOR
Deficiency Location/Instance	Entrance from Corridor
Deficiency Quantity	1
Quantity Uom	EACH
Potential Action	MAINTENANCE
Urgency of Action	PRIORITY 3
Purpose of Action	LEVEL 2
Deficiency Photo1

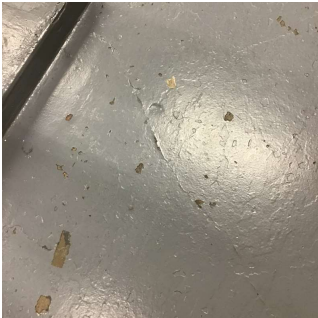
Violations	Entrance from Corridor No violations recorded.
Floor Finish	
Instance on Basement (356 Lockers)	Inspected
Condition	2 - Between Good and Fair
Deficiency	CONCRETE: CRACKS
Deficiency Location/Instance	Near Hand Washing Sink
Deficiency Quantity	10
Quantity Uom	S.F.
Potential Action	REPLACE
Urgency of Action	PRIORITY 3
Purpose of Action	LEVEL 2
Deficiency Photo1

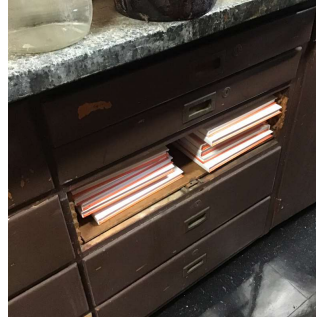
Question	Response
INTERIOR	
LOCKER ROOM	
Walls	
Deficiency Photo1	 
Violations	Near Locker 355 No violations recorded.
MULTI-PURPOSE ROOM	Does not Exist
SCIENCE DEMO ROOM	Inspected
Instance on Rooms 240, 244, 340, 344	Inspected
Alternative use	No
Fixed Equipment	
Instance on Rooms 240, 244, 340, 344	Inspected
Condition	5 - Poor
Deficiency	CABINETRY: MISSING/DAMAGED
Deficiency Location/Instance	Rooms 240, 244, 340, 344
Deficiency Quantity	30
Quantity Uom	L.F.
Potential Action	REPLACE
Urgency of Action	PRIORITY 3
Purpose of Action	LEVEL 2
Deficiency Photo1	 
Violations	Room 344 No violations recorded.
SCIENCE LAB	Does not Exist
SCIENCE PREP ROOM	Inspected
Instance on Room 242	Inspected
Alternative use	No
Instance on Room 342	Inspected
Alternative use	No
Fixed Equipment	
Instance on Room 242	Inspected
Condition	3 - Fair
Deficiency	CABINETRY: MISSING/DAMAGED

Deficiency Location/Instance	Room 242
Deficiency Quantity	10
Quantity Uom	L.F.
Potential Action	REPLACE
Urgency of Action	PRIORITY 3
Purpose of Action	LEVEL 2
Deficiency Photo1

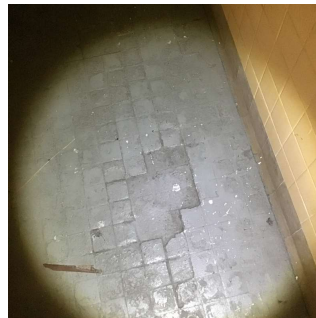
Center

Instance on Basement	Inspected
Condition	4 - Between Fair and Poor
Deficiency	CERAMIC TILE: BROKEN/MISSING TILES
Deficiency Location/Instance	Center, Left Side Entrance
Deficiency Quantity	20
Quantity Uom	S.F.
Potential Action	REPLACE
Urgency of Action	PRIORITY 3
Purpose of Action	LEVEL 2
Deficiency Photo1

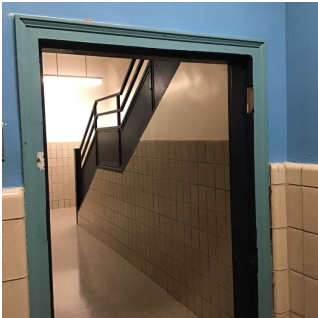
Question	Response
INTERIOR	
SHOWER ROOM	
Floor Finish	
Violations	No violations recorded.
Walls	
Instance on Basement	Inspected
Condition	2 - Between Good and Fair
Deficiency	No deficiencies recorded
STAIRS/RAMPS: INTERIOR	Inspected
Do Letter Stair Signs Exist?	Yes
Ceiling	Inspected
Condition	2 - Between Good and Fair
Deficiency	No deficiencies recorded
Door(s)	Inspected
Condition	2 - Between Good and Fair
Deficiency	METAL: MISSING DOOR
Deficiency Location/Instance	Stair HI/Basement Vestibule
Deficiency Quantity	1
Quantity Uom	EACH
Potential Action	MAINTENANCE
Urgency of Action	PRIORITY 3
Purpose of Action	LEVEL 2
Deficiency Photo1

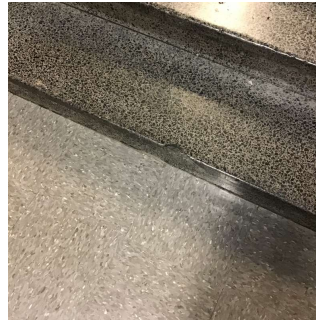
Violations	Stair HI/Basement Vestibule No violations recorded.
Partition	Does not Exist
Railings	Inspected
Condition	2 - Between Good and Fair
Deficiency	No deficiencies recorded
Stairs and Landings	Inspected
Condition	3 - Fair
Deficiency	TERRAZZO: CRACKS
Deficiency Location/Instance	Corridor Across from Room 132

Deficiency Quantity	10
Quantity Uom	S.F.
Potential Action	REPLACE
Urgency of Action	PRIORITY 5
Purpose of Action	LEVEL 6

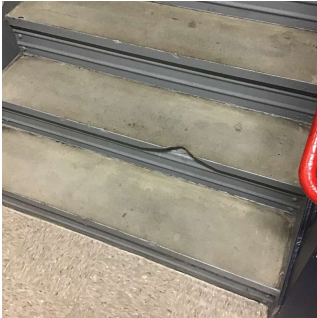
Question	Response
INTERIOR	
STAIRS/RAMPS: INTERIOR	
Stairs and Landings	
Deficiency	STONE: BROKEN/MISSING
Deficiency Location/Instance	Stair HI/Basement
Deficiency Quantity	10
Quantity Uom	S.F.
Potential Action	REPLACE
Urgency of Action	PRIORITY 5
Purpose of Action	LEVEL 6
Deficiency Photo1

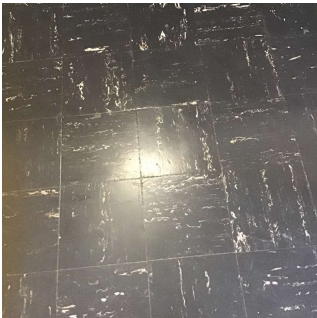
Violations	Stair HI/Basement No violations recorded.
Deficiency	VINYL TILES: BROKEN/DETERIORATED/MISSING TILES
Deficiency Location/Instance	Stairs BC/2,3, EF/2, HI/2, and others
Deficiency Quantity	200
Quantity Uom	S.F.
Potential Action	REPLACE
Urgency of Action	PRIORITY 3
Purpose of Action	LEVEL 2
Deficiency Photo1

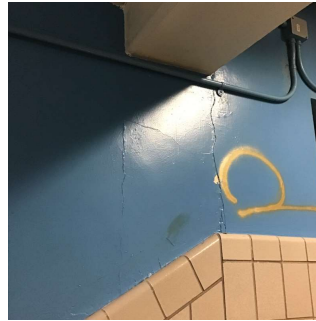
Stair HI/Basement Vestibule

Violations	Stair BC/3 No violations recorded.
Walls	Inspected
Condition	2 - Between Good and Fair
Deficiency	PLASTER: CRACKS/SPALLING
Deficiency Location/Instance	Stairs D/1, HI/Basement Vestibule
Deficiency Quantity	30
Quantity Uom	S.F.
Potential Action	REPLACE
Urgency of Action	PRIORITY 3
Purpose of Action	LEVEL 2

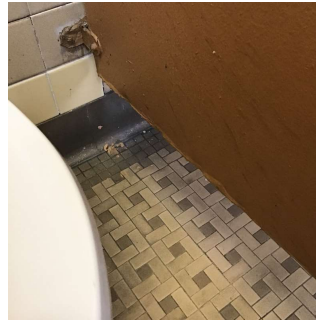
1st Floor Locker Room

Stalls

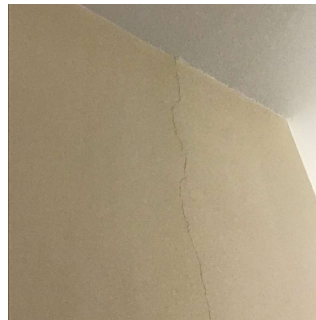
Room 328

PLASTER: CRACKS/SPALLING

REPLACE

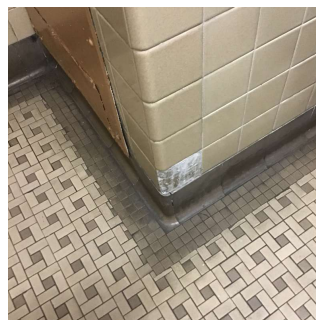
CERAMIC TILE: BROKEN/ MISSING

REPLACE

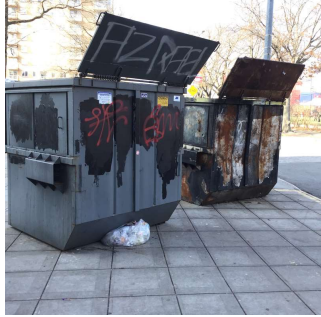
Question	Response
INTERIOR	Inspected
TOILET ROOMS - STUDENTS	Inspected
Walls	
Violations	Basement Locker Room No violations recorded.
LIFE SAFETY	Inspected
F.D. HOLDING AREA	Does not Exist
STEEL STAIRS	Does not Exist
SITE	Inspected
CONTAINERIZATION	Inspected
Condition	5 - Poor
Deficiency	CONTAINER DAMAGED
Deficiency Location/Instance	4th Street
Deficiency Quantity	1
Quantity Uom	EACH
Potential Action	REPLACE
Urgency of Action	PRIORITY 3
Purpose of Action	LEVEL 2
Deficiency Photo1

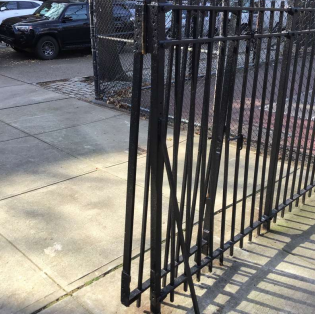
Violations	4th Street No violations recorded.
Drainage System for Asphalt	Does not Exist
Drainage System for Concrete	Inspected
Catch Basins/Manhole - Surrounded by concrete	Inspected
Condition	2 - Between Good and Fair
Deficiency	No deficiencies recorded
Culverts - Concrete Covering	Does not Exist
Drainage System for Soil	Does not Exist
DRINKING FOUNTAINS	Does not Exist
FENCES	Inspected
Condition	3 - Fair
Deficiency	WROUGHT IRON: DAMAGED/DETERIORATED

Deficiency Location/Instance	5th Street Adjacent to Park
Deficiency Quantity	40
Quantity Uom	S.F.
Potential Action	REPLACE
Urgency of Action	PRIORITY 5
Purpose of Action	LEVEL 6

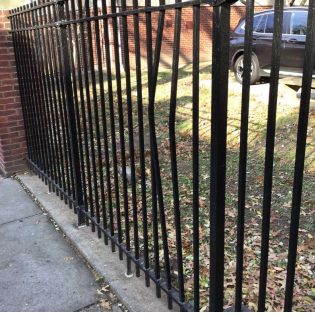
Violations	5th Street Adjacent to Park No violations recorded.
Deficiency	WROUGHT IRON: DAMAGED/DETERIORATED
Deficiency Location/Instance	5th Street
Deficiency Quantity	160
Quantity Uom	S.F.
Potential Action	REPLACE
Urgency of Action	PRIORITY 3
Purpose of Action	LEVEL 2
Deficiency Photo1

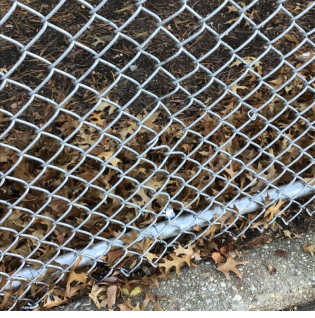
Violations	5th Street No violations recorded.
Deficiency	CHAIN LINK: DAMAGED/DETERIORATED
Deficiency Location/Instance	4th Street
Deficiency Quantity	50
Quantity Uom	S.F.
Potential Action	REPLACE
Urgency of Action	PRIORITY 3
Purpose of Action	LEVEL 2
Deficiency Photo1

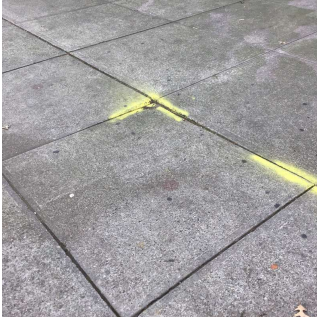
4th Street
Violations	No violations recorded.
Deficiency	HEAVING
Deficiency Location/Instance	4th Street, 5th Street
Deficiency Quantity	625
Quantity Uom	S.F.
Potential Action	REPLACE
Urgency of Action	PRIORITY 3
Purpose of Action	LEVEL 2

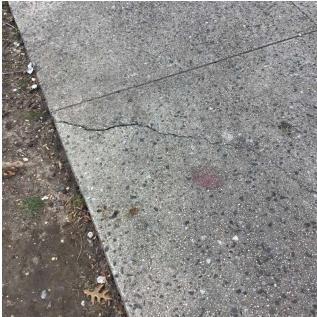
Violations	4th Street No violations recorded.
Deficiency	DAMAGED/DETERIORATED/MISSING SECTIONS
Deficiency Location/Instance	4th Street, 5th Avenue
Deficiency Quantity	725
Quantity Uom	S.F.
Potential Action	REPLACE
Urgency of Action	PRIORITY 3
Purpose of Action	LEVEL 2
Deficiency Photo1

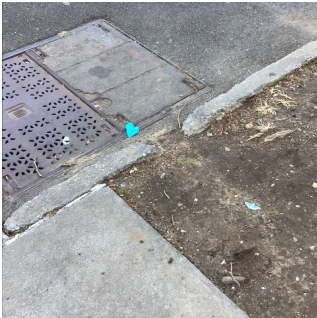
Violations	4th Street No violations recorded.
Deficiency	DAMAGED CURBS
Deficiency Location/Instance	4th Street, 5th Avenue, 5th Street
Deficiency Quantity	220
Quantity Uom	L.F.
Potential Action	REPLACE
Urgency of Action	PRIORITY 3
Purpose of Action	LEVEL 2
Deficiency Photo1

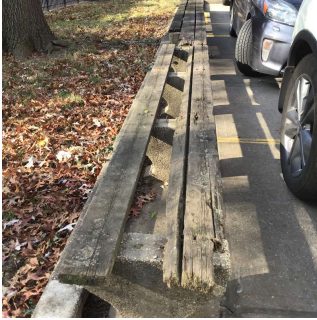
Question	Response
SITE	
PAVING	Inspected
DOT Sidewalk	
Concrete	Inspected
Violations	No violations recorded.
Pavers	Does not Exist
PLAYGROUNDS	Does not Exist
PLAYING SURFACE	Does not Exist
RETAINING WALLS	Does not Exist
SEATING	Inspected
Benches	Inspected
Concrete	Does not Exist
Metal/Wood/Plastic	Inspected
Condition	5 - Poor
Deficiency	DAMAGED/DETERIORATED
Deficiency Location/Instance	Parking Lot
Deficiency Quantity	12
Quantity Uom	EACH
Potential Action	REPLACE
Urgency of Action	PRIORITY 5
Purpose of Action	LEVEL 6
Deficiency Photo1
