**NYC Department of Education**  
**Building Condition Assessment Survey 2023 - 2024**

Architectural Inspection

**K056**

**Asset:** P.S. 56 - BROOKLYN, 170 GATES AVENUE, New York, 11238

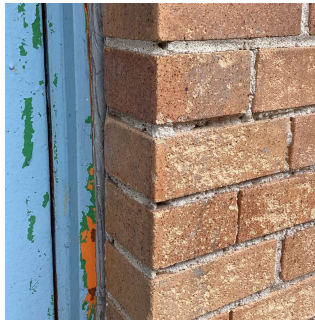
Facade B

Deficiency	BRICK: DETERIORATED JOINTS
------------	----------------------------

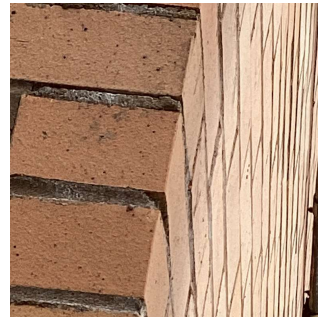
Facade F

**BRICK: DETERIORATED JOINTS**

10  
S.F.  
REPOINT  
PRIORITY 3  
LEVEL 2

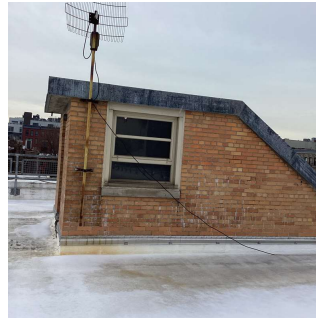
Roof 1 - BH2

**BULKHEAD/PENTHOUSE WALLS/EXTERIOR:  
EFFLORESCENCE**

80  
S.F.  
MAINTENANCE  
PRIORITY 1  
LEVEL 1

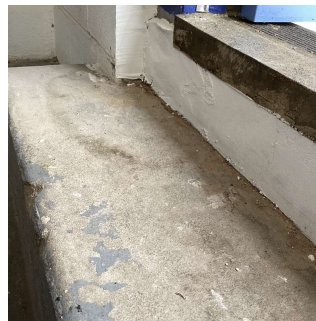
Roof 1 - BH1

**BULKHEAD/PENTHOUSE WALLS/EXTERIOR: WATER INFILTRATION**

REPAIR

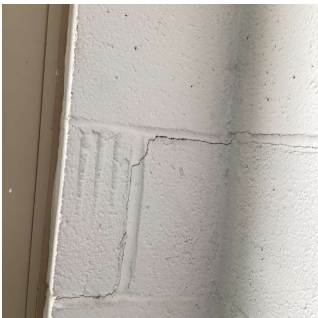
**BULKHEAD/PENTHOUSE WALLS/INTERIOR: CMU CRACKS/SPALLING**

Deficiency Quantity	15
Quantity Uom	S.F.
Potential Action	REPLACE
Urgency of Action	PRIORITY 3
Purpose of Action	LEVEL 2
Deficiency Photo1

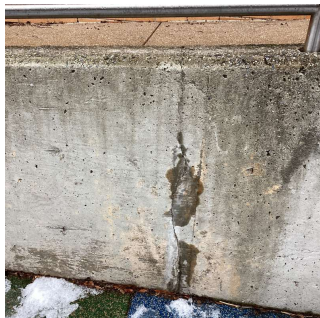
Violations	Roof 6 No violations recorded.
<b>SKYLIGHT/ROOF VENT</b>	Does not Exist
<b>ROOF/GRAVITY TANK</b>	Does not Exist
<b>STAIRS/RAMPS: EXTERIOR</b>	Inspected
<b>BUILDING CHEEK/FLANK WALLS</b>	Inspected
Condition	4 - Between Fair and Poor
Deficiency	CAST IN PLACE CONCRETE: CRACKS/SPALLING - MAJOR
Roof Plan reference	K056
Deficiency Quantity	20
Quantity Uom	S.F.
Potential Action	REPLACE
Urgency of Action	PRIORITY 4
Purpose of Action	LEVEL 2
Deficiency Photo1

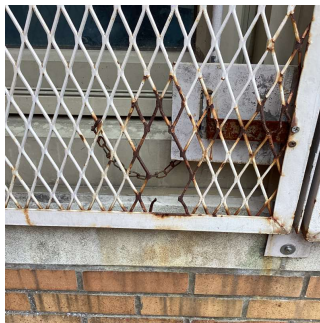
DETERIORATED/TORN-OUT/MISSING

REPLACE

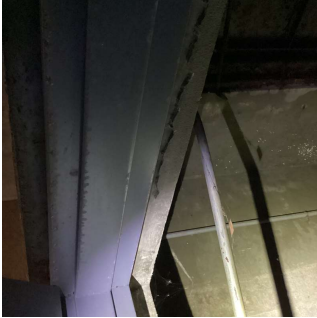
Question	Response
<b>INTERIOR</b>	
<b>STRUCTURAL</b>	
<b>VAULTS-BUNKERS</b>	
<b>Foundation Walls</b>	
Purpose of Action	LEVEL 5
Deficiency Photo1

Basement - Ash Hoist Vault
Violations	No violations recorded.
<b>Slab Structure</b>	Inspected
Condition	2 - Between Good and Fair
Deficiency	No deficiencies recorded
<b>Vault/Ash Hoist Doors and Framing</b>	Inspected
Condition	5 - Poor
Deficiency	DETERIORATED/DAMAGED VAULT/ASH HOIST DOORS AND FRAMING
Deficiency Location/Instance	Basement - Ash Hoist Vault
Deficiency Quantity	2
Quantity Uom	EACH
Potential Action	REPLACE
Urgency of Action	PRIORITY 4
Purpose of Action	LEVEL 2
Deficiency Photo1

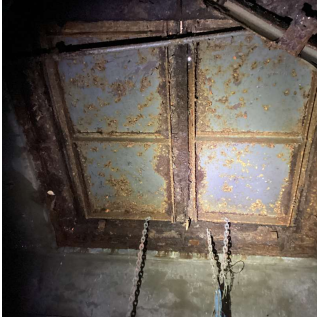
Basement - Ash Hoist Vault
Violations	No violations recorded.
Deficiency	WATER INFILTRATION
Deficiency Location/Instance	Basement - Ash Hoist Vault
Deficiency Quantity	10
Quantity Uom	S.F.
Potential Action	REPAIR
Urgency of Action	PRIORITY 5
Purpose of Action	LEVEL 2

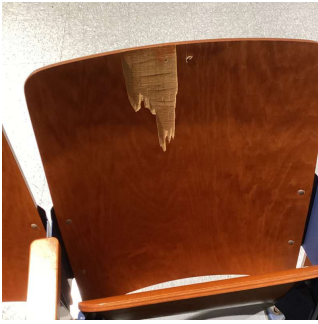
Violations	Seat O/16 No violations recorded.
<b>Floor Finish</b>	
Instance on 1st Floor (458 Seats)	Inspected
Condition	2 - Between Good and Fair
Deficiency	VINYL TILES: DETERIORATED SUBSTRATE
Deficiency Location/Instance	Exit Vestibule, near Seat A/16

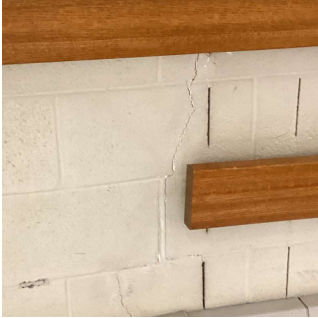
Question	Response
<b>INTERIOR</b>	
<b>AUDITORIUM</b>	
<b>Walls</b>	
Condition	2 - Between Good and Fair
Deficiency	MASONRY: CRACKS/SPALLING
Deficiency Location/Instance	Near seat O/19, N/20, Exit Vestibule
Deficiency Quantity	20
Quantity Uom	S.F.
Potential Action	REPLACE
Urgency of Action	PRIORITY 3
Purpose of Action	LEVEL 2
Deficiency Photo1

Violations	Near seat O/19 No violations recorded.
<b>Window Curtains/Shades/Blinds</b>	
Instance on 1st Floor (458 Seats)	Inspected
Condition	5 - Poor
Deficiency	INOPERABLE CURTAINS
Deficiency Location/Instance	Near Windows
Deficiency Quantity	3
Quantity Uom	EACH
Potential Action	MAINTENANCE
Urgency of Action	PRIORITY 3
Purpose of Action	LEVEL 2
Deficiency Photo1	No photo recorded
Violations	No violations recorded.
<b>CAFETERIA</b>	
Instance on 1st Floor - Staff (600 SF)	Inspected
Instance on 1st Floor - Students	Inspected
<b>Ceiling</b>	
Instance on 1st Floor - Students	Inspected

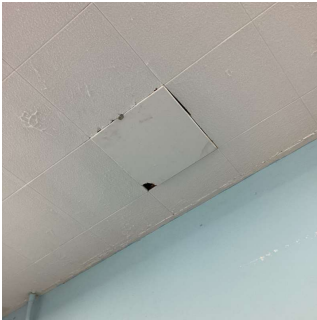
Near center
Violations	No violations recorded.
Instance on 1st Floor - Staff (600 SF)	Inspected
Condition	2 - Between Good and Fair
Deficiency	ACOUSTIC TILES ON PLASTER: DAMAGED/MISSING
Deficiency Location/Instance	Near sink
Deficiency Quantity	10
Quantity Uom	S.F.
Potential Action	REPLACE
Urgency of Action	PRIORITY 3
Purpose of Action	LEVEL 2
Deficiency Photo1

Near sink
Violations	No violations recorded.
<b>Door(s)</b>	
Instance on 1st Floor - Staff (600 SF)	Inspected
Condition	2 - Between Good and Fair
Deficiency	No deficiencies recorded
Instance on 1st Floor - Students	Inspected
Condition	2 - Between Good and Fair
Deficiency	No deficiencies recorded
<b>Fixed Equipment</b>	
Instance on 1st Floor - Staff (600 SF)	Does not Exist
Instance on 1st Floor - Students	Does not Exist
<b>Floor Finish</b>	
Instance on 1st Floor - Students	Inspected

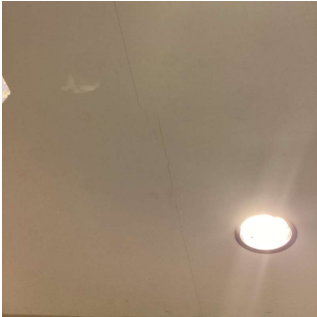
Question	Response
<b>INTERIOR</b>	
<b>CAFETERIA</b>	
<b>Walls</b>	
Violations	No violations recorded.
<b>Window Curtains/Shades/Blinds</b>	
Instance on 1st Floor - Students	Does not Exist
Instance on 1st Floor - Staff (600 SF)	Does not Exist
<b>CLASSROOMS/CORRIDORS/ADMIN SPACES</b>	
<b>Ceiling</b>	Inspected
Condition	2 - Between Good and Fair
Deficiency	GYP SUM BOARD: DAMAGED/DETERIORATED
Deficiency Location/Instance	Exit near Auditorium
Deficiency Quantity	15
Quantity Uom	S.F.
Potential Action	REPLACE
Urgency of Action	PRIORITY 3
Purpose of Action	LEVEL 2
Deficiency Photo1

Violations	Exit near Auditorium No violations recorded.
Deficiency	ACOUSTIC TILES ON PLASTER: DAMAGED/MISSING
Deficiency Location/Instance	Corridor near Room 117
Deficiency Quantity	10
Quantity Uom	S.F.
Potential Action	REPLACE
Urgency of Action	PRIORITY 3
Purpose of Action	LEVEL 2
Deficiency Photo1

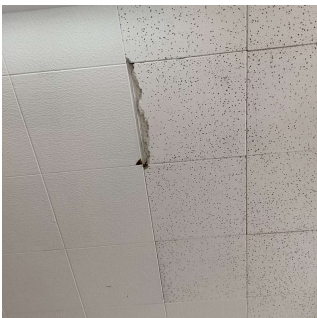
Violations	Corridor near Room 117 No violations recorded.

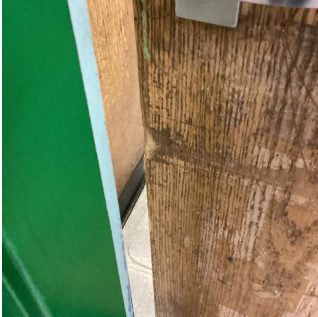
<b>Door(s)</b>	Inspected
Condition	5 - Poor
Deficiency	WOOD: DETERIORATED DOOR

Question	Response
<b>INTERIOR</b>	
<b>CLASSROOMS/CORRIDORS/ADMIN SPACES</b>	
<b>Door(s)</b>	
Deficiency Location/Instance	Room 309, 308, 307, 306, 305, and others
Deficiency Quantity	24
Quantity Uom	EACH
Potential Action	MAINTENANCE
Urgency of Action	PRIORITY 3
Purpose of Action	LEVEL 2
Deficiency Photo1

Room 307
Violations	No violations recorded.
<b>Floor Finish</b>	Inspected
Condition	2 - Between Good and Fair
Deficiency	TERRAZZO: CRACKS
Deficiency Location/Instance	Main Entrance Vestibule, Main Entrance Lobby
Deficiency Quantity	10
Quantity Uom	S.F.
Potential Action	REPLACE
Urgency of Action	PRIORITY 3
Purpose of Action	LEVEL 2
Deficiency Photo1

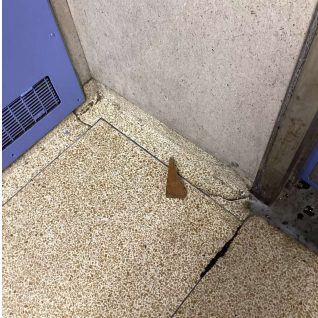
Main Entrance Vestibule
Violations	No violations recorded.
Deficiency	VINYL TILES: BROKEN/DETERIORATED/MISSING TILES
Deficiency Location/Instance	Room 300, Corridor near Room 209
Deficiency Quantity	10
Quantity Uom	S.F.
Potential Action	REPLACE
Urgency of Action	PRIORITY 3

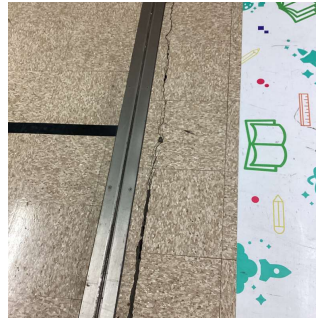
Corridor near Elevator/3

VINYL TILES: DETERIORATED SUBSTRATE

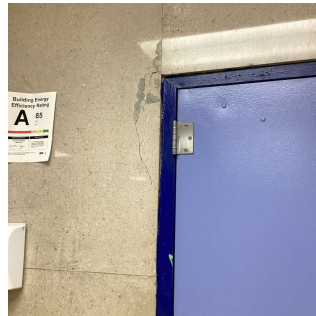
STONE: CRACKS/SPALLING

Question	Response
<b>INTERIOR</b>	
<b>CLASSROOMS/CORRIDORS/ADMIN SPACES</b>	
<b>Walls</b>	
Violations	Main Entrance Lobby No violations recorded.
Deficiency	PLASTER: CRACKS/SPALLING
Deficiency Location/Instance	Corridor near Room 233, 231, 207, 117
Deficiency Quantity	25
Quantity Uom	S.F.
Potential Action	REPLACE
Urgency of Action	PRIORITY 3
Purpose of Action	LEVEL 2
Deficiency Photo1

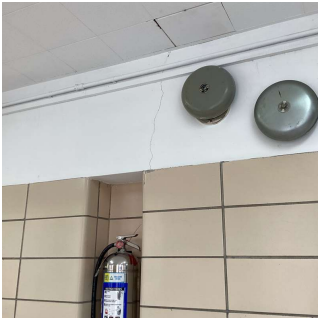
Violations	Corridor near Room 117 No violations recorded.
Deficiency	GLAZED BLOCK: CRACKS/SPALLING
Deficiency Location/Instance	Room 200, Corridor near Room 211, 117
Deficiency Quantity	10
Quantity Uom	S.F.
Potential Action	REPLACE
Urgency of Action	PRIORITY 3
Purpose of Action	LEVEL 2
Deficiency Photo1

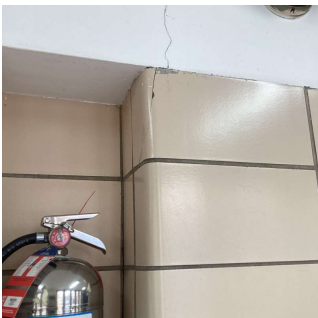
Violations	Corridor near Room 117 No violations recorded.
<b>Specialties</b>	Does not Exist
<b>GYMNASIUM</b>	Inspected
Instance on 1st Floor	Inspected
<b>Ceiling</b>	
Instance on 1st Floor	Inspected
Condition	2 - Between Good and Fair

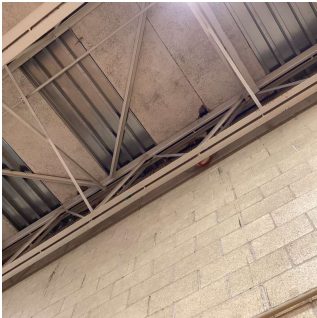
Deficiency	TECTUM: DAMAGED/MISSING
Deficiency Location/Instance	Near Entrance, windows

Question	Response
<b>INTERIOR</b>	
<b>GYMNASIUM</b>	
<b>Ceiling</b>	
Deficiency Quantity	60
Quantity Uom	S.F.
Potential Action	REPLACE
Urgency of Action	PRIORITY 3
Purpose of Action	LEVEL 2
Deficiency Photo1

Near Entrance
Violations	No violations recorded.
<b>Door(s)</b>	
Instance on 1st Floor	Inspected
Condition	5 - Poor
Deficiency	WOOD: DETERIORATED DOOR
Deficiency Location/Instance	Storage, office
Deficiency Quantity	6
Quantity Uom	EACH
Potential Action	MAINTENANCE
Urgency of Action	PRIORITY 3
Purpose of Action	LEVEL 2
Deficiency Photo1

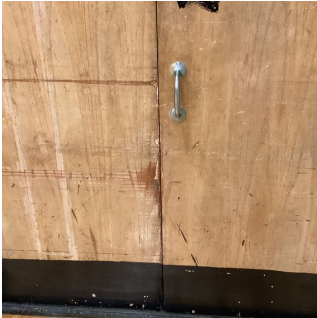
Storage
Violations	No violations recorded.
<b>Fixed Equipment</b>	
Instance on 1st Floor	Inspected
Condition	2 - Between Good and Fair
Deficiency	No deficiencies recorded
<b>Floor Finish</b>	
Instance on 1st Floor	Inspected
Condition	2 - Between Good and Fair
Deficiency	VINYL TILES: BROKEN/DETERIORATED/MISSING TILES
Deficiency Location/Instance	Gymnasium Office
Deficiency Quantity	10

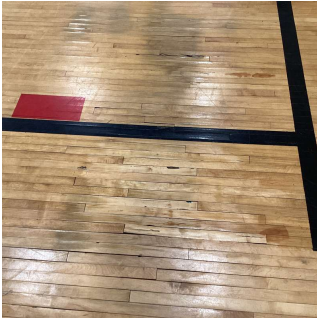
Question	Response
<b>INTERIOR</b>	
<b>GYMNASIUM</b>	
<b>Floor Finish</b>	
Quantity Uom	S.F.
Potential Action	REPLACE
Urgency of Action	PRIORITY 3
Purpose of Action	LEVEL 2
Deficiency Photo1	 
	Gymnasium Office
Violations	No violations recorded.
Deficiency	WOOD: DAMAGED/DETERIORATED
Deficiency Location/Instance	Near Entrance, center, windows, stage
Deficiency Quantity	50
Quantity Uom	S.F.
Potential Action	REPLACE
Urgency of Action	PRIORITY 3
Purpose of Action	LEVEL 2
Deficiency Photo1

Near Entrance
Violations	No violations recorded.
<b>Seating</b>	
Instance on 1st Floor	Does not Exist
<b>Sliding-folding Partition</b>	
Instance on 1st Floor	Does not Exist
<b>Stage</b>	
Instance on 1st Floor	Inspected
<b>Stage</b>	
Instance on 1st Floor	Inaccessible
<b>Stage Curtain Rigging</b>	
Instance on 1st Floor	Inspected
Condition	5 - Poor
Deficiency	INOPERABLE
Deficiency Location/Instance	Stage
Deficiency Quantity	2

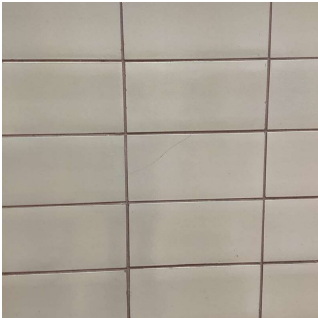
Question	Response
<b>INTERIOR</b>	
<b>GYMNASIUM</b>	
<b>Walls</b>	
Violations	No violations recorded.
Deficiency	GLAZED BLOCK: CRACKS/SPALLING
Deficiency Location/Instance	Near Windows
Deficiency Quantity	10
Quantity Uom	S.F.
Potential Action	REPLACE
Urgency of Action	PRIORITY 3
Purpose of Action	LEVEL 2
Deficiency Photo1

Violations	Near Windows
Violations	No violations recorded.
<b>Window Curtains/Shades/Blinds</b>	
Instance on 1st Floor	Inspected
Condition	3 - Fair
Deficiency	WORN/DAMAGED CURTAINS
Deficiency Location/Instance	Near Windows
Deficiency Quantity	100
Quantity Uom	S.F.
Potential Action	MAINTENANCE
Urgency of Action	PRIORITY 3
Purpose of Action	LEVEL 2
Deficiency Photo1

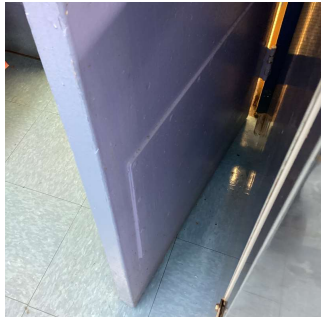
Question	Response
<b>INTERIOR</b>	
<b>KITCHEN</b>	
<b>Door(s)</b>	
Purpose of Action	LEVEL 2
Deficiency Photo1

Violations	Entrance No violations recorded.

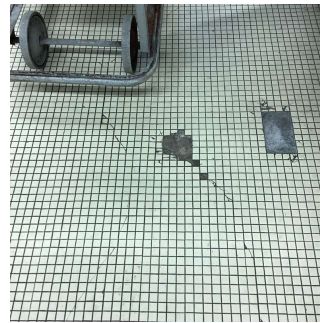
Near center

Deficiency	CERAMIC TILE: BROKEN/MISSING TILES
Deficiency Location/Instance	Near Windows, Entrance, center, servery, slop sink area
Deficiency Quantity	75
Quantity Uom	S.F.
Potential Action	REPLACE
Urgency of Action	PRIORITY 3
Purpose of Action	LEVEL 2

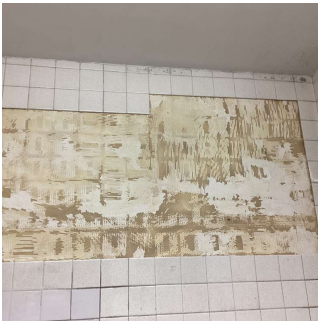
Deficiency	CERAMIC TILE: BROKEN/ MISSING
Deficiency Location/Instance	Near Entrance, sink, slop sink area
Deficiency Quantity	30
Quantity Uom	S.F.
Potential Action	REPLACE
Urgency of Action	PRIORITY 3
Purpose of Action	LEVEL 2

Violations	Slop sink area No violations recorded.
<b>LIBRARY</b>	Inspected
Instance on Room 207	Inspected
<b>Built-in Furnishing</b>	
Instance on Room 207	Inspected
Condition	2 - Between Good and Fair
Deficiency	SINK/STORAGE CABINET - DAMAGED/DETERIORATED
Deficiency Location/Instance	Sink area
Deficiency Quantity	10
Quantity Uom	L.F.
Potential Action	REPLACE
Urgency of Action	PRIORITY 3
Purpose of Action	LEVEL 2
Deficiency Photo1

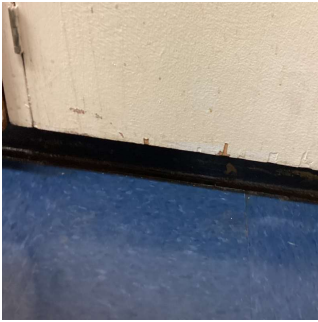
Violations	Sink area No violations recorded.
<b>Ceiling</b>	
Instance on Room 207	Inspected
Condition	2 - Between Good and Fair
Deficiency	No deficiencies recorded
<b>Door(s)</b>	
Instance on Room 207	Inspected
Condition	3 - Fair
Deficiency	WOOD: DETERIORATED DOOR
Deficiency Location/Instance	Entrance
Deficiency Quantity	1
Quantity Uom	EACH
Potential Action	MAINTENANCE
Urgency of Action	PRIORITY 3

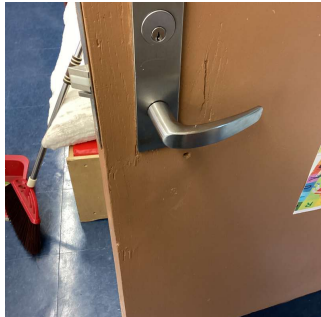
Violations	Entrance No violations recorded.

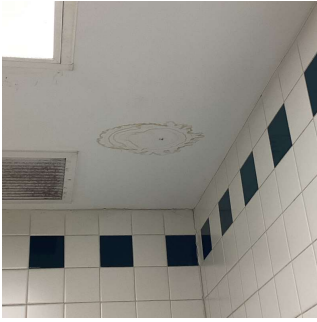
Violations	Stair AB/3 No violations recorded.
<b>Walls</b>	Inspected
Condition	2 - Between Good and Fair
Deficiency	No deficiencies recorded
<b>TOILET ROOMS - STAFF</b>	
<b>Ceiling</b>	Inspected
Condition	2 - Between Good and Fair
Deficiency	GYPNUM BOARD: DAMAGED/DETERIORATED
Deficiency Location/Instance	Room A5, A4
Deficiency Quantity	10
Quantity Uom	S.F.
Potential Action	REPLACE
Urgency of Action	PRIORITY 3
Purpose of Action	LEVEL 2
Deficiency Photo1

Violations	Room A5 No violations recorded.
<b>Door(s)</b>	Inspected
Condition	5 - Poor
Deficiency	WOOD: DETERIORATED DOOR
Deficiency Location/Instance	Room 327, 321, 227, 142, 127, and others
Deficiency Quantity	7
Quantity Uom	EACH
Potential Action	MAINTENANCE
Urgency of Action	PRIORITY 3
Purpose of Action	LEVEL 2

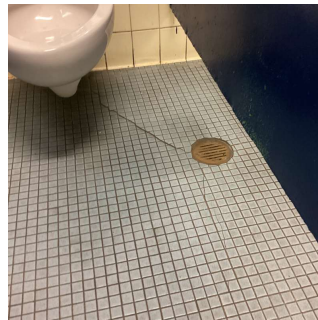
Room 142

CERAMIC TILE: DETERIORATED SUBSTRATE

REPLACE

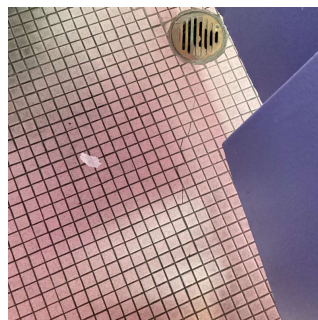
CERAMIC TILE: BROKEN/MISSING TILES

REPLACE

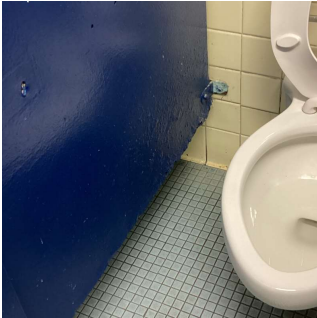
<b>Question</b>	<b>Response</b>
<b>INTERIOR</b>	
<b>TOILET ROOMS - STAFF</b>	
<b>Floor Finish</b>	Inspected
	Room 138
Violations	No violations recorded.
<b>Stalls</b>	Inspected
Condition	5 - Poor
Deficiency	RUST - MAJOR
Deficiency Location/Instance	Room 327, 321, 227, 142, 138
Deficiency Quantity	5
Quantity Uom	EACH
Potential Action	REPLACE
Urgency of Action	PRIORITY 3
Purpose of Action	LEVEL 2
Deficiency Photo1

Room 142
Violations	No violations recorded.
<b>Walls</b>	Inspected
Condition	2 - Between Good and Fair
Deficiency	CERAMIC TILE: BROKEN/ MISSING
Deficiency Location/Instance	Room 327, 321, 227, 127, gymnasium, and others
Deficiency Quantity	50
Quantity Uom	S.F.
Potential Action	REPLACE
Urgency of Action	PRIORITY 3
Purpose of Action	LEVEL 2
Deficiency Photo1

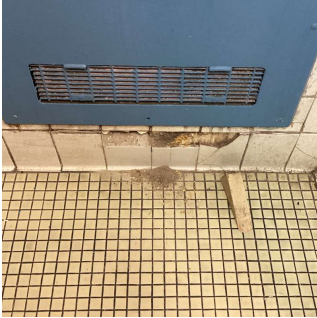
Room 127
Violations	No violations recorded.
<b>TOILET ROOMS - STUDENTS</b>	
	Inspected
<b>Ceiling</b>	Inspected
Condition	2 - Between Good and Fair

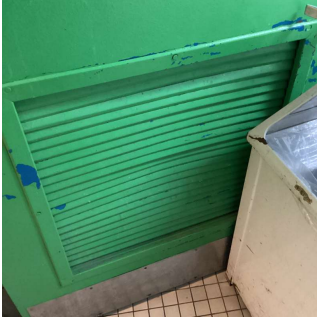
Question	Response
<b>INTERIOR</b>	
<b>TOILET ROOMS - STUDENTS</b>	
<b>Door(s)</b>	
Condition	5 - Poor
Deficiency	METAL: DAMAGED LOUVER
Deficiency Location/Instance	Room A2, A3
Deficiency Quantity	2
Quantity Uom	EACH
Potential Action	MAINTENANCE
Urgency of Action	PRIORITY 3
Purpose of Action	LEVEL 2
Deficiency Photo1

Violations	Room A2 No violations recorded.
Deficiency	WOOD: DETERIORATED DOOR AND FRAME
Deficiency Location/Instance	Room 105, 103
Deficiency Quantity	2
Quantity Uom	EACH
Potential Action	MAINTENANCE
Urgency of Action	PRIORITY 3
Purpose of Action	LEVEL 2
Deficiency Photo1

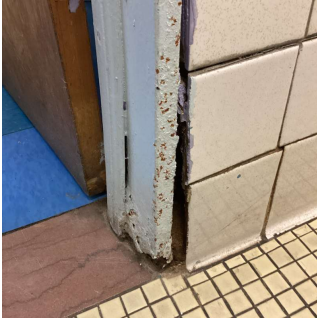
Violations	Room 105 No violations recorded.
Deficiency	WOOD: DETERIORATED DOOR
Deficiency Location/Instance	Room 231, 225, 146, 144
Deficiency Quantity	4
Quantity Uom	EACH
Potential Action	MAINTENANCE
Urgency of Action	PRIORITY 3
Purpose of Action	LEVEL 2

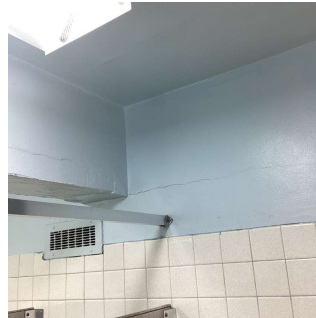
Room 146

PLASTER: CRACKS/SPALLING

REPLACE

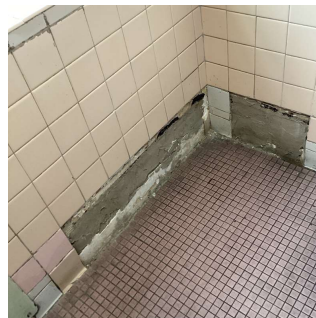
CERAMIC TILE: BROKEN/ MISSING

REPLACE

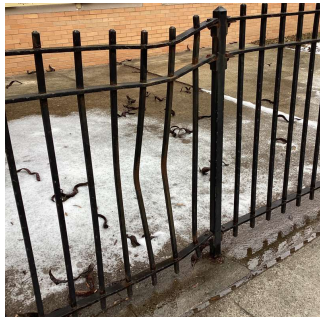
Violations	Along Downing Street No violations recorded.
Deficiency	<b>WROUGHT IRON: DAMAGED/DETERIORATED</b>
Deficiency Location/Instance	Along Downing Street, Irving Place
Deficiency Quantity	80
Quantity Uom	S.F.
Potential Action	REPLACE
Urgency of Action	PRIORITY 3
Purpose of Action	LEVEL 2
Deficiency Photo1

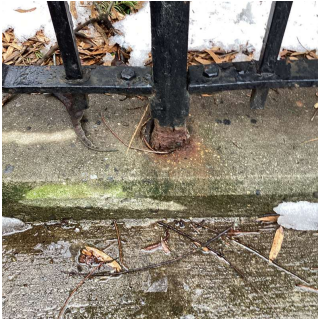
Violations	Along Downing Street No violations recorded.
Deficiency	<b>WROUGHT IRON: RUST - MAJOR</b>
Deficiency Location/Instance	Near exit 12, along Irving Place, Gates Avenue, Downing Street
Deficiency Quantity	520
Quantity Uom	S.F.
Potential Action	REPLACE
Urgency of Action	PRIORITY 3
Purpose of Action	LEVEL 2

Violations	Near Exit 12 No violations recorded.
<b>IRRIGATION SYSTEM</b>	Does not Exist
<b>PAVING</b>	Inspected
<b>Student Non-Use</b>	Inspected
Gravel Exists?	No
<b>Asphalt</b>	Does not Exist
<b>Concrete</b>	Inspected
Condition	3 - Fair
Deficiency	DAMAGED/DETERIORATED/MISSING SECTIONS
Deficiency Location/Instance	Along Irving Place
Deficiency Quantity	150
Quantity Uom	S.F.
Potential Action	REPLACE
Urgency of Action	PRIORITY 3
Purpose of Action	LEVEL 2
Deficiency Photo1

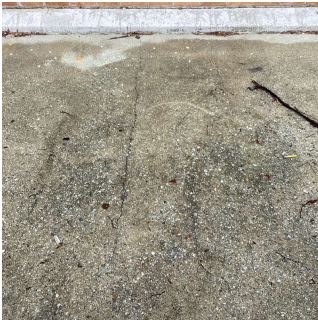
Violations	Along Irving Place No violations recorded.
<b>Pavers</b>	Does not Exist
<b>Student Use</b>	Inspected
Gravel Exists?	No
<b>Asphalt</b>	Inspected
Condition	2 - Between Good and Fair
Deficiency	CRACKS - MAJOR
Deficiency Location/Instance	Schoolyard
Deficiency Quantity	20
Quantity Uom	S.F.
Potential Action	REPLACE
Urgency of Action	PRIORITY 3

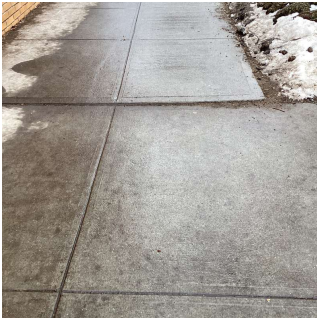
Question	Response
<b>SITE</b>	
<b>PAVING</b>	
<b>Site Sidewalks &amp; Walkways</b>	
<b>Concrete</b>	
Deficiency Photo1	 
	Courtyard
Violations	No violations recorded.
<b>Pavers</b>	Does not Exist
<b>DOT Sidewalk</b>	Inspected
<b>Asphalt</b>	Does not Exist
<b>Concrete</b>	Inspected
Condition	4 - Between Fair and Poor
Deficiency	HEAVING
Deficiency Location/Instance	Along Gates Avenue, Downing Street, Irving Place
Deficiency Quantity	625
Quantity Uom	S.F.
Potential Action	REPLACE
Urgency of Action	PRIORITY 3
Purpose of Action	LEVEL 2
Deficiency Photo1

Along Downing Street
Violations	No violations recorded.
Deficiency	DAMAGED/DETERIORATED/MISSING SECTIONS
Deficiency Location/Instance	Along Gates Avenue, Downing Street, Irving Place
Deficiency Quantity	425
Quantity Uom	S.F.
Potential Action	REPLACE
Urgency of Action	PRIORITY 3
Purpose of Action	LEVEL 2

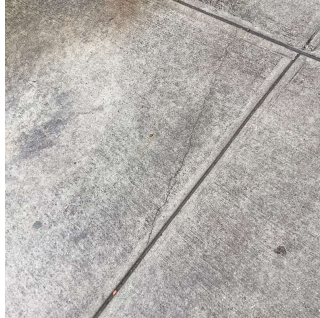
Violations	Along Gates Avenue No violations recorded.
Deficiency	<b>DAMAGED CURBS</b>
Deficiency Location/Instance	Along Gates Avenue, Downing Street, Irving Place
Deficiency Quantity	60
Quantity Uom	L.F.
Potential Action	REPLACE
Urgency of Action	PRIORITY 3
Purpose of Action	LEVEL 2
Deficiency Photo1	 
Violations	Along Gates Avenue No violations recorded.
<b>Pavers</b>	Does not Exist
<b>PLAYGROUNDS</b>	Inspected
Instance on Schoolyard	Inspected
<b>Benches</b>	
Instance on Schoolyard	Does not Exist
<b>Fence</b>	
Instance on Schoolyard	Inspected
Condition	2 - Between Good and Fair
Deficiency	<b>CONCRETE CURB: DAMAGED/DETERIORATED</b>
Deficiency Location/Instance	Schoolyard
Deficiency Quantity	10
Quantity Uom	S.F.
Potential Action	REPLACE
Urgency of Action	PRIORITY 3
Purpose of Action	LEVEL 2
