NYC Department of Education
Building Condition Assessment Survey 2023 - 2024

Architectural Inspection

Asset: J.H.S. 57 - BROOKLYN, 125 STUYVESANT AVENUE, New York, 11221

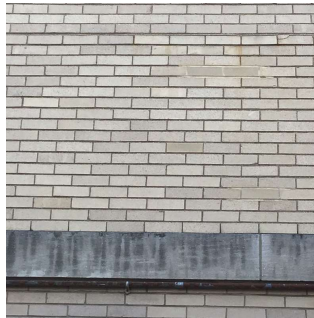
Facade A

BRICK: MINOR CRACKS AND SPALLING

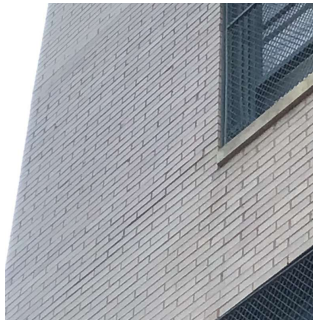
Facade D

BRICK: MINOR BULGING

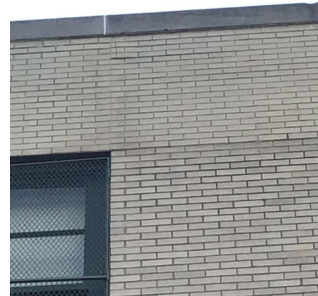
Facade D

BRICK: MAJOR / THRU CRACKS

PRIORITY 4
LEVEL 2

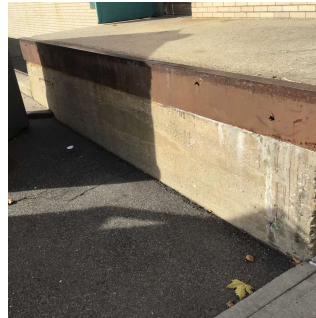
BAD BUMPERS

No Bumper at Loading Dock

REPLACE

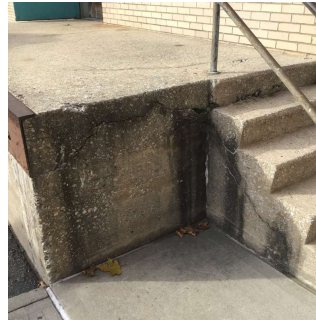
Facade C

CHEEK WALL/CRACKS, SPALLING - MAJOR

REPLACE

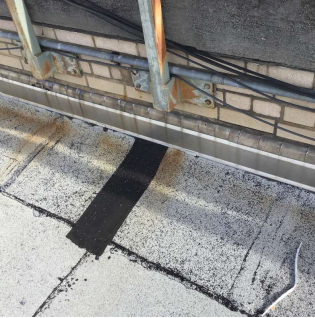
Question	Response
EXTERIOR	
PARAPETS	
Violations	No violations recorded.
Deficiency	BRICK: DETERIORATED JOINTS
Roof Plan reference

Deficiency Quantity	150
Quantity Uom	S.F.
Potential Action	REPOINT
Urgency of Action	PRIORITY 3
Purpose of Action	LEVEL 2
Deficiency Photo1

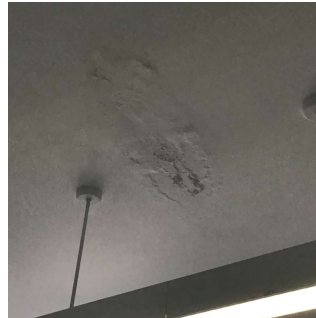
Rom 302

Deficiency	MODIFIED BITUMEN: ROOFING: MAJOR ACTIVE ROOF LEAKS IN INSTRUCTIONAL SPACE
------------	---

Potential Action	REPLACE ROOFING WITHOUT MAJOR EQUIPMENT REMOVAL
------------------	---

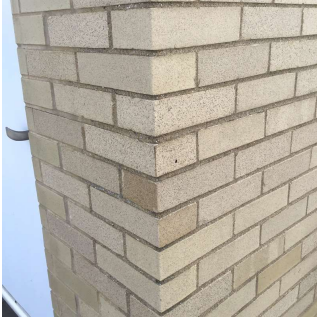
Deficiency **BULKHEAD/PENTHOUSE WALLS/EXTERIOR: DETERIORATED JOINTS**

300
S.F.
REPOINT
PRIORITY 3
LEVEL 2

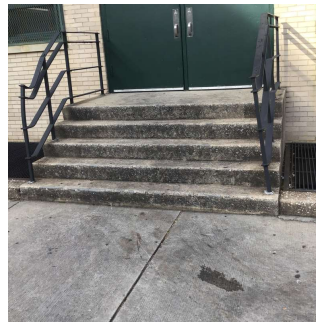
Facade C

Violations	Bulkhead 2 No violations recorded.
CUPOLA/ SPIRES/ TOWERS	Does not Exist
DORMER	Does not Exist
DUNNAGE STEEL	Does not Exist
SKYLIGHT/ROOF VENT	Does not Exist
ROOF/GRAVITY TANK	Does not Exist
STAIRS/RAMPS: EXTERIOR	Inspected
BUILDING CHEEK/FLANK WALLS	Inspected
Condition	2 - Between Good and Fair
Deficiency	No deficiencies recorded
RAILINGS	Inspected
Condition	3 - Fair
Deficiency	DAMAGED
Roof Plan reference

Deficiency Quantity	15
Quantity Uom	L.F.
Potential Action	REPLACE
Urgency of Action	PRIORITY 4
Purpose of Action	LEVEL 2

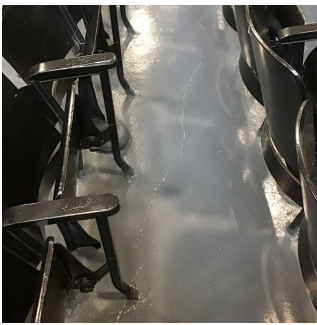
VINYL TILES: BROKEN/DETERIORATED/MISSING TILES

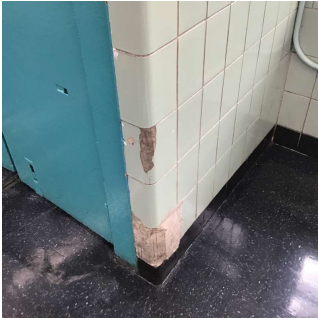
Question	Response
INTERIOR	
CAFETERIA	
Sliding-folding Partition	
Violations	No violations recorded.
Stage	
Instance on 1st Floor	Does not Exist
Walls	
Instance on 1st Floor	Inspected
Condition	2 - Between Good and Fair
Deficiency	GLAZED BLOCK: CRACKS/SPALLING
Deficiency Location/Instance	Near Windows, Columns at Center
Deficiency Quantity	20
Quantity Uom	S.F.
Potential Action	REPLACE
Urgency of Action	PRIORITY 3
Purpose of Action	LEVEL 2
Deficiency Photo1

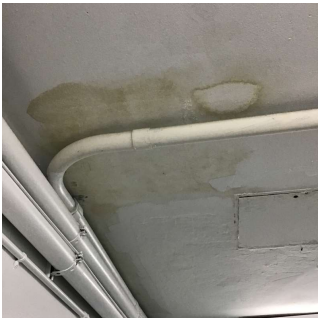
Violations	Corridor near Room B3

Violations	Near Windows No violations recorded.
Window Curtains/Shades/Blinds	
Instance on 1st Floor	Does not Exist
CLASSROOMS/CORRIDORS/ADMIN SPACES	
Ceiling	Inspected
Condition	2 - Between Good and Fair
Deficiency	PLASTER: CRACKS/SPALLING
Deficiency Location/Instance	Corridor near Room B3
Deficiency Quantity	10
Quantity Uom	S.F.
Potential Action	REPLACE
Urgency of Action	PRIORITY 3
Purpose of Action	LEVEL 2
Deficiency Photo1

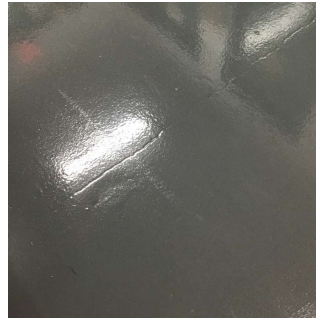
Question	Response
INTERIOR	
CLASSROOMS/CORRIDORS/ADMIN SPACES	
Ceiling	
Violations	No violations recorded.
Deficiency	PLASTER: CRACKS/SPALLING - ACTIVE LEAK
Deficiency Location/Instance	Rooms 301, 302, 308
Deficiency Quantity	40
Quantity Uom	S.F.
Potential Action	REPLACE
Urgency of Action	PRIORITY 5
Purpose of Action	LEVEL 2
Deficiency Photo1	 
	Room 308
Violations	No violations recorded.
Door(s)	Inspected
Condition	5 - Poor
Deficiency	WOOD: DETERIORATED DOOR
Deficiency Location/Instance	Rooms 110, 201, 222, 307, 308, and others
Deficiency Quantity	15
Quantity Uom	EACH
Potential Action	MAINTENANCE
Urgency of Action	PRIORITY 3
Purpose of Action	LEVEL 2
Deficiency Photo1	 
	Room 308
Violations	No violations recorded.
Floor Finish	Inspected
Condition	2 - Between Good and Fair
Deficiency	CONCRETE: CRACKS
Deficiency Location/Instance	Corridor near Room B3
Deficiency Quantity	10
Quantity Uom	S.F.
Potential Action	REPLACE
Urgency of Action	PRIORITY 3

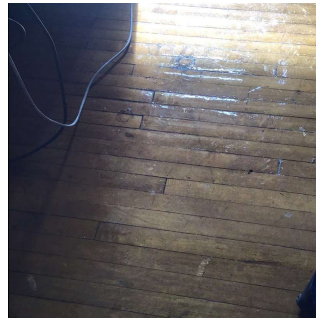
Room 330

WOOD: DAMAGED/DETERIORATED

REPLACE

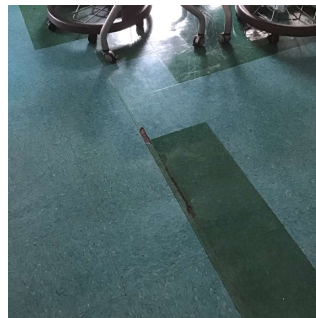
Room 337

VINYL TILES: DETERIORATED SUBSTRATE

REPLACE

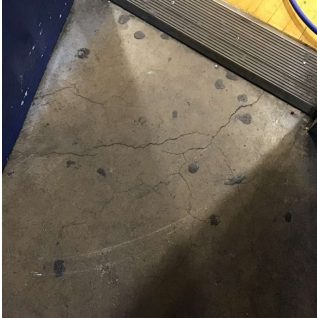
Question	Response
INTERIOR	
GYMNASIUM	
Floor Finish	
Instance on 1st Floor	Inspected
Condition	2 - Between Good and Fair
Deficiency	CONCRETE: CRACKS
Deficiency Location/Instance	Storage Room
Deficiency Quantity	10
Quantity Uom	S.F.
Potential Action	REPLACE
Urgency of Action	PRIORITY 3
Purpose of Action	LEVEL 2
Deficiency Photo1

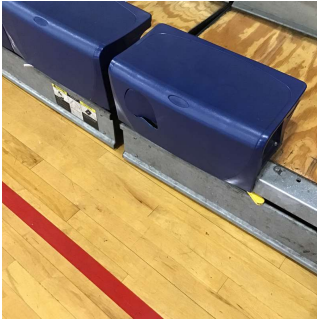
Question	Response
INTERIOR	
GYMNASIUM	
Seating	
Purpose of Action	LEVEL 2
Deficiency Photo1	No photo recorded
Violations	No violations recorded.
Deficiency	DAMAGED BLEACHERS
Deficiency Location/Instance	Left Side
Deficiency Quantity	10
Quantity Uom	S.F.
Potential Action	REPLACE
Urgency of Action	PRIORITY 3
Purpose of Action	LEVEL 2
Deficiency Photo1

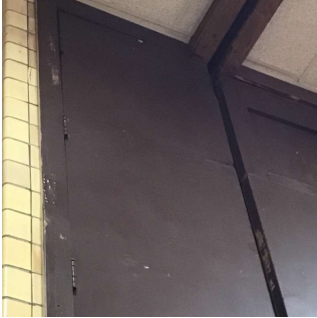
Violations	Left Side No violations recorded.
Sliding-folding Partition	
Instance on 1st Floor	Inspected
Condition	3 - Fair
Deficiency	MOVABLE PANELS: DAMAGED
Deficiency Location/Instance	Center
Deficiency Quantity	40
Quantity Uom	S.F.
Potential Action	REPLACE
Urgency of Action	PRIORITY 3
Purpose of Action	LEVEL 2
Deficiency Photo1

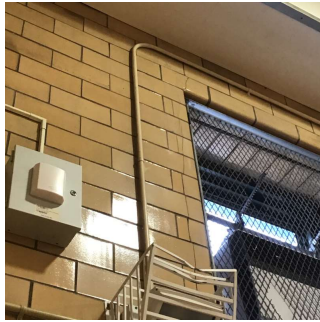
Violations	Near Main Entrance No violations recorded.
Deficiency	GLAZED BLOCK: CRACKS/SPALLING
Deficiency Location/Instance	Near Windows, Near Drinking Fountain, Exit Vestibule
Deficiency Quantity	50
Quantity Uom	S.F.
Potential Action	REPLACE
Urgency of Action	PRIORITY 3
Purpose of Action	LEVEL 2
Deficiency Photo1

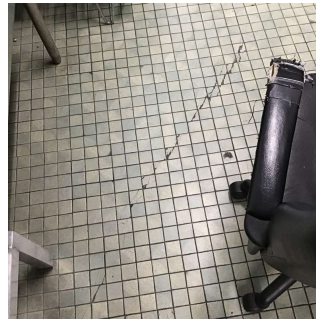
Adjacent to Serving Area

Condition	5 - Poor
-----------	----------

Deficiency CERAMIC TILE: DETERIORATED SUBSTRATE

Potential Action REPLACE

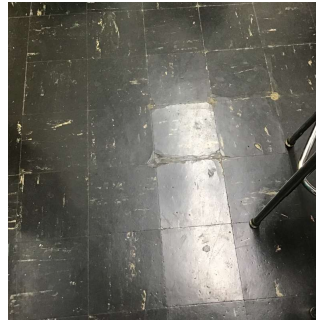
Office

Deficiency VINYL TILES: BROKEN/DETERIORATED/MISSING TILES

Potential Action REPLACE

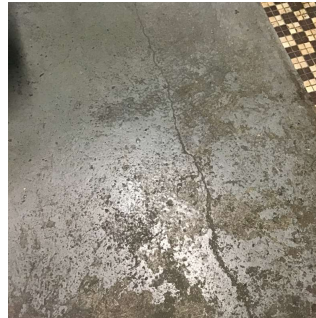
Near Exit to Exterior

CONCRETE: CRACKS

REPLACE

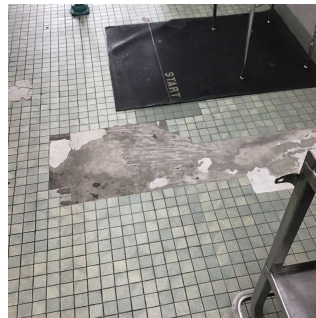
Serving Area

CERAMIC TILE: BROKEN/MISSING TILES

REPLACE

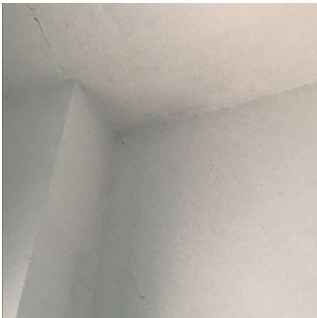
Question	Response
INTERIOR	
KITCHEN	
Floor Finish	
Violations	No violations recorded.
Walls	
Instance on 1st Floor	Inspected
Condition	2 - Between Good and Fair
Deficiency	PLASTER: CRACKS/SPALLING
Deficiency Location/Instance	Near Exit to Exterior
Deficiency Quantity	10
Quantity Uom	S.F.
Potential Action	REPLACE
Urgency of Action	PRIORITY 3
Purpose of Action	LEVEL 2
Deficiency Photo1

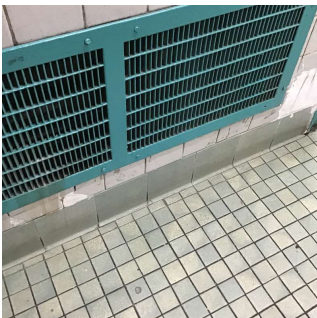
Violations	Near Exit to Exterior No violations recorded.
Deficiency	CERAMIC TILE: BROKEN/ MISSING
Deficiency Location/Instance	Near Office
Deficiency Quantity	10
Quantity Uom	S.F.
Potential Action	REPLACE
Urgency of Action	PRIORITY 3
Purpose of Action	LEVEL 2
Deficiency Photo1

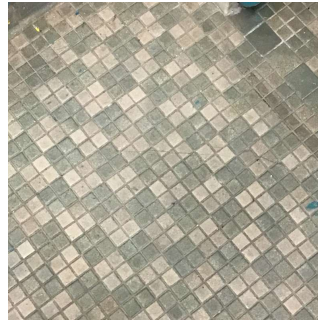
Condition	3 - Fair
Deficiency	CERAMIC TILE: BROKEN/MISSING TILES
Deficiency Location/Instance	Rear
Deficiency Quantity	10
Quantity Uom	S.F.
Potential Action	REPLACE
Urgency of Action	PRIORITY 3
Purpose of Action	LEVEL 2

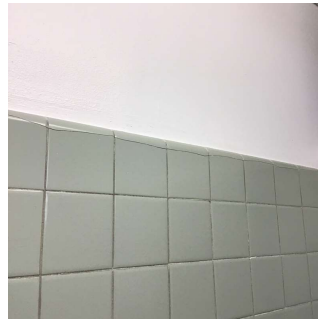
Instance on Basement - Girls	Inspected
Condition	2 - Between Good and Fair
Deficiency	CERAMIC TILE: BROKEN/ MISSING
Deficiency Location/Instance	Rear
Deficiency Quantity	10
Quantity Uom	S.F.
Potential Action	REPLACE
Urgency of Action	PRIORITY 3
Purpose of Action	LEVEL 2
Deficiency Photo1

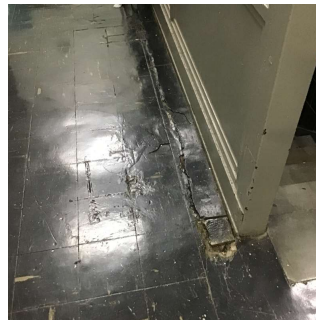
Stairway between Auditorium and Library

VINYL TILES: DETERIORATED SUBSTRATE

REPLACE

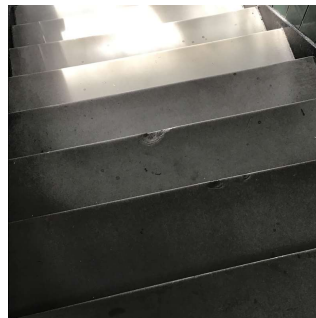
STONE: BROKEN/MISSING

REPLACE

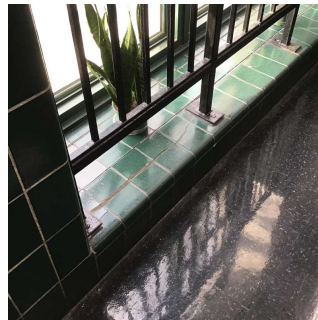
Stair B/2

GLAZED BLOCK: CRACKS/SPALLING

REPLACE

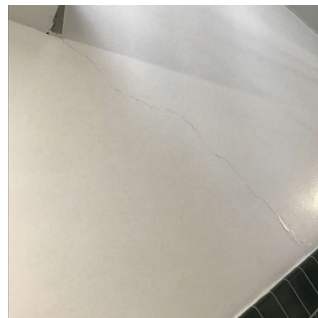
PLASTER: CRACKS/SPALLING

REPLACE

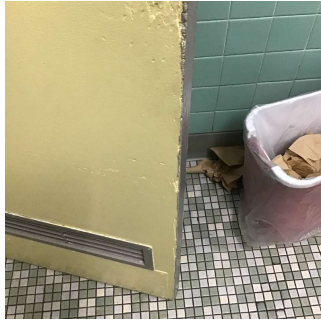
Question	Response
INTERIOR	
STAIRS/RAMPS: INTERIOR	Inspected
Walls	Inspected
Violations	Stair C/3 No violations recorded.
TOILET ROOMS - STAFF	Inspected
Ceiling	Inspected
Condition	2 - Between Good and Fair
Deficiency	No deficiencies recorded
Door(s)	Inspected
Condition	5 - Poor
Deficiency	WOOD: DETERIORATED DOOR
Deficiency Location/Instance	In Rooms 104, 207, 307, Gymnasium Office, Room 107
Deficiency Quantity	5
Quantity Uom	EACH
Potential Action	MAINTENANCE
Urgency of Action	PRIORITY 3
Purpose of Action	LEVEL 2
Deficiency Photo1

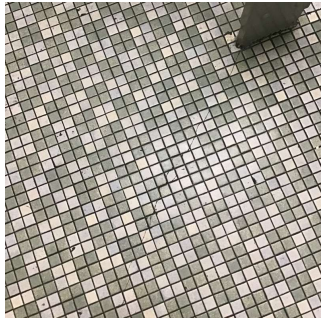
Violations	In Room 307 No violations recorded.
Floor Finish	Inspected
Condition	3 - Fair
Deficiency	CERAMIC TILE: BROKEN/MISSING TILES
Deficiency Location/Instance	In Room 307, Rooms 107, 124
Deficiency Quantity	15
Quantity Uom	S.F.
Potential Action	REPLACE
Urgency of Action	PRIORITY 3
Purpose of Action	LEVEL 2
Deficiency Photo1

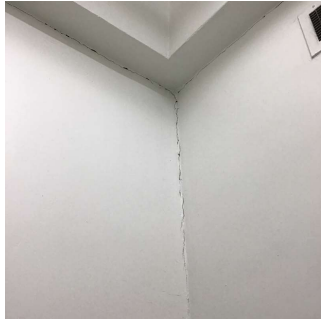
In Room 307
Violations	No violations recorded.
Walls	Inspected
Condition	2 - Between Good and Fair
Deficiency	PLASTER: CRACKS/SPALLING
Deficiency Location/Instance	Gymnasium Office, In Room 104
Deficiency Quantity	20
Quantity Uom	S.F.
Potential Action	REPLACE
Urgency of Action	PRIORITY 3
Purpose of Action	LEVEL 2
Deficiency Photo1

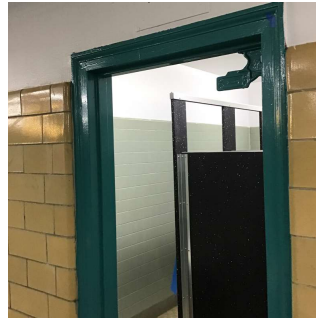
Girls Locker Room

METAL: MISSING DOOR

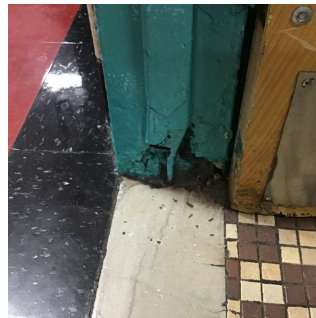
Room 117

METAL: DETERIORATED DOOR AND FRAME

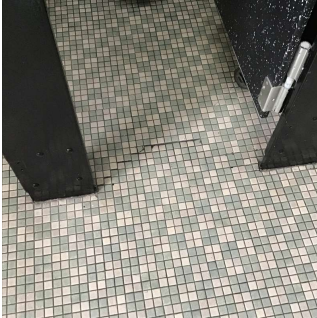
Question	Response
INTERIOR	
TOILET ROOMS - STUDENTS	
Floor Finish	Inspected
Condition	2 - Between Good and Fair
Deficiency	CERAMIC TILE: DETERIORATED SUBSTRATE
Deficiency Location/Instance	Rooms 115, 117, 315
Deficiency Quantity	30
Quantity Uom	S.F.
Potential Action	REPLACE
Urgency of Action	PRIORITY 3
Purpose of Action	LEVEL 2
Deficiency Photo1

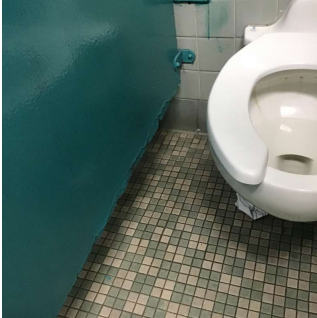
Violations	Room 315 No violations recorded.
Stalls	Inspected
Condition	5 - Poor
Deficiency	RUST - MAJOR
Deficiency Location/Instance	Rooms 115, 315
Deficiency Quantity	8
Quantity Uom	EACH
Potential Action	REPLACE
Urgency of Action	PRIORITY 3
Purpose of Action	LEVEL 2
Deficiency Photo1

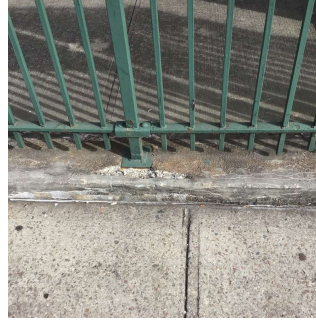
Drainage System for Soil	Does not Exist
DRINKING FOUNTAINS	Does not Exist
FENCES	Inspected
Condition	4 - Between Fair and Poor
Deficiency	CONCRETE CURB: DAMAGED/DETERIORATED
Deficiency Location/Instance	Stuyvesant Avenue
Deficiency Quantity	40
Quantity Uom	S.F.
Potential Action	REPLACE
Urgency of Action	PRIORITY 3
Purpose of Action	LEVEL 2

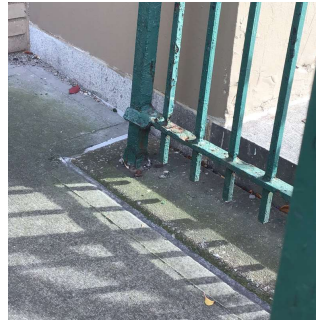
Stuyvesant Avenue

WROUGHT IRON: RUST - MAJOR

REPLACE

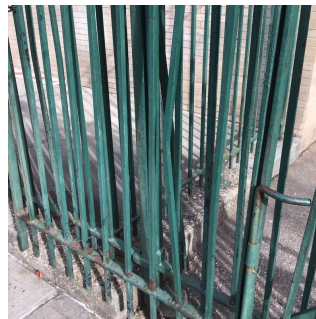
Stuyvesant Avenue

WROUGHT IRON: DAMAGED/DETERIORATED

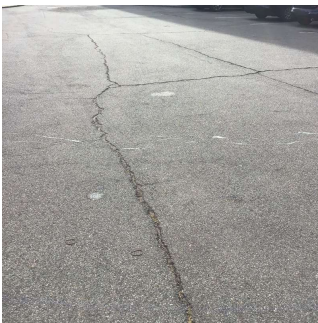
Violations	Near Parking Lot No violations recorded.
IRRIGATION SYSTEM	Does not Exist
PAVING	Inspected
Student Non-Use	Inspected
Gravel Exists?	No
Asphalt	Inspected
Condition	4 - Between Fair and Poor
Deficiency	CRACKS - MAJOR
Deficiency Location/Instance	Parking Lot
Deficiency Quantity	800
Quantity Uom	S.F.
Potential Action	REPLACE
Urgency of Action	PRIORITY 3
Purpose of Action	LEVEL 2
Deficiency Photo1

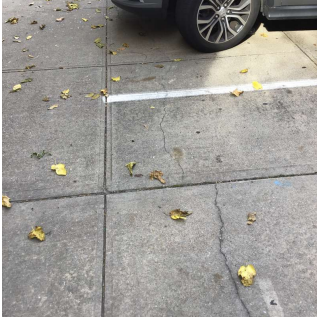
Violations	Parking Lot No violations recorded.
Concrete	Inspected
Condition	3 - Fair
Deficiency	DAMAGED/DETERIORATED/MISSING SECTIONS
Deficiency Location/Instance	Parking Lot
Deficiency Quantity	425
Quantity Uom	S.F.
Potential Action	REPLACE

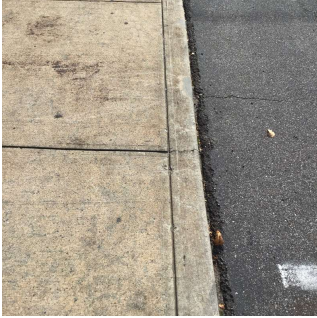
Violations	Parking Lot No violations recorded.
Pavers	Does not Exist
Student Use	Does not Exist
Site Sidewalks & Walkways	Inspected
Asphalt	Does not Exist
Concrete	Inspected
Condition	3 - Fair
Deficiency	DAMAGED CURBS
Deficiency Location/Instance	Near Parking Lot
Deficiency Quantity	55
Quantity Uom	L.F.
Potential Action	REPLACE
Urgency of Action	PRIORITY 3
Purpose of Action	LEVEL 2
Deficiency Photo1

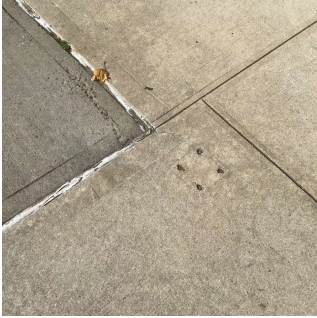
Violations	Near Parking Lot No violations recorded.
Deficiency	DAMAGED/DETERIORATED/MISSING SECTIONS
Deficiency Location/Instance	Near Parking Lot
Deficiency Quantity	75
Quantity Uom	S.F.
Potential Action	REPLACE
Urgency of Action	PRIORITY 3
Purpose of Action	LEVEL 2

Question	Response
SITE	
PAVING	
Site Sidewalks & Walkways	
Concrete	
Deficiency Photo1

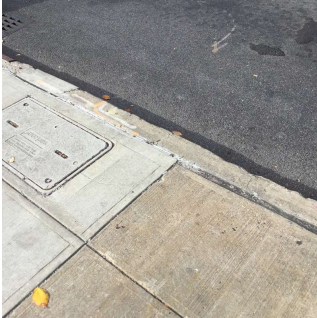
Violations	Near Parking Lot No violations recorded.
Pavers	Does not Exist
DOT Sidewalk	Inspected
Asphalt	Does not Exist
Concrete	Inspected
Condition	4 - Between Fair and Poor
Deficiency	DAMAGED CURBS
Deficiency Location/Instance	Lafayette Avenue
Deficiency Quantity	40
Quantity Uom	L.F.
Potential Action	REPLACE
Urgency of Action	PRIORITY 3
Purpose of Action	LEVEL 2
Deficiency Photo1

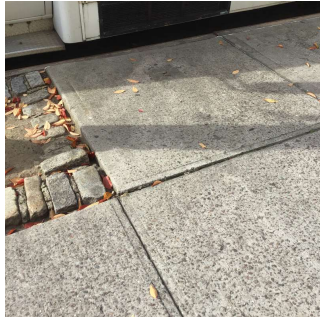
Violations	Lafayette Avenue No violations recorded.
Deficiency	HEAVING
Deficiency Location/Instance	Stuyvesant Avenue
Deficiency Quantity	25
Quantity Uom	S.F.
Potential Action	REPLACE
Urgency of Action	PRIORITY 3
Purpose of Action	LEVEL 2

Question	Response
SITE	
PAVING	
DOT Sidewalk	
Concrete	
Deficiency Photo1

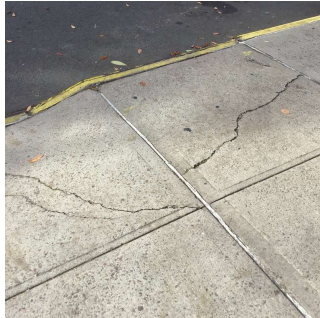
Violations	Stuyvesant Avenue No violations recorded.
Deficiency	DAMAGED/DETERIORATED/MISSING SECTIONS
Deficiency Location/Instance	Stuyvesant Avenue, Lafayette Avenue
Deficiency Quantity	975
Quantity Uom	S.F.
Potential Action	REPLACE
Urgency of Action	PRIORITY 3
Purpose of Action	LEVEL 2
Deficiency Photo1
