**NYC Department of Education**  
**Building Condition Assessment Survey 2023 - 2024**

Architectural Inspection

**K058**

**Asset:** P.S. 58 - BROOKLYN, 330 SMITH STREET, New York, 11231

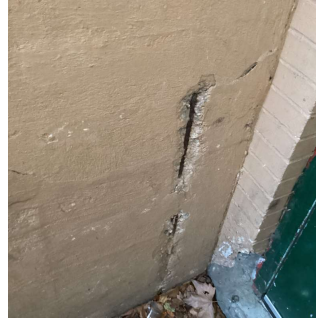
Question	Response
<b>Architectural</b>	
<b>EXTERIOR</b>	Inspected
<b>AREAWAY</b>	Inspected
Instance on AW1 - AW3	Inspected
Instance Condition	5 - Poor
Instance Quantity	3
Instance Quantity Uom	EACH
Deficiency	AREAWAY WALLS: CRACKS AND SPALLING
Roof Plan reference	
Deficiency Quantity	20
Quantity Uom	S.F.
Potential Action	REPLACE
Urgency of Action	PRIORITY 4
Purpose of Action	LEVEL 2

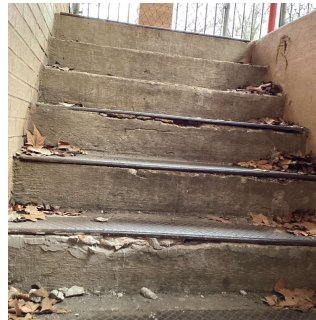
AW3

AREAWAY STAIRS: DETERIORATED TREADS/RISERS/NOSINGS

REPLACE

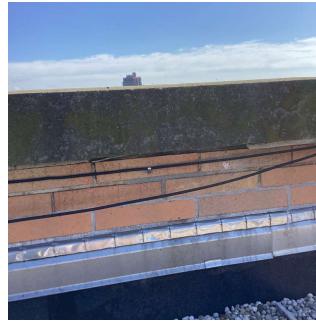
Roof 1 - Facade C

CAST STONE: DETERIORATED BED JOINT

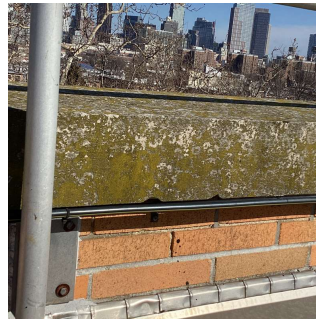
Roof 1 - Facade B

**CAST STONE: CRACKED/BROKEN PIECES**

REPLACE-IN-KIND

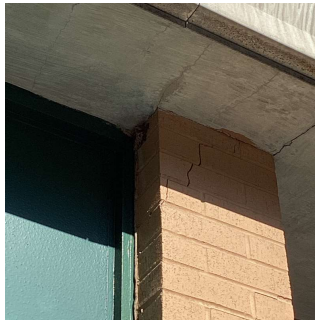
Facade F

**BRICK: MAJOR / THRU CRACKS**

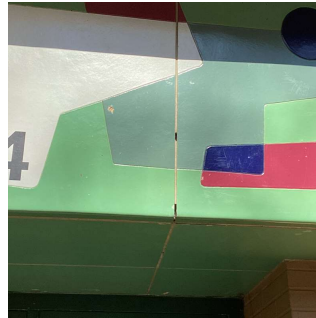
Facade F (Glazed Block)

CERAMIC TILE: DETERIORATED JOINTS

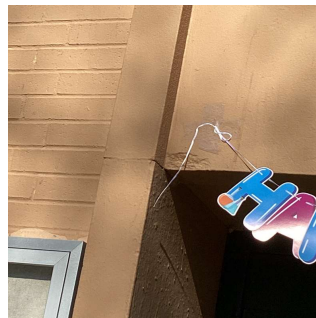
Facade D - Exit 3

Yes	Potential Falling Debris	Severely damaged stone facade is a potential falling debris hazard.	EXTERIOR   EXTERIOR WALLS	Exit 3 leading out to 1st Place	Ryan Deforest	Custodian

**STONE: CHIPPED/SPALLED/BROKEN PIECES - MAJOR**

REPLACE

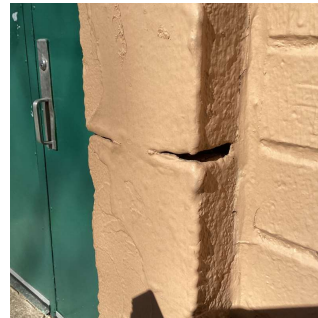
Facade D - Exit 3

STONE: DETERIORATED JOINTS

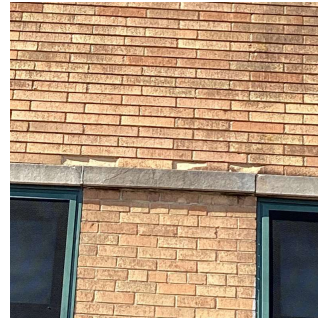
Facade C - 2nd Floor

BRICK: MAJOR / THRU CRACKS

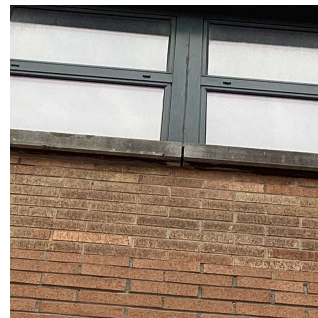
Facade B

**BRICK: DETERIORATED MASONRY SILLS - MINOR**

30  
L.F.  
REPAIR  
PRIORITY 3  
LEVEL 2

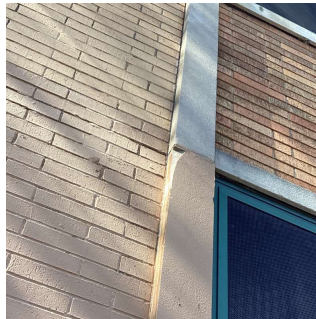
Facade C

**CAST IN PLACE / PRE-CAST CONCRETE: MAJOR  
CRACKS/SPALLING**

REPLACE

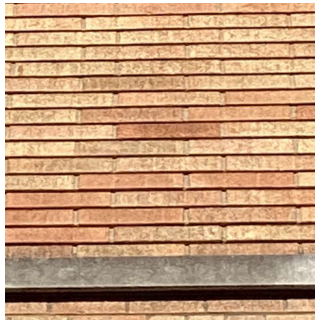
Facade F

**BRICK: DETERIORATED JOINTS**

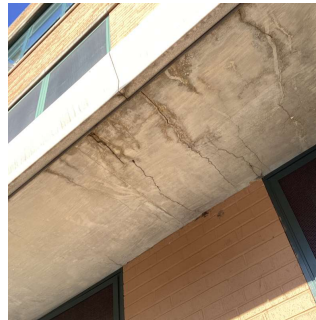
Facade F

CONCRETE: MAJOR CRACKS/SPALLING

REPLACE

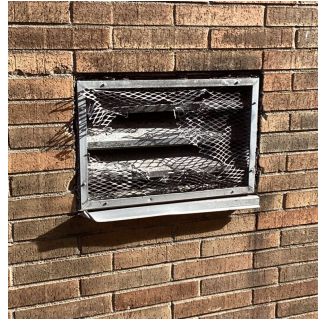
Facade H

MISSING/DAMAGED SCREEN

Deficiency Quantity	10
Quantity Uom	S.F.
Potential Action	REPLACE
Urgency of Action	PRIORITY 4
Purpose of Action	LEVEL 2
Deficiency Photo1

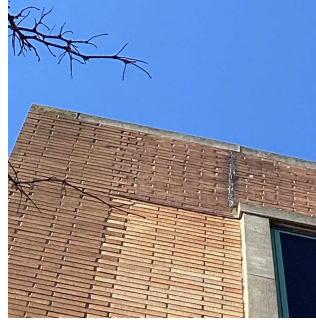
Facade C

Material Type(s)	Inspected Masonry
Replacement Quantity	5,000
Replacement Uom	C.F.
Instance on All Facades	Inspected
Instance Condition	4 - Between Fair and Poor
Instance Quantity	5,000
Instance Quantity Uom	C.F.
Deficiency	<b>BRICK: MAJOR DETERIORATION/CRACKS</b>
Roof Plan reference

Deficiency Quantity	20
Quantity Uom	S.F.
Potential Action	REMOVE AND REBUILD
Urgency of Action	PRIORITY 4
Purpose of Action	LEVEL 2

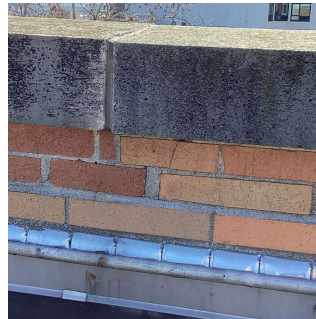
Roof 1 - Facade D

**BRICK: MINOR CRACKS, SPALLING**

REPAIR

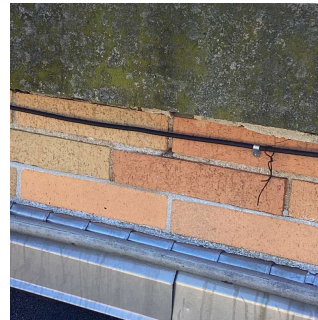
Facade C

**BRICK: DETERIORATED JOINTS**

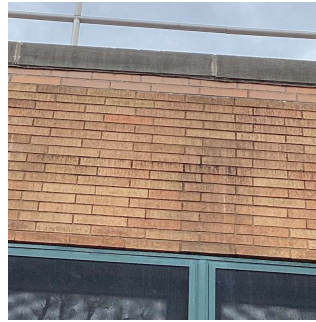
Facade L

**BRICK: DETERIORATED JOINTS**

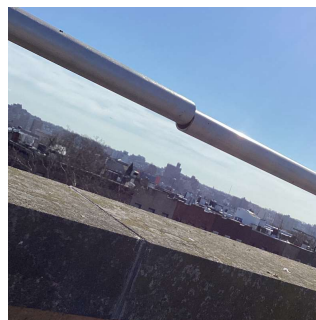
Roof 1 - Facade C

RAILINGS/PANELS: DETERIORATED, MAJOR RUSTING

REPLACE

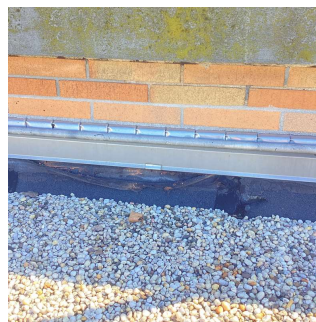
Roof 1 - Facade C

**BUILT-UP: FLASHING: BASE FLASHING DETERIORATED**

REMOVE AND REPLACE

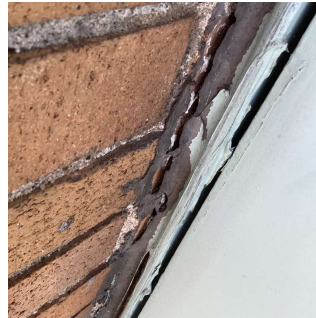
Roof 1 - BH2

Roof 4
Instance Quantity	500
Instance Quantity Uom	S.F.
Does the roof have major mechanical equipment sitting on Dunnage Steel less than 18" above the Roofing?	No
Does this roof instance have a Sustainable Roof System?	No
Do solar panels exist on these roofs?	No
Is/Are the roof(s) suitable for Solar Panel installation?	No
Installation Year	2009
Source of Installation	Custodial Staff
Deficiency	No deficiencies recorded
<b>ROOFING DRAINS</b>	Inspected
Condition	2 - Between Good and Fair
Deficiency	No deficiencies recorded
<b>Specialties</b>	Inspected
<b>BULKHEAD/PENTHOUSE</b>	Inspected
Condition	3 - Fair
Deficiency	<b>BULKHEAD/PENTHOUSE DOORS: AIR/WATER INFILTRATION WITH DAMAGED CAULKING</b>
Roof Plan reference

Deficiency Quantity	30
Quantity Uom	L.F.
Potential Action	MAINTENANCE
Urgency of Action	PRIORITY 3
Purpose of Action	LEVEL 2

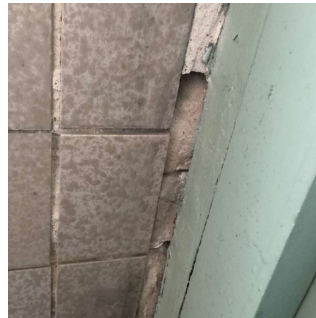
Roof 1 - BH1

**BULKHEAD/PENTHOUSE WALLS/INTERIOR: GLAZED BLOCK DETERIORATED JOINTS**

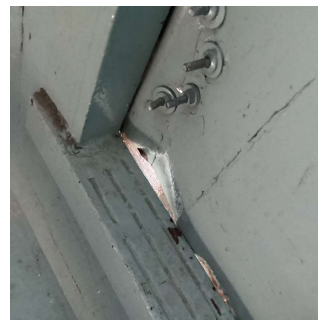
Roof 1 - BH1

**BULKHEAD/PENTHOUSE DOORS: DETERIORATED DOOR**

1  
EACH  
REPLACE DOOR  
PRIORITY 4  
LEVEL 2

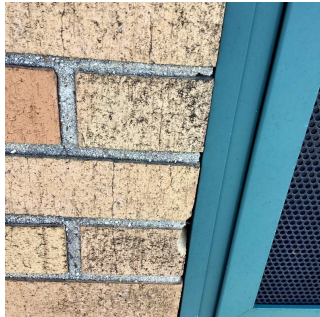
**BULKHEAD/PENTHOUSE WALLS/EXTERIOR:  
CRACKS/SPALLING - MINOR**

10  
S.F.  
REPAIR  
PRIORITY 3  
LEVEL 2

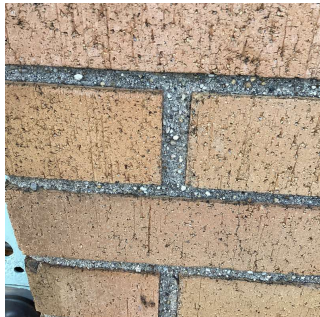
Violations	Roof 1 - BH2 No violations recorded.
Deficiency	<b>BULKHEAD/PENTHOUSE WALLS/EXTERIOR: DETERIORATED JOINTS</b>
Roof Plan reference

Deficiency Quantity	200
Quantity Uom	S.F.
Potential Action	REPOINT
Urgency of Action	PRIORITY 3
Purpose of Action	LEVEL 2
Deficiency Photo1

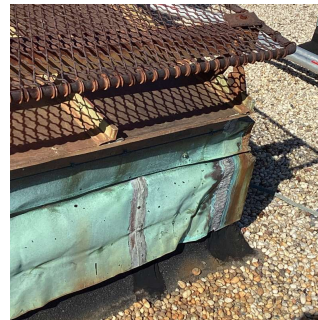
Roof 1 - SK  
 No violations recorded.

Violations	Roof 1 - BH2 No violations recorded.
<b>CUPOLA/ SPIRES/ TOWERS</b>	Does not Exist
<b>DORMER</b>	Does not Exist
<b>DUNNAGE STEEL</b>	Does not Exist
<b>SKYLIGHT/ROOF VENT</b>	Inspected
Material Type(s)	Glass
Condition	3 - Fair
Deficiency	DAMAGED FLASHING

20  
 L.F.  
 MAINTENANCE  
 PRIORITY 3  
 LEVEL 2

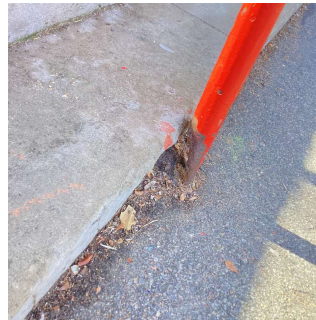
Facade C

**RUST - MAJOR**

REPLACE

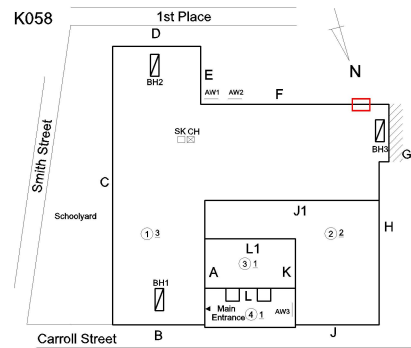
**CONCRETE: CRACKS/SPALLING - MAJOR**

10  
S.F.  
REPLACE  
PRIORITY 4  
LEVEL 2

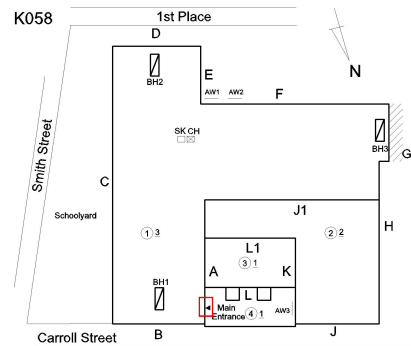
**STONE: DETERIORATED JOINTS**

30  
L.F.  
REPOINT  
PRIORITY 4  
LEVEL 2

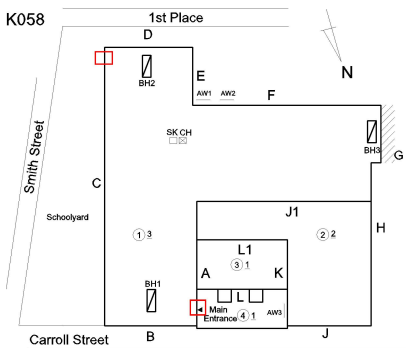
Violations	Facade A - Main Entrance No violations recorded.
Deficiency	<b>STONE: CRACKS/SPALLING - MAJOR</b>
Roof Plan reference

Deficiency Quantity	60
Quantity Uom	S.F.
Potential Action	REPLACE
Urgency of Action	PRIORITY 4
Purpose of Action	LEVEL 2
Deficiency Photo1

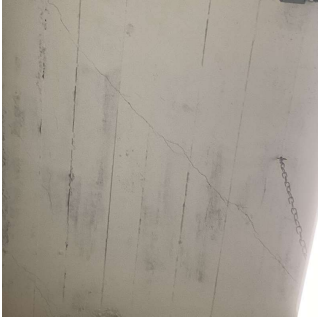
Question	Response
<b>INTERIOR</b>	
<b>STRUCTURAL</b>	
<b>FLOOR STRUCTURE</b>	
Potential Action	REPAIR
Urgency of Action	PRIORITY 3
Purpose of Action	LEVEL 5
Deficiency Photo1

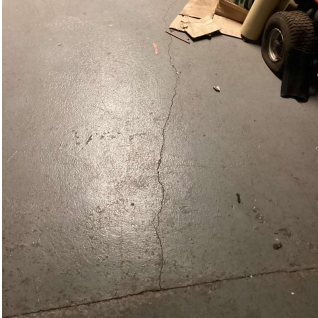
Basement - Boiler Room
Violations	No violations recorded.
Deficiency	CONCRETE SLAB ON GRADE: THRU CRACKS
Deficiency Location/Instance	Basement - Fan Room, Electrical Room, Storage Room
Deficiency Quantity	100
Quantity Uom	S.F.
Potential Action	REPAIR
Urgency of Action	PRIORITY 3
Purpose of Action	LEVEL 5
Deficiency Photo1

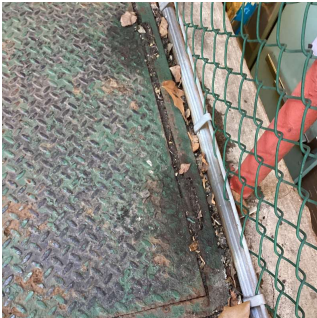
<b>Question</b>	<b>Response</b>
<b>INTERIOR</b>	
<b>STRUCTURAL</b>	
<b>VAULTS-BUNKERS</b>	
<b>Vault/Ash Hoist Doors and Framing</b>	
Condition	5 - Poor
Deficiency	DETERIORATED/DAMAGED VAULT/ASH HOIST DOORS AND FRAMING
Deficiency Location/Instance	Basement - Sidewalk Elevator
Deficiency Quantity	2
Quantity Uom	EACH
Potential Action	REPLACE
Urgency of Action	PRIORITY 4
Purpose of Action	LEVEL 2
Deficiency Photo1

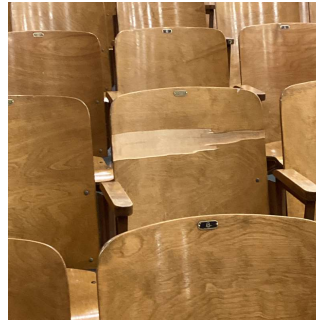
Seat C/6

Instance on 1st Floor (414 Seats)	Inspected
Condition	5 - Poor
Deficiency	DAMAGED/BROKEN/INOPERABLE
Deficiency Location/Instance	Seat A/2, B/2, 6, 12, C/6, and others
Deficiency Quantity	88
Quantity Uom	EACH
Potential Action	REPLACE
Urgency of Action	PRIORITY 3
Purpose of Action	LEVEL 2

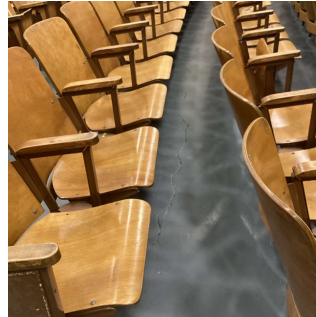
Near seat K/101

CONCRETE: CRACKS

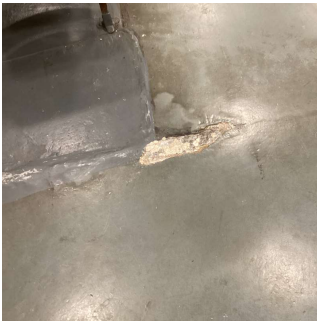
SHEET VINYL: BROKEN/DETERIORATED

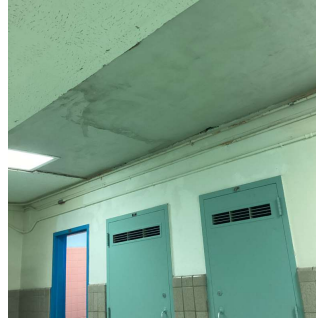
Corridor near Room B11

Potential Action	REPLACE
Urgency of Action	PRIORITY 3
Purpose of Action	LEVEL 2
Deficiency Photo1

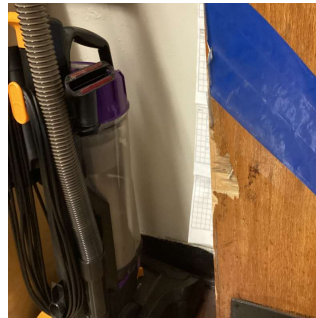
Room 301

Deficiency	WOOD: DETERIORATED DOOR
Deficiency Location/Instance	Room 301, 302, 304, 305, 306, and others
Deficiency Quantity	30
Quantity Uom	EACH
Potential Action	MAINTENANCE
Urgency of Action	PRIORITY 3
Purpose of Action	LEVEL 2
Deficiency Photo1

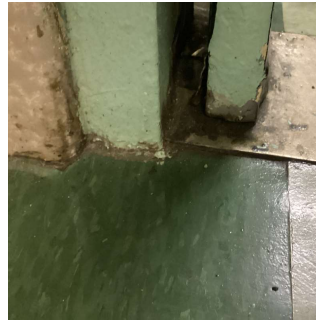
Deficiency	METAL CLAD WOOD: DETERIORATED DOOR
Deficiency Location/Instance	Corridor near Room 207
Deficiency Quantity	1
Quantity Uom	EACH
Potential Action	MAINTENANCE
Urgency of Action	PRIORITY 3
Purpose of Action	LEVEL 2

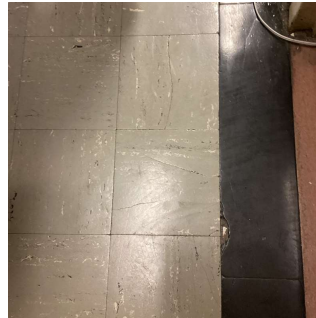
Room 308

VINYL TILES: BROKEN/DETERIORATED/MISSING TILES

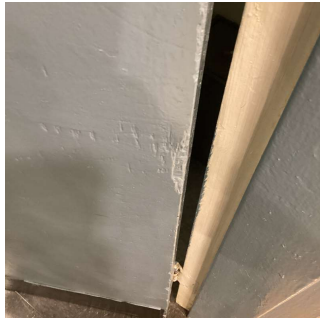
Near center
Violations	No violations recorded.
<b>Door(s)</b>	
Instance on 1st Floor	Inspected
Condition	3 - Fair
Deficiency	WOOD: DETERIORATED DOOR
Deficiency Location/Instance	Nurses Office
Deficiency Quantity	1
Quantity Uom	EACH
Potential Action	MAINTENANCE
Urgency of Action	PRIORITY 3
Purpose of Action	LEVEL 2
Deficiency Photo1

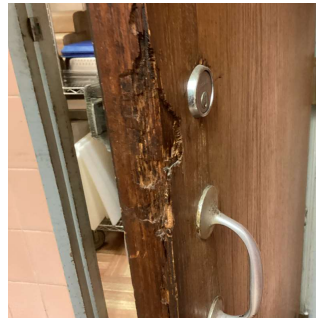
Deficiency	WOOD: DETERIORATED DOOR
Deficiency Location/Instance	Storage
Deficiency Quantity	1
Quantity Uom	EACH
Potential Action	MAINTENANCE
Urgency of Action	PRIORITY 3
Purpose of Action	LEVEL 2
Deficiency Photo1

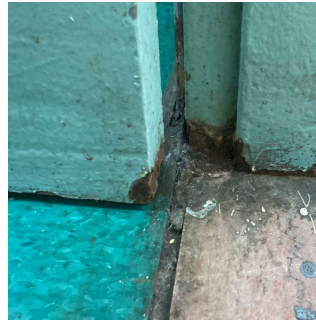
Deficiency	METAL: DETERIORATED DOOR AND FRAME
Deficiency Location/Instance	Entrance
Deficiency Quantity	2
Quantity Uom	EACH
Potential Action	MAINTENANCE
Urgency of Action	PRIORITY 3
Purpose of Action	LEVEL 2

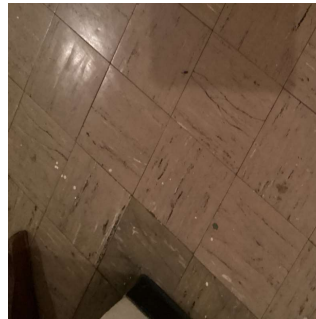
Instance on Basement	Inspected
Condition	5 - Poor
Deficiency	VINYL TILES: BROKEN/DETERIORATED/MISSING TILES
Deficiency Location/Instance	Kitchen Locker Room
Deficiency Quantity	100
Quantity Uom	S.F.
Potential Action	REPLACE
Urgency of Action	PRIORITY 3
Purpose of Action	LEVEL 2
Deficiency Photo1

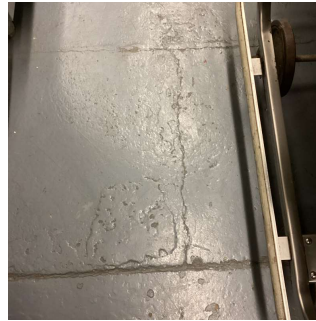
Deficiency	CONCRETE: CRACKS
Deficiency Location/Instance	Storage
Deficiency Quantity	50
Quantity Uom	S.F.
Potential Action	REPLACE
Urgency of Action	PRIORITY 3
Purpose of Action	LEVEL 2

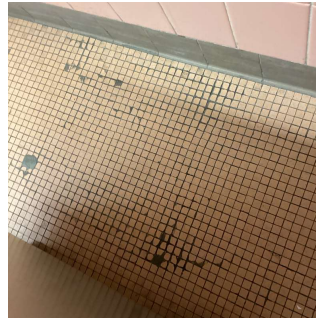
Near Entrance

CERAMIC TILE: BROKEN/MISSING TILES

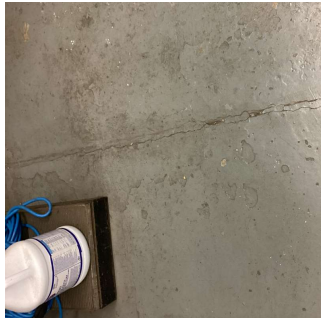
Deficiency	No deficiencies recorded
<b>Floor Finish</b>	
Instance on Basement - Near Stair E (5 Lockers)	Inspected
Condition	3 - Fair
Deficiency	CONCRETE: CRACKS
Deficiency Location/Instance	Center
Deficiency Quantity	100
Quantity Uom	S.F.
Potential Action	REPLACE
Urgency of Action	PRIORITY 3
Purpose of Action	LEVEL 2
Deficiency Photo1

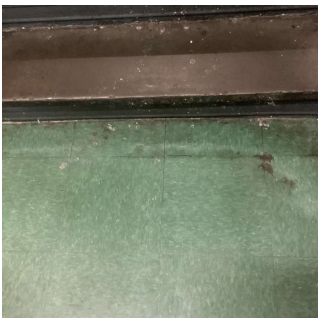
Violations	Stair A/Basement No violations recorded.
Deficiency	VINYL TILES: DETERIORATED SUBSTRATE
Deficiency Location/Instance	Stair A/Basement, 1
Deficiency Quantity	50
Quantity Uom	S.F.
Potential Action	REPLACE
Urgency of Action	PRIORITY 3
Purpose of Action	LEVEL 2
Deficiency Photo1

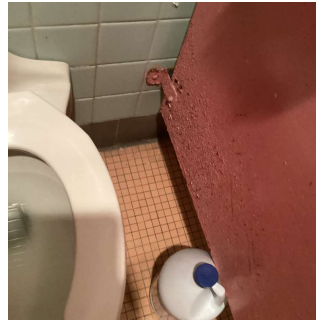
Kitchen Staff

Condition	5 - Poor
Deficiency	RUST - MAJOR
Deficiency Location/Instance	Kitchen Staff, Room 308, 222, 122, 106, and others
Deficiency Quantity	6
Quantity Uom	EACH
Potential Action	REPLACE
Urgency of Action	PRIORITY 3
Purpose of Action	LEVEL 2

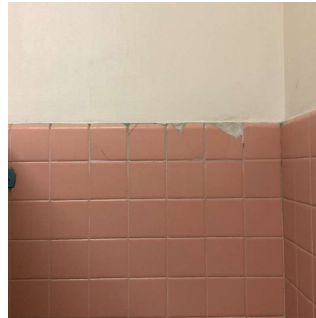
Room 102

CERAMIC TILE: BROKEN/ MISSING

REPLACE

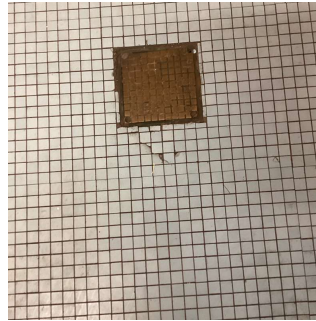
Room B3

Room 317
Violations	No violations recorded.
<b>Floor Finish</b>	Inspected
Condition	5 - Poor
Deficiency	CERAMIC TILE: BROKEN/MISSING TILES
Deficiency Location/Instance	Room B3, B11, 217, 317
Deficiency Quantity	40
Quantity Uom	S.F.
Potential Action	REPLACE
Urgency of Action	PRIORITY 3
Purpose of Action	LEVEL 2

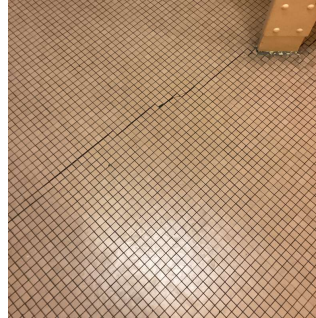
Room 217

CERAMIC TILE: DETERIORATED SUBSTRATE

REPLACE

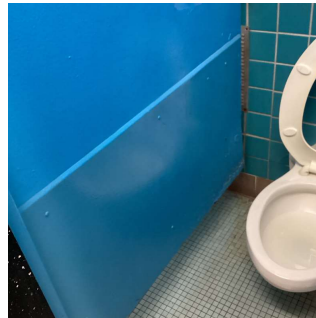
RUST - MAJOR

REPLACE

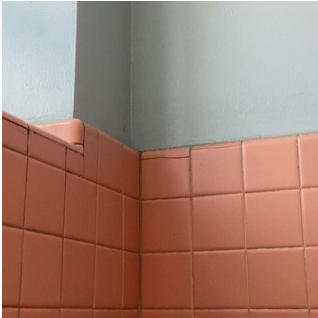
Question	Response
<b>INTERIOR</b>	
<b>TOILET ROOMS - STUDENTS</b>	
<b>Stalls</b>	Inspected
	Room B3
Violations	No violations recorded.
<b>Walls</b>	Inspected
Condition	2 - Between Good and Fair
Deficiency	CERAMIC TILE: BROKEN/ MISSING
Deficiency Location/Instance	Room B3, B11, 109, 117, 125, and others
Deficiency Quantity	100
Quantity Uom	S.F.
Potential Action	REPLACE
Urgency of Action	PRIORITY 3
Purpose of Action	LEVEL 2
Deficiency Photo1

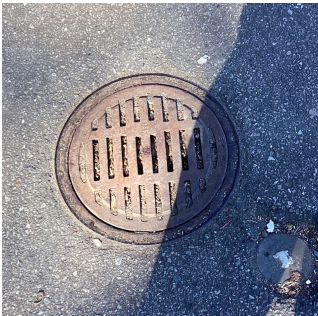
Violations	Room B3 No violations recorded.
<b>LIFE SAFETY</b>	Inspected
<b>F.D. HOLDING AREA</b>	Does not Exist
<b>STEEL STAIRS</b>	Does not Exist
<b>SITE</b>	Inspected
<b>CONTAINERIZATION</b>	Does not Exist
<b>Drainage System for Asphalt</b>	Inspected
<b>Catch Basins/Manhole - Surrounded by asphalt</b>	Inspected
Condition	5 - Poor
Deficiency	BLOCKED
Deficiency Location/Instance	Schoolyard
Deficiency Quantity	1
Quantity Uom	EACH
Potential Action	MAINTENANCE
Urgency of Action	PRIORITY 3

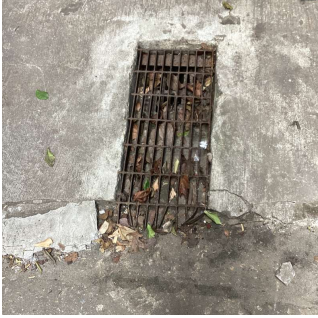
<b>Question</b>	<b>Response</b>
<b>SITE</b>	
<b>Drainage System for Asphalt</b>	Inspected
<b>Catch Basins/Manhole - Surrounded by asphalt</b>	Inspected
Violations	Schoolyard No violations recorded.
<b>Culverts - Asphalt Covering</b>	Does not Exist
<b>Drainage System for Concrete</b>	Inspected
<b>Catch Basins/Manhole - Surrounded by concrete</b>	Inspected
Condition	3 - Fair
Deficiency	DAMAGED COVER
Deficiency Location/Instance	Alleyway along Carroll Street
Deficiency Quantity	1
Quantity Uom	EACH
Potential Action	REPLACE
Urgency of Action	PRIORITY 3
Purpose of Action	LEVEL 2
Deficiency Photo1

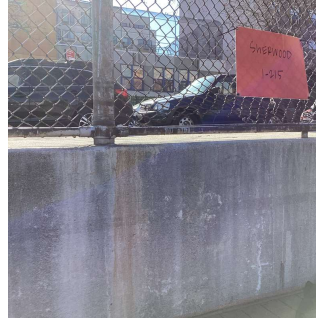
<b>DRINKING FOUNTAINS</b>	Does not Exist
<b>FENCES</b>	Inspected
Condition	4 - Between Fair and Poor
Deficiency	CHAIN LINK: DAMAGED/DETERIORATED
Deficiency Location/Instance	Along 1st Place
Deficiency Quantity	50
Quantity Uom	S.F.
Potential Action	REPLACE
Urgency of Action	PRIORITY 3
Purpose of Action	LEVEL 2

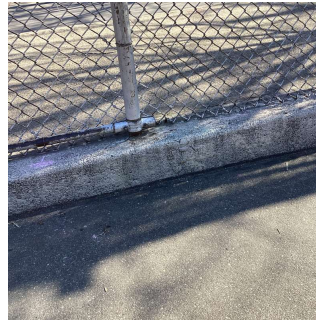
Along Smith Street

CHAIN LINK: DAMAGED POST/RAIL

REPLACE

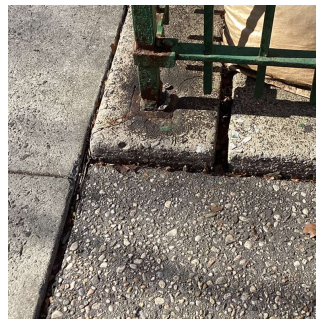
Along 1st Place

CONCRETE CURB: DAMAGED/DETERIORATED

REPLACE

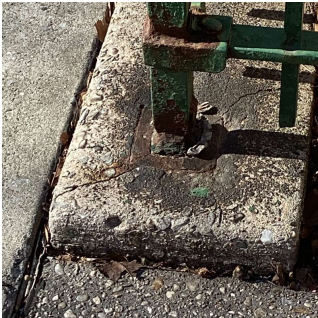
WROUGHT IRON: RUST - MAJOR

<b>Question</b>	<b>Response</b>
<b>SITE</b>	
<b>FENCES</b>	
Deficiency Location/Instance	Along 1st Place
Deficiency Quantity	280
Quantity Uom	S.F.
Potential Action	REPLACE
Urgency of Action	PRIORITY 3
Purpose of Action	LEVEL 2
Deficiency Photo1

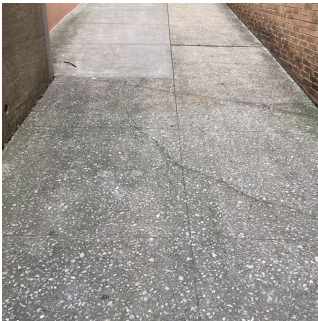
Violations	Along 1st Place No violations recorded.
<b>IRRIGATION SYSTEM</b>	Does not Exist
<b>PAVING</b>	Inspected
<b>Student Non-Use</b>	Inspected
Gravel Exists?	No
<b>Asphalt</b>	Does not Exist
<b>Concrete</b>	Inspected
Condition	3 - Fair
Deficiency	DAMAGED/DETERIORATED/MISSING SECTIONS
Deficiency Location/Instance	Alleyway along Carroll Street
Deficiency Quantity	300
Quantity Uom	S.F.
Potential Action	REPLACE
Urgency of Action	PRIORITY 3
Purpose of Action	LEVEL 2
Deficiency Photo1

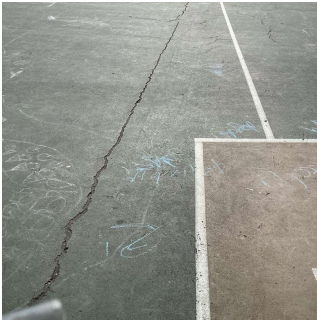
Question	Response
<b>SITE</b>	
<b>PAVING</b>	
<b>Student Use</b>	
<b>Asphalt</b>	
Condition	4 - Between Fair and Poor
Deficiency	CRACKS - MAJOR
Deficiency Location/Instance	Schoolyard
Deficiency Quantity	1,500
Quantity Uom	S.F.
Potential Action	REPLACE
Urgency of Action	PRIORITY 3
Purpose of Action	LEVEL 2
Deficiency Photo1

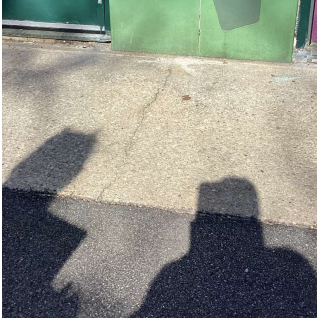
Violations	Schoolyard No violations recorded.
<b>Concrete</b>	Inspected
Condition	3 - Fair
Deficiency	DAMAGED/DETERIORATED/MISSING SECTIONS
Deficiency Location/Instance	Schoolyard
Deficiency Quantity	100
Quantity Uom	S.F.
Potential Action	REPLACE
Urgency of Action	PRIORITY 3
Purpose of Action	LEVEL 2
Deficiency Photo1

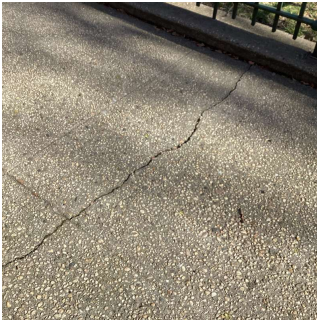
Question	Response
<b>SITE</b>	
<b>PAVING</b>	
<b>Site Sidewalks &amp; Walkways</b>	
<b>Concrete</b>	
Deficiency	DAMAGED/DETERIORATED/MISSING SECTIONS
Deficiency Location/Instance	Near exit 4, exit 3, along 1st Place
Deficiency Quantity	600
Quantity Uom	S.F.
Potential Action	REPLACE
Urgency of Action	PRIORITY 3
Purpose of Action	LEVEL 2
Deficiency Photo1

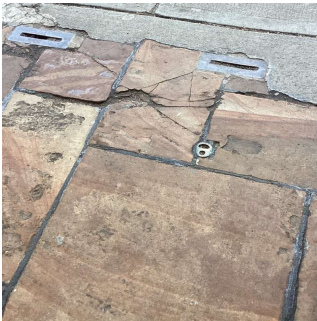
Violations	Near exit 4 No violations recorded.
<b>Pavers</b>	Inspected
Condition	2 - Between Good and Fair
Deficiency	DAMAGED/MISSING
Deficiency Location/Instance	Near exit 1 (Main Entrance)
Deficiency Quantity	25
Quantity Uom	S.F.
Potential Action	REPLACE
Urgency of Action	PRIORITY 3
Purpose of Action	LEVEL 2
Deficiency Photo1

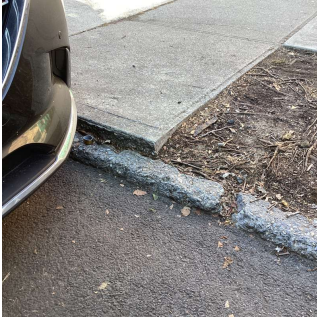
Violations	Near exit 1 (Main Entrance) No violations recorded.
<b>DOT Sidewalk</b>	Inspected
<b>Asphalt</b>	Does not Exist
<b>Concrete</b>	Inspected
Condition	4 - Between Fair and Poor
Deficiency	HEAVING
Deficiency Location/Instance	Along 1st Place

Question	Response
<b>SITE</b>	
<b>PAVING</b>	
<b>DOT Sidewalk</b>	
<b>Concrete</b>	
Potential Action	REPLACE
Urgency of Action	PRIORITY 5
Purpose of Action	LEVEL 6
Deficiency Photo1

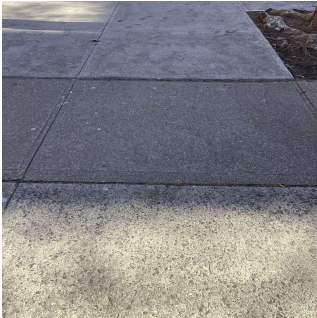
Violations	Along 1st Place 51538
Deficiency	HEAVING
Deficiency Location/Instance	Along 1st Place, Carroll Street
Deficiency Quantity	150
Quantity Uom	S.F.
Potential Action	REPLACE
Urgency of Action	PRIORITY 4
Purpose of Action	LEVEL 4
Deficiency Photo1

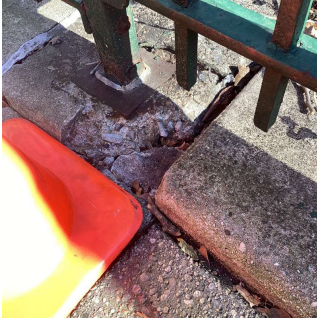
Question	Response
<b>SITE</b>	
<b>PLAYGROUNDS</b>	
<b>Fence</b>	
Condition	3 - Fair
Deficiency	CONCRETE CURB: DAMAGED/DETERIORATED
Deficiency Location/Instance	Schoolyard
Deficiency Quantity	10
Quantity Uom	S.F.
Potential Action	REPLACE
Urgency of Action	PRIORITY 3
Purpose of Action	LEVEL 2
Deficiency Photo1

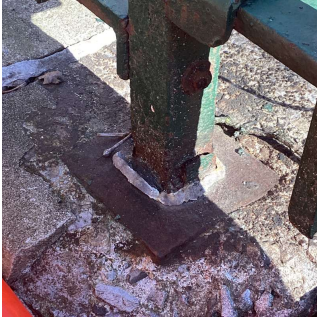
Violations	Schoolyard No violations recorded.
Deficiency	WROUGHT IRON: RUST - MAJOR
Deficiency Location/Instance	Schoolyard
Deficiency Quantity	40
Quantity Uom	S.F.
Potential Action	REPLACE
Urgency of Action	PRIORITY 3
Purpose of Action	LEVEL 2
Deficiency Photo1

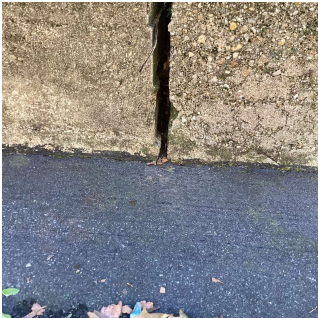
Question	Response
<b>SITE</b>	
<b>PLAYGROUNDS</b>	
<b>Safety Surfacing</b>	
Condition	3 - Fair
Deficiency	DETERIORATED/MISSING
Deficiency Location/Instance	Schoolyard
Deficiency Quantity	100
Quantity Uom	S.F.
Potential Action	REPLACE
Urgency of Action	PRIORITY 5
Purpose of Action	LEVEL 6
Deficiency Photo1	 
Violations	Schoolyard No violations recorded.
Deficiency	DETERIORATED/MISSING
Deficiency Location/Instance	Schoolyard
Deficiency Quantity	50
Quantity Uom	S.F.
Potential Action	REPLACE
Urgency of Action	PRIORITY 3
Purpose of Action	LEVEL 2
Deficiency Photo1	 
Violations	Schoolyard No violations recorded.
<b>Unpaved Area</b>	
Instance on South Side	Inspected
Condition	2 - Between Good and Fair
Deficiency	No deficiencies recorded
<b>PLAYING SURFACE</b>	
	Does not Exist
<b>RETAINING WALLS</b>	
Are there any Retaining Walls 6' OR higher facing public street/sidewalk?	Inspected No
Condition	4 - Between Fair and Poor
Deficiency	CAST IN PLACE CONCRETE; DETERIORATED CONTROL/EXPANSION JOINT

<b>Question</b>	<b>Response</b>
<b>SITE</b>	
<b>RETAINING WALLS</b>	
Deficiency Location/Instance	Schoolyard
Deficiency Quantity	50
Quantity Uom	L.F.
Potential Action	REPLACE
Urgency of Action	PRIORITY 3
Purpose of Action	LEVEL 2
Deficiency Photo1

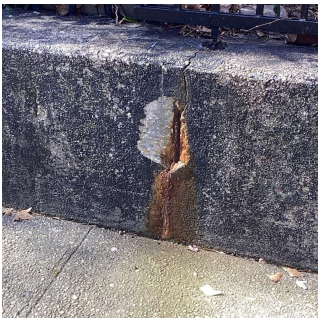
Violations	Schoolyard No violations recorded.
Deficiency	<b>CAST IN PLACE CONCRETE: CRACKS/SPALLING - MAJOR</b>
Deficiency Location/Instance	Near exit 4, Schoolyard, Along Smith Street, 1st Place, Carroll Street
Deficiency Quantity	250
Quantity Uom	S.F.
Potential Action	REPLACE
Urgency of Action	PRIORITY 3
Purpose of Action	LEVEL 2
Deficiency Photo1
