**NYC Department of Education**  
**Building Condition Assessment Survey 2023 - 2024**

Architectural Inspection

**Asset:** P.S. 59 - BROOKLYN, 211 THROOP AVENUE, New York, 11206

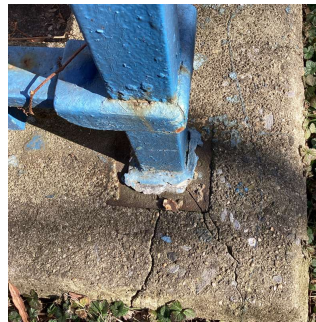
AW2  
 No violations recorded.

AREAWAY WALLS: CRACKS AND SPALLING

20  
 S.F.  
 REPAIR  
 PRIORITY 3  
 LEVEL 2

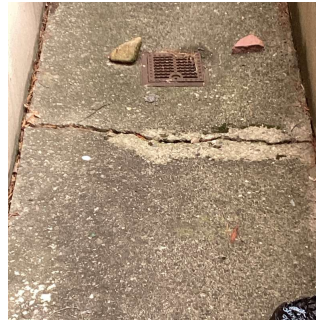
AW7

**AREAWAY SLAB: CRACKS AND SPALLING**

20  
 S.F.  
 REPLACE  
 PRIORITY 4  
 LEVEL 2

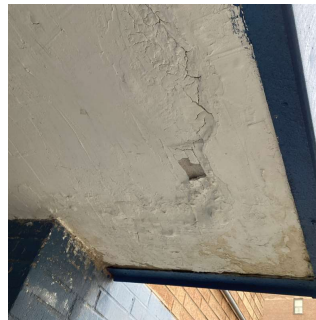
Facade B

CONCRETE: MAJOR CRACKS/SPALLING

REPAIR

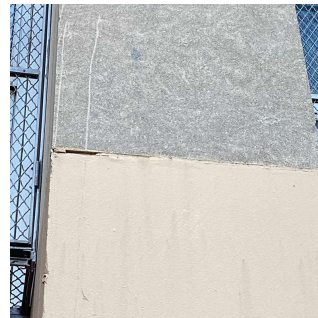
Facade B

CAST IN PLACE / PRE-CAST CONCRETE: DETERIORATED JOINTS

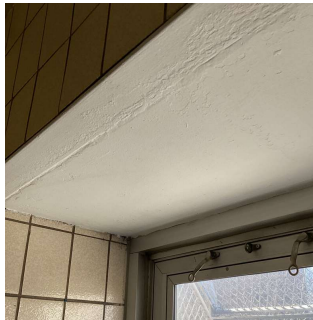
Facade A - Stair C/3

BRICK: WATER INFILTRATION IN INSTRUCTIONAL SPACE

REPAIR

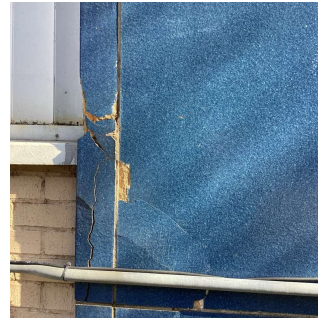
Facade A

CERAMIC TILE: CHIPPED, SPALLED, BROKEN PIECES

REPLACE

PRIORITY 4  
LEVEL 2

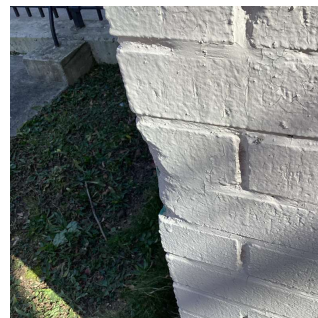
Facade A

**BRICK: CRACKS/DISPLACED/SPALLED BRICK AT BUILDING CORNERS**

20  
S.F.  
**REMOVE AND REBUILD**  
PRIORITY 4  
LEVEL 2

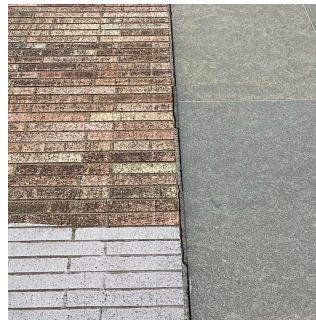
Facade C

**BRICK: DETERIORATED CONTROL/EXPANSION JOINTS**

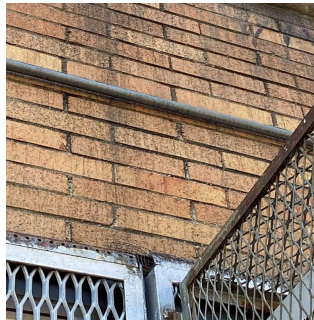
Facade E

**BRICK: DETERIORATED JOINTS**

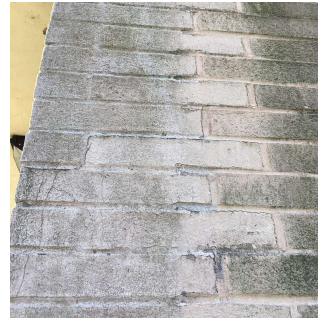
Facade E

**BRICK: MINOR CRACKS AND SPALLING**

PRIORITY 3  
LEVEL 2

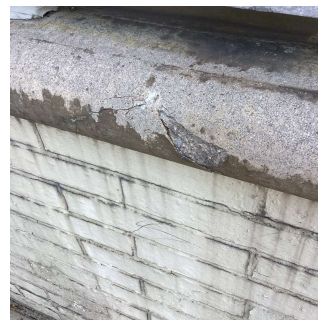
Facade D

**BRICK: DETERIORATED MASONRY SILLS - MINOR**

REPAIR

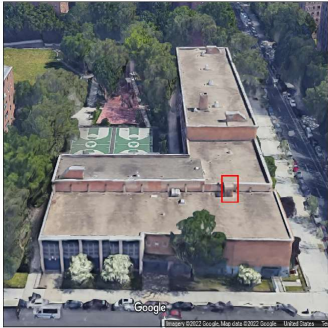
Question	Response
<b>EXTERIOR</b>	
<b>EXTERIOR WALLS</b>	Inspected
Violations	No violations recorded.
<b>EXTERIOR SOFFITS</b>	Does not Exist
<b>LOADING DOCK</b>	Does not Exist
<b>LOUVER</b>	Inspected
Condition	3 - Fair
Deficiency	MISSING/DAMAGED SCREEN
Roof Plan reference	K059
Elevation

Deficiency Quantity	10
Quantity Uom	S.F.
Potential Action	REPLACE
Urgency of Action	PRIORITY 4
Purpose of Action	LEVEL 2
Deficiency Photo1

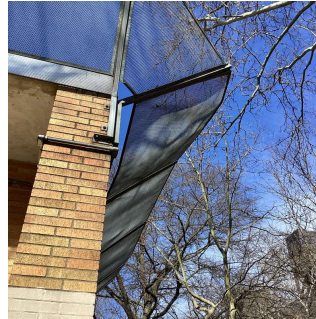
Roof 4

Deficiency	RAILINGS/PANELS: DETERIORATED, MAJOR RUSTING
------------	--

Deficiency Quantity	40
Quantity Uom	S.F.
Potential Action	REPLACE
Urgency of Action	PRIORITY 4
Purpose of Action	LEVEL 2
Deficiency Photo1

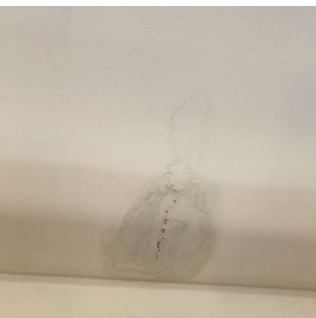
Deficiency	IRMA: ROOFING: MAJOR ACTIVE ROOF LEAKS IN INSTRUCTIONAL SPACE
------------	---

Violations	Roof 7 - Room 237 (shown), Roof 7 - Room 228, Corridor near Room 233 (similar) No violations recorded.
Deficiency	IRMA: FLASHING: BASE FLASHING DETERIORATED
Roof Plan reference	K059
Deficiency Quantity	10
Quantity Uom	S.F.
Potential Action	REPLACE
Urgency of Action	PRIORITY 4
Purpose of Action	LEVEL 2
Deficiency Photo1

Question	Response
<b>EXTERIOR</b>	
<b>ROOF</b>	
<b>Roofing</b>	
<b>ROOFING</b>	
Deficiency Quantity	300
Quantity Uom	S.F.
Potential Action	REPLACE ROOFING WITHOUT MAJOR EQUIPMENT REMOVAL
Urgency of Action	PRIORITY 5
Purpose of Action	LEVEL 2
Deficiency Photo1

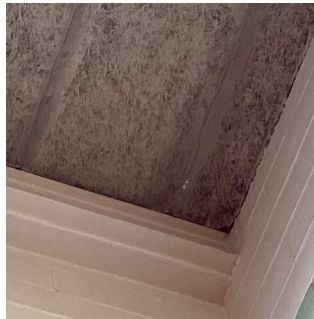
Roof 3 - Gymnasium

Question	Response
<b>EXTERIOR</b>	
<b>ROOF</b>	
<b>Roofing</b>	
<b>ROOFING</b>	
Roof Plan reference	
Deficiency Quantity	50
Quantity Uom	L.F.
Potential Action	REPLACE
Urgency of Action	PRIORITY 4
Purpose of Action	LEVEL 2
Deficiency Photo1	
Violations	No violations recorded.
Instance on Built-Up: Roofs 1 - 6	Inspected
Instance Condition	3 - Fair
Instance Photo	
	Roof 1
Instance Quantity	37,000
Instance Quantity Uom	S.F.
Does the roof have major mechanical equipment sitting on Dunnage Steel less than 18" above the Roofing?	No
Does this roof instance have a Sustainable Roof System?	No
Do solar panels exist on these roofs?	No
Is/Are the roof(s) suitable for Solar Panel installation?	Yes
Installation Year	1998
Source of Installation	Custodial Staff
Deficiency	<b>BUILT-UP: ROOFING: MAJOR ACTIVE ROOF LEAKS IN INSTRUCTIONAL SPACE</b>

REPLACE ROOFING WITHOUT MAJOR EQUIPMENT REMOVAL

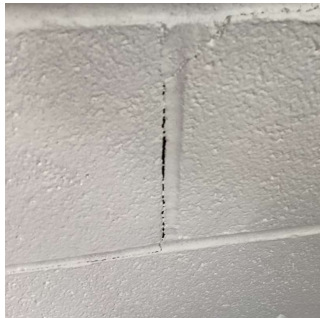
Roof 1	Roof 1
Violations	No violations recorded.
<b>ROOFING DRAINS</b>	Inspected
Condition	2 - Between Good and Fair
Deficiency	No deficiencies recorded
<b>Specialties</b>	Inspected
<b>BULKHEAD/PENTHOUSE</b>	Inspected
Condition	4 - Between Fair and Poor
Deficiency	BULKHEAD/PENTHOUSE WALLS/INTERIOR: CMU DETERIORATED JOINTS
Roof Plan reference	K059

Deficiency Quantity	10
Quantity Uom	S.F.
Potential Action	REPOINT
Urgency of Action	PRIORITY 3
Purpose of Action	LEVEL 2
Deficiency Photo1

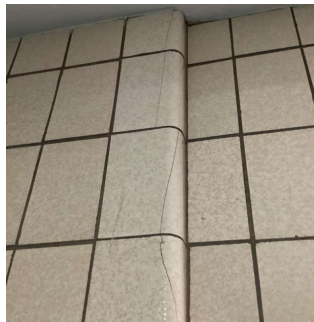
BH2  
No violations recorded.

BH3	BH3
Violations	No violations recorded.
Deficiency	BULKHEAD/PENTHOUSE WALLS/INTERIOR: GLAZED BLOCK CRACKS/SPALLING

10  
S.F.  
REPLACE  
PRIORITY 3  
LEVEL 2

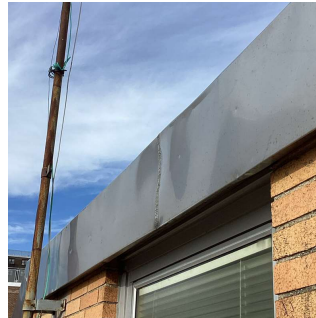
BH2

**BULKHEAD/PENTHOUSE ROOF: DETERIORATED**

10  
S.F.  
REPLACE  
PRIORITY 4  
LEVEL 2

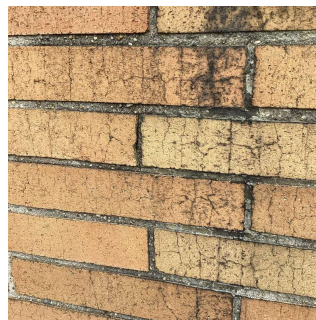
BH2

**BULKHEAD/PENTHOUSE WALLS/EXTERIOR:  
CRACKS/SPALLING - MINOR**

REPAIR

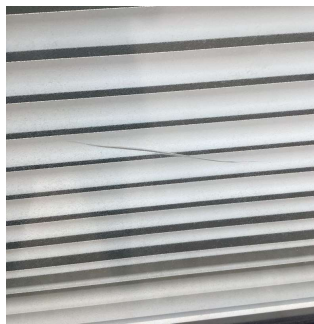
BH2  
No violations recorded.

**BULKHEAD/PENTHOUSE WINDOWS: DAMAGED,  
DETERIORATED WINDOWS**

10  
S.F.  
REPLACE  
PRIORITY 4  
LEVEL 2

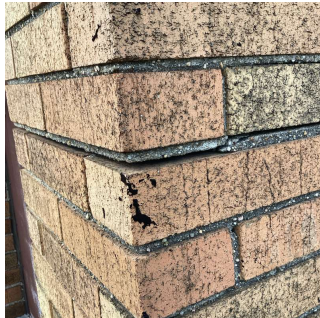
**BULKHEAD/PENTHOUSE WALLS/EXTERIOR: DETERIORATED JOINTS**

Violations	BH2 No violations recorded.
Deficiency	BULKHEAD/PENTHOUSE WALLS/EXTERIOR: DETERIORATED JOINTS
Roof Plan reference	K059

190  
S.F.  
REPOINT  
PRIORITY 4  
LEVEL 2

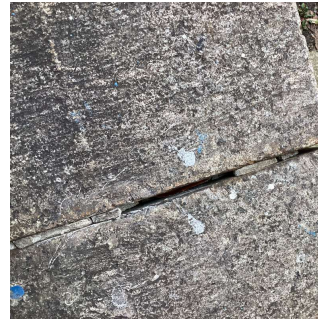
Facade A

STONE: DETERIORATED JOINTS

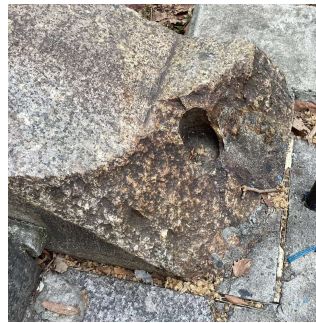
Facade A

STONE: CRACKS/SPALLING - MAJOR

REPLACE

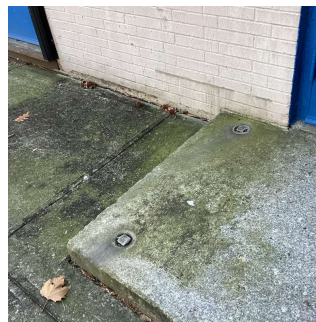
Facade E

MISSING RAILING

REPLACE

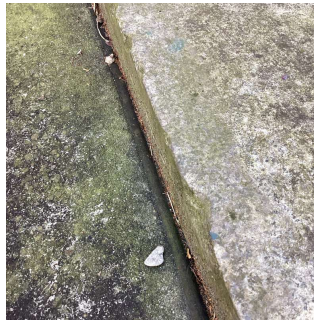
Facade E  
 No violations recorded.

STONE: CRACKS/SPALLING - MINOR

10  
 S.F.  
 REPAIR  
 PRIORITY 3  
 LEVEL 2

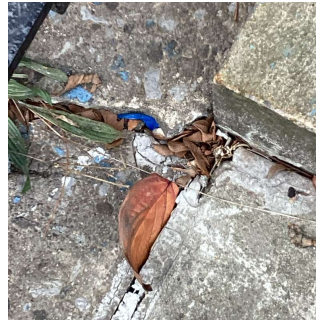
Facade B

**STONE: CRACKS/SPALLING - MAJOR**

25  
 S.F.  
 REPLACE  
 PRIORITY 4  
 LEVEL 2

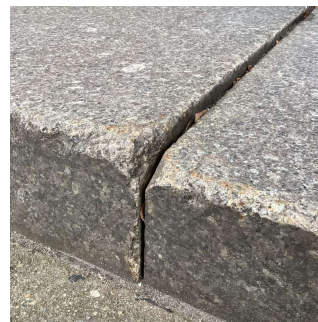
Facade A

**STONE: DETERIORATED JOINTS**

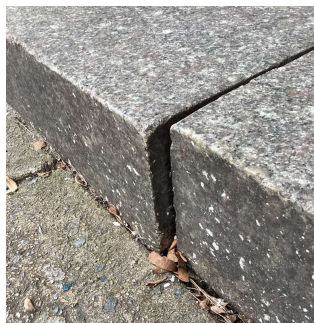
Facade A  
 No violations recorded.

**STONE: DETERIORATED SUBSTRATE**

20  
 S.F.  
 REPLACE SUBSTRATE AND RESET  
 PRIORITY 4  
 LEVEL 2

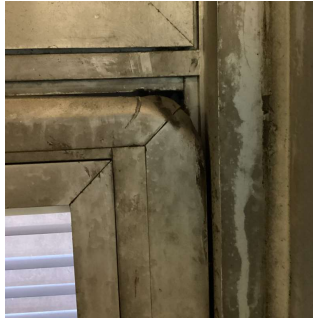
Facade E - AW5  
No violations recorded.

ALUMINUM - OTHER: DETERIORATED

30  
S.F.  
REPLACE WINDOW  
PRIORITY 4  
LEVEL 2

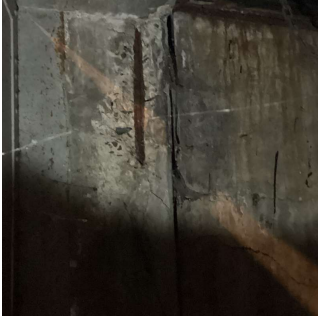
Question	Response
<b>INTERIOR</b>	
<b>STRUCTURAL</b>	
<b>COLUMNS/BEAMS/BEARING WALLS</b>	
Violations	Basement - Boiler Room No violations recorded.
Deficiency	CONCRETE COLUMNS/BEAMS: CRACKED/SPALLED/REINFORCEMENT EXPOSED
Deficiency Location/Instance	Basement - Vault
Deficiency Quantity	10
Quantity Uom	S.F.
Potential Action	REPLACE
Urgency of Action	PRIORITY 4
Purpose of Action	LEVEL 5
Deficiency Photo1

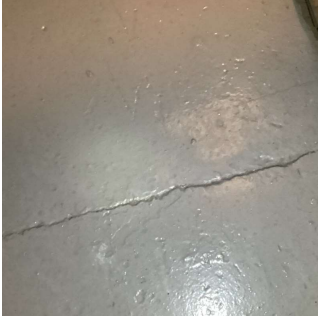
Violations	Basement - Vault No violations recorded.
<b>FLOOR STRUCTURE</b>	
Condition	Inspected 3 - Fair
Deficiency	CONCRETE SLAB ON GRADE: THRU CRACKS
Deficiency Location/Instance	Basement - Waste Room, Boiler Room
Deficiency Quantity	20
Quantity Uom	S.F.
Potential Action	REPLACE
Urgency of Action	PRIORITY 4
Purpose of Action	LEVEL 5
Deficiency Photo1

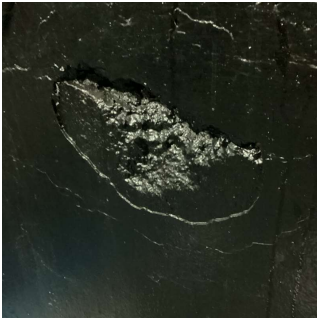
Violations	Basement - Waste Room No violations recorded.
<b>FOUNDATION WALLS</b>	
Material Type(s)	Inspected Concrete
Condition	3 - Fair
Deficiency	CONCRETE: CRACKED/SPALLED/REINFORCEMENT EXPOSED

Deficiency Location/Instance	Basement - Boiler Room

Question	Response
<b>INTERIOR</b>	
<b>STRUCTURAL</b>	
<b>FOUNDATION WALLS</b>	
Deficiency Quantity	20
Quantity Uom	S.F.
Potential Action	REPAIR
Urgency of Action	PRIORITY 4
Purpose of Action	LEVEL 5
Deficiency Photo1

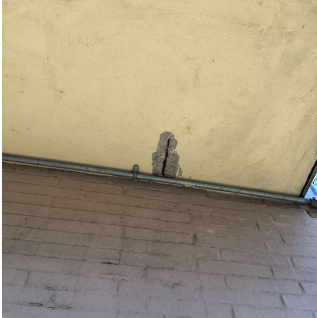
Basement - Boiler Room
Violations	No violations recorded.
<b>ROOF STRUCTURE</b>	
	Inspected
Condition	3 - Fair
Deficiency	CONCRETE: CRACKED/SPALLED/REINFORCEMENT EXPOSED
Deficiency Location/Instance	BH2, Roof 3 - Facades B and D, Roof 5 - Facade F
Deficiency Quantity	40
Quantity Uom	S.F.
Potential Action	REPAIR
Urgency of Action	PRIORITY 4
Purpose of Action	LEVEL 5
Deficiency Photo1

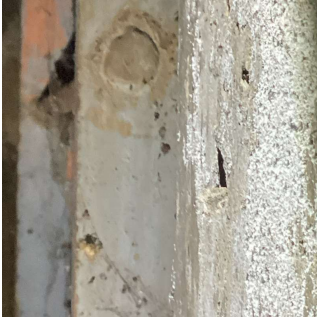
Roof 5 - Facade F
Violations	No violations recorded.
<b>VAULTS-BUNKERS</b>	
	Inspected
<b>Foundation Walls</b>	
	Inspected
Condition	3 - Fair
Deficiency	CRACKS, SPALLING
Deficiency Location/Instance	Basement - Vault
Deficiency Quantity	10
Quantity Uom	S.F.
Potential Action	REPAIR
Urgency of Action	PRIORITY 4
Purpose of Action	LEVEL 5

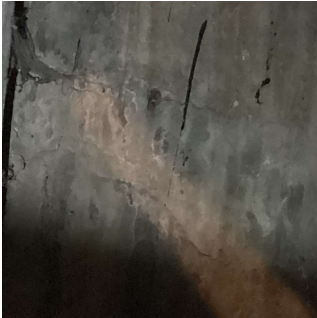
Violations	Basement - Vault No violations recorded.
Deficiency	CRACKS, SPALLING
Deficiency Location/Instance	Basement - Vault
Deficiency Quantity	10
Quantity Uom	S.F.
Potential Action	REPAIR
Urgency of Action	PRIORITY 3
Purpose of Action	LEVEL 5
Deficiency Photo1

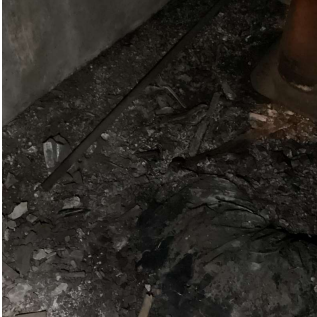
Violations	Basement - Vault No violations recorded.
<b>Slab Structure</b>	Inspected
Condition	3 - Fair
Deficiency	CONCRETE SLAB ON GRADE: THRU CRACKS
Deficiency Location/Instance	Basement - Ash Hoist Vault
Deficiency Quantity	15
Quantity Uom	S.F.
Potential Action	REPLACE
Urgency of Action	PRIORITY 4
Purpose of Action	LEVEL 5

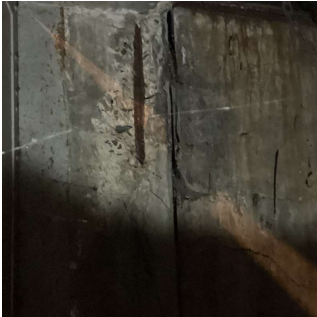
Violations	Basement - Ash Hoist Vault No violations recorded.
<b>Vault/Ash Hoist Doors and Framing</b>	Inspected
Condition	5 - Poor
Deficiency	WATER INFILTRATION
Deficiency Location/Instance	Basement - Ash Hoist Vault
Deficiency Quantity	10
Quantity Uom	S.F.
Potential Action	REPAIR
Urgency of Action	PRIORITY 5
Purpose of Action	LEVEL 2
Deficiency Photo1

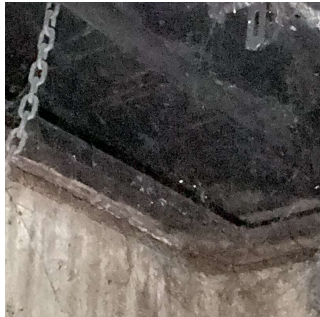
Violations	Basement - Ash Hoist Vault No violations recorded.
Deficiency	DETERIORATED/DAMAGED VAULT/ASH HOIST DOORS AND FRAMING
Deficiency Location/Instance	Basement - Ash Hoist Vault
Deficiency Quantity	2
Quantity Uom	EACH
Potential Action	REPLACE
Urgency of Action	PRIORITY 4
Purpose of Action	LEVEL 2

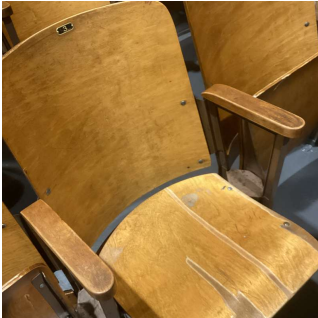
Question	Response
<b>INTERIOR</b>	
<b>AUDITORIUM</b>	
<b>Fixed Seating</b>	
Quantity Uom	EACH
Potential Action	MAINTENANCE
Urgency of Action	PRIORITY 3
Purpose of Action	LEVEL 2
Deficiency Photo1	No photo recorded
Violations	No violations recorded.
Deficiency	DAMAGED/BROKEN/INOPERABLE
Deficiency Location/Instance	Seats O/1, 3, 5, 7, P/1 and others
Deficiency Quantity	83
Quantity Uom	EACH
Potential Action	REPLACE
Urgency of Action	PRIORITY 3
Purpose of Action	LEVEL 2
Deficiency Photo1

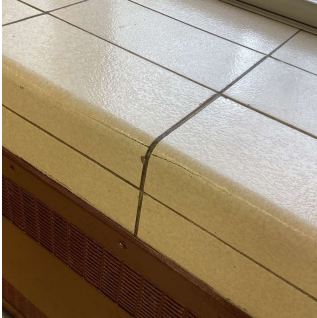
Question	Response
<b>INTERIOR</b>	
<b>CAFETERIA</b>	
<b>Walls</b>	
Condition	2 - Between Good and Fair
Deficiency	GLAZED BLOCK: CRACKS/SPALLING
Deficiency Location/Instance	Near Windows
Deficiency Quantity	20
Quantity Uom	S.F.
Potential Action	REPLACE
Urgency of Action	PRIORITY 3
Purpose of Action	LEVEL 2
Deficiency Photo1

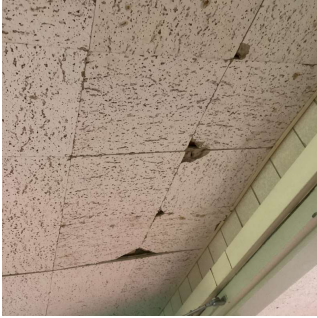
Near Windows
Violations	No violations recorded.
<b>Window Curtains/Shades/Blinds</b>	
Instance on 1st Floor	Does not Exist
<b>CLASSROOMS/CORRIDORS/ADMIN SPACES</b>	
<b>Ceiling</b>	Inspected
Condition	2 - Between Good and Fair
Deficiency	ACOUSTIC TILES ON PLASTER: DAMAGED/MISSING
Deficiency Location/Instance	Corridor near Rooms B9, B7C
Deficiency Quantity	80
Quantity Uom	S.F.
Potential Action	REPLACE
Urgency of Action	PRIORITY 3
Purpose of Action	LEVEL 2
Deficiency Photo1

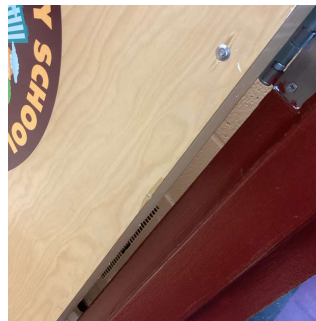
Room 226

WOOD: DETERIORATED DOOR

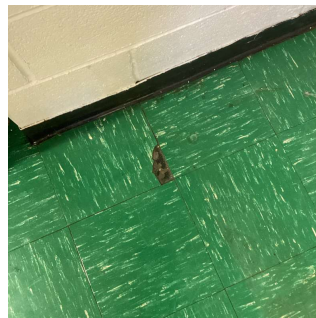
VINYL TILES: BROKEN/DETERIORATED/MISSING TILES

REPLACE

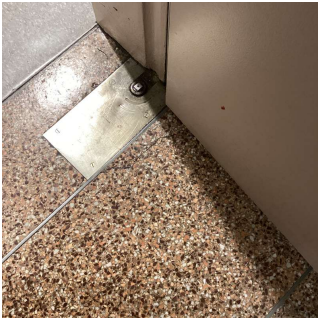
Question	Response
<b>INTERIOR</b>	
<b>CLASSROOMS/CORRIDORS/ADMIN SPACES</b>	
<b>Floor Finish</b>	
Violations	Teachers Lounge No violations recorded.
Deficiency	TERRAZZO: CRACKS
Deficiency Location/Instance	Corridor near Auditorium, Exits 8, 6- Vestibules
Deficiency Quantity	30
Quantity Uom	S.F.
Potential Action	REPLACE
Urgency of Action	PRIORITY 3
Purpose of Action	LEVEL 2
Deficiency Photo1

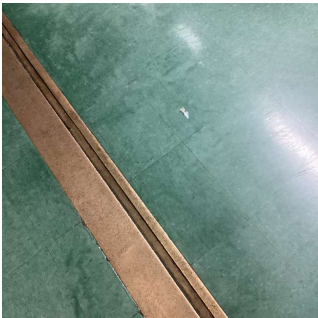
Violations	Corridor near Auditorium No violations recorded.
Deficiency	VINYL TILES: DETERIORATED SUBSTRATE
Deficiency Location/Instance	Corridor near Room 124
Deficiency Quantity	10
Quantity Uom	S.F.
Potential Action	REPLACE
Urgency of Action	PRIORITY 3
Purpose of Action	LEVEL 2
Deficiency Photo1

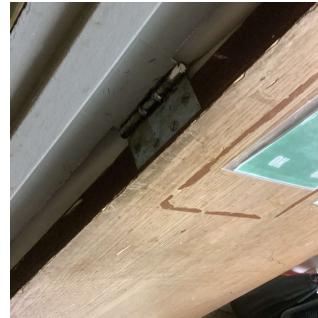
Office Room

WOOD: DETERIORATED DOOR

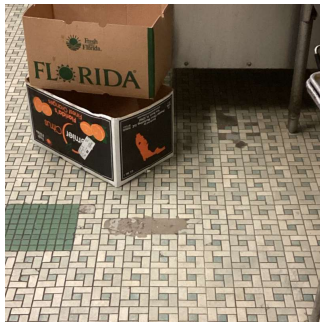
CERAMIC TILE: BROKEN/MISSING TILES

REPLACE

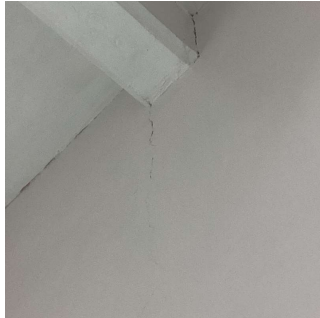
Violations	Near Sink No violations recorded.
<b>Walls</b>	
Instance on 1st Floor	Inspected
Condition	2 - Between Good and Fair
Deficiency	PLASTER: CRACKS/SPALLING
Deficiency Location/Instance	Office Room
Deficiency Quantity	10
Quantity Uom	S.F.
Potential Action	REPLACE
Urgency of Action	PRIORITY 3
Purpose of Action	LEVEL 2
Deficiency Photo1

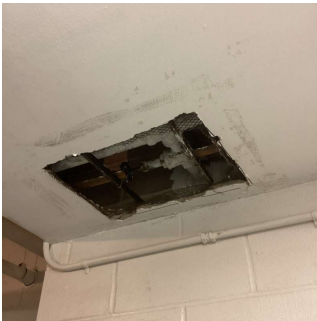
Alternative use	No
<b>Ceiling</b>	
Instance on Basement - Girls (242 Lockers)	Inspected
Condition	2 - Between Good and Fair
Deficiency	PLASTER: CRACKS/SPALLING
Deficiency Location/Instance	Near Toilet Room
Deficiency Quantity	20
Quantity Uom	S.F.
Potential Action	REPLACE
Urgency of Action	PRIORITY 3
Purpose of Action	LEVEL 2

Violations	Near Toilet Room No violations recorded.
<b>Door(s)</b>	
Instance on Basement - Girls (242 Lockers)	Inspected
Condition	3 - Fair
Deficiency	WOOD: DETERIORATED DOOR
Deficiency Location/Instance	Main Entrance
Deficiency Quantity	1
Quantity Uom	EACH
Potential Action	MAINTENANCE
Urgency of Action	PRIORITY 3
Purpose of Action	LEVEL 2
Deficiency Photo1

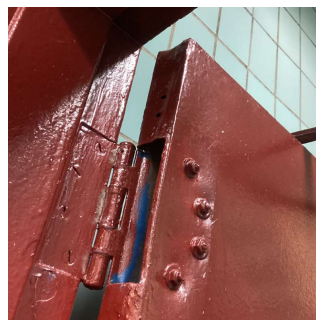
Stair A/2

METAL: DETERIORATED DOOR

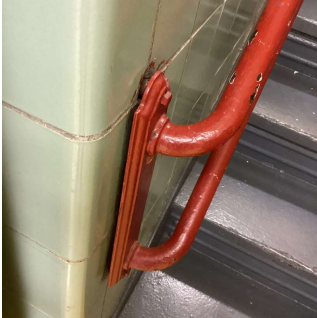
Question	Response
<b>INTERIOR</b>	
<b>STAIRS/RAMPS: INTERIOR</b>	
<b>Door(s)</b>	Inspected
Violations	No violations recorded.
<b>Partition</b>	Does not Exist
<b>Railings</b>	Inspected
Condition	3 - Fair
Deficiency	METAL: BROKEN BRACKET
Deficiency Location/Instance	Cafeteria near Exit 1, Auditorium Right and Left side near Stage
Deficiency Quantity	3
Quantity Uom	EACH
Potential Action	REPLACE
Urgency of Action	PRIORITY 3
Purpose of Action	LEVEL 2
Deficiency Photo1

Violations	Cafeteria near Exit 1 No violations recorded.
<b>Stairs and Landings</b>	Inspected
Condition	3 - Fair
Deficiency	TERRAZZO: CRACKS
Deficiency Location/Instance	Corridor near Auditorium
Deficiency Quantity	10
Quantity Uom	S.F.
Potential Action	REPLACE
Urgency of Action	PRIORITY 5
Purpose of Action	LEVEL 6
Deficiency Photo1

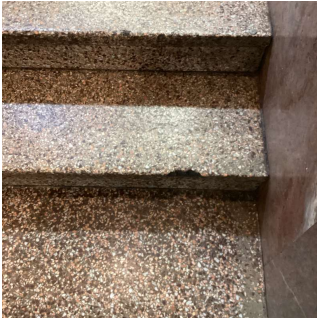
Violations	Corridor near Auditorium No violations recorded.
Deficiency	STONE: BROKEN/MISSING
Deficiency Location/Instance	Stairs A/1, 2, C/1, Cafeteria near Main Entrance, by Exit 1 and others

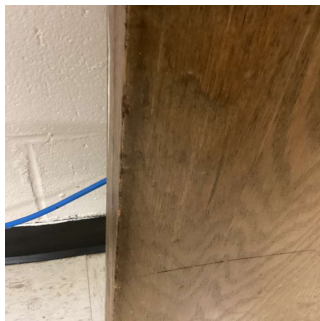
Stair C/3
Violations	No violations recorded.
<b>TOILET ROOMS - STAFF</b>	Inspected
<b>Ceiling</b>	Inspected
Condition	2 - Between Good and Fair
Deficiency	No deficiencies recorded
<b>Door(s)</b>	Inspected
Condition	5 - Poor
Deficiency	WOOD: DETERIORATED DOOR
Deficiency Location/Instance	In Room B9
Deficiency Quantity	1
Quantity Uom	EACH
Potential Action	MAINTENANCE
Urgency of Action	PRIORITY 3
Purpose of Action	LEVEL 2
Deficiency Photo1

In Room B9
Violations	No violations recorded.
<b>Floor Finish</b>	Inspected
Condition	2 - Between Good and Fair
Deficiency	No deficiencies recorded
<b>Stalls</b>	Inspected
Condition	5 - Poor
Deficiency	RUST - MAJOR
Deficiency Location/Instance	In Room 203, In Girls Locker Room
Deficiency Quantity	2
Quantity Uom	EACH
Potential Action	REPLACE
Urgency of Action	PRIORITY 3
Purpose of Action	LEVEL 2

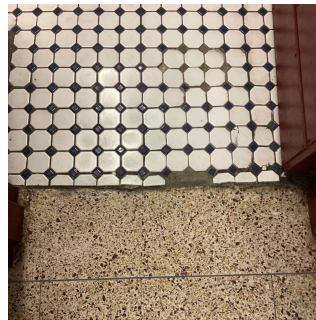
Boys Toilet Room - 1st Floor

CERAMIC TILE: BROKEN/MISSING TILES

REPLACE

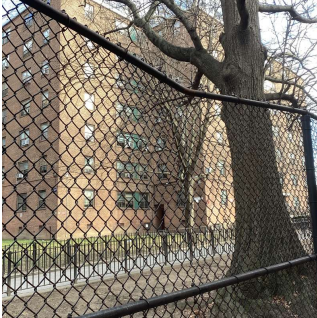
Violations	Near Exit 1 No violations recorded.
Deficiency	CHAIN LINK: DAMAGED POST/RAIL
Deficiency Location/Instance	Near Exit 1

Question	Response
<b>SITE</b>	
<b>FENCES</b>	
Deficiency Quantity	10
Quantity Uom	L.F.
Potential Action	REPLACE
Urgency of Action	PRIORITY 3
Purpose of Action	LEVEL 2
Deficiency Photo1

Near Exit 1
Violations	No violations recorded.
Deficiency	WROUGHT IRON: DAMAGED/DETERIORATED
Deficiency Location/Instance	Park Avenue
Deficiency Quantity	160
Quantity Uom	S.F.
Potential Action	MAINTENANCE
Urgency of Action	PRIORITY 3
Purpose of Action	LEVEL 2
Deficiency Photo1

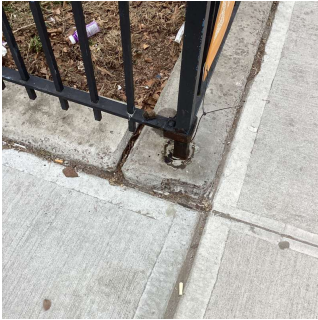
Park Avenue
Violations	No violations recorded.
Deficiency	CONCRETE CURB: DAMAGED/DETERIORATED
Deficiency Location/Instance	Park Avenue
Deficiency Quantity	80
Quantity Uom	S.F.
Potential Action	REPLACE
Urgency of Action	PRIORITY 3
Purpose of Action	LEVEL 2

Violations	Park Avenue No violations recorded.
<b>IRRIGATION SYSTEM</b>	Does not Exist
<b>PAVING</b>	Inspected
<b>Student Non-Use</b>	Inspected
Gravel Exists?	Yes
<b>Asphalt</b>	Does not Exist
<b>Concrete</b>	Inspected
Condition	3 - Fair
Deficiency	DAMAGED/DETERIORATED/MISSING SECTIONS
Deficiency Location/Instance	Park Avenue
Deficiency Quantity	50
Quantity Uom	S.F.
Potential Action	REPLACE
Urgency of Action	PRIORITY 3
Purpose of Action	LEVEL 2
Deficiency Photo1	 
Violations	Park Avenue No violations recorded.
<b>Pavers</b>	Does not Exist
<b>Student Use</b>	Does not Exist
<b>Site Sidewalks &amp; Walkways</b>	Inspected
<b>Asphalt</b>	Does not Exist
<b>Concrete</b>	Inspected
Condition	3 - Fair
Deficiency	DAMAGED/DETERIORATED/MISSING SECTIONS
Deficiency Location/Instance	Near NYC Park, by Exits 8, 6, 5, Throop Avenue
Deficiency Quantity	300
Quantity Uom	S.F.

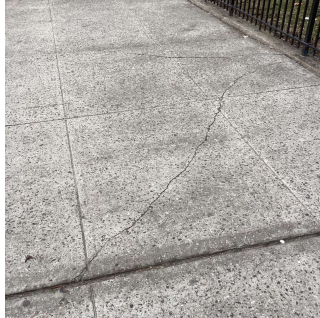
Question	Response
<b>SITE</b>	
<b>PAVING</b>	
<b>DOT Sidewalk</b>	
<b>Concrete</b>	
Deficiency Photo1

Violations	Park Avenue No violations recorded.
<b>Pavers</b>	Does not Exist
<b>PLAYGROUNDS</b>	Does not Exist
<b>PLAYING SURFACE</b>	Does not Exist
<b>RETAINING WALLS</b>	Does not Exist
<b>SEATING</b>	Does not Exist
<b>SITE WALLS (NOT RETAINING WALLS)</b>	Does not Exist
<b>STAIRS/RAMPS: EXTERIOR</b>	Does not Exist
<b>ARTWORK</b>	Inspected
Instance	Exterior - Building Facade near the corner on Throop Avenue and Park Avenue - 11568
Instance Photo
