NYC Department of Education
Building Condition Assessment Survey 2023 - 2024

Architectural Inspection

**Asset: PRE-K CENTER @ 1340 EAST 29TH STREET - BROOKLYN, 1340 EAST 29TH STREET,
 New York, 11210**

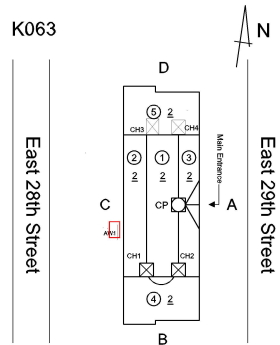
AREAWAY SLAB: CRACKS AND SPALLING

REPLACE

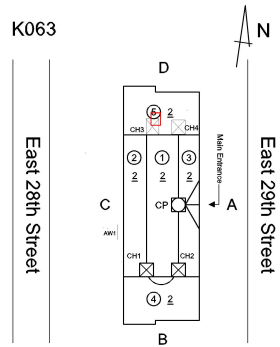
BRICK: MINOR CRACKS AND SPALLING

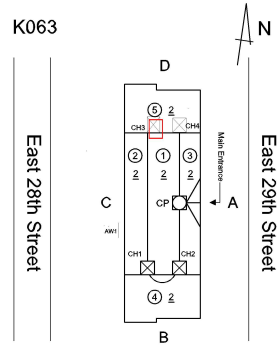
BRICK: MAJOR / THRU CRACKS

K063
25
S.F.
REMOVE AND REBUILD
PRIORITY 4
LEVEL 2

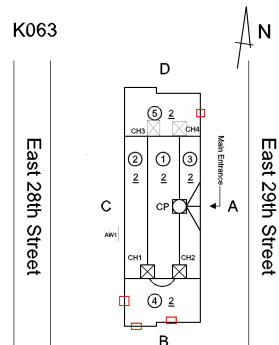
CAST STONE: CRACKED/BROKEN PIECES

K063
30
L.F.
REPLACE-IN-KIND
PRIORITY 4
LEVEL 2

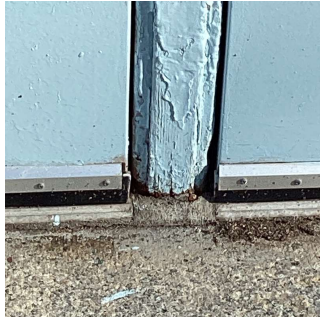
Violations	Roof 5 No violations recorded.
CORNICE	
Condition	Inspected
Deficiency	2 - Between Good and Fair No deficiencies recorded
DOORS	
DOORS AND FRAMES	
Condition	Inspected
Deficiency	4 - Between Fair and Poor METAL: DETERIORATED DOOR AND FRAME - MAJOR DETERIORATION
Roof Plan reference	K063

Deficiency Quantity	2
Quantity Uom	EACH
Potential Action	REPLACE
Urgency of Action	PRIORITY 4
Purpose of Action	LEVEL 2
Deficiency Photo1

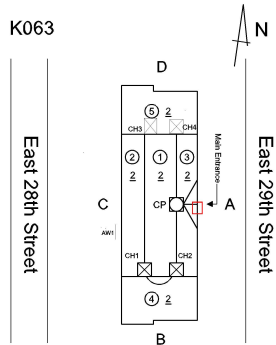
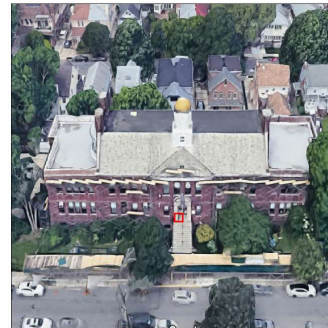
STONE: CHIPPED/SPALLED/BROKEN PIECES - MINOR

REPAIR

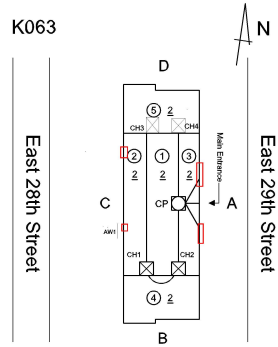
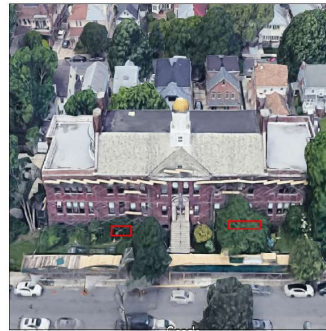
BRICK: DETERIORATED JOINTS

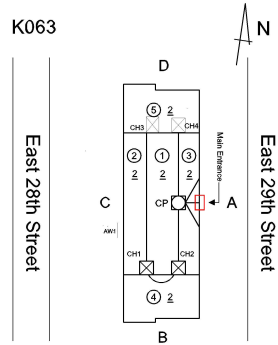
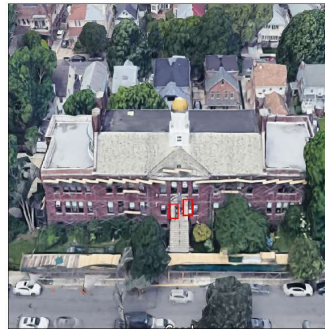
STONE: DETERIORATED JOINTS

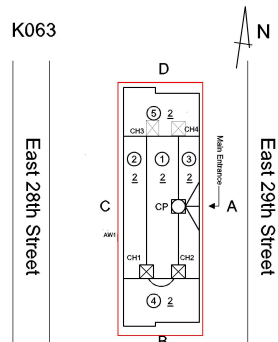
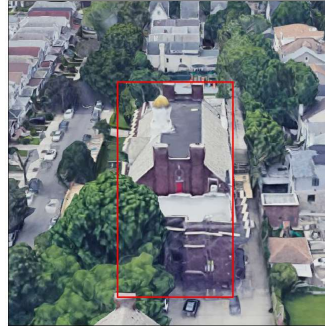
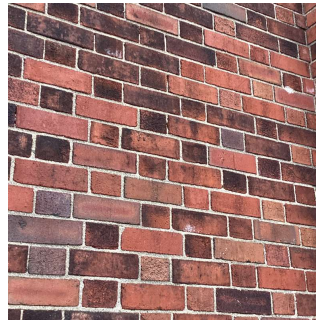
Roof 5

BRICK: DETERIORATED JOINTS

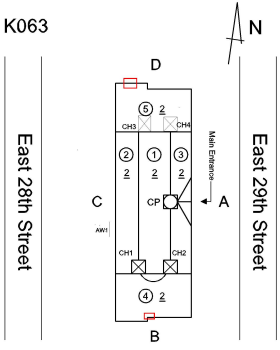
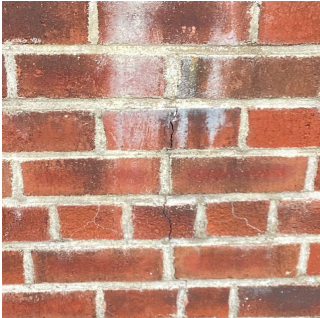
Attic
Violations	No violations recorded.
EXTERIOR SOFFITS	
Condition	Inspected
	2 - Between Good and Fair
Deficiency	No deficiencies recorded
LOADING DOCK	
	Does not Exist
LOUVER	
Condition	Inspected
	2 - Between Good and Fair
Deficiency	No deficiencies recorded
PARAPETS	
Material Type(s)	Inspected
	Masonry
Replacement Quantity	800
Replacement Uom	C.F.
Instance on All Roofs	Inspected
Instance Condition	3 - Fair
Instance Quantity	800
Instance Quantity Uom	C.F.
Deficiency	BRICK: MINOR CRACKS, SPALLING
Roof Plan reference	K063

Deficiency Quantity	30
Quantity Uom	S.F.
Potential Action	REPAIR
Urgency of Action	PRIORITY 3
Purpose of Action	LEVEL 2

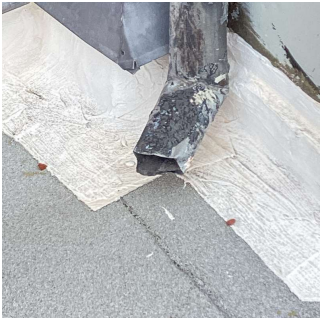
Violations	Roof 5 No violations recorded.
PLAZA DECK	Does not Exist
ROOF	Inspected
Roofing	Inspected
Replacement Quantity	6,700
Replacement Uom	S.F.
ROOF HATCH/SMOKE HATCH	Does not Exist
LEADERS, GUTTERS, DOWNSPOUTS, SCUPPERS	Inspected
Condition	3 - Fair
Deficiency	DAMAGED/MISSING
Roof Plan reference	K063
Deficiency Quantity	15
Quantity Uom	L.F.
Potential Action	REPLACE
Urgency of Action	PRIORITY 4
Purpose of Action	LEVEL 2
Deficiency Photo1

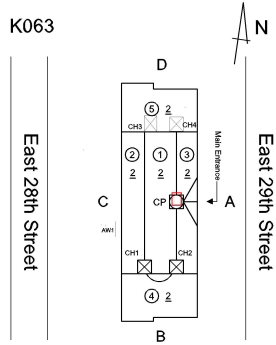
WATER INFILTRATION

REPAIR

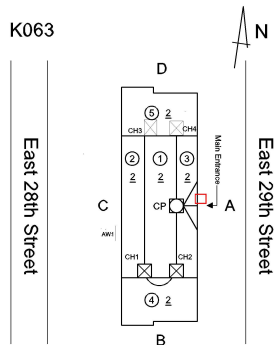
STONE: DETERIORATED JOINTS

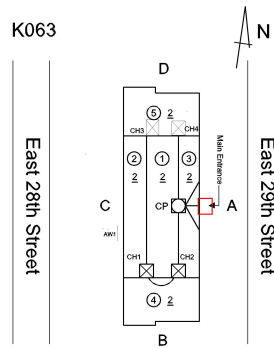
MASONRY UNIT: BULGING/DISPLACED

25
 S.F.
 REPLACE
 PRIORITY 4
 LEVEL 2

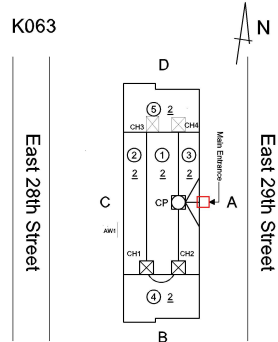
STONE: DETERIORATED JOINTS

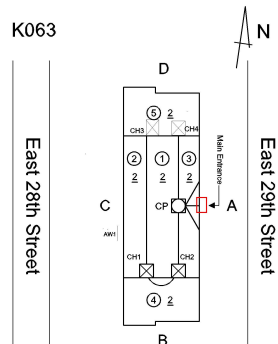
CONCRETE: WATER INFILTRATION IN NON-INSTRUCTIONAL SPACE BELOW

REPLACE

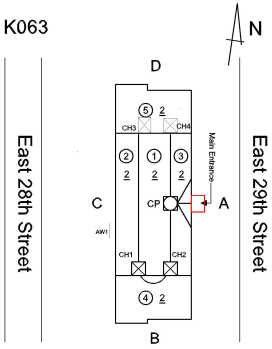
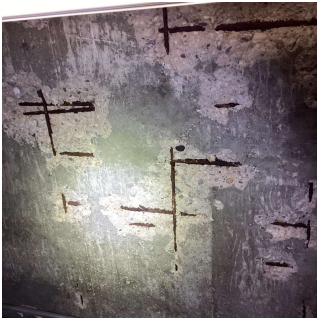
Violations	Main Entrance Stair - Room B02 No violations recorded.
Deficiency	CONCRETE: CRACKS/SPALLING - MAJOR
Roof Plan reference	K063

Deficiency Quantity	30
Quantity Uom	S.F.
Potential Action	REPLACE
Urgency of Action	PRIORITY 4
Purpose of Action	LEVEL 2
Deficiency Photo1

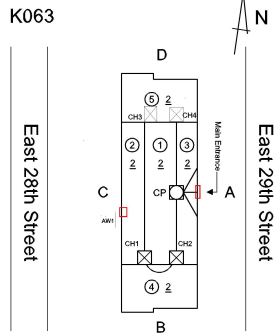
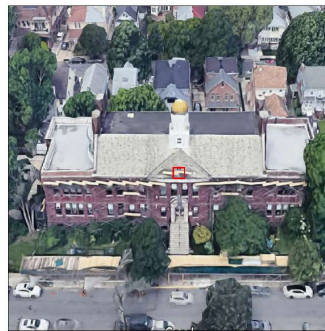
Material Type(s)	Inspected Aluminum, Solid Wood
Instance on Aluminum - Double Hung: All Facades	Inspected
Instance Condition	2 - Between Good and Fair
Instance Quantity	3,800
Instance Quantity Uom	S.F.
Are these windows insulated	Yes
Installation Year	2008
Source of Installation	Custodial Staff
Deficiency	No deficiencies recorded
Instance on Wood: Attic	Inspected
Instance Condition	3 - Fair
Instance Quantity	100
Instance Quantity Uom	S.F.
Are these windows insulated	No
Installation Year	1937
Source of Installation	Inspector Estimate
Deficiency	WOOD: BROKEN PANE
Roof Plan reference

Deficiency Quantity	60
Quantity Uom	S.F.
Potential Action	MAINTENANCE
Urgency of Action	PRIORITY 3
Purpose of Action	LEVEL 2

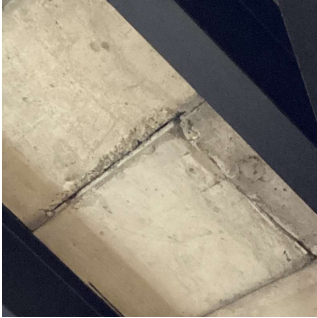
Question	Response
INTERIOR	
STRUCTURAL	
FOUNDATION WALLS	Inspected
Violations	Room B20 (Room B07 similar) No violations recorded.
ROOF STRUCTURE	Inspected
Condition	4 - Between Fair and Poor
Deficiency	STEEL COLUMNS/BEAMS: DETERIORATED CONCRETE FIREPROOFING
Deficiency Location/Instance	Northeast side of the Attic
Deficiency Quantity	90
Quantity Uom	S.F.
Potential Action	REPLACE
Urgency of Action	PRIORITY 3
Purpose of Action	LEVEL 5
Deficiency Photo1	No photo recorded
Violations	No violations recorded.
Deficiency	CONCRETE: CRACKED/SPALLED/REINFORCEMENT EXPOSED
Deficiency Location/Instance	Attic
Deficiency Quantity	100
Quantity Uom	S.F.
Potential Action	REPAIR
Urgency of Action	PRIORITY 4
Purpose of Action	LEVEL 5
Deficiency Photo1

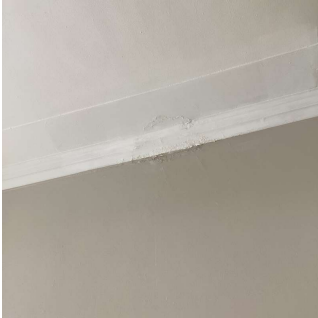
Condition	2 - Between Good and Fair
Deficiency	No deficiencies recorded
Vault/Ash Hoist Doors and Framing	Does not Exist
AUDITORIUM	Does not Exist
CAFETERIA	Does not Exist
CLASSROOMS/CORRIDORS/ADMIN SPACES	Inspected
Ceiling	Inspected
Condition	2 - Between Good and Fair
Deficiency	PLASTER: CRACKS/SPALLING

Question	Response
INTERIOR	
CLASSROOMS/CORRIDORS/ADMIN SPACES	
Ceiling	
Deficiency Location/Instance	Room 301
Deficiency Quantity	10
Quantity Uom	S.F.
Potential Action	REPLACE
Urgency of Action	PRIORITY 3
Purpose of Action	LEVEL 2
Deficiency Photo1

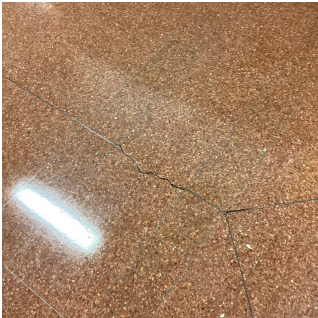
Violations	Room 301 No violations recorded.
Door(s)	Inspected
Condition	2 - Between Good and Fair
Deficiency	No deficiencies recorded
Floor Finish	Inspected
Condition	2 - Between Good and Fair
Deficiency	TERRAZZO: CRACKS
Deficiency Location/Instance	Corridor near 108, 203, 208 near Stair B/2
Deficiency Quantity	40
Quantity Uom	S.F.
Potential Action	REPLACE
Urgency of Action	PRIORITY 3
Purpose of Action	LEVEL 2
Deficiency Photo1

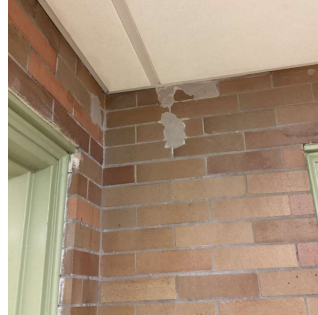
Corridor near room B12
No violations recorded.

Violations	Corridor near 108 No violations recorded.
Walls	Inspected
Condition	2 - Between Good and Fair
Deficiency	BRICK: CRACKS/SPALLING
Deficiency Location/Instance	Corridor near room B12
Deficiency Quantity	10
Quantity Uom	S.F.
Potential Action	REPLACE

Urgency of Action
Purpose of Action
Deficiency Photo1

PRIORITY 3
LEVEL 2

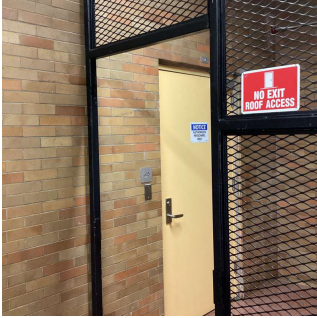
Question	Response
INTERIOR	
CLASSROOMS/CORRIDORS/ADMIN SPACES	Inspected
Walls	Inspected
Violations	Main Entrance Vestibule No violations recorded.
Specialties	Does not Exist
GYMNASIUM	Does not Exist
INTERIOR DOOR HARDWARE	Inspected
Condition	2 - Between Good and Fair
Deficiency	No deficiencies recorded
INTERIOR GUARDS	Inspected
Condition	2 - Between Good and Fair
Deficiency	DETERIORATED/TORN-OUT/MISSING
Deficiency Location/Instance	Near room 305
Deficiency Quantity	40
Quantity Uom	S.F.
Potential Action	REPLACE
Urgency of Action	PRIORITY 3
Purpose of Action	LEVEL 2
Deficiency Photo1

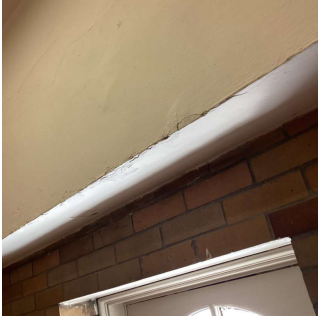
Question	Response
INTERIOR	
MULTI-PURPOSE ROOM	Inspected
Window Curtains/Shades/Blinds	
Instance on Basement	Does not Exist
SCIENCE DEMO ROOM	Does not Exist
SCIENCE LAB	Does not Exist
SCIENCE PREP ROOM	Does not Exist
SHOWER ROOM	Does not Exist
STAIRS/RAMPS: INTERIOR	Inspected
Do Letter Stair Signs Exist?	Yes
Ceiling	Inspected
Condition	2 - Between Good and Fair
Deficiency	PLASTER: CRACKS/SPALLING
Deficiency Location/Instance	Stair A/2
Deficiency Quantity	15
Quantity Uom	S.F.
Potential Action	REPLACE
Urgency of Action	PRIORITY 3
Purpose of Action	LEVEL 2
Deficiency Photo1

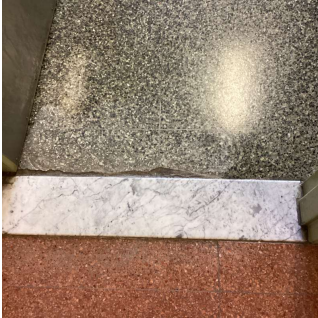
Question	Response
INTERIOR	
TOILET ROOMS - STAFF	
Walls	
Quantity Uom	S.F.
Potential Action	REPLACE
Urgency of Action	PRIORITY 3
Purpose of Action	LEVEL 2
Deficiency Photo1	 
Violations	Nurse No violations recorded.
Deficiency	PLASTER: CRACKS/SPALLING
Deficiency Location/Instance	Room 304
Deficiency Quantity	10
Quantity Uom	S.F.
Potential Action	REPLACE
Urgency of Action	PRIORITY 3
Purpose of Action	LEVEL 2
Deficiency Photo1	 
Violations	Room 304 No violations recorded.
TOILET ROOMS - STUDENTS	
Ceiling	Inspected
Condition	2 - Between Good and Fair
Deficiency	No deficiencies recorded
Door(s)	Inspected
Condition	2 - Between Good and Fair
Deficiency	No deficiencies recorded
Floor Finish	Inspected
Condition	2 - Between Good and Fair
Deficiency	TERRAZZO: CRACKS
Deficiency Location/Instance	Room 212
Deficiency Quantity	15
Quantity Uom	S.F.
Potential Action	REPLACE

Question	Response
INTERIOR	
TOILET ROOMS - STUDENTS	
Floor Finish	
Urgency of Action	PRIORITY 3
Purpose of Action	LEVEL 2
Deficiency Photo1

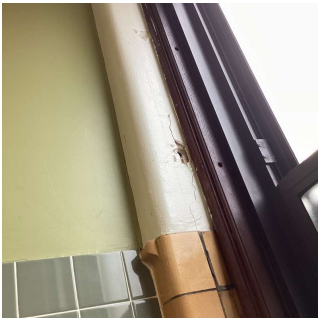
Violations	Room 212 No violations recorded.
Stalls	Inspected
Condition	2 - Between Good and Fair
Deficiency	No deficiencies recorded
Walls	Inspected
Condition	2 - Between Good and Fair
Deficiency	PLASTER: CRACKS/SPALLING
Deficiency Location/Instance	Room 115
Deficiency Quantity	15
Quantity Uom	S.F.
Potential Action	REPLACE
Urgency of Action	PRIORITY 3
Purpose of Action	LEVEL 2
Deficiency Photo1

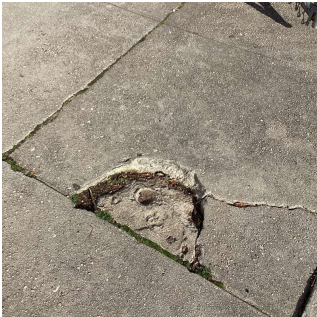
Question	Response
SITE	
FENCES	Inspected
	Schoolyard
Violations	No violations recorded.
IRRIGATION SYSTEM	Does not Exist
PAVING	Inspected
Student Non-Use	Inspected
Gravel Exists?	No
Asphalt	Does not Exist
Concrete	Inspected
Condition	2 - Between Good and Fair
Deficiency	No deficiencies recorded
Pavers	Does not Exist
Student Use	Inspected
Gravel Exists?	No
Asphalt	Does not Exist
Concrete	Inspected
Condition	4 - Between Fair and Poor
Deficiency	CRACKS - MAJOR
Deficiency Location/Instance	Schoolyard
Deficiency Quantity	25
Quantity Uom	S.F.
Potential Action	REPLACE
Urgency of Action	PRIORITY 5
Purpose of Action	LEVEL 6
Deficiency Photo1

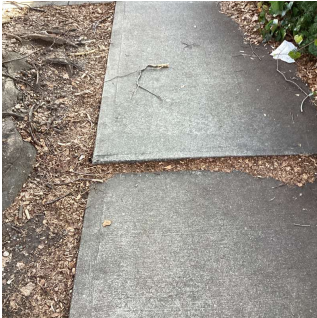
Violations	E.29th Street No violations recorded.
Deficiency	HEAVING
Deficiency Location/Instance	E.29th Street
Deficiency Quantity	100
Quantity Uom	S.F.
Potential Action	REPLACE
Urgency of Action	PRIORITY 3
Purpose of Action	LEVEL 2
Deficiency Photo1
