**NYC Department of Education**  
**Building Condition Assessment Survey 2023 - 2024**

Architectural Inspection

**K065**

**Asset:** P.S. 65 - BROOKLYN, 158 RICHMOND STREET, New York, 11208

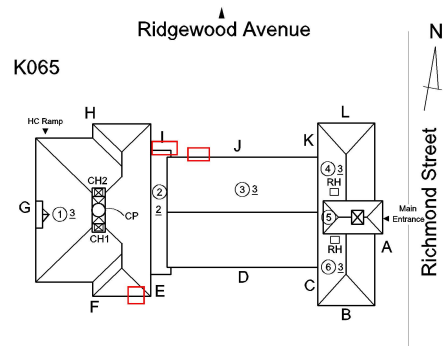
Roof Plan reference

Question	Response
<b>Architectural</b>	
<b>EXTERIOR</b>	Inspected
<b>AREAWAY</b>	Does not Exist
<b>AWNINGS AND CANOPIES</b>	Does not Exist
<b>CHIMNEY</b>	Inspected
Material Type(s)	Masonry
Condition	2 - Between Good and Fair
Deficiency	No deficiencies recorded
<b>COPING</b>	Inspected
Condition	2 - Between Good and Fair
Deficiency	No deficiencies recorded
<b>CORNICE</b>	Inspected
Condition	2 - Between Good and Fair
Deficiency	No deficiencies recorded
<b>DOORS</b>	Inspected
<b>DOORS AND FRAMES</b>	Inspected
Condition	5 - Poor
Deficiency	METAL: DETERIORATED DOOR AND FRAME - MAJOR DETERIORATION

**DOORS AND FRAMES**

Deficiency Quantity  
Quantity Uom  
Potential Action  
Urgency of Action  
Purpose of Action  
Deficiency Photo1

3  
EACH  
REPLACE  
PRIORITY 4  
LEVEL 2

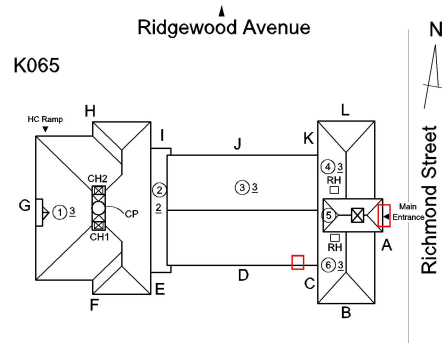
Roof Plan reference

**METAL: DETERIORATED DOOR AND FRAME - MINOR DETERIORATION**

Deficiency Quantity  
Quantity Uom  
Potential Action  
Urgency of Action  
Purpose of Action

3  
EACH  
MAINTENANCE  
PRIORITY 3  
LEVEL 2

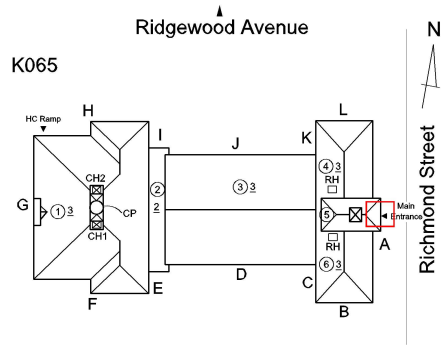
Roof Plan reference

WOOD: EXCESSIVELY WEATHERED

REPLACE

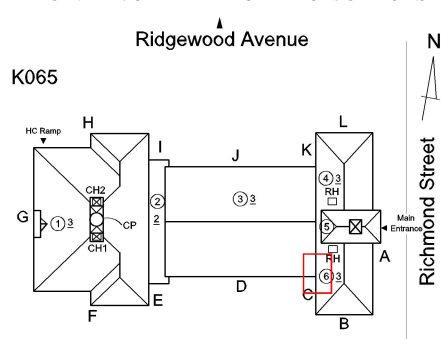
Question	Response
<b>EXTERIOR</b>	
<b>EXTERIOR WALLS</b>	
Replacement Uom	S.F.
Instance on All Facades	Under Construction
Instance Quantity	19,000
Instance Quantity Uom	S.F.
<b>EXTERIOR SOFFITS</b>	
	Does not Exist
<b>LOADING DOCK</b>	
	Does not Exist
<b>LOUVER</b>	
Condition	2 - Between Good and Fair
Deficiency	No deficiencies recorded
<b>PARAPETS</b>	
Material Type(s)	Masonry
Replacement Quantity	500
Replacement Uom	C.F.
Instance on Facades C, K	Inspected
Instance Condition	4 - Between Fair and Poor
Instance Quantity	500
Instance Quantity Uom	C.F.
Deficiency	BRICK: MAJOR DETERIORATION/CRACKS
Roof Plan reference

Deficiency Quantity	10
Quantity Uom	S.F.
Potential Action	REMOVE AND REBUILD
Urgency of Action	PRIORITY 4
Purpose of Action	LEVEL 2
Deficiency Photo1

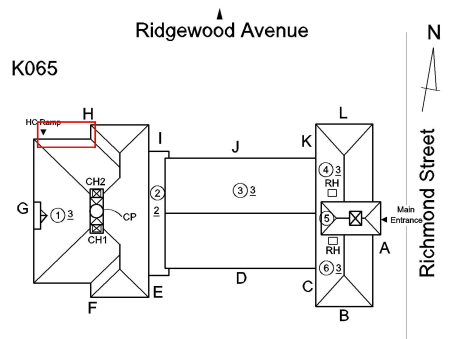
<b>ROOF/GRAVITY TANK</b>	Does not Exist
<b>STAIRS/RAMPS: EXTERIOR</b>	Inspected
<b>BUILDING CHEEK/FLANK WALLS</b>	Inspected
Condition	5 - Poor
Deficiency	CAST IN PLACE CONCRETE: CRACKS/SPALLING - MAJOR
Roof Plan reference

Deficiency Quantity	25
Quantity Uom	S.F.
Potential Action	REPLACE
Urgency of Action	PRIORITY 4
Purpose of Action	LEVEL 2
Deficiency Photo1

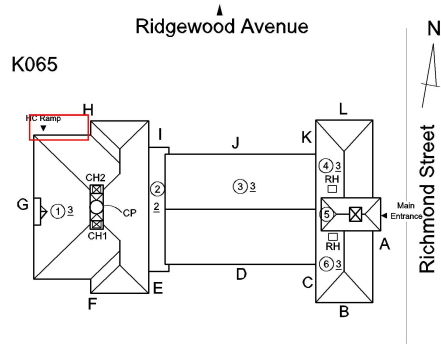
Roof Plan reference

Condition 3 - Fair

Deficiency CONCRETE: CRACKS/SPALLING - MINOR

Deficiency Quantity	20
Quantity Uom	S.F.
Potential Action	REPAIR
Urgency of Action	PRIORITY 3
Purpose of Action	LEVEL 2
Deficiency Photo1
