NYC Department of Education
Building Condition Assessment Survey 2023 - 2024

Architectural Inspection

K066

Asset: P.S. 66 - BROOKLYN, 845 EAST 96TH STREET, New York, 11236

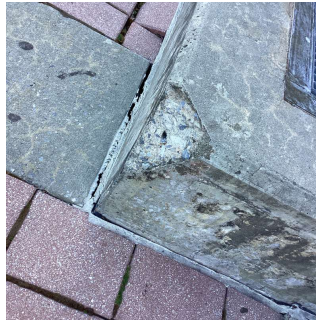
AW4
 No violations recorded.

Instance on AW1-AW9	Inspected
Instance Condition	3 - Fair
Instance Quantity	9
Instance Quantity Uom	EACH
Deficiency	AREAWAY WALLS: CRACKS AND SPALLING
Roof Plan reference

15
 S.F.
 REPLACE
 PRIORITY 4
 LEVEL 2

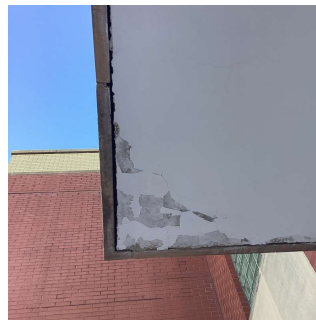
Facade A - Main Entrance
No violations recorded.

CONCRETE: DETERIORATED

REPLACE

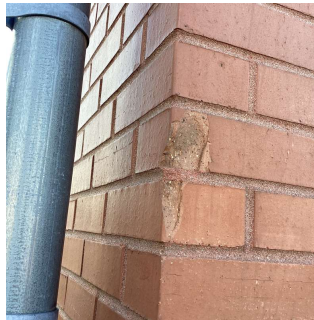
Corner of Facade D and Facade E

BRICK: CRACKS/DISPLACED/SPALLED BRICK AT BUILDING CORNERS

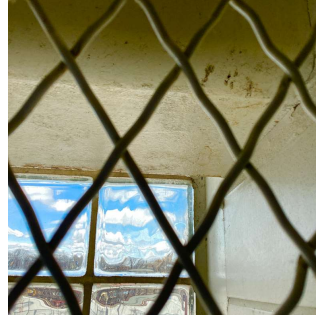
GLASS BLOCK: WATER INFILTRATION IN INSTRUCTIONAL SPACE

Facade D - Stair B/2 (shown), Stair B/1,3, Facade A - Stair D/1,2, Facade B - Stair A/1,2,3, Facade F - Stair C/1,2,3, Facade O - Stair E/1,2 (similar)

REPAIR
PRIORITY 5
LEVEL 2

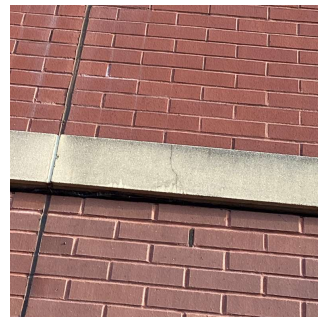
Facade O

CAST IN PLACE / PRE-CAST CONCRETE: MINOR CRACKS/SPALLING

REPAIR

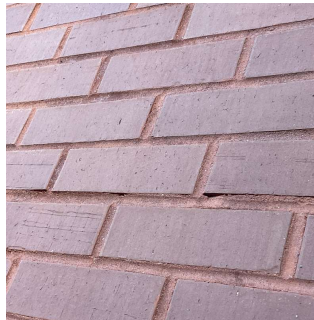
Facade P - Near Exit 6

BRICK: DETERIORATED JOINTS

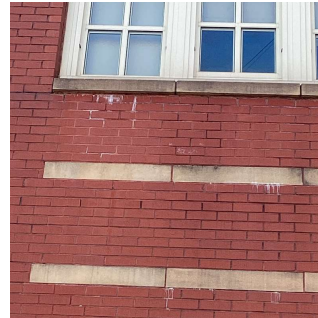
Facade L

BRICK: EFFLORESCENCE

PRIORITY 1
LEVEL 1

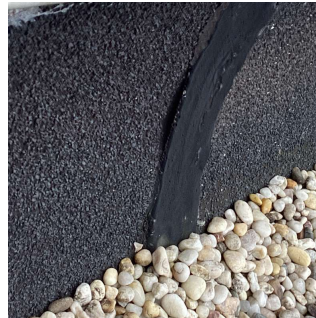
Roof 1 - PH

BUILT-UP: FLASHING: BASE FLASHING DETERIORATED

10
S.F.
REMOVE AND REPLACE
PRIORITY 4
LEVEL 2

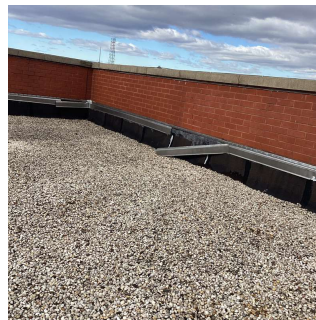
PH1 roof

BUILT-UP: FLASHING: CAP FLASHING DAMAGED

REPLACE

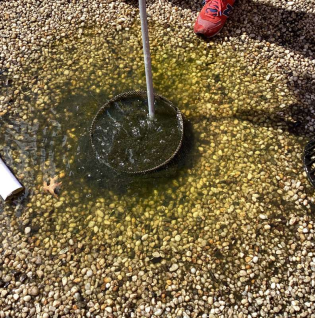
Question	Response
EXTERIOR	
ROOF	
Roofing	
ROOFING	
	Roof 3
Instance Quantity	4,400
Instance Quantity Uom	S.F.
Does the roof have major mechanical equipment sitting on Dunnage Steel less than 18" above the Roofing?	No
Does this roof instance have a Sustainable Roof System?	No
Do solar panels exist on these roofs?	No
Is/Are the roof(s) suitable for Solar Panel installation?	No
Installation Year	2003
Source of Installation	Custodial Staff
Deficiency	No deficiencies recorded
ROOFING DRAINS	
	Inspected
Condition	3 - Fair
Deficiency	CLOGGED
Roof Plan reference	<p>K066</p>

<p>Rockaway Pkwy Foster Avenue East 96th Street</p>
Deficiency Quantity	1
Quantity Uom	EACH
Potential Action	MAINTENANCE
Urgency of Action	PRIORITY 5
Purpose of Action	LEVEL 2
Deficiency Photo1

<p>Roof 2 - Near Facade O</p>
Violations	No violations recorded.
Specialties	
	Inspected
BULKHEAD/PENTHOUSE	
	Inspected
Condition	3 - Fair
Deficiency	BULKHEAD/PENTHOUSE WALLS/EXTERIOR: EFFLORESCENCE

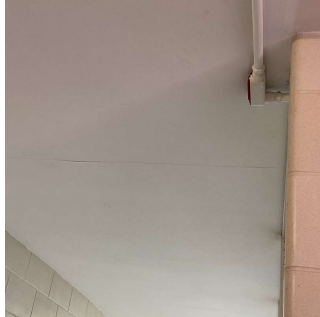
BULKHEAD/PENTHOUSE CEILING: GYPSUM BOARD DAMAGED/DETERIORATED

40
S.F.
REPLACE
PRIORITY 3
LEVEL 2

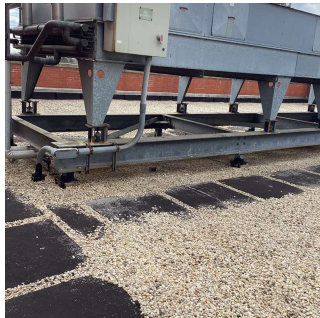
Violations	BH1 No violations recorded.
CUPOLA/ SPIRES/ TOWERS	Does not Exist
DORMER	Does not Exist
DUNNAGE STEEL	Inspected
Condition	3 - Fair
Deficiency	HEIGHT LESS THAN 18"
Roof Plan reference

Deficiency Quantity	100
Quantity Uom	L.F.
Potential Action	REPLACE
Urgency of Action	PRIORITY 3
Purpose of Action	LEVEL 2
Deficiency Photo1

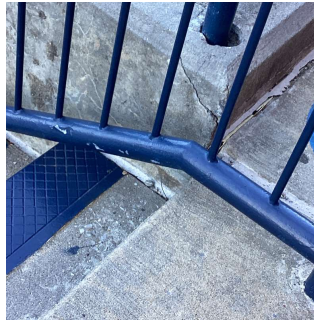
Facade A - Exit 1

Deficiency	CAST IN PLACE CONCRETE: CRACKS/SPALLING - MINOR
------------	---

REPAIR

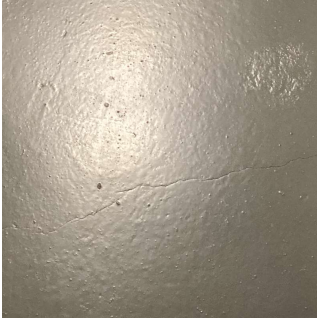
Question	Response
INTERIOR	
STRUCTURAL	
FLOOR STRUCTURE	
Condition	3 - Fair
Deficiency	CONCRETE SLAB ON GRADE: THRU CRACKS
Deficiency Location/Instance	Basement - Oil Tank, Boiler Room, Room B19
Deficiency Quantity	20
Quantity Uom	S.F.
Potential Action	REPAIR
Urgency of Action	PRIORITY 3
Purpose of Action	LEVEL 5
Deficiency Photo1

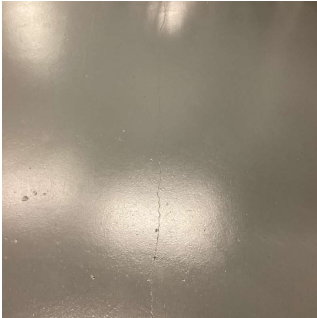
Violations	Basement - Oil Tank No violations recorded.
Deficiency	CONCRETE: CRACKS/SPALLED/REINFORCEMENT EXPOSED
Deficiency Location/Instance	Roof 1 - PH1, Roof 2 - PH2
Deficiency Quantity	50
Quantity Uom	S.F.
Potential Action	REPAIR
Urgency of Action	PRIORITY 3
Purpose of Action	LEVEL 5
Deficiency Photo1

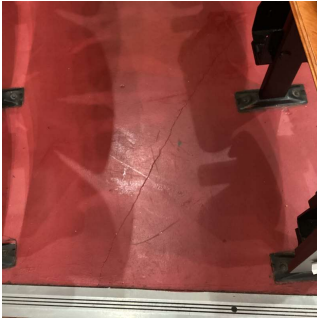
Question	Response
INTERIOR	
AUDITORIUM	
Fixed Seating	
Violations	No violations recorded.
Floor Finish	
Instance on 1st Floor (325 Seats)	Inspected
Condition	3 - Fair
Deficiency	CONCRETE: CRACKS
Deficiency Location/Instance	Near Seats E/3, 101, F/10, H/10, K/2, and others
Deficiency Quantity	100
Quantity Uom	S.F.
Potential Action	REPLACE
Urgency of Action	PRIORITY 3
Purpose of Action	LEVEL 2
Deficiency Photo1

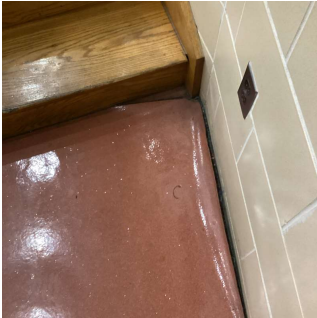
Violations	Near Seat K/2 No violations recorded.
Deficiency	SHEET VINYL: BROKEN/DETERIORATED
Deficiency Location/Instance	Left Side of Stage, Near Exit 5, Left Aisle, Near Ramp, Near Entrance, and others
Deficiency Quantity	150
Quantity Uom	S.F.
Potential Action	REPLACE
Urgency of Action	PRIORITY 3
Purpose of Action	LEVEL 2
Deficiency Photo1

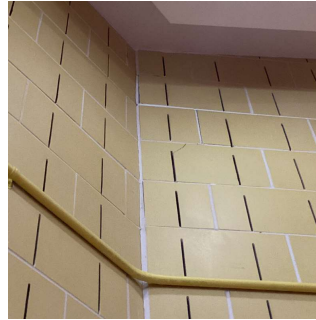
Condition	2 - Between Good and Fair
Deficiency	GLAZED BLOCK: CRACKS/SPALLING
Deficiency Location/Instance	Near Ramp
Deficiency Quantity	10
Quantity Uom	S.F.
Potential Action	REPLACE
Urgency of Action	PRIORITY 3
Purpose of Action	LEVEL 2
Deficiency Photo1

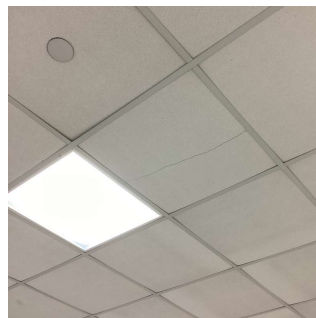
Instance on 1st Floor	Inspected
Condition	2 - Between Good and Fair
Deficiency	ACOUSTIC TILES: DAMAGED/MISSING
Deficiency Location/Instance	Right Side
Deficiency Quantity	10
Quantity Uom	S.F.
Potential Action	REPLACE
Urgency of Action	PRIORITY 3
Purpose of Action	LEVEL 2
Deficiency Photo1

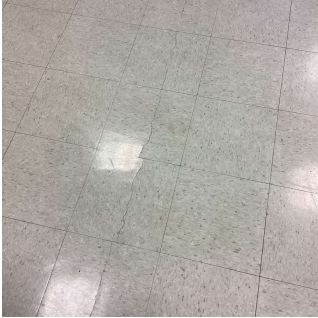
Question	Response
INTERIOR	
CAFETERIA	
Door(s)	
Instance on 1st Floor	Inspected
Condition	2 - Between Good and Fair
Deficiency	No deficiencies recorded
Fixed Equipment	
Instance on 1st Floor	Does not Exist
Floor Finish	
Instance on 1st Floor	Inspected
Condition	2 - Between Good and Fair
Deficiency	VINYL TILES: DETERIORATED SUBSTRATE
Deficiency Location/Instance	Near Serving Area, Near Room 120G, Near Main Entrance Lobby
Deficiency Quantity	50
Quantity Uom	S.F.
Potential Action	REPLACE
Urgency of Action	PRIORITY 3
Purpose of Action	LEVEL 2
Deficiency Photo1

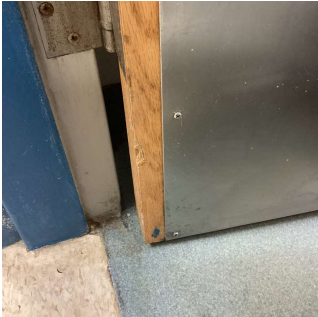
Question	Response
INTERIOR	
CLASSROOMS/CORRIDORS/ADMIN SPACES	
Ceiling	Inspected
Violations	No violations recorded.
Door(s)	Inspected
Condition	5 - Poor
Deficiency	WOOD: DETERIORATED DOOR
Deficiency Location/Instance	Main Entrance Vestibule, Rooms 201, 230, 307, 310, and others
Deficiency Quantity	10
Quantity Uom	EACH
Potential Action	MAINTENANCE
Urgency of Action	PRIORITY 3
Purpose of Action	LEVEL 2
Deficiency Photo1

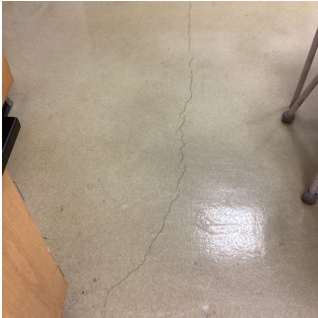
Violations	Room 310 No violations recorded.
Floor Finish	Inspected
Condition	2 - Between Good and Fair
Deficiency	EPOXY FLOORING: CRACKS/SPALLING
Deficiency Location/Instance	Room 218
Deficiency Quantity	20
Quantity Uom	S.F.
Potential Action	REPLACE
Urgency of Action	PRIORITY 3
Purpose of Action	LEVEL 2
Deficiency Photo1

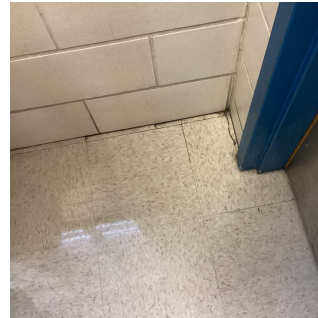
Corridor near Room 301
No violations recorded.

Violations	Room 218 No violations recorded.
Deficiency	VINYL TILES: BROKEN/DETERIORATED/MISSING TILES
Deficiency Location/Instance	Corridor near Room 301, Rooms 219, 313
Deficiency Quantity	30

Quantity Uom	S.F.
Potential Action	REPLACE
Urgency of Action	PRIORITY 3

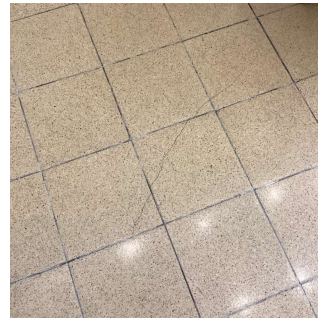
Main Entrance Lobby
No violations recorded.

Deficiency	CERAMIC TILE: BROKEN/MISSING TILES
Deficiency Location/Instance	Main Entrance Lobby, Main Entrance Vestibule
Deficiency Quantity	75
Quantity Uom	S.F.
Potential Action	REPLACE
Urgency of Action	PRIORITY 3
Purpose of Action	LEVEL 2
Deficiency Photo1

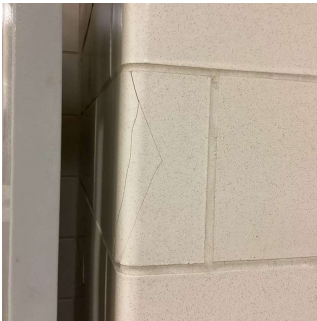
Condition	2 - Between Good and Fair
Deficiency	GLAZED BLOCK: CRACKS/SPALLING
Deficiency Location/Instance	Corridor near Exit 7
Deficiency Quantity	10
Quantity Uom	S.F.
Potential Action	REPLACE
Urgency of Action	PRIORITY 3
Purpose of Action	LEVEL 2

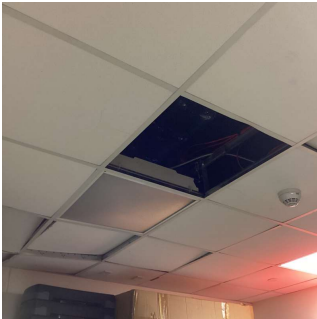
Corridor near Exit 7
Violations	No violations recorded.
Specialties	Does not Exist
GYMNASIUM	
Instance on 2nd Floor	Inspected
	Inspected
Ceiling	
Instance on 2nd Floor	Inspected
Condition	2 - Between Good and Fair
Deficiency	ACOUSTIC TILES: DAMAGED/MISSING
Deficiency Location/Instance	Storage Room 222B
Deficiency Quantity	10
Quantity Uom	S.F.
Potential Action	REPLACE
Urgency of Action	PRIORITY 3
Purpose of Action	LEVEL 2
Deficiency Photo1

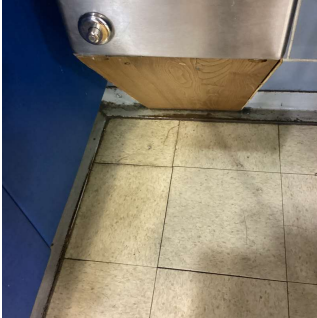
Storage Room 222B
Violations	No violations recorded.
Door(s)	
Instance on 2nd Floor	Inspected
Condition	2 - Between Good and Fair
Deficiency	No deficiencies recorded
Fixed Equipment	
Instance on 2nd Floor	Inspected
Condition	2 - Between Good and Fair
Deficiency	No deficiencies recorded
Floor Finish	
Instance on 2nd Floor	Inspected
Condition	2 - Between Good and Fair
Deficiency	VINYL TILES: BROKEN/DETERIORATED/MISSING TILES

Question	Response
INTERIOR	
GYMNASIUM	
Floor Finish	
Deficiency Location/Instance	Near Drinking Fountain
Deficiency Quantity	10
Quantity Uom	S.F.
Potential Action	REPLACE
Urgency of Action	PRIORITY 3
Purpose of Action	LEVEL 2
Deficiency Photo1

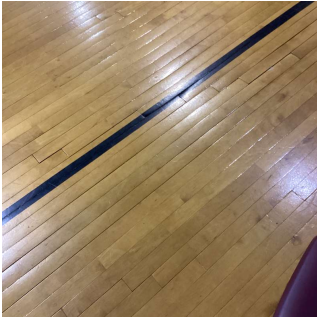
Violations	Near Drinking Fountain No violations recorded.
Deficiency	WOOD: DAMAGED/DETERIORATED
Deficiency Location/Instance	Near Office
Deficiency Quantity	10
Quantity Uom	S.F.
Potential Action	REPLACE
Urgency of Action	PRIORITY 3
Purpose of Action	LEVEL 2
Deficiency Photo1

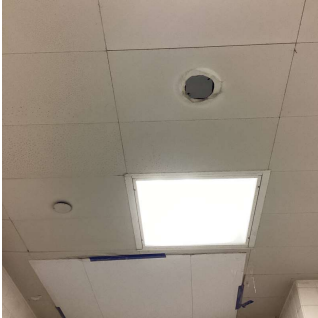
Question	Response
INTERIOR	
GYMNASIUM	
Walls	
Quantity Uom	S.F.
Potential Action	REPLACE
Urgency of Action	PRIORITY 3
Purpose of Action	LEVEL 2
Deficiency Photo1	 
	Near Entrance
Violations	No violations recorded.
Window Curtains/Shades/Blinds	
Instance on 2nd Floor	Does not Exist
INTERIOR DOOR HARDWARE	
Condition	Inspected
Deficiency	2 - Between Good and Fair
	No deficiencies recorded
INTERIOR GUARDS	
Condition	Inspected
Deficiency	2 - Between Good and Fair
	No deficiencies recorded
KITCHEN	
Instance on 1st Floor	Inspected
Ceiling	
Instance on 1st Floor	Inspected
Condition	2 - Between Good and Fair
Deficiency	GYPSUM BOARD: DAMAGED/DETERIORATED
Deficiency Location/Instance	Storage Room 122B
Deficiency Quantity	10
Quantity Uom	S.F.
Potential Action	REPLACE
Urgency of Action	PRIORITY 3
Purpose of Action	LEVEL 2
Deficiency Photo1	 
	Storage Room 122B
Violations	No violations recorded.
Deficiency	METAL PAN: DAMAGED/MISSING

Question	Response
INTERIOR	
KITCHEN	
Ceiling	
Deficiency Location/Instance	Room 122E
Deficiency Quantity	10
Quantity Uom	S.F.
Potential Action	REPLACE
Urgency of Action	PRIORITY 3
Purpose of Action	LEVEL 2
Deficiency Photo1

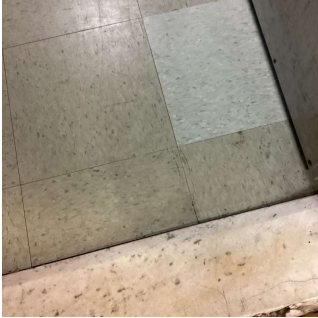
Room 122E
Violations	No violations recorded.
Door(s)	
Instance on 1st Floor	Inspected
Condition	2 - Between Good and Fair
Deficiency	No deficiencies recorded
Floor Finish	
Instance on 1st Floor	Inspected
Condition	2 - Between Good and Fair
Deficiency	VINYL TILES: BROKEN/DETERIORATED/MISSING TILES
Deficiency Location/Instance	Storage Room 122B
Deficiency Quantity	10
Quantity Uom	S.F.
Potential Action	REPLACE
Urgency of Action	PRIORITY 3
Purpose of Action	LEVEL 2
Deficiency Photo1

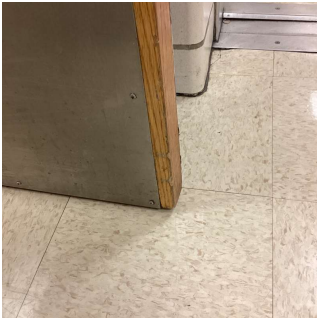
Question	Response
INTERIOR	
KITCHEN	
Floor Finish	
Urgency of Action	PRIORITY 3
Purpose of Action	LEVEL 2
Deficiency Photo1	 
Violations	Near Office No violations recorded.
Walls	
Instance on 1st Floor	Inspected
Condition	2 - Between Good and Fair
Deficiency	No deficiencies recorded
LIBRARY	
Instance on Room 215	Inspected
Built-in Furnishing	
Instance on Room 215	Does not Exist
Ceiling	
Instance on Room 215	Inspected
Condition	2 - Between Good and Fair
Deficiency	ACOUSTIC TILES: DAMAGED/MISSING
Deficiency Location/Instance	Near Entrance
Deficiency Quantity	10
Quantity Uom	S.F.
Potential Action	REPLACE
Urgency of Action	PRIORITY 3
Purpose of Action	LEVEL 2
Deficiency Photo1	 
Violations	Near Entrance No violations recorded.
Door(s)	
Instance on Room 215	Inspected
Condition	3 - Fair
Deficiency	WOOD: DETERIORATED DOOR
Deficiency Location/Instance	Entrance

Question	Response
INTERIOR	
LIBRARY	
Door(s)	
Deficiency Quantity	1
Quantity Uom	EACH
Potential Action	MAINTENANCE
Urgency of Action	PRIORITY 3
Purpose of Action	LEVEL 2
Deficiency Photo1

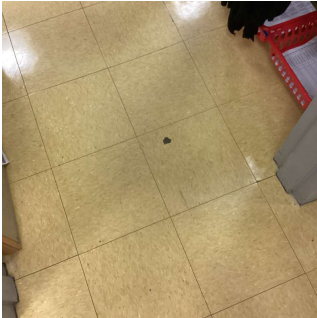
Violations	Entrance No violations recorded.
Floor Finish	
Instance on Room 215	Inspected
Condition	2 - Between Good and Fair
Deficiency	VINYL TILES: BROKEN/DETERIORATED/MISSING TILES
Deficiency Location/Instance	Office
Deficiency Quantity	10
Quantity Uom	S.F.
Potential Action	REPLACE
Urgency of Action	PRIORITY 3
Purpose of Action	LEVEL 2
Deficiency Photo1

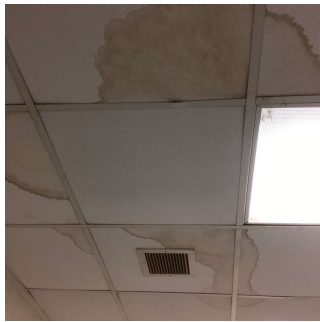
Violations	Stair E/2 No violations recorded.
TOILET ROOMS - STAFF	
Ceiling	Inspected
Condition	4 - Between Fair and Poor
Deficiency	ACOUSTIC TILES: DAMAGED/MISSING
Deficiency Location/Instance	2nd Floor Men, 2nd Floor Women
Deficiency Quantity	40
Quantity Uom	S.F.
Potential Action	REPLACE
Urgency of Action	PRIORITY 3
Purpose of Action	LEVEL 2
Deficiency Photo1

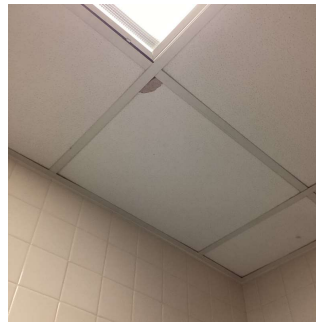
Question	Response
INTERIOR	
TOILET ROOMS - STAFF	
Door(s)	
Deficiency Photo1	 
Violations	2nd Floor Men No violations recorded.
Floor Finish	Inspected
Condition	2 - Between Good and Fair
Deficiency	No deficiencies recorded
Stalls	Inspected
Condition	2 - Between Good and Fair
Deficiency	No deficiencies recorded
Walls	Inspected
Condition	2 - Between Good and Fair
Deficiency	CERAMIC TILE: BROKEN/ MISSING
Deficiency Location/Instance	2nd Floor Women
Deficiency Quantity	10
Quantity Uom	S.F.
Potential Action	REPLACE
Urgency of Action	PRIORITY 3
Purpose of Action	LEVEL 2
Deficiency Photo1	 
Violations	2nd Floor Women No violations recorded.
TOILET ROOMS - STUDENTS	
Ceiling	Inspected
Condition	2 - Between Good and Fair
Deficiency	ACOUSTIC TILES: DAMAGED/MISSING
Deficiency Location/Instance	2nd Floor Boys, 2nd Floor Girls, 3rd Floor Boys
Deficiency Quantity	30
Quantity Uom	S.F.
Potential Action	REPLACE
Urgency of Action	PRIORITY 3

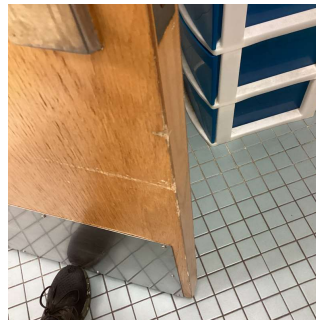
In Room 201

WOOD: DETERIORATED DOOR

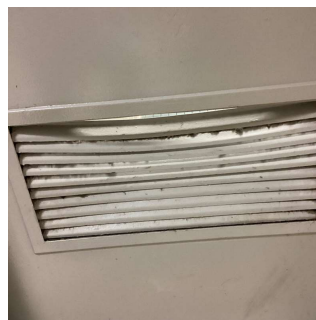
METAL: DAMAGED LOUVER

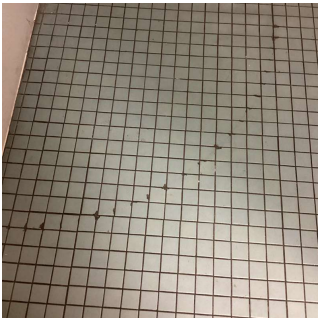
Question	Response
INTERIOR	
TOILET ROOMS - STUDENTS	
Door(s)	Inspected 3rd Floor Girls
Violations	No violations recorded.
Floor Finish	Inspected
Condition	2 - Between Good and Fair
Deficiency	CERAMIC TILE: BROKEN/MISSING TILES
Deficiency Location/Instance	Room 118 Girls, Room 118 Boys, 3rd Floor Boys
Deficiency Quantity	30
Quantity Uom	S.F.
Potential Action	REPLACE
Urgency of Action	PRIORITY 3
Purpose of Action	LEVEL 2
Deficiency Photo1

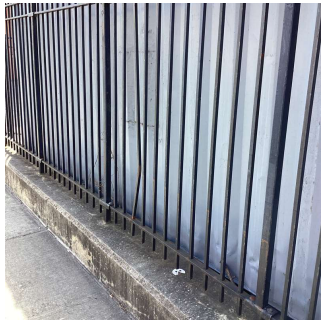
Question	Response
SITE	
Drainage System for Soil	Inspected
Catch Basins/Manhole - Surrounded by Soil	Inspected
Deficiency	No deficiencies recorded
Culverts - Soil Covering	Does not Exist
DRINKING FOUNTAINS	Does not Exist
FENCES	Inspected
Condition	3 - Fair
Deficiency	WROUGHT IRON: DAMAGED/DETERIORATED
Deficiency Location/Instance	Rockaway Parkway
Deficiency Quantity	40
Quantity Uom	S.F.
Potential Action	REPLACE
Urgency of Action	PRIORITY 3
Purpose of Action	LEVEL 2
Deficiency Photo1

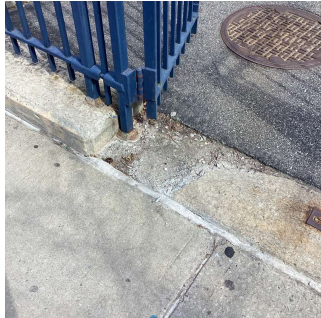
Rockaway Parkway
Violations	No violations recorded.
Deficiency	CONCRETE CURB: DAMAGED/DETERIORATED
Deficiency Location/Instance	East 96th Street, Rockaway Parkway, Foster Avenue
Deficiency Quantity	90
Quantity Uom	S.F.
Potential Action	REPLACE
Urgency of Action	PRIORITY 3
Purpose of Action	LEVEL 2
Deficiency Photo1

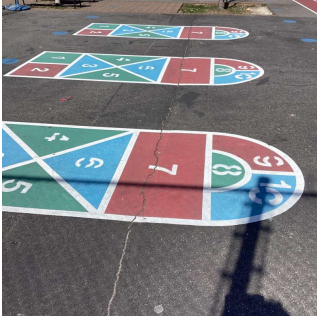
Question	Response
SITE	
PAVING	
Student Use	
Asphalt	
Urgency of Action	PRIORITY 3
Purpose of Action	LEVEL 2
Deficiency Photo1

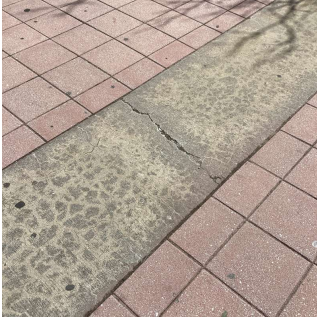
Violations	Main Schoolyard No violations recorded.
Concrete	Inspected
Condition	3 - Fair
Deficiency	DAMAGED/DETERIORATED/MISSING SECTIONS
Deficiency Location/Instance	Main Entrance Plaza
Deficiency Quantity	75
Quantity Uom	S.F.
Potential Action	REPLACE
Urgency of Action	PRIORITY 3
Purpose of Action	LEVEL 2
Deficiency Photo1

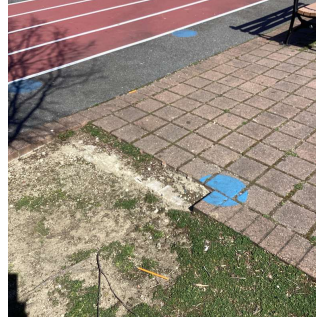
Violations	Main Entrance Plaza No violations recorded.
Pavers	Inspected
Condition	2 - Between Good and Fair
Deficiency	DAMAGED/MISSING
Deficiency Location/Instance	Main Schoolyard
Deficiency Quantity	20
Quantity Uom	S.F.
Potential Action	REPLACE
Urgency of Action	PRIORITY 3
Purpose of Action	LEVEL 2

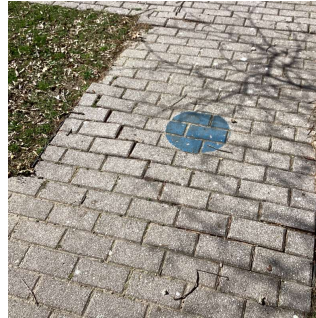
Garden Area Near Foster Avenue

CRACKS - MAJOR

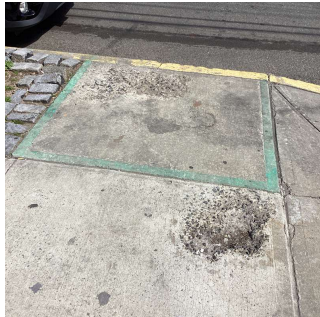
Question	Response
SITE	
PAVING	
DOT Sidewalk	
Concrete	
Deficiency Photo1

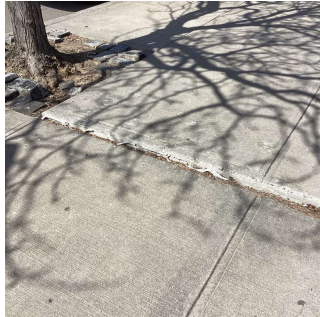
Violations	Rockaway Parkway No violations recorded.
Deficiency	HEAVING
Deficiency Location/Instance	East 96th Street, Rockaway Parkway
Deficiency Quantity	550
Quantity Uom	S.F.
Potential Action	REPLACE
Urgency of Action	PRIORITY 5
Purpose of Action	LEVEL 6
Deficiency Photo1

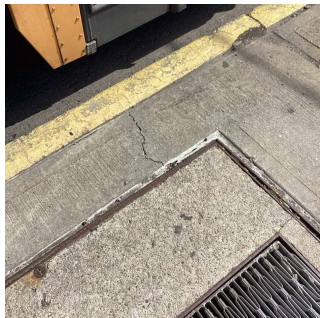
Violations	East 96th Street No violations recorded.
Deficiency	DAMAGED/DETERIORATED/MISSING SECTIONS
Deficiency Location/Instance	East 96th Street, Rockaway Parkway, Foster Avenue
Deficiency Quantity	275
Quantity Uom	S.F.
Potential Action	REPLACE
Urgency of Action	PRIORITY 3
Purpose of Action	LEVEL 2
Deficiency Photo1

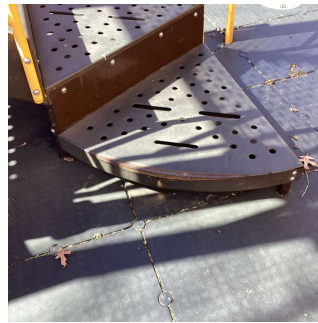
Question	Response
SITE	
PLAYGROUNDS	
Benches	
Instance on Foster Avenue	Does not Exist
Fence	
Instance on Main Schoolyard North	Does not Exist
Instance on Foster Avenue	Inspected
Condition	2 - Between Good and Fair
Deficiency	No deficiencies recorded
Instance on Main Schoolyard South	Inspected
Condition	2 - Between Good and Fair
Deficiency	No deficiencies recorded
Pavement	
Instance on Main Schoolyard North	Does not Exist
Instance on Main Schoolyard South	Does not Exist
Instance on Foster Avenue	Does not Exist
Play Equipment	
Instance on Main Schoolyard South	Inspected
Condition	5 - Poor
Deficiency	BROKEN/DETERIORATED/MISSING
Deficiency Location/Instance	Center
Deficiency Quantity	1
Quantity Uom	EACH
Potential Action	REPLACE
Urgency of Action	PRIORITY 3
Purpose of Action	LEVEL 2
Deficiency Photo1	 
	Center
Violations	No violations recorded.
Instance on Foster Avenue	Inspected
Condition	5 - Poor
Deficiency	BROKEN/DETERIORATED/MISSING

Deficiency Location/Instance	Center
Deficiency Quantity	1
Quantity Uom	EACH
Potential Action	REPLACE
Urgency of Action	PRIORITY 3
Purpose of Action	LEVEL 2

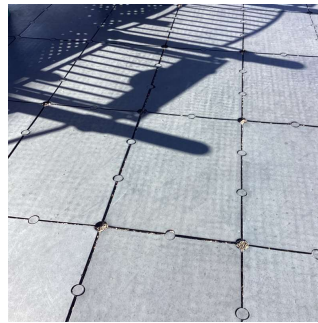
Center

DETERIORATED/MISSING

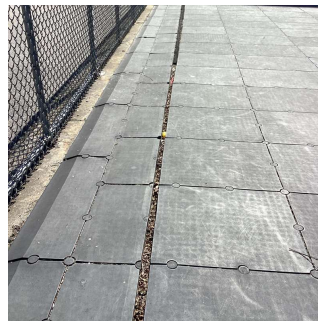
Along the Short Schoolyard Fence

DETERIORATED/MISSING
