**NYC Department of Education**  
**Building Condition Assessment Survey 2023 - 2024**

Architectural Inspection

**K069**

**Asset:** P.S. 69 - BROOKLYN, 6302 9TH AVENUE, New York, 11220

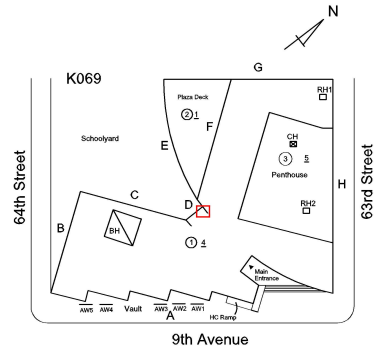
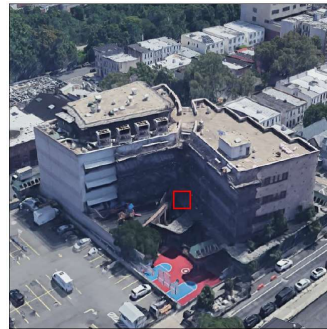
**EXTERIOR WALLS**

CAST IN PLACE / PRE-CAST CONCRETE: DETERIORATED JOINTS

REPAIR

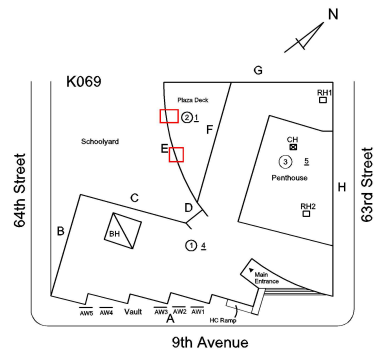
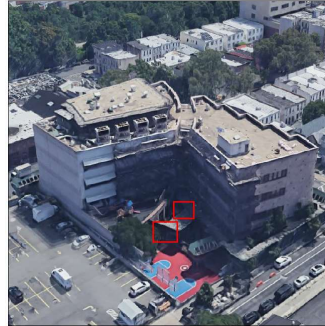
**EXTERIOR WALLS**

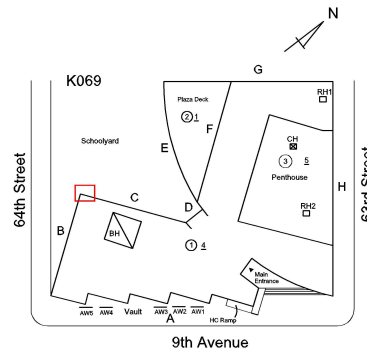
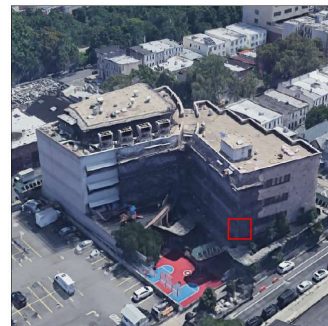
Corner of Facades B and C  
No violations recorded.

BRICK: CRACKS/DISPLACED/SPALLED BRICK AT BUILDING CORNERS

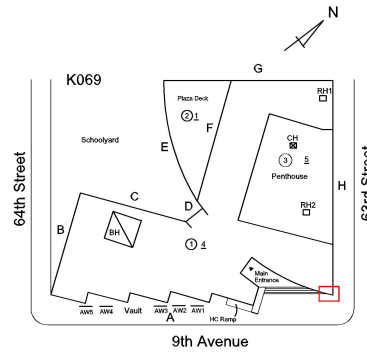
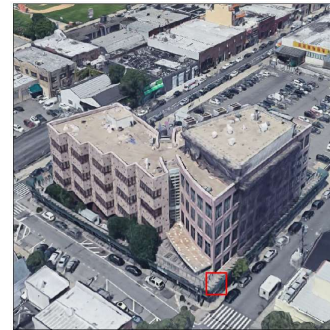
Corner of Facades A and H  
No violations recorded.

CAST IN PLACE / PRE-CAST CONCRETE: DETERIORATED CONTROL/EXPANSION JOINTS

10  
L.F.  
MAINTENANCE  
PRIORITY 3  
LEVEL 2

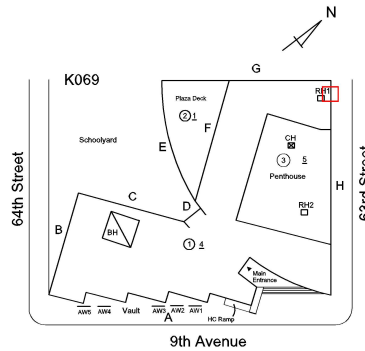
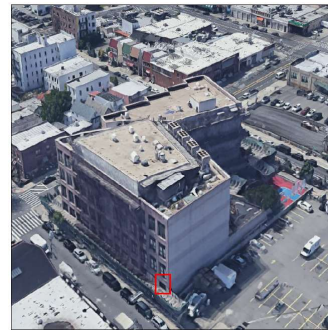
Facade H  
No violations recorded.

CAST IN PLACE / PRE-CAST CONCRETE: MINOR  
CRACKS/SPALLING

10  
S.F.  
REPAIR  
PRIORITY 3  
LEVEL 2

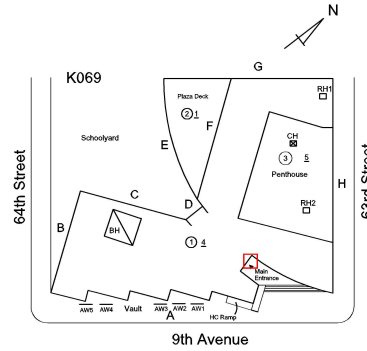
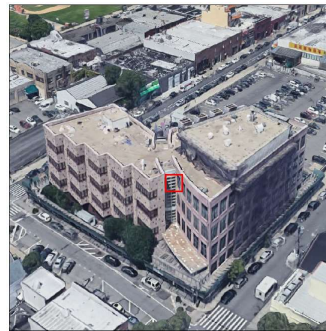
METAL/GLASS CURT WALL: WATER INFILTRATION IN INSTRUCTIONAL SPACE

REPAIR

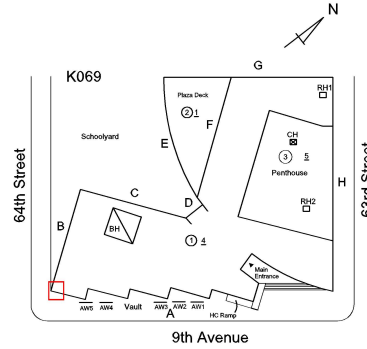
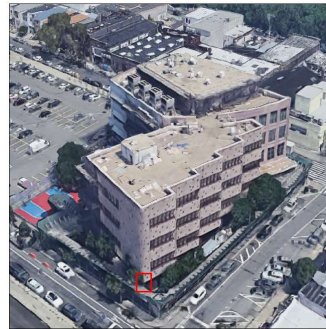
Corner of Facades A and B  
No violations recorded.

STUCCO/PLASTER: MAJOR CRACKS/SPALLING

10  
S.F.  
REPLACE  
PRIORITY 4  
LEVEL 2

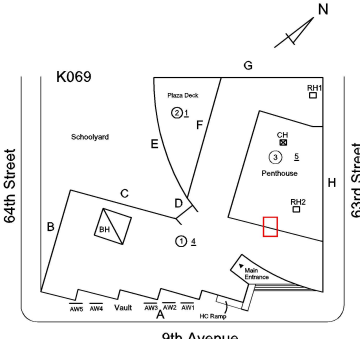
Question	Response
<b>EXTERIOR</b>	
<b>ROOF</b>	
<b>Specialties</b>	
<b>BULKHEAD/PENTHOUSE</b>	
Deficiency	BULKHEAD/PENTHOUSE WALLS/INTERIOR: CMU CRACKS/SPALLING
Roof Plan reference

Deficiency Quantity	10
Quantity Uom	S.F.
Potential Action	REPLACE
Urgency of Action	PRIORITY 3
Purpose of Action	LEVEL 2
Deficiency Photo1

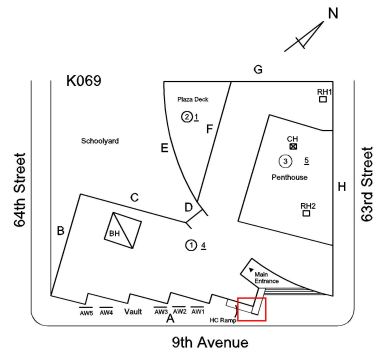
Facade A - HC Ramp  
No violations recorded.

**BUILDING CHEEK/FLANK WALLS**

10  
S.F.  
REPAIR  
PRIORITY 3  
LEVEL 2

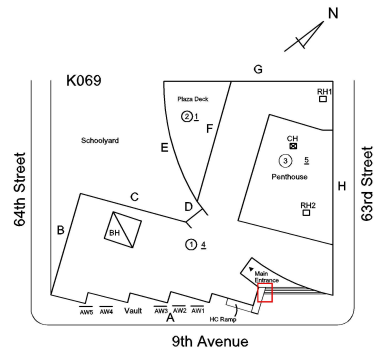
**CAST IN PLACE CONCRETE: CRACKS/SPALLING - MAJOR**

10  
S.F.  
REPLACE  
PRIORITY 4  
LEVEL 2

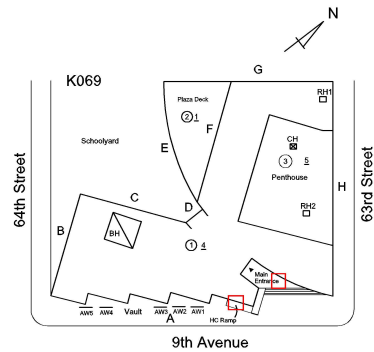
Facade A - Main Entrance  
No violations recorded.

**STAIRS/RAMPS**

20  
S.F.  
REPLACE  
PRIORITY 4  
LEVEL 2

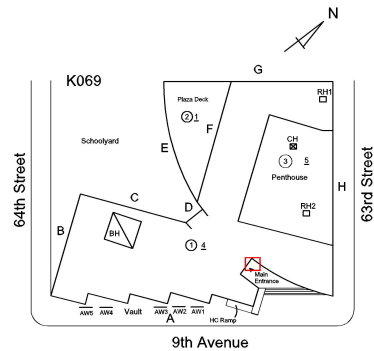
**CONCRETE: WATER INFILTRATION IN NON-INSTRUCTIONAL SPACE BELOW**

100  
S.F.  
REPLACE  
PRIORITY 5  
LEVEL 2

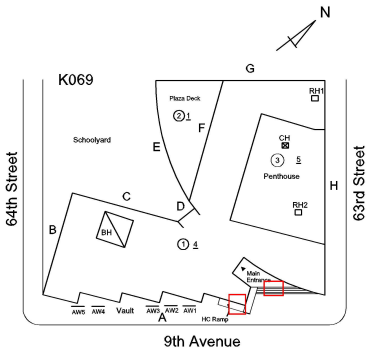
Violations	Basement - Room C06 (leak from Main Entrance Stairs) No violations recorded.
Deficiency	<b>CONCRETE: CRACKS/SPALLING - MINOR</b>
Roof Plan reference

Deficiency Quantity	20
Quantity Uom	S.F.
Potential Action	REPAIR
Urgency of Action	PRIORITY 3
Purpose of Action	LEVEL 2
Deficiency Photo1

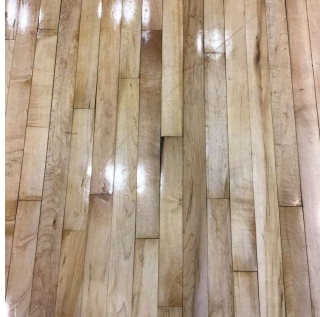
Question	Response
<b>INTERIOR</b>	
<b>AUDITORIUM</b>	
<b>Floor Finish</b>	
Deficiency Photo1	 
Violations	Near Seat C/101 No violations recorded.
Deficiency	VINYL TILES: DETERIORATED SUBSTRATE
Deficiency Location/Instance	Right Side Stage
Deficiency Quantity	10
Quantity Uom	S.F.
Potential Action	REPLACE
Urgency of Action	PRIORITY 3
Purpose of Action	LEVEL 2
Deficiency Photo1	 
Violations	Right Side Stage No violations recorded.
<b>Sliding-folding Partition</b>	
Instance on 1st Floor (263 Seats)	Does not Exist
<b>Stage</b>	
Instance on 1st Floor (263 Seats)	Inspected
<b>Stage</b>	Inspected
Instance on 1st Floor (263 Seats)	Inspected
Condition	3 - Fair
Deficiency	DAMAGED FLOOR
Deficiency Location/Instance	Right, Center and Left Side
Deficiency Quantity	30
Quantity Uom	S.F.
Potential Action	REPLACE
Urgency of Action	PRIORITY 3
Purpose of Action	LEVEL 2

Right Side
Violations	No violations recorded.
<b>Stage Curtain Rigging</b>	Inspected
Instance on 1st Floor (263 Seats)	Inspected
Condition	2 - Between Good and Fair
Deficiency	No deficiencies recorded
<b>Stage Curtains</b>	Inspected
Instance on 1st Floor (263 Seats)	Inspected
Condition	2 - Between Good and Fair
Deficiency	No deficiencies recorded
<b>Walls</b>	
Instance on 1st Floor (263 Seats)	Inspected
Condition	2 - Between Good and Fair
Deficiency	No deficiencies recorded
<b>Window Curtains/Shades/Blinds</b>	
Instance on 1st Floor (263 Seats)	Inspected
Condition	2 - Between Good and Fair
Deficiency	No deficiencies recorded
<b>CAFETERIA</b>	Inspected
Instance on 1st Floor	Inspected
<b>Ceiling</b>	
Instance on 1st Floor	Inspected
Condition	2 - Between Good and Fair
Deficiency	GYPSUM BOARD: DAMAGED/DETERIORATED
Deficiency Location/Instance	Near Exit 6 Door

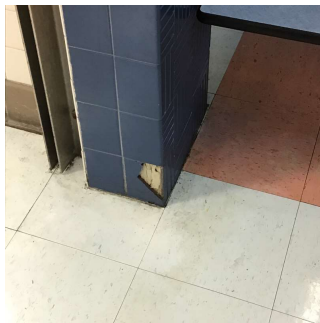
Question	Response
<b>INTERIOR</b>	
<b>CAFETERIA</b>	
<b>Walls</b>	
Deficiency Photo1

Violations	By Servery No violations recorded.
<b>Window Curtains/Shades/Blinds</b>	
Instance on 1st Floor	Does not Exist
<b>CLASSROOMS/CORRIDORS/ADMIN SPACES</b>	
<b>Ceiling</b>	Inspected
Condition	2 - Between Good and Fair
Deficiency	GYPSUM BOARD: DAMAGED/DETERIORATED
Deficiency Location/Instance	Above Main Entrance Stair
Deficiency Quantity	30
Quantity Uom	S.F.
Potential Action	REPLACE
Urgency of Action	PRIORITY 3
Purpose of Action	LEVEL 2
Deficiency Photo1

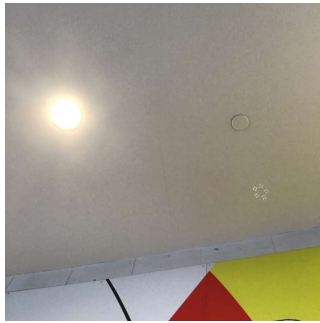
Violations	Above Main Entrance Stair No violations recorded.
Deficiency	ACOUSTIC TILES: DAMAGED/MISSING
Deficiency Location/Instance	Rooms 202,302, Corridor near Exit Plaza Deck - 2nd Floor
Deficiency Quantity	50
Quantity Uom	S.F.
Potential Action	REPLACE
Urgency of Action	PRIORITY 3
Purpose of Action	LEVEL 2

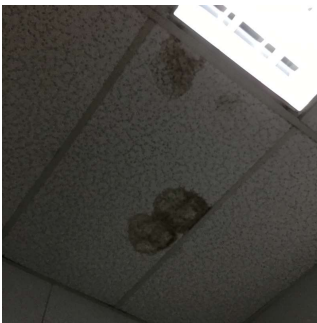
Room 202
Violations	No violations recorded.
Deficiency	GYPSUM BOARD: DAMAGED/DETERIORATED - ACTIVE LEAK
Deficiency Location/Instance	3rd Floor Atrium East Side
Deficiency Quantity	20
Quantity Uom	S.F.
Potential Action	REPLACE
Urgency of Action	PRIORITY 5
Purpose of Action	LEVEL 2
Deficiency Photo1

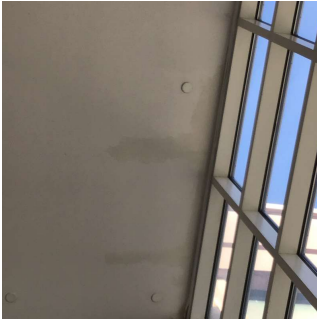
3rd Floor Atrium East Side
Violations	No violations recorded.
<b>Door(s)</b>	Inspected
Condition	2 - Between Good and Fair
Deficiency	No deficiencies recorded
<b>Floor Finish</b>	Inspected
Condition	2 - Between Good and Fair
Deficiency	VINYL TILES: BROKEN/DETERIORATED/MISSING TILES
Deficiency Location/Instance	Corridor near Room 121
Deficiency Quantity	10
Quantity Uom	S.F.
Potential Action	REPLACE
Urgency of Action	PRIORITY 3
Purpose of Action	LEVEL 2

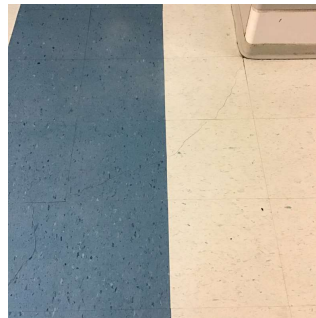
Corridor near Elevator 1st Floor

**VINYL TILES: DETERIORATED SUBSTRATE**

REPLACE

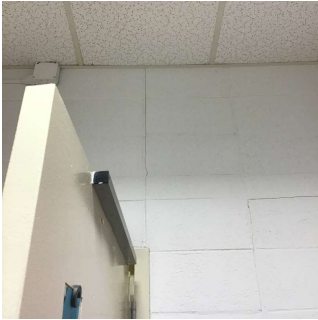
Question	Response
<b>INTERIOR</b>	
<b>CLASSROOMS/CORRIDORS/ADMIN SPACES</b>	
<b>Floor Finish</b>	Inspected
Violations	No violations recorded.
<b>Walls</b>	Inspected
Condition	2 - Between Good and Fair
Deficiency	MASONRY: CRACKS/SPALLING
Deficiency Location/Instance	Rooms 305,220,202
Deficiency Quantity	30
Quantity Uom	S.F.
Potential Action	REPLACE
Urgency of Action	PRIORITY 3
Purpose of Action	LEVEL 2
Deficiency Photo1

Violations	Room 202 No violations recorded.
Deficiency	PLASTER: CRACKS/SPALLING - ACTIVE LEAK
Deficiency Location/Instance	Exit 5 Vestibule
Deficiency Quantity	20
Quantity Uom	S.F.
Potential Action	REPLACE
Urgency of Action	PRIORITY 5
Purpose of Action	LEVEL 2
Deficiency Photo1

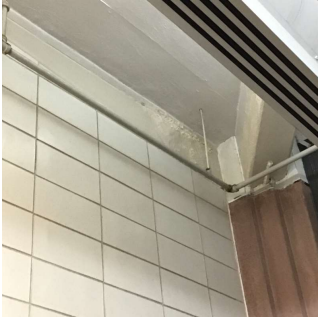
Violations	Exit 5 Vestibule No violations recorded.
Deficiency	GYPSUM BOARD: DETERIORATED
Deficiency Location/Instance	Main Entrance Vestibule, Rooms 412
Deficiency Quantity	30
Quantity Uom	S.F.
Potential Action	REPLACE

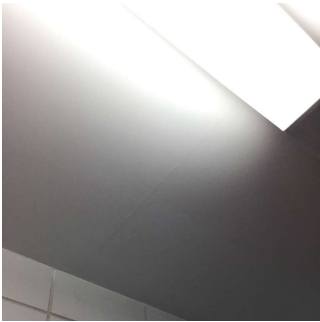
Violations	Stair B/4 No violations recorded.

<b>Question</b>	<b>Response</b>
<b>INTERIOR</b>	
<b>LIBRARY</b>	Inspected
<b>Walls</b>	
Deficiency	No deficiencies recorded
<b>LOCKER ROOM</b>	Does not Exist
<b>MULTI-PURPOSE ROOM</b>	Does not Exist
<b>SCIENCE DEMO ROOM</b>	Inspected
Instance on Room 321	Inspected
Alternative use	No
<b>Fixed Equipment</b>	
Instance on Room 321	Inspected
Condition	2 - Between Good and Fair
Deficiency	No deficiencies recorded
<b>SCIENCE LAB</b>	Does not Exist
<b>SCIENCE PREP ROOM</b>	Inspected
Instance on Room 321A	Inaccessible
<b>SHOWER ROOM</b>	Does not Exist
<b>STAIRS/RAMPS: INTERIOR</b>	Inspected
Do Letter Stair Signs Exist?	Yes
<b>Ceiling</b>	Inspected
Condition	2 - Between Good and Fair
Deficiency	GYPSUM BOARD: DAMAGED/DETERIORATED
Deficiency Location/Instance	Stair B/4, Exit 8 Vestibule
Deficiency Quantity	30
Quantity Uom	S.F.
Potential Action	REPLACE
Urgency of Action	PRIORITY 3
Purpose of Action	LEVEL 2
Deficiency Photo1

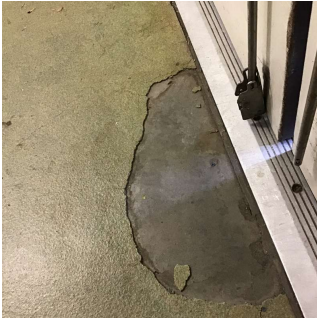
<b>Door(s)</b>	Inspected
Condition	2 - Between Good and Fair
Deficiency	No deficiencies recorded
<b>Partition</b>	Does not Exist
<b>Railings</b>	Inspected
Condition	2 - Between Good and Fair
Deficiency	No deficiencies recorded
<b>Stairs and Landings</b>	Inspected
Condition	2 - Between Good and Fair
Deficiency	EPOXY FLOORING: CRACKS/SPALLING
Deficiency Location/Instance	Exit 8 Vestibule

Question	Response
<b>INTERIOR</b>	
<b>STAIRS/RAMPS: INTERIOR</b>	
<b>Stairs and Landings</b>	
Deficiency Quantity	50
Quantity Uom	S.F.
Potential Action	REPLACE
Urgency of Action	PRIORITY 3
Purpose of Action	LEVEL 2
Deficiency Photo1

Violations	Exit 8 Vestibule No violations recorded.
Deficiency	TERRAZZO: CRACKS
Deficiency Location/Instance	Stairs A/4, B/Bulkhead,1, Exit 8 Vestibule
Deficiency Quantity	40
Quantity Uom	S.F.
Potential Action	REPLACE
Urgency of Action	PRIORITY 3
Purpose of Action	LEVEL 2
Deficiency Photo1

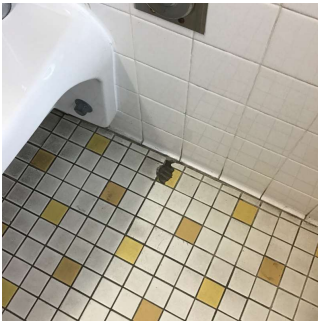
Question	Response
<b>INTERIOR</b>	
<b>TOILET ROOMS - STUDENTS</b>	
<b>Floor Finish</b>	
Deficiency Photo1

Violations	Room 315 No violations recorded.
<b>Stalls</b>	Inspected
Condition	2 - Between Good and Fair
Deficiency	No deficiencies recorded
<b>Walls</b>	Inspected
Condition	2 - Between Good and Fair
Deficiency	CERAMIC TILE: BROKEN/ MISSING
Deficiency Location/Instance	Rooms 409,315,309,215, In Room 101
Deficiency Quantity	50
Quantity Uom	S.F.
Potential Action	REPLACE
Urgency of Action	PRIORITY 3
Purpose of Action	LEVEL 2
Deficiency Photo1

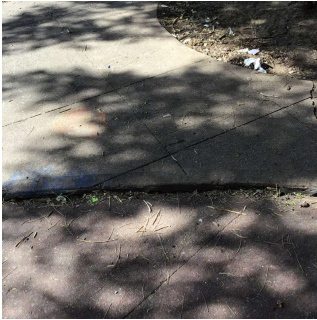
Question	Response
<b>SITE</b>	
<b>PAVING</b>	
<b>Student Use</b>	
<b>Concrete</b>	
Condition	3 - Fair
Deficiency	HEAVING
Deficiency Location/Instance	Schoolyard
Deficiency Quantity	25
Quantity Uom	S.F.
Potential Action	REPLACE
Urgency of Action	PRIORITY 3
Purpose of Action	LEVEL 2
Deficiency Photo1

Violations	Schoolyard No violations recorded.
Deficiency	CRACKS - MAJOR
Deficiency Location/Instance	Schoolyard
Deficiency Quantity	350
Quantity Uom	S.F.
Potential Action	REPLACE
Urgency of Action	PRIORITY 3
Purpose of Action	LEVEL 2
Deficiency Photo1

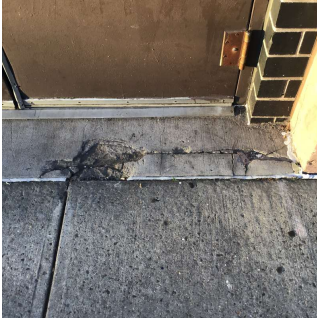
Violations	Schoolyard No violations recorded.
<b>Pavers</b>	Does not Exist
<b>Site Sidewalks &amp; Walkways</b>	Inspected
<b>Asphalt</b>	Does not Exist
<b>Concrete</b>	Inspected
Condition	3 - Fair
Deficiency	DAMAGED/DETERIORATED/MISSING SECTIONS
Deficiency Location/Instance	63rd Street, 9th Avenue, 64th Street
Deficiency Quantity	150
Quantity Uom	S.F.

Question	Response
<b>SITE</b>	
<b>PAVING</b>	
<b>Site Sidewalks &amp; Walkways</b>	
<b>Concrete</b>	
Potential Action	REPLACE
Urgency of Action	PRIORITY 3
Purpose of Action	LEVEL 2
Deficiency Photo1

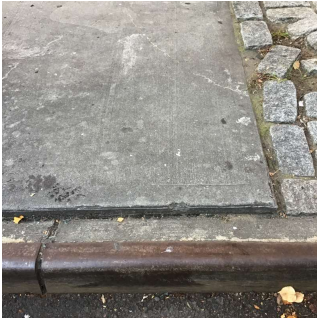
63rd Street
Violations	No violations recorded.
Deficiency	DAMAGED/DETERIORATED/MISSING SECTIONS
Deficiency Location/Instance	63rd Street, 9th Avenue
Deficiency Quantity	1,050
Quantity Uom	S.F.
Potential Action	REPLACE
Urgency of Action	PRIORITY 3
Purpose of Action	LEVEL 2

63rd Street
Violations	No violations recorded.
<b>Pavers</b>	Does not Exist
<b>DOT Sidewalk</b>	Inspected
<b>Asphalt</b>	Does not Exist
<b>Concrete</b>	Inspected
Condition	4 - Between Fair and Poor
Deficiency	HEAVING
Deficiency Location/Instance	63rd Street, 9th Avenue, 64th Street
Deficiency Quantity	275
Quantity Uom	S.F.
Potential Action	REPLACE
Urgency of Action	PRIORITY 3
Purpose of Action	LEVEL 2
Deficiency Photo1

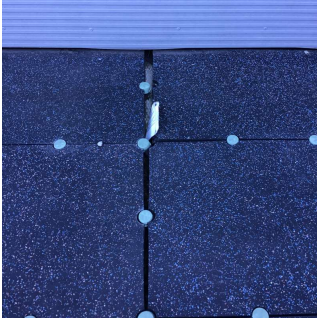
Question	Response
<b>SITE</b>	
<b>PLAYGROUNDS</b>	
<b>Safety Surfacing</b>	
Condition	3 - Fair
Deficiency	DETERIORATED/MISSING
Deficiency Location/Instance	Near jumped jungle, By Exit Door
Deficiency Quantity	50
Quantity Uom	S.F.
Potential Action	REPLACE
Urgency of Action	PRIORITY 3
Purpose of Action	LEVEL 2
Deficiency Photo1

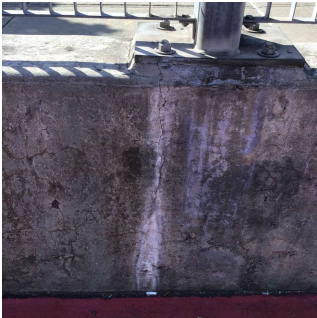
Violations	Schoolyard No violations recorded.
<b>SEATING</b>	Inspected

Violations	Near jumped jungle No violations recorded.
<b>Unpaved Area</b>	
Instance on 2nd Floor Plaza Deck	Does not Exist
<b>PLAYING SURFACE</b>	Does not Exist
<b>RETAINING WALLS</b>	Inspected
Are there any Retaining Walls 6' OR higher facing public street/sidewalk?	Yes
Condition	3 - Fair
Deficiency	CAST IN PLACE CONCRETE: CRACKS/SPALLING - MAJOR
Deficiency Location/Instance	Schoolyard
Deficiency Quantity	30
Quantity Uom	S.F.
Potential Action	REPLACE
Urgency of Action	PRIORITY 3
Purpose of Action	LEVEL 2
Deficiency Photo1
