NYC Department of Education
Building Condition Assessment Survey 2023 - 2024

Architectural Inspection

Asset: P.S. 72 - BROOKLYN, 605 SHEPHERD AVENUE, New York, 11208

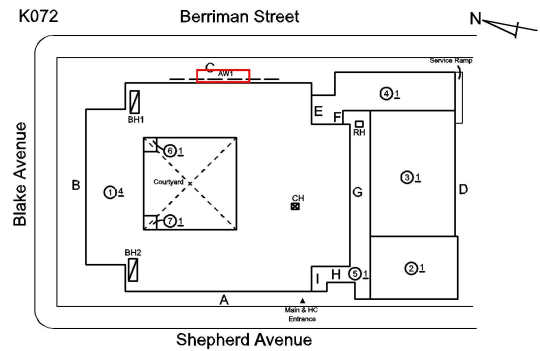
AREAWAY DRAINS: DETERIORATED

2
EACH
REPLACE
PRIORITY 4
LEVEL 2

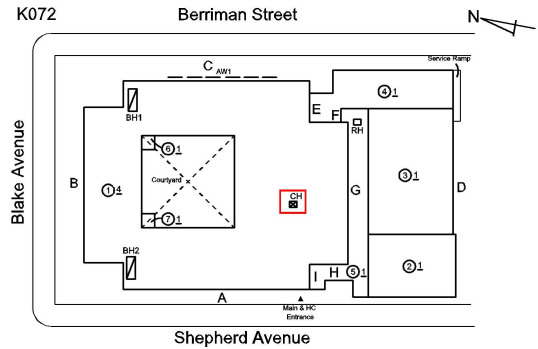
CHIMNEY

BRICK: MINOR CRACKS AND SPALLING

30
S.F.
RESTITCH
PRIORITY 3
LEVEL 2

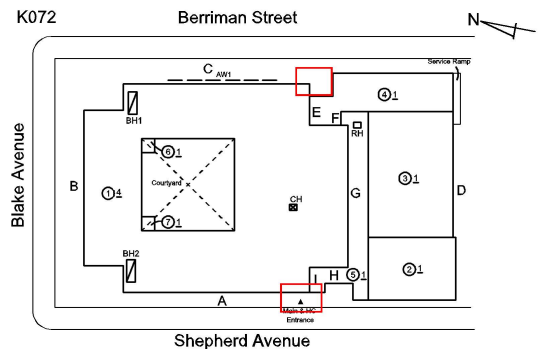
METAL CLAD: DETERIORATED DOOR - MAJOR DETERIORATION

5
EACH
REPLACE
PRIORITY 4

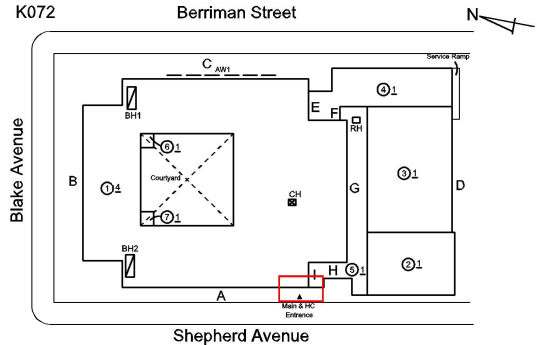
Violations	Facade C No violations recorded.
DOOR HARDWARE	
Condition	Inspected
Deficiency	3 - Fair No deficiencies recorded
LINTELS	
Condition	Inspected
Deficiency	2 - Between Good and Fair No deficiencies recorded
TRANSOM/SIDE LIGHT	
Condition	Inspected
Deficiency	5 - Poor
Roof Plan reference	METAL: DENTED, MAJOR RUSTING K072

Deficiency Quantity	25
Quantity Uom	S.F.
Potential Action	REPLACE
Urgency of Action	PRIORITY 4
Purpose of Action	LEVEL 2
Deficiency Photo1

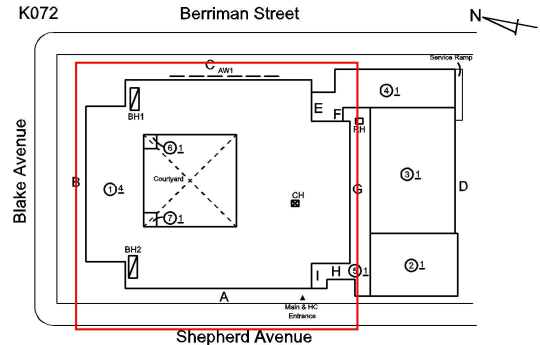
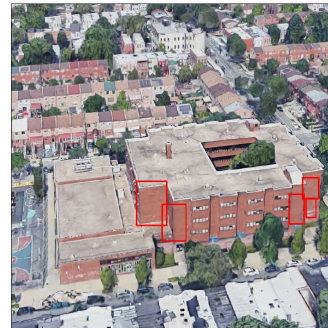
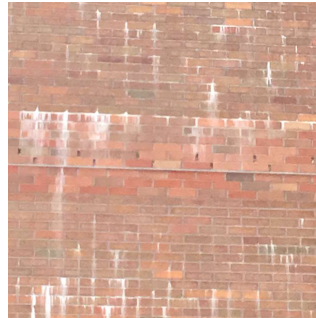
Facade F

BRICK: EFFLORESCENCE

630

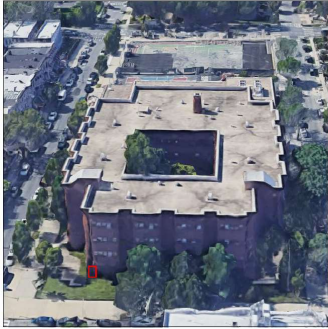
Question	Response
EXTERIOR	
LOUVER	
Condition	3 - Fair
Deficiency	BROKEN/ DENTED BLADES
Roof Plan reference	K072 Berriman Street

Deficiency Quantity	10
Quantity Uom	S.F.
Potential Action	REPLACE
Urgency of Action	PRIORITY 4
Purpose of Action	LEVEL 2
Deficiency Photo1	 
Violations	Facade B No violations recorded.
PARAPETS	
Material Type(s)	Inspected Masonry
Replacement Quantity	13,000
Replacement Uom	C.F.
Instance on All Roofs	Inspected
Instance Condition	1 - Good
Instance Quantity	13,000
Instance Quantity Uom	C.F.
Deficiency	No deficiencies recorded
PLAZA DECK	
	Does not Exist
ROOF	
	Inspected

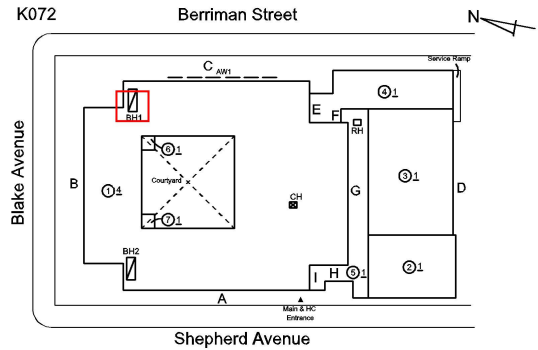
Installation Year	2023
Source of Installation	Custodial Staff
Deficiency	No deficiencies recorded
ROOFING DRAINS	Inspected
Condition	1 - Good
Deficiency	No deficiencies recorded
Specialties	Inspected
BULKHEAD/PENTHOUSE	Inspected
Condition	3 - Fair
Deficiency	BULKHEAD/PENTHOUSE WALLS/EXTERIOR: CRACKS/SPALLING - MINOR

25
 S.F.
 REPAIR
 PRIORITY 3
 LEVEL 2

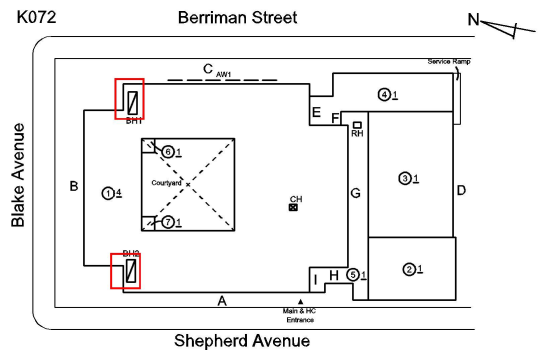
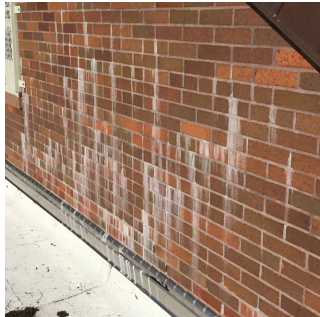
**BULKHEAD/PENTHOUSE WALLS/EXTERIOR:
 EFFLORESCENCE**

150
 S.F.
 MAINTENANCE
 PRIORITY 1
 LEVEL 1

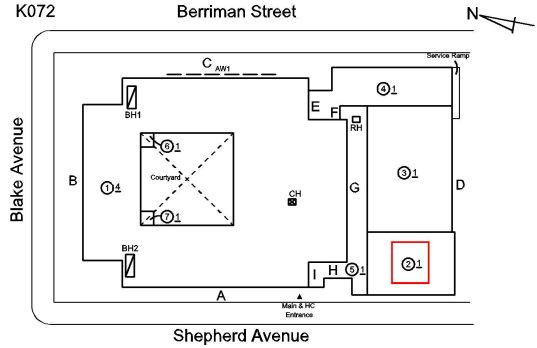
Violations	BH1 No violations recorded.
CUPOLA/ SPIRES/ TOWERS	Does not Exist
DORMER	Does not Exist
DUNNAGE STEEL	Inspected
Condition	3 - Fair
Deficiency	HEIGHT LESS THAN 18"
Roof Plan reference	K072 Berriman Street

Deficiency Quantity	60
Quantity Uom	L.F.
Potential Action	REPLACE
Urgency of Action	PRIORITY 3
Purpose of Action	LEVEL 2
Deficiency Photo1

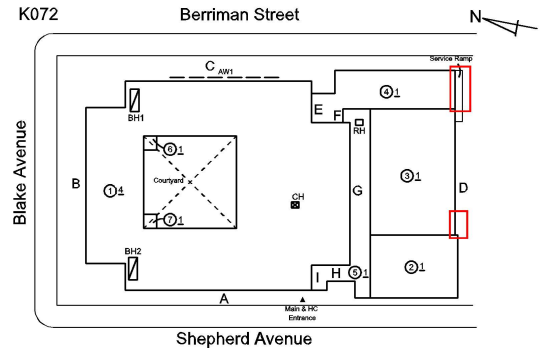
CAST IN PLACE CONCRETE: CRACKS/SPALLING - MAJOR
K072

30
S.F.
REPLACE
PRIORITY 4
LEVEL 2

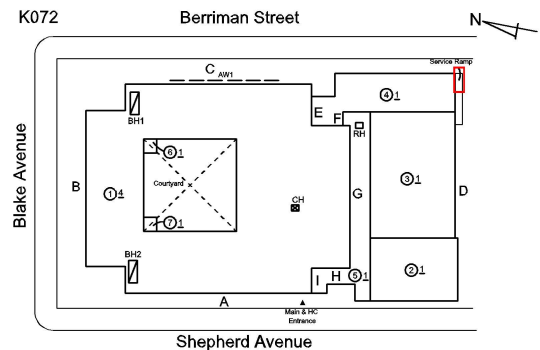
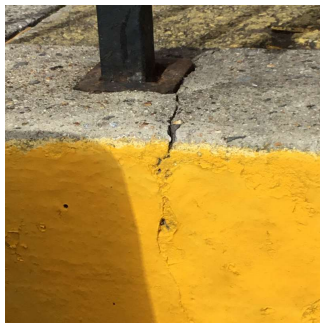
CAST IN PLACE CONCRETE: CRACKS/SPALLING - MINOR
K072

25
S.F.
REPAIR
PRIORITY 3
LEVEL 2

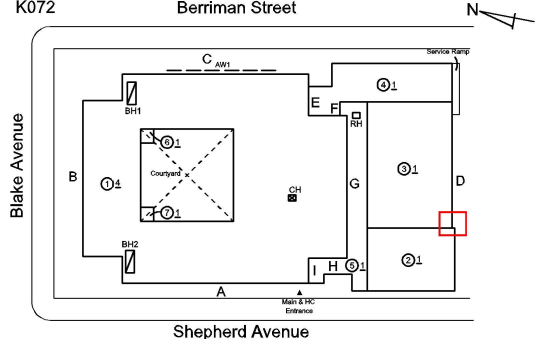
Violations	Facade D No violations recorded.
RAILINGS	Inspected
Condition	5 - Poor
Deficiency	RUST - MAJOR
Roof Plan reference	K072 Berriman Street

Blake Avenue Shepherd Avenue
Deficiency Quantity	10
Quantity Uom	L.F.
Potential Action	REPLACE
Urgency of Action	PRIORITY 4
Purpose of Action	LEVEL 2
Deficiency Photo1

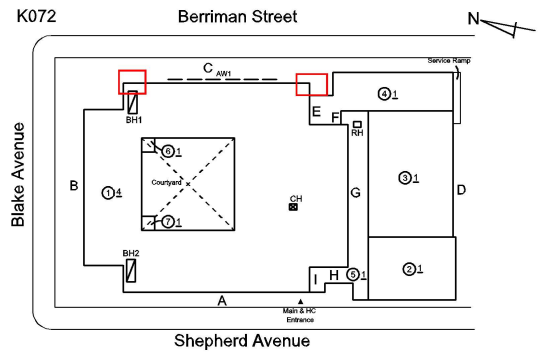
RAILINGS

Violations	Facade D No violations recorded.
Deficiency	DAMAGED

35
L.F.
REPLACE
PRIORITY 4
LEVEL 2

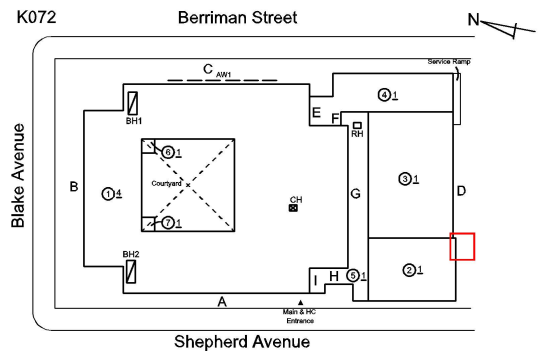
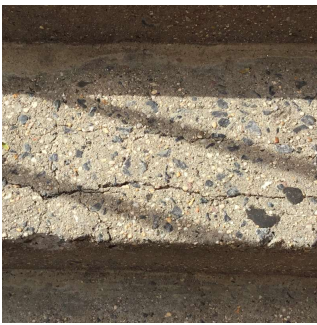
CONCRETE: CRACKS/SPALLING - MINOR

20
S.F.
REPAIR
PRIORITY 3
LEVEL 2

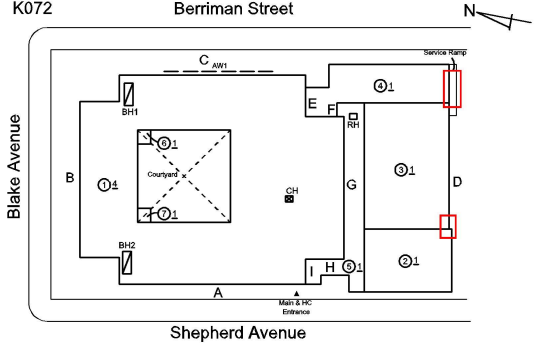
Violations	Facade D No violations recorded.
Deficiency	CONCRETE: CRACKS/SPALLING - MAJOR
Roof Plan reference	K072 Berriman Street

Blake Avenue Shepherd Avenue
Deficiency Quantity	45
Quantity Uom	S.F.
Potential Action	REPLACE
Urgency of Action	PRIORITY 4
Purpose of Action	LEVEL 2
Deficiency Photo1

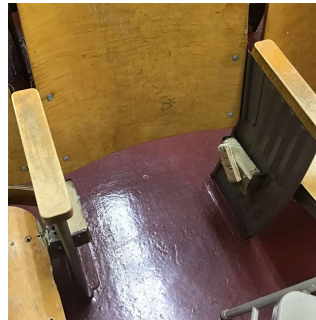
Seat A/20

Violations	No violations recorded.
FOUNDATION WALLS	
Material Type(s)	Inspected Concrete
Condition	2 - Between Good and Fair
Deficiency	No deficiencies recorded
ROOF STRUCTURE	
Condition	Inspected 2 - Between Good and Fair
Deficiency	No deficiencies recorded
VAULTS-BUNKERS	
Does not Exist	
AUDITORIUM	
Instance on 1st Floor (216 seats)	Inspected Inspected
Ceiling	
Instance on 1st Floor (216 seats)	Inspected
Condition	2 - Between Good and Fair
Deficiency	No deficiencies recorded
Door(s)	
Instance on 1st Floor (216 seats)	Inspected
Condition	2 - Between Good and Fair
Deficiency	No deficiencies recorded
Fixed H/C Lift	
Instance on 1st Floor (216 seats)	Does not Exist
Fixed Seating	
Instance on 1st Floor (216 seats)	Inspected
Condition	5 - Poor
Deficiency	DAMAGED/BROKEN/INOPERABLE
Deficiency Location/Instance	Seats A/6, B/2, D/8, E/22, F/18, and others

Deficiency Quantity	12
Quantity Uom	EACH
Potential Action	REPLACE
Urgency of Action	PRIORITY 3
Purpose of Action	LEVEL 2

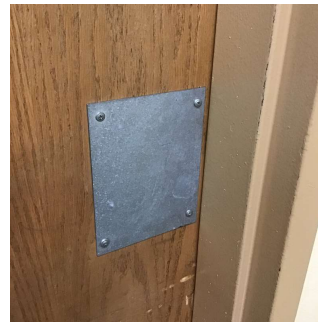
Corridor near Stair B/4

Room 203
Violations	No violations recorded.
Deficiency	WOOD: DETERIORATED DOOR
Deficiency Location/Instance	Rooms 405, 331, 125, Corridor near Stair B/4, D/3, and others
Deficiency Quantity	18
Quantity Uom	EACH
Potential Action	MAINTENANCE
Urgency of Action	PRIORITY 3
Purpose of Action	LEVEL 2

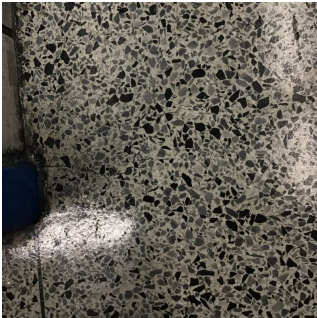
Question	Response
INTERIOR	
CLASSROOMS/CORRIDORS/ADMIN SPACES	
Floor Finish	Inspected
	Corridor near Room 435B
Violations	No violations recorded.
Deficiency	TERRAZZO: CRACKS
Deficiency Location/Instance	Exit 5
Deficiency Quantity	10
Quantity Uom	S.F.
Potential Action	REPLACE
Urgency of Action	PRIORITY 3
Purpose of Action	LEVEL 2
Deficiency Photo1

Exit 5
Violations	No violations recorded.
Walls	Inspected
Condition	2 - Between Good and Fair
Deficiency	GLAZED BLOCK: CRACKS/SPALLING
Deficiency Location/Instance	Corridor near Stair B/3, 2, Exit 8 Vestibule
Deficiency Quantity	20
Quantity Uom	S.F.
Potential Action	REPLACE
Urgency of Action	PRIORITY 3
Purpose of Action	LEVEL 2
Deficiency Photo1

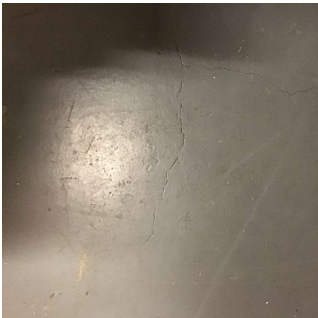
Question	Response
INTERIOR	
KITCHEN	
Door(s)	
Violations	Near exit No violations recorded.
Floor Finish	
Instance on 1st Floor	Inspected
Condition	2 - Between Good and Fair
Deficiency	CONCRETE: CRACKS
Deficiency Location/Instance	Storage
Deficiency Quantity	10
Quantity Uom	S.F.
Potential Action	REPLACE
Urgency of Action	PRIORITY 3
Purpose of Action	LEVEL 2
Deficiency Photo1

Violations	Storage No violations recorded.
Walls	
Instance on 1st Floor	Inspected
Condition	3 - Fair
Deficiency	CERAMIC TILE: BROKEN/ MISSING - ACTIVE LEAK
Deficiency Location/Instance	Kitchen Slop Sink
Deficiency Quantity	20
Quantity Uom	S.F.
Potential Action	REPLACE
Urgency of Action	PRIORITY 5
Purpose of Action	LEVEL 2
Deficiency Photo1

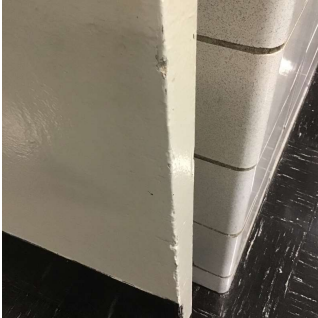
Question	Response
INTERIOR	
MULTI-PURPOSE ROOM	
Door(s)	
Instance on 1st Floor	Inspected
Condition	4 - Between Fair and Poor
Deficiency	WOOD: DETERIORATED DOOR
Deficiency Location/Instance	Entrance
Deficiency Quantity	2
Quantity Uom	EACH
Potential Action	MAINTENANCE
Urgency of Action	PRIORITY 3
Purpose of Action	LEVEL 2
Deficiency Photo1

Violations	Entrance No violations recorded.
Fixed Equipment	
Instance on 1st Floor	Does not Exist
Floor Finish	
Instance on 1st Floor	Inspected
Condition	2 - Between Good and Fair
Deficiency	No deficiencies recorded
Sliding-folding Partition	
Instance on 1st Floor	Inspected
Condition	2 - Between Good and Fair
Deficiency	No deficiencies recorded
Stage	
Instance on 1st Floor	Does not Exist
Walls	
Instance on 1st Floor	Inspected
Condition	2 - Between Good and Fair
Deficiency	PLASTER: CRACKS/SPALLING
Deficiency Location/Instance	Near Sink
Deficiency Quantity	10
Quantity Uom	S.F.
Potential Action	REPLACE

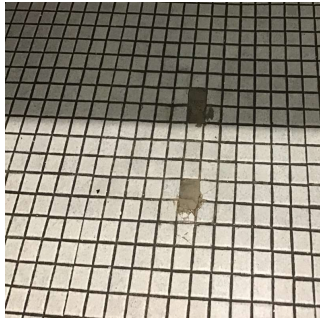
Question	Response
INTERIOR	
TOILET ROOMS - STUDENTS	
Floor Finish	
Violations	Room 326 No violations recorded.
Deficiency	CERAMIC TILE: BROKEN/MISSING TILES
Deficiency Location/Instance	Room 436, 406, 404, Near Room 421 - Boys, Girls, and others
Deficiency Quantity	60
Quantity Uom	S.F.
Potential Action	REPLACE
Urgency of Action	PRIORITY 3
Purpose of Action	LEVEL 2
Deficiency Photo1

Violations	Room 406 No violations recorded.
Stalls	Inspected
Condition	2 - Between Good and Fair
Deficiency	BROKEN/MISSING
Deficiency Location/Instance	Near Room 421 - Boys, Rooms 226, 224
Deficiency Quantity	3
Quantity Uom	EACH
Potential Action	REPLACE
Urgency of Action	PRIORITY 3
Purpose of Action	LEVEL 2
Deficiency Photo1

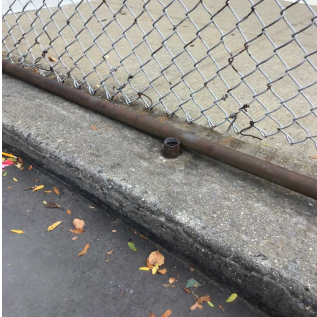
Question	Response
SITE	
Drainage System for Concrete	Inspected
Culverts - Concrete Covering	Does not Exist
Drainage System for Soil	Inspected
Catch Basins/Manhole - Surrounded by Soil	Inspected
Condition	2 - Between Good and Fair
Deficiency	No deficiencies recorded
Culverts - Soil Covering	Does not Exist
DRINKING FOUNTAINS	Does not Exist
FENCES	Inspected
Condition	4 - Between Fair and Poor
Deficiency	CHAIN LINK: DAMAGED POST/RAIL
Deficiency Location/Instance	Schoolyard
Deficiency Quantity	10
Quantity Uom	L.F.
Potential Action	REPLACE
Urgency of Action	PRIORITY 5
Purpose of Action	LEVEL 6
Deficiency Photo1

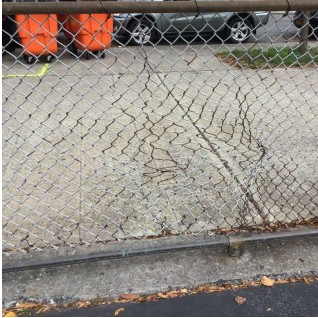
Deficiency	CHAIN LINK: DAMAGED/DETERIORATED
Deficiency Location/Instance	Schoolyard
Deficiency Quantity	500

Question	Response
SITE	
FENCES	
Quantity Uom	S.F.
Potential Action	REPLACE
Urgency of Action	PRIORITY 3
Purpose of Action	LEVEL 2
Deficiency Photo1

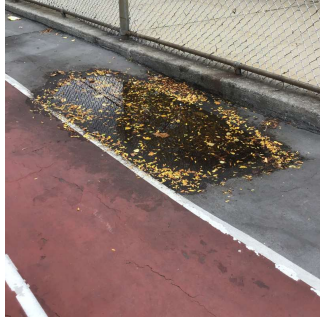
Violations	Schoolyard No violations recorded.
IRRIGATION SYSTEM	
	Does not Exist
PAVING	
	Inspected
Student Non-Use	
	Does not Exist
Student Use	
Gravel Exists?	No
Asphalt	
Condition	Inspected 4 - Between Fair and Poor
Deficiency	LOCALIZED SINK AREA
Deficiency Location/Instance	Schoolyard
Deficiency Quantity	40
Quantity Uom	S.F.
Potential Action	REPAIR
Urgency of Action	PRIORITY 3
Purpose of Action	LEVEL 2

Question	Response
SITE	
PAVING	
Student Use	
Asphalt	
Deficiency Photo1

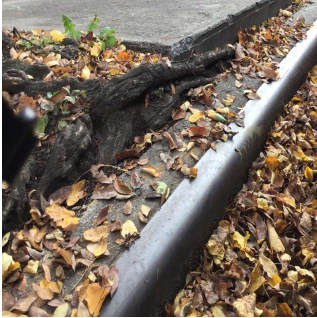
Question	Response
SITE	
PAVING	
Student Use	
Concrete	Inspected
Deficiency Photo1	 
	Courtyard
Violations	No violations recorded.
Pavers	Does not Exist
Site Sidewalks & Walkways	Inspected
Asphalt	Does not Exist
Concrete	Inspected
Condition	4 - Between Fair and Poor
Deficiency	CRACKS - MAJOR
Deficiency Location/Instance	Walkway Between school and Schoolyard
Deficiency Quantity	500
Quantity Uom	S.F.
Potential Action	REPLACE
Urgency of Action	PRIORITY 3
Purpose of Action	LEVEL 2
Deficiency Photo1	 
	Walkway Between school and Schoolyard
Violations	No violations recorded.
Pavers	Does not Exist
DOT Sidewalk	Inspected
Asphalt	Does not Exist
Concrete	Inspected
Condition	4 - Between Fair and Poor
Deficiency	HEAVING
Deficiency Location/Instance	Along Blake Avenue, Berriman Street
Deficiency Quantity	125
Quantity Uom	S.F.
Potential Action	REPLACE
Urgency of Action	PRIORITY 5

Question	Response
SITE	
PAVING	
DOT Sidewalk	
Concrete	
Purpose of Action	LEVEL 6
Deficiency Photo1

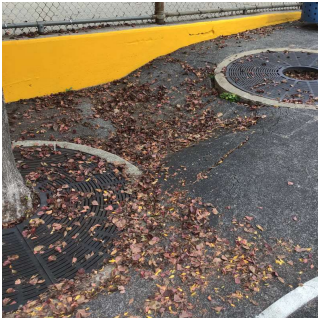
Question	Response
SITE	
PLAYGROUNDS	
Pavement	
Deficiency	ASPHALT: LOCALIZED SINK AREA
Deficiency Location/Instance	Near Equipment
Deficiency Quantity	50
Quantity Uom	S.F.
Potential Action	REPAIR
Urgency of Action	PRIORITY 5
Purpose of Action	LEVEL 6
Deficiency Photo1

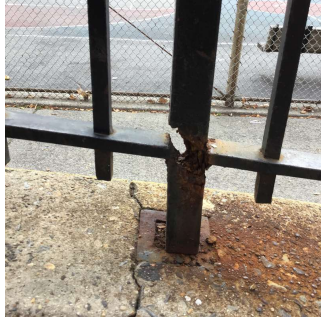
Question	Response
SITE	
STAIRS/RAMPS: EXTERIOR	Inspected
Railings	Inspected
Condition	3 - Fair
Deficiency	RUST - MAJOR
Deficiency Location/Instance	Between school and Schoolyard
Deficiency Quantity	80
Quantity Uom	L.F.
Potential Action	REPLACE
Urgency of Action	PRIORITY 3
Purpose of Action	LEVEL 2
Deficiency Photo1

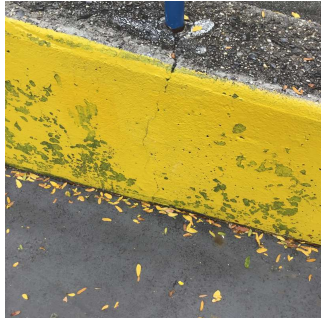
Violations	Between school and Schoolyard No violations recorded.
Site Cheek/flank Walls	Inspected
Condition	2 - Between Good and Fair
Deficiency	CAST IN PLACE CONCRETE: CRACKS/SPALLING - MAJOR
Deficiency Location/Instance	Schoolyard
Deficiency Quantity	10
Quantity Uom	S.F.
Potential Action	REPLACE
Urgency of Action	PRIORITY 3
Purpose of Action	LEVEL 2
Deficiency Photo1
