NYC Department of Education
Building Condition Assessment Survey 2023 - 2024

Architectural Inspection

K075

Asset: P.S. 75 - BROOKLYN, 95 GROVE STREET, New York, 11221

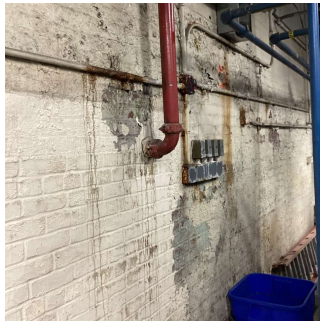
Violations	Boiler Room No violations recorded.
FOUNDATION WALLS	
Material Type(s)	Inspected Masonry
Condition	5 - Poor
Deficiency	BRICK: CRACKED/SPALLED
Deficiency Location/Instance	Basement - Boiler Room
Deficiency Quantity	20
Quantity Uom	S.F.
Potential Action	RESTITCH
Urgency of Action	PRIORITY 3
Purpose of Action	LEVEL 5
Deficiency Photo1

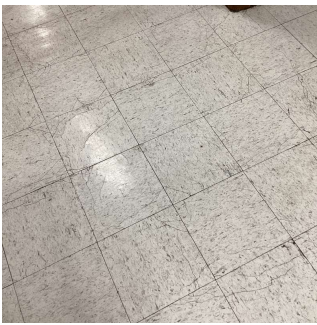
Question	Response
INTERIOR	
CAFETERIA	
Floor Finish	
Deficiency Photo1

Violations	Near Stair A/B No violations recorded.
Sliding-folding Partition	
Instance on Basement	Does not Exist
Stage	
Instance on Basement	Does not Exist
Walls	
Instance on Basement	Inspected
Condition	2 - Between Good and Fair
Deficiency	PLASTER: CRACKS/SPALLING - ACTIVE LEAK
Deficiency Location/Instance	Exit 8, 9 Vestibules
Deficiency Quantity	80
Quantity Uom	S.F.
Potential Action	REPLACE
Urgency of Action	PRIORITY 5
Purpose of Action	LEVEL 2
Deficiency Photo1

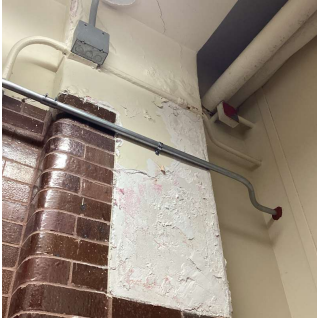
Violations	Exit 9 Vestibule No violations recorded.
Deficiency	SALT GLAZED BRICK: CRACKS/SPALLING
Deficiency Location/Instance	Near Stair A/B, Along Windows, Exit 8, Center
Deficiency Quantity	20
Quantity Uom	S.F.
Potential Action	REPLACE
Urgency of Action	PRIORITY 3
Purpose of Action	LEVEL 2

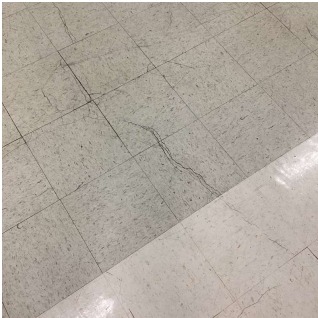
Question	Response
INTERIOR	
CLASSROOMS/CORRIDORS/ADMIN SPACES	
Floor Finish	
Violations	Room 411 No violations recorded.
Deficiency	VINYL TILES: DETERIORATED SUBSTRATE
Deficiency Location/Instance	Corridor near rooms 100, 108, 111, 115, 116 and others
Deficiency Quantity	7,500
Quantity Uom	S.F.
Potential Action	REPLACE
Urgency of Action	PRIORITY 3
Purpose of Action	LEVEL 2
Deficiency Photo1

Violations	Corridor near room 115 No violations recorded.
Walls	Inspected
Condition	2 - Between Good and Fair
Deficiency	CERAMIC TILE: BROKEN/ MISSING
Deficiency Location/Instance	Main Entrance Vestibule
Deficiency Quantity	10
Quantity Uom	S.F.
Potential Action	REPLACE
Urgency of Action	PRIORITY 3
Purpose of Action	LEVEL 2
Deficiency Photo1

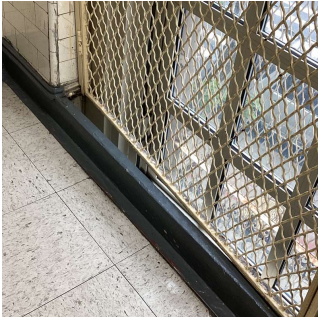
Question	Response
INTERIOR	
GYMNASIUM	
Sliding-folding Partition	
Purpose of Action	LEVEL 2
Deficiency Photo1	No photo recorded
Violations	No violations recorded.
Stage	
Instance on 3rd Floor	Does not Exist
Walls	
Instance on 3rd Floor	Inspected
Condition	2 - Between Good and Fair
Deficiency	No deficiencies recorded
Window Curtains/Shades/Blinds	
Instance on 3rd Floor	Does not Exist
INTERIOR DOOR HARDWARE	
Condition	Inspected
Condition	3 - Fair
Deficiency	No deficiencies recorded
INTERIOR GUARDS	
Condition	Inspected
Condition	2 - Between Good and Fair
Deficiency	DETERIORATED/TORN-OUT/MISSING
Deficiency Location/Instance	Boys Toilet Room - Basement
Deficiency Quantity	25
Quantity Uom	S.F.
Potential Action	REPLACE
Urgency of Action	PRIORITY 3
Purpose of Action	LEVEL 2
Deficiency Photo1

Stair AB/1
Violations	No violations recorded.
KITCHEN	
Instance on Basement	Inspected
Instance on Basement	Inspected
Ceiling	
Instance on Basement	Inspected

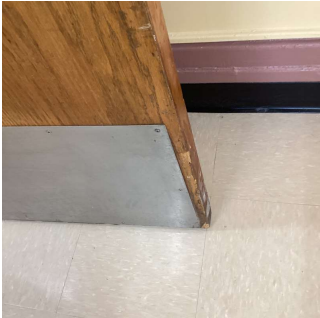
Question	Response
INTERIOR	
LIBRARY	
Ceiling	
Deficiency	No deficiencies recorded
Door(s)	
Instance on Room 310	Inspected
Condition	3 - Fair
Deficiency	WOOD: DETERIORATED DOOR
Deficiency Location/Instance	Entrance
Deficiency Quantity	1
Quantity Uom	EACH
Potential Action	MAINTENANCE
Urgency of Action	PRIORITY 3
Purpose of Action	LEVEL 2
Deficiency Photo1

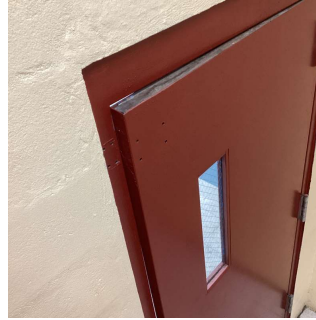
Deficiency	METAL: DETERIORATED DOOR AND FRAME
Deficiency Location/Instance	Stair A/B Basement
Deficiency Quantity	1
Quantity Uom	EACH

MAINTENANCE
PRIORITY 3
LEVEL 2

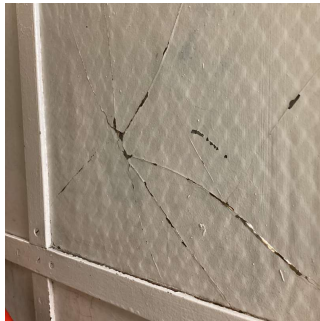
Question	Response
INTERIOR	
STAIRS/RAMPS: INTERIOR	
Partition	
Deficiency Photo1

Stair C/D 1
Violations	No violations recorded.
Deficiency	METAL PANEL: DAMAGED/DETERIORATED
Deficiency Location/Instance	Stair A/B Basement, C/D 2
Deficiency Quantity	10
Quantity Uom	S.F.
Potential Action	REPLACE
Urgency of Action	PRIORITY 3
Purpose of Action	LEVEL 2
Deficiency Photo1

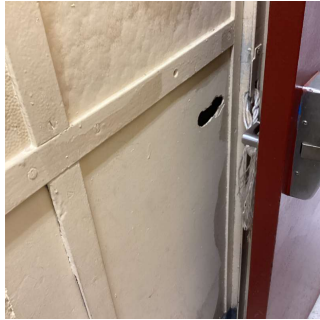
Stair A/B Basement
Violations	No violations recorded.
Railings	Inspected
Condition	2 - Between Good and Fair
Deficiency	No deficiencies recorded
Stairs and Landings	Inspected
Condition	5 - Poor
Deficiency	STONE: BROKEN/MISSING
Deficiency Location/Instance	Stairs A/B 1, 2, C/D 1,2
Deficiency Quantity	30
Quantity Uom	S.F.
Potential Action	REPLACE
Urgency of Action	PRIORITY 3
Purpose of Action	LEVEL 2

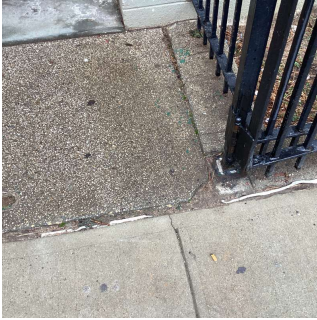
Question	Response
SITE	
PAVING	
Site Sidewalks & Walkways	
Asphalt	Inspected
Condition	1 - Good
Deficiency	No deficiencies recorded
Concrete	Inspected
Condition	3 - Fair
Deficiency	CRACKS - MAJOR
Deficiency Location/Instance	Exit 5, Exit 7
Deficiency Quantity	225
Quantity Uom	S.F.
Potential Action	REPLACE
Urgency of Action	PRIORITY 3
Purpose of Action	LEVEL 2
Deficiency Photo1

Violations	Exit 5 No violations recorded.
Pavers	Does not Exist
DOT Sidewalk	Inspected
Asphalt	Does not Exist
Concrete	Inspected
Condition	4 - Between Fair and Poor
Deficiency	HEAVING
Deficiency Location/Instance	Evergreen Avenue
Deficiency Quantity	50
Quantity Uom	S.F.
Potential Action	REPLACE
Urgency of Action	PRIORITY 5
Purpose of Action	LEVEL 6
Deficiency Photo1

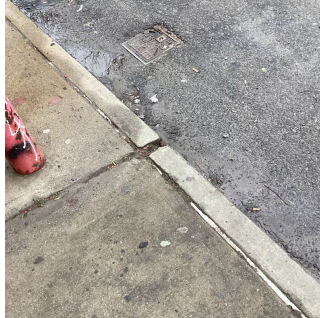
Question	Response
SITE	
PAVING	
DOT Sidewalk	
Concrete	
Deficiency Photo1

Violations	Grove Street No violations recorded.
Pavers	Does not Exist
PLAYGROUNDS	Does not Exist
PLAYING SURFACE	Does not Exist
RETAINING WALLS	Does not Exist
SEATING	Does not Exist
SITE WALLS (NOT RETAINING WALLS)	Inspected
Condition	3 - Fair
Deficiency	BRICK: CRACKS/SPALLING - MAJOR
Deficiency Location/Instance	Schoolyard
Deficiency Quantity	30
Quantity Uom	S.F.
Potential Action	REPLACE
Urgency of Action	PRIORITY 3
Purpose of Action	LEVEL 2
Deficiency Photo1	 
Violations	Schoolyard No violations recorded.
STAIRS/RAMPS: EXTERIOR	Does not Exist
ARTWORK	Inspected
Instance	Interior - Library Room 310 - 71181
Instance Photo
