NYC Department of Education
Building Condition Assessment Survey 2023 - 2024

Architectural Inspection

Asset: I.S. 88 - BROOKLYN, 544 7TH AVENUE, New York, 11215

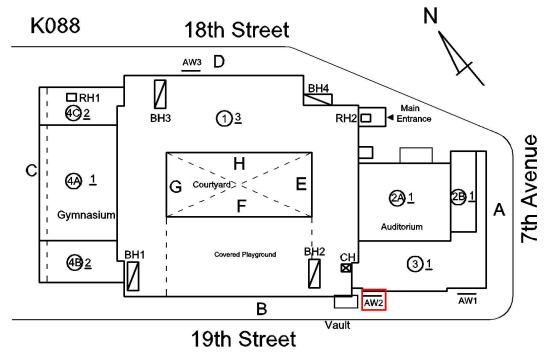
Roof Plan reference

Question	Response
Architectural	
EXTERIOR	Inspected
AREAWAY	Inspected
Instance on AW1 - AW2	Inspected
Instance Condition	3 - Fair
Instance Quantity	2
Instance Quantity Uom	EACH
Deficiency	AREAWAY WALLS: CRACKS AND SPALLING

AREAWAY

30
S.F.
REPAIR
PRIORITY 3
LEVEL 2

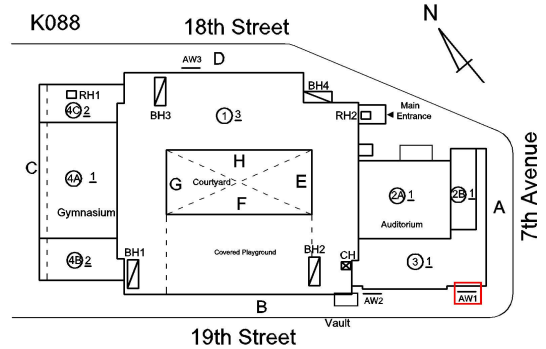
Roof Plan reference

AREAWAY STAIRS: DETERIORATED MATERIAL SLIDE

10
S.F.
REPLACE
PRIORITY 3
LEVEL 2

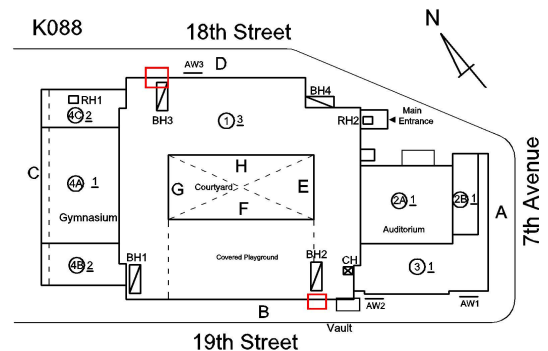
Roof Plan reference

Deficiency METAL: DETERIORATED DOOR AND FRAME - MAJOR DETERIORATION

Deficiency Quantity	4
Quantity Uom	EACH
Potential Action	REPLACE
Urgency of Action	PRIORITY 4
Purpose of Action	LEVEL 2

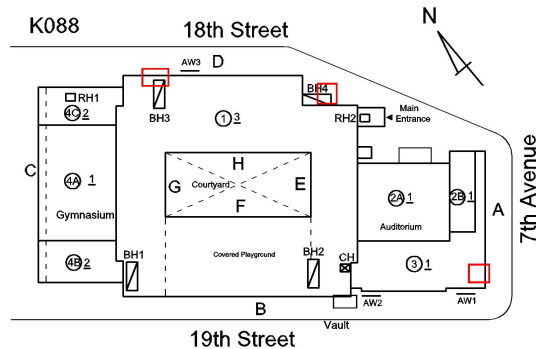
Violations	Facade B - Stair D Exit No violations recorded.
Deficiency	METAL: DETERIORATED DOOR AND FRAME - MINOR DETERIORATION
Roof Plan reference

Deficiency Quantity	6
Quantity Uom	EACH
Potential Action	MAINTENANCE
Urgency of Action	PRIORITY 3
Purpose of Action	LEVEL 2
Deficiency Photo1

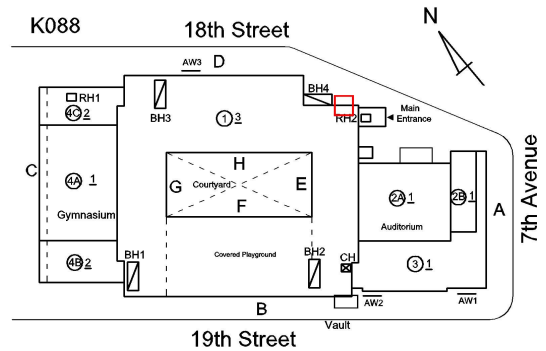
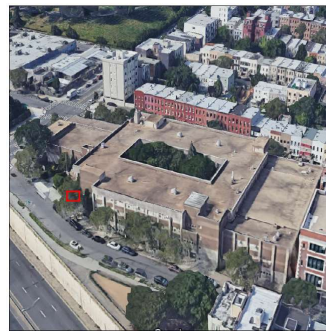
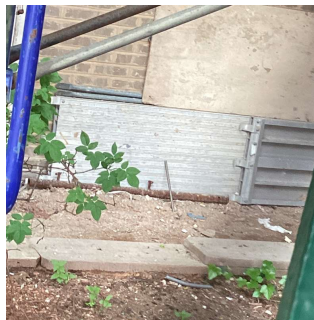
Facade D
No violations recorded.

Deficiency Broken/ Dented Blades
Roof Plan reference

Deficiency Quantity 10
Quantity Uom S.F.
Potential Action REPLACE
Urgency of Action PRIORITY 4
Purpose of Action LEVEL 2
Deficiency Photo1

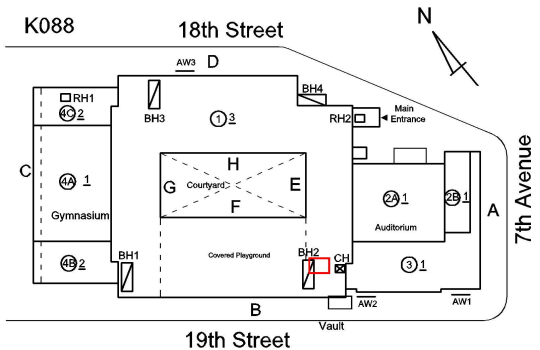
Question	Response
EXTERIOR	
PARAPETS	Inspected
Material Type(s)	Masonry
Replacement Quantity	12,000
Replacement Uom	C.F.
Instance on All Roofs	Under Construction
Instance Quantity	12,000
Instance Quantity Uom	C.F.
PLAZA DECK	Does not Exist
ROOF	Inspected
Roofing	Inspected
Replacement Quantity	60,000
Replacement Uom	S.F.
ROOF HATCH/SMOKE HATCH	Inspected
Condition	2 - Between Good and Fair
Deficiency	No deficiencies recorded
LEADERS, GUTTERS, DOWNSPOUTS, SCUPPERS	Inspected
Condition	3 - Fair
Deficiency	DAMAGED/MISSING
Roof Plan reference

Deficiency Quantity	10
Quantity Uom	L.F.
Potential Action	REPLACE
Urgency of Action	PRIORITY 4
Purpose of Action	LEVEL 2
Deficiency Photo1

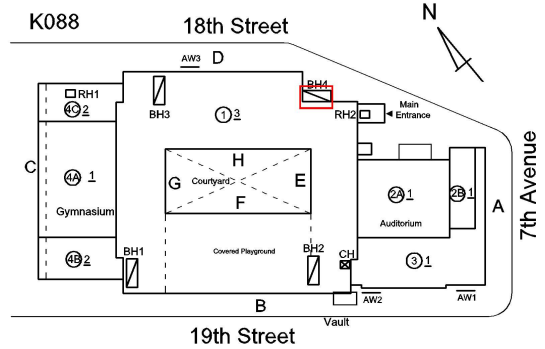
Roof 1
Instance Quantity	60,000
Instance Quantity Uom	S.F.
ROOFING DRAINS	Inspected
Condition	2 - Between Good and Fair
Deficiency	No deficiencies recorded
Specialties	Inspected
BULKHEAD/PENTHOUSE	Inspected
Condition	3 - Fair
Deficiency	BULKHEAD/PENTHOUSE CEILING: PLASTER DAMAGED/DETERIORATED
Roof Plan reference

Deficiency Quantity	20
Quantity Uom	S.F.
Potential Action	REPLACE
Urgency of Action	PRIORITY 3
Purpose of Action	LEVEL 2
Deficiency Photo1

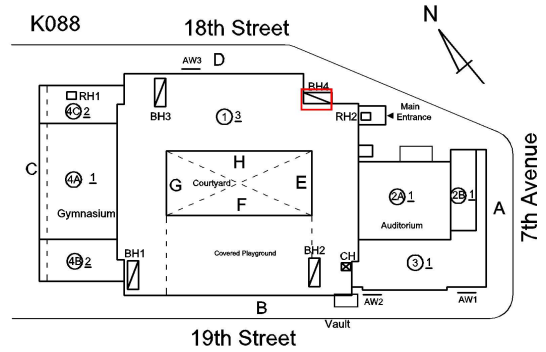
Roof Plan reference

BH4
Violations	No violations recorded.
Deficiency	BULKHEAD/PENTHOUSE ROOF: MINOR LEAKAGE

50
S.F.
MAINTENANCE
PRIORITY 3
LEVEL 2

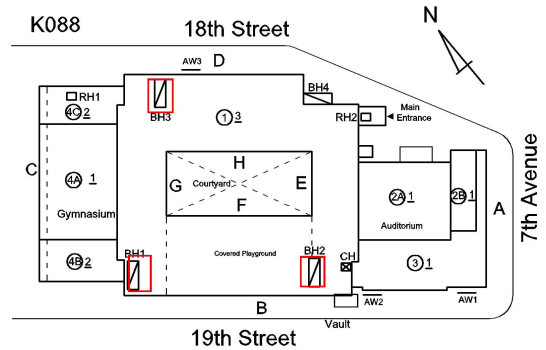
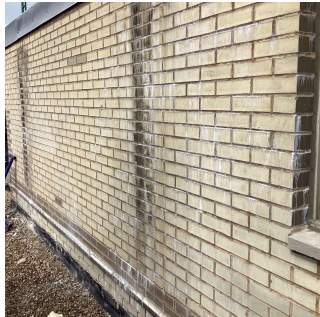
**BULKHEAD/PENTHOUSE WALLS/EXTERIOR:
EFFLORESCENCE**

200
S.F.
MAINTENANCE
PRIORITY 1
LEVEL 1

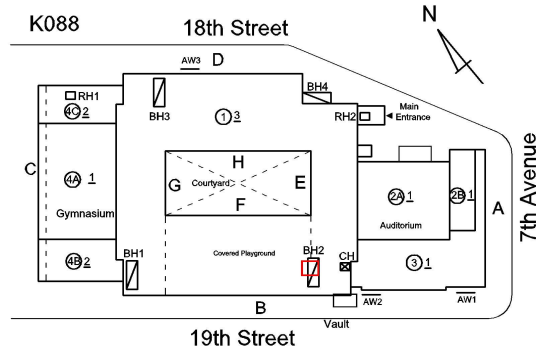
BH2
Violations	No violations recorded.
Deficiency	BULKHEAD/PENTHOUSE WINDOWS: DAMAGED, DETERIORATED WINDOWS
Roof Plan reference

Deficiency Quantity	10
Quantity Uom	S.F.
Potential Action	REPLACE
Urgency of Action	PRIORITY 4
Purpose of Action	LEVEL 2
Deficiency Photo1

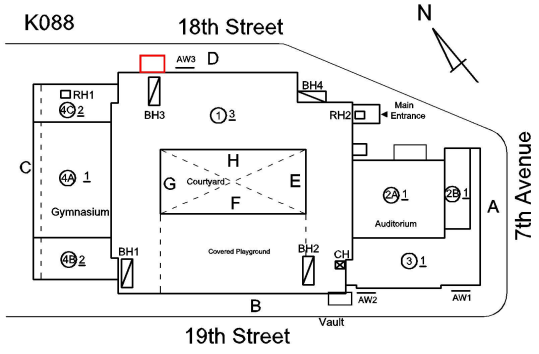
Question	Response
EXTERIOR	
ROOF	Inspected
Specialties	Inspected
ROOF/GRAVITY TANK	Does not Exist
STAIRS/RAMPS: EXTERIOR	Inspected
BUILDING CHEEK/FLANK WALLS	Does not Exist
RAILINGS	Inspected
Condition	2 - Between Good and Fair
Deficiency	No deficiencies recorded
STAIRS/RAMPS	Inspected
Condition	5 - Poor
Deficiency	STONE: DETERIORATED SUBSTRATE
RooF Plan reference

Deficiency Quantity	25
Quantity Uom	S.F.
Potential Action	REPLACE SUBSTRATE AND RESET
Urgency of Action	PRIORITY 4
Purpose of Action	LEVEL 2
Deficiency Photo1	 
Violations	Facade D - Stair B Exit No violations recorded.

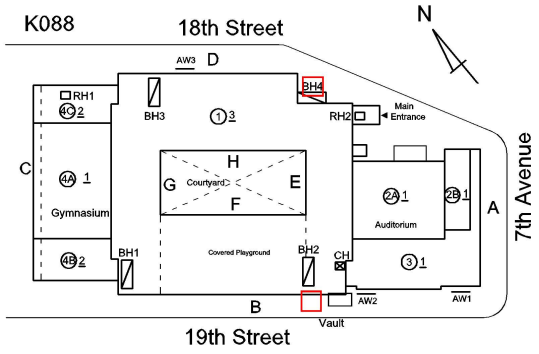
Deficiency	STONE: DETERIORATED JOINTS
RooF Plan reference

Question	Response
EXTERIOR	
STAIRS/RAMPS: EXTERIOR	Inspected
STAIRS/RAMPS	
Quantity Uom	L.F.
Potential Action	REPOINT
Urgency of Action	PRIORITY 3
Purpose of Action	LEVEL 2
Deficiency Photo1

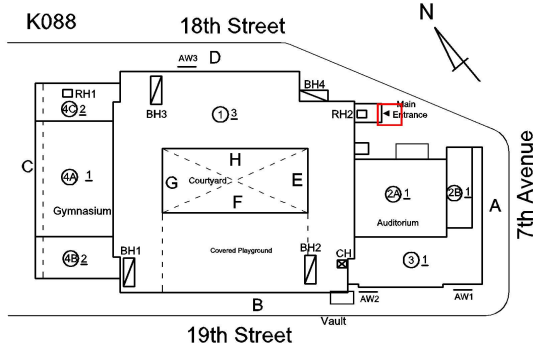
Violations	Facade B - Stair D Exit No violations recorded.
Deficiency	STONE: DETERIORATED JOINTS
Roof Plan reference

Deficiency Quantity	10
Quantity Uom	L.F.
Potential Action	REPOINT
Urgency of Action	PRIORITY 4
Purpose of Action	LEVEL 2
Deficiency Photo1

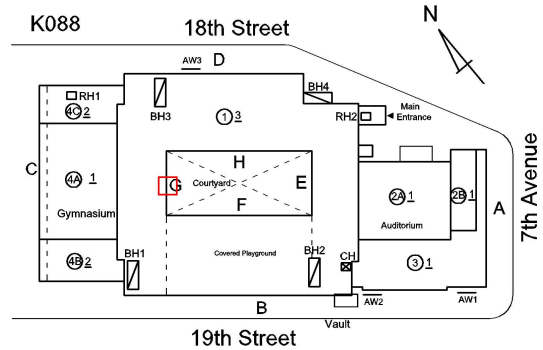
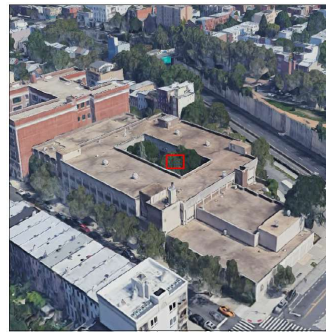
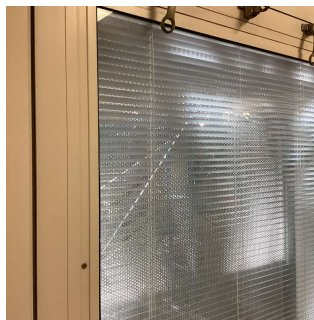
Facade G
No violations recorded.

Instance Quantity Uom	S.F.
Are these windows insulated	Yes
Installation Year	2007
Source of Installation	Custodial Staff
Deficiency	ALUMINUM - OTHER: BROKEN PANE
Roof Plan reference

Deficiency Quantity	30
Quantity Uom	S.F.
Potential Action	MAINTENANCE
Urgency of Action	PRIORITY 3
Purpose of Action	LEVEL 2
Deficiency Photo1

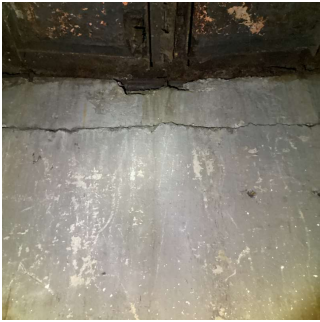
Question	Response
INTERIOR	
STRUCTURAL	
FLOOR STRUCTURE	
Deficiency Photo1	 
Violations	Boiler Room No violations recorded.
FOUNDATION WALLS	
Material Type(s)	Inspected Concrete
Condition	2 - Between Good and Fair
Deficiency	No deficiencies recorded
ROOF STRUCTURE	
Condition	Inspected 2 - Between Good and Fair
Deficiency	No deficiencies recorded
VAULTS-BUNKERS	
Foundation Walls	Inspected
Condition	Inspected 2 - Between Good and Fair
Deficiency	CRACKS, SPALLING
Deficiency Location/Instance	Facade B - Vault
Deficiency Quantity	20
Quantity Uom	S.F.
Potential Action	REPAIR
Urgency of Action	PRIORITY 3
Purpose of Action	LEVEL 5
Deficiency Photo1

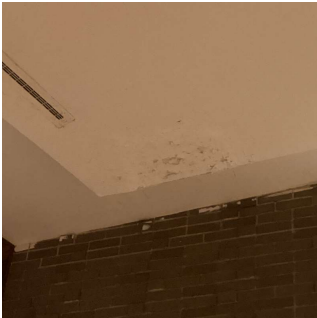
Violations	Facade B - Vault No violations recorded.
AUDITORIUM	
Instance on 1st Floor (500 Seats)	Inspected
Instance on 1st Floor (500 Seats)	Inspected
Ceiling	
Instance on 1st Floor (500 Seats)	Inspected
Condition	2 - Between Good and Fair
Deficiency	PLASTER: CRACKS/SPALLING
Deficiency Location/Instance	Near Seat U/11
Deficiency Quantity	10
Quantity Uom	S.F.
Potential Action	REPLACE
Urgency of Action	PRIORITY 3
Purpose of Action	LEVEL 2
Deficiency Photo1

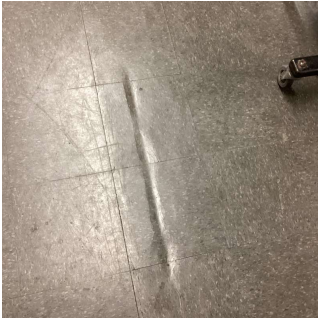
Question	Response
INTERIOR	
CAFETERIA	
Door(s)	Side Entrance
Violations	No violations recorded.
Fixed Equipment	
Instance on Basement	Does not Exist
Floor Finish	
Instance on Basement	Inspected
Condition	2 - Between Good and Fair
Deficiency	VINYL TILES: DETERIORATED SUBSTRATE
Deficiency Location/Instance	Toward the rear
Deficiency Quantity	10
Quantity Uom	S.F.
Potential Action	REPLACE
Urgency of Action	PRIORITY 3
Purpose of Action	LEVEL 2
Deficiency Photo1

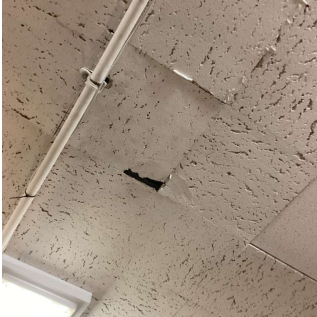
Question	Response
INTERIOR	
CAFETERIA	
Walls	
Deficiency Photo1	 
Violations	Column No violations recorded.
Window Curtains/Shades/Blinds	
Instance on Basement	Does not Exist
CLASSROOMS/CORRIDORS/ADMIN SPACES	
Ceiling	Inspected
Condition	2 - Between Good and Fair
Deficiency	ACOUSTIC TILES ON PLASTER: DAMAGED/MISSING
Deficiency Location/Instance	Room 235, Corridor near Rooms 102, 125
Deficiency Quantity	20
Quantity Uom	S.F.
Potential Action	REPLACE
Urgency of Action	PRIORITY 3
Purpose of Action	LEVEL 2
Deficiency Photo1	No photo recorded
Violations	No violations recorded.
Deficiency	ACOUSTIC TILES: DAMAGED/MISSING
Deficiency Location/Instance	Room 156, Lobby Area
Deficiency Quantity	30
Quantity Uom	S.F.
Potential Action	REPLACE
Urgency of Action	PRIORITY 3
Purpose of Action	LEVEL 2
Deficiency Photo1

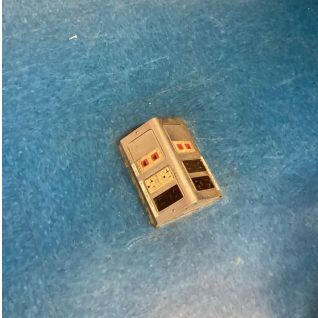
Violations	Room 152 No violations recorded.
Floor Finish	
Condition	Inspected 2 - Between Good and Fair
Deficiency	VINYL TILES: TRIPPING HAZARD - ELECTRICAL OUTLET
Deficiency Location/Instance	Room 231
Deficiency Quantity	10
Quantity Uom	S.F.
Potential Action	REMOVE
Urgency of Action	PRIORITY 5
Purpose of Action	LEVEL 6
Deficiency Photo1

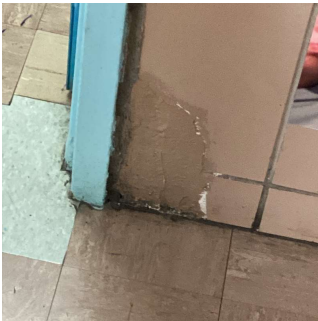
Question	Response
INTERIOR	
CLASSROOMS/CORRIDORS/ADMIN SPACES	
Walls	
Violations	Room 131 No violations recorded.
Deficiency	CERAMIC TILE: BROKEN/ MISSING
Deficiency Location/Instance	Lobby Area
Deficiency Quantity	15
Quantity Uom	S.F.
Potential Action	REPLACE
Urgency of Action	PRIORITY 3
Purpose of Action	LEVEL 2
Deficiency Photo1	 
Violations	Lobby Area No violations recorded.
Deficiency	GLAZED BLOCK: CRACKS/SPALLING
Deficiency Location/Instance	Corridor near Rooms B43, 263, Stair C/2
Deficiency Quantity	20
Quantity Uom	S.F.
Potential Action	REPLACE
Urgency of Action	PRIORITY 3
Purpose of Action	LEVEL 2
Deficiency Photo1

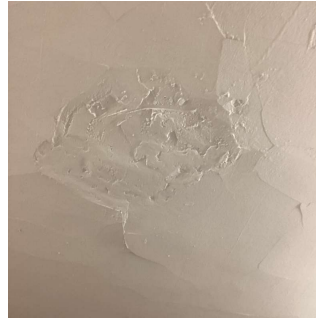
Violations	Corridor near Stair C/2 No violations recorded.
Specialties	Does not Exist
GYMNASIUM	Inspected
Instance on 1st Floor	Inspected
Ceiling	
Instance on 1st Floor	Inspected
Condition	2 - Between Good and Fair
Deficiency	PLASTER: CRACKS/SPALLING
Deficiency Location/Instance	Room 161

Deficiency Quantity	10
Quantity Uom	S.F.
Potential Action	REPLACE
Urgency of Action	PRIORITY 3
Purpose of Action	LEVEL 2
Deficiency Photo1

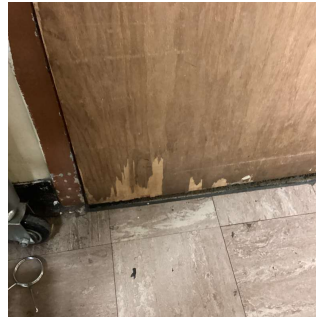
Instance on 1st Floor	Inspected
Condition	3 - Fair
Deficiency	WOOD: DETERIORATED DOOR
Deficiency Location/Instance	Room 169
Deficiency Quantity	1
Quantity Uom	EACH
Potential Action	MAINTENANCE
Urgency of Action	PRIORITY 3
Purpose of Action	LEVEL 2
Deficiency Photo1

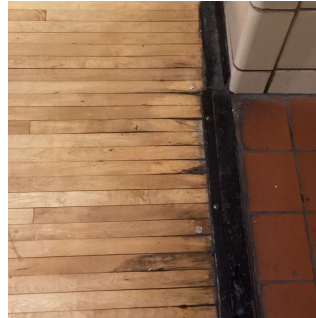
Near Drinking Fountain

Quantity Uom	S.F.
Potential Action	REPLACE
Urgency of Action	PRIORITY 3
Purpose of Action	LEVEL 2
Deficiency Photo1

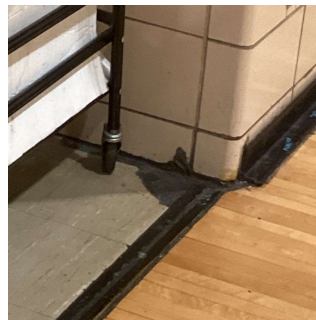
Near Room 169

Deficiency	VINYL TILES: BROKEN/DETERIORATED/MISSING TILES
Deficiency Location/Instance	Room 169, near Room 169
Deficiency Quantity	10
Quantity Uom	S.F.
Potential Action	REPLACE
Urgency of Action	PRIORITY 3
Purpose of Action	LEVEL 2
Deficiency Photo1

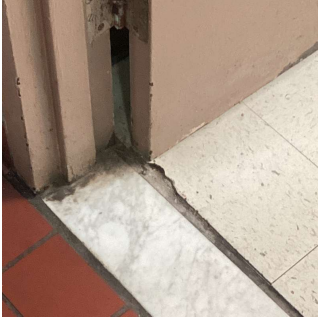
Instance on Basement	Inspected
Condition	2 - Between Good and Fair
Deficiency	VINYL TILES: BROKEN/DETERIORATED/MISSING TILES
Deficiency Location/Instance	Office
Deficiency Quantity	10
Quantity Uom	S.F.
Potential Action	REPLACE
Urgency of Action	PRIORITY 3
Purpose of Action	LEVEL 2
Deficiency Photo1

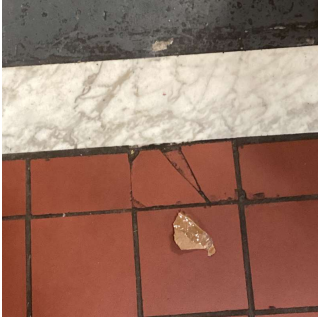
Deficiency	QUARRY TILE: BROKEN/MISSING TILES
Deficiency Location/Instance	Food Preparation Area, Servery Area
Deficiency Quantity	10
Quantity Uom	S.F.
Potential Action	REPLACE
Urgency of Action	PRIORITY 3
Purpose of Action	LEVEL 2
Deficiency Photo1

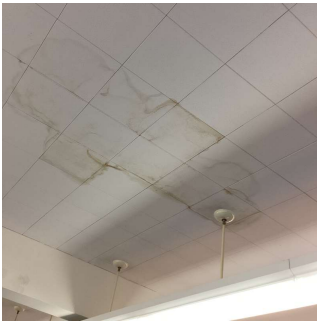
Question	Response
INTERIOR	
LIBRARY	
Ceiling	
Deficiency Photo1

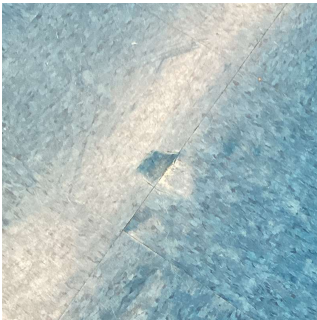
Near the center
Violations	No violations recorded.
Door(s)	
Instance on Room 228/230	Inspected
Condition	2 - Between Good and Fair
Deficiency	No deficiencies recorded
Floor Finish	
Instance on Room 228/230	Inspected
Condition	2 - Between Good and Fair
Deficiency	VINYL TILES: BROKEN/DETERIORATED/MISSING TILES
Deficiency Location/Instance	Near the center
Deficiency Quantity	10
Quantity Uom	S.F.
Potential Action	REPLACE
Urgency of Action	PRIORITY 3
Purpose of Action	LEVEL 2
Deficiency Photo1

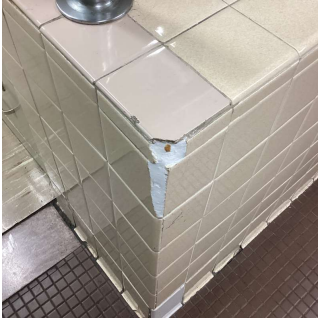
Question	Response
INTERIOR	
SHOWER ROOM	
Walls	
Condition	2 - Between Good and Fair
Deficiency	CERAMIC TILE: BROKEN/ MISSING
Deficiency Location/Instance	Near the Entrance
Deficiency Quantity	10
Quantity Uom	S.F.
Potential Action	REPLACE
Urgency of Action	PRIORITY 3
Purpose of Action	LEVEL 2
Deficiency Photo1

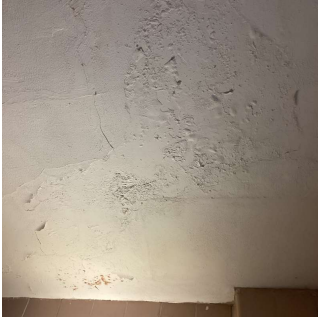
Violations	Near the Entrance No violations recorded.
STAIRS/RAMPS: INTERIOR	
Do Letter Stair Signs Exist?	Inspected Yes
Ceiling	
Condition	Inspected 2 - Between Good and Fair
Deficiency	PLASTER: CRACKS/SPALLING
Deficiency Location/Instance	Stairs A/1 Vestibule, B/2, D/1 Vestibule
Deficiency Quantity	60
Quantity Uom	S.F.
Potential Action	REPLACE
Urgency of Action	PRIORITY 3
Purpose of Action	LEVEL 2
Deficiency Photo1

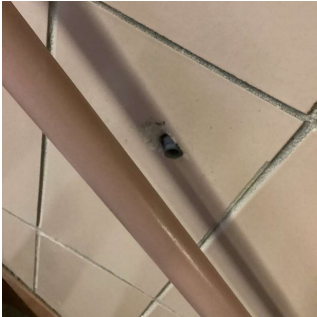
Stair B/3
Violations	No violations recorded.
Partition	Does not Exist
Railings	Inspected
Condition	4 - Between Fair and Poor
Deficiency	METAL: BROKEN BRACKET
Deficiency Location/Instance	Stair C/Bulkhead
Deficiency Quantity	1
Quantity Uom	EACH
Potential Action	REPLACE
Urgency of Action	PRIORITY 3
Purpose of Action	LEVEL 2
Deficiency Photo1

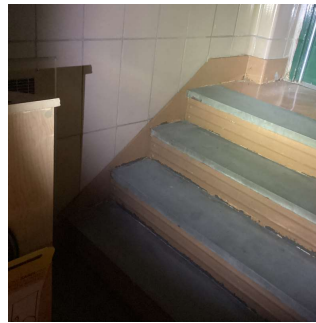
Exit Vestibule by Auditorium Right Stage
No violations recorded.

Stair C/Bulkhead
Violations	No violations recorded.
Deficiency	METAL: MISSING
Deficiency Location/Instance	Exit Vestibule by Auditorium Right Stage, by Left Stage leading to corridor
Deficiency Quantity	20
Quantity Uom	L.F.
Potential Action	REPLACE
Urgency of Action	PRIORITY 5
Purpose of Action	LEVEL 6

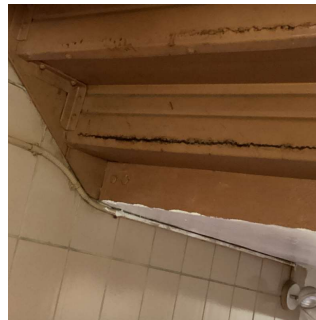
Stair A/Basement

METAL: RUST - MAJOR

REPLACE

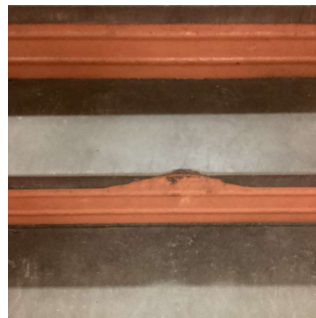
STONE: BROKEN/MISSING

REPLACE

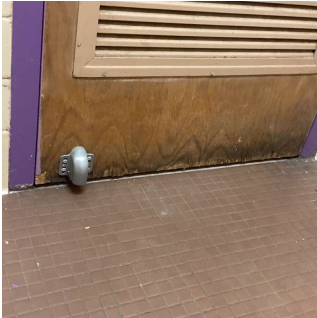
Question	Response
INTERIOR	
TOILET ROOMS - STAFF	
Door(s)	
Deficiency	WOOD: DETERIORATED DOOR
Deficiency Location/Instance	Rooms 210, 310, 314, Inside Rooms 101, 103, and others
Deficiency Quantity	10
Quantity Uom	EACH
Potential Action	MAINTENANCE
Urgency of Action	PRIORITY 3
Purpose of Action	LEVEL 2
Deficiency Photo1

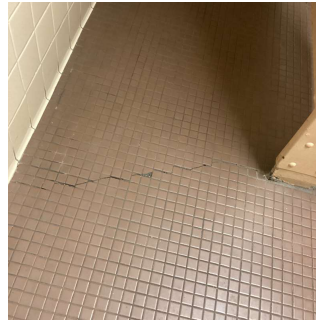
Room 310

Room B27
Violations	No violations recorded.
Deficiency	CERAMIC TILE: BROKEN/MISSING TILES
Deficiency Location/Instance	Room 310, inside Room 131
Deficiency Quantity	15
Quantity Uom	S.F.
Potential Action	REPLACE
Urgency of Action	PRIORITY 3
Purpose of Action	LEVEL 2

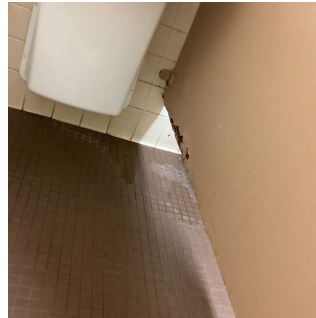
Room 310

RUST - MAJOR

REPLACE

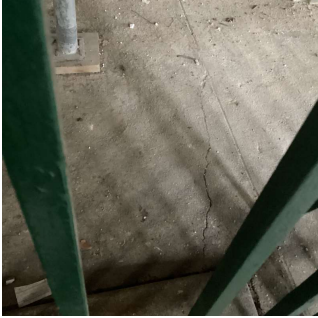
Question	Response
SITE	
DRINKING FOUNTAINS	Does not Exist
FENCES	Inaccessible
IRRIGATION SYSTEM	Does not Exist
PAVING	Inspected
Student Non-Use	Inspected
Gravel Exists?	No
Asphalt	Does not Exist
Concrete	Inspected
Condition	3 - Fair
Deficiency	CRACKS - MAJOR
Deficiency Location/Instance	19th Street
Deficiency Quantity	125
Quantity Uom	S.F.
Potential Action	REPLACE
Urgency of Action	PRIORITY 3
Purpose of Action	LEVEL 2
Deficiency Photo1

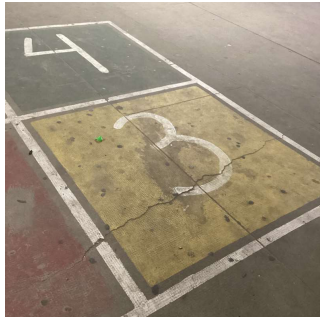
Violations	No violations recorded.
Pavers	Does not Exist
Student Use	Inspected
Gravel Exists?	No
Asphalt	Does not Exist
Concrete	Inspected
Condition	3 - Fair
Deficiency	CRACKS - MAJOR
Deficiency Location/Instance	Schoolyard - Facing 19th Street
Deficiency Quantity	200
Quantity Uom	S.F.
Potential Action	REPLACE
Urgency of Action	PRIORITY 3
Purpose of Action	LEVEL 2

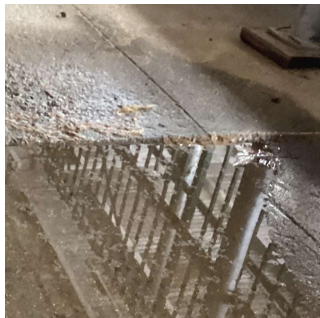
Violations	Schoolyard - Facing 19th Street No violations recorded.
Pavers	Does not Exist
Site Sidewalks & Walkways	Inspected
Asphalt	Does not Exist
Concrete	Inspected
Condition	3 - Fair
Deficiency	HEAVING
Deficiency Location/Instance	18th Street
Deficiency Quantity	50
Quantity Uom	S.F.
Potential Action	REPLACE
Urgency of Action	PRIORITY 3
Purpose of Action	LEVEL 2
Deficiency Photo1

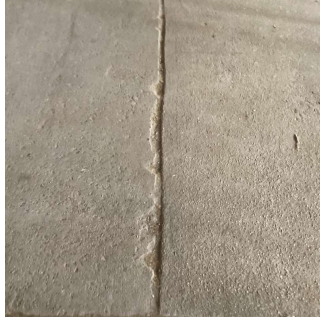
Violations	18th Street No violations recorded.
Deficiency	DAMAGED/DETERIORATED/MISSING SECTIONS
Deficiency Location/Instance	18th Street
Deficiency Quantity	125
Quantity Uom	S.F.
Potential Action	REPLACE
Urgency of Action	PRIORITY 3
Purpose of Action	LEVEL 2

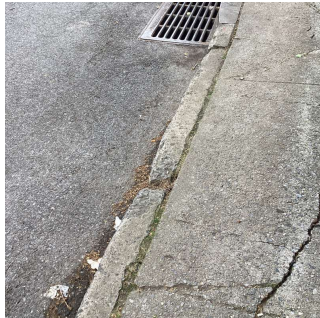
18th Street
Violations	No violations recorded.
Pavers	Does not Exist
DOT Sidewalk	Inspected
Asphalt	Does not Exist
Concrete	Inspected
Condition	4 - Between Fair and Poor
Deficiency	DAMAGED CURBS
Deficiency Location/Instance	18th Street, 19th Street, 7th Avenue
Deficiency Quantity	120
Quantity Uom	L.F.
Potential Action	REPLACE
Urgency of Action	PRIORITY 3
Purpose of Action	LEVEL 2
Deficiency Photo1

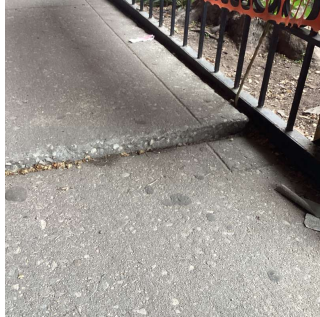
19th Street
Violations	No violations recorded.
Deficiency	HEAVING
Deficiency Location/Instance	18th Street, 19th Street, 7th Avenue
Deficiency Quantity	500
Quantity Uom	S.F.
Potential Action	REPLACE
Urgency of Action	PRIORITY 3
Purpose of Action	LEVEL 2

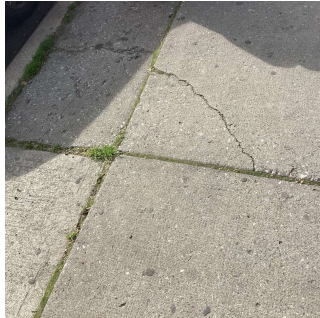
Violations	18th Street No violations recorded.
Deficiency	DAMAGED/DETERIORATED/MISSING SECTIONS
Deficiency Location/Instance	18th Street, 19th Street, 7th Avenue
Deficiency Quantity	3,575
Quantity Uom	S.F.
Potential Action	REPLACE
Urgency of Action	PRIORITY 3
Purpose of Action	LEVEL 2
Deficiency Photo1

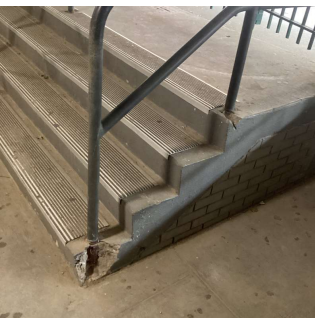
Question	Response
SITE	
RETAINING WALLS	
Deficiency Photo1	 
Violations	18th Street No violations recorded.
Deficiency	CAST IN PLACE CONCRETE: CRACKS/SPALLING - MAJOR
Deficiency Location/Instance	Schoolyard - facing 19th Street
Deficiency Quantity	10
Quantity Uom	S.F.
Potential Action	REPLACE
Urgency of Action	PRIORITY 3
Purpose of Action	LEVEL 2
Deficiency Photo1	 
Violations	Schoolyard - facing 19th Street No violations recorded.
SEATING	Inspected
Benches	Inspected
Concrete	Inaccessible
Metal/Wood/Plastic	Does not Exist
Bleachers	Does not Exist
SITE WALLS (NOT RETAINING WALLS)	Inaccessible
STAIRS/RAMPS: EXTERIOR	Inspected
Railings	Inspected
Condition	2 - Between Good and Fair
Deficiency	No deficiencies recorded
Site Cheek/flank Walls	Inspected
Condition	2 - Between Good and Fair
Deficiency	No deficiencies recorded
Stairs/ramps	Inspected
Condition	2 - Between Good and Fair
Deficiency	CAST IN PLACE CONCRETE: CRACKS/SPALLING - MAJOR

Deficiency Location/Instance	Schoolyard - facing 19th Street
Deficiency Quantity	20

Question	Response
SITE	
STAIRS/RAMPS: EXTERIOR	
Stairs/ramps	
Quantity Uom	S.F.
Potential Action	REPLACE
Urgency of Action	PRIORITY 3
Purpose of Action	LEVEL 2
Deficiency Photo1
