NYC Department of Education
Building Condition Assessment Survey 2023 - 2024

Architectural Inspection

Asset: P.S. 90 - BROOKLYN, 2840 WEST 12 STREET, New York, 11224

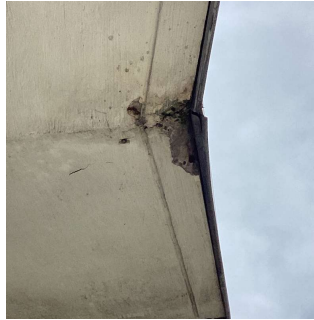
Facade A

Question	Response
Architectural	
EXTERIOR	Inspected
AREAWAY	Inspected
Instance on AW1 - AW2	Inspected
Instance Condition	2 - Between Good and Fair
Instance Quantity	2
Instance Quantity Uom	EACH
Deficiency	No deficiencies recorded
AWNINGS AND CANOPIES	Inspected
Condition	3 - Fair
Deficiency	CONCRETE: MAJOR CRACKS/SPALLING

10
S.F.
REPAIR
PRIORITY 4
LEVEL 2

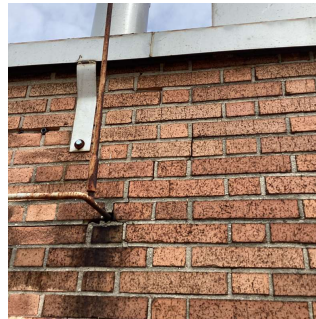
Roof 1 - CH

**BRICK: MAJOR / THRU CRACKS
K090**

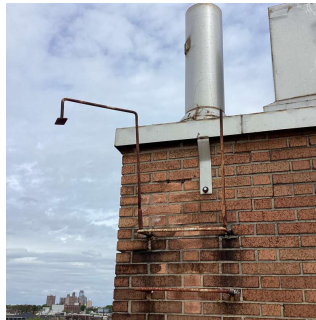
Roof 1 - CH

BRICK: DETERIORATED LADDER

1
 EACH
 REPLACE
 PRIORITY 4
 LEVEL 2

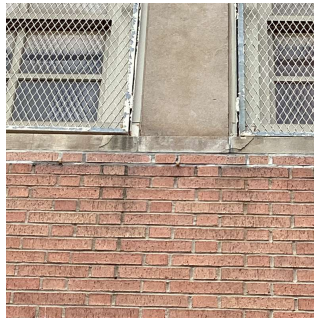
Facade A

Violations	Facade B - Exit 7 No violations recorded.
DOOR HARDWARE	Inspected
Condition	3 - Fair
Deficiency	No deficiencies recorded
LINTELS	Inspected
Condition	2 - Between Good and Fair
Deficiency	No deficiencies recorded
TRANSOM/SIDE LIGHT	Inspected
Condition	2 - Between Good and Fair
Deficiency	No deficiencies recorded
EXTERIOR WALLS	Inspected
Material Type(s)	Concrete, Masonry
Replacement Quantity	18,000
Replacement Uom	S.F.
Instance on All Facades	Inspected
Instance Condition	3 - Fair
Instance Quantity	18,000
Instance Quantity Uom	S.F.
Deficiency	BRICK: DETERIORATED MASONRY SILLS - MINOR

REPAIR

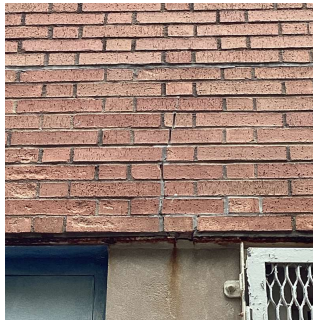
Facade B

BRICK: MAJOR / THRU CRACKS

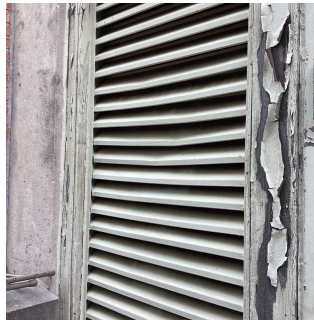
Facade B

BROKEN/ DENTED BLADES

REPLACE

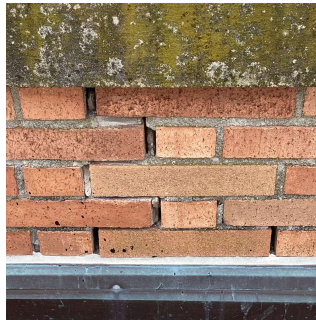
Roof 1 - Facade B

BRICK: DETERIORATED JOINTS

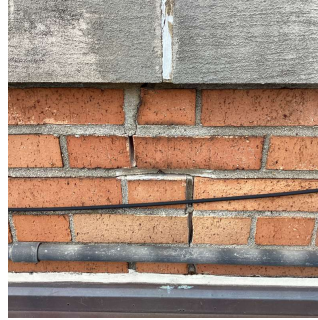
Roof 1 - Facade G

BRICK: MAJOR DETERIORATION/CRACKS

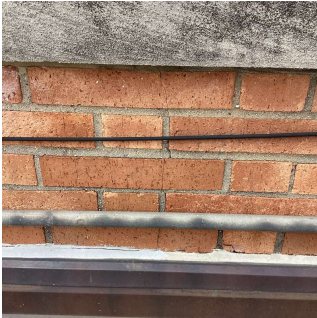
BRICK: MINOR CRACKS, SPALLING

REPAIR

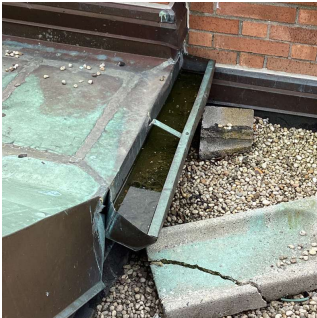
Violations	Roof 1 - Facade G No violations recorded.
PLAZA DECK	Does not Exist
ROOF	Inspected
Roofing	Inspected
Replacement Quantity	28,000
Replacement Uom	S.F.
ROOF HATCH/SMOKE HATCH	Does not Exist
LEADERS, GUTTERS, DOWNSPOUTS, SCUPPERS	Inspected
Condition	3 - Fair
Deficiency	DAMAGED/MISSING
Roof Plan reference	K090

Deficiency Quantity	10
Quantity Uom	L.F.
Potential Action	REPLACE
Urgency of Action	PRIORITY 4
Purpose of Action	LEVEL 2
Deficiency Photo1

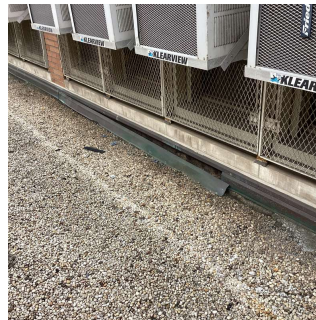
Roof 2
No violations recorded.

BUILT-UP: FLASHING: CAP FLASHING DAMAGED

Deficiency Quantity
Quantity Uom
Potential Action
Urgency of Action
Purpose of Action
Deficiency Photo1

50
L.F.
REPLACE
PRIORITY 4
LEVEL 2

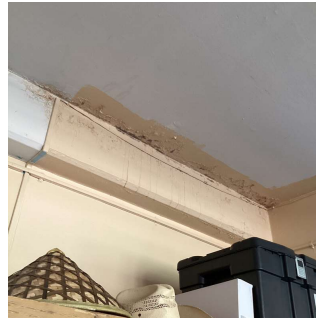
Roof 1 - Room 328

BUILT-UP: ROOFING: MAJOR ACTIVE ROOF LEAKS IN INSTRUCTIONAL SPACE

Deficiency Quantity
Quantity Uom
Potential Action
Urgency of Action
Purpose of Action

100
S.F.
REPLACE ROOFING WITHOUT MAJOR EQUIPMENT REMOVAL
PRIORITY 5
LEVEL 2

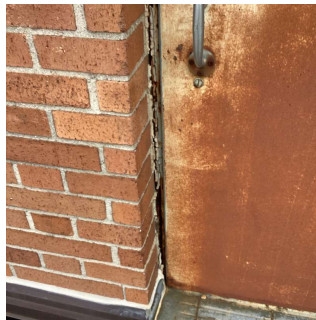
BH2
 No violations recorded.

BULKHEAD/PENTHOUSE DOORS: AIR/WATER INFILTRATION WITH DAMAGED CAULKING

Deficiency Quantity
 Quantity Uom
 Potential Action
 Urgency of Action
 Purpose of Action
 Deficiency Photo1

40
 L.F.
 MAINTENANCE
 PRIORITY 3
 LEVEL 2

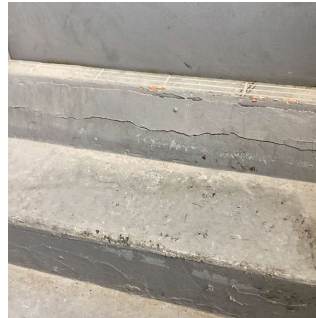
BH2

**BULKHEAD/PENTHOUSE WALLS/INTERIOR: PLASTER
 CRACKS/SPALLING**

Deficiency Quantity
 Quantity Uom
 Potential Action
 Urgency of Action
 Purpose of Action

20
 S.F.
 REPLACE
 PRIORITY 3
 LEVEL 2

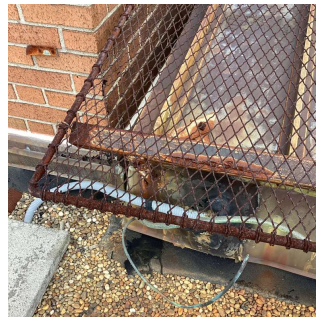
Roof 1 - SK

DAMAGED GUARDS

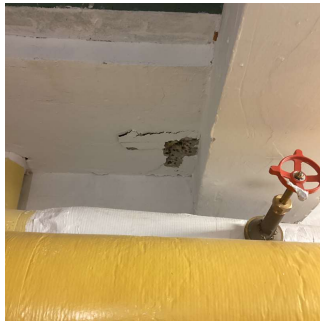
Violations	Universal Waste/Fluorescent Bulb Storage Area No violations recorded.
FOUNDATION WALLS	
Material Type(s)	Inspected Concrete
Condition	4 - Between Fair and Poor
Deficiency	CONCRETE: WATER INFILTRATION IN NON- INSTRUCTIONAL SPACE
Deficiency Location/Instance	Basement - Gas Meter Room
Deficiency Quantity	100
Quantity Uom	S.F.
Potential Action	INSTALL WATERPROOFING
Urgency of Action	PRIORITY 5
Purpose of Action	LEVEL 5
Deficiency Photo1

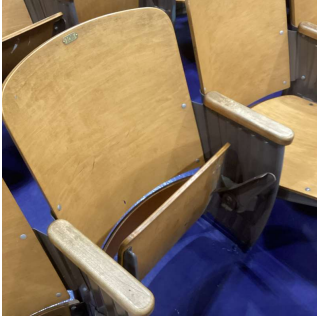
Question	Response
INTERIOR	
AUDITORIUM	
Fixed H/C Lift	
Instance on 1st Floor (400 Seats)	Inspected
Condition	2 - Between Good and Fair
Deficiency	No deficiencies recorded
Fixed Seating	
Instance on 1st Floor (400 Seats)	Inspected
Condition	2 - Between Good and Fair
Deficiency	DAMAGED/BROKEN/INOPERABLE
Deficiency Location/Instance	Seat L/106
Deficiency Quantity	1
Quantity Uom	EACH
Potential Action	REPLACE
Urgency of Action	PRIORITY 5
Purpose of Action	LEVEL 6
Deficiency Photo1

Seat L/106
Violations	No violations recorded.
Deficiency	DAMAGED/BROKEN/INOPERABLE
Deficiency Location/Instance	Seats E/2, G/101, N/2, O/2, P/2 and others
Deficiency Quantity	10
Quantity Uom	EACH
Potential Action	REPLACE
Urgency of Action	PRIORITY 3
Purpose of Action	LEVEL 2
Deficiency Photo1

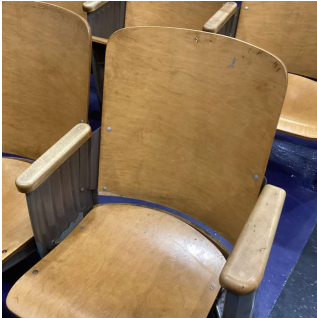
Seat E/2
Violations	No violations recorded.
Floor Finish	
Instance on 1st Floor (400 Seats)	Inspected
Condition	2 - Between Good and Fair
Deficiency	CONCRETE: CRACKS

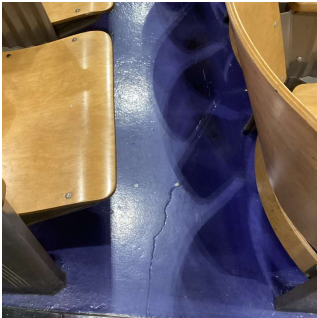
Deficiency Location/Instance	Near Row I

Question	Response
INTERIOR	
AUDITORIUM	
Floor Finish	
Deficiency Quantity	20
Quantity Uom	S.F.
Potential Action	REPLACE
Urgency of Action	PRIORITY 3
Purpose of Action	LEVEL 2
Deficiency Photo1

Violations	Near Row I No violations recorded.
Sliding-folding Partition	
Instance on 1st Floor (400 Seats)	Does not Exist
Stage	
Instance on 1st Floor (400 Seats)	Inspected
Stage	Inspected
Instance on 1st Floor (400 Seats)	Inspected
Condition	2 - Between Good and Fair
Deficiency	No deficiencies recorded
Stage Curtain Rigging	
Instance on 1st Floor (400 Seats)	Inspected
Condition	2 - Between Good and Fair
Deficiency	No deficiencies recorded
Stage Curtains	
Instance on 1st Floor (400 Seats)	Inspected
Condition	2 - Between Good and Fair
Deficiency	No deficiencies recorded
Walls	
Instance on 1st Floor (400 Seats)	Inspected
Condition	2 - Between Good and Fair
Deficiency	No deficiencies recorded
Window Curtains/Shades/Blinds	
Instance on 1st Floor (400 Seats)	Does not Exist

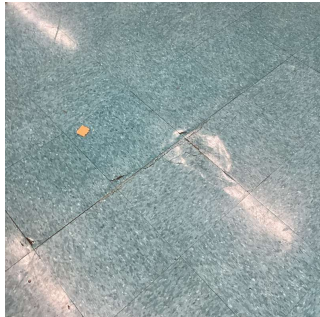
Question	Response
INTERIOR	
CAFETERIA	
Floor Finish	
Purpose of Action	LEVEL 2
Deficiency Photo1

Violations	Near Servery No violations recorded.
Sliding-folding Partition	
Instance on 1st Floor	Does not Exist
Stage	
Instance on 1st Floor	Does not Exist
Walls	
Instance on 1st Floor	Inspected
Condition	2 - Between Good and Fair
Deficiency	GLAZED BLOCK: CRACKS/SPALLING
Deficiency Location/Instance	Columns, Near Exit 6
Deficiency Quantity	30
Quantity Uom	S.F.
Potential Action	REPLACE
Urgency of Action	PRIORITY 3
Purpose of Action	LEVEL 2
Deficiency Photo1

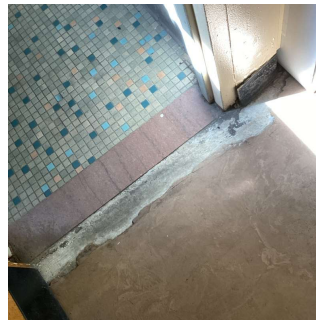
Room 101

SHEET VINYL: BROKEN/DETERIORATED

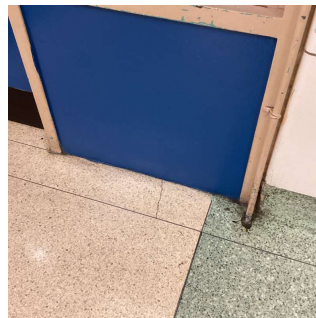
TERRAZZO: CRACKS

Question	Response
INTERIOR	
CLASSROOMS/CORRIDORS/ADMIN SPACES	
Floor Finish	
Violations	Corridor near Exit 4 No violations recorded.
Deficiency	VINYL TILES: TRIPPING HAZARD - ELECTRICAL OUTLET
Deficiency Location/Instance	Room 304
Deficiency Quantity	10
Quantity Uom	S.F.
Potential Action	REMOVE
Urgency of Action	PRIORITY 5
Purpose of Action	LEVEL 6
Deficiency Photo1

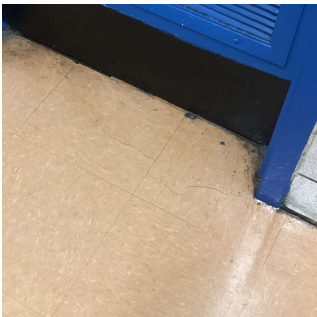
Violations	Room 304 No violations recorded.
Deficiency	VINYL TILES: DETERIORATED SUBSTRATE
Deficiency Location/Instance	Corridor near Room 114
Deficiency Quantity	10
Quantity Uom	S.F.
Potential Action	REPLACE
Urgency of Action	PRIORITY 3
Purpose of Action	LEVEL 2
Deficiency Photo1

Violations	Corridor near Room 114 No violations recorded.
Deficiency	VINYL TILES: BROKEN/DETERIORATED/MISSING TILES
Deficiency Location/Instance	Rooms 100, 306
Deficiency Quantity	70
Quantity Uom	S.F.
Potential Action	REPLACE
Urgency of Action	PRIORITY 3
Purpose of Action	LEVEL 2

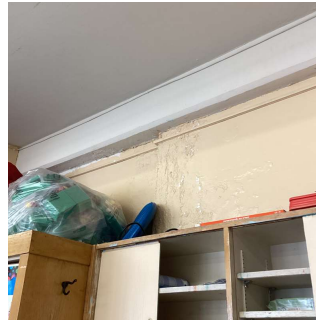
Room 328

PLASTER: CRACKS/SPALLING - ACTIVE LEAK

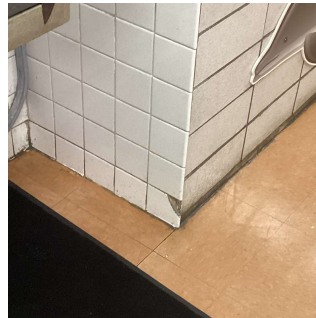
CERAMIC TILE: BROKEN/ MISSING

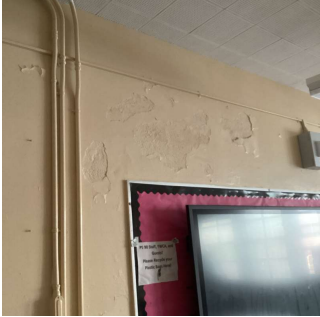
Room 104
Violations	No violations recorded.
Deficiency	GLAZED BLOCK: CRACKS/SPALLING
Deficiency Location/Instance	Corridor near Rooms 211, 130, by Gymnasium
Deficiency Quantity	30
Quantity Uom	S.F.
Potential Action	REPLACE
Urgency of Action	PRIORITY 3
Purpose of Action	LEVEL 2
Deficiency Photo1

Question	Response
INTERIOR	
CLASSROOMS/CORRIDORS/ADMIN SPACES	
Walls	
Violations	Corridor near Room 114 No violations recorded.
Deficiency	PLASTER: CRACKS/SPALLING
Deficiency Location/Instance	Rooms 104, 304, Corridor near Gymnasium, by Stair C/1, next to Room 117 and others
Deficiency Quantity	90
Quantity Uom	S.F.
Potential Action	REPLACE
Urgency of Action	PRIORITY 3
Purpose of Action	LEVEL 2
Deficiency Photo1

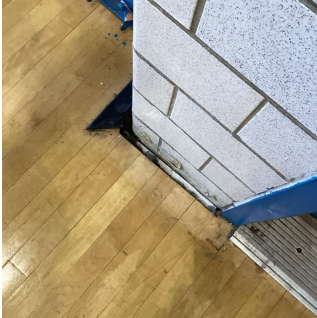
Instance on 1st Floor	Inspected
Condition	2 - Between Good and Fair
Deficiency	WOOD: DAMAGED/DETERIORATED
Deficiency Location/Instance	Near Main Entrance
Deficiency Quantity	10

Question	Response
INTERIOR	
GYMNASIUM	
Floor Finish	
Quantity Uom	S.F.
Potential Action	REPLACE
Urgency of Action	PRIORITY 3
Purpose of Action	LEVEL 2
Deficiency Photo1

Violations	Near Main Entrance No violations recorded.
Seating	
Instance on 1st Floor	Inspected
Condition	4 - Between Fair and Poor
Deficiency	DAMAGED FIXED SEATING
Deficiency Location/Instance	Near Office Room, by Right Side Windows
Deficiency Quantity	2
Quantity Uom	EACH
Potential Action	REPLACE
Urgency of Action	PRIORITY 3
Purpose of Action	LEVEL 2
Deficiency Photo1

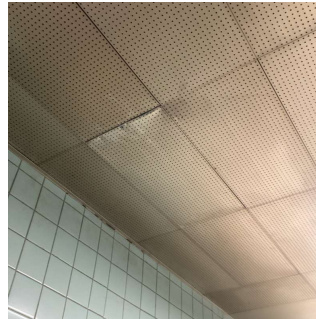
Near Storage Room
No violations recorded.

Instance on 1st Floor	Inspected
Condition	2 - Between Good and Fair
Deficiency	METAL PAN: DAMAGED/MISSING
Deficiency Location/Instance	Near Storage Room, by Windows
Deficiency Quantity	20
Quantity Uom	S.F.
Potential Action	REPLACE
Urgency of Action	PRIORITY 3
Purpose of Action	LEVEL 2
Deficiency Photo1

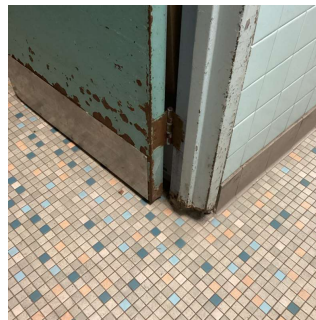
Instance on 1st Floor	Inspected
Condition	5 - Poor
Deficiency	METAL: DETERIORATED DOOR AND FRAME
Deficiency Location/Instance	Mop Room
Deficiency Quantity	1
Quantity Uom	EACH
Potential Action	MAINTENANCE
Urgency of Action	PRIORITY 3
Purpose of Action	LEVEL 2
Deficiency Photo1

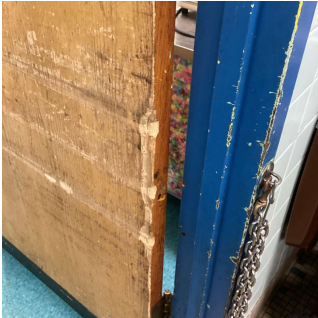
Violations	No violations recorded.
Deficiency	WOOD: DETERIORATED DOOR
Deficiency Location/Instance	Servery(4x), Kitchen Locker Room
Deficiency Quantity	5
Quantity Uom	EACH
Potential Action	MAINTENANCE
Urgency of Action	PRIORITY 3
Purpose of Action	LEVEL 2
Deficiency Photo1

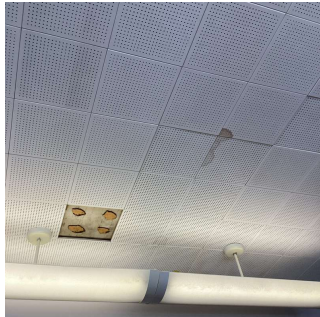
Question	Response
INTERIOR	
LIBRARY	
Ceiling	
Purpose of Action	LEVEL 2
Deficiency Photo1

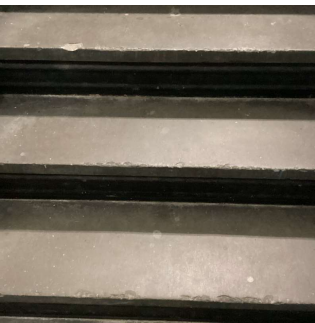
Question	Response
INTERIOR	
STAIRS/RAMPS: INTERIOR	
Stairs and Landings	
Deficiency Photo1 Violations

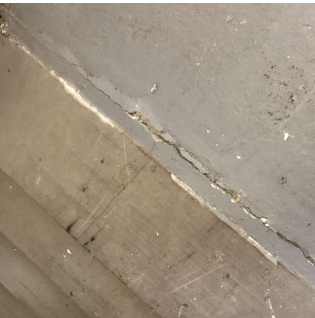
Stair B/1 No violations recorded.
Deficiency Deficiency Location/Instance Deficiency Quantity Quantity Uom Potential Action Urgency of Action Purpose of Action Deficiency Photo1 Violations	CONCRETE: CRACKS/SPALLING - MAJOR Stair C/Bulkhead 25 S.F. REPLACE PRIORITY 3 LEVEL 2

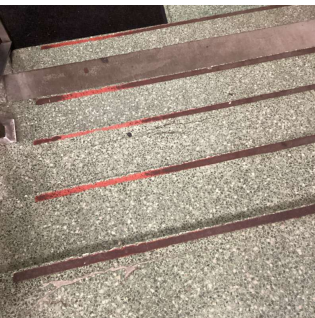
Exit 4 - Vestibule No violations recorded.

Stair C/Bulkhead No violations recorded.
Deficiency Deficiency Location/Instance Deficiency Quantity Quantity Uom Potential Action Urgency of Action Purpose of Action Deficiency Photo1 Violations	TERRAZZO: CRACKS Exit 4 - Vestibule, Main Entrance - Vestibule 40 S.F. REPLACE PRIORITY 3 LEVEL 2

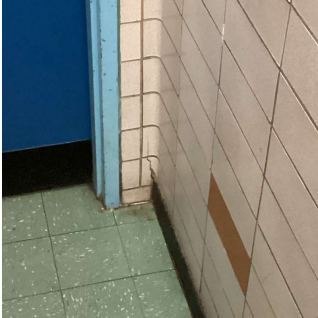
Question	Response
INTERIOR	
STAIRS/RAMPS: INTERIOR	
Walls	Inspected
Condition	2 - Between Good and Fair
Deficiency	GLAZED BLOCK: CRACKS/SPALLING
Deficiency Location/Instance	Stairs A/1, B/1, 2
Deficiency Quantity	30
Quantity Uom	S.F.
Potential Action	REPLACE
Urgency of Action	PRIORITY 3
Purpose of Action	LEVEL 2
Deficiency Photo1

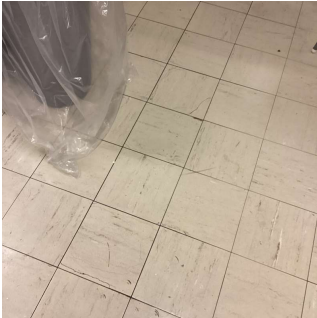
Violations	Stair B/1 No violations recorded.
TOILET ROOMS - STAFF	
Ceiling	Inspected
Condition	2 - Between Good and Fair
Deficiency	No deficiencies recorded
Door(s)	Inspected
Condition	5 - Poor
Deficiency	WOOD: DETERIORATED DOOR
Deficiency Location/Instance	Rooms 130, 214
Deficiency Quantity	2
Quantity Uom	EACH
Potential Action	MAINTENANCE
Urgency of Action	PRIORITY 3
Purpose of Action	LEVEL 2
Deficiency Photo1	 
Violations	Room 130 No violations recorded.
Floor Finish	Inspected
Condition	3 - Fair
Deficiency	VINYL TILES: BROKEN/DETERIORATED/MISSING TILES
Deficiency Location/Instance	Room 132

Question	Response
INTERIOR	
TOILET ROOMS - STAFF	
Floor Finish	
Deficiency Quantity	10
Quantity Uom	S.F.
Potential Action	REPLACE
Urgency of Action	PRIORITY 3
Purpose of Action	LEVEL 2
Deficiency Photo1

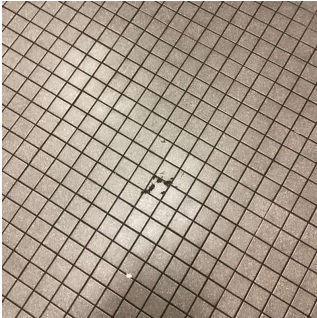
Room 132
Violations	No violations recorded.
Deficiency	CERAMIC TILE: BROKEN/MISSING TILES
Deficiency Location/Instance	Room 130
Deficiency Quantity	10
Quantity Uom	S.F.
Potential Action	REPLACE
Urgency of Action	PRIORITY 3
Purpose of Action	LEVEL 2
Deficiency Photo1

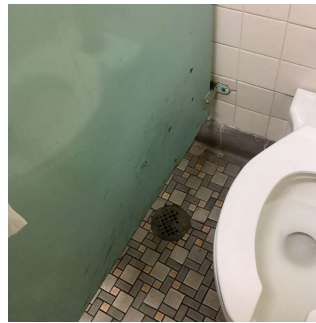
Room 130
Violations	No violations recorded.
Stalls	Inspected
Condition	5 - Poor
Deficiency	RUST - MAJOR
Deficiency Location/Instance	Room 214
Deficiency Quantity	1
Quantity Uom	EACH
Potential Action	REPLACE
Urgency of Action	PRIORITY 3
Purpose of Action	LEVEL 2

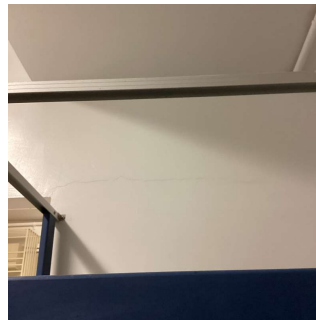
Room 132

PLASTER: CRACKS/SPALLING

REPLACE

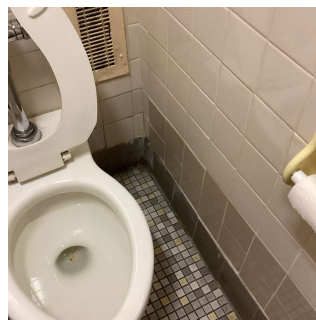
CERAMIC TILE: BROKEN/ MISSING

REPLACE

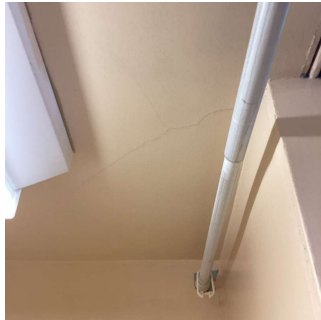
Question	Response
INTERIOR	
TOILET ROOMS - STAFF	Inspected
Walls	Inspected
Violations	In Room 100 No violations recorded.
TOILET ROOMS - STUDENTS	Inspected
Ceiling	Inspected
Condition	2 - Between Good and Fair
Deficiency	PLASTER: CRACKS/SPALLING
Deficiency Location/Instance	In Room 101
Deficiency Quantity	10
Quantity Uom	S.F.
Potential Action	REPLACE
Urgency of Action	PRIORITY 3
Purpose of Action	LEVEL 2
Deficiency Photo1

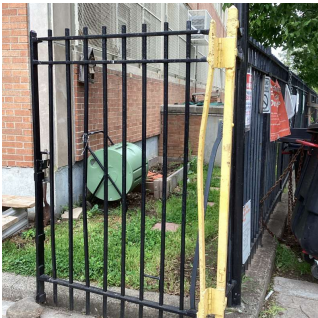
Question	Response
SITE	
FENCES	Inspected
Condition	3 - Fair
Deficiency	WROUGHT IRON: DAMAGED/DETERIORATED
Deficiency Location/Instance	West 12th Street
Deficiency Quantity	240
Quantity Uom	S.F.
Potential Action	REPLACE
Urgency of Action	PRIORITY 3
Purpose of Action	LEVEL 2
Deficiency Photo1

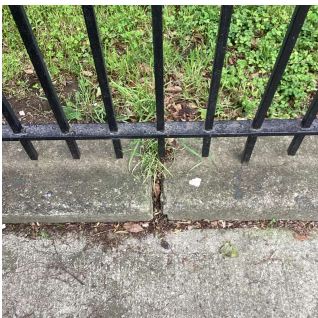
Violations	West 12th Street No violations recorded.
Deficiency	CONCRETE CURB: DAMAGED/DETERIORATED
Deficiency Location/Instance	West 12th Street
Deficiency Quantity	20
Quantity Uom	S.F.
Potential Action	REPLACE
Urgency of Action	PRIORITY 3
Purpose of Action	LEVEL 2
Deficiency Photo1

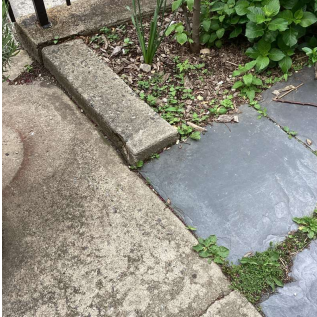
Violations	West 12th Street No violations recorded.
IRRIGATION SYSTEM	Does not Exist
PAVING	Inspected
Student Non-Use	Does not Exist
Student Use	Does not Exist
Site Sidewalks & Walkways	Inspected
Asphalt	Does not Exist
Concrete	Inspected
Condition	3 - Fair
Deficiency	DAMAGED CURBS
Deficiency Location/Instance	West 12th Street

Question	Response
SITE	
PAVING	
Site Sidewalks & Walkways	
Concrete	
Deficiency Quantity	20
Quantity Uom	L.F.
Potential Action	REPLACE
Urgency of Action	PRIORITY 3
Purpose of Action	LEVEL 2
Deficiency Photo1

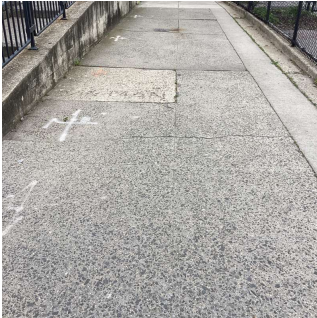
West 12th Street
Violations	No violations recorded.
Deficiency	DAMAGED/DETERIORATED/MISSING SECTIONS
Deficiency Location/Instance	West 12th Street, near Exit 4, by NYC Park
Deficiency Quantity	375
Quantity Uom	S.F.
Potential Action	REPLACE
Urgency of Action	PRIORITY 3
Purpose of Action	LEVEL 2
Deficiency Photo1

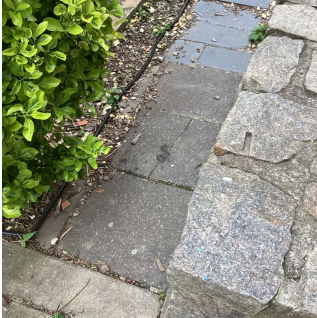
West 12th Street
Violations	No violations recorded.
Pavers	Inspected
Condition	2 - Between Good and Fair
Deficiency	DAMAGED/MISSING
Deficiency Location/Instance	West 12th Street
Deficiency Quantity	20
Quantity Uom	S.F.
Potential Action	REPLACE
Urgency of Action	PRIORITY 3
Purpose of Action	LEVEL 2

Question	Response
SITE	
PAVING	
Site Sidewalks & Walkways	
Pavers	
Deficiency Photo1

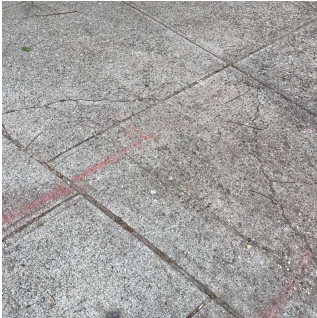
Violations	West 12th Street No violations recorded.
DOT Sidewalk	Inspected
Asphalt	Does not Exist
Concrete	Inspected
Condition	3 - Fair
Deficiency	DAMAGED/DETERIORATED/MISSING SECTIONS
Deficiency Location/Instance	West 12th Street
Deficiency Quantity	300
Quantity Uom	S.F.
Potential Action	REPLACE
Urgency of Action	PRIORITY 3
Purpose of Action	LEVEL 2
Deficiency Photo1

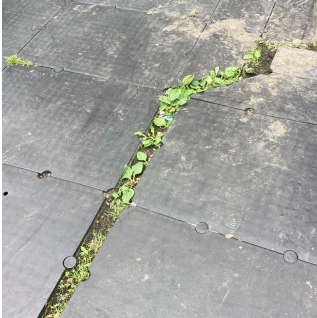
Question	Response
SITE	
PLAYGROUNDS	
Safety Surfacing	
Instance on West 12th Street	Inspected
Condition	3 - Fair
Deficiency	DETERIORATED/MISSING
Deficiency Location/Instance	Near Classroom 107
Deficiency Quantity	20
Quantity Uom	S.F.
Potential Action	MAINTENANCE
Urgency of Action	PRIORITY 5
Purpose of Action	LEVEL 6
Deficiency Photo1

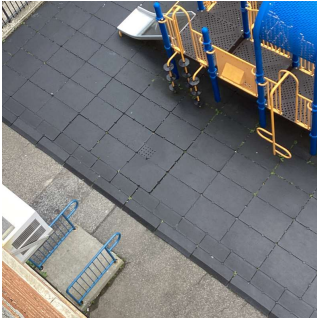
Violations	Near Classroom 107 No violations recorded.
Deficiency	DETERIORATED/MISSING
Deficiency Location/Instance	Near Slide
Deficiency Quantity	200
Quantity Uom	S.F.
Potential Action	MAINTENANCE
Urgency of Action	PRIORITY 3
Purpose of Action	LEVEL 2
Deficiency Photo1

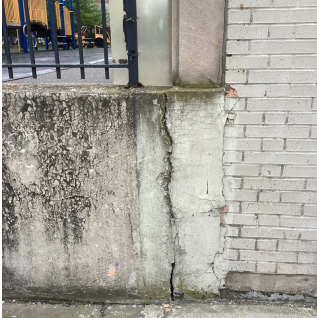
Violations	Near Slide No violations recorded.
Unpaved Area	
Instance on West 12th Street	Does not Exist
PLAYING SURFACE	
Does not Exist	
RETAINING WALLS	
Are there any Retaining Walls 6' OR higher facing public street/sidewalk?	Inspected
Condition	No
Condition	3 - Fair
Deficiency	CAST IN PLACE CONCRETE: CRACKS/SPALLING - MAJOR

Deficiency Location/Instance	Near Exit 3

Question	Response
SITE	
RETAINING WALLS	
Deficiency Quantity	20
Quantity Uom	S.F.
Potential Action	REPLACE
Urgency of Action	PRIORITY 3
Purpose of Action	LEVEL 2
Deficiency Photo1

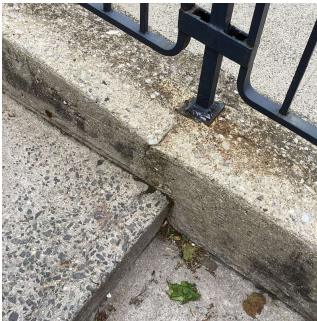
Question	Response
SITE	
STAIRS/RAMPS: EXTERIOR	
Site Cheek/flank Walls	
Deficiency Photo1
