**NYC Department of Education**  
**Building Condition Assessment Survey 2023 - 2024**

Architectural Inspection

**Asset: P.S. 92 - BROOKLYN, 601 PARKSIDE AVENUE, New York, 11226**

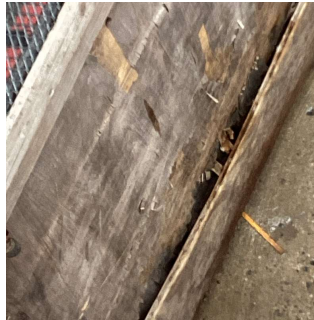
Facade C

Deficiency	WOOD: DETERIORATED DOOR AND FRAME - MAJOR DETERIORATION
------------	---

REPLACE

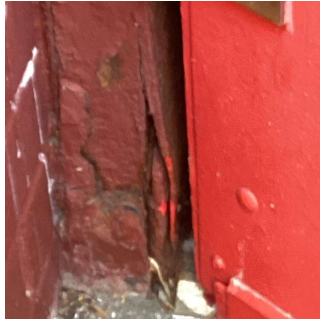
Facade C
Violations	No violations recorded.
<b>DOOR HARDWARE</b>	Inspected
Condition	3 - Fair
Deficiency	No deficiencies recorded
<b>LINTELS</b>	Inspected
Condition	2 - Between Good and Fair
Deficiency	No deficiencies recorded
<b>TRANSOM/SIDE LIGHT</b>	Inspected
Condition	5 - Poor
Deficiency	METAL: DENTED, MAJOR RUSTING
Roof Plan reference	<p>K092</p>

Question	Response
<b>EXTERIOR</b>	
<b>DOORS</b>	
<b>DOORS AND FRAMES</b>	
Potential Action	REPLACE
Urgency of Action	PRIORITY 4
Purpose of Action	LEVEL 2
Deficiency Photo1

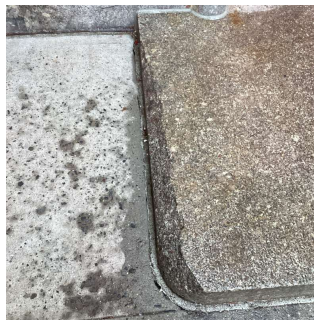
Facade C

STONE: CRACKS/SPALLING - MAJOR

REPLACE

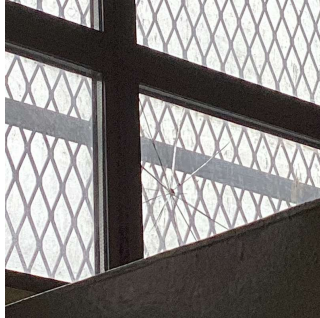
Violations	Facade D - Cafeteria No violations recorded.
Deficiency	ALUMINUM - DOUBLE HUNG: INOPERABLE BALANCE
Roof Plan reference	K092

Question	Response
<b>EXTERIOR</b>	
<b>WINDOWS</b>	Inspected
<b>WINDOWS</b>	
Potential Action	MAINTENANCE
Urgency of Action	PRIORITY 3
Purpose of Action	LEVEL 2
Deficiency Photo1

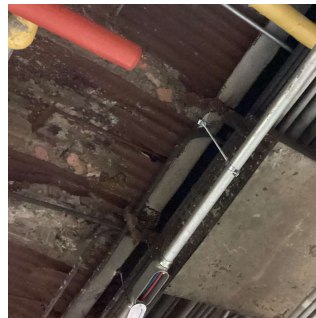
Basement - Boiler Room

**STEEL COLUMNS/BEAMS: DETERIORATED/MISSING SPRAY-ON FIREPROOFING**

REPLACE

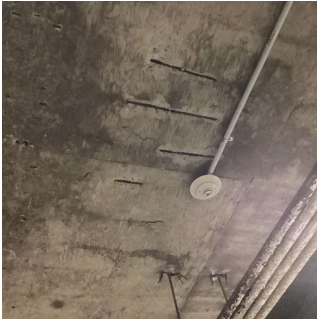
<b>Question</b>	<b>Response</b>
<b>INTERIOR</b>	
<b>STRUCTURAL</b>	
<b>COLUMNS/BEAMS/BEARING WALLS</b>	Inspected
Violations	No violations recorded.
<b>FLOOR STRUCTURE</b>	Inspected
Condition	4 - Between Fair and Poor
Deficiency	CONCRETE: CRACKS/SPALLED/REINFORCEMENT EXPOSED
Deficiency Location/Instance	1950 Addition - Sub-Basement - Mechanical Equipment Room
Deficiency Quantity	20
Quantity Uom	S.F.
Potential Action	REPAIR
Urgency of Action	PRIORITY 4
Purpose of Action	LEVEL 5
Deficiency Photo1

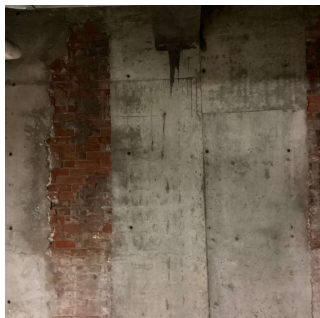
Basement - Boiler Room
Violations	No violations recorded.
<b>FOUNDATION WALLS</b>	
Material Type(s)	Inspected Concrete, Masonry
Condition	3 - Fair
Deficiency	BRICK: CRACKED/SPALLED
Deficiency Location/Instance	1950 Addition - Sub-Basement - Mechanical Equipment Room
Deficiency Quantity	50
Quantity Uom	S.F.
Potential Action	RESTITCH
Urgency of Action	PRIORITY 3
Purpose of Action	LEVEL 5
Deficiency Photo1

1950 Addition - Sub-Basement - Mechanical Equipment Room
Violations	No violations recorded.
<b>ROOF STRUCTURE</b>	
Condition	Inspected 2 - Between Good and Fair
Deficiency	No deficiencies recorded
<b>VAULTS-BUNKERS</b>	
<b>Foundation Walls</b>	Inspected
Condition	Inspected 3 - Fair
Deficiency	CRACKS, SPALLING
Deficiency Location/Instance	Basement - Vault
Deficiency Quantity	30
Quantity Uom	S.F.

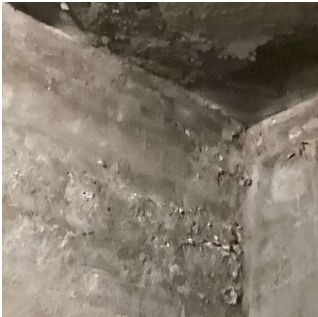
Violations	Basement - Vault No violations recorded.
<b>Slab Structure</b>	Inspected
Condition	4 - Between Fair and Poor
Deficiency	CONCRETE: WATER INFILTRATION IN NON- INSTRUCTIONAL SPACE
Deficiency Location/Instance	Basement - Vault
Deficiency Quantity	100
Quantity Uom	S.F.
Potential Action	INSTALL WATERPROOFING
Urgency of Action	PRIORITY 5
Purpose of Action	LEVEL 5
Deficiency Photo1

Potential Action	REPAIR
Urgency of Action	PRIORITY 3
Purpose of Action	LEVEL 5

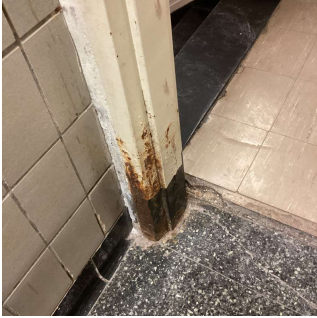
Question	Response
<b>INTERIOR</b>	
<b>CAFETERIA</b>	
<b>Ceiling</b>	
Violations	No violations recorded.
<b>Door(s)</b>	
Instance on Basement	Inspected
Condition	5 - Poor
Deficiency	METAL: DETERIORATED DOOR AND FRAME
Deficiency Location/Instance	Exits J, K - Vestibules
Deficiency Quantity	2
Quantity Uom	EACH
Potential Action	MAINTENANCE
Urgency of Action	PRIORITY 3
Purpose of Action	LEVEL 2
Deficiency Photo1

Violations	Exit K - Vestibule No violations recorded.
Deficiency	WOOD: DETERIORATED DOOR
Deficiency Location/Instance	Main Entrance near Kitchen, Main Entrance
Deficiency Quantity	4
Quantity Uom	EACH
Potential Action	MAINTENANCE
Urgency of Action	PRIORITY 3
Purpose of Action	LEVEL 2
Deficiency Photo1

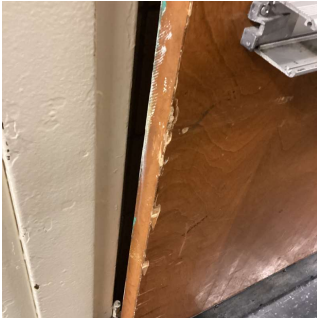
Violations	Main Entrance near Kitchen No violations recorded.
<b>Fixed Equipment</b>	
Instance on Basement	Does not Exist
<b>Floor Finish</b>	
Instance on Basement	Inspected
Condition	4 - Between Fair and Poor

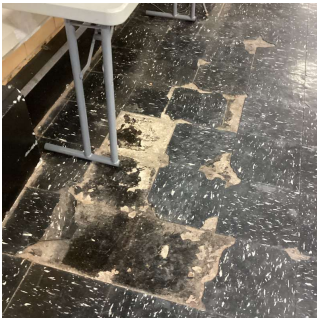
Question	Response
<b>INTERIOR</b>	
<b>CAFETERIA</b>	
<b>Floor Finish</b>	
Deficiency Quantity	10
Quantity Uom	S.F.
Potential Action	REPLACE
Urgency of Action	PRIORITY 3
Purpose of Action	LEVEL 2
Deficiency Photo1	 
Violations	Exit J - Vestibule No violations recorded.
Deficiency	VINYL TILES: BROKEN/DETERIORATED/MISSING TILES
Deficiency Location/Instance	Near Windows, by Kitchen, near Main Entrance, close to Exits I, J and others
Deficiency Quantity	200
Quantity Uom	S.F.
Potential Action	REPLACE
Urgency of Action	PRIORITY 3
Purpose of Action	LEVEL 2
Deficiency Photo1

Violations	Near Windows No violations recorded.
Deficiency	VINYL TILES: DETERIORATED SUBSTRATE
Deficiency Location/Instance	Near Main Entrance, by Exit J, next to Kitchen
Deficiency Quantity	180
Quantity Uom	S.F.
Potential Action	REPLACE
Urgency of Action	PRIORITY 5
Purpose of Action	LEVEL 6

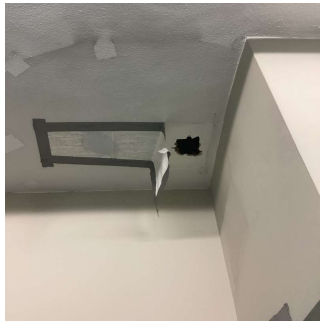
Violations	Exit K - Vestibule No violations recorded.
<b>Window Curtains/Shades/Blinds</b>	
Instance on Basement	Does not Exist
<b>CLASSROOMS/CORRIDORS/ADMIN SPACES</b>	
<b>Ceiling</b>	Inspected
Condition	2 - Between Good and Fair
Deficiency	PLASTER: CRACKS/SPALLING - ACTIVE LEAK
Deficiency Location/Instance	Corridor near Stair F/3, Rooms 210, 215, 316, 323
Deficiency Quantity	50
Quantity Uom	S.F.
Potential Action	REPLACE
Urgency of Action	PRIORITY 5
Purpose of Action	LEVEL 2
Deficiency Photo1

Violations	Corridor near Stair F/3 No violations recorded.
Deficiency	ACOUSTIC TILES: DAMAGED/MISSING
Deficiency Location/Instance	Corridor near Room B28
Deficiency Quantity	20
Quantity Uom	S.F.
Potential Action	REPLACE
Urgency of Action	PRIORITY 3
Purpose of Action	LEVEL 2

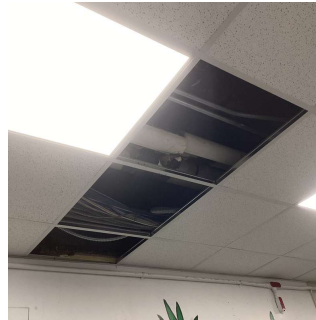
Corridor near Room B26

ACOUSTIC TILES: DAMAGED/MISSING - ACTIVE LEAK

REPLACE

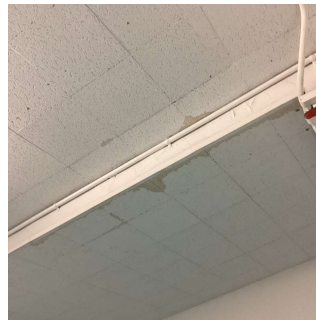
Corridor near Stair F/2

ACOUSTIC TILES ON PLASTER: DAMAGED/MISSING

REPLACE

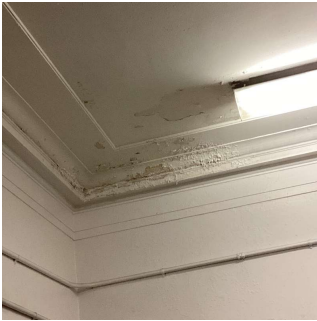
Question	Response
<b>INTERIOR</b>	
<b>CLASSROOMS/CORRIDORS/ADMIN SPACES</b>	
<b>Ceiling</b>	
Deficiency	PLASTER: CRACKS/SPALLING
Deficiency Location/Instance	Exit 13 - Vestibule, Rooms 100, 201, Corridor near Rooms 418, 421 and others
Deficiency Quantity	120
Quantity Uom	S.F.
Potential Action	REPLACE
Urgency of Action	PRIORITY 3
Purpose of Action	LEVEL 2
Deficiency Photo1

Violations	Exit 13 - Vestibule No violations recorded.
<b>Door(s)</b>	Inspected
Condition	5 - Poor
Deficiency	WOOD: DETERIORATED DOOR AND FRAME
Deficiency Location/Instance	Room 416
Deficiency Quantity	1
Quantity Uom	EACH
Potential Action	MAINTENANCE
Urgency of Action	PRIORITY 3
Purpose of Action	LEVEL 2
Deficiency Photo1	 
Violations	Room 416 No violations recorded.
Deficiency	WOOD: DETERIORATED DOOR
Deficiency Location/Instance	Corridor near Room 106, Rooms 116, 138, 204, 206 and others
Deficiency Quantity	20
Quantity Uom	EACH
Potential Action	MAINTENANCE

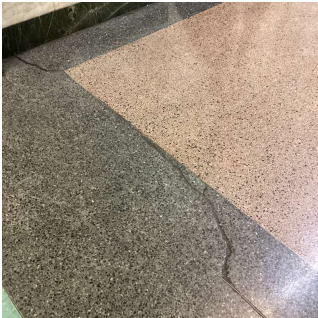
Question	Response
<b>INTERIOR</b>	
<b>CLASSROOMS/CORRIDORS/ADMIN SPACES</b>	
<b>Floor Finish</b>	
Violations	Room 215 No violations recorded.
Deficiency	TERRAZZO: CRACKS
Deficiency Location/Instance	Corridor near Exit 13, by Auditorium
Deficiency Quantity	30
Quantity Uom	S.F.
Potential Action	REPLACE
Urgency of Action	PRIORITY 3
Purpose of Action	LEVEL 2
Deficiency Photo1

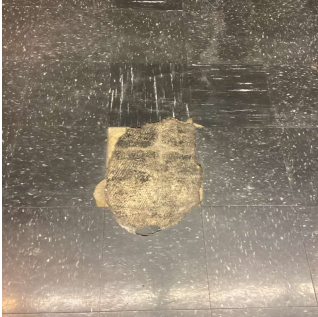
Violations	Corridor near Exit 13 No violations recorded.
Deficiency	VINYL TILES: BROKEN/DETERIORATED/MISSING TILES
Deficiency Location/Instance	Rooms 415, 315, Corridor near Stair C/1, by Girls Toilet Room - 1st Floor, close to Kitchen and others
Deficiency Quantity	4,000
Quantity Uom	S.F.
Potential Action	REPLACE
Urgency of Action	PRIORITY 3
Purpose of Action	LEVEL 2
Deficiency Photo1

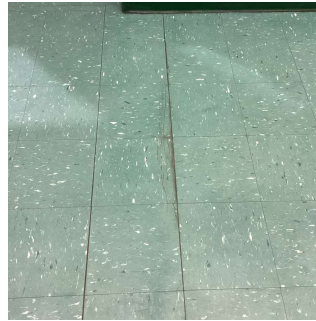
Corridor near Gymnasium

Violations	Corridor close to Kitchen No violations recorded.
Deficiency	VINYL TILES: DETERIORATED SUBSTRATE
Deficiency Location/Instance	Corridor near Gymnasium, by Rooms 113, 110, 108, next Girls Toilet Room - 1st Floor and others

Deficiency Quantity	150
Quantity Uom	S.F.
Potential Action	REPLACE
Urgency of Action	PRIORITY 3
Purpose of Action	LEVEL 2

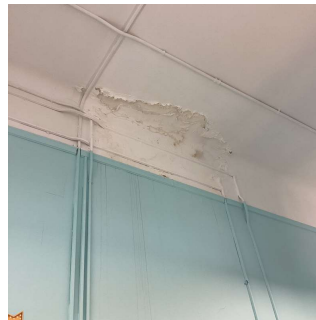
Room 316

PLASTER: CRACKS/SPALLING - ACTIVE LEAK

REPLACE

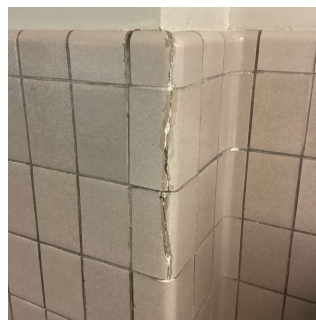
GLAZED BLOCK: CRACKS/SPALLING

REPLACE

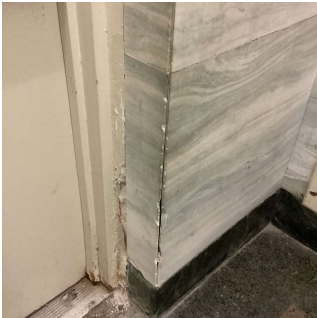
Question	Response
<b>INTERIOR</b>	
<b>CLASSROOMS/CORRIDORS/ADMIN SPACES</b>	
<b>Walls</b>	
Violations	Corridor near Stair F/3 No violations recorded.
Deficiency	STONE: CRACKS/SPALLING
Deficiency Location/Instance	Exit 13 - Vestibule
Deficiency Quantity	20
Quantity Uom	S.F.
Potential Action	REPLACE
Urgency of Action	PRIORITY 3
Purpose of Action	LEVEL 2
Deficiency Photo1

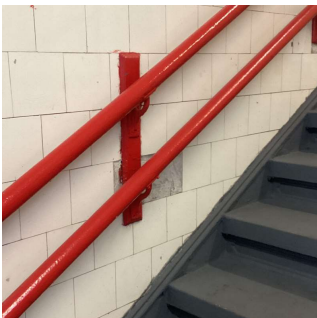
Violations	Exit 13 - Vestibule No violations recorded.
Deficiency	CERAMIC TILE: BROKEN/ MISSING
Deficiency Location/Instance	Main Entrance - Vestibule
Deficiency Quantity	10
Quantity Uom	S.F.
Potential Action	REPLACE
Urgency of Action	PRIORITY 3
Purpose of Action	LEVEL 2
Deficiency Photo1

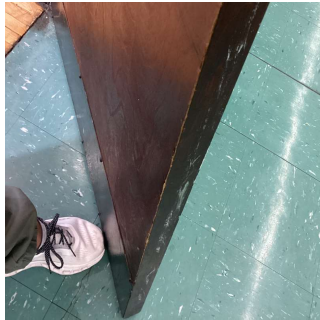
Violations	Near Main Entrance No violations recorded.
<b>Door(s)</b>	
Instance on 1st Floor	Inspected
Condition	5 - Poor
Deficiency	WOOD: DETERIORATED DOOR
Deficiency Location/Instance	Main Entrance, near Boys Locker Room
Deficiency Quantity	3
Quantity Uom	EACH
Potential Action	MAINTENANCE
Urgency of Action	PRIORITY 3
Purpose of Action	LEVEL 2
Deficiency Photo1

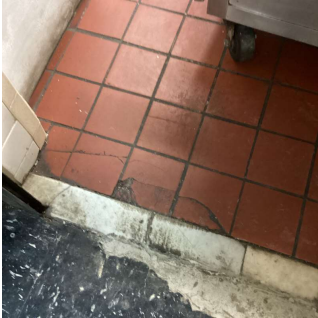
Near Servery
Violations	No violations recorded.

Instance on Basement	Inspected
Condition	2 - Between Good and Fair
Deficiency	QUARRY TILE: BROKEN/MISSING TILES
Deficiency Location/Instance	Near Servery, by Sink, close to Exit 6
Deficiency Quantity	30
Quantity Uom	S.F.
Potential Action	REPLACE
Urgency of Action	PRIORITY 3
Purpose of Action	LEVEL 2
Deficiency Photo1

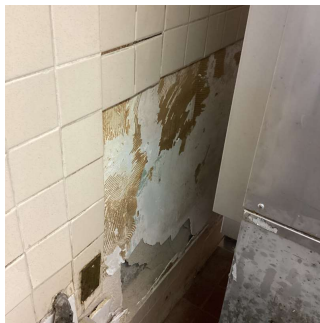
Instance on Basement	Inspected
Condition	3 - Fair
Deficiency	CERAMIC TILE: BROKEN/ MISSING
Deficiency Location/Instance	Near Servery, behind Ovens, by Windows, close to Exit 6
Deficiency Quantity	100
Quantity Uom	S.F.
Potential Action	REPLACE
Urgency of Action	PRIORITY 3
Purpose of Action	LEVEL 2

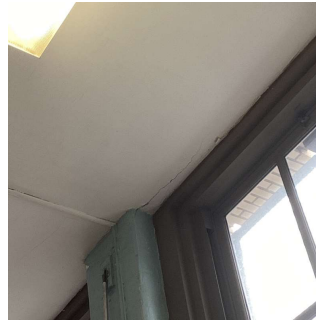
Condition	2 - Between Good and Fair
Deficiency	PLASTER: CRACKS/SPALLING
Deficiency Location/Instance	Near Windows
Deficiency Quantity	10
Quantity Uom	S.F.
Potential Action	REPLACE
Urgency of Action	PRIORITY 3
Purpose of Action	LEVEL 2

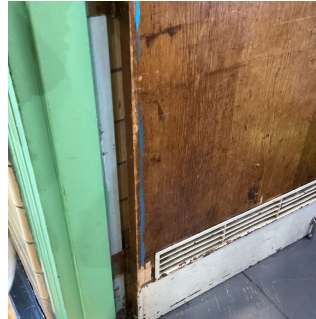
Instance on 1st Floor - Boys (500 SF)	Inspected
Condition	3 - Fair
Deficiency	WOOD: DETERIORATED DOOR
Deficiency Location/Instance	Main Entrance
Deficiency Quantity	1
Quantity Uom	EACH
Potential Action	MAINTENANCE
Urgency of Action	PRIORITY 3
Purpose of Action	LEVEL 2
Deficiency Photo1

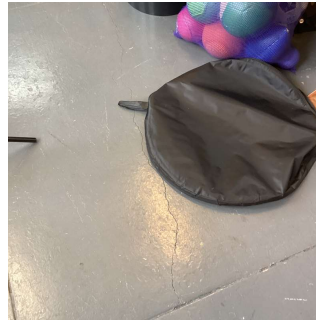
Instance on 1st Floor - Boys (500 SF)	Inspected
Condition	3 - Fair
Deficiency	CONCRETE: CRACKS
Deficiency Location/Instance	Near Drinking Water
Deficiency Quantity	20
Quantity Uom	S.F.
Potential Action	REPLACE
Urgency of Action	PRIORITY 3
Purpose of Action	LEVEL 2

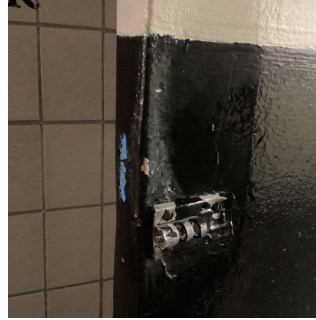
Stair C/1

Question	Response
<b>INTERIOR</b>	
<b>LOCKER ROOM</b>	
<b>Walls</b>	
Deficiency Photo1	 
Violations	Near Windows No violations recorded.
<b>MULTI-PURPOSE ROOM</b>	Does not Exist
<b>SCIENCE DEMO ROOM</b>	Does not Exist
<b>SCIENCE LAB</b>	Does not Exist
<b>SCIENCE PREP ROOM</b>	Does not Exist
<b>SHOWER ROOM</b>	Inspected
Instance on 1st Floor - Boys	Inaccessible
Instance on 1st Floor - Girls	Inaccessible
<b>STAIRS/RAMPS: INTERIOR</b>	Inspected
Do Letter Stair Signs Exist?	Partially
<b>Ceiling</b>	Inspected
Condition	2 - Between Good and Fair
Deficiency	PLASTER: CRACKS/SPALLING
Deficiency Location/Instance	Exits 10, 5 - Vestibules
Deficiency Quantity	50
Quantity Uom	S.F.
Potential Action	REPLACE
Urgency of Action	PRIORITY 3
Purpose of Action	LEVEL 2
Deficiency Photo1	 
Violations	Exit 5 - Vestibule No violations recorded.
<b>Door(s)</b>	Inspected
Condition	3 - Fair
Deficiency	METAL: DETERIORATED DOOR
Deficiency Location/Instance	Stairs C/1, 2

Potential Action	MAINTENANCE
Urgency of Action	PRIORITY 3
Purpose of Action	LEVEL 2
Deficiency Photo1

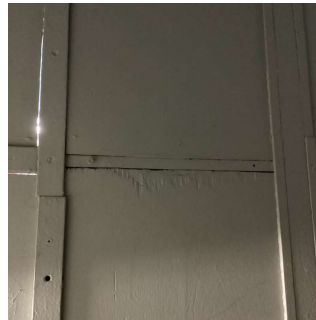
Stair E/3

Deficiency	METAL FRAME: DAMAGED/DETERIORATED
Deficiency Location/Instance	Stairs E/4, 3
Deficiency Quantity	20
Quantity Uom	L.F.
Potential Action	REPLACE
Urgency of Action	PRIORITY 3
Purpose of Action	LEVEL 2
Deficiency Photo1

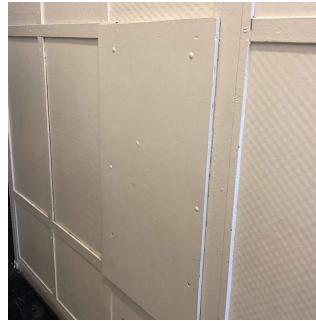
Stair E/4

Deficiency	GLASS PANEL: DAMAGED/DETERIORATED
Deficiency Location/Instance	Stairs E/4, 3
Deficiency Quantity	60
Quantity Uom	S.F.
Potential Action	REPLACE
Urgency of Action	PRIORITY 3
Purpose of Action	LEVEL 2

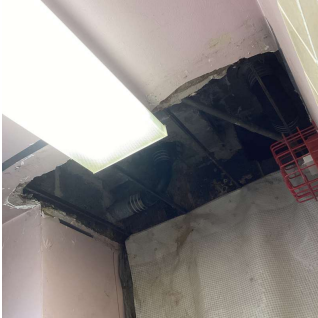
<b>Question</b>	<b>Response</b>
<b>INTERIOR</b>	
<b>TOILET ROOMS - STAFF</b>	Inspected
<b>Ceiling</b>	Inspected
Condition	3 - Fair
Deficiency	GYPSUM BOARD: DAMAGED/DETERIORATED
Deficiency Location/Instance	In Kitchen Staff Toilet, In Room 100
Deficiency Quantity	40
Quantity Uom	S.F.
Potential Action	REPLACE
Urgency of Action	PRIORITY 3
Purpose of Action	LEVEL 2
Deficiency Photo1

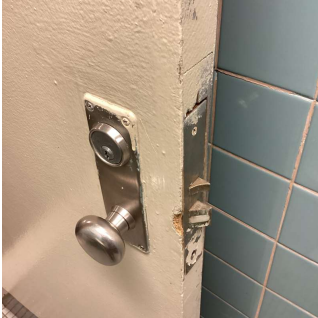
In Room 100
Violations	No violations recorded.
<b>Door(s)</b>	Inspected
Condition	5 - Poor
Deficiency	WOOD: DETERIORATED DOOR
Deficiency Location/Instance	Rooms 413, 114, B25, In Kitchen Staff Toilet
Deficiency Quantity	4
Quantity Uom	EACH
Potential Action	MAINTENANCE
Urgency of Action	PRIORITY 3
Purpose of Action	LEVEL 2
Deficiency Photo1

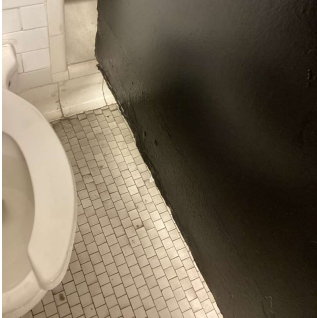
<b>Question</b>	<b>Response</b>
<b>INTERIOR</b>	
<b>TOILET ROOMS - STUDENTS</b>	
<b>Stalls</b>	Inspected
Condition	4 - Between Fair and Poor
Deficiency	RUST - MAJOR
Deficiency Location/Instance	Room B13
Deficiency Quantity	4
Quantity Uom	EACH
Potential Action	REPLACE
Urgency of Action	PRIORITY 3
Purpose of Action	LEVEL 2
Deficiency Photo1

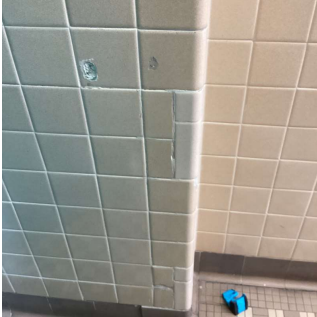
Violations	Room B13 No violations recorded.
<b>Walls</b>	Inspected
Condition	2 - Between Good and Fair
Deficiency	CERAMIC TILE: BROKEN/ MISSING
Deficiency Location/Instance	Rooms 411, 322, In Rooms 130, 126, In Boys Locker Room and others
Deficiency Quantity	70
Quantity Uom	S.F.
Potential Action	REPLACE
Urgency of Action	PRIORITY 3
Purpose of Action	LEVEL 2
Deficiency Photo1

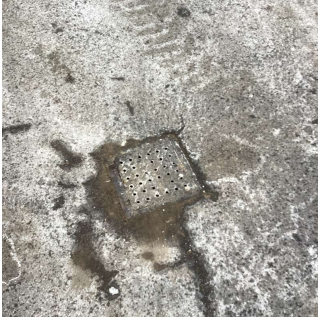
Question	Response
<b>SITE</b>	
<b>Drainage System for Asphalt</b>	
<b>Catch Basins/Manhole - Surrounded by asphalt</b>	
Condition	3 - Fair
Deficiency	DAMAGED COVER
Deficiency Location/Instance	Near Exit 6
Deficiency Quantity	1
Quantity Uom	EACH
Potential Action	REPLACE
Urgency of Action	PRIORITY 3
Purpose of Action	LEVEL 2
Deficiency Photo1

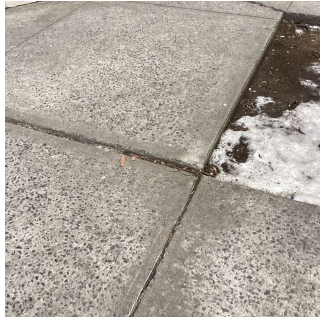
Question	Response
<b>SITE</b>	
<b>PAVING</b>	
<b>DOT Sidewalk</b>	
<b>Concrete</b>	
Deficiency Photo1	 
Violations	Rogers Avenue No violations recorded.
Deficiency	HEAVING
Deficiency Location/Instance	Parkside Avenue
Deficiency Quantity	25
Quantity Uom	S.F.
Potential Action	REPLACE
Urgency of Action	PRIORITY 3
Purpose of Action	LEVEL 2
Deficiency Photo1

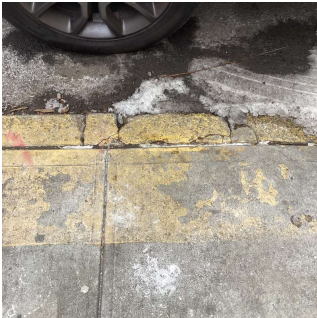
Question	Response
<b>SITE</b>	
<b>PAVING</b>	
<b>DOT Sidewalk</b>	
<b>Concrete</b>	
Violations	No violations recorded.
Deficiency	DAMAGED CURBS
Deficiency Location/Instance	Parkside Avenue, Rogers Avenue
Deficiency Quantity	300
Quantity Uom	L.F.
Potential Action	REPLACE
Urgency of Action	PRIORITY 3
Purpose of Action	LEVEL 2
Deficiency Photo1

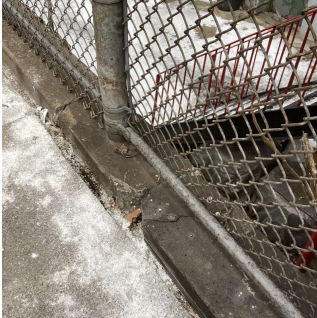
Violations	Parkside Avenue No violations recorded.
<b>Pavers</b>	Does not Exist
<b>PLAYGROUNDS</b>	Inspected
Instance on Near Rogers Avenue	Inaccessible
<b>PLAYING SURFACE</b>	Does not Exist
<b>RETAINING WALLS</b>	Inspected
Are there any Retaining Walls 6' OR higher facing public street/sidewalk?	Yes
Condition	3 - Fair
Deficiency	CAST IN PLACE CONCRETE: CRACKS/SPALLING - MAJOR
Deficiency Location/Instance	Near Playground
Deficiency Quantity	30
Quantity Uom	S.F.
Potential Action	REPLACE
Urgency of Action	PRIORITY 3
Purpose of Action	LEVEL 2
Deficiency Photo1

Violations	Near Playground No violations recorded.
