NYC Department of Education
Building Condition Assessment Survey 2023 - 2024

Architectural Inspection

Asset: P.S. 93 - BROOKLYN, 31 NEW YORK AVENUE, New York, 11216

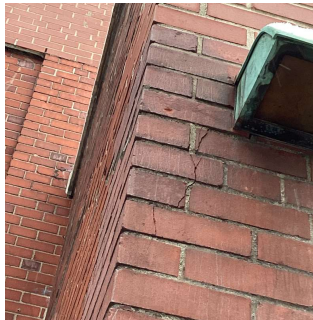
Facade A - Exit 3

BRICK: CRACKS/DISPLACED/SPALLED BRICK AT BUILDING CORNERS

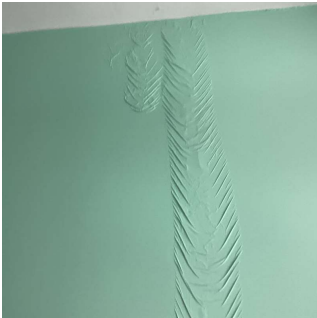
BH2
Violations	No violations recorded.
Deficiency	BULKHEAD/PENTHOUSE WALLS/EXTERIOR: DETERIORATED JOINTS
Roof Plan reference	K093

BULKHEAD/PENTHOUSE WALLS/INTERIOR: PLASTER CRACKS/SPALLING

Question	Response
EXTERIOR	
ROOF	
Specialties	
BULKHEAD/PENTHOUSE	
Quantity Uom	S.F.
Potential Action	REPLACE
Urgency of Action	PRIORITY 3
Purpose of Action	LEVEL 2
Deficiency Photo1

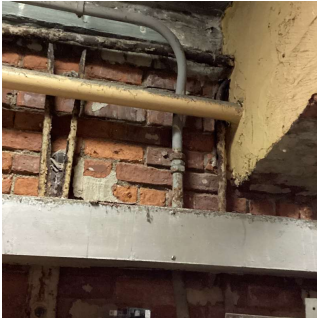
Question	Response
INTERIOR	
STRUCTURAL	
FLOOR STRUCTURE	Inspected
Violations	No violations recorded.
FOUNDATION WALLS	Inspected
Material Type(s)	Concrete, Masonry
Condition	2 - Between Good and Fair
Deficiency	No deficiencies recorded
ROOF STRUCTURE	Inspected
Condition	2 - Between Good and Fair
Deficiency	No deficiencies recorded
VAULTS-BUNKERS	Inspected
Foundation Walls	Inspected
Condition	3 - Fair
Deficiency	DETERIORATED JOINTS
Deficiency Location/Instance	Basement - B6B
Deficiency Quantity	20
Quantity Uom	S.F.
Potential Action	REPOINT
Urgency of Action	PRIORITY 3
Purpose of Action	LEVEL 5
Deficiency Photo1

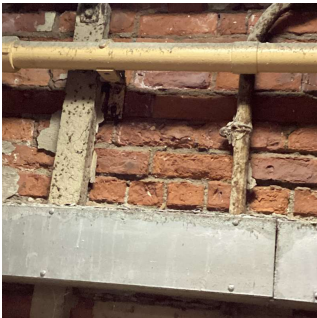
Violations	Basement - B6B No violations recorded.
Deficiency	CRACKS, SPALLING
Deficiency Location/Instance	Basement - B6B
Deficiency Quantity	50
Quantity Uom	S.F.
Potential Action	REPAIR
Urgency of Action	PRIORITY 4
Purpose of Action	LEVEL 5
Deficiency Photo1

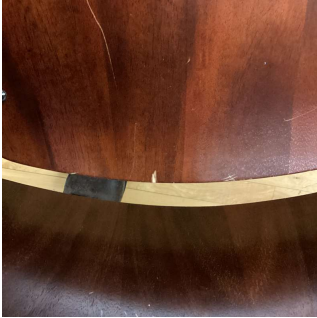
Question	Response
INTERIOR	
AUDITORIUM	
Door(s)	
Condition	2 - Between Good and Fair
Deficiency	No deficiencies recorded
Fixed H/C Lift	
Instance on 1st Floor (559 seats)	Inspected
Condition	1 - Good
Deficiency	No deficiencies recorded
Fixed Seating	
Instance on 1st Floor (559 seats)	Inspected
Condition	3 - Fair
Deficiency	DAMAGED/BROKEN/INOPERABLE
Deficiency Location/Instance	Seat A/102,112,B/2,D/12,18, and others
Deficiency Quantity	21
Quantity Uom	EACH
Potential Action	REPLACE
Urgency of Action	PRIORITY 3
Purpose of Action	LEVEL 2
Deficiency Photo1

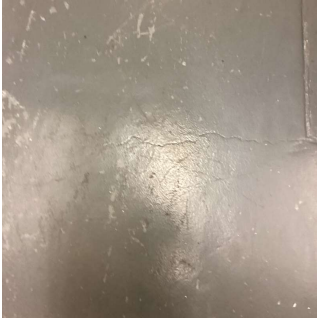
Question	Response
INTERIOR	
AUDITORIUM	
Floor Finish	
Condition	2 - Between Good and Fair
Deficiency	CONCRETE: CRACKS
Deficiency Location/Instance	Right side of stage
Deficiency Quantity	10
Quantity Uom	S.F.
Potential Action	REPLACE
Urgency of Action	PRIORITY 3
Purpose of Action	LEVEL 2
Deficiency Photo1

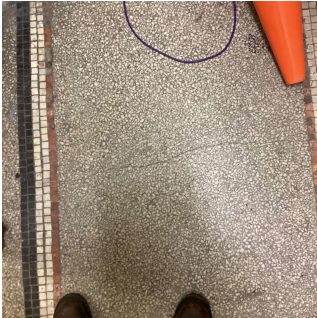
Violations	Right side of stage No violations recorded.
Deficiency	TERRAZZO: CRACKS
Deficiency Location/Instance	Exit Vestibule
Deficiency Quantity	10
Quantity Uom	S.F.
Potential Action	REPLACE
Urgency of Action	PRIORITY 3
Purpose of Action	LEVEL 2
Deficiency Photo1

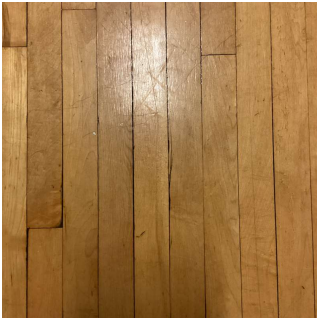
Violations	Exit Vestibule No violations recorded.
Sliding-folding Partition	
Instance on 1st Floor (559 seats)	Does not Exist
Stage	
Instance on 1st Floor (559 seats)	Inspected
Stage	Inspected
Instance on 1st Floor (559 seats)	Inspected
Condition	2 - Between Good and Fair
Deficiency	DAMAGED FLOOR
Deficiency Location/Instance	Near center
Deficiency Quantity	10

Question	Response
INTERIOR	
AUDITORIUM	
Stage	
Stage	
Quantity Uom	S.F.
Potential Action	REPLACE
Urgency of Action	PRIORITY 3
Purpose of Action	LEVEL 2
Deficiency Photo1

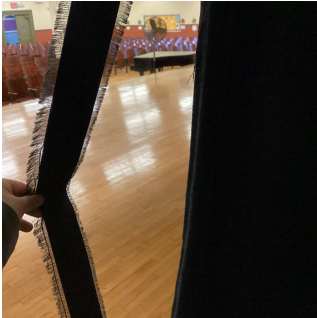
Near center
Violations	No violations recorded.
Stage Curtain Rigging	Inspected
Instance on 1st Floor (559 seats)	Inspected
Condition	1 - Good
Deficiency	No deficiencies recorded
Stage Curtains	Inspected
Instance on 1st Floor (559 seats)	Inspected
Condition	3 - Fair
Deficiency	WORN/DETERIORATED
Deficiency Location/Instance	Left side, right side
Deficiency Quantity	200
Quantity Uom	S.F.
Potential Action	REPLACE
Urgency of Action	PRIORITY 3
Purpose of Action	LEVEL 2
Deficiency Photo1

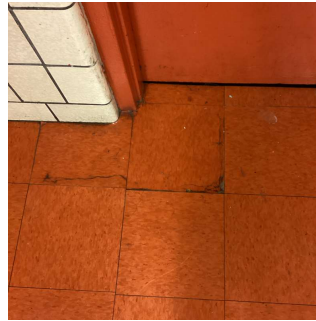
Near Stair BC

Floor Finish

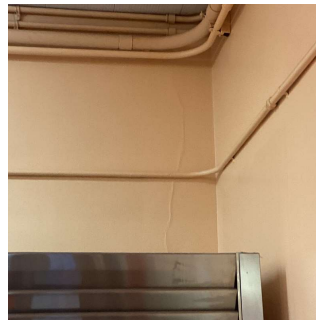
Near Room B1

PLASTER: CRACKS/SPALLING

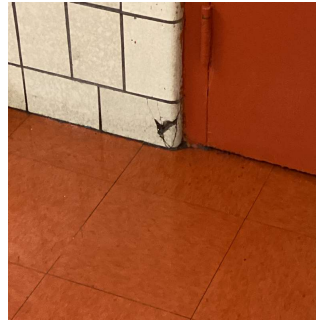
Near Room B1

GLAZED BLOCK: CRACKS/SPALLING

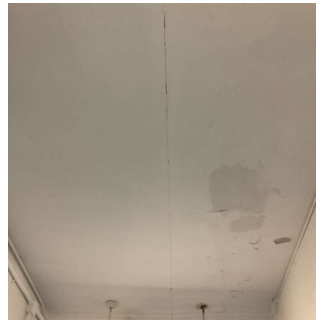
Corridor near Room 116

PLASTER: CRACKS/SPALLING

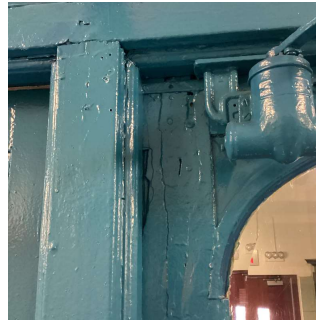
Main Entrance Vestibule

WOOD: DETERIORATED DOOR

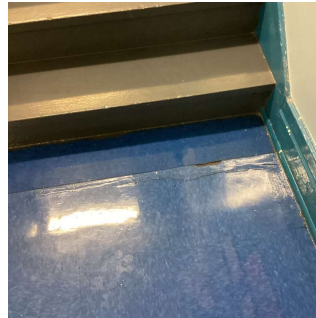
Corridor near Room 116B

VINYL TILES: DETERIORATED SUBSTRATE

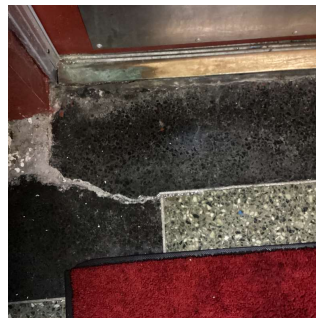
TERRAZZO: CRACKS

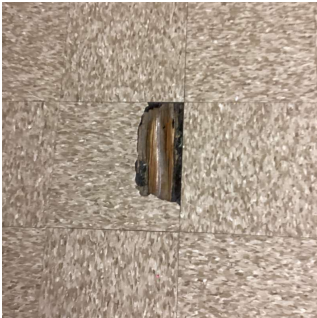
Question	Response
INTERIOR	
CLASSROOMS/CORRIDORS/ADMIN SPACES	
Floor Finish	
Violations	Main Entrance Vestibule No violations recorded.
Deficiency	VINYL TILES: BROKEN/DETERIORATED/MISSING TILES
Deficiency Location/Instance	Room 309,114
Deficiency Quantity	10
Quantity Uom	S.F.
Potential Action	REPLACE
Urgency of Action	PRIORITY 3
Purpose of Action	LEVEL 2
Deficiency Photo1

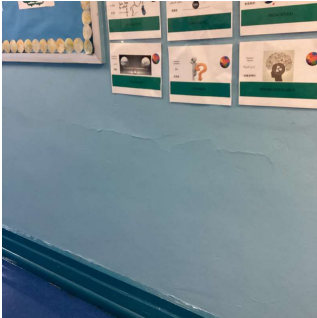
Violations	Room 309 No violations recorded.
Walls	Inspected
Condition	2 - Between Good and Fair
Deficiency	PLASTER: CRACKS/SPALLING
Deficiency Location/Instance	Corridor near Room 316, 309, 306, 120, B22
Deficiency Quantity	50
Quantity Uom	S.F.
Potential Action	REPLACE
Urgency of Action	PRIORITY 3
Purpose of Action	LEVEL 2
Deficiency Photo1

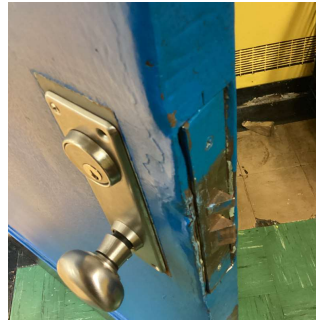
Office

Door(s)

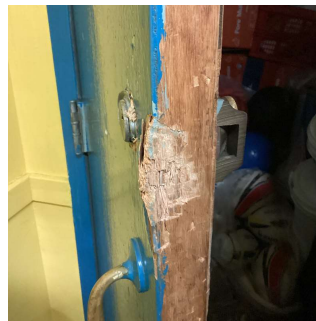
Storage

WOOD: DETERIORATED DOOR

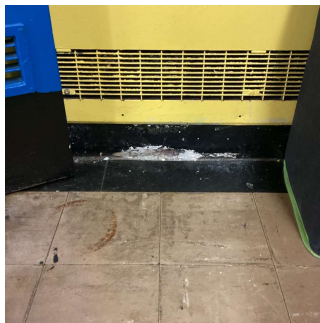
Question	Response
INTERIOR	
GYMNASIUM	
Floor Finish	
Deficiency Photo1	 
Violations	Office No violations recorded.
Deficiency	WOOD: DAMAGED/DETERIORATED
Deficiency Location/Instance	Near center, Entrance, windows
Deficiency Quantity	40
Quantity Uom	S.F.
Potential Action	REPLACE
Urgency of Action	PRIORITY 3
Purpose of Action	LEVEL 2
Deficiency Photo1	 
Violations	Near center No violations recorded.
Seating	
Instance on Basement	Inspected
Condition	2 - Between Good and Fair
Deficiency	No deficiencies recorded
Sliding-folding Partition	
Instance on Basement	Does not Exist
Stage	
Instance on Basement	Does not Exist
Walls	
Instance on Basement	Inspected
Condition	2 - Between Good and Fair
Deficiency	PLASTER: CRACKS/SPALLING
Deficiency Location/Instance	Office
Deficiency Quantity	10
Quantity Uom	S.F.
Potential Action	REPLACE
Urgency of Action	PRIORITY 3
Purpose of Action	LEVEL 2

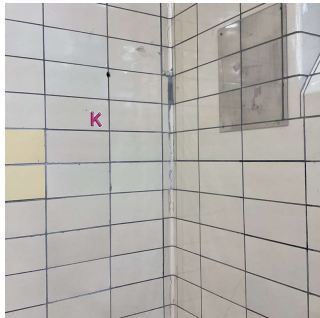
Office
Violations	No violations recorded.
Deficiency	GLAZED BLOCK: CRACKS/SPALLING
Deficiency Location/Instance	Near Entrance, windows
Deficiency Quantity	20
Quantity Uom	S.F.
Potential Action	REPLACE
Urgency of Action	PRIORITY 3
Purpose of Action	LEVEL 2
Deficiency Photo1

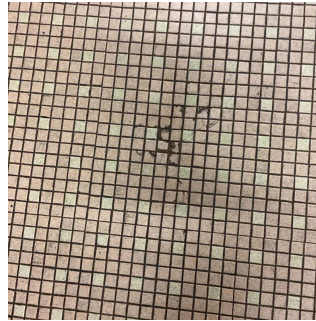
Near center

Floor Finish

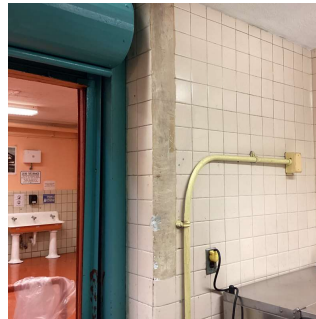
Servery

Instance on Basement	Inspected
Condition	2 - Between Good and Fair
Deficiency	CERAMIC TILE: BROKEN/ MISSING
Deficiency Location/Instance	Near Entrance, servery, center
Deficiency Quantity	20
Quantity Uom	S.F.
Potential Action	REPLACE
Urgency of Action	PRIORITY 3
Purpose of Action	LEVEL 2
Deficiency Photo1

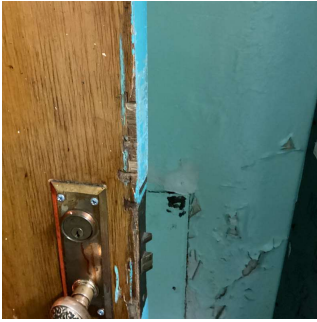
Question	Response
INTERIOR	
LIBRARY	Inspected
Walls	
Instance on Room 122	Inspected
Condition	2 - Between Good and Fair
Deficiency	No deficiencies recorded
LOCKER ROOM	Inspected
Instance on Basement - Boys (50 lockers)	Inspected
Alternative use	Yes
Instance on Basement - Girls	Inspected
Alternative use	Yes
Ceiling	
Instance on Basement - Girls	Inspected
Condition	2 - Between Good and Fair
Deficiency	No deficiencies recorded
Instance on Basement - Boys (50 lockers)	Inspected
Condition	2 - Between Good and Fair
Deficiency	No deficiencies recorded
Door(s)	
Instance on Basement - Boys (50 lockers)	Inspected
Condition	3 - Fair
Deficiency	WOOD: DETERIORATED DOOR
Deficiency Location/Instance	Entrance
Deficiency Quantity	1
Quantity Uom	EACH
Potential Action	MAINTENANCE
Urgency of Action	PRIORITY 3
Purpose of Action	LEVEL 2
Deficiency Photo1

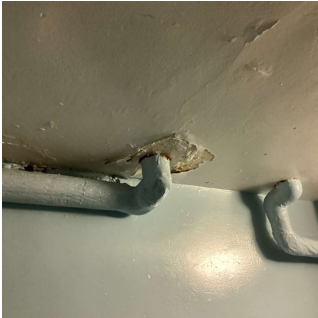
Question	Response
INTERIOR	
SCIENCE LAB	
Instance on Room 411	Inspected
Alternative use	No
Fixed Equipment	
Instance on Room 411	Inspected
Condition	1 - Good
Deficiency	No deficiencies recorded
SCIENCE PREP ROOM	
	Does not Exist
SHOWER ROOM	
	Inspected
Instance on Basement - Boys	Inaccessible
Instance on Basement - Girls	Inaccessible
STAIRS/RAMPS: INTERIOR	
	Inspected
Do Letter Stair Signs Exist?	Yes
Ceiling	
	Inspected
Condition	2 - Between Good and Fair
Deficiency	PLASTER: CRACKS/SPALLING
Deficiency Location/Instance	Stair DE/2
Deficiency Quantity	10
Quantity Uom	S.F.
Potential Action	REPLACE
Urgency of Action	PRIORITY 3
Purpose of Action	LEVEL 2
Deficiency Photo1

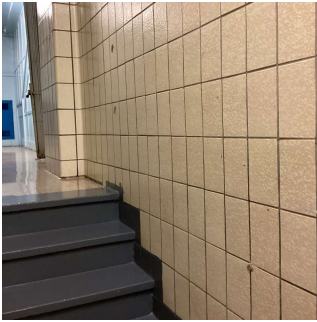
Question	Response
INTERIOR	
STAIRS/RAMPS: INTERIOR	
Door(s)	
Deficiency Photo1	 
Violations	Stair DE/Basement No violations recorded.
Partition	Inspected
Condition	2 - Between Good and Fair
Deficiency	No deficiencies recorded
Railings	Inspected
Condition	3 - Fair
Deficiency	METAL: MISSING
Deficiency Location/Instance	Stair BC/Basement
Deficiency Quantity	15
Quantity Uom	L.F.
Potential Action	REPLACE
Urgency of Action	PRIORITY 5
Purpose of Action	LEVEL 6
Deficiency Photo1

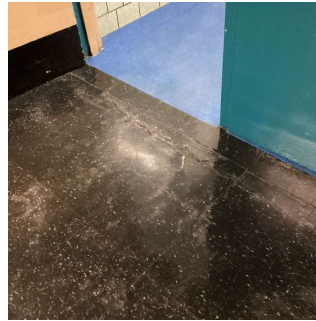
Violations	Stair BC/Basement No violations recorded.
Stairs and Landings	Inspected
Condition	2 - Between Good and Fair
Deficiency	VINYL TILES: BROKEN/DETERIORATED/MISSING TILES
Deficiency Location/Instance	Stair DE/Basement
Deficiency Quantity	10
Quantity Uom	S.F.
Potential Action	REPLACE
Urgency of Action	PRIORITY 3
Purpose of Action	LEVEL 2

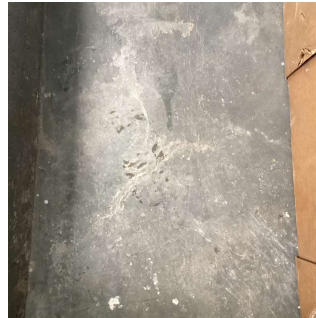
Stair BC/Bulkhead

CONCRETE: CRACKS/SPALLING - MAJOR

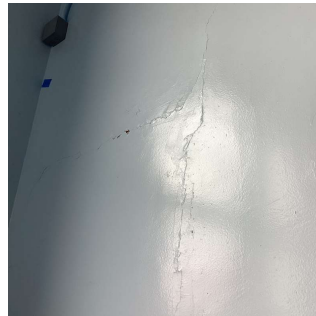
PLASTER: CRACKS/SPALLING

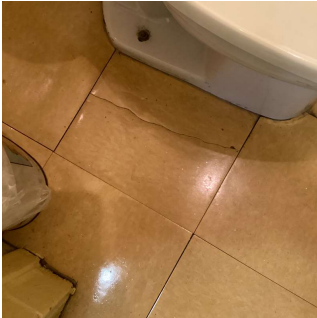
Question	Response
INTERIOR	
TOILET ROOMS - STAFF	
Floor Finish	
Deficiency	VINYL TILES: BROKEN/DETERIORATED/MISSING TILES
Deficiency Location/Instance	Room 112B
Deficiency Quantity	10
Quantity Uom	S.F.
Potential Action	REPLACE
Urgency of Action	PRIORITY 3
Purpose of Action	LEVEL 2
Deficiency Photo1

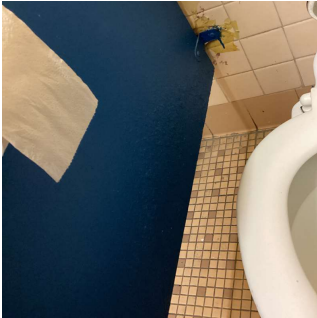
Violations	Room 112B No violations recorded.
Stalls	Inspected
Condition	5 - Poor
Deficiency	RUST - MAJOR
Deficiency Location/Instance	Gymnasium Staff
Deficiency Quantity	1
Quantity Uom	EACH
Potential Action	REPLACE
Urgency of Action	PRIORITY 3
Purpose of Action	LEVEL 2
Deficiency Photo1

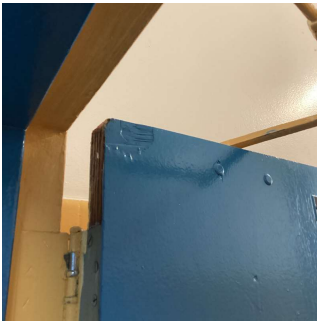
Question	Response
INTERIOR	
TOILET ROOMS - STAFF	
Walls	
Deficiency Photo1	 
Violations	Room 404B No violations recorded.
TOILET ROOMS - STUDENTS	
Ceiling	Inspected
Condition	2 - Between Good and Fair
Deficiency	PLASTER: CRACKS/SPALLING
Deficiency Location/Instance	Room 419
Deficiency Quantity	10
Quantity Uom	S.F.
Potential Action	REPLACE
Urgency of Action	PRIORITY 3
Purpose of Action	LEVEL 2
Deficiency Photo1	 
Violations	Room 419 No violations recorded.
Door(s)	Inspected
Condition	5 - Poor
Deficiency	WOOD: DETERIORATED DOOR
Deficiency Location/Instance	Room 321,319,221,219,121,119
Deficiency Quantity	6
Quantity Uom	EACH
Potential Action	MAINTENANCE
Urgency of Action	PRIORITY 3
Purpose of Action	LEVEL 2

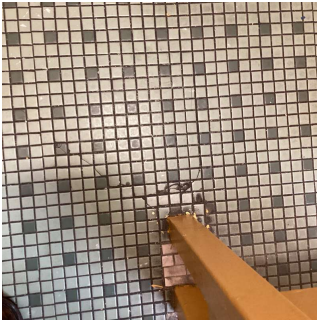
Violations	Room 321 No violations recorded.
Floor Finish	Inspected
Condition	2 - Between Good and Fair
Deficiency	CERAMIC TILE: BROKEN/MISSING TILES
Deficiency Location/Instance	Room 321,221,121,119
Deficiency Quantity	20
Quantity Uom	S.F.
Potential Action	REPLACE
Urgency of Action	PRIORITY 3
Purpose of Action	LEVEL 2
Deficiency Photo1

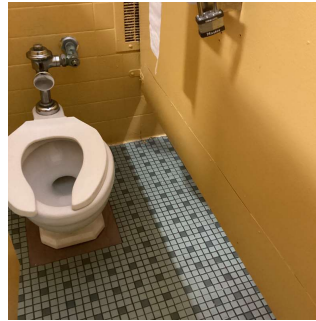
Room 421

Violations	Room 321 No violations recorded.
Stalls	Inspected
Condition	5 - Poor
Deficiency	RUST - MAJOR
Deficiency Location/Instance	Room 421,419,321,319,221, and others
Deficiency Quantity	30
Quantity Uom	EACH
Potential Action	REPLACE
Urgency of Action	PRIORITY 3
Purpose of Action	LEVEL 2

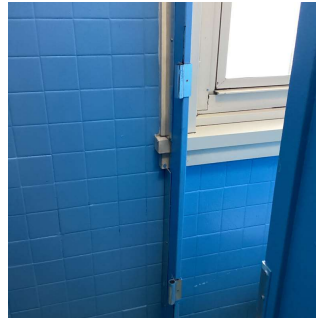
Room 319

BROKEN/MISSING

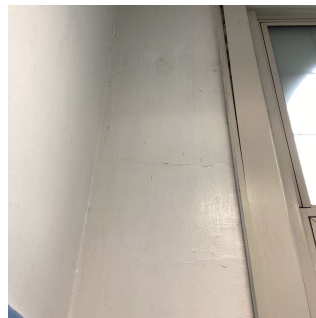
PLASTER: CRACKS/SPALLING

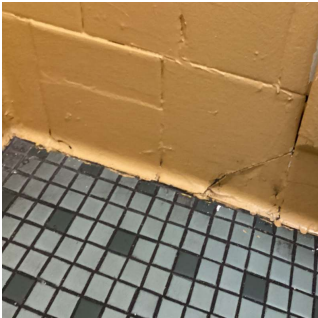
Question	Response
INTERIOR	
TOILET ROOMS - STUDENTS	
Walls	
Violations	Room 422 No violations recorded.
Deficiency	CERAMIC TILE: BROKEN/ MISSING
Deficiency Location/Instance	Room 421,321,319,221,219, and others
Deficiency Quantity	50
Quantity Uom	S.F.
Potential Action	REPLACE
Urgency of Action	PRIORITY 3
Purpose of Action	LEVEL 2
Deficiency Photo1

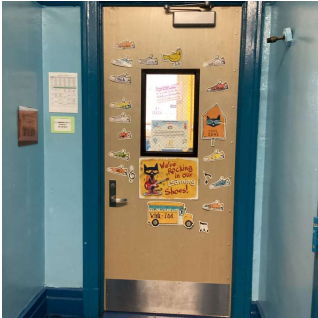
Violations	4th Floor - Girls No violations recorded.
LIFE SAFETY	Inspected
F.D. HOLDING AREA	Inspected
Condition	5 - Poor
Deficiency	HOLDING AREAS NOT IDENTIFIED
Deficiency Location/Instance	Rooms 201, 301, 401
Deficiency Quantity	3
Quantity Uom	EACH
Potential Action	PROVIDE IDENTIFICATION AT DOOR
Urgency of Action	PRIORITY 5
Purpose of Action	LEVEL 2
Deficiency Photo1

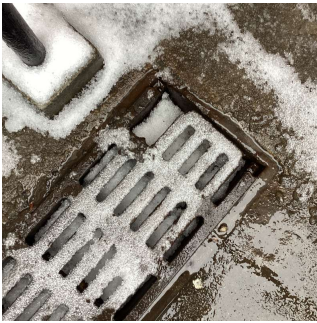
Question	Response
SITE	
CONTAINERIZATION	
Deficiency Location/Instance	Schoolyard
Deficiency Quantity	100
Quantity Uom	S.F.
Potential Action	REPAIR
Urgency of Action	PRIORITY 3
Purpose of Action	LEVEL 2
Deficiency Photo1	 
Violations	Schoolyard No violations recorded.
Deficiency	CONCRETE PAD MISSING
Deficiency Location/Instance	Schoolyard
Deficiency Quantity	100
Quantity Uom	S.F.
Potential Action	INSTALL NEW
Urgency of Action	PRIORITY 3
Purpose of Action	LEVEL 2
Deficiency Photo1	No photo recorded
Violations	No violations recorded.
Drainage System for Asphalt	Inspected
Catch Basins/Manhole - Surrounded by asphalt	Inspected
Condition	2 - Between Good and Fair
Deficiency	No deficiencies recorded
Culverts - Asphalt Covering	Does not Exist
Drainage System for Concrete	Inspected
Catch Basins/Manhole - Surrounded by concrete	Inspected
Condition	5 - Poor
Deficiency	DAMAGED COVER
Deficiency Location/Instance	Near Exit 2
Deficiency Quantity	3

Quantity Uom	EACH
Potential Action	REPLACE
Urgency of Action	PRIORITY 5
Purpose of Action	LEVEL 6

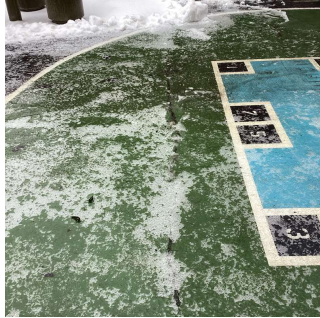
Violations	Along New York Avenue No violations recorded.
IRRIGATION SYSTEM	Does not Exist
PAVING	Inspected
Student Non-Use	Inspected
Gravel Exists?	No
Asphalt	Inspected
Condition	2 - Between Good and Fair
Deficiency	No deficiencies recorded
Concrete	Does not Exist
Pavers	Does not Exist
Student Use	Inspected
Gravel Exists?	No
Asphalt	Inspected
Condition	4 - Between Fair and Poor
Deficiency	CRACKS - MAJOR
Deficiency Location/Instance	Schoolyard
Deficiency Quantity	500
Quantity Uom	S.F.
Potential Action	REPLACE
Urgency of Action	PRIORITY 3
Purpose of Action	LEVEL 2
Deficiency Photo1

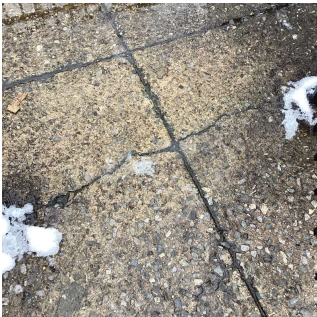
Question	Response
SITE	
PAVING	
Student Use	Inspected
Concrete	Inspected
Condition	2 - Between Good and Fair
Deficiency	No deficiencies recorded
Pavers	Does not Exist
Site Sidewalks & Walkways	Inspected
Asphalt	Does not Exist
Concrete	Inspected
Condition	3 - Fair
Deficiency	DAMAGED/DETERIORATED/MISSING SECTIONS
Deficiency Location/Instance	Along New York Avenue
Deficiency Quantity	50
Quantity Uom	S.F.
Potential Action	REPLACE
Urgency of Action	PRIORITY 3
Purpose of Action	LEVEL 2
Deficiency Photo1

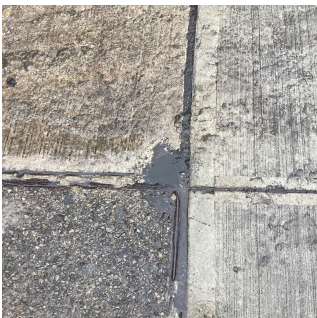
Violations	Along New York Avenue No violations recorded.
Pavers	Does not Exist
DOT Sidewalk	Inspected
Asphalt	Does not Exist
Concrete	Inspected
Condition	3 - Fair
Deficiency	DAMAGED/DETERIORATED/MISSING SECTIONS
Deficiency Location/Instance	Along Herkimer Street, New Yorker Avenue
Deficiency Quantity	100
Quantity Uom	S.F.
Potential Action	REPLACE
Urgency of Action	PRIORITY 3
Purpose of Action	LEVEL 2
Deficiency Photo1

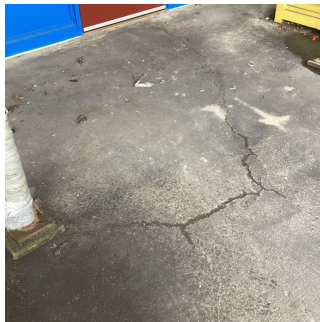
Question	Response
SITE	
PAVING	Inspected
DOT Sidewalk	
Concrete	Inspected
Violations	Along Herkimer Street No violations recorded.
Pavers	Does not Exist
PLAYGROUNDS	
Instance on Atlantic Avenue	Inspected
Instance on Schoolyard	Inspected
Benches	
Instance on Schoolyard	Does not Exist
Instance on Atlantic Avenue	Inspected
Condition	2 - Between Good and Fair
Deficiency	No deficiencies recorded
Fence	
Instance on Atlantic Avenue	Inspected
Condition	2 - Between Good and Fair
Deficiency	No deficiencies recorded
Instance on Schoolyard	Inspected
Condition	2 - Between Good and Fair
Deficiency	No deficiencies recorded
Pavement	
Instance on Atlantic Avenue	Inspected
Condition	3 - Fair
Deficiency	ASPHALT: CRACKS - MAJOR
Deficiency Location/Instance	Near Benches
Deficiency Quantity	50
Quantity Uom	S.F.
Potential Action	REPLACE
Urgency of Action	PRIORITY 3
Purpose of Action	LEVEL 2
Deficiency Photo1

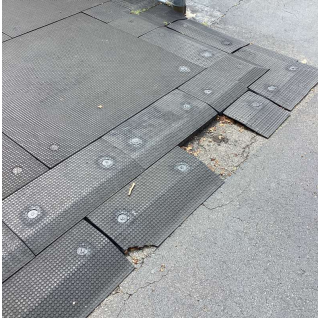
Question	Response
SITE	
PLAYGROUNDS	Inspected
Safety Surfacing	
Instance on Atlantic Avenue	Inspected
Condition	2 - Between Good and Fair
Deficiency	DETERIORATED/MISSING
Deficiency Location/Instance	Near Stairway
Deficiency Quantity	10
Quantity Uom	S.F.
Potential Action	REPLACE
Urgency of Action	PRIORITY 3
Purpose of Action	LEVEL 2
Deficiency Photo1	 
	Near Stairway
Violations	No violations recorded.
Instance on Schoolyard	Inspected
Condition	2 - Between Good and Fair
Deficiency	DETERIORATED/MISSING
Deficiency Location/Instance	Schoolyard
Deficiency Quantity	15
Quantity Uom	S.F.
Potential Action	REPLACE
Urgency of Action	PRIORITY 3
Purpose of Action	LEVEL 2
Deficiency Photo1

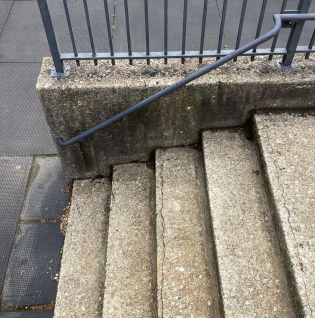
Question	Response
SITE	
SEATING	
Benches	
Metal/Wood/Plastic	
Potential Action	REPLACE
Urgency of Action	PRIORITY 3
Purpose of Action	LEVEL 2
Deficiency Photo1	 
Violations	Schoolyard No violations recorded.
Bleachers	Does not Exist
SITE WALLS (NOT RETAINING WALLS)	Does not Exist
STAIRS/RAMPS: EXTERIOR	Inspected
Railings	Inspected
Condition	2 - Between Good and Fair
Deficiency	No deficiencies recorded
Site Cheek/flank Walls	Inspected
Condition	2 - Between Good and Fair
Deficiency	CAST IN PLACE CONCRETE: CRACKS/SPALLING - MAJOR
Deficiency Location/Instance	Schoolyard
Deficiency Quantity	10
Quantity Uom	S.F.
Potential Action	REPLACE
Urgency of Action	PRIORITY 3
Purpose of Action	LEVEL 2
Deficiency Photo1	 
Violations	Schoolyard No violations recorded.
Stairs/ramps	Inspected
Condition	2 - Between Good and Fair
Deficiency	CAST IN PLACE CONCRETE: CRACKS/SPALLING - MAJOR
Deficiency Location/Instance	Near Exit 2, Atlantic Avenue Playground

Deficiency Quantity	45
Quantity Uom	S.F.

Question	Response
SITE	
STAIRS/RAMPS: EXTERIOR	
Stairs/ramps	
Potential Action	REPLACE
Urgency of Action	PRIORITY 3
Purpose of Action	LEVEL 2
Deficiency Photo1
