**NYC Department of Education**  
**Building Condition Assessment Survey 2023 - 2024**

Architectural Inspection

**Asset: P.S. 95 - BROOKLYN, 345 VAN SICKLEN STREET, New York, 11223**

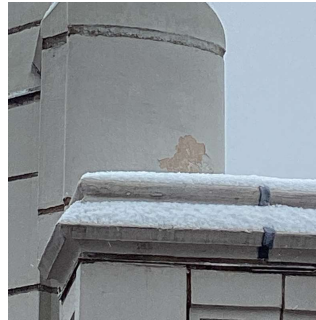
Roof 1

**CAST STONE: CRACKED/BROKEN PIECES**

REPLACE-IN-KIND

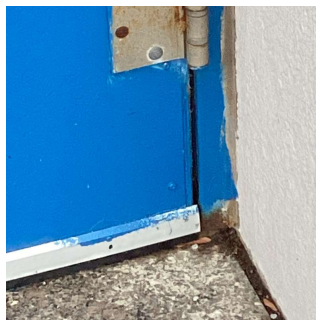
**METAL CLAD: DETERIORATED DOOR AND FRAME - MINOR DETERIORATION**

8  
EACH  
MAINTENANCE  
PRIORITY 3  
LEVEL 2

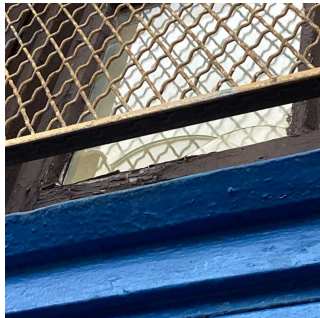
Violations	Facade C - Exit 4 No violations recorded.
<b>DOOR HARDWARE</b>	Inspected
Condition	3 - Fair
Deficiency	No deficiencies recorded
<b>LINTELS</b>	Inspected
Condition	2 - Between Good and Fair
Deficiency	No deficiencies recorded
<b>TRANSOM/SIDE LIGHT</b>	Inspected
Condition	5 - Poor
Deficiency	WOOD: BROKEN GLASS
Roof Plan reference	K095
Deficiency Quantity	10
Quantity Uom	S.F.
Potential Action	MAINTENANCE
Urgency of Action	PRIORITY 3
Purpose of Action	LEVEL 2
Deficiency Photo1

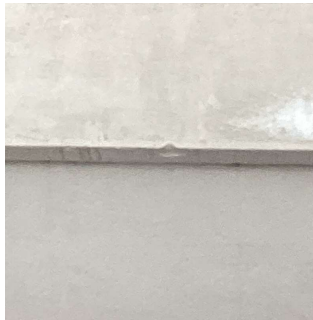
Facade A

STONE: CHIPPED/SPALLED/BROKEN PIECES - MINOR

REPAIR

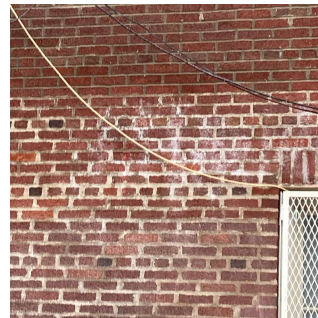
Facade E

**BRICK: EFFLORESCENCE**

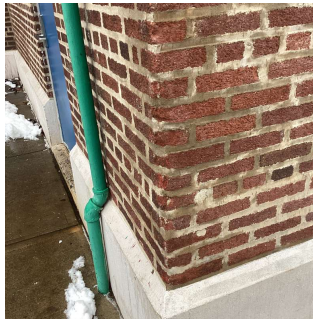
Facade E

**BRICK: MAJOR / THRU CRACKS**

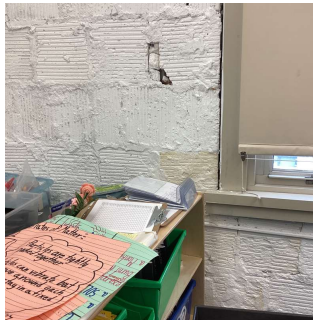
Facade E - Room 425 (Facade E - Rooms 203, 303, 325, 336, 338, 403 similar)

**BRICK: WATER INFILTRATION IN INSTRUCTIONAL SPACE**

REPAIR

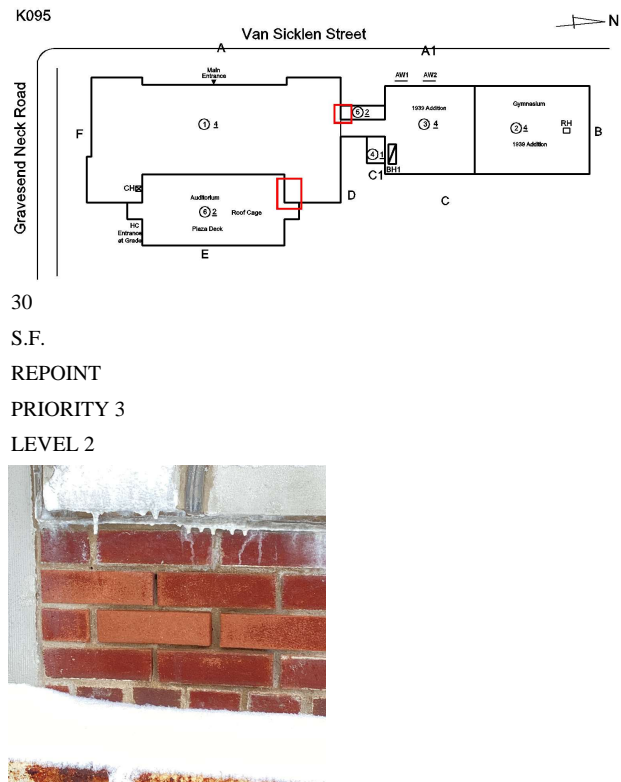
Question	Response
<b>EXTERIOR</b>	
<b>PARAPETS</b>	
Violations	No violations recorded.
Deficiency	<b>BRICK: DETERIORATED JOINTS</b>
Roof Plan reference	K095
Deficiency Quantity	30
Quantity Uom	S.F.
Potential Action	REPOINT
Urgency of Action	PRIORITY 3
Purpose of Action	LEVEL 2
Deficiency Photo1

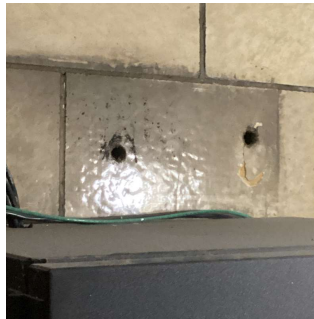
BH1

Deficiency	<b>BULKHEAD/PENTHOUSE WALLS/INTERIOR: GLAZED BLOCK CRACKS/SPALLING</b>
------------	--

REPLACE

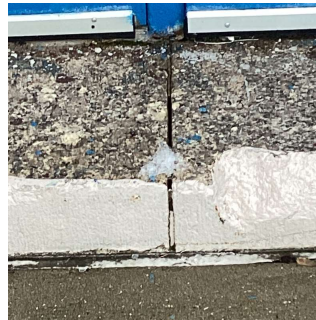
Facade C

STONE: DETERIORATED JOINTS

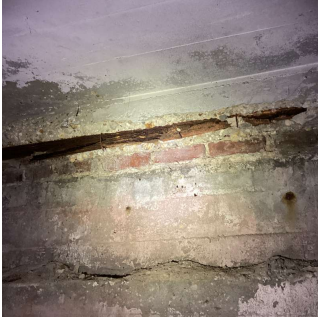
Violations	Basement Crawl Space under Exit 3 No violations recorded.
Deficiency	<b>STEEL COLUMNS/BEAMS: DETERIORATED CONCRETE FIREPROOFING</b>
Deficiency Location/Instance	Basement, 1st Floor
Deficiency Quantity	140
Quantity Uom	S.F.
Potential Action	REPLACE
Urgency of Action	PRIORITY 3
Purpose of Action	LEVEL 5
Deficiency Photo1

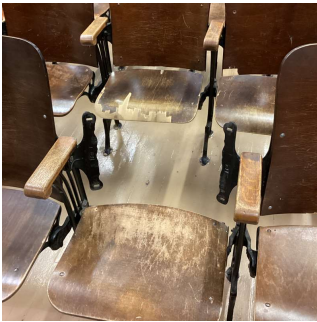
Boiler Room
Violations	No violations recorded.
<b>ROOF STRUCTURE</b>	
Condition	Inspected
	2 - Between Good and Fair
Deficiency	No deficiencies recorded
<b>VAULTS-BUNKERS</b>	
	Does not Exist
<b>AUDITORIUM</b>	
Instance on 2nd Floor (652 Seats)	Inspected
<b>Ceiling</b>	
Instance on 2nd Floor (652 Seats)	Inspected
Condition	2 - Between Good and Fair
Deficiency	No deficiencies recorded
<b>Door(s)</b>	
Instance on 2nd Floor (652 Seats)	Inspected
Condition	2 - Between Good and Fair
Deficiency	No deficiencies recorded
<b>Fixed H/C Lift</b>	
Instance on 2nd Floor (652 Seats)	Does not Exist
<b>Fixed Seating</b>	
Instance on 2nd Floor (652 Seats)	Inspected
Condition	5 - Poor
Deficiency	DAMAGED/BROKEN/INOPERABLE
Deficiency Location/Instance	Seat A/3 , G/40, H/63,84,87
Deficiency Quantity	5
Quantity Uom	EACH
Potential Action	REPLACE

Urgency of Action	PRIORITY 5
Purpose of Action	LEVEL 6
Deficiency Photo1

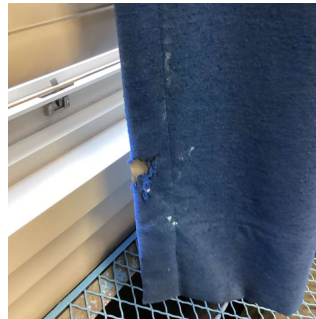
Instance on 2nd Floor (652 Seats)	Inspected
Condition	3 - Fair
Deficiency	WORN/DAMAGED CURTAINS
Deficiency Location/Instance	Right Side , Rear
Deficiency Quantity	200
Quantity Uom	S.F.
Potential Action	MAINTENANCE
Urgency of Action	PRIORITY 3
Purpose of Action	LEVEL 2
Deficiency Photo1

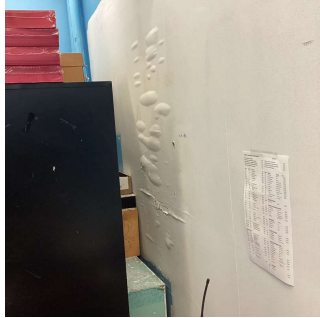
Question	Response
<b>INTERIOR</b>	
<b>CLASSROOMS/CORRIDORS/ADMIN SPACES</b>	
<b>Floor Finish</b>	Inspected
	4th Floor Staff Lounge
Violations	No violations recorded.
<b>Walls</b>	Inspected
Condition	2 - Between Good and Fair
Deficiency	GYPSUM BOARD: DETERIORATED - ACTIVE LEAK
Deficiency Location/Instance	Room 125-C
Deficiency Quantity	30
Quantity Uom	S.F.
Potential Action	REPLACE
Urgency of Action	PRIORITY 5
Purpose of Action	LEVEL 2
Deficiency Photo1

Room 125C
Violations	No violations recorded.
Deficiency	PLASTER: CRACKS/SPALLING
Deficiency Location/Instance	Corridor near room 237, Main Lobby
Deficiency Quantity	40
Quantity Uom	S.F.
Potential Action	REPLACE
Urgency of Action	PRIORITY 3
Purpose of Action	LEVEL 2
Deficiency Photo1

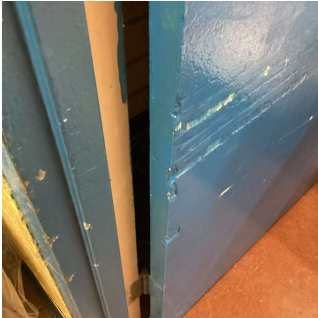
Instance on 1st Floor	Inspected
<b>Ceiling</b>	
Instance on 1st Floor	Inspected
Condition	2 - Between Good and Fair
Deficiency	No deficiencies recorded
<b>Door(s)</b>	
Instance on 1st Floor	Inspected
Condition	3 - Fair
Deficiency	WOOD: DETERIORATED DOOR
Deficiency Location/Instance	Entrance

Deficiency Quantity	1
Quantity Uom	EACH
Potential Action	MAINTENANCE
Urgency of Action	PRIORITY 3
Purpose of Action	LEVEL 2
Deficiency Photo1

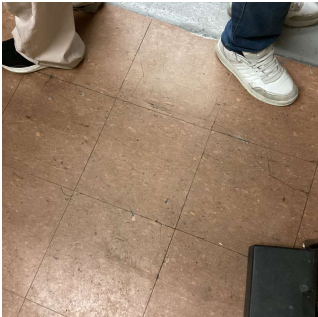
Instance on 1st Floor	Inspected
Condition	3 - Fair
Deficiency	VINYL TILES: DETERIORATED SUBSTRATE
Deficiency Location/Instance	Near Entrance
Deficiency Quantity	35
Quantity Uom	S.F.
Potential Action	REPLACE
Urgency of Action	PRIORITY 3
Purpose of Action	LEVEL 2
Deficiency Photo1

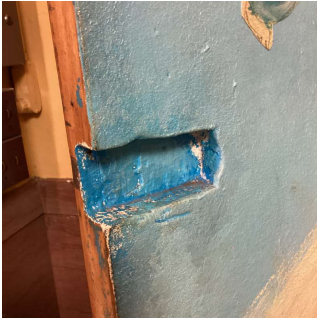
Question	Response
<b>INTERIOR</b>	
<b>MULTI-PURPOSE ROOM</b>	
<b>Door(s)</b>	
Deficiency	WOOD: DETERIORATED DOOR
Deficiency Location/Instance	Entrance to main lobby
Deficiency Quantity	1
Quantity Uom	EACH
Potential Action	MAINTENANCE
Urgency of Action	PRIORITY 3
Purpose of Action	LEVEL 2
Deficiency Photo1

Violations	Entrance to main lobby No violations recorded.
<b>Fixed Equipment</b>	
Instance on 1st Floor - North	Inspected
Condition	3 - Fair
Deficiency	DAMAGED/MISSING
Deficiency Location/Instance	North Side
Deficiency Quantity	1
Quantity Uom	EACH
Potential Action	REPLACE
Urgency of Action	PRIORITY 3
Purpose of Action	LEVEL 2
Deficiency Photo1

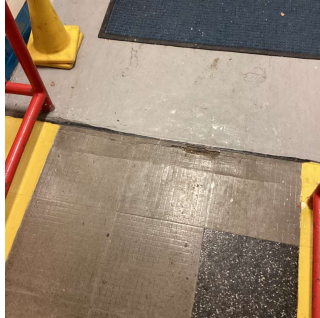
Violations	North Side No violations recorded.
<b>Floor Finish</b>	
Instance on 1st Floor - South	Inspected
Condition	2 - Between Good and Fair
Deficiency	VINYL TILES: DETERIORATED SUBSTRATE
Deficiency Location/Instance	Near room 101
Deficiency Quantity	10
Quantity Uom	S.F.

Violations	Near room 101 No violations recorded.
Instance on 1st Floor - North	Inspected
Condition	5 - Poor
Deficiency	VINYL TILES: DETERIORATED SUBSTRATE
Deficiency Location/Instance	Center, Along Windows, Near Entrance, Exit, near room 125-B and others
Deficiency Quantity	450
Quantity Uom	S.F.
Potential Action	REPLACE
Urgency of Action	PRIORITY 3
Purpose of Action	LEVEL 2
Deficiency Photo1

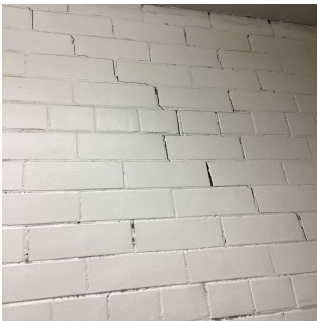
Near Entrance
Violations	No violations recorded.
<b>Sliding-folding Partition</b>	
Instance on 1st Floor - South	Does not Exist
Instance on 1st Floor - North	Does not Exist
<b>Stage</b>	
Instance on 1st Floor - North	Does not Exist
Instance on 1st Floor - South	Does not Exist
<b>Walls</b>	
Instance on 1st Floor - North	Inspected
Condition	2 - Between Good and Fair
Deficiency	BRICK: CRACKS/SPALLING
Deficiency Location/Instance	Near Exit 5
Deficiency Quantity	15
Quantity Uom	S.F.
Potential Action	REPLACE
Urgency of Action	PRIORITY 3
Purpose of Action	LEVEL 2
Deficiency Photo1

Near Exit 5
Violations	No violations recorded.
<b>Window Curtains/Shades/Blinds</b>	
Instance on 1st Floor - South	Does not Exist
Instance on 1st Floor - North	Does not Exist
<b>SCIENCE DEMO ROOM</b>	
	Inspected
Instance on Room 335	Inspected

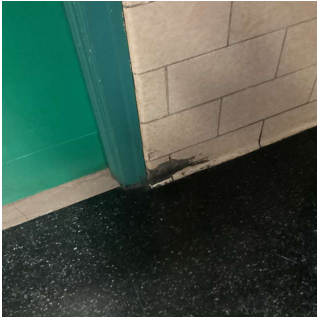
Question	Response
<b>INTERIOR</b>	
<b>STAIRS/RAMPS: INTERIOR</b>	
<b>Walls</b>	
Deficiency Quantity	10
Quantity Uom	S.F.
Potential Action	REPLACE
Urgency of Action	PRIORITY 3
Purpose of Action	LEVEL 2
Deficiency Photo1

Stair E/F 1
Violations	No violations recorded.
Deficiency	CERAMIC TILE: BROKEN/ MISSING
Deficiency Location/Instance	Stair C/D 3, 2
Deficiency Quantity	25
Quantity Uom	S.F.
Potential Action	REPLACE
Urgency of Action	PRIORITY 3
Purpose of Action	LEVEL 2
Deficiency Photo1

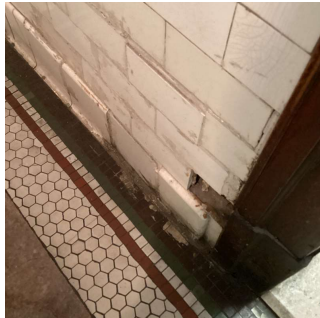
Violations	Teachers Lounge No violations recorded.
<b>Stalls</b>	Inspected
Condition	2 - Between Good and Fair
Deficiency	No deficiencies recorded
<b>Walls</b>	Inspected
Condition	2 - Between Good and Fair
Deficiency	CERAMIC TILE: BROKEN/ MISSING
Deficiency Location/Instance	Room 423
Deficiency Quantity	10
Quantity Uom	S.F.
Potential Action	REPLACE
Urgency of Action	PRIORITY 3
Purpose of Action	LEVEL 2
Deficiency Photo1

Violations	Room 423 No violations recorded.
<b>TOILET ROOMS - STUDENTS</b>	
<b>Ceiling</b>	Inspected
Condition	2 - Between Good and Fair
Deficiency	No deficiencies recorded
<b>Door(s)</b>	Inspected
Condition	5 - Poor
Deficiency	WOOD: DETERIORATED DOOR
Deficiency Location/Instance	Room 132
Deficiency Quantity	1
Quantity Uom	EACH
Potential Action	MAINTENANCE
Urgency of Action	PRIORITY 3
Purpose of Action	LEVEL 2

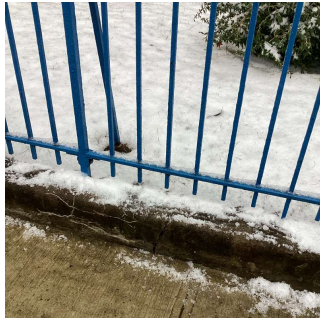
Question	Response
<b>SITE</b>	
<b>Drainage System for Soil</b>	Inspected
<b>Catch Basins/Manhole - Surrounded by Soil</b>	Inspected
Condition	2 - Between Good and Fair
Deficiency	No deficiencies recorded
<b>Culverts - Soil Covering</b>	Does not Exist
<b>DRINKING FOUNTAINS</b>	Does not Exist
<b>FENCES</b>	Inspected
Condition	4 - Between Fair and Poor
Deficiency	CONCRETE CURB: DAMAGED/DETERIORATED
Deficiency Location/Instance	Van Sicklen Street
Deficiency Quantity	30
Quantity Uom	S.F.
Potential Action	REPLACE
Urgency of Action	PRIORITY 3
Purpose of Action	LEVEL 2
Deficiency Photo1

Violations	Van Sicklen Street No violations recorded.
Deficiency	CHAIN LINK: RUST - MAJOR
Deficiency Location/Instance	Van Sicklen Street, Avenue U
Deficiency Quantity	1,000
Quantity Uom	S.F.
Potential Action	REPLACE
Urgency of Action	PRIORITY 3
Purpose of Action	LEVEL 2
Deficiency Photo1

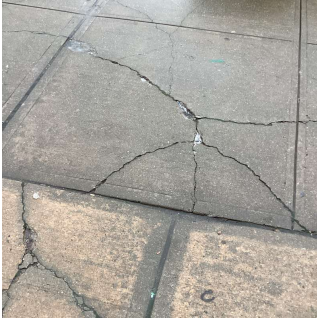
Question	Response
<b>SITE</b>	
<b>PAVING</b>	
<b>Student Non-Use</b>	
<b>Asphalt</b>	Does not Exist
<b>Concrete</b>	Inspected
Condition	2 - Between Good and Fair
Deficiency	No deficiencies recorded
<b>Pavers</b>	Does not Exist
<b>Student Use</b>	
Gravel Exists?	No
<b>Asphalt</b>	Does not Exist
<b>Concrete</b>	Inspected
Condition	4 - Between Fair and Poor
Deficiency	CRACKS - MAJOR
Deficiency Location/Instance	Schoolyard
Deficiency Quantity	3,200
Quantity Uom	S.F.
Potential Action	REPLACE
Urgency of Action	PRIORITY 3
Purpose of Action	LEVEL 2
Deficiency Photo1

Violations	Schoolyard No violations recorded.
<b>Pavers</b>	Does not Exist
<b>Site Sidewalks &amp; Walkways</b>	
<b>Asphalt</b>	Does not Exist
<b>Concrete</b>	Inspected
Condition	4 - Between Fair and Poor
Deficiency	CRACKS - MAJOR
Deficiency Location/Instance	Near Exit 2, TCU Perimeter
Deficiency Quantity	600
Quantity Uom	S.F.
Potential Action	REPLACE
Urgency of Action	PRIORITY 3
