**NYC Department of Education**  
**Building Condition Assessment Survey 2023 - 2024**

Architectural Inspection

**K096**

**Asset:**        **I.S. 96 - BROOKLYN, 99 AVENUE P, New York, 11204**

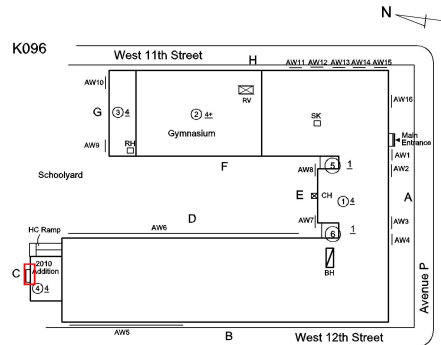
Question	Response
<b>EXTERIOR</b>	
<b>COPING</b>	
Deficiency	No deficiencies recorded
<b>CORNICE</b>	Under Construction
<b>DOORS</b>	Inspected
<b>DOORS AND FRAMES</b>	Inspected
Condition	4 - Between Fair and Poor
Deficiency	METAL: DETERIORATED DOOR - MINOR DETERIORATION
Roof Plan reference

Deficiency Quantity	2
Quantity Uom	EACH
Potential Action	MAINTENANCE
Urgency of Action	PRIORITY 3
Purpose of Action	LEVEL 2
Deficiency Photo1

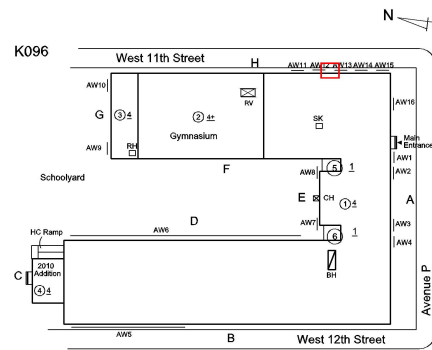
**METAL CLAD: DETERIORATED DOOR - MAJOR DETERIORATION**

REPLACE

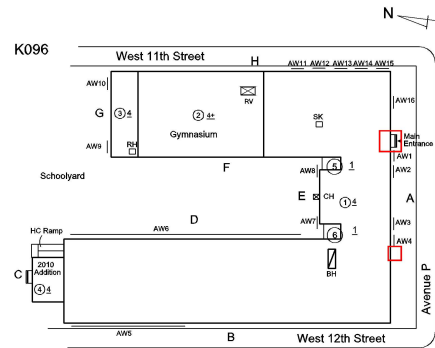
**METAL CLAD: DETERIORATED DOOR AND FRAME - MAJOR DETERIORATION**

4  
EACH  
REPLACE  
PRIORITY 4  
LEVEL 2

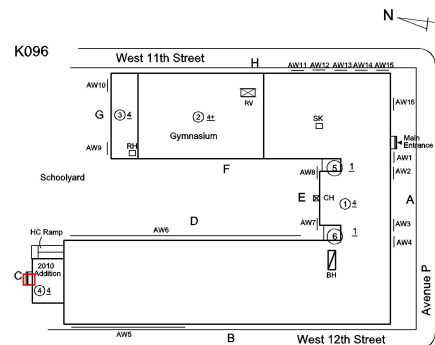
METAL: BROKEN GLASS

10  
S.F.  
MAINTENANCE

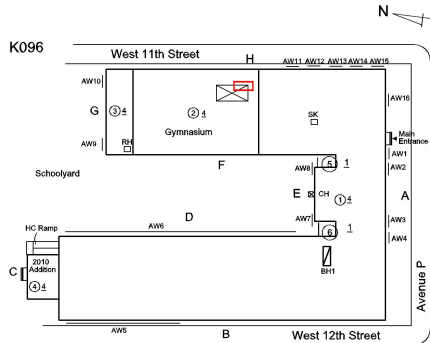
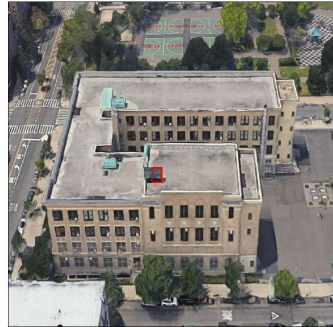
Exit 10
Violations	No violations recorded.
<b>EXTERIOR WALLS</b>	Inspected
Material Type(s)	Masonry
Replacement Quantity	54,500
Replacement Uom	S.F.
Instance on All Facades	Under Construction
Instance Quantity	54,500
Instance Quantity Uom	S.F.
<b>EXTERIOR SOFFITS</b>	Does not Exist
<b>LOADING DOCK</b>	Does not Exist
<b>LOUVER</b>	Inspected
Condition	3 - Fair
Deficiency	MISSING/DAMAGED SCREEN
Roof Plan reference

Question	Response
<b>EXTERIOR</b>	
<b>LOUVER</b>	
Potential Action	REPLACE
Urgency of Action	PRIORITY 4
Purpose of Action	LEVEL 2
Deficiency Photo1

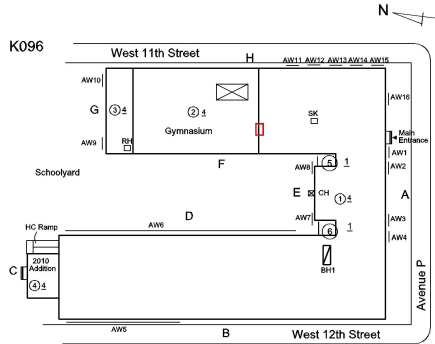
Roof 2
Violations	No violations recorded.
<b>PARAPETS</b>	
	Inspected
Material Type(s)	Masonry
Replacement Quantity	9,000
Replacement Uom	C.F.
Instance on All Roofs	Inspected
Instance Condition	1 - Good
Instance Quantity	9,000
Instance Quantity Uom	C.F.
Deficiency	No deficiencies recorded
<b>PLAZA DECK</b>	Does not Exist
<b>ROOF</b>	Inspected
<b>Roofing</b>	Inspected
Replacement Quantity	30,600
Replacement Uom	S.F.
<b>ROOF HATCH/SMOKE HATCH</b>	Under Construction
<b>LEADERS, GUTTERS, DOWNSPOUTS, SCUPPERS</b>	Inspected
Condition	3 - Fair
Deficiency	DAMAGED/MISSING
Roof Plan reference

Deficiency Quantity	10
Quantity Uom	L.F.
Potential Action	REPLACE
Urgency of Action	PRIORITY 4
Purpose of Action	LEVEL 2

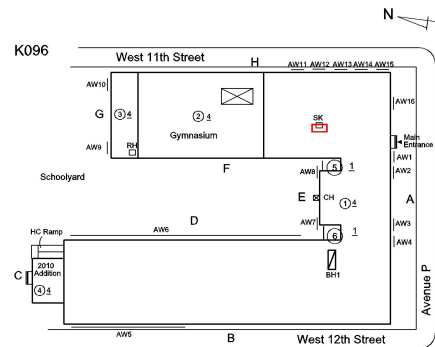
**BROKEN GLASS**

20  
S.F.  
MAINTENANCE  
PRIORITY 3  
LEVEL 2

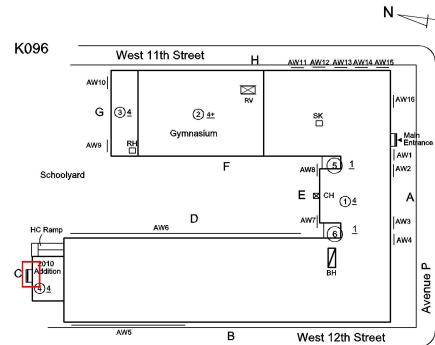
CONCRETE: WORN-OUT TREAD/RISER/NOSING

25  
S.F.  
REPLACE  
PRIORITY 4  
LEVEL 2

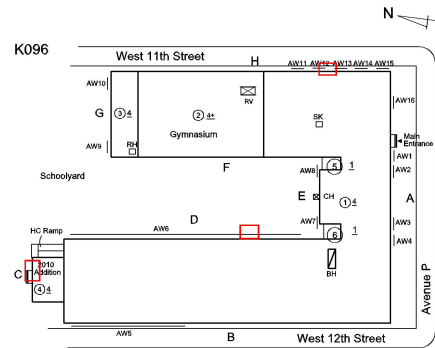
**CONCRETE: CRACKS/SPALLING - MINOR**

REPAIR

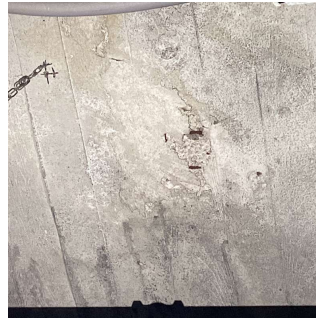
Basement Storage Area (Boiler Room, Custodian Shop similar)

CONCRETE: CRACKS/SPALLED/REINFORCEMENT EXPOSED

REPAIR

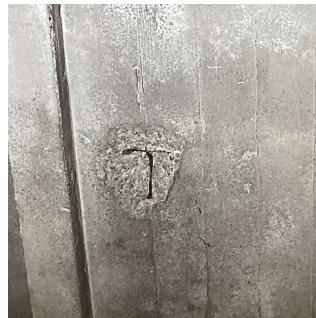
Basement Storage Area

CONCRETE: CRACKS/SPALLED/REINFORCEMENT EXPOSED

REPAIR

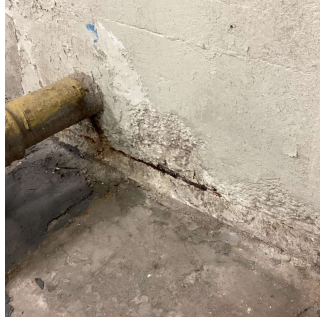
Boiler Room (Basement Fan Area similar)
Violations	No violations recorded.
Deficiency	CONCRETE: CRACKED/SPALLED/REINFORCEMENT EXPOSED
Deficiency Location/Instance	Basement

Basement Fan Area (Boiler Room similar)
Violations	No violations recorded.
<b>ROOF STRUCTURE</b>	
	Inspected
Condition	2 - Between Good and Fair
Deficiency	No deficiencies recorded
<b>VAULTS-BUNKERS</b>	
	Inspected
<b>Foundation Walls</b>	
	Inspected
Condition	3 - Fair
Deficiency	CRACKS, SPALLING
Deficiency Location/Instance	Vault
Deficiency Quantity	30
Quantity Uom	S.F.
Potential Action	REPAIR
Urgency of Action	PRIORITY 3
Purpose of Action	LEVEL 5
Deficiency Photo1

Deficiency Quantity	55
Quantity Uom	S.F.
Potential Action	REPAIR
Urgency of Action	PRIORITY 4

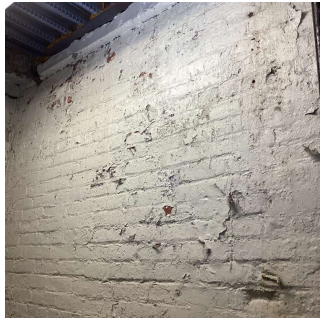
Vault
Violations	No violations recorded.
<b>Slab Structure</b>	
	Inspected
Condition	2 - Between Good and Fair
Deficiency	No deficiencies recorded
<b>Vault/Ash Hoist Doors and Framing</b>	
	Inspected
Condition	2 - Between Good and Fair
Deficiency	No deficiencies recorded
<b>AUDITORIUM</b>	
	Inspected
Instance on 1st Floor (682 Seats)	Inspected

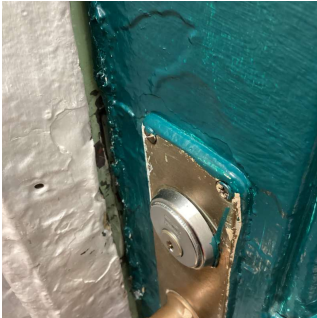
Question	Response
<b>INTERIOR</b>	
<b>AUDITORIUM</b>	
<b>Ceiling</b>	
Deficiency	No deficiencies recorded
<b>Door(s)</b>	
Instance on 1st Floor (682 Seats)	Inspected
Condition	5 - Poor
Deficiency	METAL CLAD WOOD: DETERIORATED DOOR
Deficiency Location/Instance	Left Side Stage Room
Deficiency Quantity	1
Quantity Uom	EACH
Potential Action	MAINTENANCE
Urgency of Action	PRIORITY 3
Purpose of Action	LEVEL 2
Deficiency Photo1

Violations	Left Side Stage Room No violations recorded.
Deficiency	WOOD: DETERIORATED DOOR
Deficiency Location/Instance	Main Entrance, Right Side Door near Stage
Deficiency Quantity	2
Quantity Uom	EACH
Potential Action	MAINTENANCE
Urgency of Action	PRIORITY 3
Purpose of Action	LEVEL 2
Deficiency Photo1

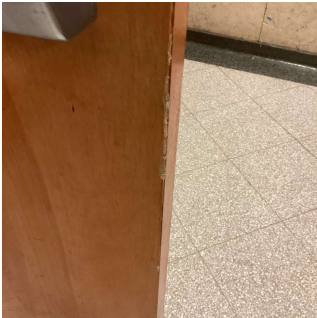
Violations	Main Entrance No violations recorded.
<b>Fixed H/C Lift</b>	
Instance on 1st Floor (682 Seats)	Inspected
Condition	2 - Between Good and Fair
Deficiency	No deficiencies recorded
<b>Fixed Seating</b>

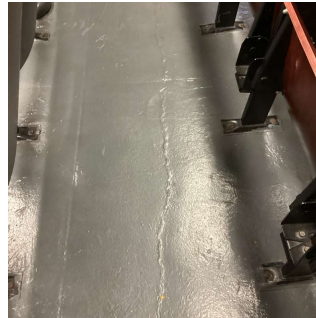
Near Row V

CONCRETE: CRACKS

REPLACE

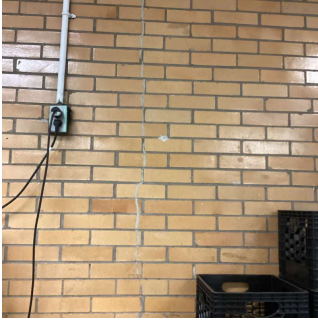
Question	Response
<b>INTERIOR</b>	
<b>CAFETERIA</b>	
<b>Floor Finish</b>	
Violations	Close to fridges No violations recorded.
<b>Sliding-folding Partition</b>	
Instance on Basement	Does not Exist
<b>Stage</b>	
Instance on Basement	Does not Exist
<b>Walls</b>	
Instance on Basement	Inspected
Condition	2 - Between Good and Fair
Deficiency	SALT GLAZED BRICK: CRACKS/SPALLING
Deficiency Location/Instance	Near Kitchen, by Windows, next to Drinking Fountain
Deficiency Quantity	30
Quantity Uom	S.F.
Potential Action	REPLACE
Urgency of Action	PRIORITY 3
Purpose of Action	LEVEL 2
Deficiency Photo1

Violations	Near Kitchen No violations recorded.
<b>Window Curtains/Shades/Blinds</b>	
Instance on Basement	Does not Exist
<b>CLASSROOMS/CORRIDORS/ADMIN SPACES</b>	
Inspected	Inspected
<b>Ceiling</b>	
Condition	2 - Between Good and Fair
Deficiency	No deficiencies recorded
<b>Door(s)</b>	
Condition	5 - Poor
Deficiency	METAL: DETERIORATED DOOR

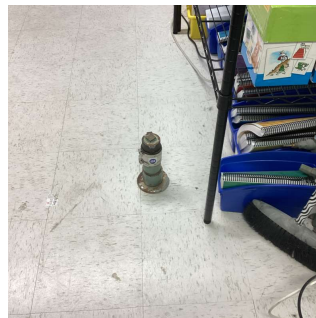
VINYL TILES: TRIPPING HAZARD - ELECTRICAL OUTLET

Question	Response
<b>INTERIOR</b>	
<b>CLASSROOMS/CORRIDORS/ADMIN SPACES</b>	
<b>Floor Finish</b>	
Violations	Room 404 No violations recorded.
Deficiency	CONCRETE: CRACKS
Deficiency Location/Instance	Room 435A
Deficiency Quantity	50
Quantity Uom	S.F.
Potential Action	REPLACE
Urgency of Action	PRIORITY 3
Purpose of Action	LEVEL 2
Deficiency Photo1

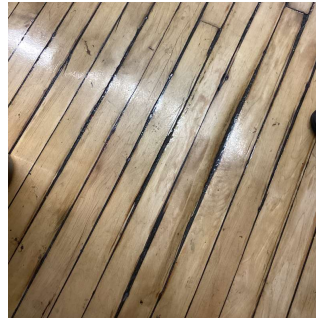
Room 315

**WOOD: DAMAGED/DETERIORATED**

REPLACE

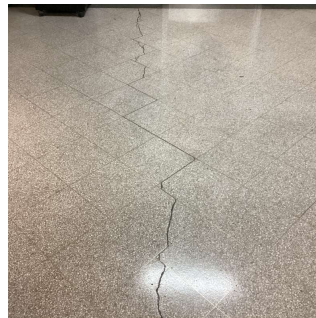
Corridor near Room 112

**TERRAZZO: CRACKS**

REPLACE

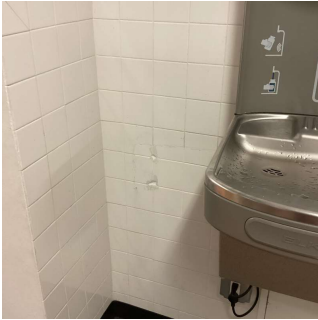
Question	Response
<b>INTERIOR</b>	
<b>CLASSROOMS/CORRIDORS/ADMIN SPACES</b>	
<b>Floor Finish</b>	Inspected
Violations	No violations recorded.
<b>Walls</b>	Inspected
Condition	2 - Between Good and Fair
Deficiency	CERAMIC TILE: BROKEN/ MISSING
Deficiency Location/Instance	Corridor near Room 418
Deficiency Quantity	10
Quantity Uom	S.F.
Potential Action	REPLACE
Urgency of Action	PRIORITY 3
Purpose of Action	LEVEL 2
Deficiency Photo1

Violations	Corridor near Room 418 No violations recorded.
Deficiency	STONE MOLDINGS: CRACKS/SPALLING
Deficiency Location/Instance	Corridor near Main Entrance Lobby, Exit 2 - Vestibule
Deficiency Quantity	50
Quantity Uom	L.F.
Potential Action	REPLACE
Urgency of Action	PRIORITY 3
Purpose of Action	LEVEL 2
Deficiency Photo1

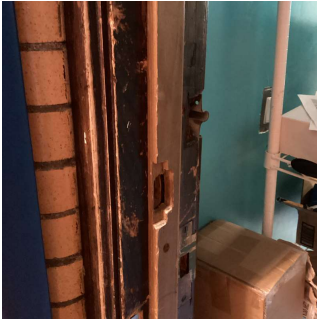
Violations	Near Right Side Windows No violations recorded.
<b>Door(s)</b>	
Instance on 4th Floor	Inspected
Condition	5 - Poor
Deficiency	WOOD: DETERIORATED DOOR AND FRAME
Deficiency Location/Instance	Office Room
Deficiency Quantity	1
Quantity Uom	EACH
Potential Action	MAINTENANCE
Urgency of Action	PRIORITY 3
Purpose of Action	LEVEL 2
Deficiency Photo1

Violations	Office Room No violations recorded.
Deficiency	WOOD: DETERIORATED DOOR
Deficiency Location/Instance	Main Entrance, Storage Room(2x)
Deficiency Quantity	3
Quantity Uom	EACH
Potential Action	MAINTENANCE
Urgency of Action	PRIORITY 3
Purpose of Action	LEVEL 2

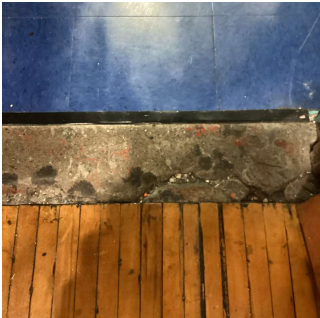
Near Main Entrance
Violations	No violations recorded.
Deficiency	CONCRETE: CRACKS
Deficiency Location/Instance	Office Room
Deficiency Quantity	10
Quantity Uom	S.F.
Potential Action	REPLACE
Urgency of Action	PRIORITY 3
Purpose of Action	LEVEL 2
Deficiency Photo1

Office Room
Violations	No violations recorded.
Instance on 3rd Floor	Inspected
Condition	2 - Between Good and Fair
Deficiency	WOOD: DAMAGED/DETERIORATED
Deficiency Location/Instance	Near Stair I, by Office Room, next to Weight Room, close to Right Side Windows
Deficiency Quantity	120
Quantity Uom	S.F.
Potential Action	REPLACE
Urgency of Action	PRIORITY 3
Purpose of Action	LEVEL 2

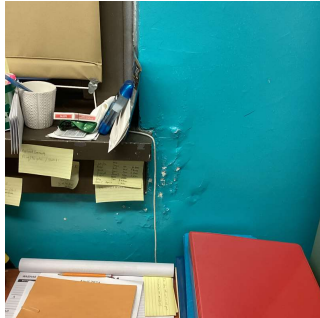
Violations	Near Main Entrance No violations recorded.
Deficiency	PLASTER: CRACKS/SPALLING
Deficiency Location/Instance	Office Room
Deficiency Quantity	10
Quantity Uom	S.F.
Potential Action	REPLACE
Urgency of Action	PRIORITY 3
Purpose of Action	LEVEL 2
Deficiency Photo1

Violations	Office Room No violations recorded.
Instance on 3rd Floor	Inspected
Condition	2 - Between Good and Fair
Deficiency	PLASTER: CRACKS/SPALLING
Deficiency Location/Instance	Office Room
Deficiency Quantity	10
Quantity Uom	S.F.
Potential Action	REPLACE
Urgency of Action	PRIORITY 3
Purpose of Action	LEVEL 2

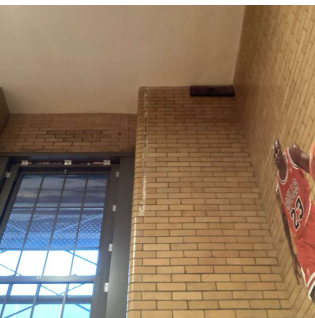
Violations	Near Left Side Windows
Violations	No violations recorded.
Deficiency	SALT GLAZED BRICK: CRACKS/SPALLING
Deficiency Location/Instance	Near Right and Left Side Windows
Deficiency Quantity	40
Quantity Uom	S.F.
Potential Action	REPLACE
Urgency of Action	PRIORITY 3
Purpose of Action	LEVEL 2
Deficiency Photo1

Violations	Near Left Side Windows
Violations	No violations recorded.

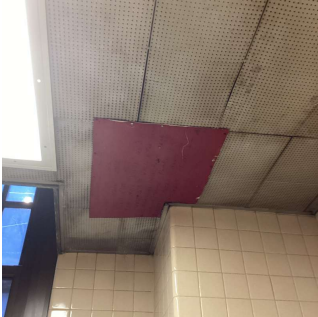
Question	Response
<b>INTERIOR</b>	
<b>KITCHEN</b>	
Instance on Basement	Inspected
<b>Ceiling</b>	
Instance on Basement	Inspected
Condition	3 - Fair
Deficiency	METAL PAN: DAMAGED/MISSING
Deficiency Location/Instance	Storage Room, near Windows, Servery
Deficiency Quantity	50
Quantity Uom	S.F.
Potential Action	REPLACE
Urgency of Action	PRIORITY 3
Purpose of Action	LEVEL 2
Deficiency Photo1

Storage Room
Violations	No violations recorded.
<b>Door(s)</b>	
Instance on Basement	Inspected
Condition	5 - Poor
Deficiency	METAL: DETERIORATED DOOR AND FRAME
Deficiency Location/Instance	Mopping Room, Small Storage Room
Deficiency Quantity	2
Quantity Uom	EACH
Potential Action	MAINTENANCE
Urgency of Action	PRIORITY 3
Purpose of Action	LEVEL 2
Deficiency Photo1

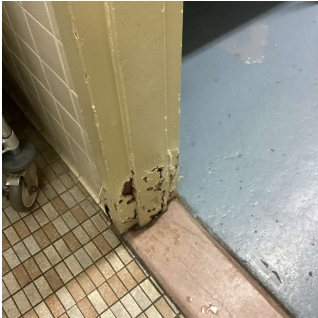
Small Storage Room
Violations	No violations recorded.
Deficiency	WOOD: DETERIORATED DOOR
Deficiency Location/Instance	Kitchen Women Locker Room
Deficiency Quantity	1
Quantity Uom	EACH

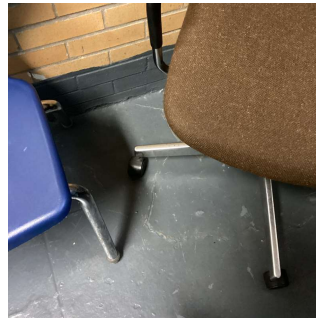
Kitchen Women Locker Room  
No violations recorded.

CONCRETE: CRACKS  
Kitchen Women Locker Room, Small Storage Room  
20  
S.F.  
REPLACE  
PRIORITY 3  
LEVEL 2

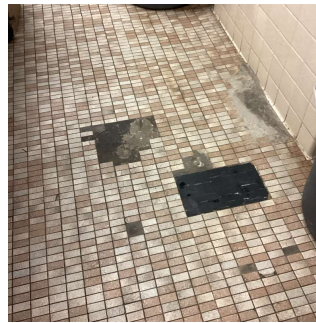
Near Sinks

CERAMIC TILE: BROKEN/MISSING TILES  
Near Sinks, Preparation Area  
50  
S.F.  
REPLACE  
PRIORITY 3  
LEVEL 2

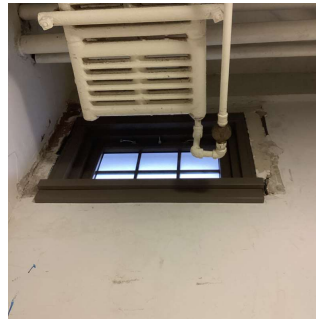
Kitchen Women Locker Room

Instance on Basement	Inspected
Condition	2 - Between Good and Fair
Deficiency	PLASTER: CRACKS/SPALLING
Deficiency Location/Instance	Kitchen Women Locker Room, Small Storage Room
Deficiency Quantity	20
Quantity Uom	S.F.
Potential Action	REPLACE
Urgency of Action	PRIORITY 3
Purpose of Action	LEVEL 2
Deficiency Photo1

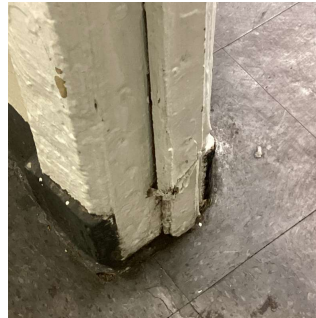
Stair GH/Basement

WOOD: DETERIORATED DOOR AND FRAME

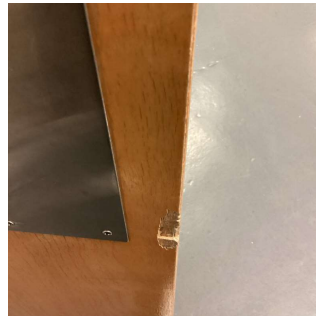
WOOD: DETERIORATED DOOR

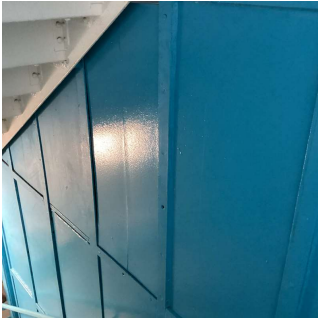
<b>Question</b>	<b>Response</b>
<b>INTERIOR</b>	
<b>STAIRS/RAMPS: INTERIOR</b>	
<b>Door(s)</b>	Inspected
	Stair AB/1
Violations	No violations recorded.
<b>Partition</b>	Inspected
Condition	3 - Fair
Deficiency	METAL PANEL: DAMAGED/DETERIORATED
Deficiency Location/Instance	Stairs AB/2, CD/2
Deficiency Quantity	40
Quantity Uom	S.F.
Potential Action	REPLACE
Urgency of Action	PRIORITY 3
Purpose of Action	LEVEL 2
Deficiency Photo1

Violations	Stair CD/2 No violations recorded.
Deficiency	METAL FRAME: DAMAGED/DETERIORATED
Deficiency Location/Instance	Stairs AB/1, EF/1, 4, Basement, GH/Basement and others
Deficiency Quantity	130
Quantity Uom	L.F.
Potential Action	REPLACE
Urgency of Action	PRIORITY 3
Purpose of Action	LEVEL 2
Deficiency Photo1

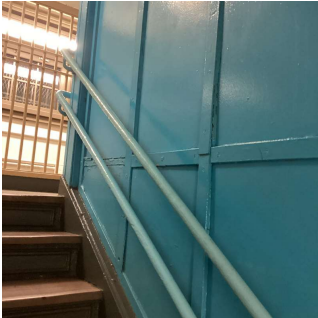
Violations	Stair AB/1 No violations recorded.
<b>Railings</b>	Inspected
Condition	3 - Fair
Deficiency	METAL: MISSING
Deficiency Location/Instance	Cafeteria - near Exit 11
Deficiency Quantity	10

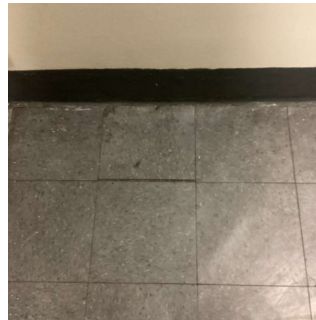
Stair GH/Basement

VINYL TILES: BROKEN/DETERIORATED/MISSING TILES

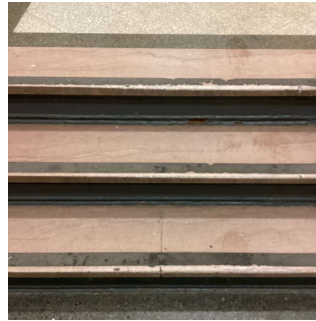
Main Entrance

STONE: BROKEN/MISSING

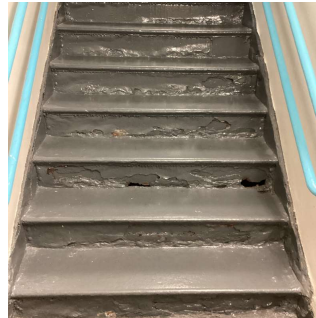
Stair EF/Basement

METAL: RUST - MAJOR

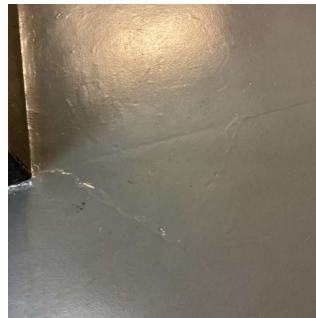
Stair GH/4

CONCRETE: CRACKS/SPALLING - MAJOR

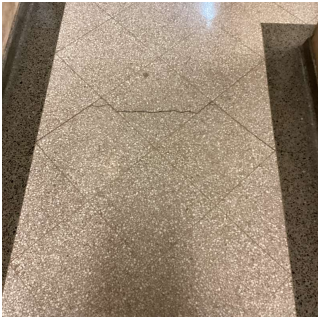
Question	Response
<b>INTERIOR</b>	
<b>STAIRS/RAMPS: INTERIOR</b>	
<b>Stairs and Landings</b>	
Deficiency	VINYL TILES: DETERIORATED SUBSTRATE
Deficiency Location/Instance	Stair EF/Basement
Deficiency Quantity	10
Quantity Uom	S.F.
Potential Action	REPLACE
Urgency of Action	PRIORITY 3
Purpose of Action	LEVEL 2
Deficiency Photo1	 
Violations	Stair EF/Basement No violations recorded.
Deficiency	TERRAZZO: CRACKS
Deficiency Location/Instance	Stair AB/1
Deficiency Quantity	40
Quantity Uom	S.F.
Potential Action	REPLACE
Urgency of Action	PRIORITY 3
Purpose of Action	LEVEL 2
Deficiency Photo1

Violations	Stair AB/1 No violations recorded.
Deficiency	STONE: WORN-OUT TREAD/NOSINGS
Deficiency Location/Instance	Stair AB/1
Deficiency Quantity	140
Quantity Uom	S.F.
Potential Action	REPLACE
Urgency of Action	PRIORITY 3
Purpose of Action	LEVEL 2

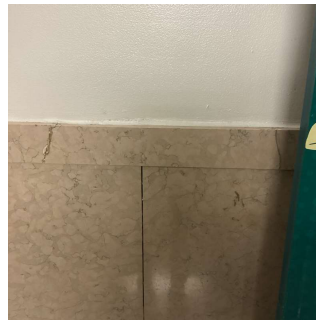
Stair AB/1

STONE MOLDINGS: CRACKS/SPALLING

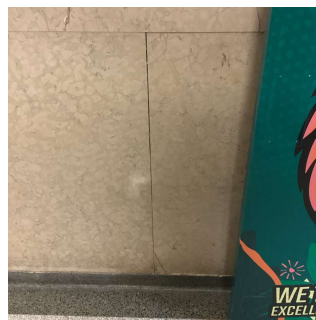
STONE: CRACKS/SPALLING

Question	Response
<b>INTERIOR</b>	
<b>STAIRS/RAMPS: INTERIOR</b>	
<b>Walls</b>	
Violations	Stair AB/1 No violations recorded.
Deficiency	PLASTER: CRACKS/SPALLING
Deficiency Location/Instance	Stairs CD/4, GH/Basement, I/4, 3, 1 and others
Deficiency Quantity	100
Quantity Uom	S.F.
Potential Action	REPLACE
Urgency of Action	PRIORITY 3
Purpose of Action	LEVEL 2
Deficiency Photo1

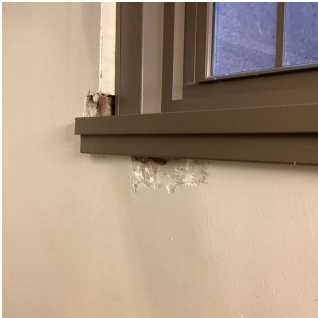
Violations	Stair GH/Basement No violations recorded.
<b>TOILET ROOMS - STAFF</b>	
<b>Ceiling</b>	Inspected
Condition	2 - Between Good and Fair
Deficiency	PLASTER: CRACKS/SPALLING
Deficiency Location/Instance	Women Toilet Room - 1st Floor
Deficiency Quantity	10
Quantity Uom	S.F.
Potential Action	REPLACE
Urgency of Action	PRIORITY 3
Purpose of Action	LEVEL 2
Deficiency Photo1

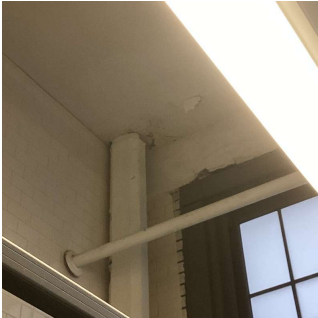
Violations	Women Toilet Room - 1st Floor No violations recorded.
<b>Door(s)</b>	Inspected
Condition	2 - Between Good and Fair
Deficiency	No deficiencies recorded
<b>Floor Finish</b>	Inspected

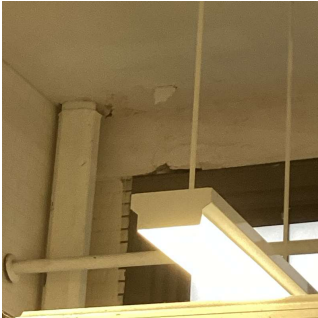
<b>Question</b>	<b>Response</b>
<b>INTERIOR</b>	
<b>TOILET ROOMS - STAFF</b>	
<b>Stalls</b>	Inspected
Condition	2 - Between Good and Fair
Deficiency	No deficiencies recorded
<b>Walls</b>	Inspected
Condition	2 - Between Good and Fair
Deficiency	PLASTER: CRACKS/SPALLING
Deficiency Location/Instance	Women Toilet Room - 1st Floor
Deficiency Quantity	10
Quantity Uom	S.F.
Potential Action	REPLACE
Urgency of Action	PRIORITY 3
Purpose of Action	LEVEL 2
Deficiency Photo1

Violations	Women Toilet Room - 1st Floor No violations recorded.
<b>TOILET ROOMS - STUDENTS</b>	
<b>Ceiling</b>	Inspected
Condition	2 - Between Good and Fair
Deficiency	No deficiencies recorded
<b>Door(s)</b>	Inspected
Condition	5 - Poor
Deficiency	WOOD: DAMAGED LOUVER
Deficiency Location/Instance	Neutral Gender near Gymnasium - 3rd Floor
Deficiency Quantity	1
Quantity Uom	EACH
Potential Action	MAINTENANCE
Urgency of Action	PRIORITY 3
Purpose of Action	LEVEL 2

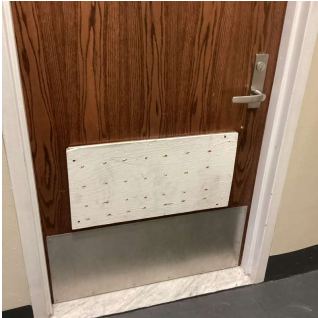
Violations	Neutral Gender near Gymnasium - 3rd Floor No violations recorded.
Deficiency	WOOD: DETERIORATED DOOR

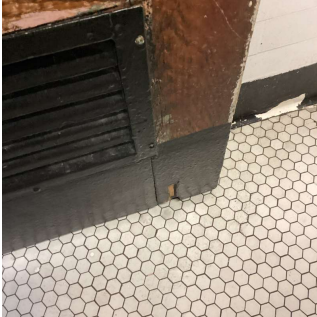
Question	Response
<b>INTERIOR</b>	
<b>TOILET ROOMS - STUDENTS</b>	
<b>Door(s)</b>	
Deficiency Location/Instance	Boys Toilet Room - 3rd Floor, Neutral Gender Toilet Room - 1st Floor
Deficiency Quantity	2
Quantity Uom	EACH
Potential Action	MAINTENANCE
Urgency of Action	PRIORITY 3
Purpose of Action	LEVEL 2
Deficiency Photo1

Boys Toilet Room - 3rd Floor
Violations	No violations recorded.
<b>Floor Finish</b>	Inspected
Condition	2 - Between Good and Fair
Deficiency	CERAMIC TILE: DETERIORATED SUBSTRATE
Deficiency Location/Instance	Girls Toilet Room - 2nd Floor
Deficiency Quantity	20
Quantity Uom	S.F.
Potential Action	REPLACE
Urgency of Action	PRIORITY 3
Purpose of Action	LEVEL 2
Deficiency Photo1

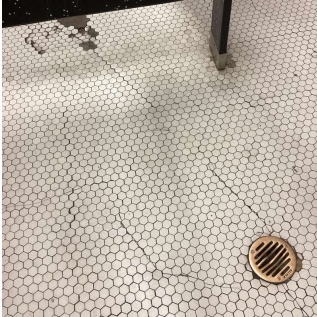
Girls Toilet Room - 2nd Floor
Violations	No violations recorded.
Deficiency	CERAMIC TILE: BROKEN/MISSING TILES
Deficiency Location/Instance	Boys Toilet Room - 3rd Floor, Girls Toilet Room - 2nd Floor, Neutral Gender Toilet Room - 1st Floor

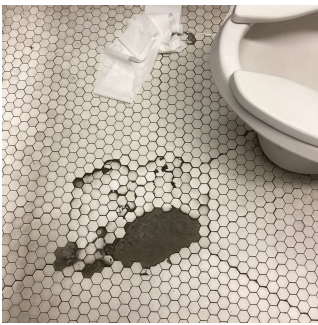
Girls Toilet Room - 2nd Floor
Violations	No violations recorded.
<b>Stalls</b>	Inspected
Condition	2 - Between Good and Fair
Deficiency	No deficiencies recorded
<b>Walls</b>	Inspected
Condition	2 - Between Good and Fair
Deficiency	No deficiencies recorded
<b>LIFE SAFETY</b>	Inspected
<b>F.D. HOLDING AREA</b>	Does not Exist
<b>STEEL STAIRS</b>	Does not Exist
<b>SITE</b>	Inspected
<b>CONTAINERIZATION</b>	Does not Exist
<b>Drainage System for Asphalt</b>	Inspected
<b>Catch Basins/Manhole - Surrounded by asphalt</b>	Inspected
Condition	2 - Between Good and Fair
Deficiency	No deficiencies recorded
<b>Culverts - Asphalt Covering</b>	Does not Exist
<b>Drainage System for Concrete</b>	Does not Exist
<b>Drainage System for Soil</b>	Inspected
<b>Catch Basins/Manhole - Surrounded by Soil</b>	Inspected
Condition	2 - Between Good and Fair

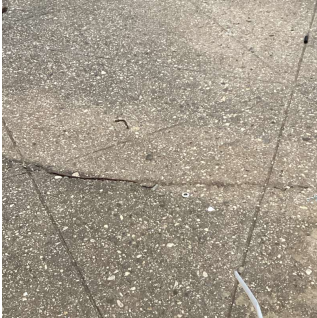
Deficiency	No deficiencies recorded
<b>Culverts - Soil Covering</b>	Does not Exist
<b>DRINKING FOUNTAINS</b>	Does not Exist
<b>FENCES</b>	Inaccessible
<b>IRRIGATION SYSTEM</b>	Does not Exist
<b>PAVING</b>	Inspected
<b>Student Non-Use</b>	Inspected
Gravel Exists?	No
<b>Asphalt</b>	Does not Exist
<b>Concrete</b>	Inspected
Condition	3 - Fair
Deficiency	DAMAGED/DETERIORATED/MISSING SECTIONS
Deficiency Location/Instance	W 12th Street
Deficiency Quantity	50
Quantity Uom	S.F.

W 12th Street
Violations	No violations recorded.
<b>Pavers</b>	Does not Exist
<b>Student Use</b>	Inspected
Gravel Exists?	No
<b>Asphalt</b>	Inspected
Condition	3 - Fair
Deficiency	CRACKS - MAJOR
Deficiency Location/Instance	Schoolyard
Deficiency Quantity	250
Quantity Uom	S.F.
Potential Action	REPLACE
Urgency of Action	PRIORITY 3
Purpose of Action	LEVEL 2
Deficiency Photo1

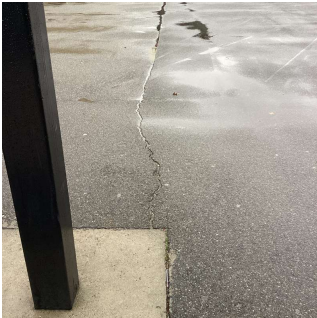
Schoolyard
Violations	No violations recorded.
<b>Concrete</b>	Inspected
Condition	2 - Between Good and Fair
Deficiency	No deficiencies recorded
<b>Pavers</b>	Inspected
Condition	3 - Fair
Deficiency	DAMAGED/MISSING
Deficiency Location/Instance	Schoolyard
Deficiency Quantity	80
Quantity Uom	S.F.

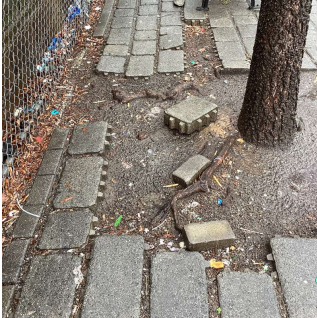
Violations	Schoolyard No violations recorded.
<b>Site Sidewalks &amp; Walkways</b>	Inspected
<b>Asphalt</b>	Does not Exist
<b>Concrete</b>	Inspected
Condition	2 - Between Good and Fair
Deficiency	DAMAGED/DETERIORATED/MISSING SECTIONS
Deficiency Location/Instance	Avenue P
Deficiency Quantity	25
Quantity Uom	S.F.
Potential Action	REPLACE
Urgency of Action	PRIORITY 3
Purpose of Action	LEVEL 2
Deficiency Photo1

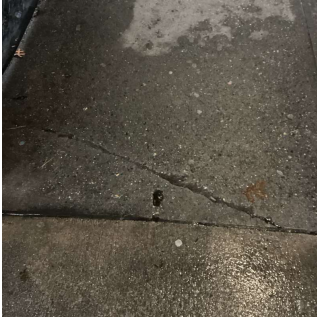
Violations	Avenue P No violations recorded.
<b>Pavers</b>	Does not Exist
<b>DOT Sidewalk</b>	Inspected
<b>Asphalt</b>	Does not Exist
<b>Concrete</b>	Inspected
Condition	4 - Between Fair and Poor
Deficiency	HEAVING
Deficiency Location/Instance	W 12th Street, W 11st Street
Deficiency Quantity	175
Quantity Uom	S.F.

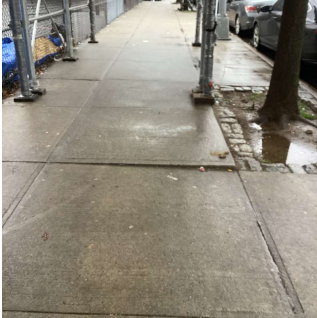
W 11st Street
Violations	No violations recorded.
Deficiency	DAMAGED/DETERIORATED/MISSING SECTIONS
Deficiency Location/Instance	W 12th Street, Avenue P, W 11st Street
Deficiency Quantity	325
Quantity Uom	S.F.
Potential Action	REPLACE
Urgency of Action	PRIORITY 3
Purpose of Action	LEVEL 2
Deficiency Photo1	 
	W 12th Street
Violations	No violations recorded.
Deficiency	DAMAGED CURBS
Deficiency Location/Instance	W 12th Street, W 11st Street
Deficiency Quantity	60
Quantity Uom	L.F.
Potential Action	REPLACE
Urgency of Action	PRIORITY 3
Purpose of Action	LEVEL 2

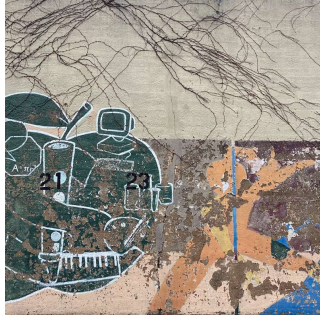
Question	Response
<b>SITE</b>	
<b>PAVING</b>	
<b>DOT Sidewalk</b>	
<b>Concrete</b>	
Deficiency Photo1	 
Violations	W 12th Street No violations recorded.
<b>Pavers</b>	Does not Exist
<b>PLAYGROUNDS</b>	Does not Exist
<b>PLAYING SURFACE</b>	Does not Exist
<b>RETAINING WALLS</b>	Does not Exist
<b>SEATING</b>	Inspected
<b>Benches</b>	Inspected
<b>Concrete</b>	Does not Exist
<b>Metal/Wood/Plastic</b>	Inspected
Condition	4 - Between Fair and Poor
Deficiency	DAMAGED/DETERIORATED
Deficiency Location/Instance	Schoolyard
Deficiency Quantity	2
Quantity Uom	EACH
Potential Action	REPLACE
Urgency of Action	PRIORITY 3
Purpose of Action	LEVEL 2
Deficiency Photo1	 
Violations	Schoolyard No violations recorded.
<b>Bleachers</b>	Does not Exist
<b>SITE WALLS (NOT RETAINING WALLS)</b>	Inspected
Condition	3 - Fair
Deficiency	CAST IN PLACE CONCRETE: CRACKS/SPALLING - MAJOR
Deficiency Location/Instance	Schoolyard
Deficiency Quantity	90
Quantity Uom	S.F.

Question	Response
<b>SITE</b>	
<b>SITE WALLS (NOT RETAINING WALLS)</b>	
Potential Action	REPLACE
Urgency of Action	PRIORITY 3
Purpose of Action	LEVEL 2
Deficiency Photo1
