NYC Department of Education
Building Condition Assessment Survey 2023 - 2024

Architectural Inspection

K097

Asset: P.S. 97 - BROOKLYN, 1855 STILLWELL AVENUE, New York, 11223

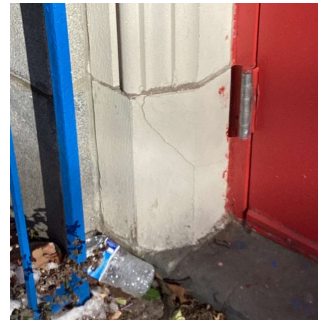
Facade A

Violations	Facade K No violations recorded.
Deficiency	STONE: CHIPPED/SPALLED/BROKEN PIECES - MINOR

REPAIR

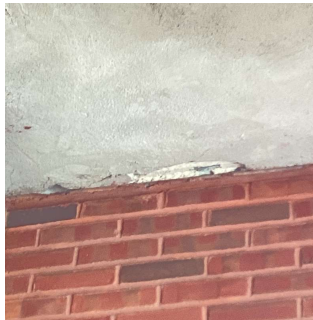
Facade H

CONCRETE: DETERIORATED

REPLACE

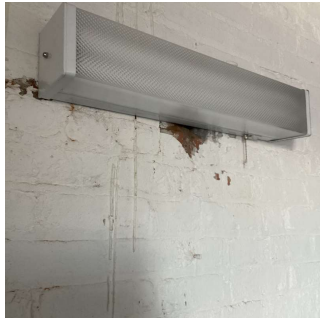
**BULKHEAD/PENTHOUSE WALLS/INTERIOR: BRICK
CRACKS/SPALLING**

10
S.F.
REPLACE
PRIORITY 4
LEVEL 2

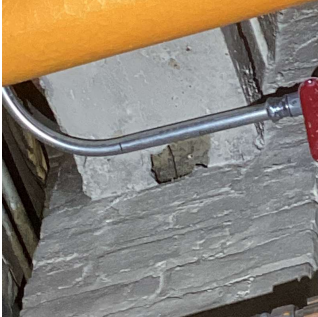
Question	Response
EXTERIOR	
WINDOWS	
WINDOWS	
Instance Quantity	10,500
Instance Quantity Uom	S.F.
Are these windows insulated	No
Installation Year	1999
Source of Installation	Custodial Staff
Deficiency	No deficiencies recorded
INTERIOR	Inspected
POOLS	Does not Exist
STRUCTURAL	Inspected
COLUMNS/BEAMS/BEARING WALLS	Inspected
Condition	3 - Fair
Deficiency	STEEL COLUMNS/BEAMS: DETERIORATED CONCRETE FIREPROOFING
Deficiency Location/Instance	1st Floor
Deficiency Quantity	10
Quantity Uom	S.F.
Potential Action	REPLACE
Urgency of Action	PRIORITY 4
Purpose of Action	LEVEL 5
Deficiency Photo1

Violations	Boiler Room No violations recorded.
Deficiency	STEEL COLUMNS/BEAMS: DETERIORATED CONCRETE FIREPROOFING
Deficiency Location/Instance	Basement, 1st Floor
Deficiency Quantity	40
Quantity Uom	S.F.
Potential Action	REPLACE
Urgency of Action	PRIORITY 3
Purpose of Action	LEVEL 5
Deficiency Photo1

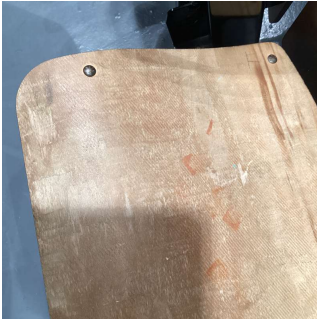
PH1 (PH2 similar)
Violations	No violations recorded.
VAULTS-BUNKERS	
	Does not Exist
AUDITORIUM	
	Inspected
Instance on 2nd Floor (280 Seats)	Inspected
Ceiling	
Instance on 2nd Floor (280 Seats)	Inspected
Condition	2 - Between Good and Fair
Deficiency	No deficiencies recorded
Door(s)	
Instance on 2nd Floor (280 Seats)	Inspected
Condition	2 - Between Good and Fair
Deficiency	No deficiencies recorded
Fixed H/C Lift	
Instance on 2nd Floor (280 Seats)	Does not Exist
Fixed Seating	
Instance on 2nd Floor (280 Seats)	Inspected
Condition	2 - Between Good and Fair
Deficiency	DAMAGED/BROKEN/INOPERABLE
Deficiency Location/Instance	Seat M/8
Deficiency Quantity	1
Quantity Uom	EACH
Potential Action	REPLACE
Urgency of Action	PRIORITY 3
Purpose of Action	LEVEL 2
Deficiency Photo1

Seat M/8
Violations	No violations recorded.
Floor Finish	
Instance on 2nd Floor (280 Seats)	Inspected

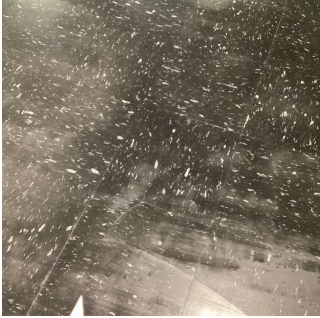
Question	Response
INTERIOR	
CAFETERIA	
Fixed Equipment	
Instance on 1st Floor (7200 SF)	Inspected
Condition	2 - Between Good and Fair
Deficiency	No deficiencies recorded
Floor Finish	
Instance on 1st Floor (7200 SF)	Inspected
Condition	2 - Between Good and Fair
Deficiency	VINYL TILES: DETERIORATED SUBSTRATE
Deficiency Location/Instance	Near Servery
Deficiency Quantity	20
Quantity Uom	S.F.
Potential Action	REPLACE
Urgency of Action	PRIORITY 3
Purpose of Action	LEVEL 2
Deficiency Photo1

Violations	Near Servery No violations recorded.
Deficiency	VINYL TILES: BROKEN/DETERIORATED/MISSING TILES
Deficiency Location/Instance	Center
Deficiency Quantity	15
Quantity Uom	S.F.
Potential Action	REPLACE
Urgency of Action	PRIORITY 3
Purpose of Action	LEVEL 2
Deficiency Photo1

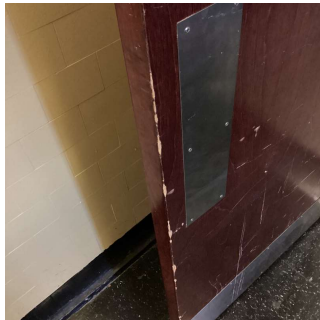
Question	Response
INTERIOR	
LIBRARY	
Ceiling	
Instance on Room 305	Inspected
Condition	2 - Between Good and Fair
Deficiency	No deficiencies recorded
Door(s)	
Instance on Room 305	Inspected
Condition	2 - Between Good and Fair
Deficiency	No deficiencies recorded
Floor Finish	
Instance on Room 305	Inspected
Condition	2 - Between Good and Fair
Deficiency	No deficiencies recorded
Walls	
Instance on Room 305	Inspected
Condition	2 - Between Good and Fair
Deficiency	No deficiencies recorded
LOCKER ROOM	Does not Exist
MULTI-PURPOSE ROOM	Inspected
Instance on 1st Floor	Inspected
Ceiling	
Instance on 1st Floor	Inspected
Condition	2 - Between Good and Fair
Deficiency	No deficiencies recorded
Door(s)	
Instance on 1st Floor	Inspected
Condition	4 - Between Fair and Poor
Deficiency	WOOD: DETERIORATED DOOR
Deficiency Location/Instance	Entrance, Exit near stair H
Deficiency Quantity	2
Quantity Uom	EACH
Potential Action	MAINTENANCE
Urgency of Action	PRIORITY 3

Violations	Entrance No violations recorded.
Fixed Equipment	
Instance on 1st Floor	Inspected
Condition	2 - Between Good and Fair
Deficiency	No deficiencies recorded

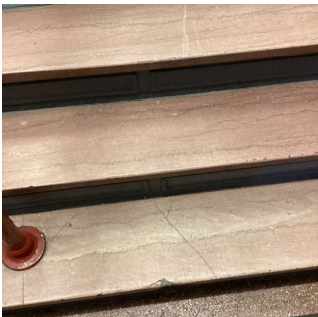
Question	Response
INTERIOR	
STAIRS/RAMPS: INTERIOR	
Stairs and Landings	
Violations	Stair H/2 No violations recorded.
Deficiency	TERRAZZO: CRACKS
Deficiency Location/Instance	Grand Stair leading to Auditorium Vestibule Exit
Deficiency Quantity	20
Quantity Uom	S.F.
Potential Action	REPLACE
Urgency of Action	PRIORITY 3
Purpose of Action	LEVEL 2
Deficiency Photo1	 
Violations	Grand Stair leading to Auditorium Vestibule Exit No violations recorded.
Deficiency	STONE: DETERIORATED SUBSTRATE
Deficiency Location/Instance	Grand Stair leading to Auditorium
Deficiency Quantity	50
Quantity Uom	S.F.
Potential Action	REPLACE
Urgency of Action	PRIORITY 3
Purpose of Action	LEVEL 2
Deficiency Photo1

Violations	Grand Stair leading to Auditorium No violations recorded.
Deficiency	CONCRETE: CRACKS/SPALLING - MAJOR
Deficiency Location/Instance	Stairs D/Bulkhead, 4
Deficiency Quantity	20
Quantity Uom	S.F.
Potential Action	REPLACE
Urgency of Action	PRIORITY 3

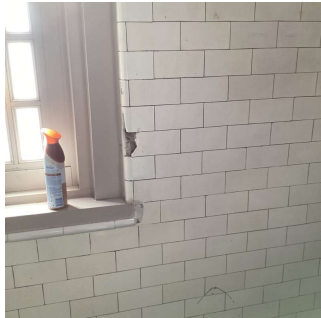
Question	Response
INTERIOR	
TOILET ROOMS - STAFF	Inspected
Stalls	Does not Exist
Walls	Inspected
Condition	2 - Between Good and Fair
Deficiency	CERAMIC TILE: BROKEN/ MISSING
Deficiency Location/Instance	3rd Floor near Stair H, Principal
Deficiency Quantity	10
Quantity Uom	S.F.
Potential Action	REPLACE
Urgency of Action	PRIORITY 3
Purpose of Action	LEVEL 2
Deficiency Photo1

Violations	3rd Floor near Stair H No violations recorded.
TOILET ROOMS - STUDENTS	Inspected
Ceiling	Inspected
Condition	2 - Between Good and Fair
Deficiency	No deficiencies recorded
Door(s)	Inspected
Condition	3 - Fair
Deficiency	WOOD: DETERIORATED DOOR
Deficiency Location/Instance	1st Floor Girls
Deficiency Quantity	1
Quantity Uom	EACH
Potential Action	MAINTENANCE
Urgency of Action	PRIORITY 3
Purpose of Action	LEVEL 2
Deficiency Photo1

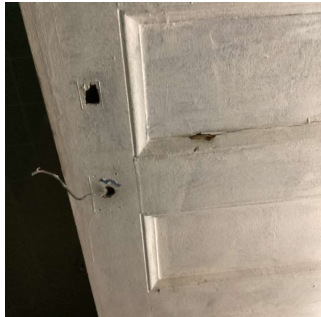
Violations	1st Floor Girls No violations recorded.
Floor Finish	Inspected
Condition	2 - Between Good and Fair

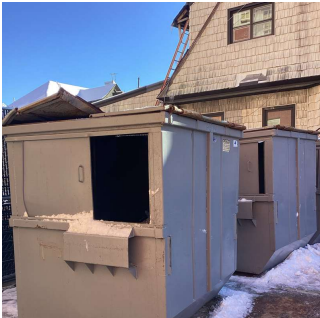
Question	Response
INTERIOR	
TOILET ROOMS - STUDENTS	
Stalls	Inspected
Condition	2 - Between Good and Fair
Deficiency	No deficiencies recorded
Walls	Inspected
Condition	2 - Between Good and Fair
Deficiency	No deficiencies recorded
LIFE SAFETY	Inspected
F.D. HOLDING AREA	Does not Exist
STEEL STAIRS	Does not Exist
SITE	Inspected
CONTAINERIZATION	Inspected
Condition	5 - Poor
Deficiency	CONTAINER DAMAGED
Deficiency Location/Instance	Stillwell Avenue
Deficiency Quantity	3
Quantity Uom	EACH
Potential Action	REPLACE
Urgency of Action	PRIORITY 3
Purpose of Action	LEVEL 2
Deficiency Photo1

Violations	Stillwell Avenue No violations recorded.
Drainage System for Asphalt	Inspected
Catch Basins/Manhole - Surrounded by asphalt	Inspected
Condition	2 - Between Good and Fair
Deficiency	No deficiencies recorded
Culverts - Asphalt Covering	Does not Exist
Drainage System for Concrete	Inspected
Catch Basins/Manhole - Surrounded by concrete	Inspected

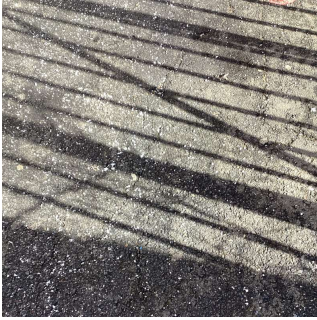
Violations	Schoolyard No violations recorded.
Concrete	Inspected
Condition	2 - Between Good and Fair
Deficiency	No deficiencies recorded
Pavers	Does not Exist
Site Sidewalks & Walkways	Inspected
Asphalt	Inspected
Condition	3 - Fair
Deficiency	CRACKS - MAJOR
Deficiency Location/Instance	Along Exit 18
Deficiency Quantity	80
Quantity Uom	S.F.
Potential Action	REPLACE
Urgency of Action	PRIORITY 3
Purpose of Action	LEVEL 2
Deficiency Photo1

Violations	Along Exit 18 No violations recorded.
Concrete	Inspected
Condition	3 - Fair

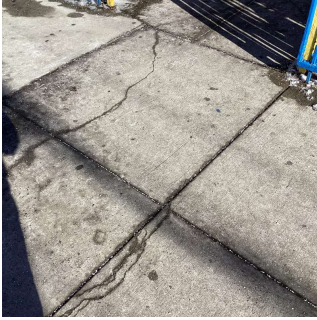
Violations	Exit 3 No violations recorded.
Pavers	Does not Exist
DOT Sidewalk	Inspected
Asphalt	Does not Exist
Concrete	Inspected
Condition	3 - Fair
Deficiency	DAMAGED/DETERIORATED/MISSING SECTIONS
Deficiency Location/Instance	Stillwell Avenue
Deficiency Quantity	225
Quantity Uom	S.F.
Potential Action	REPLACE
Urgency of Action	PRIORITY 3
Purpose of Action	LEVEL 2
Deficiency Photo1

Violations	Stillwell Avenue No violations recorded.
Pavers	Inspected
Condition	1 - Good
Deficiency	No deficiencies recorded
PLAYGROUNDS	Inspected
Instance on Courtyard	Inspected

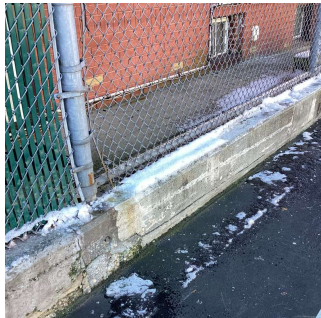
Question	Response
SITE	
PLAYGROUNDS	
Benches	
Instance on Courtyard	Inspected
Condition	1 - Good
Deficiency	No deficiencies recorded
Fence	
Instance on Courtyard	Inspected
Condition	1 - Good
Deficiency	No deficiencies recorded
Pavement	
Instance on Courtyard	Inspected
Condition	1 - Good
Deficiency	No deficiencies recorded
Play Equipment	
Instance on Courtyard	Inspected
Condition	1 - Good
Deficiency	No deficiencies recorded
Safety Surfacing	
Instance on Courtyard	Inspected
Condition	1 - Good
Deficiency	No deficiencies recorded
Unpaved Area	
Instance on Courtyard	Does not Exist
PLAYING SURFACE	Inspected
Playing Field	Inaccessible
Running Track	Does not Exist
RETAINING WALLS	
Are there any Retaining Walls 6' OR higher facing public street/sidewalk?	No
Condition	3 - Fair
Deficiency	CAST IN PLACE CONCRETE: CRACKS/SPALLING - MAJOR
Deficiency Location/Instance	Schoolyard
Deficiency Quantity	100
Quantity Uom	S.F.
Potential Action	REPLACE

Urgency of Action	PRIORITY 3
Purpose of Action	LEVEL 2
Deficiency Photo1

Violations	Schoolyard No violations recorded.
SEATING	Inspected
