NYC Department of Education
Building Condition Assessment Survey 2023 - 2024

Architectural Inspection

Asset: P.S. 99 - BROOKLYN, 1120 EAST 10 STREET, New York, 11230

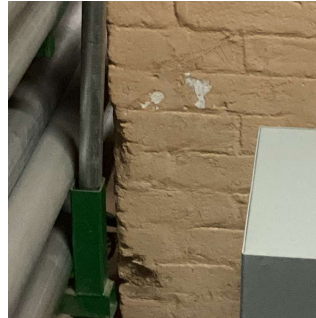
Boiler Room (Basement Fan Room similar)

STEEL COLUMNS/BEAMS: DETERIORATED MASONRY FIREPROOFING

REPLACE
