NYC Department of Education
Building Condition Assessment Survey 2023 - 2024

Architectural Inspection

Asset: P.S. 102 - BROOKLYN, 211 72 STREET, New York, 11209

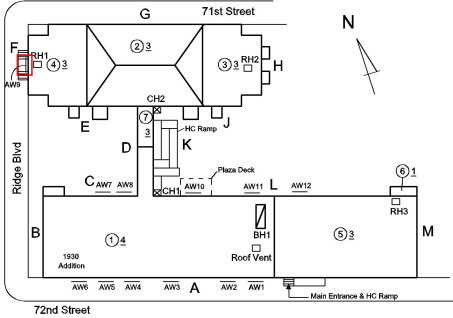
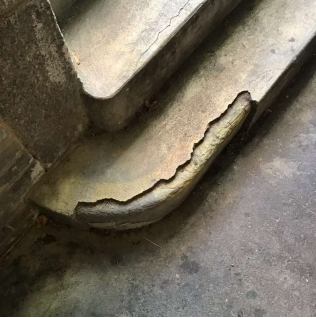
Question	Response
EXTERIOR	
AREAWAY	Inspected
Instance on AW1 - AW12	Inspected
Instance Condition	3 - Fair
Instance Quantity	12
Instance Quantity Uom	EACH
Deficiency	AREAWAY STAIRS: DETERIORATED TREADS/RISERS/NOSINGS
Roof Plan reference	K102

Deficiency Quantity	10
Quantity Uom	S.F.
Potential Action	REPLACE
Urgency of Action	PRIORITY 4
Purpose of Action	LEVEL 2
Deficiency Photo1

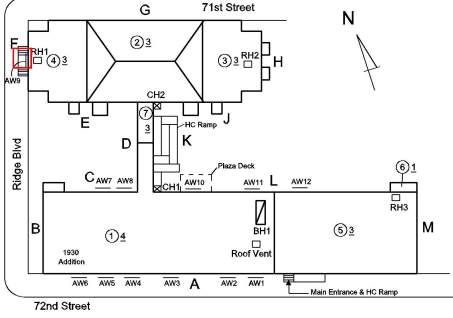
AW9
Violations	No violations recorded.
Deficiency	AREAWAY STAIRS: DETERIORATED TREADS/RISERS/NOSINGS
Roof Plan reference	K102

Deficiency Quantity	10
Quantity Uom	S.F.
Potential Action	REPAIR
Urgency of Action	PRIORITY 3
Purpose of Action	LEVEL 2

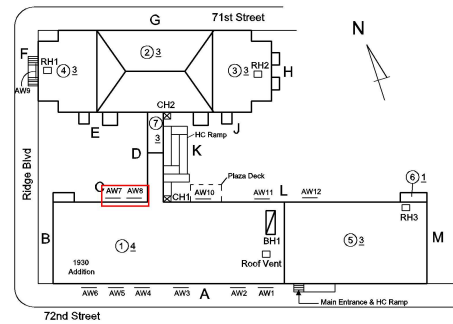
AREAWAY WALLS: CRACKS AND SPALLING

20

REPAIR

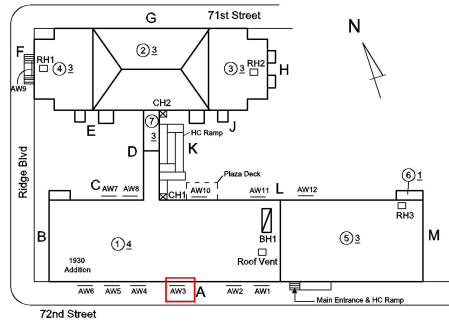
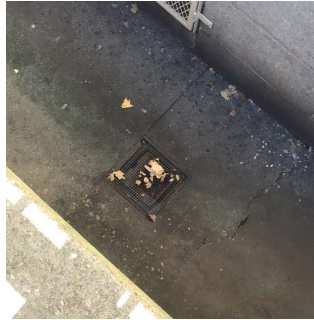
AW3

AREAWAY DRAINS: DETERIORATED

1

REPLACE

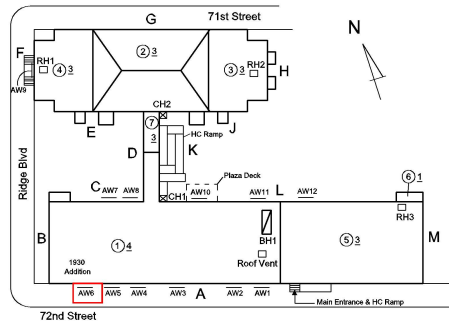
AREAWAY SLAB: CRACKS AND SPALLING

50

REPLACE

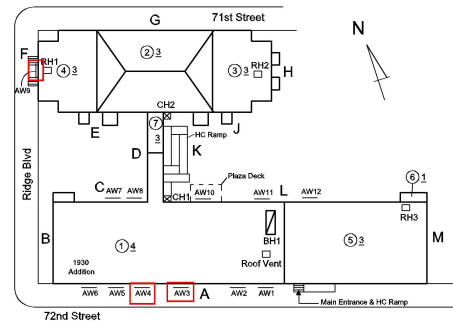
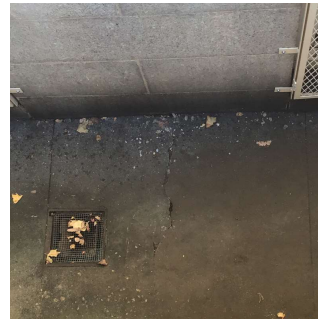
AW3

AREAWAY SLAB: CRACKS AND SPALLING

30

REPAIR

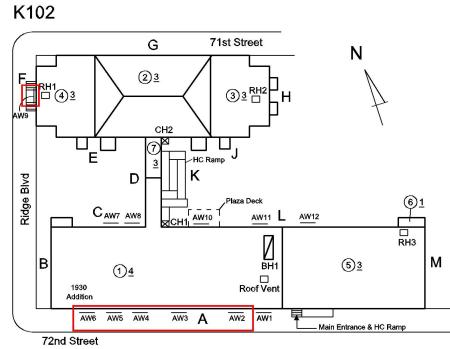
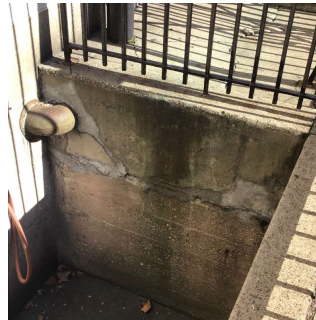
AW1
No violations recorded.

AREAWAY WALLS: CRACKS AND SPALLING

100
S.F.
REPLACE
PRIORITY 4
LEVEL 2

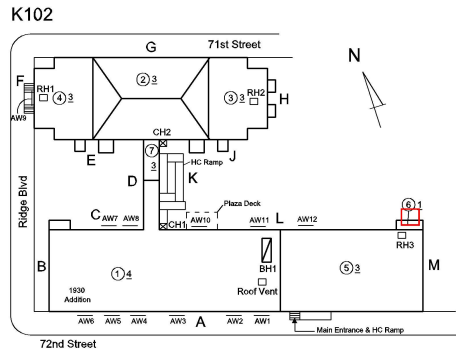
METAL CLAD: DETERIORATED DOOR - MAJOR DETERIORATION

2
EACH
REPLACE
PRIORITY 4
LEVEL 2

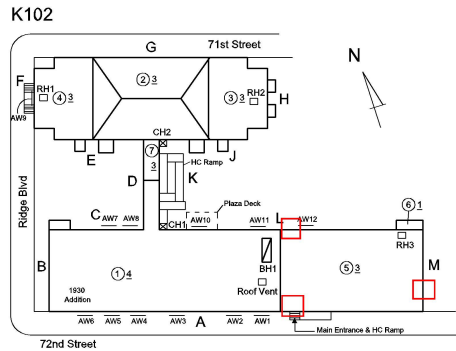
METAL: DETERIORATED DOOR AND FRAME - MINOR DETERIORATION

7
EACH
MAINTENANCE
PRIORITY 3
LEVEL 2

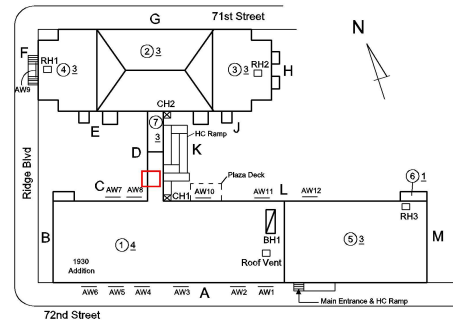
METAL CLAD: DETERIORATED DOOR AND FRAME - MAJOR DETERIORATION

2

REPLACE

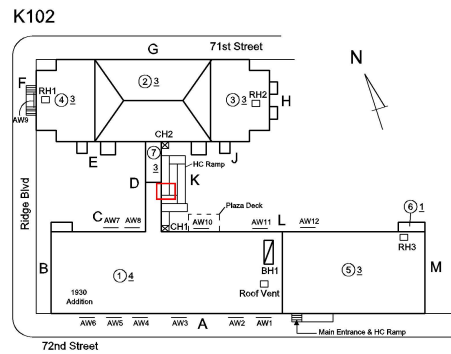
METAL CLAD: DETERIORATED DOOR AND FRAME - MINOR DETERIORATION

2
EACH
MAINTENANCE
PRIORITY 3
LEVEL 2

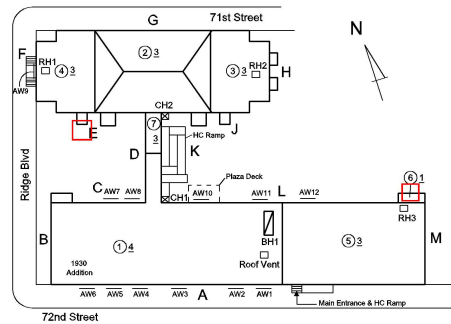
METAL: DETERIORATED DOOR AND FRAME - MAJOR DETERIORATION

3
EACH
REPLACE
PRIORITY 4
LEVEL 2

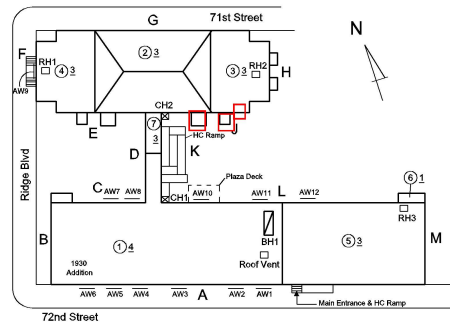
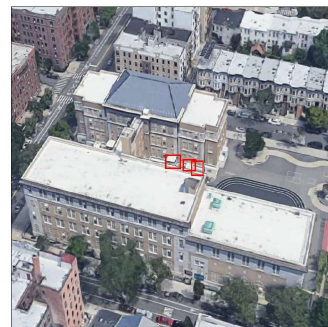
BRICK: DETERIORATED JOINTS

60

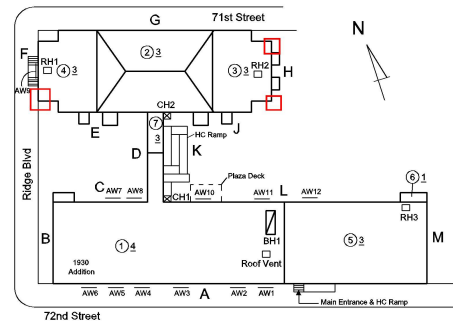
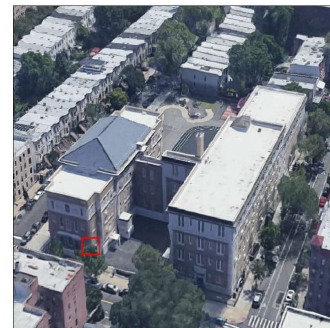
BRICK: CRACKS/DISPLACED/SPALLED BRICK AT BUILDING CORNERS

30
S.F.
REMOVE AND REBUILD
PRIORITY 4
LEVEL 2

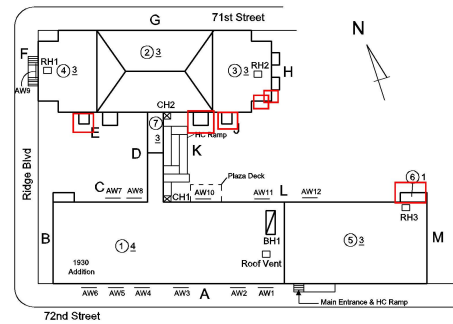
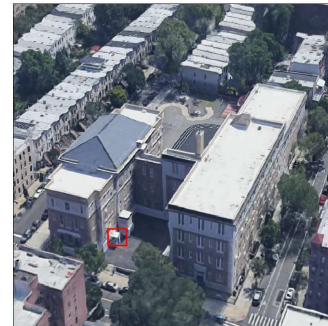
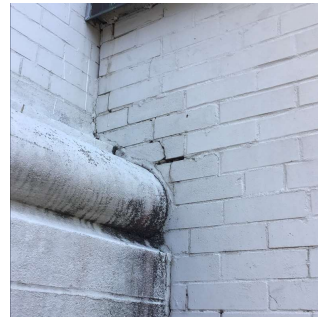
Facade E

BRICK: MINOR CRACKS AND SPALLING

100

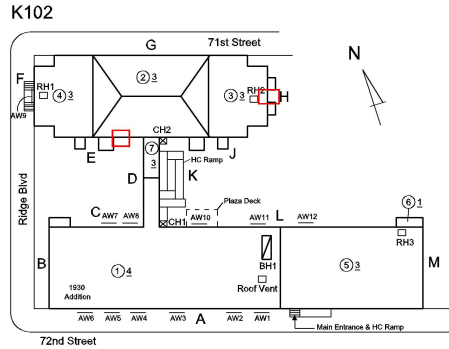
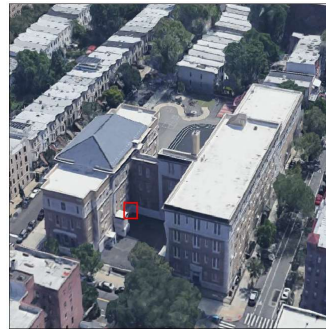
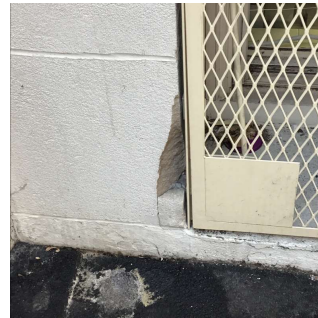
Facade E

STONE: CHIPPED/SPALLED/BROKEN PIECES - MAJOR

20

REPLACE

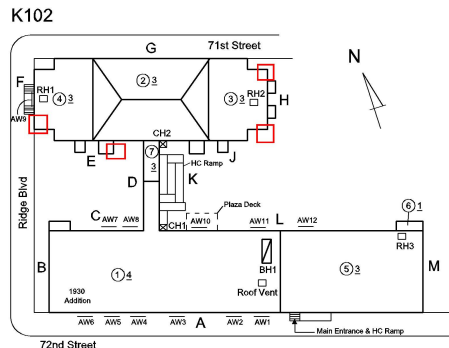
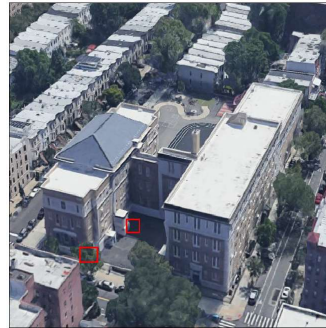
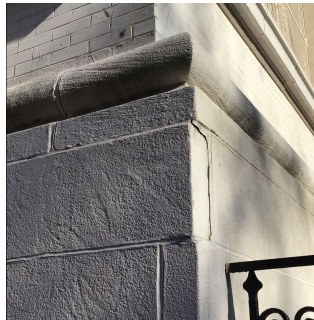
Corner of Facades E and F

STONE: CRACKS AT BUILDING CORNERS

30

REPLACE

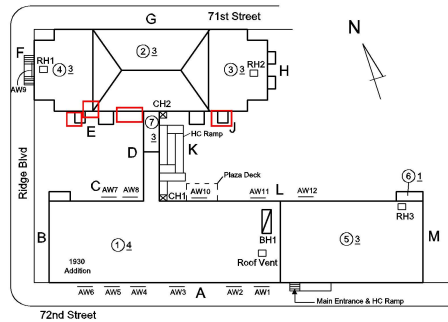
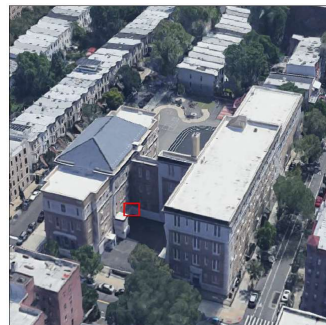
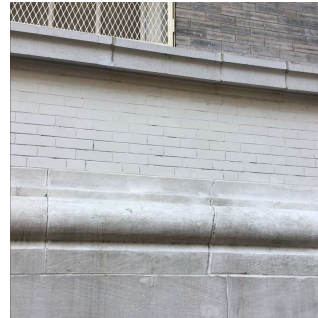
Facade E

BRICK: DETERIORATED JOINTS

100

PRIORITY 3
LEVEL 2

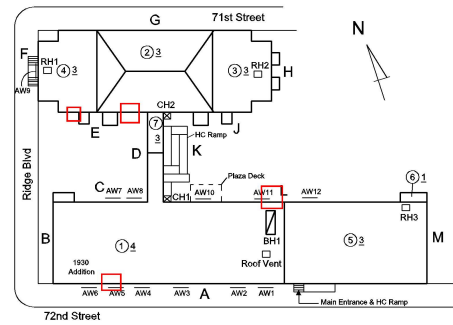
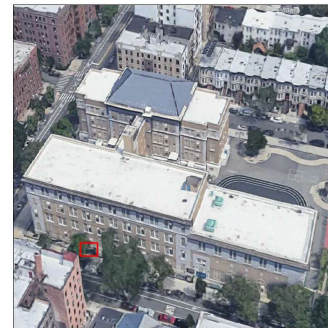
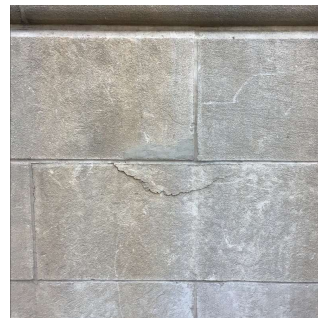
Facade A

STONE: CHIPPED/SPALLED/BROKEN PIECES - MINOR

30

REPAIR

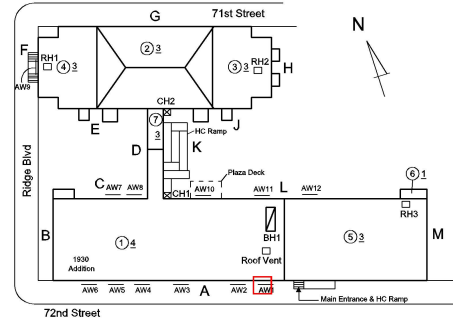
**BRICK: DETERIORATED MASONRY SILLS - MAJOR
K102**

REMOVE AND REPLACE

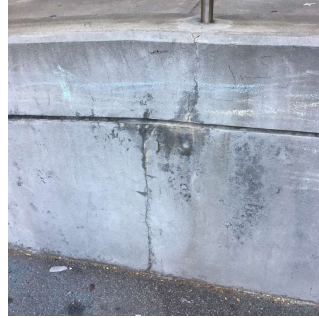
<p>Facade K - HC Ramp</p> <p>No violations recorded.</p>
Deficiency	STONE: DETERIORATED JOINTS
Roof Plan reference	K102

Does not Exist
STAIRS/RAMPS: EXTERIOR	
	Inspected
BUILDING CHEEK/FLANK WALLS	
	Inspected
Condition	5 - Poor
Deficiency	CAST IN PLACE CONCRETE: CRACKS/SPALLING - MINOR
Roof Plan reference	K102

Question	Response
EXTERIOR	
STAIRS/RAMPS: EXTERIOR	
BUILDING CHEEK/FLANK WALLS	
Deficiency Quantity Quantity Uom Potential Action Urgency of Action Purpose of Action Deficiency Photo1	20 S.F. REPAIR PRIORITY 3 LEVEL 2
Deficiency Photo1 Violations

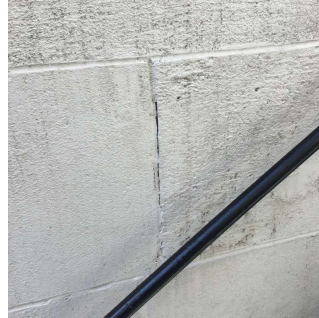
Deficiency Quantity Quantity Uom Potential Action Urgency of Action Purpose of Action Deficiency Photo1	10 S.F. REPOINT PRIORITY 3 LEVEL 2
Deficiency Photo1 Violations

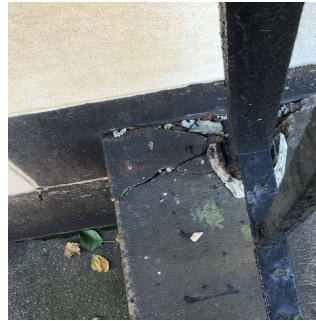
Facade B - Exit 5

STONE: CRACKS/SPALLING - MAJOR

10
S.F.
REPLACE
PRIORITY 4
LEVEL 2

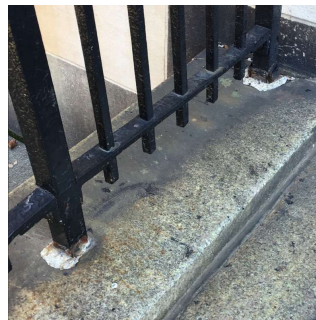
Facade B - Exit 5

RUST - MAJOR

REPLACE

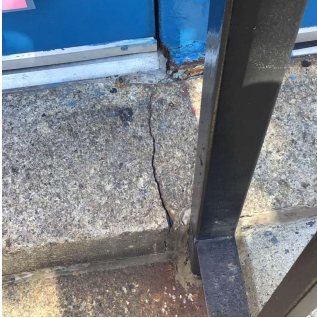
Violations	Facade F No violations recorded.
Deficiency	STONE: CRACKS/SPALLING - MAJOR
Roof Plan reference	K102

Deficiency Quantity	10
Quantity Uom	S.F.
Potential Action	REPLACE
Urgency of Action	PRIORITY 4
Purpose of Action	LEVEL 2
Deficiency Photo1

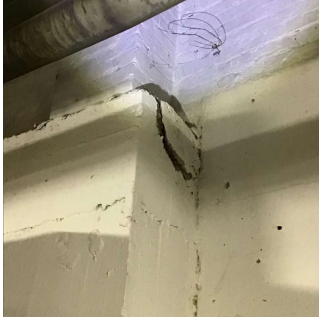
Question	Response
INTERIOR	
STRUCTURAL	
COLUMNS/BEAMS/BEARING WALLS	
Purpose of Action	LEVEL 6
Deficiency Photo1

Violations	Basement - Work Shop
Violations	No violations recorded.
Deficiency	STEEL COLUMNS/BEAMS: DETERIORATED CONCRETE FIREPROOFING
Deficiency Location/Instance	Basement - Boiler Room, Mechanical Equipment Room East
Deficiency Quantity	30
Quantity Uom	S.F.
Potential Action	REPLACE
Urgency of Action	PRIORITY 3
Purpose of Action	LEVEL 5
Deficiency Photo1

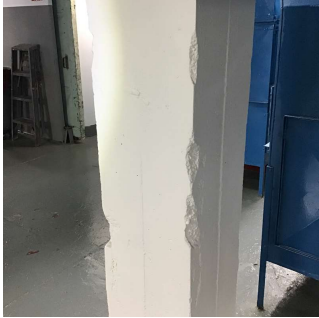
Violations	Mechanical Equipment Room East
Violations	No violations recorded.
Deficiency	STEEL COLUMNS/BEAMS: DETERIORATED CONCRETE FIREPROOFING
Deficiency Location/Instance	Basement - Boiler Room, Mechanical Equipment Room East, Work Shop
Deficiency Quantity	80
Quantity Uom	S.F.
Potential Action	REPLACE
Urgency of Action	PRIORITY 4
Purpose of Action	LEVEL 5

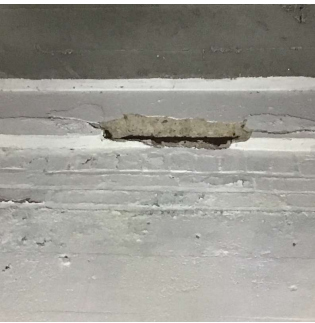
Mechanical Equipment Room East No violations recorded.
Deficiency Deficiency Location/Instance Deficiency Quantity Quantity Uom Potential Action Urgency of Action Purpose of Action Deficiency Photo1 Violations	STEEL COLUMNS/BEAMS: DETERIORATED MASONRY FIREPROOFING Basement - Crawlspace East 30 S.F. REPLACE PRIORITY 4 LEVEL 5

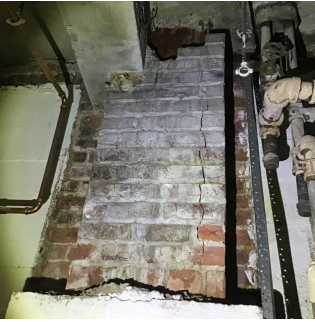
Crawlspace East No violations recorded.
FLOOR STRUCTURE	
Condition	Inspected
Deficiency Deficiency Location/Instance Deficiency Quantity Quantity Uom Potential Action Urgency of Action Purpose of Action	3 - Fair CONCRETE: CRACKS/SPALLED/REINFORCEMENT EXPOSED Basement - Work Shop 10 S.F. REPAIR PRIORITY 4 LEVEL 5

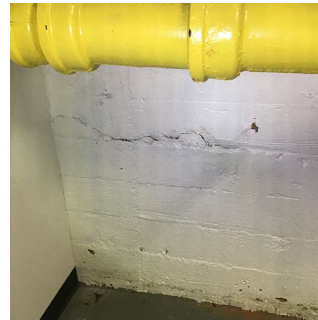
Mechanical Equipment Room East

CONCRETE: CRACKED/SPALLED/REINFORCEMENT EXPOSED

REPAIR

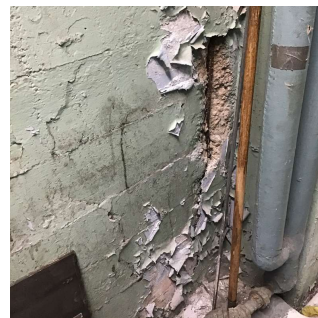
Boiler Room - Near Exit

CONCRETE: CRACKED/SPALLED/REINFORCEMENT EXPOSED

REPAIR

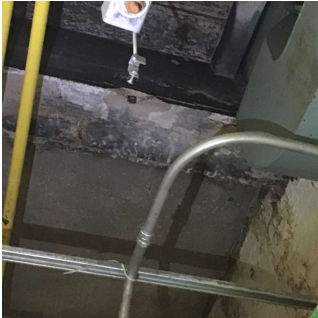
Question	Response
INTERIOR	
STRUCTURAL	
VAULTS-BUNKERS	
Slab Structure	
Deficiency Location/Instance	Basement - Boiler Room Vault
Deficiency Quantity	10
Quantity Uom	S.F.
Potential Action	REPAIR
Urgency of Action	PRIORITY 3
Purpose of Action	LEVEL 5
Deficiency Photo1

Violations	Boiler Room Vault No violations recorded.
Deficiency	STEEL COLUMNS/BEAMS: DETERIORATED/MISSING SPRAY-ON FIREPROOFING
Deficiency Location/Instance	Basement - Ash Hoist Vault
Deficiency Quantity	10
Quantity Uom	S.F.
Potential Action	REPLACE
Urgency of Action	PRIORITY 3
Purpose of Action	LEVEL 5
Deficiency Photo1	 
Violations	Ash Hoist Vault No violations recorded.
Vault/Ash Hoist Doors and Framing	Inspected
Condition	2 - Between Good and Fair
Deficiency	No deficiencies recorded
AUDITORIUM	
Instance on 1st Floor (480 Seats)	Inspected
Ceiling	
Instance on 1st Floor (480 Seats)	Inspected
Condition	2 - Between Good and Fair
Deficiency	No deficiencies recorded

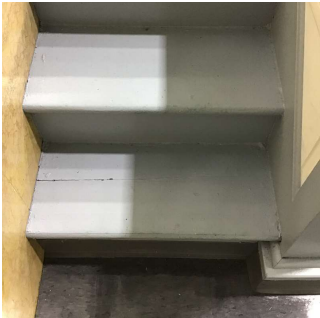
Violations	Near F Row No violations recorded.
Sliding-folding Partition	
Instance on 1st Floor (480 Seats)	Does not Exist
Stage	
Instance on 1st Floor (480 Seats)	Inspected
Stage	Inspected
Instance on 1st Floor (480 Seats)	Inspected
Condition	2 - Between Good and Fair
Deficiency	DAMAGED STEPS
Deficiency Location/Instance	Right and Left Side
Deficiency Quantity	20
Quantity Uom	S.F.
Potential Action	REPLACE
Urgency of Action	PRIORITY 3
Purpose of Action	LEVEL 2
Deficiency Photo1

Violations	Right Side No violations recorded.
Stage Curtain Rigging	
Instance on 1st Floor (480 Seats)	Inspected
Condition	1 - Good
Deficiency	No deficiencies recorded

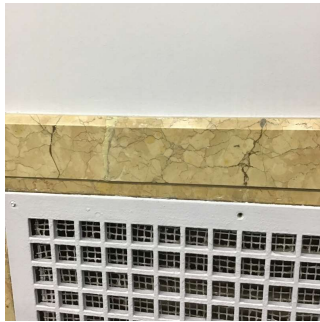
Question	Response
INTERIOR	
AUDITORIUM	
Stage	
Stage Curtains	Inspected
Instance on 1st Floor (480 Seats)	Inspected
Condition	1 - Good
Deficiency	No deficiencies recorded
Walls	
Instance on 1st Floor (480 Seats)	Inspected
Condition	2 - Between Good and Fair
Deficiency	STONE MOLDINGS: CRACKS/SPALLING
Deficiency Location/Instance	Near Entrance, Right and Left Side
Deficiency Quantity	30
Quantity Uom	L.F.
Potential Action	REPLACE
Urgency of Action	PRIORITY 3
Purpose of Action	LEVEL 2
Deficiency Photo1

Violations	Near Entrance No violations recorded.
Deficiency	STONE: CRACKS/SPALLING
Deficiency Location/Instance	Near Entrance, Right and Left Side
Deficiency Quantity	100
Quantity Uom	S.F.
Potential Action	REPLACE
Urgency of Action	PRIORITY 3
Purpose of Action	LEVEL 2
Deficiency Photo1

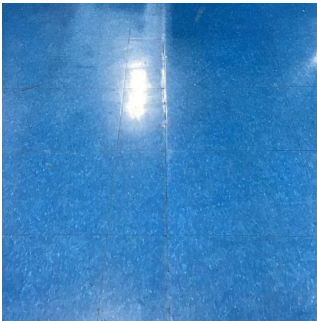
Question	Response
INTERIOR	
CAFETERIA	Inspected
Instance on Basement	Inspected
Ceiling	
Instance on Basement	Inspected
Condition	2 - Between Good and Fair
Deficiency	No deficiencies recorded
Door(s)	
Instance on Basement	Not Required
Fixed Equipment	
Instance on Basement	Does not Exist
Floor Finish	
Instance on Basement	Inspected
Condition	3 - Fair
Deficiency	VINYL TILES: DETERIORATED SUBSTRATE
Deficiency Location/Instance	Right Side, Near Ramp, Close to Kitchen
Deficiency Quantity	50
Quantity Uom	S.F.
Potential Action	REPLACE
Urgency of Action	PRIORITY 3
Purpose of Action	LEVEL 2
Deficiency Photo1

Violations	Right Side No violations recorded.
Deficiency	VINYL TILES: BROKEN/DETERIORATED/MISSING TILES
Deficiency Location/Instance	Near Servery, By Stairs BD, FG, Close to Room B2, Next to Boys Toilet - Basement and others
Deficiency Quantity	180
Quantity Uom	S.F.
Potential Action	REPLACE
Urgency of Action	PRIORITY 3

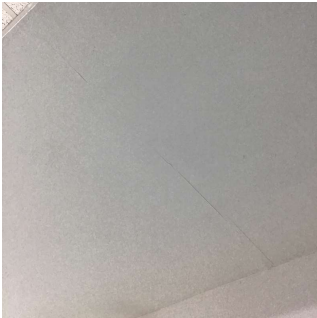
Question	Response
INTERIOR	
CLASSROOMS/CORRIDORS/ADMIN SPACES	
Ceiling	
Violations	Room 115 No violations recorded.
Deficiency	GYPSUM BOARD: DAMAGED/DETERIORATED
Deficiency Location/Instance	Room 115
Deficiency Quantity	10
Quantity Uom	S.F.
Potential Action	REPLACE
Urgency of Action	PRIORITY 3
Purpose of Action	LEVEL 2
Deficiency Photo1

Violations	Room 115 No violations recorded.
Door(s)	Inspected
Condition	5 - Poor
Deficiency	WOOD: DETERIORATED DOOR AND FRAME
Deficiency Location/Instance	Rooms 204,202,104,103,102 and others
Deficiency Quantity	6
Quantity Uom	EACH
Potential Action	MAINTENANCE
Urgency of Action	PRIORITY 3
Purpose of Action	LEVEL 2
Deficiency Photo1

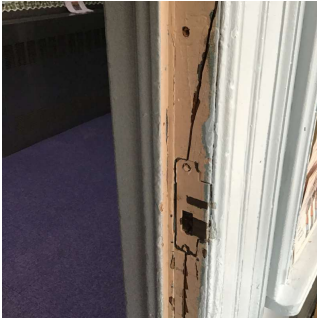
Violations	Room 202 No violations recorded.
Deficiency	WOOD: DETERIORATED DOOR
Deficiency Location/Instance	Main Entrance Vestibule, Rooms 424,422,117,116 and others
Deficiency Quantity	25
Quantity Uom	EACH
Potential Action	MAINTENANCE
Urgency of Action	PRIORITY 3

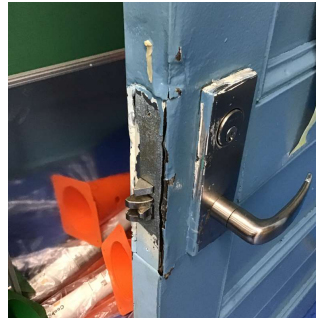
Room 108A

METAL CLAD WOOD: DETERIORATED DOOR

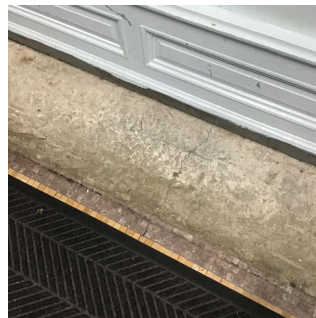
CONCRETE: CRACKS

REPLACE

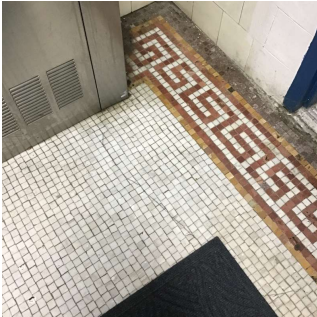
Question	Response
INTERIOR	
CLASSROOMS/CORRIDORS/ADMIN SPACES	
Floor Finish	
Violations	Exit 13 - Vestibule No violations recorded.
Deficiency	CERAMIC TILE: BROKEN/MISSING TILES
Deficiency Location/Instance	Exit 13 - Vestibule
Deficiency Quantity	10
Quantity Uom	S.F.
Potential Action	REPLACE
Urgency of Action	PRIORITY 3
Purpose of Action	LEVEL 2
Deficiency Photo1

Violations	Exit 13 - Vestibule No violations recorded.
Deficiency	TERRAZZO: CRACKS
Deficiency Location/Instance	Corridor near Auditorium, By Main Entrance Lobby
Deficiency Quantity	20
Quantity Uom	S.F.
Potential Action	REPLACE
Urgency of Action	PRIORITY 3
Purpose of Action	LEVEL 2
Deficiency Photo1

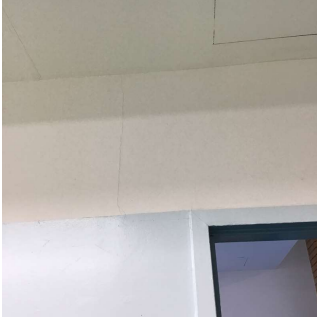
Question	Response
INTERIOR	
CLASSROOMS/CORRIDORS/ADMIN SPACES	
Walls	Inspected
Condition	2 - Between Good and Fair
Deficiency	GYPSUM BOARD: DETERIORATED
Deficiency Location/Instance	Rooms 115,116
Deficiency Quantity	20
Quantity Uom	S.F.
Potential Action	REPLACE
Urgency of Action	PRIORITY 3
Purpose of Action	LEVEL 2
Deficiency Photo1

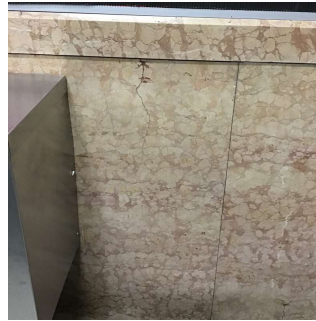
Violations	Room 115 No violations recorded.
Deficiency	SALT GLAZED BRICK: CRACKS/SPALLING
Deficiency Location/Instance	Rooms 116,115, Corridor near Girls Toilet - 1st Floor, By Boys Toilet - 1st Floor, By Stair HI/1 and others
Deficiency Quantity	80
Quantity Uom	S.F.
Potential Action	REPLACE
Urgency of Action	PRIORITY 3
Purpose of Action	LEVEL 2
Deficiency Photo1	 
Violations	Corridor near Girls Toilet - 1st Floor No violations recorded.
Deficiency	STONE: CRACKS/SPALLING
Deficiency Location/Instance	Main Entrance - Vestibule
Deficiency Quantity	20
Quantity Uom	S.F.
Potential Action	REPLACE

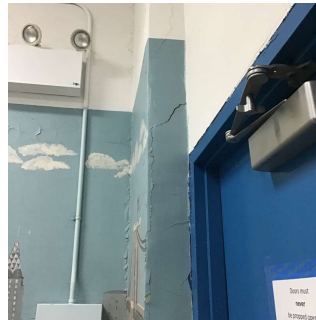
Main Entrance - Vestibule

PLASTER: CRACKS/SPALLING

REPLACE

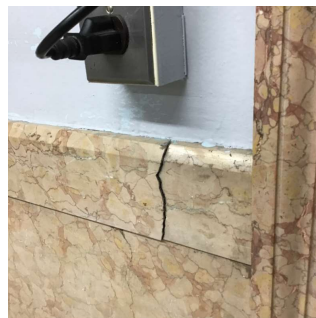
Corridor near Main Entrance Lobby

STONE MOLDINGS: CRACKS/SPALLING

REPLACE

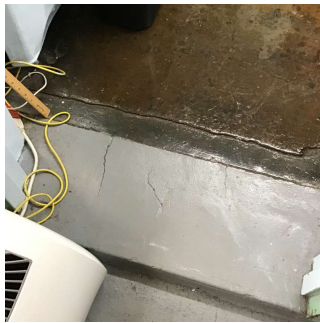
Question	Response
INTERIOR	
GYMNASIUM	Inspected
Door(s)	
Violations	No violations recorded.
Fixed Equipment	
Instance on 3rd Floor	Inspected
Condition	2 - Between Good and Fair
Deficiency	No deficiencies recorded
Floor Finish	
Instance on 3rd Floor	Inspected
Condition	2 - Between Good and Fair
Deficiency	CONCRETE: CRACKS
Deficiency Location/Instance	Office Room
Deficiency Quantity	10
Quantity Uom	S.F.
Potential Action	REPLACE
Urgency of Action	PRIORITY 3
Purpose of Action	LEVEL 2
Deficiency Photo1

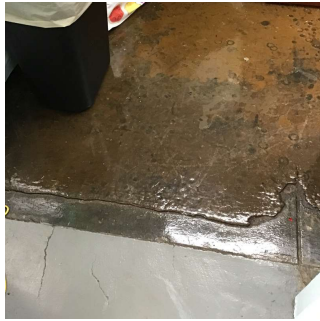
Violations	Office Room No violations recorded.
Deficiency	SHEET VINYL: BROKEN/DETERIORATED
Deficiency Location/Instance	Office Room
Deficiency Quantity	10
Quantity Uom	S.F.
Potential Action	REPLACE
Urgency of Action	PRIORITY 3
Purpose of Action	LEVEL 2
Deficiency Photo1

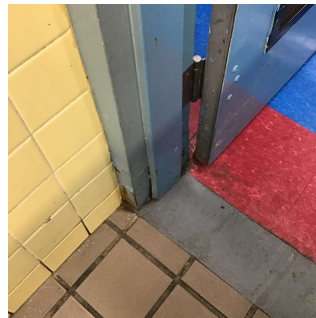
Instance on Basement	Inspected
Condition	5 - Poor
Deficiency	METAL: DETERIORATED DOOR AND FRAME
Deficiency Location/Instance	Servery Area
Deficiency Quantity	3
Quantity Uom	EACH
Potential Action	MAINTENANCE
Urgency of Action	PRIORITY 3
Purpose of Action	LEVEL 2
Deficiency Photo1

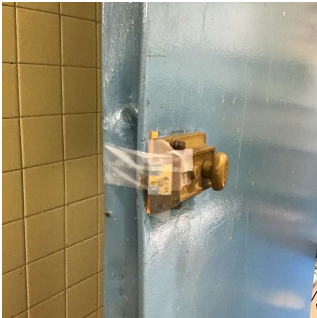
Question	Response
INTERIOR	
KITCHEN	
Door(s)	
Violations	<p>Servery Area No violations recorded.</p>
Deficiency	METAL: DETERIORATED DOOR
Deficiency Location/Instance	Office Room
Deficiency Quantity	1
Quantity Uom	EACH
Potential Action	MAINTENANCE
Urgency of Action	PRIORITY 3
Purpose of Action	LEVEL 2
Deficiency Photo1

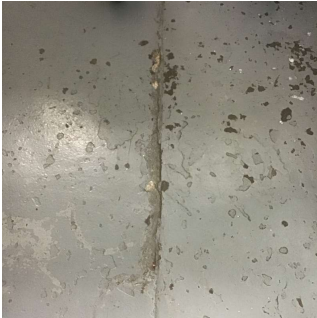
Office Room
Violations	No violations recorded.
Floor Finish	
Instance on Basement	Inspected
Condition	2 - Between Good and Fair
Deficiency	CONCRETE: CRACKS
Deficiency Location/Instance	Storage Room
Deficiency Quantity	10
Quantity Uom	S.F.
Potential Action	REPLACE
Urgency of Action	PRIORITY 3
Purpose of Action	LEVEL 2
Deficiency Photo1

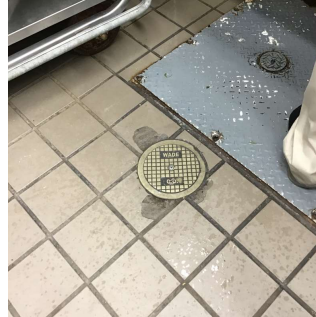
Storage Room
Violations	No violations recorded.
Deficiency	QUARRY TILE: BROKEN/MISSING TILES
Deficiency Location/Instance	Near Sink
Deficiency Quantity	10
Quantity Uom	S.F.
Potential Action	REPLACE
Urgency of Action	PRIORITY 3

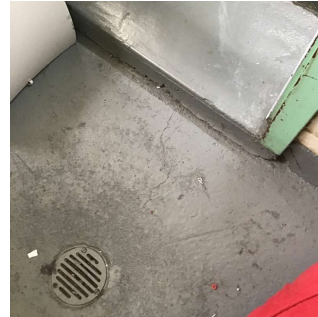
Near Entrance

CONCRETE: CRACKS

REPLACE

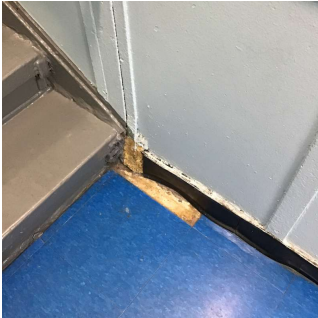
Question	Response
INTERIOR	
STAIRS/RAMPS: INTERIOR	
Railings	Inspected
Condition	2 - Between Good and Fair
Deficiency	No deficiencies recorded
Stairs and Landings	Inspected
Condition	2 - Between Good and Fair
Deficiency	VINYL TILES: BROKEN/DETERIORATED/MISSING TILES
Deficiency Location/Instance	Stair CE/Basement
Deficiency Quantity	10
Quantity Uom	S.F.
Potential Action	REPLACE
Urgency of Action	PRIORITY 3
Purpose of Action	LEVEL 2
Deficiency Photo1

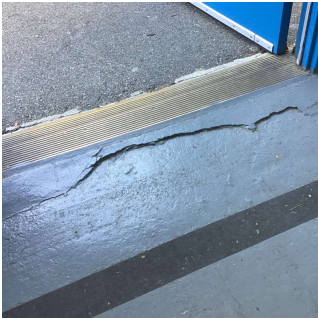
Violations	Stair CE/Basement No violations recorded.
Deficiency	CONCRETE: CRACKS/SPALLING - MAJOR
Deficiency Location/Instance	Stair BD/3, Exit 4 - Vestibule, Exit 16
Deficiency Quantity	30
Quantity Uom	S.F.
Potential Action	REPLACE
Urgency of Action	PRIORITY 3
Purpose of Action	LEVEL 2
Deficiency Photo1

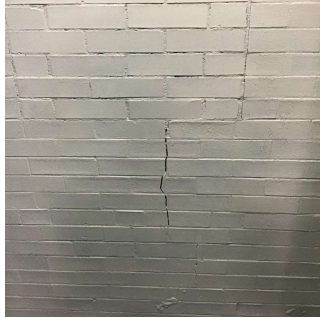
Violations	Exit 16 No violations recorded.
Walls	Inspected
Condition	2 - Between Good and Fair
Deficiency	BRICK: CRACKS/SPALLING
Deficiency Location/Instance	Near Exits 7,8, Exits 4,6,15 - Vestibules and others

Deficiency Quantity	60
Quantity Uom	S.F.
Potential Action	REPLACE

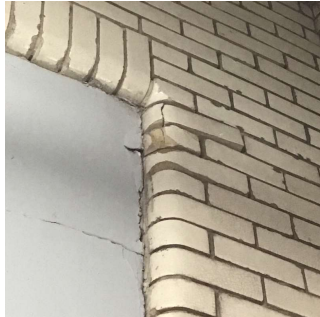
Exit 15 - Vestibule
Violations	No violations recorded.
Deficiency	GLAZED BLOCK: CRACKS/SPALLING
Deficiency Location/Instance	Exit 6 - Vestibule
Deficiency Quantity	10
Quantity Uom	S.F.
Potential Action	REPLACE
Urgency of Action	PRIORITY 5
Purpose of Action	LEVEL 6
Deficiency Photo1

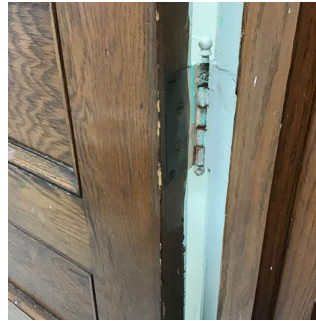
Room 210

Exit 6 - Vestibule
Violations	No violations recorded.
TOILET ROOMS - STAFF	
	Inspected
Ceiling	Inspected
Condition	2 - Between Good and Fair
Deficiency	No deficiencies recorded
Door(s)	Inspected
Condition	5 - Poor
Deficiency	WOOD: DETERIORATED DOOR
Deficiency Location/Instance	Rooms 310,210
Deficiency Quantity	2
Quantity Uom	EACH
Potential Action	MAINTENANCE
Urgency of Action	PRIORITY 3
Purpose of Action	LEVEL 2

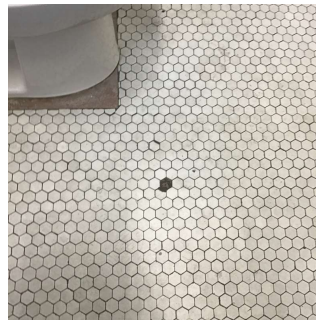
Room 410

CERAMIC TILE: BROKEN/MISSING TILES

REPLACE

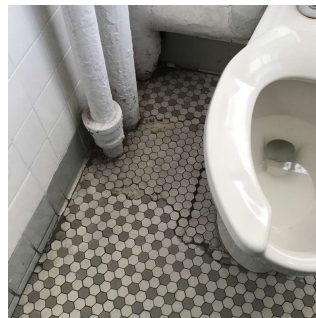
CERAMIC TILE: DETERIORATED SUBSTRATE

REPLACE

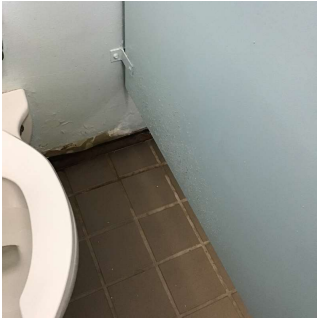
Question	Response
INTERIOR	
TOILET ROOMS - STAFF	
Floor Finish	Inspected
	Room 301C
Violations	No violations recorded.
Stalls	Inspected
Condition	5 - Poor
Deficiency	RUST - MAJOR
Deficiency Location/Instance	In Kitchen Locker Room
Deficiency Quantity	1
Quantity Uom	EACH
Potential Action	REPLACE
Urgency of Action	PRIORITY 3
Purpose of Action	LEVEL 2
Deficiency Photo1

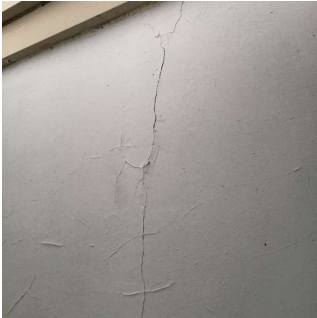
Violations	In Kitchen Locker Room No violations recorded.
Walls	Inspected
Condition	3 - Fair
Deficiency	PLASTER: CRACKS/SPALLING
Deficiency Location/Instance	Rooms 210,101C
Deficiency Quantity	20
Quantity Uom	S.F.
Potential Action	REPLACE
Urgency of Action	PRIORITY 3
Purpose of Action	LEVEL 2
Deficiency Photo1

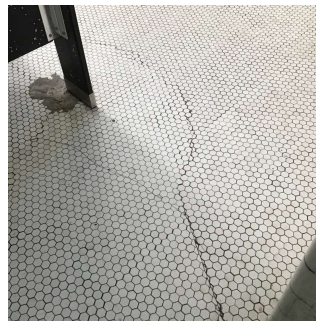
Room 311

CERAMIC TILE: DETERIORATED SUBSTRATE

REPLACE

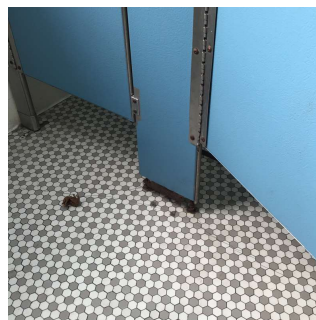
RUST - MAJOR

REPLACE

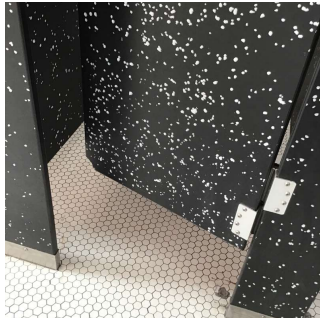
Question	Response
INTERIOR	
TOILET ROOMS - STUDENTS	
Stalls	
Violations	Room 201B No violations recorded.
Deficiency	BROKEN/MISSING
Deficiency Location/Instance	Rooms 327,109G,101B
Deficiency Quantity	6
Quantity Uom	EACH
Potential Action	REPLACE
Urgency of Action	PRIORITY 3
Purpose of Action	LEVEL 2
Deficiency Photo1

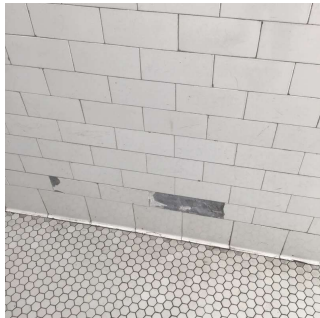
Violations	Room 327 No violations recorded.
Walls	Inspected
Condition	2 - Between Good and Fair
Deficiency	CERAMIC TILE: BROKEN/ MISSING
Deficiency Location/Instance	Rooms 327,311,301B,209G,201B and others
Deficiency Quantity	120
Quantity Uom	S.F.
Potential Action	REPLACE
Urgency of Action	PRIORITY 3
Purpose of Action	LEVEL 2
Deficiency Photo1

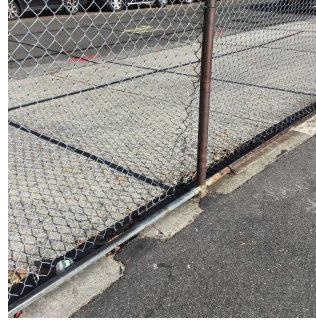
Question	Response
SITE	
Drainage System for Asphalt	
Catch Basins/Manhole - Surrounded by asphalt	Inspected
Condition	2 - Between Good and Fair
Deficiency	No deficiencies recorded
Culverts - Asphalt Covering	Does not Exist
Drainage System for Concrete	Inspected
Catch Basins/Manhole - Surrounded by concrete	Inspected
Condition	2 - Between Good and Fair
Deficiency	No deficiencies recorded
Culverts - Concrete Covering	Does not Exist
Drainage System for Soil	Does not Exist
DRINKING FOUNTAINS	Inspected
Condition	1 - Good
Deficiency	No deficiencies recorded
FENCES	Inspected
Condition	4 - Between Fair and Poor
Deficiency	WROUGHT IRON: DAMAGED/DETERIORATED
Deficiency Location/Instance	72nd Street
Deficiency Quantity	200
Quantity Uom	S.F.
Potential Action	REPLACE
Urgency of Action	PRIORITY 3
Purpose of Action	LEVEL 2
Deficiency Photo1	 
Violations	72nd Street No violations recorded.
Deficiency	CHAIN LINK: DAMAGED/DETERIORATED

Deficiency Location/Instance	71st Street
Deficiency Quantity	100
Quantity Uom	S.F.
Potential Action	REPLACE
Urgency of Action	PRIORITY 3
Purpose of Action	LEVEL 2

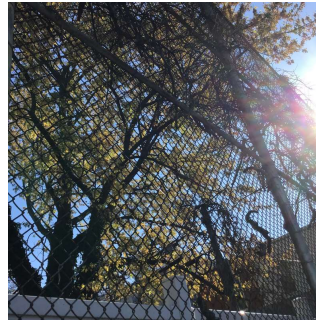
Schoolyard

CHAIN LINK: RUST - MAJOR

REPLACE

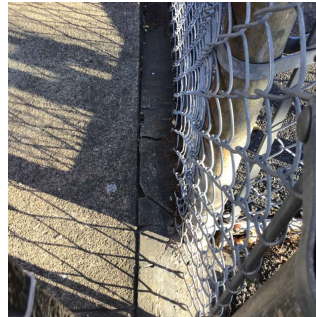
72nd Street

CONCRETE CURB: DAMAGED/DETERIORATED

REPLACE

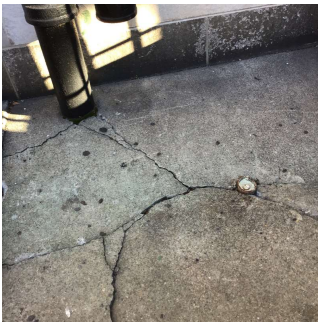
Question	Response
SITE	
IRRIGATION SYSTEM	Does not Exist
PAVING	Inspected
Student Non-Use	Inspected
Gravel Exists?	No
Asphalt	Does not Exist
Concrete	Inspected
Condition	3 - Fair
Deficiency	DAMAGED/DETERIORATED/MISSING SECTIONS
Deficiency Location/Instance	72nd Street
Deficiency Quantity	100
Quantity Uom	S.F.
Potential Action	REPLACE
Urgency of Action	PRIORITY 3
Purpose of Action	LEVEL 2
Deficiency Photo1

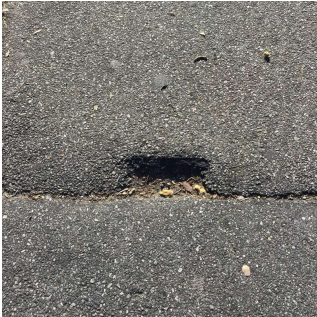
Question	Response
SITE	
PAVING	
Student Use	
Asphalt	
Violations	No violations recorded.
Deficiency	POTHOLES
Deficiency Location/Instance	Near Playground
Deficiency Quantity	10
Quantity Uom	S.F.
Potential Action	REPAIR
Urgency of Action	PRIORITY 3
Purpose of Action	LEVEL 2
Deficiency Photo1

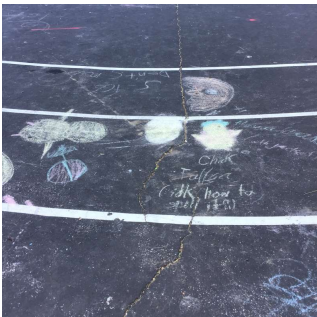
Violations	Near Playground
Violations	No violations recorded.
Deficiency	CRACKS - MAJOR
Deficiency Location/Instance	Center Schoolyard
Deficiency Quantity	100
Quantity Uom	S.F.
Potential Action	REPLACE
Urgency of Action	PRIORITY 5
Purpose of Action	LEVEL 6
Deficiency Photo1

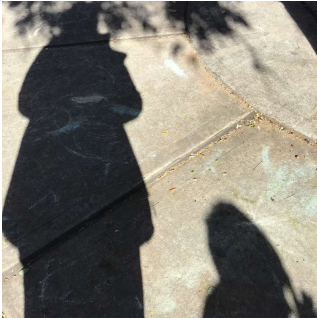
Question	Response
SITE	
PAVING	
Student Use	
Asphalt	
Deficiency Photo1	 
Violations	Schoolyard No violations recorded.
Concrete	Inspected
Condition	4 - Between Fair and Poor
Deficiency	HEAVING
Deficiency Location/Instance	Schoolyard
Deficiency Quantity	50
Quantity Uom	S.F.
Potential Action	REPLACE
Urgency of Action	PRIORITY 3
Purpose of Action	LEVEL 2
Deficiency Photo1

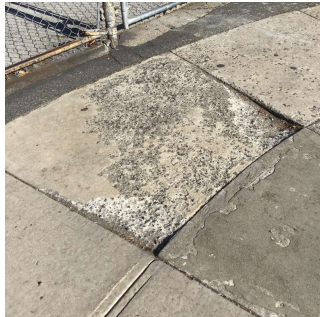
Violations	Schoolyard No violations recorded.
Deficiency	DAMAGED/DETERIORATED/MISSING SECTIONS
Deficiency Location/Instance	Schoolyard
Deficiency Quantity	475
Quantity Uom	S.F.
Potential Action	REPLACE
Urgency of Action	PRIORITY 3
Purpose of Action	LEVEL 2

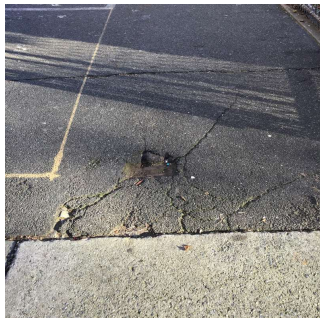
Violations	Schoolyard No violations recorded.
Pavers	Does not Exist
Site Sidewalks & Walkways	Inspected
Asphalt	Inspected
Condition	3 - Fair
Deficiency	CRACKS - MAJOR
Deficiency Location/Instance	72nd Street
Deficiency Quantity	150
Quantity Uom	S.F.
Potential Action	REPLACE
Urgency of Action	PRIORITY 3
Purpose of Action	LEVEL 2
Deficiency Photo1

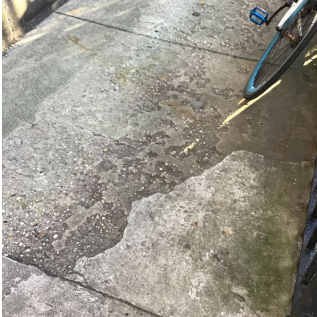
Violations	72nd Street No violations recorded.
Concrete	Inspected
Condition	3 - Fair
Deficiency	DAMAGED/DETERIORATED/MISSING SECTIONS
Deficiency Location/Instance	72nd Street, 71st Street, In the Garden
Deficiency Quantity	225
Quantity Uom	S.F.
Potential Action	REPLACE
Urgency of Action	PRIORITY 3
Purpose of Action	LEVEL 2

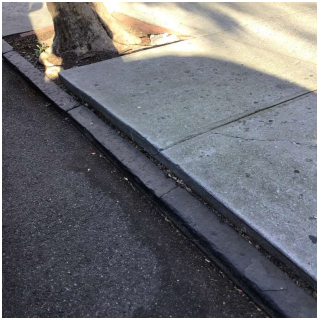
72nd Street
Violations	No violations recorded.
Pavers	Does not Exist
DOT Sidewalk	Inspected
Asphalt	Does not Exist
Concrete	Inspected
Condition	4 - Between Fair and Poor
Deficiency	HEAVING
Deficiency Location/Instance	72nd Street
Deficiency Quantity	225
Quantity Uom	S.F.
Potential Action	REPLACE
Urgency of Action	PRIORITY 3
Purpose of Action	LEVEL 2
Deficiency Photo1

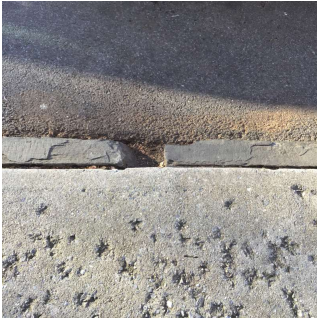
Question	Response
SITE	
PAVING	
DOT Sidewalk	
Concrete	
Deficiency Photo1	 
Violations	72nd Street No violations recorded.
Deficiency	DAMAGED CURBS
Deficiency Location/Instance	72nd Street, Ridge Boulevard, 71st Street
Deficiency Quantity	300
Quantity Uom	L.F.
Potential Action	REPLACE
Urgency of Action	PRIORITY 3
Purpose of Action	LEVEL 2
Deficiency Photo1

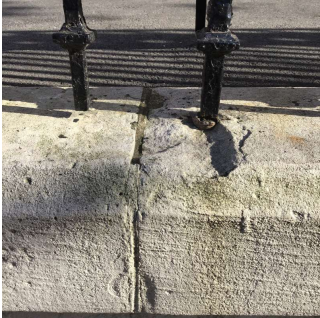
Violations	Left Side No violations recorded.
Unpaved Area	
Instance on Schoolyard - East	Does not Exist
PLAYING SURFACE	
	Inspected
Playing Field	
	Does not Exist
Running Track	
	Does not Exist
RETAINING WALLS	
	Inspected
Are there any Retaining Walls 6' OR higher facing public street/sidewalk?	No
Condition	3 - Fair
Deficiency	CAST IN PLACE CONCRETE: DETERIORATED COPING STONE
Deficiency Location/Instance	Ridge Boulevard
Deficiency Quantity	10
Quantity Uom	S.F.
Potential Action	REPLACE
Urgency of Action	PRIORITY 3
Purpose of Action	LEVEL 2
Deficiency Photo1

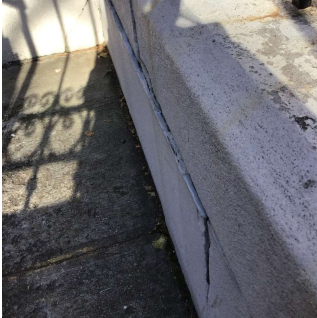
Question	Response
SITE	
RETAINING WALLS	
Deficiency	CAST IN PLACE CONCRETE: DETERIORATED JOINT AT COPING STONE
Deficiency Location/Instance	Ridge Boulevard
Deficiency Quantity	10
Quantity Uom	L.F.
Potential Action	MAINTENANCE
Urgency of Action	PRIORITY 3
Purpose of Action	LEVEL 2
Deficiency Photo1	 
Violations	Ridge Boulevard No violations recorded.
Deficiency	CAST IN PLACE CONCRETE: BULGING/DISPLACED
Deficiency Location/Instance	Ridge Boulevard
Deficiency Quantity	20
Quantity Uom	S.F.
Potential Action	REPLACE
Urgency of Action	PRIORITY 3
Purpose of Action	LEVEL 2
Deficiency Photo1

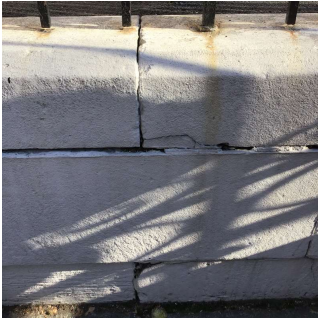
Violations	Ridge Boulevard No violations recorded.
Deficiency	CAST IN PLACE CONCRETE: CRACKS/SPALLING - MAJOR
Deficiency Location/Instance	Ridge Boulevard, near Playground
Deficiency Quantity	60
Quantity Uom	S.F.
Potential Action	REPLACE
Urgency of Action	PRIORITY 3
Purpose of Action	LEVEL 2

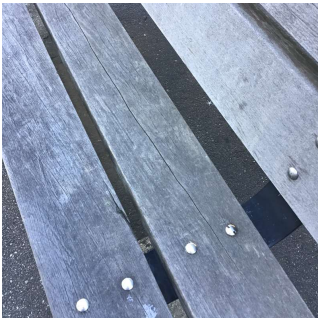
Violations	Ridge Boulevard No violations recorded.
SEATING	Inspected
Benches	Inspected
Concrete	Does not Exist
Metal/Wood/Plastic	Inspected
Condition	5 - Poor
Deficiency	DAMAGED/DETERIORATED
Deficiency Location/Instance	Schoolyard
Deficiency Quantity	4
Quantity Uom	EACH
Potential Action	REPLACE
Urgency of Action	PRIORITY 3
Purpose of Action	LEVEL 2
Deficiency Photo1

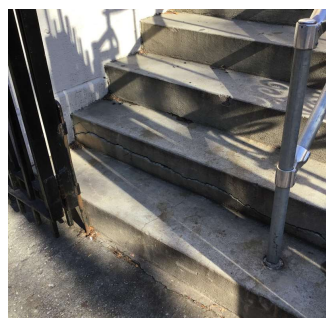
Violations	Schoolyard No violations recorded.
Bleachers	Does not Exist
SITE WALLS (NOT RETAINING WALLS)	Does not Exist
STAIRS/RAMPS: EXTERIOR	Inspected
Railings	Inspected
Condition	1 - Good
Deficiency	No deficiencies recorded
Site Cheek/flank Walls	Inspected
Condition	2 - Between Good and Fair
Deficiency	No deficiencies recorded
Stairs/ramps	Inspected
Condition	3 - Fair
Deficiency	CAST IN PLACE CONCRETE: CRACKS/SPALLING - MAJOR
Deficiency Location/Instance	Ridge Boulevard

Question	Response
SITE	
STAIRS/RAMPS: EXTERIOR	
Stairs/ramps	
Deficiency Quantity	50
Quantity Uom	S.F.
Potential Action	REPLACE
Urgency of Action	PRIORITY 3
Purpose of Action	LEVEL 2
Deficiency Photo1
