NYC Department of Education
Building Condition Assessment Survey 2023 - 2024

Architectural Inspection

Asset: P.S. 104 - BROOKLYN, 9115 5TH AVENUE, New York, 11209

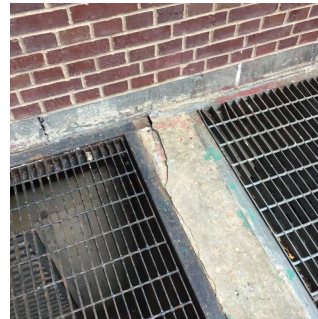
AW4

AREAWAY WALLS: CRACKS AND SPALLING

REPAIR

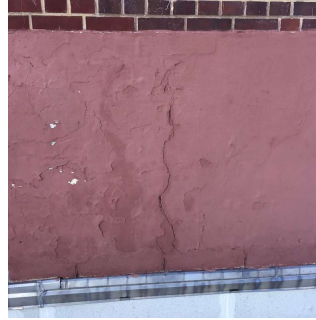
CH2

BRICK: MAJOR / THRU CRACKS

10
S.F.
REMOVE AND REBUILD
PRIORITY 4
LEVEL 2

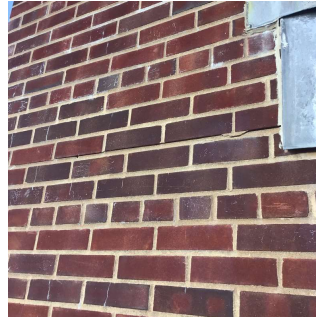
CH2

BRICK: DETERIORATED JOINTS

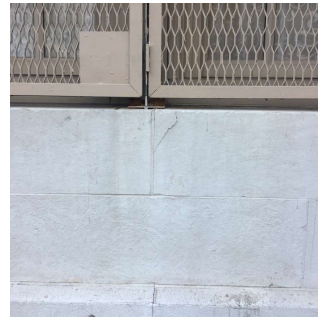
Facade G

STONE: CHIPPED/SPALLED/BROKEN PIECES - MINOR

REPAIR

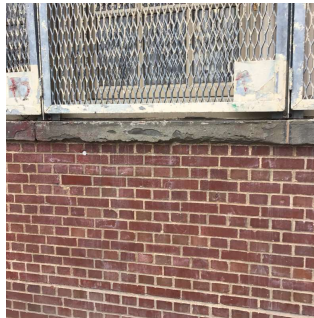
Facade D

BRICK: DETERIORATED MASONRY SILLS - MAJOR

REMOVE AND REPLACE

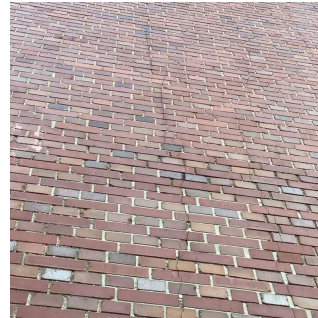
Facade C

BRICK: MINOR CRACKS AND SPALLING

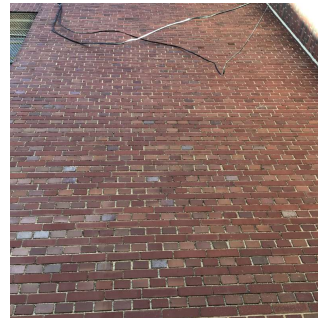
Facade C

BRICK: DETERIORATED JOINTS

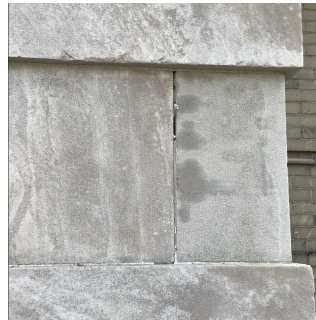
Facade A

STONE: DETERIORATED JOINTS

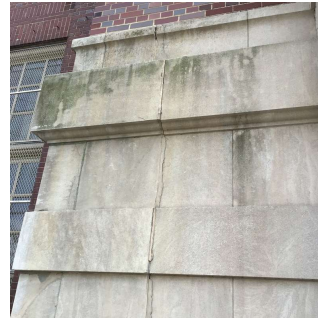
Facade A

STONE: CHIPPED/SPALLED/BROKEN PIECES - MAJOR

REPLACE

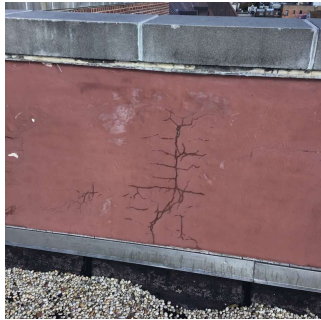
Question	Response
EXTERIOR	
EXTERIOR WALLS	Inspected
Violations	No violations recorded.
EXTERIOR SOFFITS	Does not Exist
LOADING DOCK	Does not Exist
LOUVER	Inspected
Condition	2 - Between Good and Fair
Deficiency	No deficiencies recorded
PARAPETS	Inspected
Material Type(s)	Masonry
Replacement Quantity	6,000
Replacement Uom	C.F.
Instance on Roofs 1 and 5	Inspected
Instance Condition	3 - Fair
Instance Quantity	6,000
Instance Quantity Uom	C.F.
Deficiency	BRICK: MINOR CRACKS, SPALLING
Roof Plan reference	K104
Deficiency Quantity	30
Quantity Uom	S.F.
Potential Action	REPAIR
Urgency of Action	PRIORITY 3
Purpose of Action	LEVEL 4
Deficiency Photo1

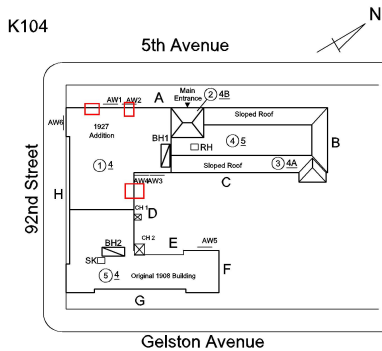
Violations	Roof 1 - Facade D 35665478N
Deficiency	BRICK: DETERIORATED JOINTS

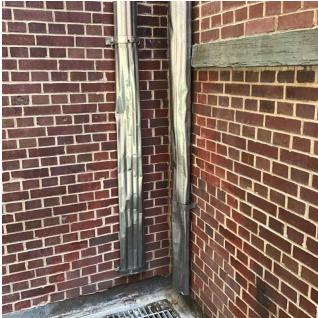
Question	Response
EXTERIOR	
ROOF	
Roofing	
LEADERS, GUTTERS, DOWNSPOUTS, SCUPPERS	
Quantity Uom	L.F.
Potential Action	REPLACE
Urgency of Action	PRIORITY 4
Purpose of Action	LEVEL 2
Deficiency Photo1

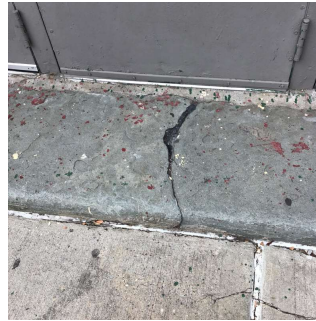
Facade G - Exit 6

STONE: CRACKS/SPALLING - MAJOR

40
S.F.
REPLACE
PRIORITY 4
LEVEL 2

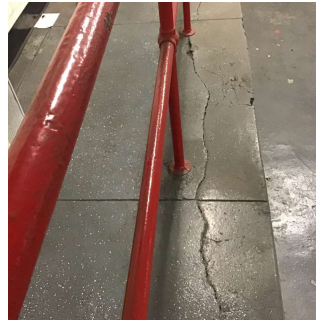
Question	Response
INTERIOR	
STRUCTURAL	
COLUMNS/BEAMS/BEARING WALLS	
Deficiency Photo1	 
Violations	Mechanical Equipment Room East No violations recorded.
FLOOR STRUCTURE	
Condition	Inspected 4 - Between Fair and Poor
Deficiency	CINDER CONCRETE ARCH: METAL PAN DETERIORATED, SPALLED
Deficiency Location/Instance	Sub-Basement - Boiler Room, Mechanical Equipment Room East, Storage Area (near Mechanical Equipment Room East)
Deficiency Quantity	60
Quantity Uom	S.F.
Potential Action	REPAIR
Urgency of Action	PRIORITY 3
Purpose of Action	LEVEL 5
Deficiency Photo1	 
Violations	Sub-Basement - Mechanical Equipment Room East No violations recorded.
Deficiency	CONCRETE SLAB ON GRADE: THRU CRACKS
Deficiency Location/Instance	Sub-Basement - Boiler Room
Deficiency Quantity	100
Quantity Uom	S.F.
Potential Action	REPLACE
Urgency of Action	PRIORITY 4
Purpose of Action	LEVEL 5

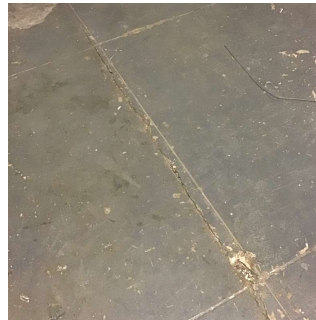
Sub-Basement - Mechanical Equipment Room

CONCRETE SLAB ON GRADE: THRU CRACKS

REPAIR

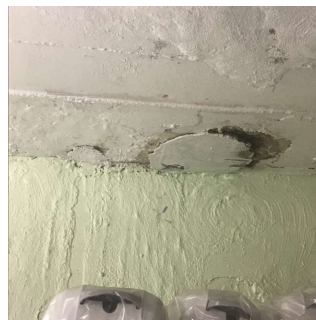
Sub-Basement - South Storage Room near Electrical Panel Room

CONCRETE: CRACKS/SPALLED/REINFORCEMENT EXPOSED

REPAIR

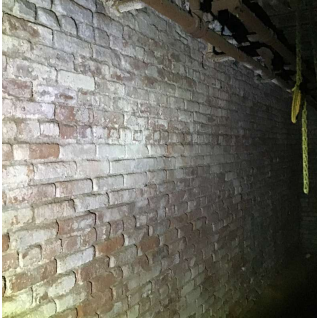
Question	Response
INTERIOR	
STRUCTURAL	
FLOOR STRUCTURE	Inspected
Violations	No violations recorded.
FOUNDATION WALLS	Inspected
Material Type(s)	Concrete, Masonry
Condition	5 - Poor
Deficiency	BRICK: DETERIORATED JOINTS
Deficiency Location/Instance	Sub-Basement - Mechanical Equipment Room East
Deficiency Quantity	300
Quantity Uom	S.F.
Potential Action	REPOINT
Urgency of Action	PRIORITY 4
Purpose of Action	LEVEL 5
Deficiency Photo1

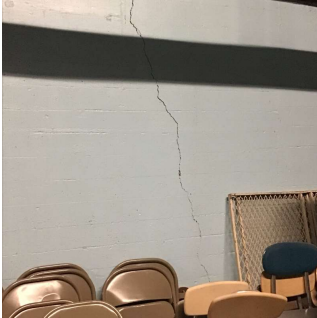
Violations	Sub-Basement - Mechanical Equipment Room East No violations recorded.
Deficiency	CONCRETE: CRACKED/SPALLED/REINFORCEMENT EXPOSED
Deficiency Location/Instance	Sub-Basement - Mechanical Equipment Room West
Deficiency Quantity	50
Quantity Uom	S.F.
Potential Action	REPAIR
Urgency of Action	PRIORITY 3
Purpose of Action	LEVEL 5
Deficiency Photo1

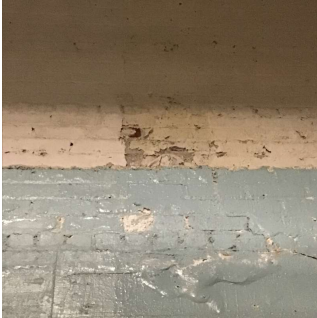
Violations	Mechanical Equipment Room West No violations recorded.
Deficiency	BRICK: WATER INFILTRATION IN NON- INSTRUCTIONAL SPACE

Deficiency Location/Instance	Sub-Basement - Mechanical Equipment Room West, Crawlspace (under Auditorium)
Deficiency Quantity	200
Quantity Uom	S.F.
Potential Action	INSTALL WATERPROOFING

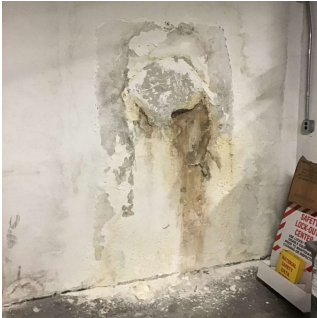
Sub-Basement - Mechanical Equipment Room West
Violations	No violations recorded.
Deficiency	CONCRETE: WATER INFILTRATION IN NON- INSTRUCTIONAL SPACE
Deficiency Location/Instance	Sub-Basement - Boiler Room, Supply Room, South Storage Room near Electrical Panel Room
Deficiency Quantity	300
Quantity Uom	S.F.
Potential Action	INSTALL WATERPROOFING
Urgency of Action	PRIORITY 5
Purpose of Action	LEVEL 5
Deficiency Photo1

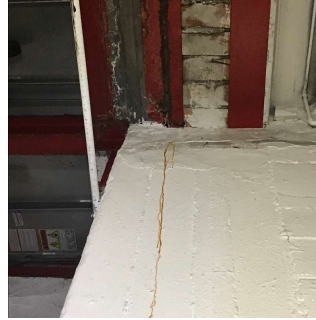
Sub-Basement - Supply Room
Violations	No violations recorded.
ROOF STRUCTURE	Inspected
Condition	2 - Between Good and Fair
Deficiency	No deficiencies recorded
VAULTS-BUNKERS	Inspected
Foundation Walls	Inspected
Condition	2 - Between Good and Fair
Deficiency	No deficiencies recorded
Slab Structure	Inspected
Condition	3 - Fair
Deficiency	CONCRETE: WATER INFILTRATION IN NON- INSTRUCTIONAL SPACE

Deficiency Location/Instance	Sub-Basement - Ash Hoist Vault
Deficiency Quantity	50
Quantity Uom	S.F.
Potential Action	INSTALL WATERPROOFING

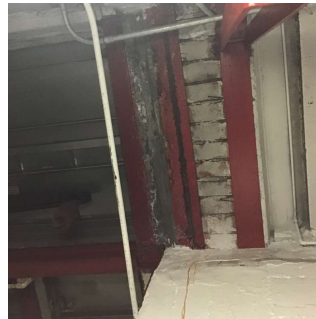
STEEL COLUMNS/BEAMS: MAJOR RUSTING

Basement - Ash Hoist Vault
10
S.F.
REPLACE
PRIORITY 4
LEVEL 5

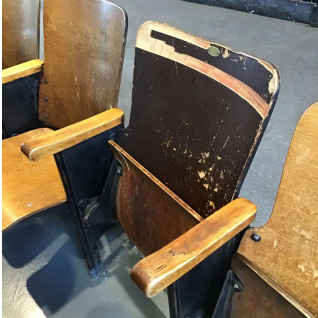
Question	Response
INTERIOR	
AUDITORIUM	
Fixed Seating	
Deficiency Location/Instance	Seats Z/8,10,16,18,24 and others
Deficiency Quantity	110
Quantity Uom	EACH
Potential Action	REPLACE
Urgency of Action	PRIORITY 3
Purpose of Action	LEVEL 2
Deficiency Photo1

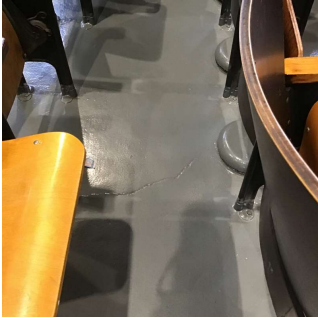
Seat Z/24
Violations	No violations recorded.
Floor Finish	
Instance on Basement (705 Seats)	Inspected
Condition	2 - Between Good and Fair
Deficiency	CONCRETE: CRACKS
Deficiency Location/Instance	Near Seats R/2, T/6, U/2
Deficiency Quantity	30
Quantity Uom	S.F.
Potential Action	REPLACE
Urgency of Action	PRIORITY 3
Purpose of Action	LEVEL 2
Deficiency Photo1

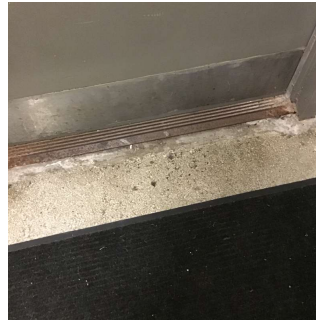
Near Seat T/6
Violations	No violations recorded.
Deficiency	TERRAZZO: CRACKS
Deficiency Location/Instance	Exit 8 - Vestibule
Deficiency Quantity	20
Quantity Uom	S.F.
Potential Action	REPLACE
Urgency of Action	PRIORITY 3
Purpose of Action	LEVEL 2

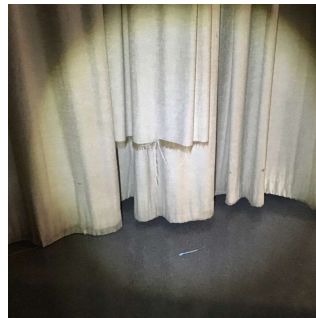
Left Side

WORN/DETERIORATED

REPLACE

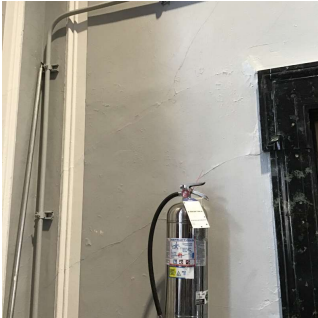
Question	Response
INTERIOR	
AUDITORIUM	
Walls	
Deficiency	PLASTER: CRACKS/SPALLING
Deficiency Location/Instance	Right and Left Side, Near Main Entrance
Deficiency Quantity	80
Quantity Uom	S.F.
Potential Action	REPLACE
Urgency of Action	PRIORITY 3
Purpose of Action	LEVEL 2
Deficiency Photo1

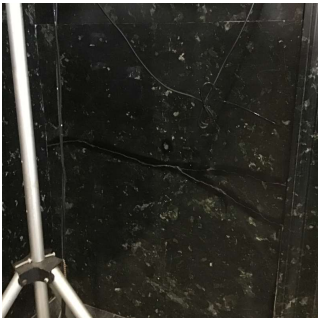
Near Main Entrance
Violations	No violations recorded.
Deficiency	STONE: CRACKS/SPALLING
Deficiency Location/Instance	Right Side
Deficiency Quantity	10
Quantity Uom	S.F.
Potential Action	REPLACE
Urgency of Action	PRIORITY 3
Purpose of Action	LEVEL 2
Deficiency Photo1

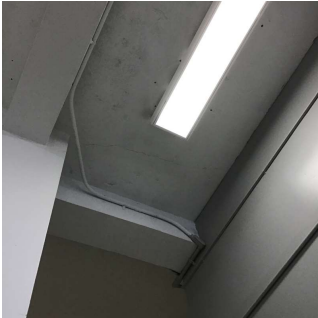
Question	Response
INTERIOR	
CAFETERIA	
Ceiling	
Deficiency	PLASTER: CRACKS/SPALLING
Deficiency Location/Instance	Near Servery, By Room B17
Deficiency Quantity	30
Quantity Uom	S.F.
Potential Action	REPLACE
Urgency of Action	PRIORITY 3
Purpose of Action	LEVEL 2
Deficiency Photo1

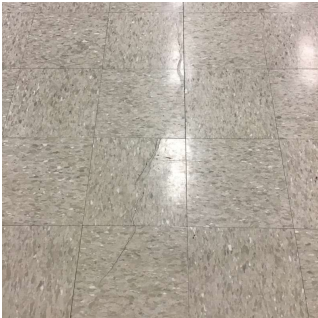
Violations	Near Servery No violations recorded.
Door(s)	
Instance on Basement	Inspected
Condition	2 - Between Good and Fair
Deficiency	No deficiencies recorded
Fixed Equipment	
Instance on Basement	Does not Exist
Floor Finish	
Instance on Basement	Inspected
Condition	3 - Fair
Deficiency	VINYL TILES: DETERIORATED SUBSTRATE
Deficiency Location/Instance	Near Fridges, By Exit 3, Next to Kitchen
Deficiency Quantity	80
Quantity Uom	S.F.
Potential Action	REPLACE
Urgency of Action	PRIORITY 3
Purpose of Action	LEVEL 2
Deficiency Photo1

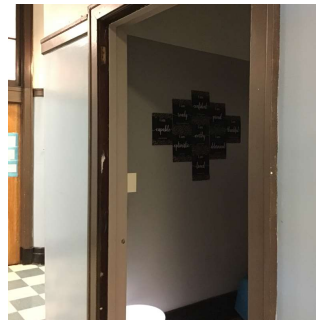
Corridor near Room 211

WOOD: MISSING DOOR

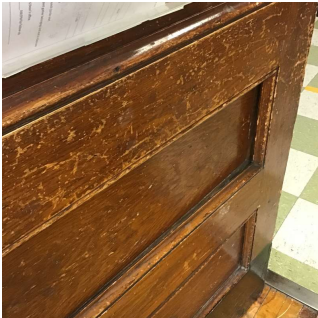
Question	Response
INTERIOR	
CLASSROOMS/CORRIDORS/ADMIN SPACES	
Door(s)	
Violations	Room 328 No violations recorded.
Deficiency	WOOD: DETERIORATED DOOR
Deficiency Location/Instance	Main Entrance Lobby, Rooms 318,314,308,307 and others
Deficiency Quantity	18
Quantity Uom	EACH
Potential Action	MAINTENANCE
Urgency of Action	PRIORITY 3
Purpose of Action	LEVEL 2
Deficiency Photo1

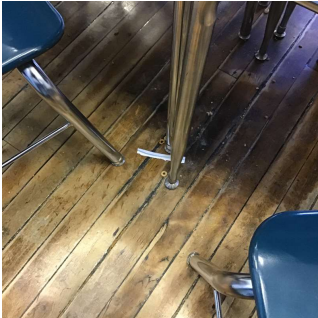
Violations	Room 308 No violations recorded.
Floor Finish	Inspected
Condition	4 - Between Fair and Poor
Deficiency	WOOD: DAMAGED/DETERIORATED
Deficiency Location/Instance	Rooms 322,308,226,222,211 and others
Deficiency Quantity	1,200
Quantity Uom	S.F.
Potential Action	REPLACE
Urgency of Action	PRIORITY 3
Purpose of Action	LEVEL 2
Deficiency Photo1

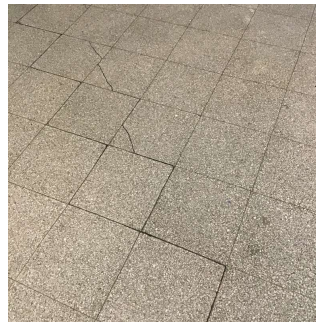
Main Entrance Lobby

Violations	Room 211 No violations recorded.
Deficiency	TERRAZZO: CRACKS
Deficiency Location/Instance	Main Entrance Lobby, Main Entrance - Vestibule
Deficiency Quantity	40
Quantity Uom	S.F.
Potential Action	REPLACE

Urgency of Action	PRIORITY 3
Purpose of Action	LEVEL 2

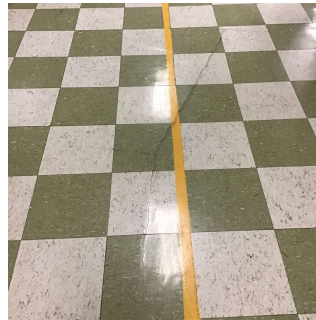
Corridor near Stair CD/3

VINYL TILES: DETERIORATED SUBSTRATE

REPLACE

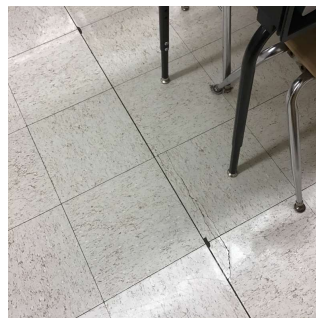
Room 109

VINYL TILES: BROKEN/DETERIORATED/MISSING TILES

REPLACE

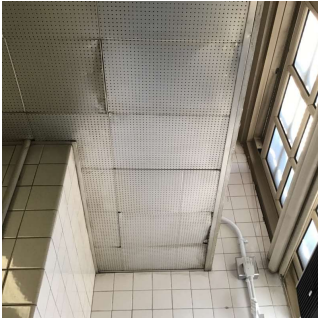
Question	Response
INTERIOR	
INTERIOR DOOR HARDWARE	Inspected
Condition	3 - Fair
Deficiency	No deficiencies recorded
INTERIOR GUARDS	Inspected
Condition	2 - Between Good and Fair
Deficiency	No deficiencies recorded
KITCHEN	Inspected
Instance on Basement	Inspected
Ceiling	
Instance on Basement	Inspected
Condition	3 - Fair
Deficiency	METAL PAN: DAMAGED/MISSING
Deficiency Location/Instance	Near Windows, Preparation Area
Deficiency Quantity	40
Quantity Uom	S.F.
Potential Action	REPLACE
Urgency of Action	PRIORITY 3
Purpose of Action	LEVEL 2
Deficiency Photo1

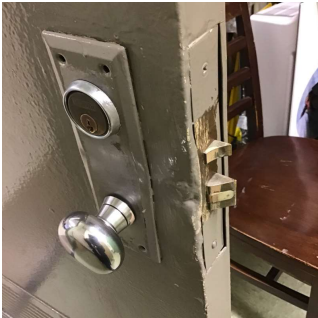
Violations	Near Windows No violations recorded.
Door(s)	
Instance on Basement	Inspected
Condition	3 - Fair
Deficiency	METAL: DETERIORATED DOOR AND FRAME
Deficiency Location/Instance	Locker Room
Deficiency Quantity	1
Quantity Uom	EACH
Potential Action	MAINTENANCE
Urgency of Action	PRIORITY 3
Purpose of Action	LEVEL 2
Deficiency Photo1

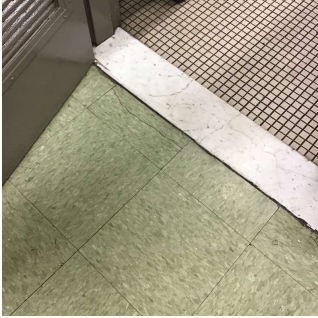
Question	Response
INTERIOR	
KITCHEN	
Door(s)	
Violations	No violations recorded.
Floor Finish	
Instance on Basement	Inspected
Condition	2 - Between Good and Fair
Deficiency	VINYL TILES: BROKEN/DETERIORATED/MISSING TILES
Deficiency Location/Instance	Office Room
Deficiency Quantity	10
Quantity Uom	S.F.
Potential Action	REPLACE
Urgency of Action	PRIORITY 3
Purpose of Action	LEVEL 2
Deficiency Photo1

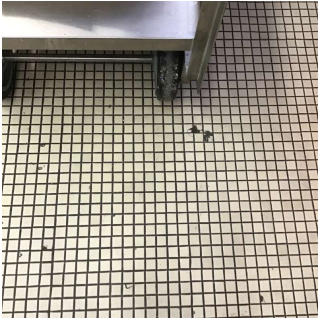
Violations	Office Room No violations recorded.
Deficiency	CERAMIC TILE: BROKEN/MISSING TILES
Deficiency Location/Instance	Near Sink, Preparation Area
Deficiency Quantity	20
Quantity Uom	S.F.
Potential Action	REPLACE
Urgency of Action	PRIORITY 3
Purpose of Action	LEVEL 2
Deficiency Photo1

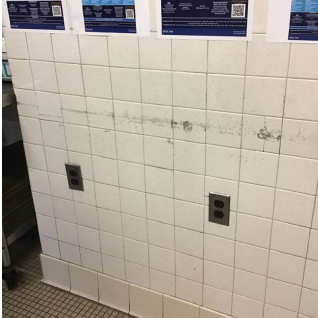
Violations	Near Sink No violations recorded.
Walls	
Instance on Basement	Inspected
Condition	3 - Fair
Deficiency	CERAMIC TILE: BROKEN/ MISSING
Deficiency Location/Instance	Near Windows, By Sink, Preparation Area, Next to Entrance, Locker Room

Question	Response
INTERIOR	
KITCHEN	
Walls	
Quantity Uom	S.F.
Potential Action	REPLACE
Urgency of Action	PRIORITY 3
Purpose of Action	LEVEL 2
Deficiency Photo1

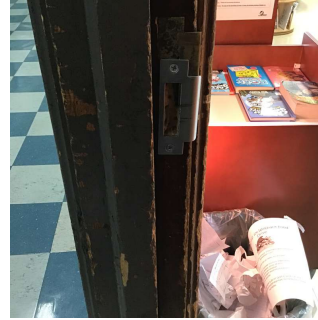
Violations	Preparation Area No violations recorded.
LIBRARY	Inspected
Instance on Room 214	Inspected
Built-in Furnishing	
Instance on Room 214	Does not Exist
Ceiling	
Instance on Room 214	Inspected
Condition	2 - Between Good and Fair
Deficiency	ACOUSTIC TILES ON PLASTER: DAMAGED/MISSING
Deficiency Location/Instance	Near Windows
Deficiency Quantity	30
Quantity Uom	S.F.
Potential Action	REPLACE
Urgency of Action	PRIORITY 3
Purpose of Action	LEVEL 2
Deficiency Photo1	 
Violations	Near Windows No violations recorded.
Door(s)	
Instance on Room 214	Inspected
Condition	3 - Fair
Deficiency	WOOD: DETERIORATED DOOR AND FRAME
Deficiency Location/Instance	Main Entrance
Deficiency Quantity	1
Quantity Uom	EACH

MAINTENANCE
PRIORITY 3
LEVEL 2

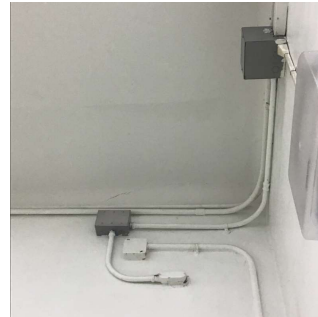
Near Exit 5

PLASTER: CRACKS/SPALLING

REPLACE

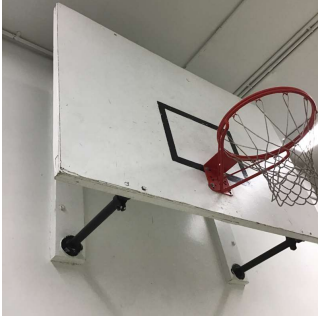
Question	Response
INTERIOR	
MULTI-PURPOSE ROOM	
Door(s)	
Instance on Basement	Inspected
Condition	2 - Between Good and Fair
Deficiency	No deficiencies recorded
Fixed Equipment	
Instance on Basement	Inspected
Condition	3 - Fair
Deficiency	DAMAGED/MISSING
Deficiency Location/Instance	Near Exit 6
Deficiency Quantity	1
Quantity Uom	EACH
Potential Action	REPLACE
Urgency of Action	PRIORITY 3
Purpose of Action	LEVEL 2
Deficiency Photo1

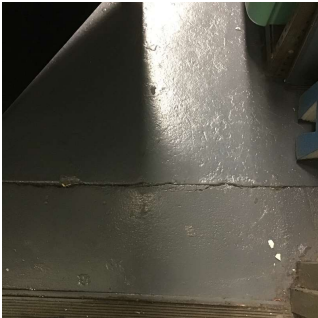
Near Exit 6
Violations	No violations recorded.
Floor Finish	
Instance on Basement	Inspected
Condition	5 - Poor
Deficiency	CONCRETE: CRACKS
Deficiency Location/Instance	Room B19
Deficiency Quantity	10
Quantity Uom	S.F.
Potential Action	REPLACE
Urgency of Action	PRIORITY 3
Purpose of Action	LEVEL 2
Deficiency Photo1

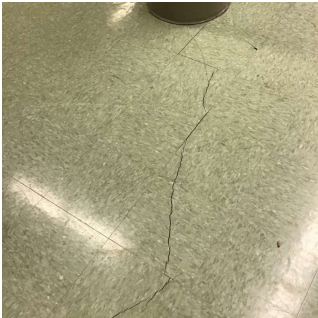
Room B19
Violations	No violations recorded.
Deficiency	VINYL TILES: DETERIORATED SUBSTRATE
Deficiency Location/Instance	Near Room B19, By Stair EF/Basement, Next to Exits 5,6

Question	Response
INTERIOR	
MULTI-PURPOSE ROOM	
Floor Finish	
Deficiency Quantity	400
Quantity Uom	S.F.
Potential Action	REPLACE
Urgency of Action	PRIORITY 3
Purpose of Action	LEVEL 2
Deficiency Photo1

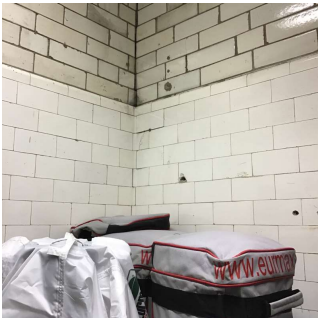
Near Room B19
Violations	No violations recorded.
Sliding-folding Partition	
Instance on Basement	Does not Exist
Stage	
Instance on Basement	Does not Exist
Walls	
Instance on Basement	Inspected
Condition	2 - Between Good and Fair
Deficiency	CERAMIC TILE: BROKEN/ MISSING
Deficiency Location/Instance	Room B19
Deficiency Quantity	10
Quantity Uom	S.F.
Potential Action	REPLACE
Urgency of Action	PRIORITY 3
Purpose of Action	LEVEL 2
Deficiency Photo1

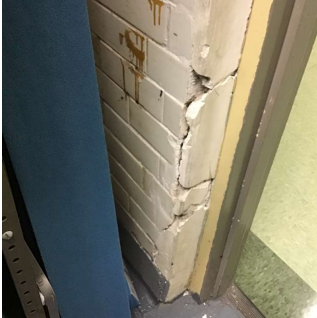
Room B19
Violations	No violations recorded.
Deficiency	PLASTER: CRACKS/SPALLING
Deficiency Location/Instance	Room B19, Near Room B18
Deficiency Quantity	30
Quantity Uom	S.F.
Potential Action	REPLACE
Urgency of Action	PRIORITY 3

Question	Response
INTERIOR	
MULTI-PURPOSE ROOM	
Walls	
Purpose of Action	LEVEL 2
Deficiency Photo1

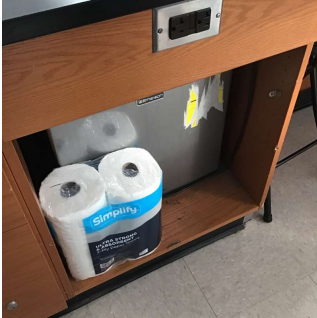
Violations	Room B19 No violations recorded.
Window Curtains/Shades/Blinds	
Instance on Basement	Does not Exist
SCIENCE DEMO ROOM	Does not Exist
SCIENCE LAB	Inspected
Instance on Room 318	Inspected
Alternative use	No
Instance on Room 311	Inspected
Alternative use	No
Fixed Equipment	
Instance on Room 318	Inspected
Condition	3 - Fair
Deficiency	CABINETS: MISSING/DAMAGED
Deficiency Location/Instance	Room 318
Deficiency Quantity	10
Quantity Uom	L.F.
Potential Action	REPLACE
Urgency of Action	PRIORITY 3
Purpose of Action	LEVEL 2
Deficiency Photo1

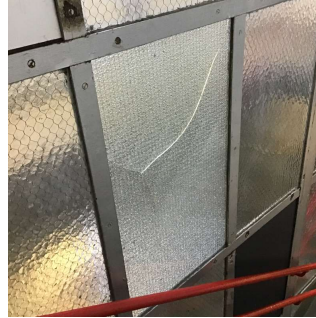
Stair GH/3

Violations	Exit 3 - Vestibule No violations recorded.
Partition	Inspected
Condition	3 - Fair
Deficiency	GLASS PANEL: DAMAGED/DETERIORATED
Deficiency Location/Instance	Stairs CD/1,2, EF/1, GH/3,Basement and others
Deficiency Quantity	180

Quantity Uom	S.F.
Potential Action	REPLACE

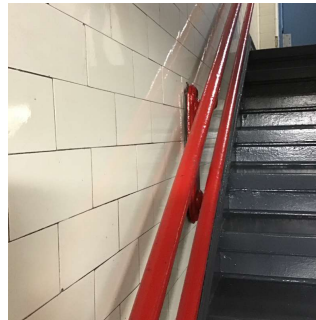
Stair GH/1

METAL: BROKEN BRACKET

REPLACE

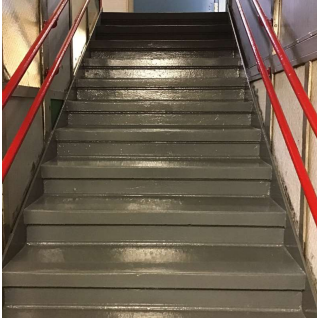
Question	Response
INTERIOR	
STAIRS/RAMPS: INTERIOR	
Stairs and Landings	
Deficiency	STONE: WORN-OUT TREAD/NOSINGS
Deficiency Location/Instance	Stair EF/2
Deficiency Quantity	140
Quantity Uom	S.F.
Potential Action	REPLACE
Urgency of Action	PRIORITY 3
Purpose of Action	LEVEL 2
Deficiency Photo1

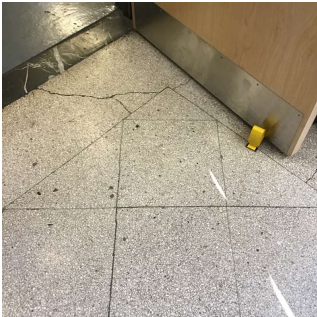
Violations	Stair EF/2 No violations recorded.
Deficiency	TERRAZZO: CRACKS
Deficiency Location/Instance	Exit 3 - Vestibule
Deficiency Quantity	50
Quantity Uom	S.F.
Potential Action	REPLACE
Urgency of Action	PRIORITY 3
Purpose of Action	LEVEL 2
Deficiency Photo1

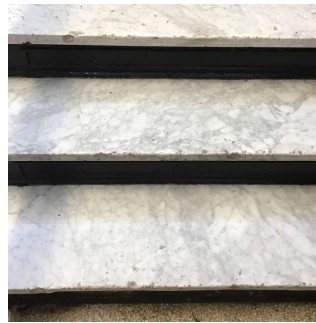
Violations	Exit 3 - Vestibule No violations recorded.
Deficiency	STONE: BROKEN/MISSING
Deficiency Location/Instance	Main Entrance Lobby Stair, Exits 3,8 - Vestibules
Deficiency Quantity	80
Quantity Uom	S.F.
Potential Action	REPLACE
Urgency of Action	PRIORITY 3
Purpose of Action	LEVEL 2

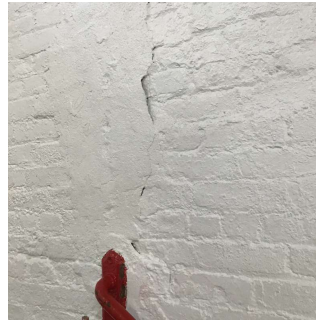
Stair I/1

BRICK: CRACKS/SPALLING

REPLACE

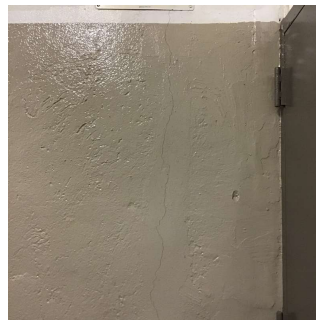
PLASTER: CRACKS/SPALLING

REPLACE

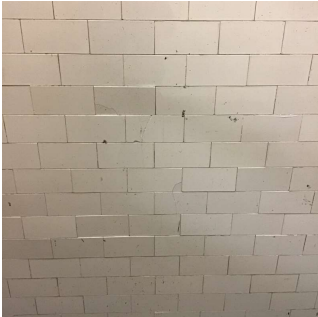
Question	Response
INTERIOR	
STAIRS/RAMPS: INTERIOR	
Walls	
Violations	Exit 4 - Vestibule No violations recorded.
Deficiency	CERAMIC TILE: BROKEN/ MISSING
Deficiency Location/Instance	Exit 2 - Vestibule, Stairs GH/3,2,Basement
Deficiency Quantity	40
Quantity Uom	S.F.
Potential Action	REPLACE
Urgency of Action	PRIORITY 3
Purpose of Action	LEVEL 2
Deficiency Photo1

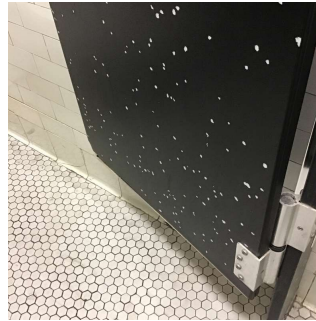
Violations	Room 358 No violations recorded.
Stalls	Inspected
Condition	5 - Poor
Deficiency	BROKEN/MISSING
Deficiency Location/Instance	Room 156
Deficiency Quantity	1
Quantity Uom	EACH
Potential Action	REPLACE
Urgency of Action	PRIORITY 3
Purpose of Action	LEVEL 2

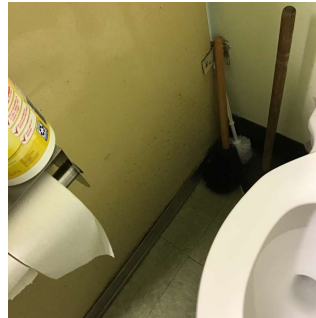
In Kitchen Locker Room

RUST - MAJOR

REPLACE

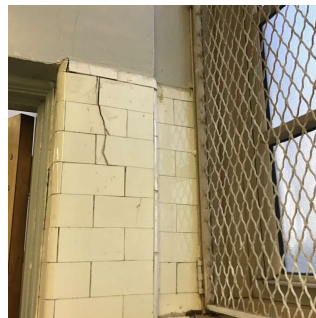
CERAMIC TILE: BROKEN/ MISSING

REPLACE

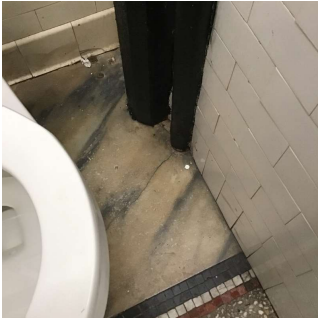
Question	Response
INTERIOR	
TOILET ROOMS - STUDENTS	Inspected
Floor Finish	
Deficiency	STONE: BROKEN/MISSING TILES
Deficiency Location/Instance	In Room 118
Deficiency Quantity	10
Quantity Uom	S.F.
Potential Action	REPLACE
Urgency of Action	PRIORITY 3
Purpose of Action	LEVEL 2
Deficiency Photo1

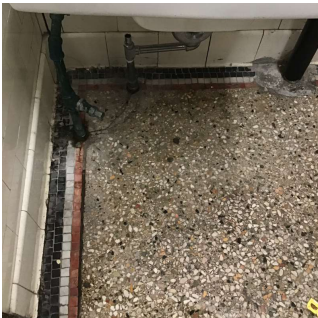
Violations	In Room 118 No violations recorded.
Deficiency	TERRAZZO: CRACKS
Deficiency Location/Instance	In Room 118
Deficiency Quantity	10
Quantity Uom	S.F.
Potential Action	REPLACE
Urgency of Action	PRIORITY 3
Purpose of Action	LEVEL 2
Deficiency Photo1

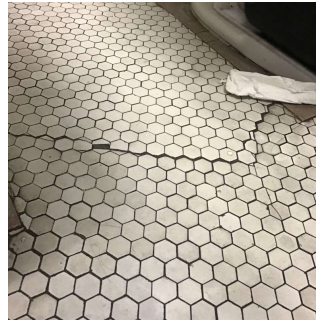
Girls Toilet Room - 2nd Floor

Violations	In Room 118 No violations recorded.
Deficiency	CERAMIC TILE: DETERIORATED SUBSTRATE
Deficiency Location/Instance	Girls Toilet Room - 2nd Floor, In Room 109
Deficiency Quantity	70
Quantity Uom	S.F.
Potential Action	REPLACE
Urgency of Action	PRIORITY 3
Purpose of Action	LEVEL 2

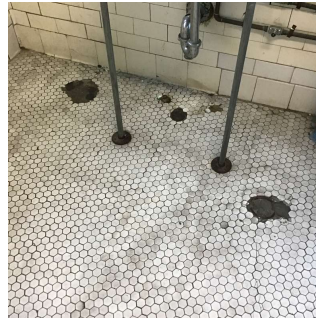
Rooms 355

CERAMIC TILE: BROKEN/MISSING TILES

REPLACE

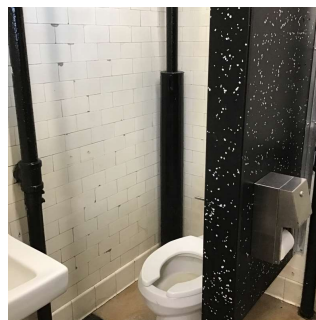
BROKEN/MISSING

REPLACE

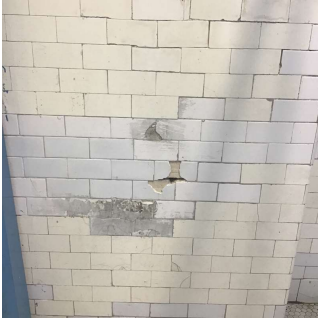
Question	Response
INTERIOR	
TOILET ROOMS - STUDENTS	
Stalls	Inspected
	In Room 118
Violations	No violations recorded.
Walls	Inspected
Condition	2 - Between Good and Fair
Deficiency	CERAMIC TILE: BROKEN/ MISSING
Deficiency Location/Instance	Rooms 356,355,B17, Girls Toilet Room - Basement, Boys Toilet Room - 2nd Floor and others
Deficiency Quantity	140
Quantity Uom	S.F.
Potential Action	REPLACE
Urgency of Action	PRIORITY 3
Purpose of Action	LEVEL 2
Deficiency Photo1

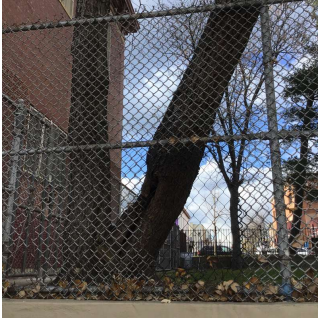
Question	Response
SITE	
FENCES	
Deficiency	CHAIN LINK: DAMAGED/DETERIORATED
Deficiency Location/Instance	Schoolyard
Deficiency Quantity	50
Quantity Uom	S.F.
Potential Action	REPLACE
Urgency of Action	PRIORITY 3
Purpose of Action	LEVEL 2
Deficiency Photo1

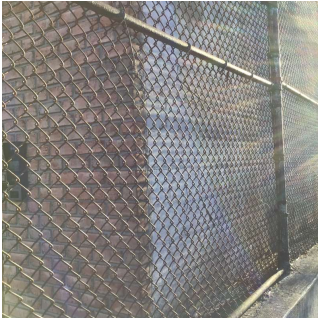
Violations	Schoolyard No violations recorded.
Deficiency	CHAIN LINK: RUST - MAJOR
Deficiency Location/Instance	5th Avenue, Gelston Avenue, Schoolyard
Deficiency Quantity	2,600
Quantity Uom	S.F.
Potential Action	REPLACE
Urgency of Action	PRIORITY 3
Purpose of Action	LEVEL 2
Deficiency Photo1

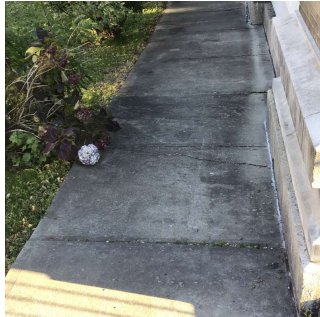
Question	Response
SITE	
PAVING	
Student Non-Use	
Concrete	
Deficiency Photo1

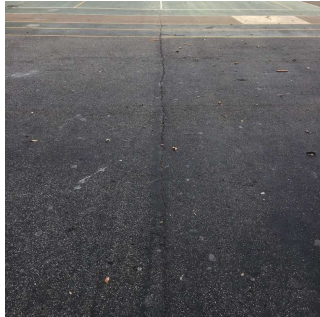
Violations	92nd Street No violations recorded.
Pavers	Does not Exist
Student Use	Inspected
Gravel Exists?	No
Asphalt	Inspected
Condition	4 - Between Fair and Poor
Deficiency	CRACKS - MAJOR
Deficiency Location/Instance	Schoolyard
Deficiency Quantity	800
Quantity Uom	S.F.
Potential Action	REPLACE
Urgency of Action	PRIORITY 3
Purpose of Action	LEVEL 2
Deficiency Photo1

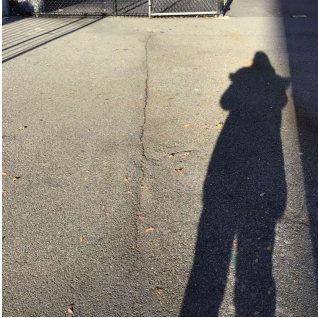
Violations	Schoolyard No violations recorded.
Concrete	Inspected
Condition	2 - Between Good and Fair
Deficiency	No deficiencies recorded
Pavers	Does not Exist
Site Sidewalks & Walkways	Inspected
Asphalt	Inspected
Condition	3 - Fair
Deficiency	CRACKS - MAJOR
Deficiency Location/Instance	Gelston Avenue
Deficiency Quantity	50
Quantity Uom	S.F.
Potential Action	REPLACE

Question	Response
SITE	
PAVING	
Site Sidewalks & Walkways	
Asphalt	
Urgency of Action	PRIORITY 3
Purpose of Action	LEVEL 2
Deficiency Photo1

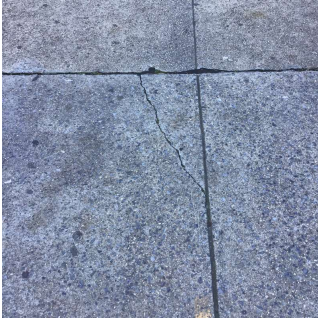
Violations	Gelston Avenue No violations recorded.
Concrete	Inspected
Condition	3 - Fair
Deficiency	DAMAGED/DETERIORATED/MISSING SECTIONS
Deficiency Location/Instance	5th Avenue, Near Exit 8, Near Garden
Deficiency Quantity	275
Quantity Uom	S.F.
Potential Action	REPLACE
Urgency of Action	PRIORITY 3
Purpose of Action	LEVEL 2
Deficiency Photo1

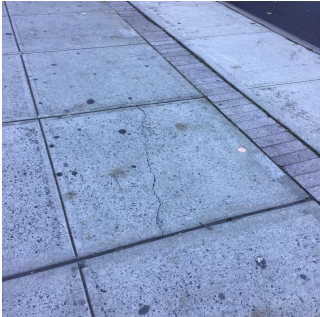
Question	Response
SITE	
PAVING	
DOT Sidewalk	
Concrete	
Deficiency Photo1	 
Violations	5th Avenue No violations recorded.
Deficiency	DAMAGED/DETERIORATED/MISSING SECTIONS
Deficiency Location/Instance	5th Avenue, 92nd Street
Deficiency Quantity	400
Quantity Uom	S.F.
Potential Action	REPLACE
Urgency of Action	PRIORITY 3
Purpose of Action	LEVEL 2
Deficiency Photo1

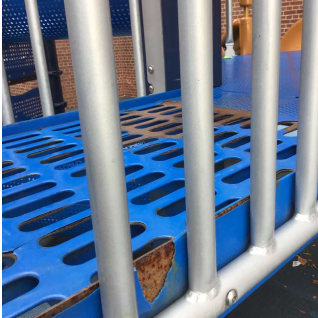
Question	Response
SITE	
PAVING	
DOT Sidewalk	
Concrete	Inspected
Violations	No violations recorded.
Pavers	Inspected
Condition	2 - Between Good and Fair
Deficiency	No deficiencies recorded
PLAYGROUNDS	
Instance on Schoolyard South	Inspected
Benches	
Instance on Schoolyard South	Inspected
Condition	2 - Between Good and Fair
Deficiency	No deficiencies recorded
Fence	
Instance on Schoolyard South	Inspected
Condition	2 - Between Good and Fair
Deficiency	No deficiencies recorded
Pavement	
Instance on Schoolyard South	Inspected
Condition	2 - Between Good and Fair
Deficiency	No deficiencies recorded
Play Equipment	
Instance on Schoolyard South	Inspected
Condition	5 - Poor
Deficiency	BROKEN/DETERIORATED/MISSING
Deficiency Location/Instance	Tunnels, Bridge
Deficiency Quantity	1
Quantity Uom	EACH
Potential Action	REPLACE
Urgency of Action	PRIORITY 3
Purpose of Action	LEVEL 2
Deficiency Photo1

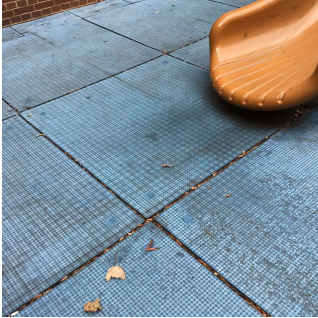
Safety Surfacing	
Instance on Schoolyard South	Inspected
Condition	3 - Fair
Deficiency	DETERIORATED/MISSING
Deficiency Location/Instance	Near Slide
Deficiency Quantity	200
Quantity Uom	S.F.

Question	Response
SITE	
PLAYGROUNDS	
Safety Surfacing	
Potential Action	MAINTENANCE
Urgency of Action	PRIORITY 3
Purpose of Action	LEVEL 2
Deficiency Photo1

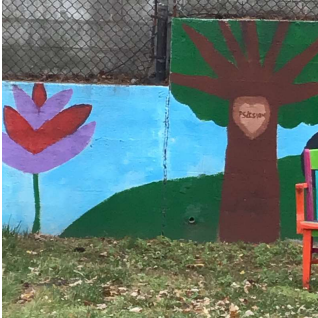
Violations	Near Slide No violations recorded.
Unpaved Area	
Instance on Schoolyard South	Does not Exist
PLAYING SURFACE	Does not Exist
RETAINING WALLS	Inspected
Are there any Retaining Walls 6' OR higher facing public street/sidewalk?	Yes
Condition	4 - Between Fair and Poor
Deficiency	MASONRY UNIT: DETERIORATED CONTROL/EXPANSION JOINT
Deficiency Location/Instance	Garden
Deficiency Quantity	20
Quantity Uom	L.F.
Potential Action	REPLACE
Urgency of Action	PRIORITY 3
Purpose of Action	LEVEL 2
Deficiency Photo1

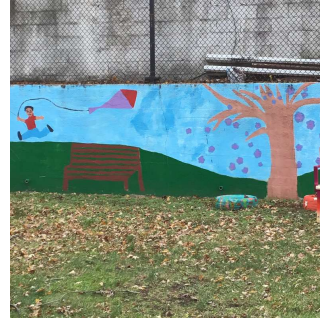
Violations	Garden No violations recorded.
Deficiency	MASONRY UNIT: CRACKS/SPALLING - MAJOR
Deficiency Location/Instance	Garden
Deficiency Quantity	20
Quantity Uom	S.F.
Potential Action	REPLACE
Urgency of Action	PRIORITY 3
Purpose of Action	LEVEL 2

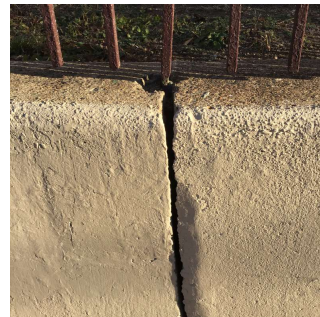
92nd Street

CAST IN PLACE CONCRETE: DETERIORATED CONTROL/EXPANSION JOINT

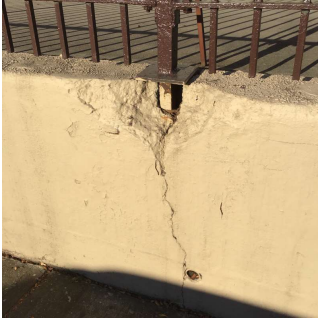
Question	Response
SITE	
RETAINING WALLS	
Deficiency	CAST IN PLACE CONCRETE: CRACKS/SPALLING - MAJOR
Deficiency Location/Instance	Near Exit 8, 5th Avenue, 92nd Street, Gelston Avenue, Schoolyard
Deficiency Quantity	250
Quantity Uom	S.F.
Potential Action	REPLACE
Urgency of Action	PRIORITY 3
Purpose of Action	LEVEL 2
Deficiency Photo1

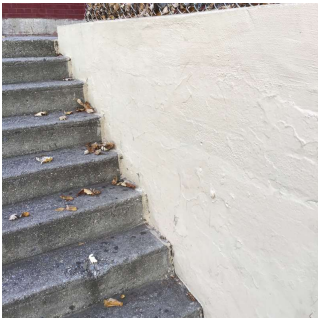
Violations	Gelston Avenue No violations recorded.
SEATING	
	Inspected
Benches	
	Inspected
Concrete	
	Does not Exist
Metal/Wood/Plastic	
	Inspected
Condition	2 - Between Good and Fair
Deficiency	No deficiencies recorded
Bleachers	
	Does not Exist
SITE WALLS (NOT RETAINING WALLS)	
	Does not Exist
STAIRS/RAMPS: EXTERIOR	
	Inspected
Railings	
	Inspected
Condition	3 - Fair
Deficiency	MISSING
Deficiency Location/Instance	Near Exit 7
Deficiency Quantity	10
Quantity Uom	L.F.
Potential Action	REPLACE
Urgency of Action	PRIORITY 5
Purpose of Action	LEVEL 6
Deficiency Photo1

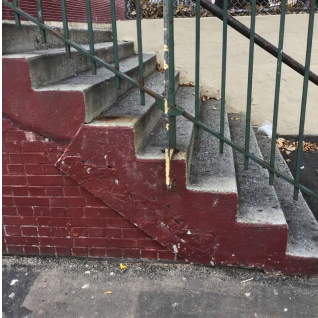
Question	Response
SITE	
STAIRS/RAMPS: EXTERIOR	
Site Cheek/flank Walls	Inspected
Condition	2 - Between Good and Fair
Deficiency	MASONRY UNIT: CRACKS/SPALLING - MAJOR
Deficiency Location/Instance	Near Exit 7
Deficiency Quantity	30
Quantity Uom	S.F.
Potential Action	REPLACE
Urgency of Action	PRIORITY 3
Purpose of Action	LEVEL 2
Deficiency Photo1

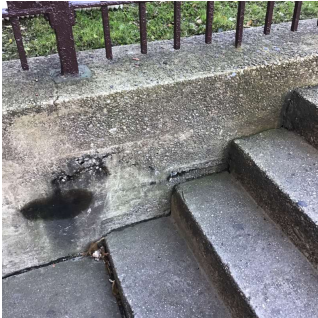
Violations	Near Exit 7 No violations recorded.
Deficiency	CAST IN PLACE CONCRETE: CRACKS/SPALLING - MAJOR
Deficiency Location/Instance	Near Exit 8
Deficiency Quantity	10
Quantity Uom	S.F.
Potential Action	REPLACE
Urgency of Action	PRIORITY 3
Purpose of Action	LEVEL 2
Deficiency Photo1

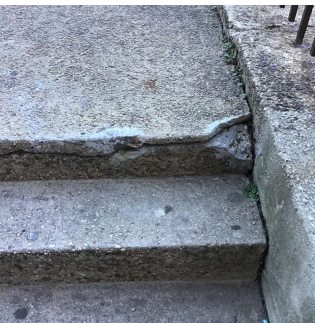
Violations	Near Exit 8 No violations recorded.
Stairs/ramps	Inspected
Condition	3 - Fair
Deficiency	CAST IN PLACE CONCRETE: CRACKS/SPALLING - MAJOR
Deficiency Location/Instance	Near Exits 7,8, Gelston Avenue
Deficiency Quantity	120
Quantity Uom	S.F.
Potential Action	REPLACE
Urgency of Action	PRIORITY 3
