**NYC Department of Education**  
**Building Condition Assessment Survey 2023 - 2024**

Architectural Inspection

**K106**

**Asset:** P.S. 106 - BROOKLYN, 1328 PUTNAM AVENUE, New York, 11221

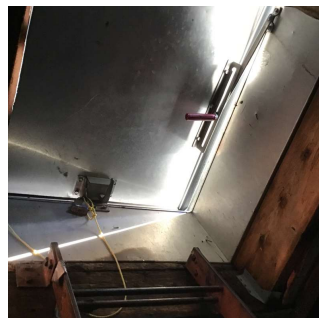
Question	Response
<b>EXTERIOR</b>	
<b>PARAPETS</b>	Inspected
Instance Quantity Uom	C.F.
Deficiency	No deficiencies recorded
<b>PLAZA DECK</b>	Does not Exist
<b>ROOF</b>	Inspected
<b>Roofing</b>	Inspected
Replacement Quantity	22,000
Replacement Uom	S.F.
<b>ROOF HATCH/SMOKE HATCH</b>	Inspected
Condition	5 - Poor
Deficiency	DETERIORATED
Roof Plan reference

<p>K106</p> <p>Putnam Avenue</p> <p>Wilson Avenue</p> <p>Cornelia Street</p>
Deficiency Quantity	1
Quantity Uom	EACH
Potential Action	REPLACE
Urgency of Action	PRIORITY 4
Purpose of Action	LEVEL 2
Deficiency Photo1

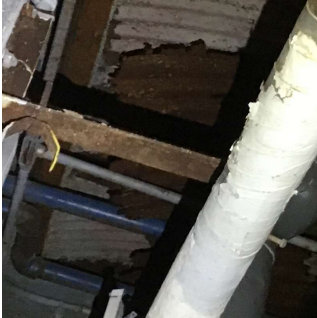
Question	Response
<b>EXTERIOR</b>	
<b>WINDOWS</b>	
<b>WINDOWS</b>	
Instance Quantity	500
Instance Quantity Uom	S.F.
Are these windows insulated	No
Installation Year	2015
Source of Installation	Custodial Staff
Deficiency	No deficiencies recorded
<b>INTERIOR</b>	Inspected
<b>POOLS</b>	Does not Exist
<b>STRUCTURAL</b>	Inspected
<b>COLUMNS/BEAMS/BEARING WALLS</b>	Inspected
Condition	2 - Between Good and Fair
Deficiency	No deficiencies recorded
<b>FLOOR STRUCTURE</b>	Inspected
Condition	3 - Fair
Deficiency	CINDER CONCRETE ARCH: METAL PAN DETERIORATED, SPALLED
Deficiency Location/Instance	Mechanical Equipment Room - North
Deficiency Quantity	80
Quantity Uom	S.F.
Potential Action	REPAIR
Urgency of Action	PRIORITY 4
Purpose of Action	LEVEL 5
Deficiency Photo1

Violations	Mechanical Equipment Room - North No violations recorded.
<b>FOUNDATION WALLS</b>	Inspected
Material Type(s)	Masonry
Condition	4 - Between Fair and Poor

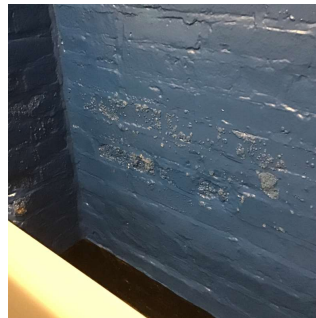
Cafeteria - Facade K

BRICK: CRACKED/SPALLED

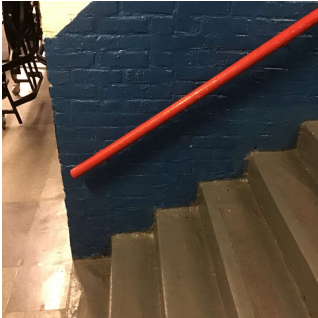
Question	Response
<b>INTERIOR</b>	
<b>STRUCTURAL</b>	
<b>FOUNDATION WALLS</b>	
Deficiency	BRICK: WATER INFILTRATION IN INSTRUCTIONAL SPACE
Deficiency Location/Instance	Cafeteria near Stair 10
Deficiency Quantity	200
Quantity Uom	S.F.
Potential Action	INSTALL WATERPROOFING
Urgency of Action	PRIORITY 5
Purpose of Action	LEVEL 5
Deficiency Photo1

Violations	Cafeteria Facade D - near Stair 10, Cafeteria - West Wall similar No violations recorded.
<b>ROOF STRUCTURE</b>	
Condition	Inspected
Deficiency	2 - Between Good and Fair
Deficiency	No deficiencies recorded
<b>VAULTS-BUNKERS</b>	
<b>Foundation Walls</b>	
Condition	Inspected
Condition	3 - Fair
Deficiency	DETERIORATED JOINTS
Deficiency Location/Instance	Vault
Deficiency Quantity	150
Quantity Uom	S.F.
Potential Action	REPOINT
Urgency of Action	PRIORITY 3
Purpose of Action	LEVEL 5
Deficiency Photo1

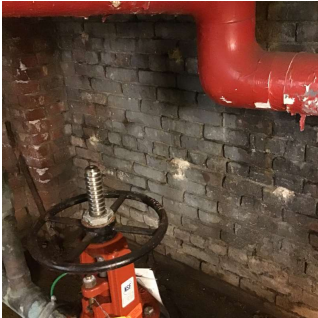
Violations	Vault at Mechanical Mechanical Equipment Room No violations recorded.

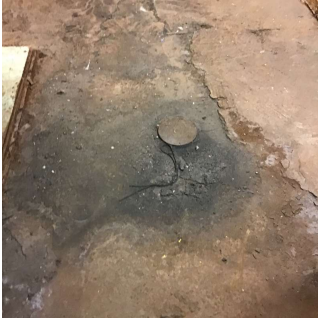
Violations	Vault North Wall No violations recorded.
<b>Slab Structure</b>	
Condition	Inspected 3 - Fair
Deficiency	CONCRETE SLAB ON GRADE: THRU CRACKS
Deficiency Location/Instance	Mechanical Equipment Room - North
Deficiency Quantity	80
Quantity Uom	S.F.
Potential Action	REPAIR
Urgency of Action	PRIORITY 3
Purpose of Action	LEVEL 5
Deficiency Photo1

Violations	Vault at Mechanical Equipment Room - North No violations recorded.
<b>Vault/Ash Hoist Doors and Framing</b>	
	Does not Exist
<b>AUDITORIUM</b>	
Instance on 4th Floor (268 Seats)	Inspected
<b>Ceiling</b>	
Instance on 4th Floor (268 Seats)	Inspected
Condition	2 - Between Good and Fair
Deficiency	No deficiencies recorded
<b>Door(s)</b>	
Instance on 4th Floor (268 Seats)	Inspected
Condition	2 - Between Good and Fair

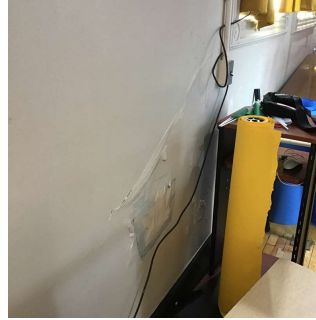
Deficiency	No deficiencies recorded
<b>Stage Curtains</b>	
Instance on 4th Floor (268 Seats)	Inspected
Condition	2 - Between Good and Fair
Deficiency	No deficiencies recorded
<b>Walls</b>	
Instance on 4th Floor (268 Seats)	Inspected
Condition	2 - Between Good and Fair
Deficiency	PLASTER: CRACKS/SPALLING - ACTIVE LEAK
Deficiency Location/Instance	Right Side
Deficiency Quantity	80
Quantity Uom	S.F.

Potential Action	REPLACE
Urgency of Action	PRIORITY 5
Purpose of Action	LEVEL 2
Deficiency Photo1

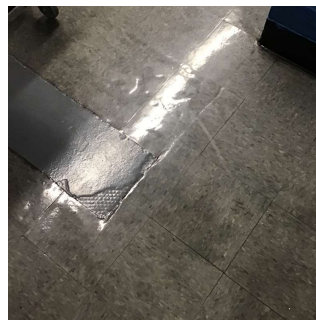
Instance on Basement	Inspected
Condition	2 - Between Good and Fair
Deficiency	VINYL TILES: DETERIORATED SUBSTRATE
Deficiency Location/Instance	Center, Near Stair B
Deficiency Quantity	40
Quantity Uom	S.F.
Potential Action	REPLACE
Urgency of Action	PRIORITY 3
Purpose of Action	LEVEL 2
Deficiency Photo1

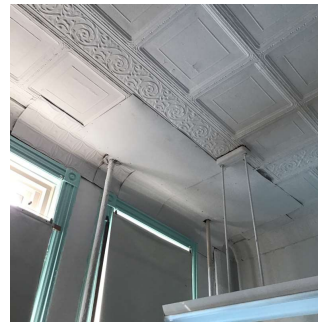
Room 317

Exit 10
Violations	No violations recorded.
<b>Window Curtains/Shades/Blinds</b>	
Instance on Basement	Does not Exist
<b>CLASSROOMS/CORRIDORS/ADMIN SPACES</b>	
	Inspected
<b>Ceiling</b>	
	Inspected
Condition	2 - Between Good and Fair
Deficiency	METAL PAN: DAMAGED/MISSING
Deficiency Location/Instance	Rooms 106, 207, 306, 316, 317, and others

Deficiency Quantity	100
Quantity Uom	S.F.
Potential Action	REPLACE
Urgency of Action	PRIORITY 3
Purpose of Action	LEVEL 2

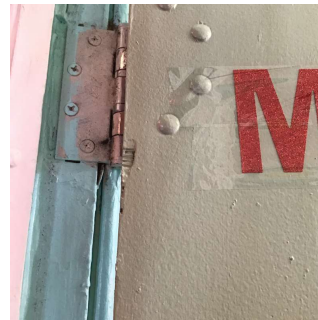
Room 313

WOOD: DETERIORATED DOOR

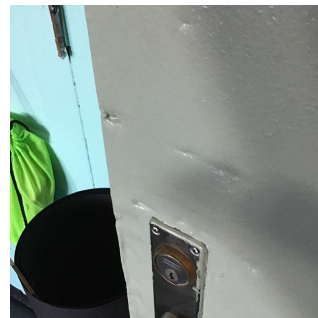
METAL: DETERIORATED DOOR

<b>Question</b>	<b>Response</b>
<b>INTERIOR</b>	
<b>CLASSROOMS/CORRIDORS/ADMIN SPACES</b>	
<b>Door(s)</b>	Inspected Room 312
Violations	No violations recorded.
<b>Floor Finish</b>	Inspected
<b>Condition</b>	2 - Between Good and Fair
<b>Deficiency</b>	VINYL TILES: BROKEN/DETERIORATED/MISSING TILES
Deficiency Location/Instance	Rooms 111, 112, 305
Deficiency Quantity	400
Quantity Uom	S.F.
Potential Action	REPLACE
Urgency of Action	PRIORITY 3
Purpose of Action	LEVEL 2
Deficiency Photo1

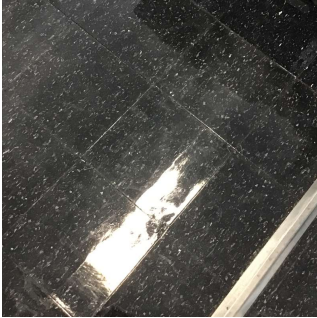
Violations	Room 305 No violations recorded.
<b>Deficiency</b>	VINYL TILES: DETERIORATED SUBSTRATE
Deficiency Location/Instance	Rooms 104, 109, 116, 306, 314, and others
Deficiency Quantity	320
Quantity Uom	S.F.
Potential Action	REPLACE
Urgency of Action	PRIORITY 3
Purpose of Action	LEVEL 2
Deficiency Photo1

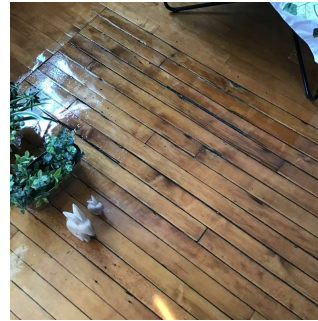
Room 317

Violations	Room 314 No violations recorded.
<b>Deficiency</b>	WOOD: DAMAGED/DETERIORATED
Deficiency Location/Instance	Rooms 212, 302, 317, Corridor near Rooms 116, 216, and others

Deficiency Quantity	450
Quantity Uom	S.F.
Potential Action	REPLACE
Urgency of Action	PRIORITY 3
Purpose of Action	LEVEL 2

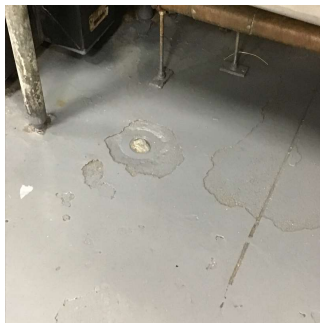
Question	Response
<b>INTERIOR</b>	
<b>KITCHEN</b>	
<b>Floor Finish</b>	
Deficiency Photo1

Violations	Near sink No violations recorded.
<b>Walls</b>	
Instance on Basement	Inspected
Condition	2 - Between Good and Fair
Deficiency	BRICK: CRACKS/SPALLING
Deficiency Location/Instance	Near Windows
Deficiency Quantity	40
Quantity Uom	S.F.
Potential Action	REPLACE
Urgency of Action	PRIORITY 3
Purpose of Action	LEVEL 2
Deficiency Photo1

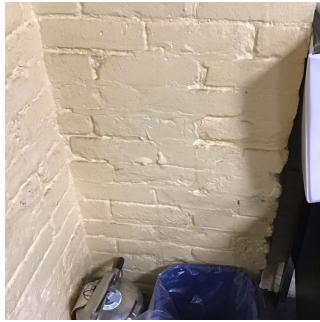
Violations	Near Windows No violations recorded.
<b>LIBRARY</b>	
Instance on 4th Floor	Inspected
<b>Built-in Furnishing</b>	
Instance on 4th Floor	Does not Exist
<b>Ceiling</b>	
Instance on 4th Floor	Inspected
Condition	2 - Between Good and Fair
Deficiency	No deficiencies recorded
<b>Door(s)</b>	
Instance on 4th Floor	Inspected
Condition	2 - Between Good and Fair
Deficiency	No deficiencies recorded
<b>Floor Finish</b>	
Instance on 4th Floor	Inspected
Condition	2 - Between Good and Fair

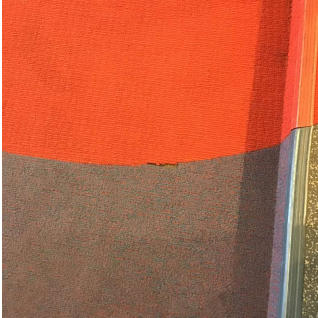
Question	Response
<b>INTERIOR</b>	
<b>LIBRARY</b>	
<b>Floor Finish</b>	
Deficiency	CARPET: WORN/DETERIORATED
Deficiency Location/Instance	Center
Deficiency Quantity	10
Quantity Uom	S.F.
Potential Action	REPLACE
Urgency of Action	PRIORITY 3
Purpose of Action	LEVEL 2
Deficiency Photo1

Violations	Center No violations recorded.
<b>Walls</b>	
Instance on 4th Floor	Inspected
Condition	2 - Between Good and Fair
Deficiency	No deficiencies recorded
<b>LOCKER ROOM</b>	Does not Exist
<b>MULTI-PURPOSE ROOM</b>	Does not Exist
<b>SCIENCE DEMO ROOM</b>	Does not Exist
<b>SCIENCE LAB</b>	Does not Exist
<b>SCIENCE PREP ROOM</b>	Does not Exist
<b>SHOWER ROOM</b>	Does not Exist
<b>STAIRS/RAMPS: INTERIOR</b>	Inspected
Do Letter Stair Signs Exist?	Partially
<b>Ceiling</b>	
Condition	Inspected 2 - Between Good and Fair
Deficiency	PLASTER: CRACKS/SPALLING
Deficiency Location/Instance	Stair G/4
Deficiency Quantity	10
Quantity Uom	S.F.
Potential Action	REPLACE

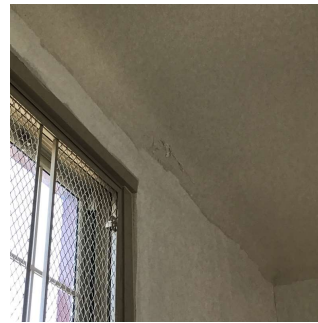
Stair G/4

Urgency of Action	PRIORITY 3
Purpose of Action	LEVEL 2

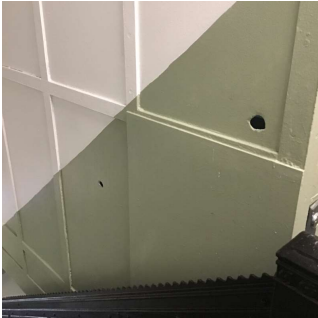
<b>Question</b>	<b>Response</b>
<b>INTERIOR</b>	
<b>STAIRS/RAMPS: INTERIOR</b>	
<b>Door(s)</b>	Inspected
Violations	Stair B/1 Vestibule No violations recorded.
<b>Partition</b>	Inspected
Condition	2 - Between Good and Fair
Deficiency	GLASS PANEL: DAMAGED/DETERIORATED
Deficiency Location/Instance	Stairs B/2, D/1, E/3
Deficiency Quantity	20
Quantity Uom	S.F.
Potential Action	REPLACE
Urgency of Action	PRIORITY 3
Purpose of Action	LEVEL 2
Deficiency Photo1

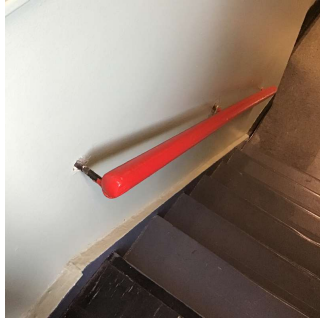
Violations	Corridor near Room 307 No violations recorded.
Deficiency	METAL: BROKEN BRACKET
Deficiency Location/Instance	Stair B/Basement

Deficiency Quantity	3
Quantity Uom	EACH
Potential Action	REPLACE

Question	Response
<b>INTERIOR</b>	
<b>STAIRS/RAMPS: INTERIOR</b>	
<b>Railings</b>	
Urgency of Action	PRIORITY 3
Purpose of Action	LEVEL 2
Deficiency Photo1

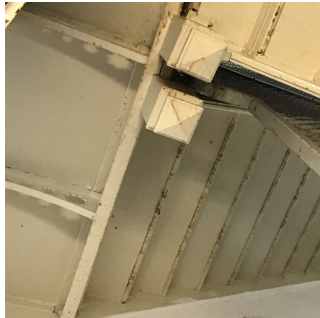
Violations	Stair B/Basement No violations recorded.
<b>Stairs and Landings</b>	
Condition	Inspected 5 - Poor
Deficiency	METAL: RUST - MAJOR
Deficiency Location/Instance	Stair F/1
Deficiency Quantity	40
Quantity Uom	S.F.
Potential Action	REPLACE
Urgency of Action	PRIORITY 3
Purpose of Action	LEVEL 2
Deficiency Photo1

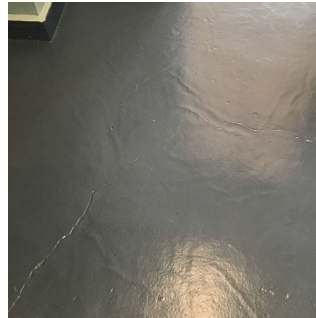
Stair F/4

ROLLED ASPHALT: CRACKS

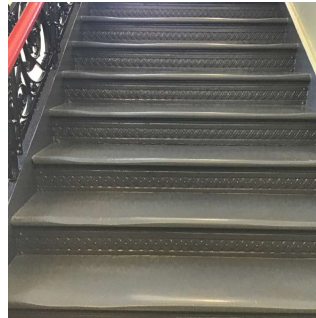
Stair G/3

STONE: WORN-OUT TREAD/NOSINGS

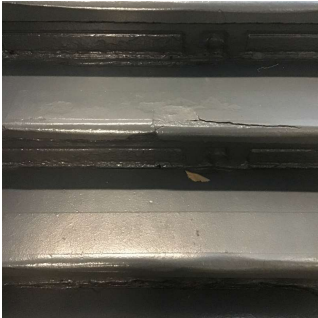
Question	Response
<b>INTERIOR</b>	
<b>STAIRS/RAMPS: INTERIOR</b>	
<b>Stairs and Landings</b>	
Deficiency	STONE: BROKEN/MISSING
Deficiency Location/Instance	Stairs B/Basement, E/Basement, F/2, G/1,2, Main Entrance Vestibule
Deficiency Quantity	60
Quantity Uom	S.F.
Potential Action	REPLACE
Urgency of Action	PRIORITY 3
Purpose of Action	LEVEL 2
Deficiency Photo1

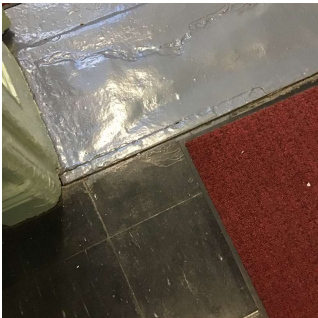
Stair B/Basement
Violations	No violations recorded.
Deficiency	VINYL TILES: BROKEN/DETERIORATED/MISSING TILES
Deficiency Location/Instance	Stair B/1
Deficiency Quantity	10
Quantity Uom	S.F.
Potential Action	REPLACE
Urgency of Action	PRIORITY 3
Purpose of Action	LEVEL 2
Deficiency Photo1

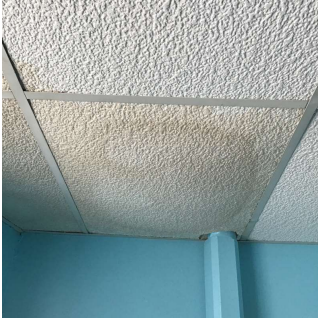
Question	Response
<b>INTERIOR</b>	
<b>TOILET ROOMS - STAFF</b>	Inspected
<b>Ceiling</b>	Inspected
Condition	3 - Fair
Deficiency	ACOUSTIC TILES: DAMAGED/MISSING
Deficiency Location/Instance	In Stair B/2, In Stair C/2
Deficiency Quantity	20
Quantity Uom	S.F.
Potential Action	REPLACE
Urgency of Action	PRIORITY 3
Purpose of Action	LEVEL 2
Deficiency Photo1

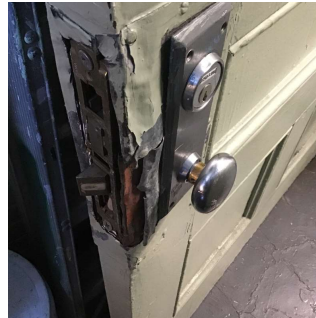
In Stair E/3

METAL CLAD WOOD: DETERIORATED DOOR

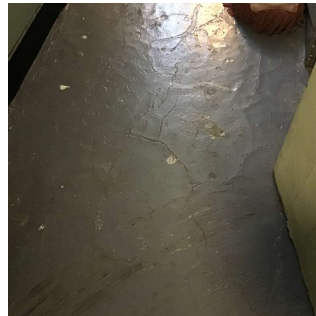
ROLLED ASPHALT: CRACKS

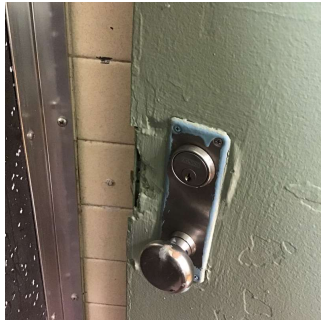
Violations	Basement Boys No violations recorded.
<b>Door(s)</b>	Inspected
Condition	5 - Poor
Deficiency	WOOD: DETERIORATED DOOR
Deficiency Location/Instance	2nd Floor Boys, 2nd Floor Girls
Deficiency Quantity	2
Quantity Uom	EACH
Potential Action	MAINTENANCE
Urgency of Action	PRIORITY 3
Purpose of Action	LEVEL 2
Deficiency Photo1

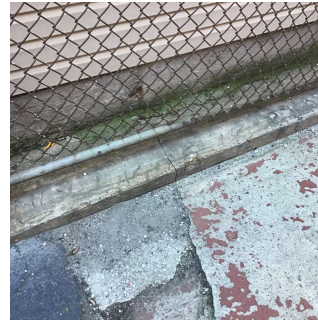
Near Playground

**CONCRETE CURB: DAMAGED/DETERIORATED**

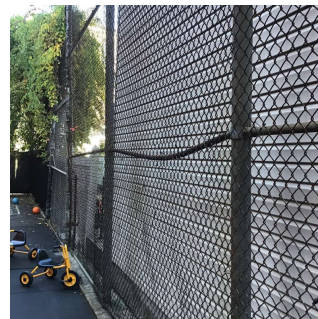
Playground

**CHAIN LINK: DAMAGED POST/RAIL**

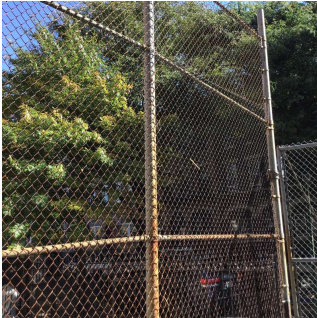
**CHAIN LINK: RUST - MAJOR**

<b>Question</b>	<b>Response</b>
<b>SITE</b>	
<b>FENCES</b>	
Deficiency Location/Instance	Near Playground
Deficiency Quantity	300
Quantity Uom	S.F.
Potential Action	REPLACE
Urgency of Action	PRIORITY 3
Purpose of Action	LEVEL 2
Deficiency Photo1

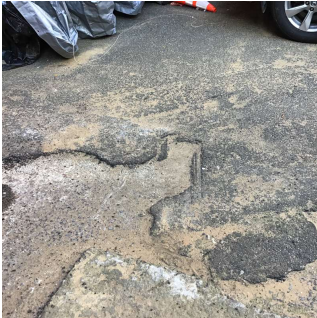
Violations	Near Playground No violations recorded.
<b>IRRIGATION SYSTEM</b>	Does not Exist
<b>PAVING</b>	Inspected
<b>Student Non-Use</b>	Inspected
Gravel Exists?	No
<b>Asphalt</b>	Inspected
Condition	3 - Fair
Deficiency	CRACKS - MAJOR
Deficiency Location/Instance	Putnam Avenue Driveway
Deficiency Quantity	150
Quantity Uom	S.F.
Potential Action	REPLACE
Urgency of Action	PRIORITY 3
Purpose of Action	LEVEL 2
Deficiency Photo1

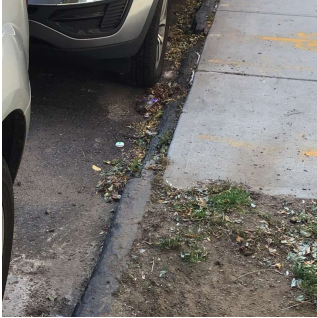
Question	Response
<b>SITE</b>	
<b>PAVING</b>	
<b>Student Non-Use</b>	
<b>Concrete</b>	
Urgency of Action	PRIORITY 3
Purpose of Action	LEVEL 2
Deficiency Photo1	 
	Cornelia Street
Violations	No violations recorded.
<b>Pavers</b>	Does not Exist
<b>Student Use</b>	Inspected
Gravel Exists?	No
<b>Asphalt</b>	Does not Exist
<b>Concrete</b>	Inspected
Condition	4 - Between Fair and Poor
Deficiency	CRACKS - MAJOR
Deficiency Location/Instance	Wilson Avenue Schoolyard
Deficiency Quantity	500
Quantity Uom	S.F.
Potential Action	REPLACE
Urgency of Action	PRIORITY 3
Purpose of Action	LEVEL 2
Deficiency Photo1	 
	Wilson Avenue Schoolyard
Violations	No violations recorded.
<b>Pavers</b>	Does not Exist
<b>Site Sidewalks &amp; Walkways</b>	Does not Exist
<b>DOT Sidewalk</b>	Inspected
<b>Asphalt</b>	Does not Exist
<b>Concrete</b>	Inspected
Condition	4 - Between Fair and Poor
Deficiency	DAMAGED CURBS
Deficiency Location/Instance	Cornelia Street, Wilson Avenue, Putnam Avenue

Question	Response
<b>SITE</b>	
<b>PAVING</b>	
<b>DOT Sidewalk</b>	
<b>Concrete</b>	
Deficiency Quantity	130
Quantity Uom	L.F.
Potential Action	REPLACE
Urgency of Action	PRIORITY 3
Purpose of Action	LEVEL 2
Deficiency Photo1

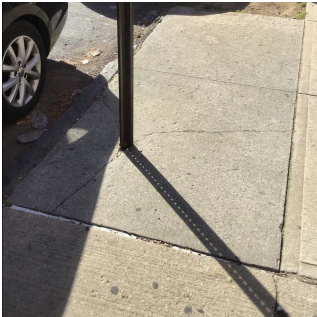
Violations	Cornelia Street No violations recorded.
Deficiency	DAMAGED/DETERIORATED/MISSING SECTIONS
Deficiency Location/Instance	Cornelia Street, Wilson Avenue, Putnam Avenue
Deficiency Quantity	850
Quantity Uom	S.F.
Potential Action	REPLACE
Urgency of Action	PRIORITY 3
Purpose of Action	LEVEL 2
Deficiency Photo1

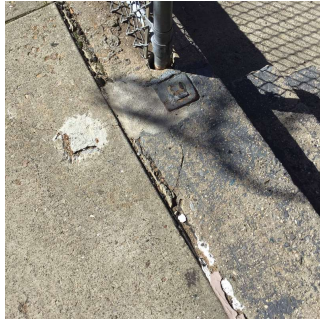
Violations	Putnam Avenue Driveway No violations recorded.
<b>SEATING</b>	Does not Exist
<b>SITE WALLS (NOT RETAINING WALLS)</b>	Does not Exist
<b>STAIRS/RAMPS: EXTERIOR</b>	Inspected
<b>Railings</b>	Does not Exist
<b>Site Cheek/flank Walls</b>	Does not Exist
<b>Stairs/ramps</b>	Inspected
Condition	2 - Between Good and Fair
Deficiency	CAST IN PLACE CONCRETE: CRACKS/SPALLING - MAJOR
Deficiency Location/Instance	Schoolyard
Deficiency Quantity	20
Quantity Uom	S.F.
Potential Action	REPLACE
Urgency of Action	PRIORITY 3
Purpose of Action	LEVEL 2
Deficiency Photo1
