**NYC Department of Education**  
**Building Condition Assessment Survey 2023 - 2024**

Architectural Inspection

**K108**

**Asset:** P.S. 108 - BROOKLYN, 200 LINWOOD STREET, New York, 11208

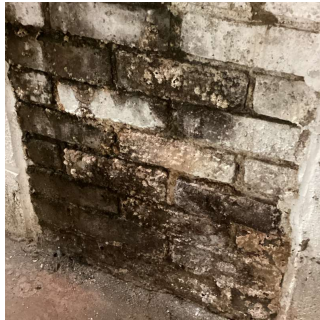
Violations	Boiler Room No violations recorded.
Deficiency	BRICK: DETERIORATED JOINTS
Deficiency Location/Instance	Basement - Oil Tank Room, Gas Meter Room, Firemans Office, Boiler Room
Deficiency Quantity	60
Quantity Uom	S.F.
Potential Action	REPOINT
Urgency of Action	PRIORITY 4
Purpose of Action	LEVEL 5
Deficiency Photo1

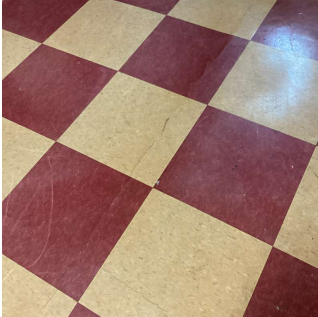
Condition	2 - Between Good and Fair
Deficiency	VINYL TILES: BROKEN/DETERIORATED/MISSING TILES

<b>Question</b>	<b>Response</b>
<b>INTERIOR</b>	
<b>CAFETERIA</b>	
<b>Floor Finish</b>	
Deficiency Location/Instance	Near Entrance, Kitchen
Deficiency Quantity	30
Quantity Uom	S.F.
Potential Action	REPLACE
Urgency of Action	PRIORITY 3
Purpose of Action	LEVEL 2
Deficiency Photo1

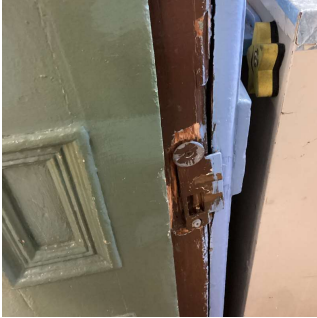
Question	Response
<b>INTERIOR</b>	
<b>CLASSROOMS/CORRIDORS/ADMIN SPACES</b>	
<b>Door(s)</b>	Inspected
Condition	5 - Poor
Deficiency	WOOD: DETERIORATED DOOR AND FRAME
Deficiency Location/Instance	Room 307
Deficiency Quantity	1
Quantity Uom	EACH
Potential Action	MAINTENANCE
Urgency of Action	PRIORITY 3
Purpose of Action	LEVEL 2
Deficiency Photo1

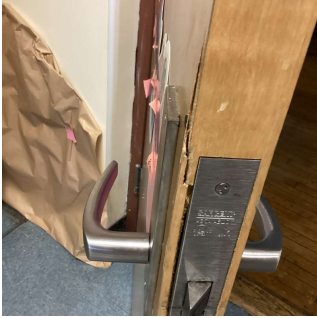
Violations	Room 307 No violations recorded.
Deficiency	WOOD: DETERIORATED DOOR
Deficiency Location/Instance	Rooms 112, 203, 304, 311, 408, and others
Deficiency Quantity	12
Quantity Uom	EACH
Potential Action	MAINTENANCE
Urgency of Action	PRIORITY 3
Purpose of Action	LEVEL 2
Deficiency Photo1

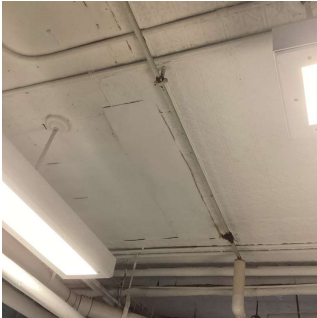
Question	Response
<b>INTERIOR</b>	
<b>KITCHEN</b>	
<b>Ceiling</b>	
Deficiency Quantity	40
Quantity Uom	S.F.
Potential Action	REPLACE
Urgency of Action	PRIORITY 3
Purpose of Action	LEVEL 2
Deficiency Photo1

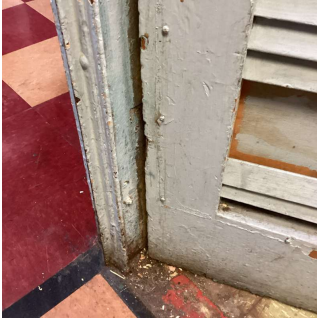
Near center
Violations	No violations recorded.
<b>Door(s)</b>	
Instance on Basement - South (400SF)	Inspected
Condition	4 - Between Fair and Poor
Deficiency	WOOD: DETERIORATED DOOR
Deficiency Location/Instance	Storage Room
Deficiency Quantity	1
Quantity Uom	EACH
Potential Action	MAINTENANCE
Urgency of Action	PRIORITY 3
Purpose of Action	LEVEL 2
Deficiency Photo1

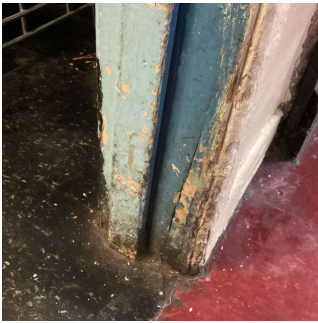
Storage Room
Violations	No violations recorded.
Deficiency	WOOD: DETERIORATED DOOR AND FRAME
Deficiency Location/Instance	Entrance
Deficiency Quantity	1
Quantity Uom	EACH
Potential Action	MAINTENANCE
Urgency of Action	PRIORITY 3
Purpose of Action	LEVEL 2

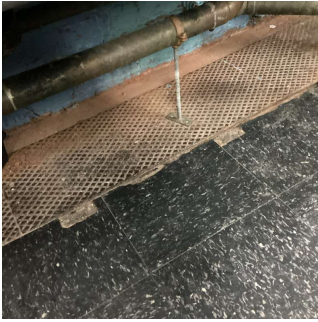
Instance on Basement - North (400SF)	Inspected
Condition	4 - Between Fair and Poor
Deficiency	VINYL TILES: BROKEN/DETERIORATED/MISSING TILES
Deficiency Location/Instance	Under Sink, Near center
Deficiency Quantity	40
Quantity Uom	S.F.
Potential Action	REPLACE
Urgency of Action	PRIORITY 3
Purpose of Action	LEVEL 2
Deficiency Photo1

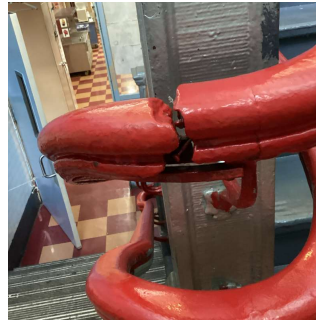
Stair D/Basement

Violations	Stair B/Vestibule No violations recorded.
<b>Partition</b>	Inspected
Condition	2 - Between Good and Fair
Deficiency	No deficiencies recorded
<b>Railings</b>	Inspected
Condition	4 - Between Fair and Poor
Deficiency	METAL: DAMAGED
Deficiency Location/Instance	Stairs B/1, 2, C/2, D/Basement
Deficiency Quantity	20
Quantity Uom	L.F.
Potential Action	REPLACE
Urgency of Action	PRIORITY 5
Purpose of Action	LEVEL 6

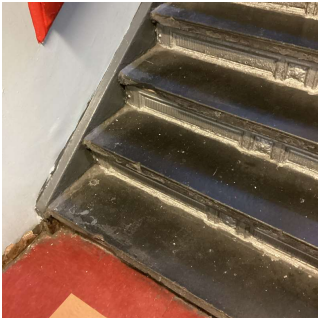
Question	Response
<b>INTERIOR</b>	
<b>STAIRS/RAMPS: INTERIOR</b>	
<b>Stairs and Landings</b>	
Violations	Stair D/1 No violations recorded.
Deficiency	STONE: BROKEN/MISSING
Deficiency Location/Instance	Stairs B/Basement, 1, C/3
Deficiency Quantity	90
Quantity Uom	S.F.
Potential Action	REPLACE
Urgency of Action	PRIORITY 3
Purpose of Action	LEVEL 2
Deficiency Photo1

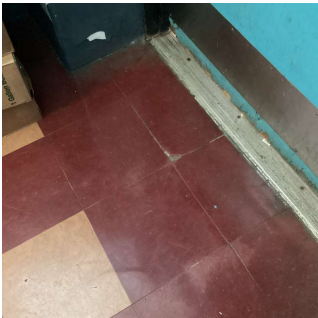
Violations	Stair D/Basement No violations recorded.
<b>Walls</b>	Inspected
Condition	2 - Between Good and Fair
Deficiency	PLASTER: CRACKS/SPALLING
Deficiency Location/Instance	Stairs B/2, D/Basement, F/1, 4, G/3, and others
Deficiency Quantity	120
Quantity Uom	S.F.

Violations	Stair B/Vestibule No violations recorded.
Deficiency	VINYL TILES: BROKEN/DETERIORATED/MISSING TILES
Deficiency Location/Instance	Stair D/Basement
Deficiency Quantity	10
Quantity Uom	S.F.
Potential Action	REPLACE
Urgency of Action	PRIORITY 3
Purpose of Action	LEVEL 2
Deficiency Photo1

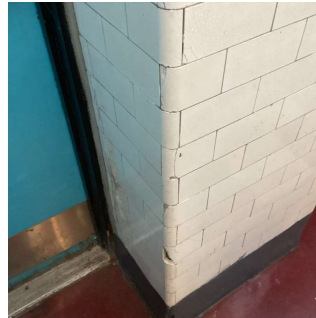
Stair D/Basement

CERAMIC TILE: BROKEN/ MISSING

REPLACE

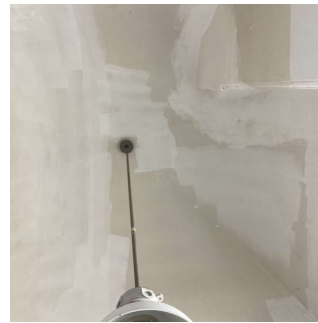
Stair F/3

PLASTER: CRACKS/SPALLING

REPLACE

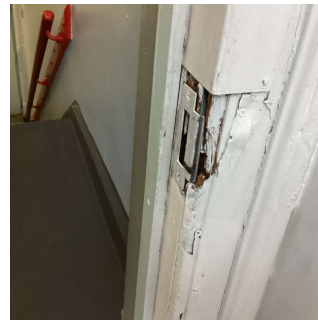
Stair G/2

WOOD: DETERIORATED DOOR AND FRAME

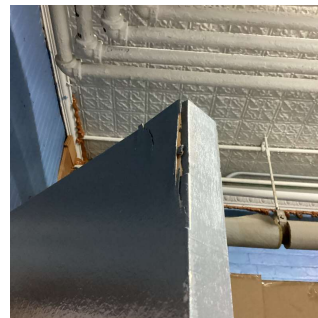
WOOD: DETERIORATED DOOR

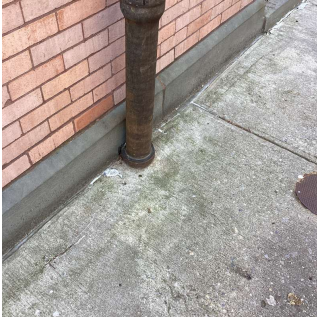
<b>Site Sidewalks &amp; Walkways</b>	Inspected
<b>Asphalt</b>	Does not Exist
<b>Concrete</b>	Inspected
Condition	3 - Fair
Deficiency	DAMAGED/DETERIORATED/MISSING SECTIONS
Deficiency Location/Instance	Near Exit 4
Deficiency Quantity	100
Quantity Uom	S.F.
Potential Action	REPLACE
Urgency of Action	PRIORITY 3
Purpose of Action	LEVEL 2

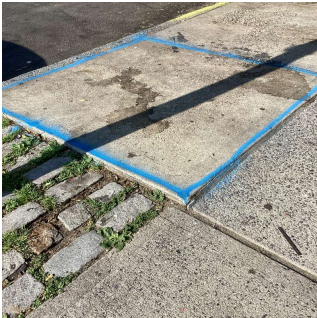
Violations	Arlington Avenue No violations recorded.
Deficiency	DAMAGED/DETERIORATED/MISSING SECTIONS
Deficiency Location/Instance	Linwood Street, Arlington Avenue
Deficiency Quantity	200
Quantity Uom	S.F.
Potential Action	REPLACE
Urgency of Action	PRIORITY 3
Purpose of Action	LEVEL 2

Violations	Near Exit 4 No violations recorded.
<b>Pavers</b>	Does not Exist
<b>DOT Sidewalk</b>	Inspected
<b>Asphalt</b>	Does not Exist
<b>Concrete</b>	Inspected
Condition	3 - Fair
Deficiency	HEAVING
Deficiency Location/Instance	Arlington Avenue
Deficiency Quantity	30
Quantity Uom	S.F.
Potential Action	REPLACE
Urgency of Action	PRIORITY 3
Purpose of Action	LEVEL 2
Deficiency Photo1
