NYC Department of Education
Building Condition Assessment Survey 2023 - 2024

Architectural Inspection

Asset: P.S. 110 - BROOKLYN, 124 MONITOR STREET, New York, 11222

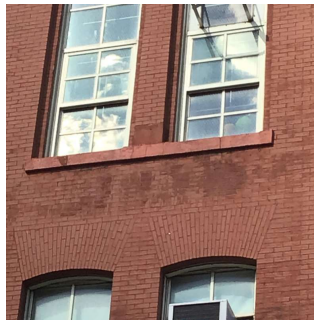
Facade H

BRICK: DETERIORATED MASONRY SILLS - MINOR

REPAIR

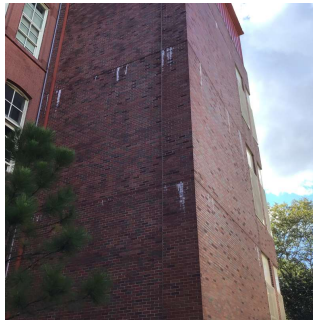
Facade E

EXTERIOR WALLS

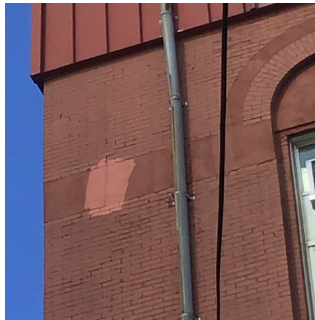
FacadeH

BRICK: CRACKS/DISPLACED/SPALLED BRICK AT BUILDING CORNERS

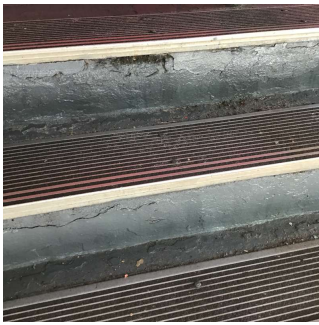
CONCRETE: CRACKS/SPALLING - MINOR

10
 S.F.
 REPAIR
 PRIORITY 3
 LEVEL 2

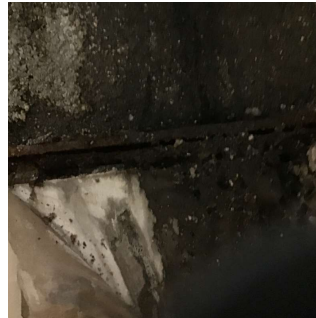
Elev Machine Room

STEEL COLUMNS/BEAMS: MAJOR RUSTING

REPLACE

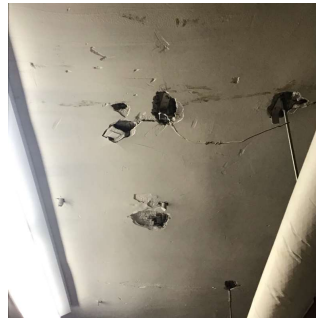
CONCRETE: CRACKS/SPALLED/REINFORCEMENT EXPOSED

REPAIR

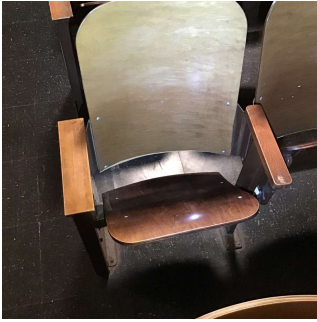
Violations	Seat D/1 No violations recorded.
Floor Finish

Violations	4th Floor, Elevator Machine Room No violations recorded.
VAULTS-BUNKERS	Does not Exist
AUDITORIUM	Inspected
Instance on 4th Floor (300 Seats)	Inspected
Ceiling	
Instance on 4th Floor (300 Seats)	Inspected
Condition	2 - Between Good and Fair
Deficiency	No deficiencies recorded
Door(s)	
Instance on 4th Floor (300 Seats)	Inspected
Condition	2 - Between Good and Fair
Deficiency	No deficiencies recorded
Fixed H/C Lift	
Instance on 4th Floor (300 Seats)	Does not Exist
Fixed Seating	
Instance on 4th Floor (300 Seats)	Inspected
Condition	3 - Fair
Deficiency	DAMAGED/BROKEN/INOPERABLE
Deficiency Location/Instance	Seats A/1, 5, 7, D/1, 3 and others
Deficiency Quantity	12
Quantity Uom	EACH
Potential Action	REPLACE
Urgency of Action	PRIORITY 3
Purpose of Action	LEVEL 2
Deficiency Photo1

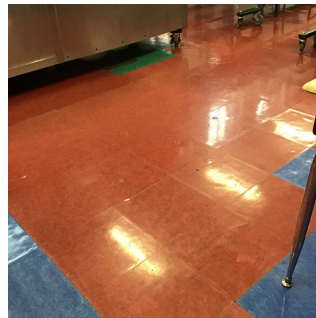
Instance on 1st Floor (2000SF)	Inspected
Condition	3 - Fair
Deficiency	VINYL TILES: BROKEN/DETERIORATED/MISSING TILES
Deficiency Location/Instance	Center, Serving area
Deficiency Quantity	30
Quantity Uom	S.F.
Potential Action	REPLACE
Urgency of Action	PRIORITY 3
Purpose of Action	LEVEL 2
Deficiency Photo1

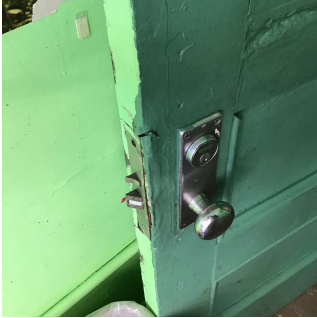
Question	Response
INTERIOR	
CLASSROOMS/CORRIDORS/ADMIN SPACES	
Door(s)	Inspected
Condition	5 - Poor
Deficiency	METAL CLAD WOOD: DETERIORATED DOOR
Deficiency Location/Instance	Room 210
Deficiency Quantity	1
Quantity Uom	EACH
Potential Action	MAINTENANCE
Urgency of Action	PRIORITY 3
Purpose of Action	LEVEL 2
Deficiency Photo1

Room 210
Violations	No violations recorded.
Deficiency	WOOD: DETERIORATED DOOR AND FRAME
Deficiency Location/Instance	Rooms 403, 300A
Deficiency Quantity	2
Quantity Uom	EACH
Potential Action	MAINTENANCE
Urgency of Action	PRIORITY 3
Purpose of Action	LEVEL 2
Deficiency Photo1

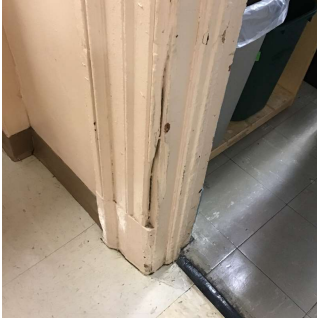
Room 403
Violations	No violations recorded.
Deficiency	WOOD: DETERIORATED DOOR
Deficiency Location/Instance	Rooms 406, 405, 404, 401, 306 and others
Deficiency Quantity	18
Quantity Uom	EACH
Potential Action	MAINTENANCE
Urgency of Action	PRIORITY 3
Purpose of Action	LEVEL 2

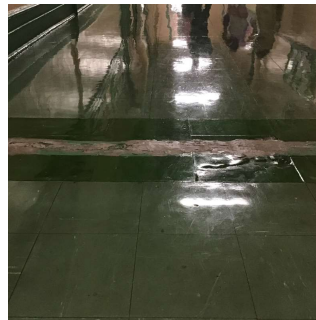
Corridor near Room 202

Yes	Tripping Hazard	Severely heaving floor is a potential tripping hazard.	INTERIOR CLASSROOMS /CORRIDORS/ ADMIN SPACES Floor Finish	Corridor near Room 311, 302	Phillip Nauetta	Custodian

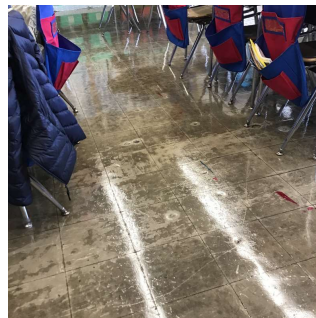
VINYL TILES: BROKEN/DETERIORATED/MISSING TILES

REPLACE

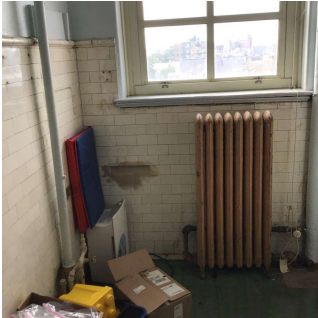
Violations	Corridor near Room 402 No violations recorded.
Walls	
Condition	Inspected 2 - Between Good and Fair
Deficiency	CERAMIC TILE: BROKEN/ MISSING
Deficiency Location/Instance	Room 406B
Deficiency Quantity	20
Quantity Uom	S.F.
Potential Action	REPLACE
Urgency of Action	PRIORITY 3
Purpose of Action	LEVEL 2
Deficiency Photo1

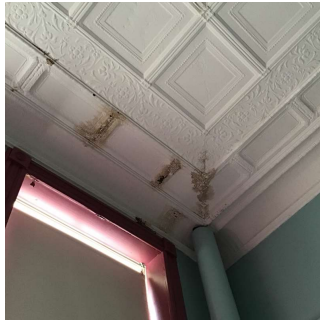
Question	Response
INTERIOR	
GYMNASIUM	
Walls	
Instance on 3rd Floor	Inspected
Condition	2 - Between Good and Fair
Deficiency	No deficiencies recorded
Window Curtains/Shades/Blinds	
Instance on 3rd Floor	Does not Exist
INTERIOR DOOR HARDWARE	
Condition	3 - Fair
Deficiency	No deficiencies recorded
INTERIOR GUARDS	
Condition	2 - Between Good and Fair
Deficiency	No deficiencies recorded
KITCHEN	
Instance on 1st Floor	Inspected
Ceiling	
Instance on 1st Floor	Not Required
Door(s)	
Instance on 1st Floor	Does not Exist
Floor Finish	
Instance on 1st Floor	Not Required
Walls	
Instance on 1st Floor	Not Required
LIBRARY	
Instance on Room 207/208	Inspected
Built-in Furnishing	
Instance on Room 207/208	Inspected
Condition	2 - Between Good and Fair
Deficiency	No deficiencies recorded
Ceiling	
Instance on Room 207/208	Inspected
Condition	2 - Between Good and Fair
Deficiency	METAL PAN: DAMAGED/MISSING
Deficiency Location/Instance	Near Windows

Deficiency Quantity	10
Quantity Uom	S.F.
Potential Action	REPLACE
Urgency of Action	PRIORITY 3
Purpose of Action	LEVEL 2
Deficiency Photo1

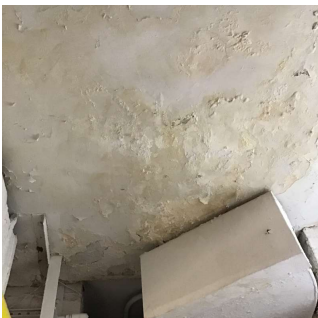
Violations	No violations recorded.
Deficiency	PLASTER: CRACKS/SPALLING
Deficiency Location/Instance	Left Side Near Windows
Deficiency Quantity	20
Quantity Uom	S.F.
Potential Action	REPLACE
Urgency of Action	PRIORITY 3
Purpose of Action	LEVEL 2
Deficiency Photo1

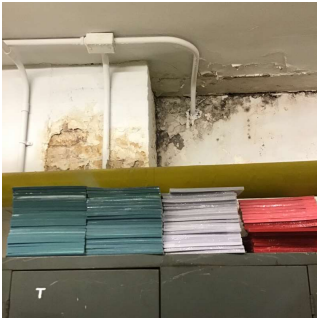
Condition	2 - Between Good and Fair
Deficiency	BRICK: CRACKS/SPALLING - ACTIVE LEAK
Deficiency Location/Instance	Right Side

Question	Response
INTERIOR	
MULTI-PURPOSE ROOM	
Walls	
Deficiency Quantity	40
Quantity Uom	S.F.
Potential Action	REPLACE
Urgency of Action	PRIORITY 5
Purpose of Action	LEVEL 2
Deficiency Photo1

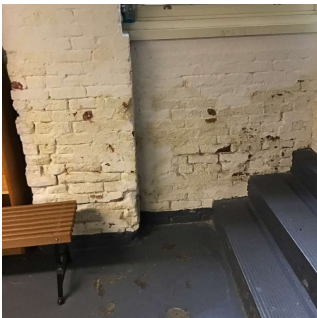
Right Side
Violations	No violations recorded.
Deficiency	BRICK: CRACKS/SPALLING
Deficiency Location/Instance	Right and Left Side Near Windows
Deficiency Quantity	80
Quantity Uom	S.F.
Potential Action	REPLACE
Urgency of Action	PRIORITY 3
Purpose of Action	LEVEL 2
Deficiency Photo1

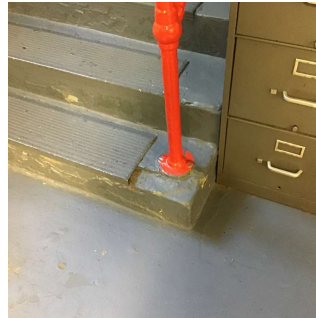
Stair AB/Basement

CONCRETE: CRACKS/SPALLING - MAJOR

REPLACE

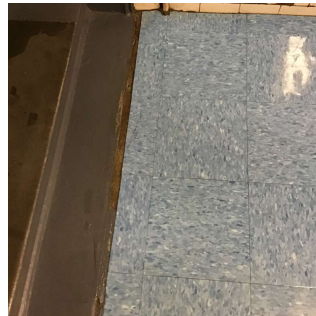
VINYL TILES: BROKEN/DETERIORATED/MISSING TILES

REPLACE

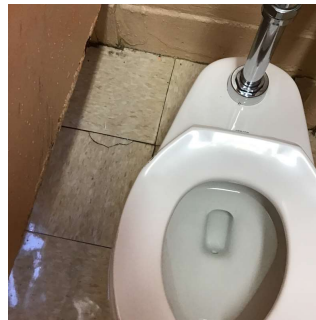
Inside Room 108

VINYL TILES: BROKEN/DETERIORATED/MISSING TILES

REPLACE

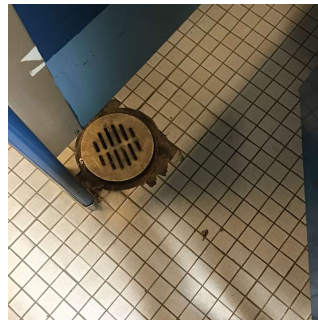
Boys Basement

CERAMIC TILE: BROKEN/MISSING TILES

REPLACE

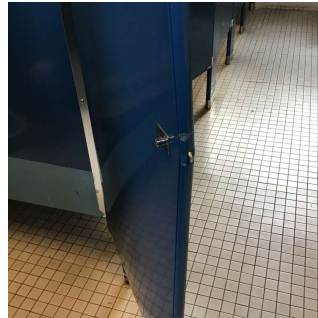
Boys Basement

BROKEN/MISSING

REPLACE

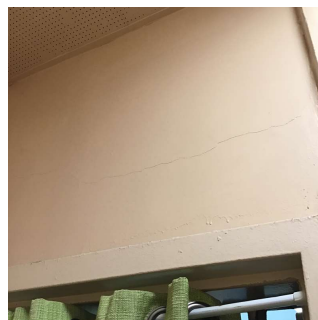
PLASTER: CRACKS/SPALLING

REPLACE

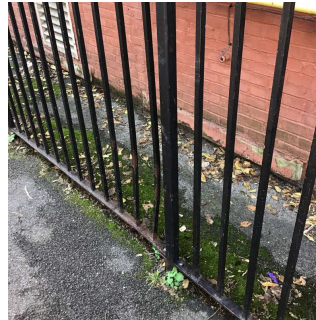
Schoolyard

WROUGHT IRON: DAMAGED/DETERIORATED

REPLACE

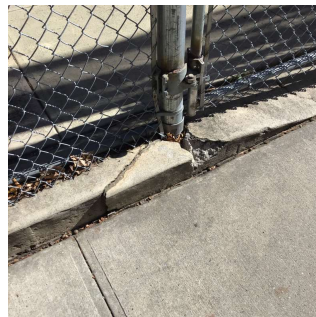
Monitor Street

CONCRETE CURB: DAMAGED/DETERIORATED

REPLACE

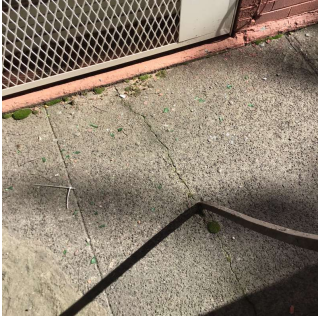
Question	Response
SITE	
IRRIGATION SYSTEM	Does not Exist
PAVING	Inspected
Student Non-Use	Inspected
Gravel Exists?	No
Asphalt	Inspected
Condition	2 - Between Good and Fair
Deficiency	No deficiencies recorded
Concrete	Inspected
Condition	3 - Fair
Deficiency	CRACKS - MAJOR
Deficiency Location/Instance	Monitor Street, Driggs Avenue
Deficiency Quantity	120
Quantity Uom	S.F.
Potential Action	REPLACE
Urgency of Action	PRIORITY 3
Purpose of Action	LEVEL 2
Deficiency Photo1

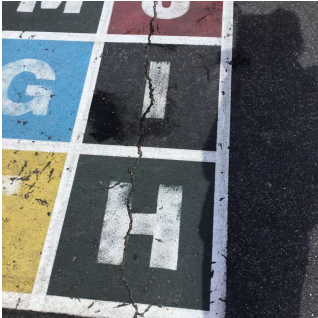
Violations	Monitor Street No violations recorded.
Pavers	Does not Exist
Student Use	Inspected
Gravel Exists?	No
Asphalt	Inspected
Condition	4 - Between Fair and Poor
Deficiency	CRACKS - MAJOR
Deficiency Location/Instance	Schoolyard
Deficiency Quantity	1,800
Quantity Uom	S.F.
Potential Action	REPLACE
Urgency of Action	PRIORITY 3
Purpose of Action	LEVEL 2
Deficiency Photo1

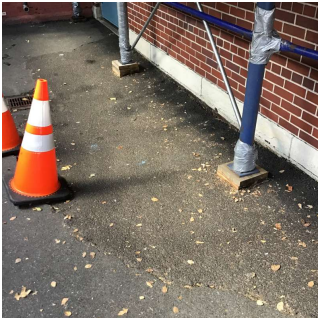
Question	Response
SITE	
PAVING	Inspected
Student Use	
Asphalt	
Violations	No violations recorded.
Deficiency	LOCALIZED SINK AREA
Deficiency Location/Instance	Near Exit 5
Deficiency Quantity	100
Quantity Uom	S.F.
Potential Action	REPAIR
Urgency of Action	PRIORITY 3
Purpose of Action	LEVEL 2
Deficiency Photo1

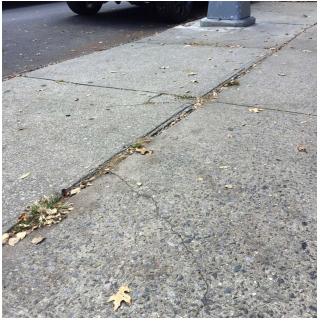
Question	Response
SITE	
PAVING	
Site Sidewalks & Walkways	Inspected
Pavers	Does not Exist
DOT Sidewalk	Inspected
Asphalt	Does not Exist
Concrete	Inspected
Condition	4 - Between Fair and Poor
Deficiency	HEAVING
Deficiency Location/Instance	Driggs Avenue
Deficiency Quantity	75
Quantity Uom	S.F.
Potential Action	REPLACE
Urgency of Action	PRIORITY 3
Purpose of Action	LEVEL 2
Deficiency Photo1

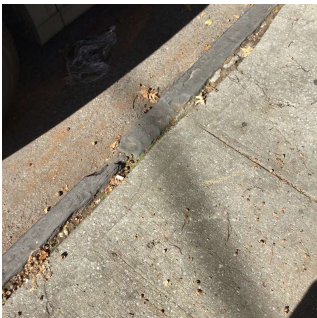
Driggs Avenue
Violations	No violations recorded.
Deficiency	DAMAGED CURBS
Deficiency Location/Instance	Monitor Street, Driggs Avenue
Deficiency Quantity	60
Quantity Uom	L.F.
Potential Action	REPLACE
Urgency of Action	PRIORITY 3
Purpose of Action	LEVEL 2
Deficiency Photo1

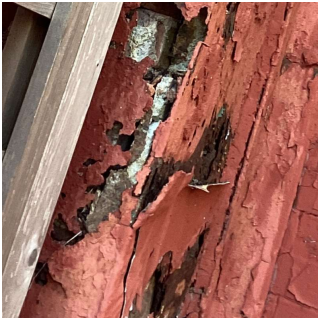
Question	Response
SITE	
SEATING	Inspected
Bleachers	Does not Exist
SITE WALLS (NOT RETAINING WALLS)	Inspected
Condition	3 - Fair
Deficiency	BRICK: CRACKS/SPALLING - MAJOR
Deficiency Location/Instance	North Schoolyard
Deficiency Quantity	30
Quantity Uom	S.F.
Potential Action	REPLACE
Urgency of Action	PRIORITY 5
Purpose of Action	LEVEL 6
Deficiency Photo1
