NYC Department of Education
Building Condition Assessment Survey 2023 - 2024

Architectural Inspection

Asset: P.S. 112 - BROOKLYN, 7115 15 AVENUE, New York, 11228

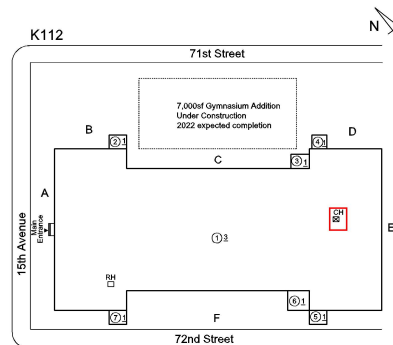
Question	Response
Architectural	
EXTERIOR	Inspected
AREAWAY	Does not Exist
AWNINGS AND CANOPIES	Does not Exist
CHIMNEY	Inspected
Material Type(s)	Masonry
Condition	2 - Between Good and Fair
Deficiency	BRICK: DETERIORATED CAP
Roof Plan reference

Deficiency Quantity	10
Quantity Uom	L.F.
Potential Action	REPLACE
Urgency of Action	PRIORITY 3
Purpose of Action	LEVEL 2

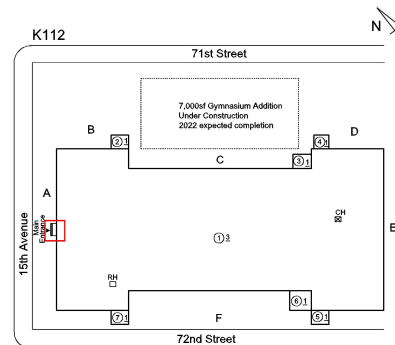
METAL CLAD: DETERIORATED DOOR AND FRAME - MINOR DETERIORATION

2
EACH
MAINTENANCE
PRIORITY 3
LEVEL 2

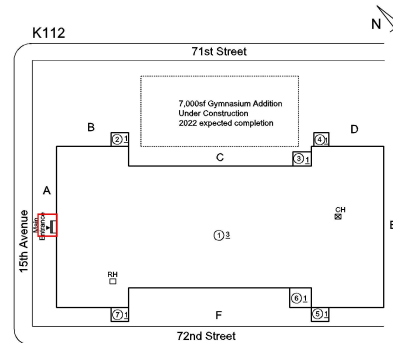
CAST IN PLACE CONCRETE: CRACKS/SPALLING - MAJOR

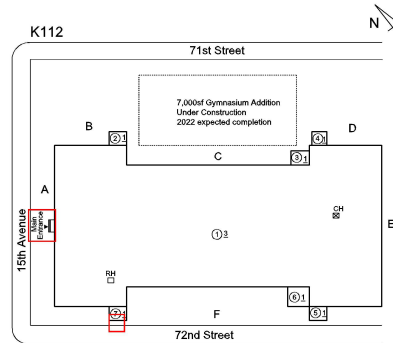
Inspected
5 - Poor
STONE: CRACKS/SPALLING - MAJOR

30
S.F.
REPLACE
PRIORITY 4
LEVEL 2

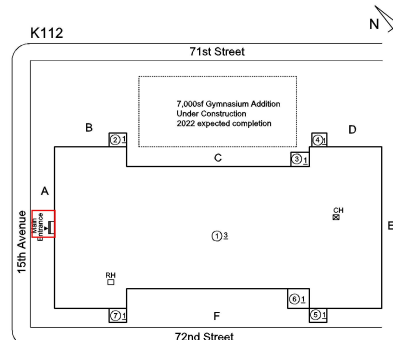
STONE: DETERIORATED JOINTS

20
L.F.

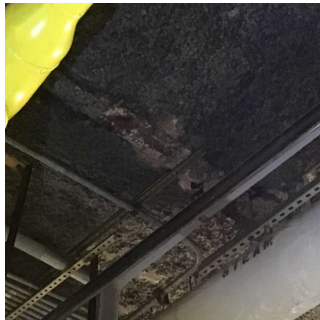
Question	Response
EXTERIOR	
WINDOWS	
WINDOWS	
Material Type(s)	Solid Wood
Instance on Wood: All Facades	Under Construction
Instance Quantity	7,200
Instance Quantity Uom	S.F.
INTERIOR	Inspected
POOLS	Does not Exist
STRUCTURAL	Inspected
COLUMNS/BEAMS/BEARING WALLS	Inspected
Condition	3 - Fair
Deficiency	STEEL COLUMNS/BEAMS: DETERIORATED/MISSING SPRAY-ON FIREPROOFING
Deficiency Location/Instance	Basement - Boiler Room
Deficiency Quantity	20
Quantity Uom	S.F.
Potential Action	REPLACE
Urgency of Action	PRIORITY 3
Purpose of Action	LEVEL 5
Deficiency Photo1

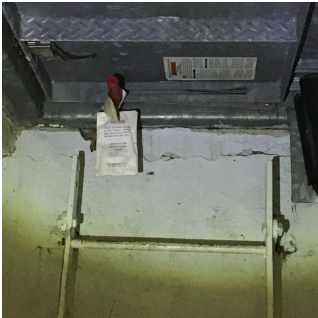
Question	Response
INTERIOR	
STRUCTURAL	
FOUNDATION WALLS	Inspected
Violations	35657631K
ROOF STRUCTURE	Inspected
Condition	2 - Between Good and Fair
Deficiency	No deficiencies recorded
VAULTS-BUNKERS	Inspected
Foundation Walls	Inspected
Condition	2 - Between Good and Fair
Deficiency	CRACKS, SPALLING
Deficiency Location/Instance	Basement - Ash Hoist Vault
Deficiency Quantity	10
Quantity Uom	S.F.
Potential Action	REPAIR
Urgency of Action	PRIORITY 3
Purpose of Action	LEVEL 5
Deficiency Photo1

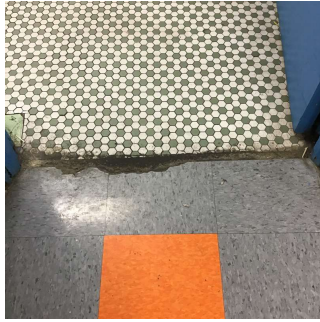
Violations	Near Stair E/Basement No violations recorded.
Door(s)	
Instance on Basement	Not Required
Fixed Equipment	
Instance on Basement	Inspected
Condition	2 - Between Good and Fair
Deficiency	No deficiencies recorded
Floor Finish	
Instance on Basement	Inspected
Condition	2 - Between Good and Fair
Deficiency	VINYL TILES: BROKEN/DETERIORATED/MISSING TILES
Deficiency Location/Instance	Near Boys Toilet Room - Basement, By Stair E/Basement
Deficiency Quantity	20
Quantity Uom	S.F.
Potential Action	REPLACE
Urgency of Action	PRIORITY 3
Purpose of Action	LEVEL 2
Deficiency Photo1

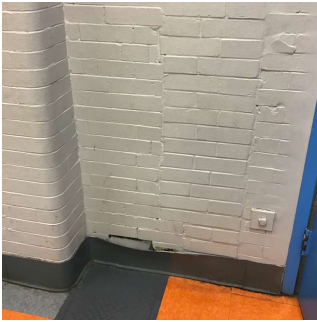
Violations	Near Windows No violations recorded.
Sliding-folding Partition	
Instance on Basement	Does not Exist
Stage	
Instance on Basement	Does not Exist
Walls	
Instance on Basement	Inspected
Condition	2 - Between Good and Fair
Deficiency	BRICK: CRACKS/SPALLING
Deficiency Location/Instance	Near Boiler Room
Deficiency Quantity	10
Quantity Uom	S.F.
Potential Action	REPLACE
Urgency of Action	PRIORITY 3
Purpose of Action	LEVEL 2
Deficiency Photo1

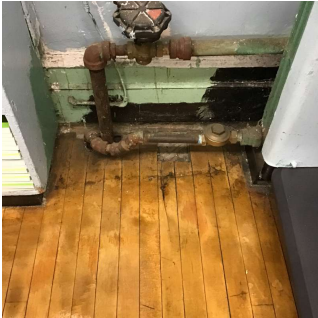
Question	Response
INTERIOR	
CLASSROOMS/CORRIDORS/ADMIN SPACES	
Door(s)	Inspected
	Main Entrance Vestibule
Violations	No violations recorded.
Floor Finish	Inspected
Condition	3 - Fair
Deficiency	WOOD: DAMAGED/DETERIORATED
Deficiency Location/Instance	Rooms 306,104
Deficiency Quantity	20
Quantity Uom	S.F.
Potential Action	REPLACE
Urgency of Action	PRIORITY 3
Purpose of Action	LEVEL 2
Deficiency Photo1

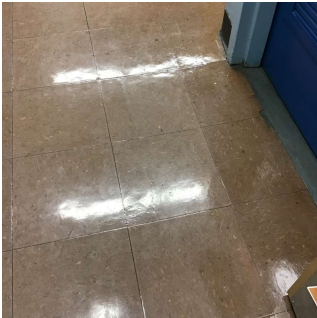
Corridor near Room 108
Violations	No violations recorded.
Deficiency	VINYL TILES: BROKEN/DETERIORATED/MISSING TILES
Deficiency Location/Instance	Rooms 310A,309,302,110, Corridor near Girls Toilet Room - 2nd Floor and others

Deficiency Quantity	850
Quantity Uom	S.F.
Potential Action	REPLACE
Urgency of Action	PRIORITY 3

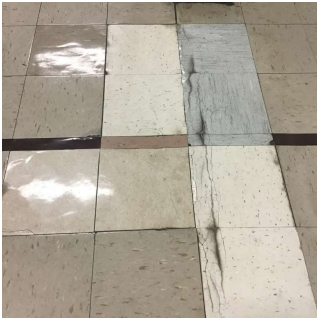
Room 310A
Violations	No violations recorded.
Deficiency	VINYL TILES: DETERIORATED SUBSTRATE
Deficiency Location/Instance	Rooms 205,105, Corridor near Rooms 310A,306, By Multiplepurpose and others
Deficiency Quantity	500
Quantity Uom	S.F.
Potential Action	REPLACE
Urgency of Action	PRIORITY 3
Purpose of Action	LEVEL 2
Deficiency Photo1

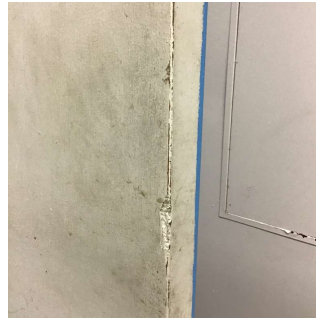
Mop Room

WOOD: DETERIORATED DOOR

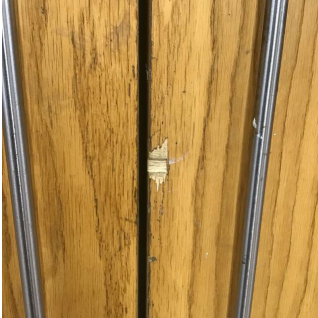
Question	Response
INTERIOR	
MULTI-PURPOSE ROOM	
Door(s)	
Instance on 3rd Floor	Inspected
Condition	3 - Fair
Deficiency	WOOD: DETERIORATED DOOR
Deficiency Location/Instance	Entrance
Deficiency Quantity	1
Quantity Uom	EACH
Potential Action	MAINTENANCE
Urgency of Action	PRIORITY 3
Purpose of Action	LEVEL 2
Deficiency Photo1

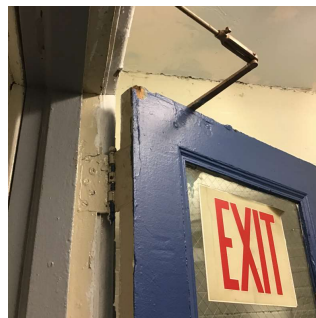
Condition	3 - Fair
Deficiency	WOOD: DETERIORATED DOOR
Deficiency Location/Instance	Exit C - Vestibule
Deficiency Quantity	1
Quantity Uom	EACH
Potential Action	MAINTENANCE
Urgency of Action	PRIORITY 3
Purpose of Action	LEVEL 2
Deficiency Photo1

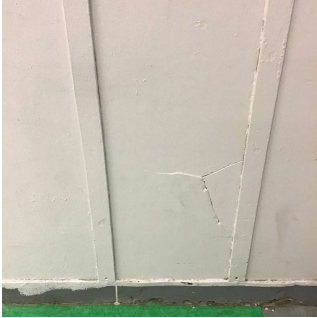
Question	Response
INTERIOR	
STAIRS/RAMPS: INTERIOR	
Door(s)	Inspected
	Exit C - Vestibule
Violations	No violations recorded.
Partition	Inspected
Condition	3 - Fair
Deficiency	METAL FRAME: DAMAGED/DETERIORATED
Deficiency Location/Instance	Stairs B/Basement, C/Basement, E/Basement
Deficiency Quantity	70
Quantity Uom	L.F.
Potential Action	REPLACE
Urgency of Action	PRIORITY 3
Purpose of Action	LEVEL 2
Deficiency Photo1

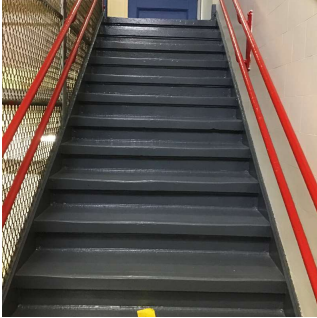
Violations	No violations recorded.
Railings	Inspected
Condition	2 - Between Good and Fair
Deficiency	No deficiencies recorded
Stairs and Landings	Inspected
Condition	3 - Fair
Deficiency	STONE: WORN-OUT TREAD/NOSINGS
Deficiency Location/Instance	Stair B/1
Deficiency Quantity	140
Quantity Uom	S.F.
Potential Action	REPLACE
Urgency of Action	PRIORITY 3
Purpose of Action	LEVEL 2
Deficiency Photo1

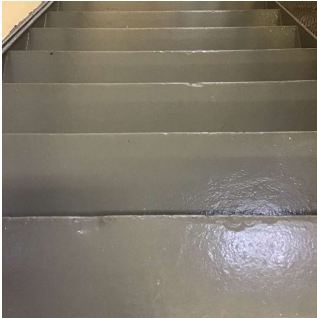
Violations	No violations recorded.
Deficiency	STONE: BROKEN/MISSING
Deficiency Location/Instance	Stairs B/3, C/1

Question	Response
INTERIOR	
STAIRS/RAMPS: INTERIOR	
Stairs and Landings	
Deficiency Quantity	50
Quantity Uom	S.F.
Potential Action	REPLACE
Urgency of Action	PRIORITY 3
Purpose of Action	LEVEL 2
Deficiency Photo1

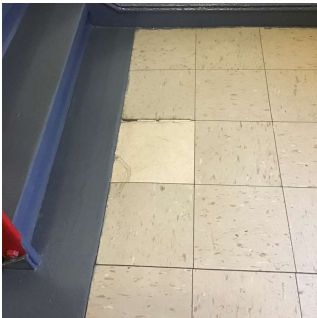
Stair B/3
Violations	No violations recorded.
Deficiency	VINYL TILES: BROKEN/DETERIORATED/MISSING TILES
Deficiency Location/Instance	Stairs B/3, C/2, D/3, E/3,2 and others
Deficiency Quantity	80
Quantity Uom	S.F.
Potential Action	REPLACE
Urgency of Action	PRIORITY 3
Purpose of Action	LEVEL 2
Deficiency Photo1

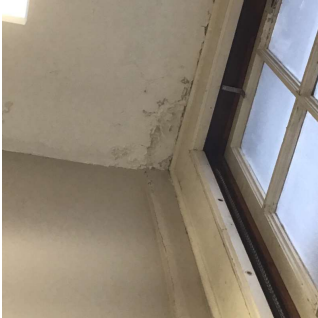
Question	Response
INTERIOR	
TOILET ROOMS - STAFF	Inspected
Ceiling	Inspected
Condition	3 - Fair
Deficiency	PLASTER: CRACKS/SPALLING
Deficiency Location/Instance	In Room 105
Deficiency Quantity	10
Quantity Uom	S.F.
Potential Action	REPLACE
Urgency of Action	PRIORITY 3
Purpose of Action	LEVEL 2
Deficiency Photo1

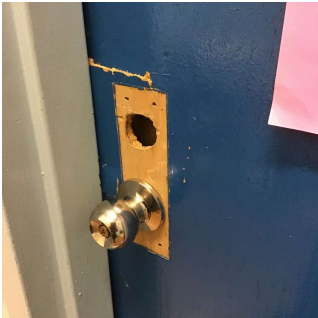
Violations	In Room 105 No violations recorded.
Door(s)	Inspected
Condition	5 - Poor
Deficiency	WOOD: DETERIORATED DOOR
Deficiency Location/Instance	Staff Toilet Room - 2nd Floor
Deficiency Quantity	1
Quantity Uom	EACH
Potential Action	MAINTENANCE
Urgency of Action	PRIORITY 3
Purpose of Action	LEVEL 2
Deficiency Photo1

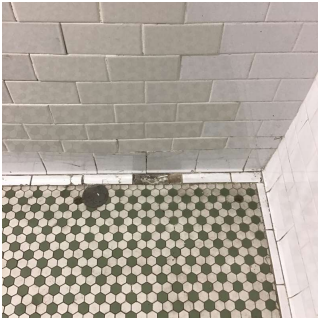
Question	Response
INTERIOR	
TOILET ROOMS - STUDENTS	
Floor Finish	
Violations	Girls Toilet Room - Basement No violations recorded.
Deficiency	CERAMIC TILE: BROKEN/MISSING TILES
Deficiency Location/Instance	Boys Toilet Room - Basement,2nd Floor, In Room 110
Deficiency Quantity	30
Quantity Uom	S.F.
Potential Action	REPLACE
Urgency of Action	PRIORITY 3
Purpose of Action	LEVEL 2
Deficiency Photo1

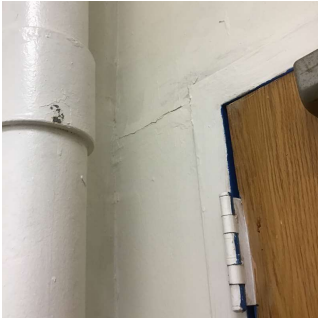
Violations	Boys Toilet Room - Basement No violations recorded.
Stalls	Inspected
Condition	2 - Between Good and Fair
Deficiency	No deficiencies recorded
Walls	Inspected
Condition	2 - Between Good and Fair
Deficiency	GYPSUM BOARD: DETERIORATED
Deficiency Location/Instance	In Room 109
Deficiency Quantity	10
Quantity Uom	S.F.
Potential Action	REPLACE
Urgency of Action	PRIORITY 3
Purpose of Action	LEVEL 2
Deficiency Photo1

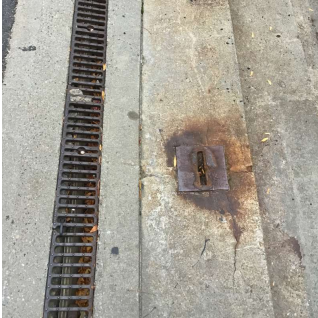
Question	Response
SITE	
PAVING	
Student Use	
Asphalt	
Deficiency Quantity	200
Quantity Uom	S.F.
Potential Action	REPLACE
Urgency of Action	PRIORITY 3
Purpose of Action	LEVEL 2
Deficiency Photo1	No photo recorded
Violations	No violations recorded.
Concrete	Inaccessible
Pavers	Inaccessible
Site Sidewalks & Walkways	Inspected
Asphalt	Does not Exist
Concrete	Inspected
Condition	2 - Between Good and Fair
Deficiency	DAMAGED/DETERIORATED/MISSING SECTIONS
Deficiency Location/Instance	72nd Street
Deficiency Quantity	25
Quantity Uom	S.F.
Potential Action	REPLACE
Urgency of Action	PRIORITY 3
Purpose of Action	LEVEL 2
Deficiency Photo1

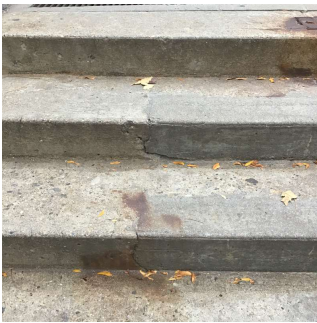
Violations	72nd Street No violations recorded.
SEATING	Inspected
Benches	Inspected
Concrete	Does not Exist
Metal/Wood/Plastic	Inaccessible
Bleachers	Does not Exist
SITE WALLS (NOT RETAINING WALLS)	Does not Exist
STAIRS/RAMPS: EXTERIOR	Inspected
Railings	Inspected
Condition	2 - Between Good and Fair
Deficiency	No deficiencies recorded
Site Cheek/flank Walls	Inspected
Condition	2 - Between Good and Fair
Deficiency	No deficiencies recorded
Stairs/ramps	Inspected
Condition	3 - Fair
Deficiency	CAST IN PLACE CONCRETE: CRACKS/SPALLING - MAJOR
Deficiency Location/Instance	72nd Street
Deficiency Quantity	50
Quantity Uom	S.F.

Question	Response
SITE	
STAIRS/RAMPS: EXTERIOR	
Stairs/ramps	
Deficiency Photo1

Potential Action	REPLACE
Urgency of Action	PRIORITY 3
Purpose of Action	LEVEL 2
