NYC Department of Education
Building Condition Assessment Survey 2023 - 2024

Architectural Inspection

Asset: I.S. 113 - BROOKLYN, 300 ADELPHI STREET, New York, 11205

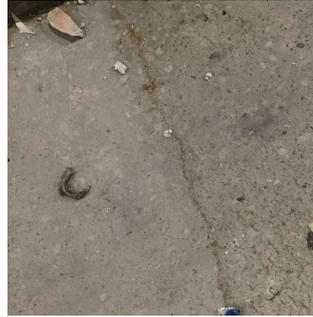
AW5

AREAWAY

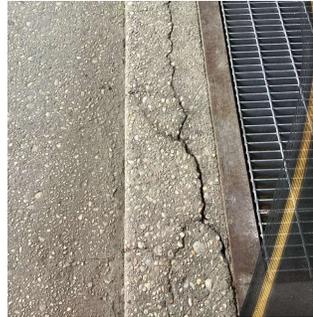
AW2

AREAWAY WALLS: CRACKS AND SPALLING

REPLACE

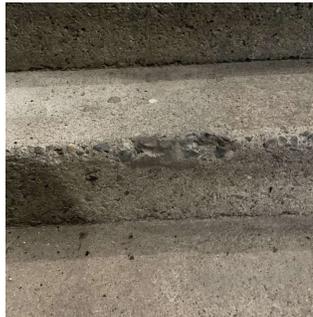
AW6
No violations recorded.

AREAWAY STAIRS: DETERIORATED TREADS/RISERS/NOSINGS

10
S.F.
REPLACE
PRIORITY 4
LEVEL 2

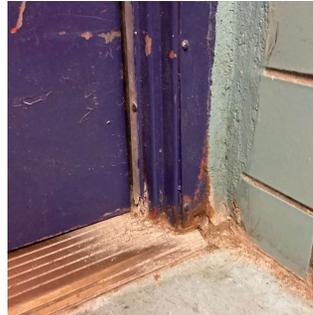
Facade H - Exit 4

METAL: DETERIORATED DOOR - MINOR DETERIORATION

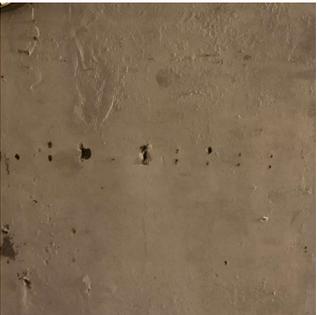
Deficiency Quantity	20
Quantity Uom	S.F.
Potential Action	REPAIR
Urgency of Action	PRIORITY 3
Purpose of Action	LEVEL 2
Deficiency Photo1

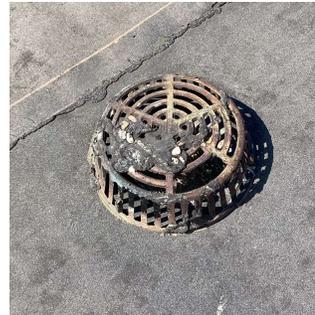
Roof 1

DETERIORATED

REPLACE

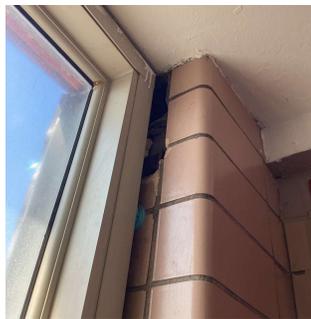
BH3
No violations recorded.

BULKHEAD/PENTHOUSE WALLS/INTERIOR: GLAZED BLOCK
CRACKS/SPALLING

10
S.F.
REPLACE
PRIORITY 4
LEVEL 2

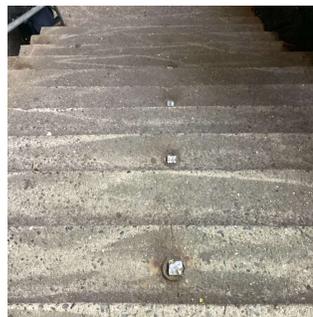
Facade K

MISSING RAILING

20
L.F.
REPLACE
PRIORITY 5
LEVEL 6

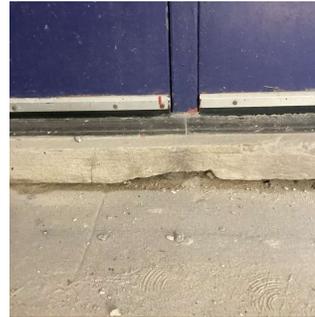
Facade D

CONCRETE: CRACKS/SPALLING - MAJOR

REPLACE

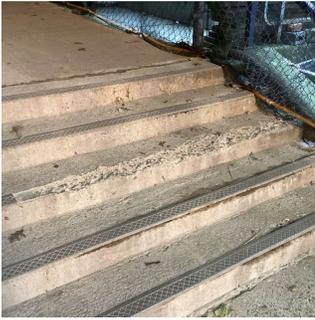
CONCRETE: WORN-OUT TREAD/RISER/NOSING

REPLACE

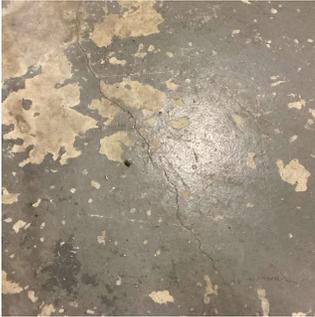
Violations	Basement - Boiler Room No violations recorded.
Deficiency	CONCRETE SLAB ON GRADE: THRU CRACKS
Deficiency Location/Instance	Basement - Fan Room, Electrical Panel Room, Fan Room above Auditorium, Corridor, Boiler Room
Deficiency Quantity	100
Quantity Uom	S.F.
Potential Action	REPAIR
Urgency of Action	PRIORITY 3
Purpose of Action	LEVEL 5
Deficiency Photo1

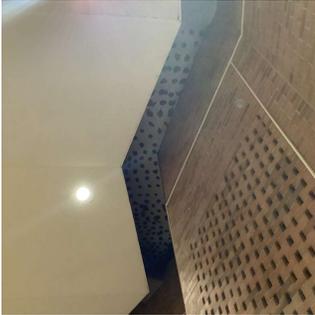
Violations	Near Stage No violations recorded.
Deficiency	ACOUSTIC TILES ON PLASTER: DAMAGED/MISSING
Deficiency Location/Instance	Left Side, Right Side
Deficiency Quantity	400
Quantity Uom	S.F.
Potential Action	REPLACE
Urgency of Action	PRIORITY 3
Purpose of Action	LEVEL 2
Deficiency Photo1

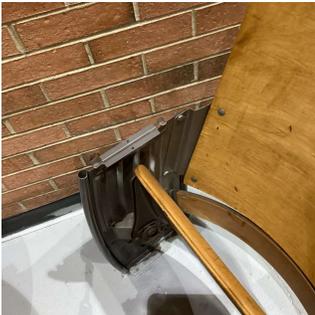
Violations	Seat B/101 No violations recorded.
Deficiency	DAMAGED/BROKEN/INOPERABLE
Deficiency Location/Instance	Seat L/14
Deficiency Quantity	1
Quantity Uom	EACH
Potential Action	REPLACE
Urgency of Action	PRIORITY 5
Purpose of Action	LEVEL 6
Deficiency Photo1

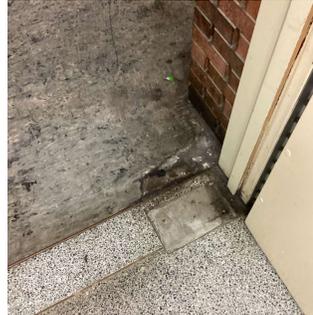
Near Entrance

SHEET VINYL: BROKEN/DETERIORATED

REPLACE

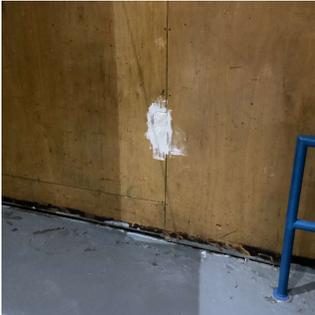
Right Lateral Curtain
Violations	No violations recorded.
Walls	
Instance on 1st Floor (650 Seats)	Inspected
Condition	2 - Between Good and Fair
Deficiency	WOOD PANELING: DETERIORATED
Deficiency Location/Instance	Near Stage Right
Deficiency Quantity	20
Quantity Uom	S.F.
Potential Action	REPLACE
Urgency of Action	PRIORITY 3
Purpose of Action	LEVEL 2
Deficiency Photo1

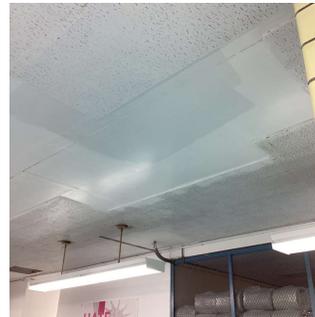
ACOUSTIC TILES ON PLASTER: DAMAGED/MISSING

REPLACE

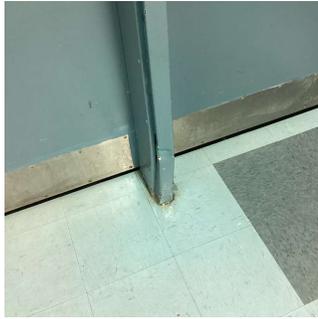
Entrance from Corridor
Violations	No violations recorded.
Instance on Basement - Main	Inspected
Condition	4 - Between Fair and Poor
Deficiency	METAL: DETERIORATED DOOR AND FRAME
Deficiency Location/Instance	Entrance Across from Room B32
Deficiency Quantity	2
Quantity Uom	EACH
Potential Action	MAINTENANCE
Urgency of Action	PRIORITY 3
Purpose of Action	LEVEL 2
Deficiency Photo1

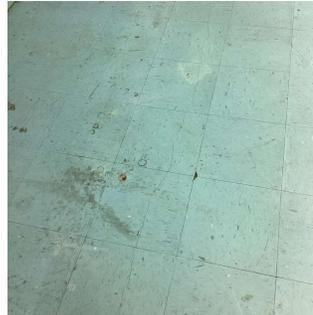
Near Serving Area

VINYL TILES: DETERIORATED SUBSTRATE

REPLACE

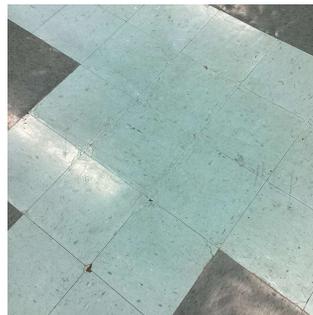
VINYL TILES: BROKEN/DETERIORATED/MISSING TILES

REPLACE

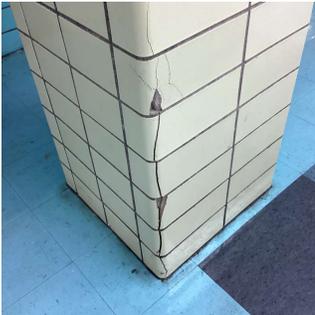
Violations	Columns at Center

Violations	Near Entrance No violations recorded.
Deficiency	GLAZED BLOCK: CRACKS/SPALLING
Deficiency Location/Instance	Columns at Center, Near Drinking Fountain
Deficiency Quantity	40
Quantity Uom	S.F.
Potential Action	REPLACE
Urgency of Action	PRIORITY 3
Purpose of Action	LEVEL 2
Deficiency Photo1

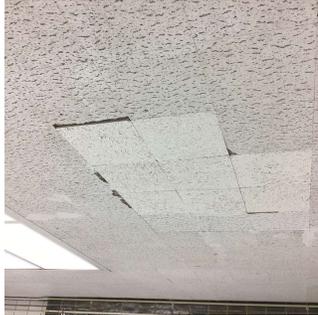
Violations	Corridor near Stair D/4 No violations recorded.
Deficiency	ACOUSTIC TILES ON PLASTER: DAMAGED/MISSING
Deficiency Location/Instance	Main Entrance Vestibule, Main Entrance Lobby, Near Exit 15, Corridor near Rooms 110, 315, and others
Deficiency Quantity	120
Quantity Uom	S.F.
Potential Action	REPLACE
Urgency of Action	PRIORITY 3
Purpose of Action	LEVEL 2

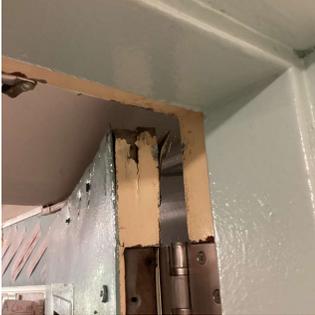
Question	Response
INTERIOR	
CLASSROOMS/CORRIDORS/ADMIN SPACES	Inspected
Door(s)	
Deficiency Location/Instance	Rooms 302, 402, 406, 408, 418
Deficiency Quantity	5
Quantity Uom	EACH
Potential Action	MAINTENANCE
Urgency of Action	PRIORITY 3
Purpose of Action	LEVEL 2
Deficiency Photo1

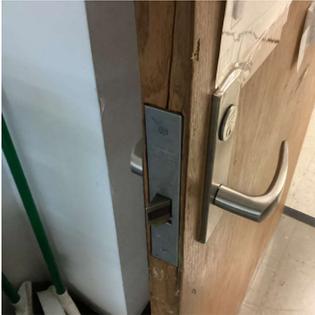
Room 406
Violations	No violations recorded.
Deficiency	WOOD: DETERIORATED DOOR
Deficiency Location/Instance	Rooms 104, 212, 324, 401, 424, and others
Deficiency Quantity	15
Quantity Uom	EACH
Potential Action	MAINTENANCE
Urgency of Action	PRIORITY 3
Purpose of Action	LEVEL 2
Deficiency Photo1

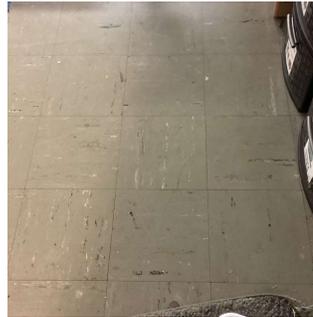
Room 424

VINYL TILES: BROKEN/DETERIORATED/MISSING TILES

REPLACE

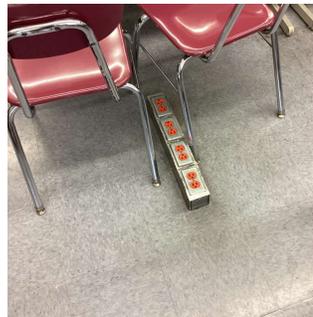
Room 329

VINYL TILES: TRIPPING HAZARD - ELECTRICAL OUTLET

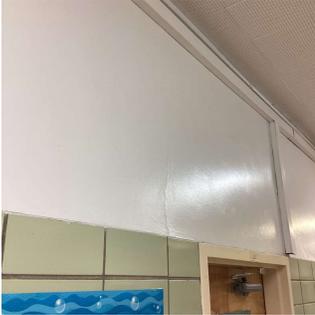
Question	Response
INTERIOR	
CLASSROOMS/CORRIDORS/ADMIN SPACES	
Walls	Inspected
Condition	2 - Between Good and Fair
Deficiency	PLASTER: CRACKS/SPALLING
Deficiency Location/Instance	Corridor near Room 201, Rooms B22, 122, 129
Deficiency Quantity	40
Quantity Uom	S.F.
Potential Action	REPLACE
Urgency of Action	PRIORITY 3
Purpose of Action	LEVEL 2
Deficiency Photo1

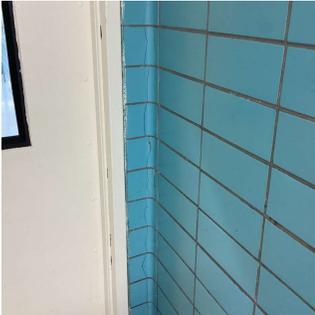
Violations	Corridor near Room 201 No violations recorded.
Deficiency	GLAZED BLOCK: CRACKS/SPALLING
Deficiency Location/Instance	Corridor near Stair D/4, Corridor near Rooms 114, 208, 302, 305, and others
Deficiency Quantity	80
Quantity Uom	S.F.
Potential Action	REPLACE
Urgency of Action	PRIORITY 3
Purpose of Action	LEVEL 2
Deficiency Photo1

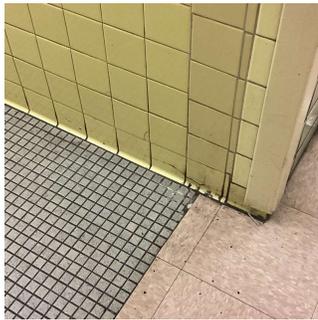
Violations	Corridor near Room 305 No violations recorded.
Deficiency	CERAMIC TILE: BROKEN/ MISSING
Deficiency Location/Instance	Corridor near Room 211
Deficiency Quantity	10
Quantity Uom	S.F.
Potential Action	REPLACE

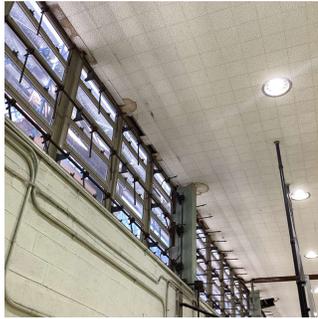
Violations	Corridor near Room 211 No violations recorded.
Specialties	Does not Exist
GYMNASIUM	
Instance on 1st Floor	Inspected
Instance on 1st Floor	Inspected
Ceiling	
Instance on 1st Floor	Inspected
Condition	5 - Poor
Deficiency	ACOUSTIC TILES: DAMAGED/MISSING
Deficiency Location/Instance	Near Windows, Center
Deficiency Quantity	600
Quantity Uom	S.F.
Potential Action	REPLACE
Urgency of Action	PRIORITY 3
Purpose of Action	LEVEL 2
Deficiency Photo1

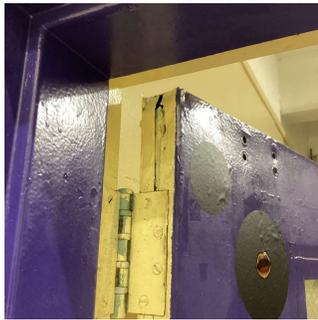
Violations	Near Windows No violations recorded.
Door(s)	
Instance on 1st Floor	Inspected
Condition	5 - Poor
Deficiency	METAL: DETERIORATED DOOR
Deficiency Location/Instance	Office Left Side, Storage Rooms, Office Right Side
Deficiency Quantity	4
Quantity Uom	EACH
Potential Action	MAINTENANCE
Urgency of Action	PRIORITY 3
Purpose of Action	LEVEL 2

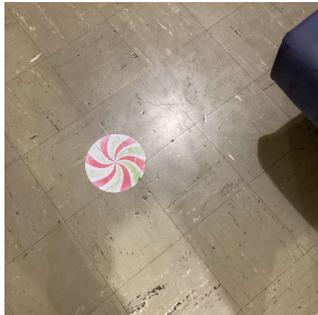
Office Left Side
Violations	No violations recorded.
Fixed Equipment	
Instance on 1st Floor	Inspected
Condition	2 - Between Good and Fair
Deficiency	No deficiencies recorded
Floor Finish	
Instance on 1st Floor	Inspected
Condition	2 - Between Good and Fair
Deficiency	VINYL TILES: BROKEN/DETERIORATED/MISSING TILES
Deficiency Location/Instance	Office Left Side, Office Right Side
Deficiency Quantity	80
Quantity Uom	S.F.
Potential Action	REPLACE
Urgency of Action	PRIORITY 3
Purpose of Action	LEVEL 2
Deficiency Photo1

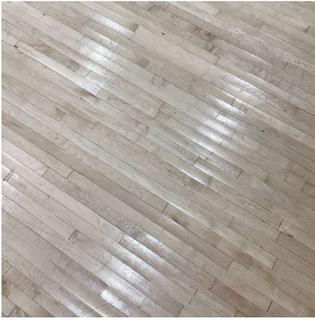
Office Left Side
Violations	No violations recorded.
Deficiency	WOOD: DAMAGED/DETERIORATED
Deficiency Location/Instance	Near Drinking Fountain
Deficiency Quantity	50
Quantity Uom	S.F.
Potential Action	REPLACE
Urgency of Action	PRIORITY 3
Purpose of Action	LEVEL 2

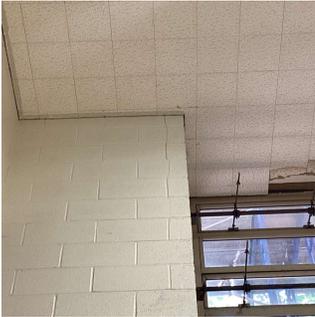
Violations	Near Drinking Fountain No violations recorded.
Seating	
Instance on 1st Floor	Does not Exist
Sliding-folding Partition	
Instance on 1st Floor	Does not Exist
Stage	
Instance on 1st Floor	Does not Exist
Walls	
Instance on 1st Floor	Inspected
Condition	2 - Between Good and Fair
Deficiency	MASONRY: CRACKS/SPALLING
Deficiency Location/Instance	Near Exit 8
Deficiency Quantity	10
Quantity Uom	S.F.
Potential Action	REPLACE
Urgency of Action	PRIORITY 3
Purpose of Action	LEVEL 2
Deficiency Photo1

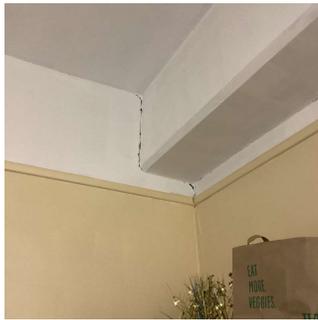
Violations	Near Exit 8 No violations recorded.
Deficiency	PLASTER: CRACKS/SPALLING
Deficiency Location/Instance	Office Left Side, Office Right Side
Deficiency Quantity	40
Quantity Uom	S.F.
Potential Action	REPLACE
Urgency of Action	PRIORITY 3
Purpose of Action	LEVEL 2

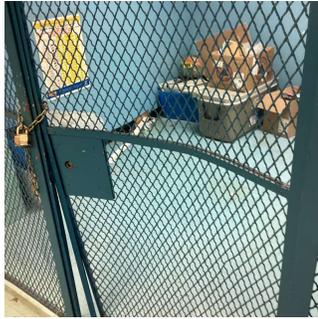
Violations	Office Left Side No violations recorded.
Window Curtains/Shades/Blinds	
Instance on 1st Floor	Does not Exist
INTERIOR DOOR HARDWARE	
Condition	Inspected 3 - Fair
Deficiency	No deficiencies recorded
INTERIOR GUARDS	
Condition	Inspected 3 - Fair
Deficiency	DETERIORATED/TORN-OUT/MISSING
Deficiency Location/Instance	Corridor near Room B32
Deficiency Quantity	50
Quantity Uom	S.F.
Potential Action	REPLACE
Urgency of Action	PRIORITY 3
Purpose of Action	LEVEL 2
Deficiency Photo1

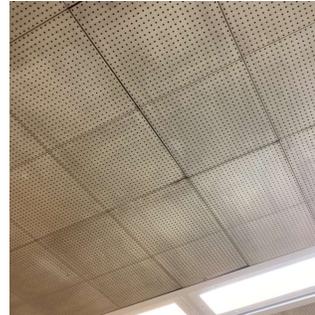
Violations	Corridor near Room B32 No violations recorded.
KITCHEN	
Instance on Basement	Inspected Inspected
Ceiling	
Instance on Basement	Inspected
Condition	2 - Between Good and Fair
Deficiency	METAL PAN: DAMAGED/MISSING
Deficiency Location/Instance	Right Side
Deficiency Quantity	10
Quantity Uom	S.F.
Potential Action	REPLACE
Urgency of Action	PRIORITY 3

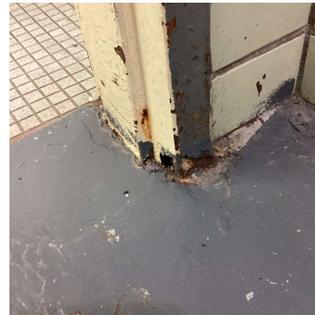
Service Exit

METAL: DETERIORATED DOOR AND FRAME

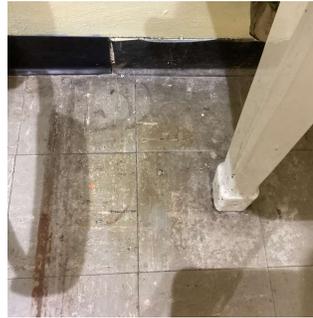
Office

VINYL TILES: BROKEN/DETERIORATED/MISSING TILES

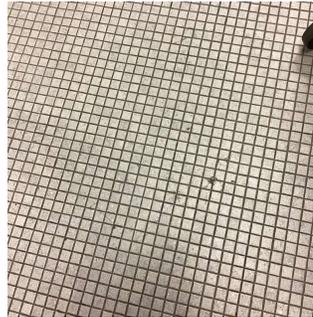
Near Serving Area

CERAMIC TILE: BROKEN/MISSING TILES

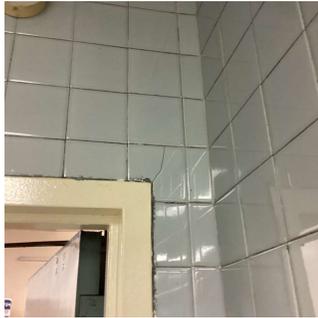
CERAMIC TILE: BROKEN/ MISSING

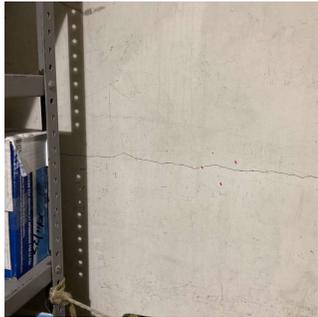
Near Office
Violations	No violations recorded.
Deficiency	PLASTER: CRACKS/SPALLING
Deficiency Location/Instance	Storage Room Left Side, Storage Room Right Side
Deficiency Quantity	25
Quantity Uom	S.F.
Potential Action	REPLACE
Urgency of Action	PRIORITY 3
Purpose of Action	LEVEL 2
Deficiency Photo1

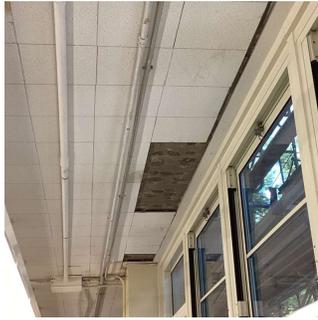
Storage Room Right Side
Violations	No violations recorded.
LIBRARY	Inspected
Instance on Room 214	Inspected
Built-in Furnishing	
Instance on Room 214	Inspected
Condition	2 - Between Good and Fair
Deficiency	No deficiencies recorded
Ceiling	
Instance on Room 214	Inspected
Condition	2 - Between Good and Fair
Deficiency	ACOUSTIC TILES ON PLASTER: DAMAGED/MISSING
Deficiency Location/Instance	Near Windows
Deficiency Quantity	10
Quantity Uom	S.F.
Potential Action	REPLACE
Urgency of Action	PRIORITY 3
Purpose of Action	LEVEL 2

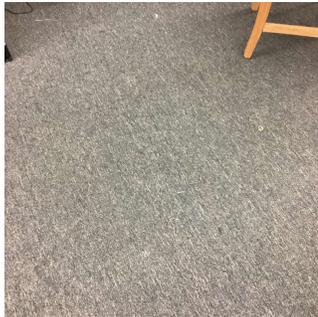
Violations	Near Windows No violations recorded.
Door(s)	
Instance on Room 214	Inspected
Condition	2 - Between Good and Fair
Deficiency	No deficiencies recorded
Floor Finish	
Instance on Room 214	Inspected
Condition	2 - Between Good and Fair
Deficiency	CARPET: WORN/DETERIORATED
Deficiency Location/Instance	Center, Near Circulation Desk
Deficiency Quantity	25
Quantity Uom	S.F.
Potential Action	REPLACE
Urgency of Action	PRIORITY 3
Purpose of Action	LEVEL 2
Deficiency Photo1

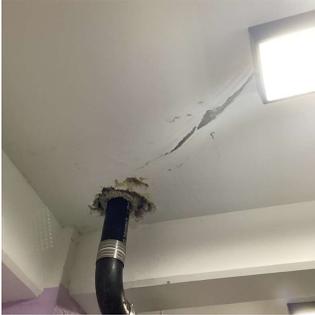
Question	Response
INTERIOR	
LOCKER ROOM	
Ceiling	
Condition	2 - Between Good and Fair
Deficiency	PLASTER: CRACKS/SPALLING
Deficiency Location/Instance	Near Locker 441, Near Entrance from Corridor, Near Skylight
Deficiency Quantity	30
Quantity Uom	S.F.
Potential Action	REPLACE
Urgency of Action	PRIORITY 3
Purpose of Action	LEVEL 2
Deficiency Photo1

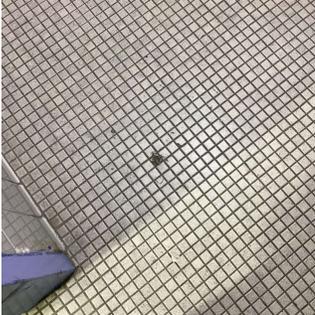
Near Locker 441
Violations	No violations recorded.
Door(s)	
Instance on 1st Floor - Boys (200 Lockers)	Inspected
Condition	2 - Between Good and Fair
Deficiency	No deficiencies recorded
Instance on 1st Floor - Girls (200 Lockers)	Inspected
Condition	2 - Between Good and Fair
Deficiency	No deficiencies recorded
Floor Finish	
Instance on 1st Floor - Boys (200 Lockers)	Inspected
Condition	2 - Between Good and Fair
Deficiency	CERAMIC TILE: BROKEN/MISSING TILES
Deficiency Location/Instance	Near Toilet Room
Deficiency Quantity	10
Quantity Uom	S.F.
Potential Action	REPLACE
Urgency of Action	PRIORITY 3

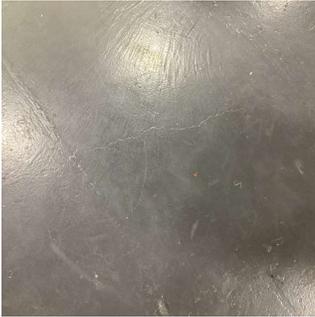
Instance on 1st Floor - Girls (200 Lockers)	Inspected
Condition	2 - Between Good and Fair
Deficiency	CONCRETE: CRACKS
Deficiency Location/Instance	Center
Deficiency Quantity	25
Quantity Uom	S.F.
Potential Action	REPLACE
Urgency of Action	PRIORITY 3
Purpose of Action	LEVEL 2
Deficiency Photo1

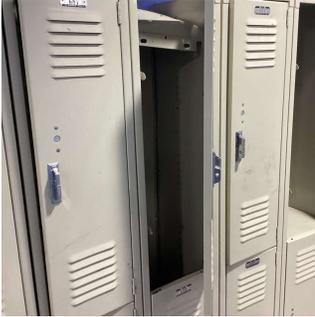
Instance on 1st Floor - Boys (200 Lockers)	Inspected
Condition	3 - Fair
Deficiency	DAMAGED UNITS
Deficiency Location/Instance	Lockers 676, 689, Near Locker 395
Deficiency Quantity	12
Quantity Uom	EACH
Potential Action	REPLACE
Urgency of Action	PRIORITY 3
Purpose of Action	LEVEL 2
Deficiency Photo1

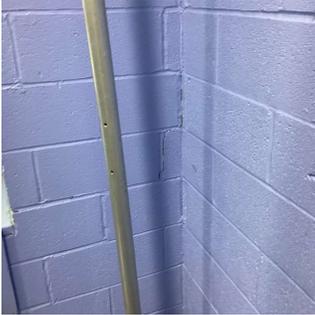
Instance on 1st Floor - Boys (200 Lockers)	Inspected
Condition	2 - Between Good and Fair
Deficiency	MASONRY: CRACKS/SPALLING
Deficiency Location/Instance	Near Windows
Deficiency Quantity	10

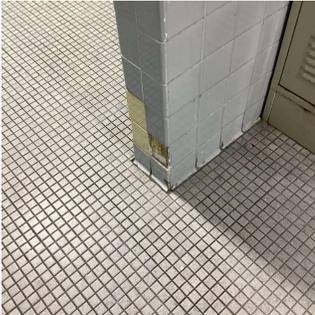
Near Windows
Violations	No violations recorded.
Deficiency	CERAMIC TILE: BROKEN/ MISSING
Deficiency Location/Instance	Near Entrance from Corridor
Deficiency Quantity	10
Quantity Uom	S.F.
Potential Action	REPLACE
Urgency of Action	PRIORITY 3
Purpose of Action	LEVEL 2
Deficiency Photo1

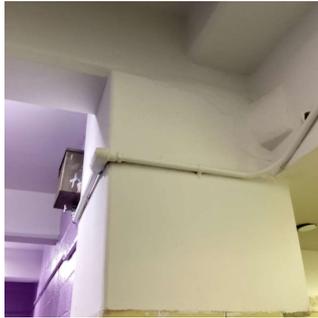
Near Entrance from Corridor
Violations	No violations recorded.
Instance on 1st Floor - Girls (200 Lockers)	Inspected
Condition	2 - Between Good and Fair
Deficiency	PLASTER: CRACKS/SPALLING
Deficiency Location/Instance	Near Shower Room
Deficiency Quantity	10
Quantity Uom	S.F.
Potential Action	REPLACE
Urgency of Action	PRIORITY 3
Purpose of Action	LEVEL 2

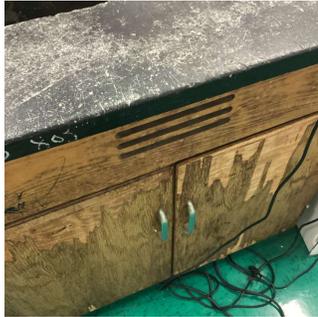
Violations	Near Shower Room No violations recorded.
MULTI-PURPOSE ROOM	Does not Exist
SCIENCE DEMO ROOM	Inspected
Instance on Room 201	Inspected
Alternative use	Yes
Instance on Room 306	Inspected
Alternative use	No
Fixed Equipment	
Instance on Room 306	Inspected
Condition	3 - Fair
Deficiency	CABINETS: MISSING/DAMAGED
Deficiency Location/Instance	Room 306
Deficiency Quantity	10
Quantity Uom	L.F.
Potential Action	REPLACE
Urgency of Action	PRIORITY 3
Purpose of Action	LEVEL 2
Deficiency Photo1

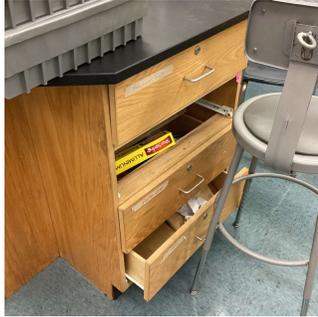
Question	Response
INTERIOR	
SCIENCE DEMO ROOM	Inspected
Fixed Equipment	
Deficiency Photo1	No photo recorded
Violations	No violations recorded.
SCIENCE LAB	Inspected
Instance on Room 208	Inspected
Alternative use	No
Fixed Equipment	
Instance on Room 208	Inspected
Condition	3 - Fair
Deficiency	CABINETS: MISSING/DAMAGED
Deficiency Location/Instance	Room 208
Deficiency Quantity	10
Quantity Uom	L.F.
Potential Action	REPLACE
Urgency of Action	PRIORITY 3
Purpose of Action	LEVEL 2
Deficiency Photo1

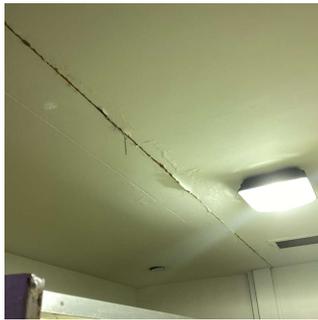
Violations	Room 208 No violations recorded.
SCIENCE PREP ROOM	Does not Exist
SHOWER ROOM	Inspected
Instance on 1st Floor - Boys	Inaccessible
Instance on 1st Floor - Girls	Inspected
Alternative use	Yes
Ceiling	
Instance on 1st Floor - Girls	Inspected
Condition	3 - Fair
Deficiency	PLASTER: CRACKS/SPALLING
Deficiency Location/Instance	Center
Deficiency Quantity	10
Quantity Uom	S.F.
Potential Action	REPLACE
Urgency of Action	PRIORITY 3

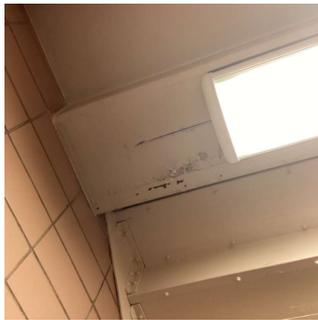
Center	Center
Violations	No violations recorded.
Door(s)	
Instance on 1st Floor - Girls	Does not Exist
Floor Finish	
Instance on 1st Floor - Girls	Inspected
Condition	2 - Between Good and Fair
Deficiency	No deficiencies recorded
Walls	
Instance on 1st Floor - Girls	Inspected
Condition	2 - Between Good and Fair
Deficiency	No deficiencies recorded
STAIRS/RAMPS: INTERIOR	Inspected
Do Letter Stair Signs Exist?	Partially
Ceiling	Inspected
Condition	2 - Between Good and Fair
Deficiency	PLASTER: CRACKS/SPALLING
Deficiency Location/Instance	Stair D/4, F/1
Deficiency Quantity	20
Quantity Uom	S.F.
Potential Action	REPLACE
Urgency of Action	PRIORITY 3
Purpose of Action	LEVEL 2
Deficiency Photo1

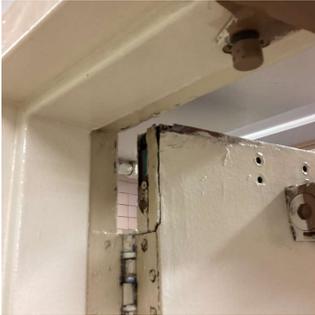
Stair D/4	Stair D/4
Violations	No violations recorded.
Door(s)	Inspected
Condition	3 - Fair
Deficiency	METAL: DETERIORATED DOOR
Deficiency Location/Instance	Stair B/2

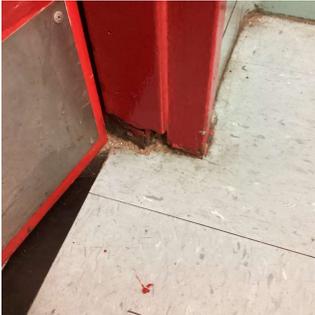
Stair B/2
Violations	No violations recorded.
Deficiency	METAL: DETERIORATED DOOR AND FRAME
Deficiency Location/Instance	Stair D/Basement
Deficiency Quantity	2
Quantity Uom	EACH
Potential Action	MAINTENANCE
Urgency of Action	PRIORITY 3
Purpose of Action	LEVEL 2
Deficiency Photo1

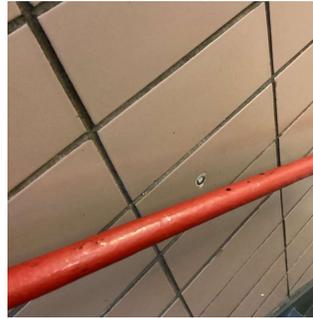
Stair D/Basement
Violations	No violations recorded.
Partition	Does not Exist
Railings	Inspected
Condition	4 - Between Fair and Poor
Deficiency	METAL: BROKEN BRACKET
Deficiency Location/Instance	Stair C/2
Deficiency Quantity	1
Quantity Uom	EACH
Potential Action	REPLACE
Urgency of Action	PRIORITY 3
Purpose of Action	LEVEL 2

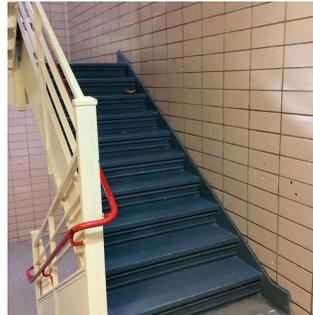
Stair C/1

METAL: MISSING

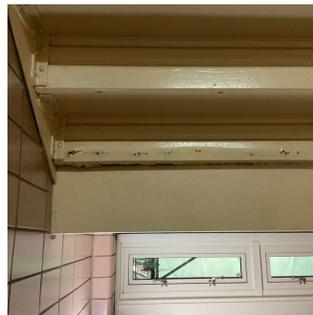
METAL: RUST - MAJOR

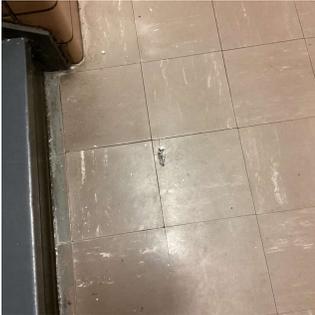
Question	Response
INTERIOR	
STAIRS/RAMPS: INTERIOR	
Stairs and Landings	
Violations	Stair D/3 No violations recorded.
Deficiency	VINYL TILES: BROKEN/DETERIORATED/MISSING TILES
Deficiency Location/Instance	Stairs A/1, B/2,4, C/2, D/Bulkhead, and others
Deficiency Quantity	120
Quantity Uom	S.F.
Potential Action	REPLACE
Urgency of Action	PRIORITY 3
Purpose of Action	LEVEL 2
Deficiency Photo1

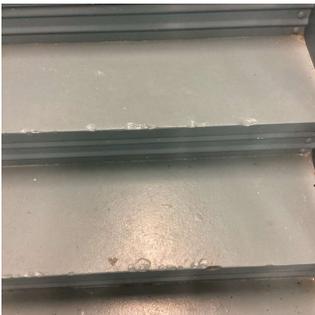
Violations	Stair A/1 No violations recorded.
Deficiency	STONE: BROKEN/MISSING
Deficiency Location/Instance	Stairs A/2, B/4, E/Basement, Room B35
Deficiency Quantity	45
Quantity Uom	S.F.
Potential Action	REPLACE
Urgency of Action	PRIORITY 3
Purpose of Action	LEVEL 2
Deficiency Photo1

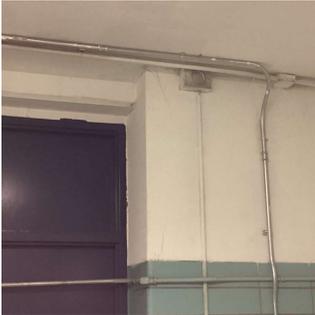
Question	Response
INTERIOR	
STAIRS/RAMPS: INTERIOR	
Walls	
Deficiency Photo1	No photo recorded
Violations	No violations recorded.
Deficiency	PLASTER: CRACKS/SPALLING
Deficiency Location/Instance	Stair A/1 Vestibule
Deficiency Quantity	10
Quantity Uom	S.F.
Potential Action	REPLACE
Urgency of Action	PRIORITY 3
Purpose of Action	LEVEL 2
Deficiency Photo1

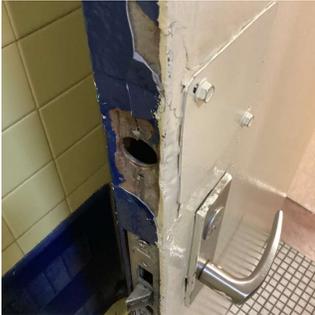
Violations	Stair A/1 Vestibule No violations recorded.
TOILET ROOMS - STAFF	Inspected
Ceiling	Inspected
Condition	2 - Between Good and Fair
Deficiency	No deficiencies recorded
Door(s)	Inspected
Condition	5 - Poor
Deficiency	METAL: DETERIORATED DOOR
Deficiency Location/Instance	Room 223A
Deficiency Quantity	1
Quantity Uom	EACH
Potential Action	MAINTENANCE
Urgency of Action	PRIORITY 3
Purpose of Action	LEVEL 2
Deficiency Photo1

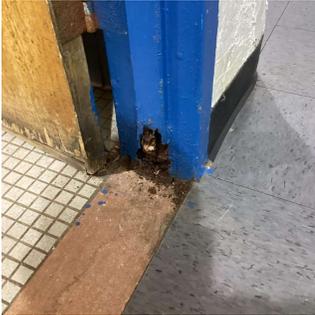
Violations	Room 223A No violations recorded.
Deficiency	METAL: DETERIORATED DOOR AND FRAME
Deficiency Location/Instance	In Room B22

Question	Response
INTERIOR	
TOILET ROOMS - STAFF	
Door(s)	
Deficiency Quantity	1
Quantity Uom	EACH
Potential Action	MAINTENANCE
Urgency of Action	PRIORITY 3
Purpose of Action	LEVEL 2
Deficiency Photo1

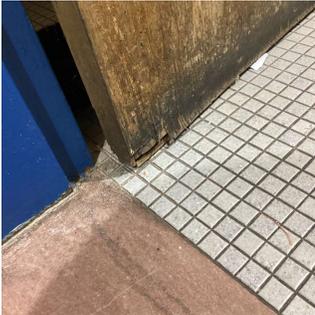
In Room B22
Violations	No violations recorded.
Deficiency	WOOD: DETERIORATED DOOR
Deficiency Location/Instance	In Rooms 122, 125, B34, Rooms B14, 425A, and others
Deficiency Quantity	9
Quantity Uom	EACH
Potential Action	MAINTENANCE
Urgency of Action	PRIORITY 3
Purpose of Action	LEVEL 2
Deficiency Photo1

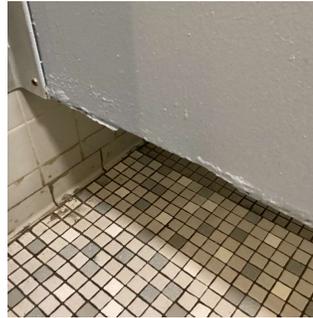
1st Floor Men

In Room B34
Violations	No violations recorded.
Floor Finish	Inspected
Condition	2 - Between Good and Fair
Deficiency	No deficiencies recorded
Stalls	Inspected
Condition	5 - Poor
Deficiency	RUST - MAJOR
Deficiency Location/Instance	1st Floor Men, 1st Floor Women, Rooms 223A, 425A, In Room B34, and others
Deficiency Quantity	8
Quantity Uom	EACH
Potential Action	REPLACE
Urgency of Action	PRIORITY 3
Purpose of Action	LEVEL 2

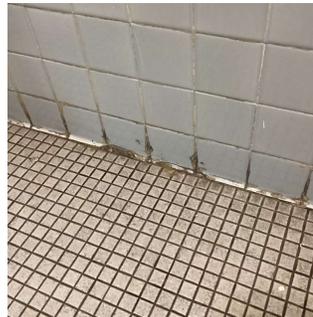
1st Floor Men

CERAMIC TILE: BROKEN/ MISSING

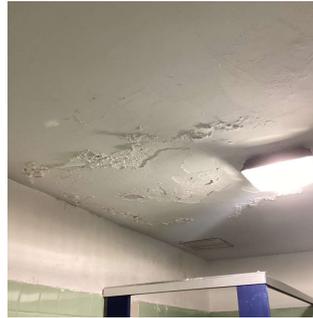
Boys Locker Room

PLASTER: CRACKS/SPALLING

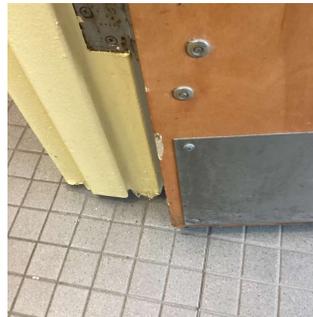
3rd Floor Girls

WOOD: DETERIORATED DOOR

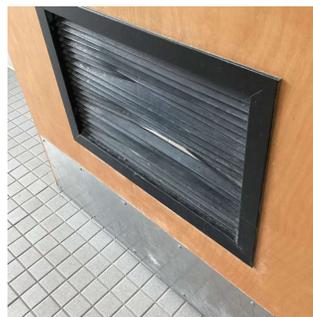
WOOD: DAMAGED LOUVER

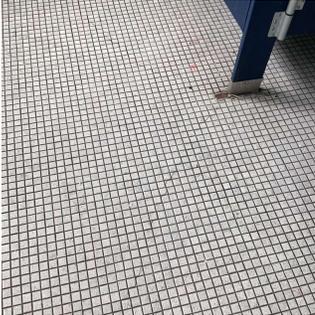
Question	Response
INTERIOR	
TOILET ROOMS - STUDENTS	
Door(s)	Inspected 4th Floor Boys
Violations	No violations recorded.
Floor Finish	Inspected
Condition	2 - Between Good and Fair
Deficiency	CERAMIC TILE: DETERIORATED SUBSTRATE
Deficiency Location/Instance	2nd Floor Girls, 4th Floor Girls
Deficiency Quantity	30
Quantity Uom	S.F.
Potential Action	REPLACE
Urgency of Action	PRIORITY 3
Purpose of Action	LEVEL 2
Deficiency Photo1

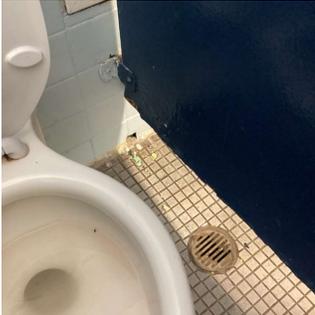
Violations	4th Floor Girls No violations recorded.
Stalls	Inspected
Condition	5 - Poor
Deficiency	RUST - MAJOR
Deficiency Location/Instance	2nd Floor Girls
Deficiency Quantity	4
Quantity Uom	EACH
Potential Action	REPLACE
Urgency of Action	PRIORITY 3
Purpose of Action	LEVEL 2
Deficiency Photo1

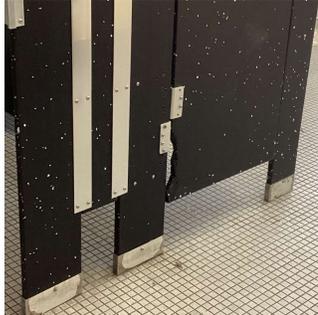
Violations	2nd Floor Girls No violations recorded.
Deficiency	BROKEN/MISSING
Deficiency Location/Instance	2nd Floor Boys
Deficiency Quantity	1
Quantity Uom	EACH
Potential Action	REPLACE

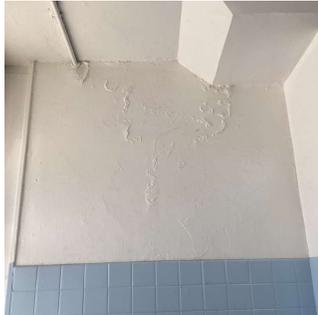
Violations	2nd Floor Boys No violations recorded.
Walls	
Condition	Inspected 2 - Between Good and Fair
Deficiency	PLASTER: CRACKS/SPALLING
Deficiency Location/Instance	2nd Floor Girls
Deficiency Quantity	15
Quantity Uom	S.F.
Potential Action	REPLACE
Urgency of Action	PRIORITY 3
Purpose of Action	LEVEL 2
Deficiency Photo1

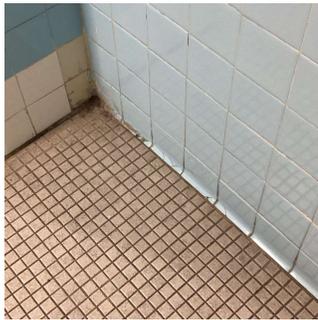
Violations	2nd Floor Girls No violations recorded.
Deficiency	CERAMIC TILE: BROKEN/ MISSING
Deficiency Location/Instance	Girls Locker Room, Boys Locker Room, 2nd Floor Boys
Deficiency Quantity	30
Quantity Uom	S.F.
Potential Action	REPLACE
Urgency of Action	PRIORITY 3
Purpose of Action	LEVEL 2

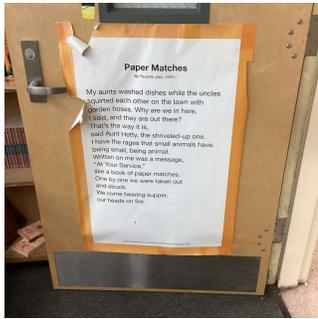
Girls Locker Room
Violations	No violations recorded.
LIFE SAFETY	
F.D. HOLDING AREA	Inspected
Condition	5 - Poor
Deficiency	HOLDING AREAS NOT IDENTIFIED
Deficiency Location/Instance	Rooms B22, 214, 318, 418
Deficiency Quantity	4
Quantity Uom	EACH
Potential Action	PROVIDE IDENTIFICATION AT DOOR
Urgency of Action	PRIORITY 5
Purpose of Action	LEVEL 2
Deficiency Photo1

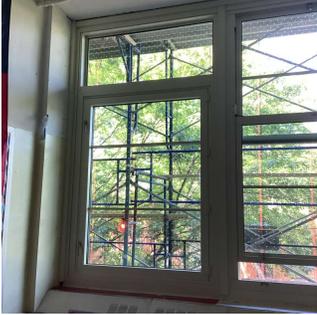
Room 214
Violations	No violations recorded.
Deficiency	HOLDING AREAS NOT IDENTIFIED
Deficiency Location/Instance	Rooms 214, 318, 418
Deficiency Quantity	3
Quantity Uom	EACH
Potential Action	PROVIDE IDENTIFICATION ON EXTERIOR SIDE OF WINDOW
Urgency of Action	PRIORITY 5
Purpose of Action	LEVEL 2

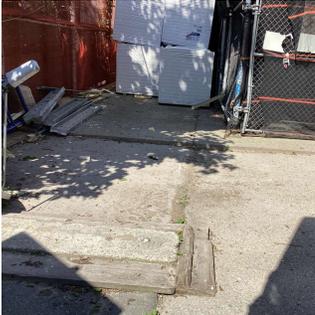
FENCES	Inaccessible
IRRIGATION SYSTEM	Does not Exist
PAVING	Inspected
Student Non-Use	Inaccessible
Student Use	Does not Exist
Site Sidewalks & Walkways	Inspected
Asphalt	Does not Exist
Concrete	Inspected
Condition	4 - Between Fair and Poor
Deficiency	HEAVING

Question	Response
SITE	
PAVING	
Site Sidewalks & Walkways	
Concrete	
Deficiency Location/Instance	South Side of Building
Deficiency Quantity	350
Quantity Uom	S.F.
Potential Action	REPLACE
Urgency of Action	PRIORITY 5
Purpose of Action	LEVEL 6
Deficiency Photo1

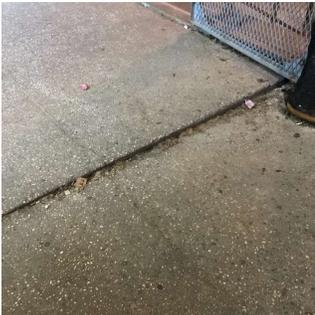
Violations	South Side of Building No violations recorded.
Deficiency	HEAVING
Deficiency Location/Instance	Near Soffit, Near NYC Park, South Side of Building
Deficiency Quantity	225
Quantity Uom	S.F.
Potential Action	REPLACE
Urgency of Action	PRIORITY 3
Purpose of Action	LEVEL 2
Deficiency Photo1

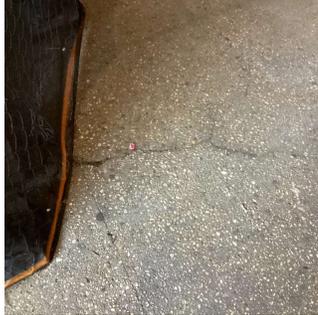
Violations	Near Soffit No violations recorded.
Deficiency	DAMAGED/DETERIORATED/MISSING SECTIONS
Deficiency Location/Instance	Near Soffit, Near NYC Park, South Side of Building
Deficiency Quantity	975
Quantity Uom	S.F.
Potential Action	REPLACE
Urgency of Action	PRIORITY 3
Purpose of Action	LEVEL 2

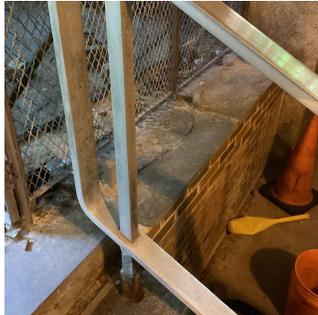
Question	Response
SITE	
PAVING	Inspected
DOT Sidewalk	
Concrete	Inspected
Violations	No violations recorded.
Pavers	Does not Exist
PLAYGROUNDS	Does not Exist
PLAYING SURFACE	Does not Exist
RETAINING WALLS	Inspected
Are there any Retaining Walls 6' OR higher facing public street/sidewalk?	No
Condition	3 - Fair
Deficiency	BRICK: DETERIORATED COPING STONE
Deficiency Location/Instance	Near Exit 6, Near Exit 7
Deficiency Quantity	30
Quantity Uom	S.F.
Potential Action	REPLACE
Urgency of Action	PRIORITY 3
Purpose of Action	LEVEL 2
Deficiency Photo1

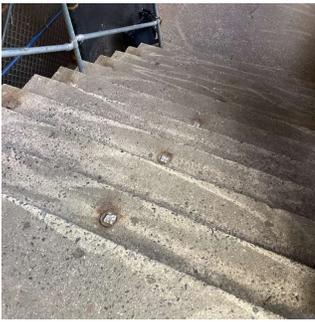
Near Exit 7	Near Exit 7
Violations	No violations recorded.
SEATING	Does not Exist
SITE WALLS (NOT RETAINING WALLS)	Does not Exist
STAIRS/RAMPS: EXTERIOR	Inspected
Railings	Inspected
Condition	4 - Between Fair and Poor
Deficiency	MISSING
Deficiency Location/Instance	Near NYC Park
Deficiency Quantity	20
Quantity Uom	L.F.
Potential Action	REPLACE
Urgency of Action	PRIORITY 5
Purpose of Action	LEVEL 6
