**NYC Department of Education**  
**Building Condition Assessment Survey 2023 - 2024**

Architectural Inspection

**Asset:** P.S. 116 - BROOKLYN, 515 KNICKERBOCKER AVENUE, New York, 11237

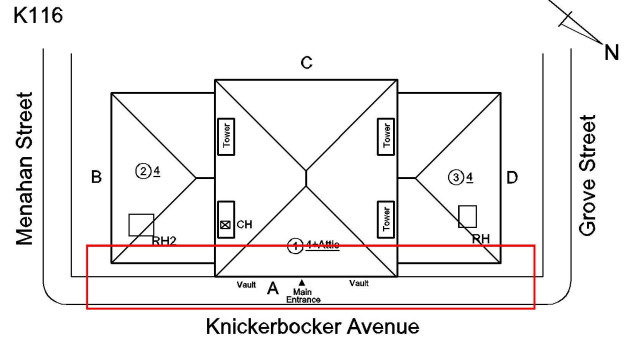
Question	Response
<b>Architectural</b>	
<b>EXTERIOR</b>	Inspected
<b>AREAWAY</b>	Does not Exist
<b>AWNINGS AND CANOPIES</b>	Does not Exist
<b>CHIMNEY</b>	Inspected
Material Type(s)	Masonry
Condition	2 - Between Good and Fair
Deficiency	No deficiencies recorded
<b>COPING</b>	Does not Exist
<b>CORNICE</b>	Inspected
Condition	3 - Fair
Deficiency	TERRA COTTA: MINOR CRACKS, SPALLING

30  
S.F.  
REPAIR  
PRIORITY 3  
LEVEL 2

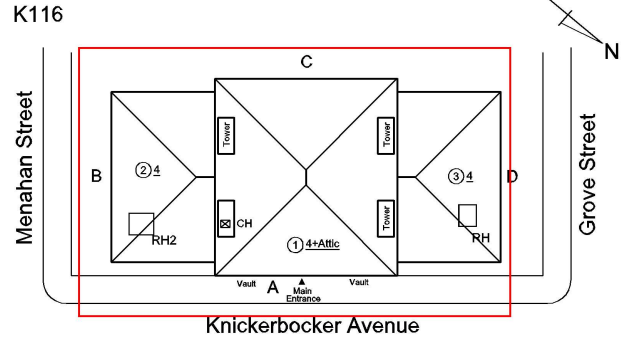
METAL: LOSS OF PAINT

450  
S.F.  
REPAINT  
PRIORITY 3  
LEVEL 2

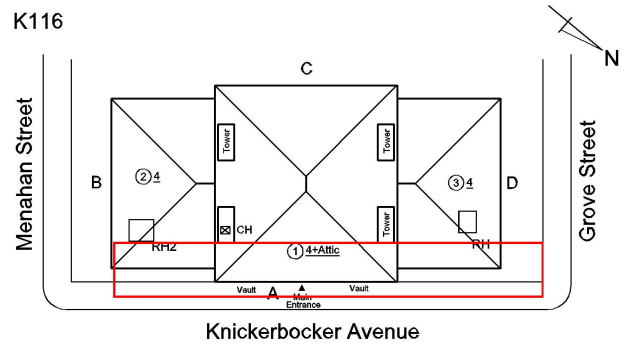
TERRA COTTA: DETERIORATED JOINTS

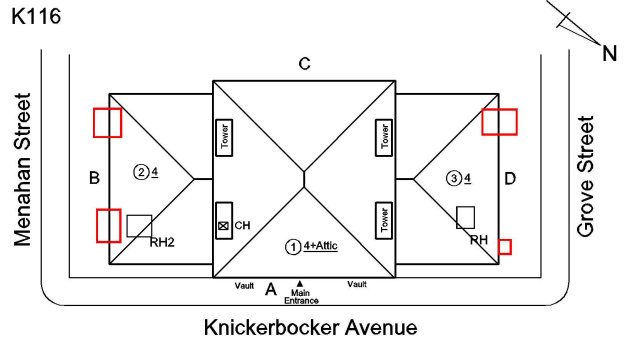
Facade D  
No violations recorded.

METAL CLAD: DETERIORATED DOOR AND FRAME - MAJOR DETERIORATION

4  
EACH  
REPLACE  
PRIORITY 4  
LEVEL 2

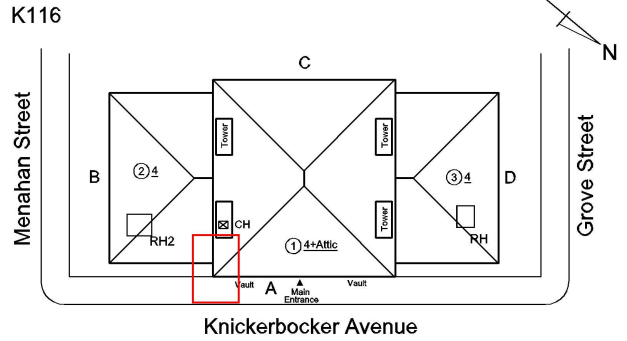
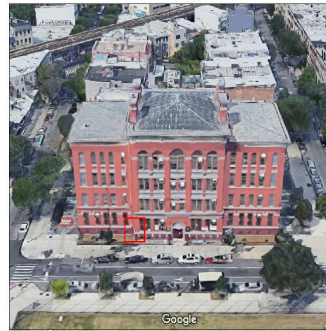
<b>DOOR HARDWARE</b>	Inspected
Condition	3 - Fair
Deficiency	No deficiencies recorded
<b>LINTELS</b>	Inspected
Condition	2 - Between Good and Fair
Deficiency	No deficiencies recorded
<b>TRANSOM/SIDE LIGHT</b>	Does not Exist
<b>EXTERIOR WALLS</b>	Inspected
Material Type(s)	Masonry
Replacement Quantity	20,000
Replacement Uom	S.F.
Instance on All Facades	Inspected
Instance Condition	4 - Between Fair and Poor
Instance Quantity	20,000
Instance Quantity Uom	S.F.
Deficiency	BRICK: EFFLORESCENCE

40  
 S.F.  
 MAINTENANCE  
 PRIORITY 3  
 LEVEL 2  
 No photo recorded  
 No violations recorded.

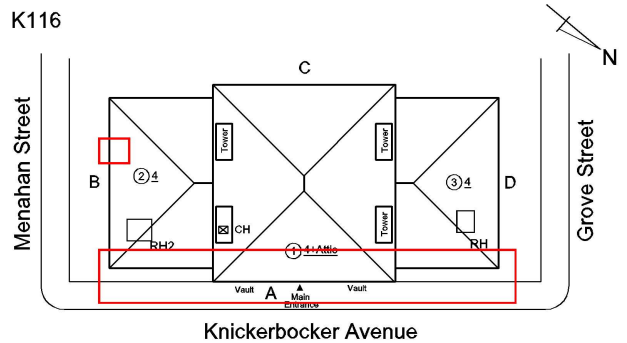
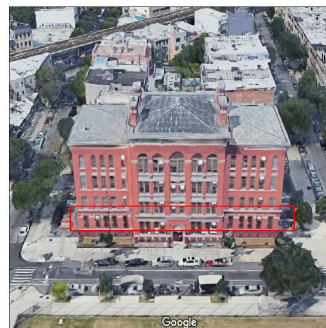
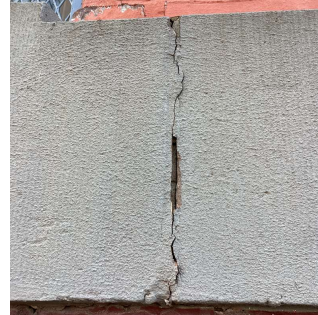
Facade B

TERRA COTTA: DETERIORATED JOINTS

REPOINT  
PRIORITY 3  
LEVEL 2

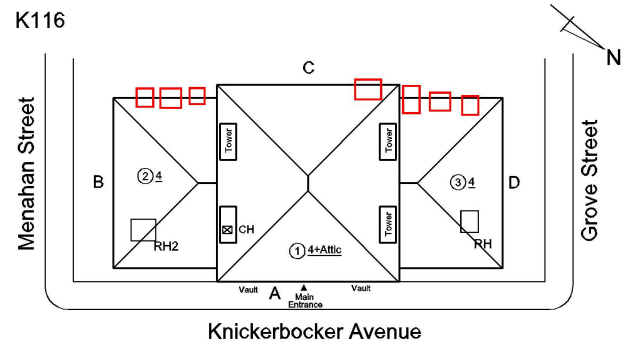
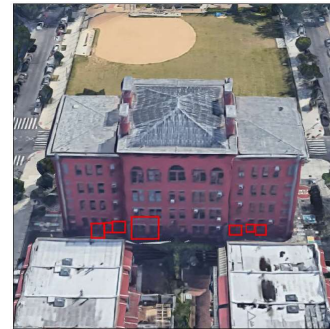
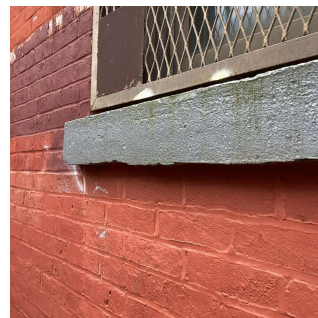
BRICK: DETERIORATED MASONRY SILLS - MINOR

L.F.  
REPAIR  
PRIORITY 3  
LEVEL 2

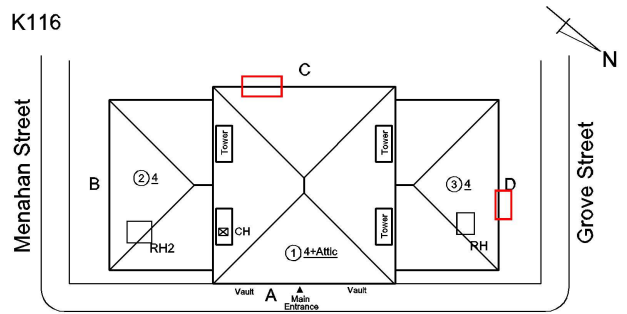
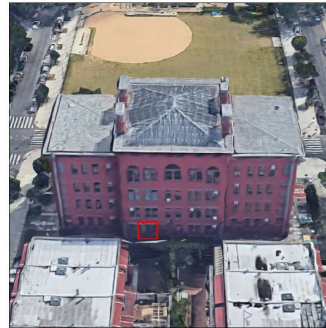
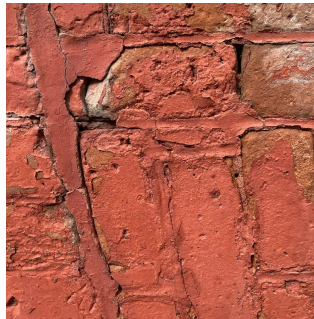
Facade D

BRICK: DETERIORATED JOINTS

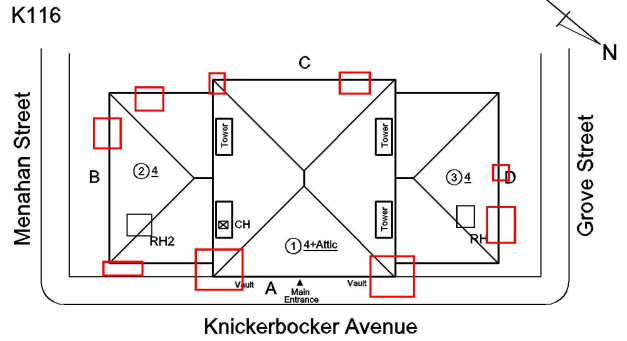
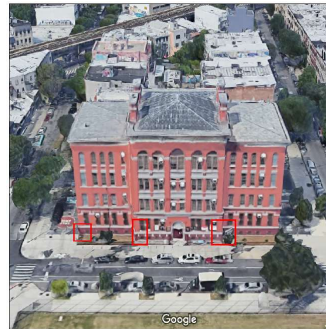
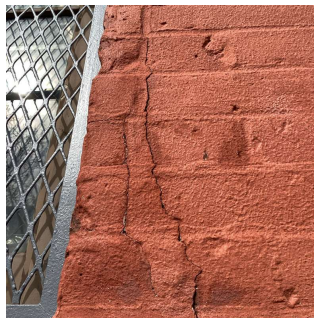
Facade D

BRICK: MAJOR / THRU CRACKS

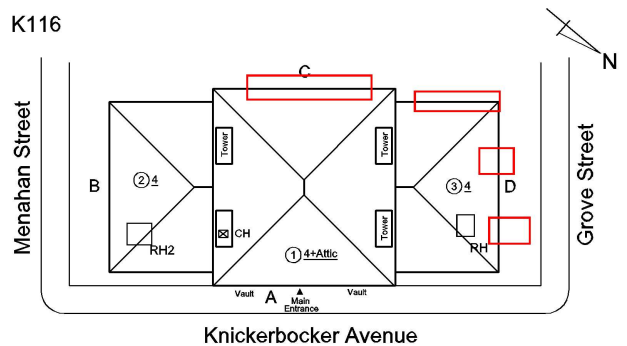
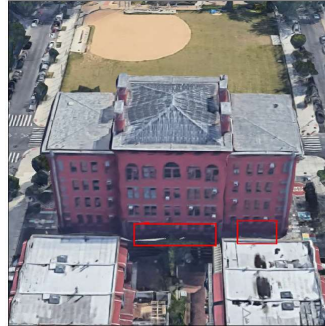
BRICK: DETERIORATED JOINTS

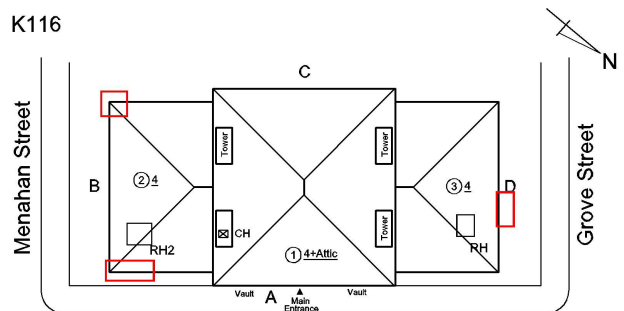
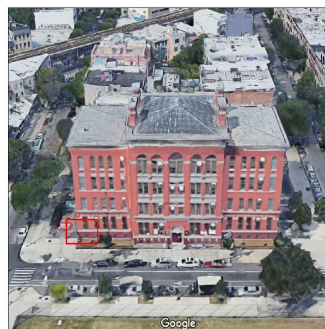
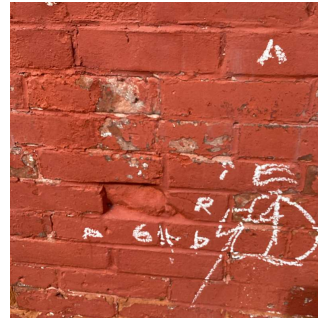
Facade D

BRICK: MINOR CRACKS AND SPALLING

PRIORITY 3  
 LEVEL 2

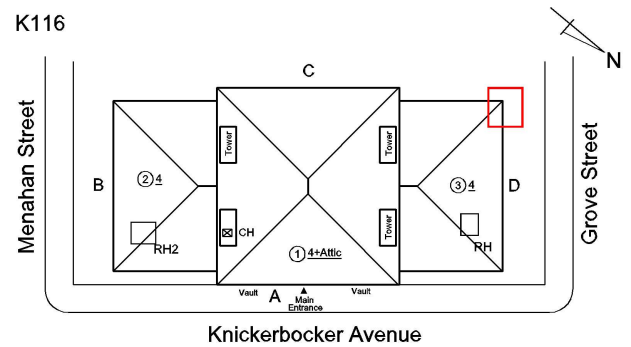
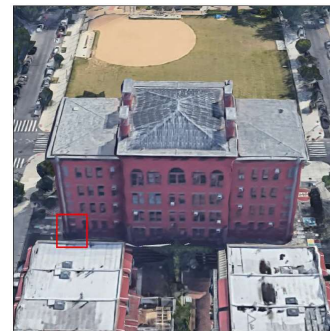
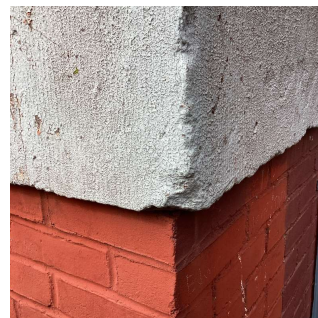
Facade D

TERRA COTTA: CRACKS AT BUILDING CORNERS

10  
 S.F.  
 REPLACE  
 PRIORITY 4  
 LEVEL 2

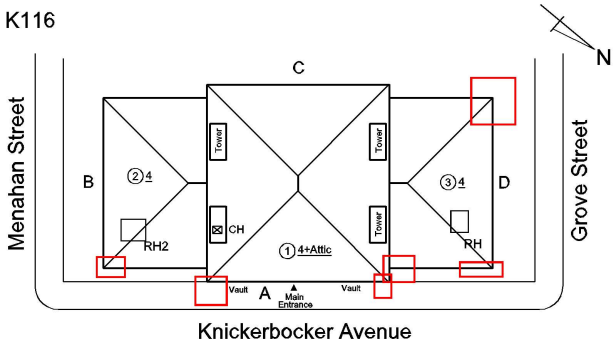
Question	Response
<b>EXTERIOR</b>	
<b>EXTERIOR WALLS</b>	
Violations	No violations recorded.
Deficiency	BRICK: CRACKS/DISPLACED/SPALLED BRICK AT BUILDING CORNERS
Roof Plan reference	K116
Elevation

Deficiency Quantity	60
Quantity Uom	S.F.
Potential Action	REMOVE AND REBUILD
Urgency of Action	PRIORITY 4
Purpose of Action	LEVEL 2
Deficiency Photo1

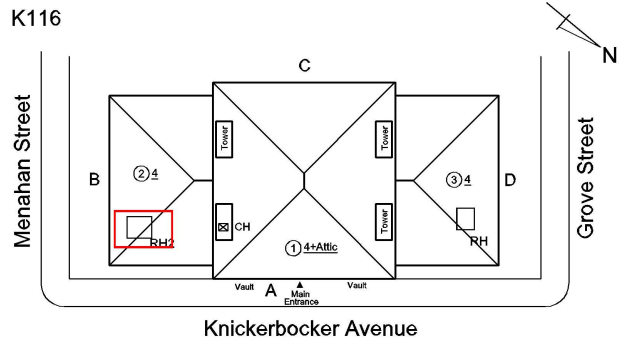
RH2  
 No violations recorded.

Condition	5 - Poor
-----------	----------

Deficiency	DETERIORATED
------------	--------------

1  
 EACH  
 REPLACE  
 PRIORITY 4  
 LEVEL 2

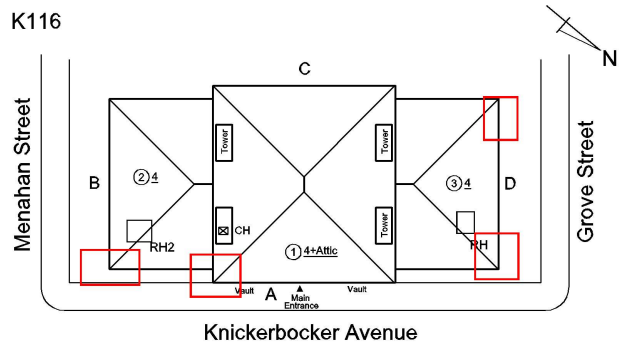
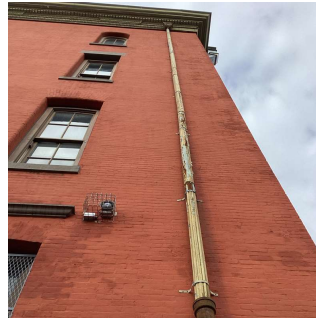
Facade D

Condition	4 - Between Fair and Poor
-----------	---------------------------

Deficiency	DAMAGED/MISSING
------------	-----------------

120  
 L.F.  
 REPLACE  
 PRIORITY 4  
 LEVEL 2

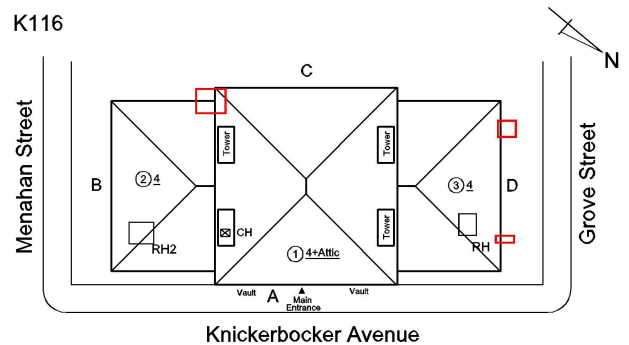
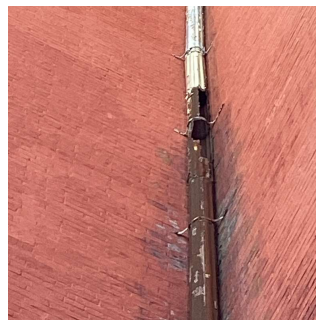
Facade C

DAMAGED/MISSING

REPLACE

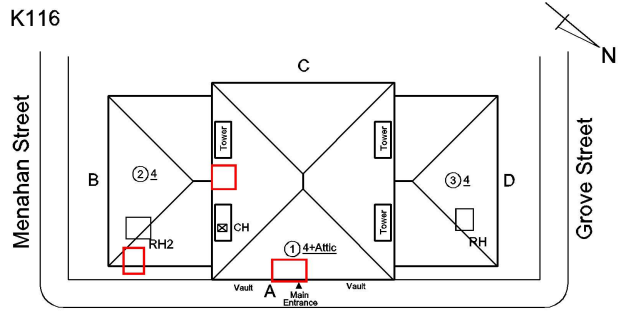
Roof 2
Instance Quantity	12,000
Instance Quantity Uom	S.F.
Does the roof have major mechanical equipment sitting on Dunnage Steel less than 18" above the Roofing?	No
Does this roof instance have a Sustainable Roof System?	No
Do solar panels exist on these roofs?	No
Is/Are the roof(s) suitable for Solar Panel installation?	No
Installation Year	2000
Source of Installation	Custodial Staff
Deficiency	METAL: ROOFING: MAJOR ACTIVE ROOF LEAKS IN INSTRUCTIONAL SPACE
Roof Plan reference	<p>K116</p>

Roof 1 - Corridor near Gymnasium (Shown), In Room 408, Roof 2 - Room 405
Violations	No violations recorded.
<b>ROOFING DRAINS</b>	Does not Exist
<b>Specialties</b>	Inspected
<b>BULKHEAD/PENTHOUSE</b>	Does not Exist

Deficiency Quantity	300
Quantity Uom	S.F.
Potential Action	REPLACE
Urgency of Action	PRIORITY 5
Purpose of Action	LEVEL 2
Deficiency Photo1

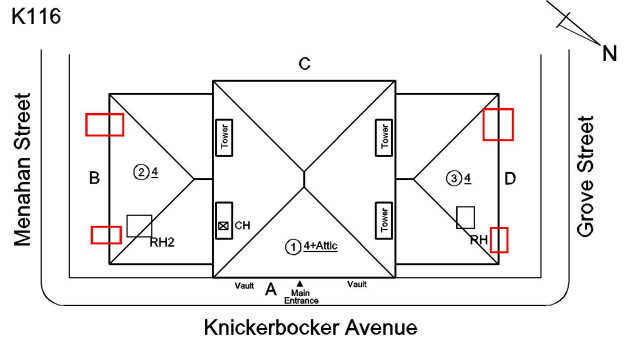
Question	Response
<b>EXTERIOR</b>	
<b>ROOF</b>	
<b>Specialties</b>	
<b>CUPOLA/ SPIRES/ TOWERS</b>	Inspected
Condition	2 - Between Good and Fair
Deficiency	No deficiencies recorded
<b>DORMER</b>	Does not Exist
<b>DUNNAGE STEEL</b>	Does not Exist
<b>SKYLIGHT/ROOF VENT</b>	Inspected
Material Type(s)	Glass
Condition	2 - Between Good and Fair
Deficiency	No deficiencies recorded
<b>ROOF/GRAVITY TANK</b>	Inspected
Condition	3 - Fair
Deficiency	TANK: NOT IN USE - MINOR DETERIORATION
Roof Plan reference	<p>K116</p>
Deficiency Quantity	2
Quantity Uom	EACH
Potential Action	NO ACTION
Urgency of Action	PRIORITY 1
Purpose of Action	LEVEL 1
Deficiency Photo1	
Violations	Attic Roof Tank Room NW, Attic Roof Tank Room SE No violations recorded.
<b>STAIRS/RAMPS: EXTERIOR</b>	Inspected
<b>BUILDING CHEEK/FLANK WALLS</b>	Does not Exist
<b>RAILINGS</b>	Does not Exist
<b>STAIRS/RAMPS</b>	Inspected
Condition	5 - Poor
Deficiency	STONE: CRACKS/SPALLING - MAJOR

K116  
 40  
 S.F.  
 REPLACE  
 PRIORITY 5  
 LEVEL 6

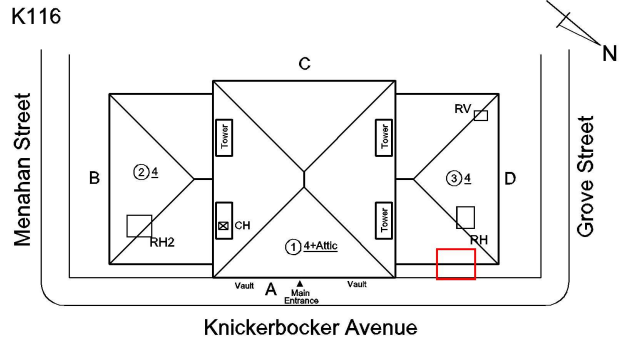
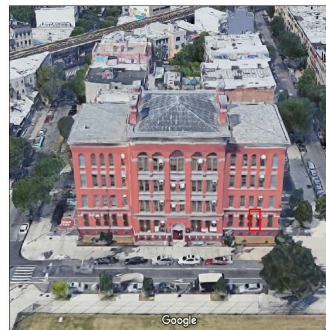
<b>WINDOWS</b>	Inspected
Replacement Quantity	7,000
Replacement Uom	S.F.
<b>EXTERIOR GUARDS</b>	Inspected
Condition	2 - Between Good and Fair
Deficiency	No deficiencies recorded
<b>LINTELS</b>	Inspected
Condition	2 - Between Good and Fair
Deficiency	No deficiencies recorded
<b>WINDOWS</b>	Inspected
Material Type(s)	Aluminum, Solid Wood
Instance on Wood: All Facades	Inspected
Instance Condition	3 - Fair
Instance Quantity	6,700
Instance Quantity Uom	S.F.
Are these windows insulated	No
Installation Year	2000
Source of Installation	Custodial Staff
Deficiency	WOOD: BROKEN PANE

30  
S.F.  
MAINTENANCE  
PRIORITY 3  
LEVEL 2

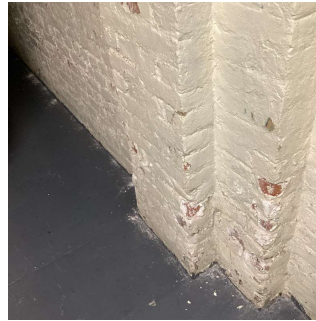
Basement - Stair C

Violations	<p>Facade A</p> <p>No violations recorded.</p>
<b>INTERIOR</b>	Inspected
<b>POOLS</b>	Does not Exist
<b>STRUCTURAL</b>	Inspected
<b>COLUMNS/BEAMS/BEARING WALLS</b>	Inspected
Condition	3 - Fair
Deficiency	MASONRY BEARING WALL: CRACKED/SPALLED
Deficiency Location/Instance	Basement - Stairs B, C, D, E
Deficiency Quantity	40
Quantity Uom	S.F.
Potential Action	RESTITCH
Urgency of Action	PRIORITY 4
Purpose of Action	LEVEL 5

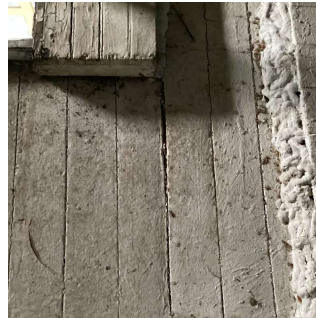
Roof 3 - Attic

WOOD: DETERIORATED/DAMAGED

REPLACE

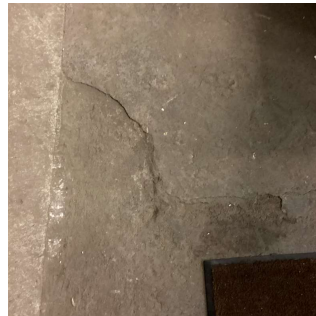
CONCRETE SLAB ON GRADE: THRU CRACKS

REPLACE

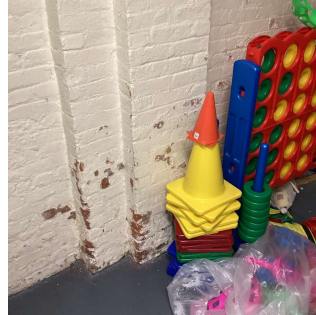
Stair B/Basement

Violations	Boiler Room No violations recorded.
Deficiency	BRICK: WATER INFILTRATION IN INSTRUCTIONAL SPACE
Deficiency Location/Instance	Stairs B/Basement, C/Basement, D/Basement, E/Basement

Deficiency Quantity	400
Quantity Uom	S.F.
Potential Action	INSTALL WATERPROOFING

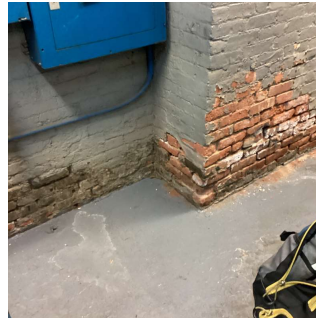
BRICK: DETERIORATED JOINTS  
Basement - Boiler Room  
200  
S.F.  
REPOINT  
PRIORITY 4  
LEVEL 5

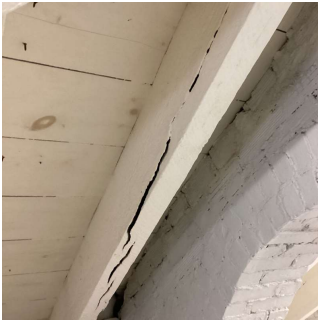
Inspected  
3 - Fair  
WOOD COLUMNS AND BEAMS: DETERIORATED  
Roof 2- Attic, Roof 3 - Attic  
60  
S.F.  
REPLACE  
PRIORITY 4  
LEVEL 5

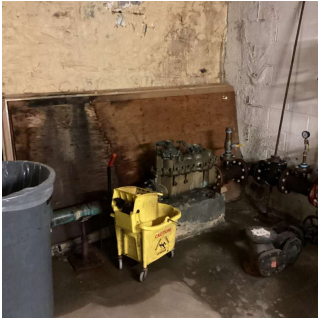
Roof 2 - Attic
Violations	No violations recorded.
<b>VAULTS-BUNKERS</b>	
<b>Foundation Walls</b>	Inspected
Condition	4 - Between Fair and Poor
Deficiency	WATER INFILTRATION IN NON- INSTRUCTIONAL SPACE
Deficiency Location/Instance	Basement - Oil Tank Room, Water Meter Room
Deficiency Quantity	200
Quantity Uom	S.F.
Potential Action	INSTALL WATERPROOFING
Urgency of Action	PRIORITY 5
Purpose of Action	LEVEL 5
Deficiency Photo1

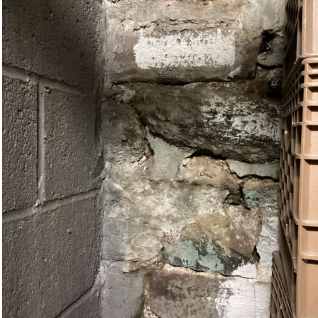
Water Meter Room
Violations	No violations recorded.
Deficiency	CRACKS, SPALLING
Deficiency Location/Instance	Basement - Vault near Oil Tank Room, Oil Tank Room, Water Meter Room
Deficiency Quantity	200
Quantity Uom	S.F.
Potential Action	REPAIR
Urgency of Action	PRIORITY 4
Purpose of Action	LEVEL 5

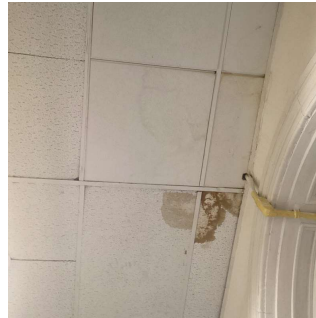
Corridor near Gymnasium

ACOUSTIC TILES: DAMAGED/MISSING - ACTIVE LEAK

REPLACE

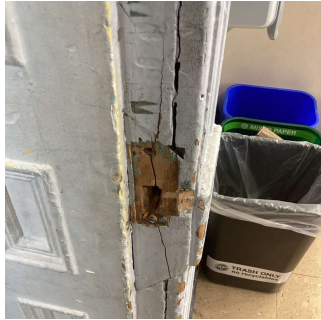
Question	Response
<b>INTERIOR</b>	
<b>CLASSROOMS/CORRIDORS/ADMIN SPACES</b>	
<b>Ceiling</b>	Inspected
Violations	No violations recorded.
<b>Door(s)</b>	Inspected
Condition	5 - Poor
Deficiency	WOOD: DETERIORATED DOOR AND FRAME
Deficiency Location/Instance	Rooms 408, 402
Deficiency Quantity	2
Quantity Uom	EACH
Potential Action	MAINTENANCE
Urgency of Action	PRIORITY 3
Purpose of Action	LEVEL 2
Deficiency Photo1

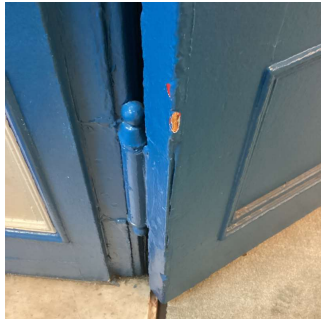
Violations	Room 408 No violations recorded.
Deficiency	WOOD: DETERIORATED DOOR
Deficiency Location/Instance	Main Entrance (2x), Rooms 309, 308, 305
Deficiency Quantity	5
Quantity Uom	EACH
Potential Action	MAINTENANCE
Urgency of Action	PRIORITY 3
Purpose of Action	LEVEL 2
Deficiency Photo1

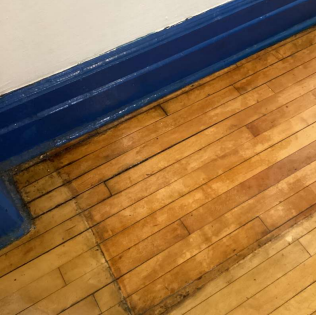
Violations	Main Entrance - Lobby No violations recorded.
<b>Floor Finish</b>	Inspected
Condition	4 - Between Fair and Poor
Deficiency	WOOD: DAMAGED/DETERIORATED
Deficiency Location/Instance	Rooms 306, 307, Corridor near Stair DB/3, by Rooms 307, 308 and others

Deficiency Quantity	120
Quantity Uom	S.F.
Potential Action	REPLACE

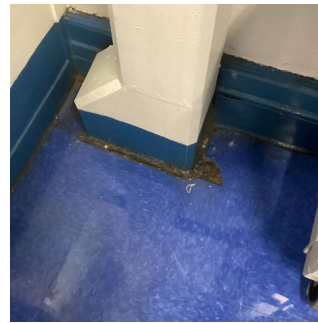
Corridor near Stair EC/4
Violations	No violations recorded.
<hr/>	
Deficiency	VINYL TILES: BROKEN/DETERIORATED/MISSING TILES
Deficiency Location/Instance	Room 203, Corridor near Stair DB/1
Deficiency Quantity	110
Quantity Uom	S.F.
Potential Action	REPLACE
Urgency of Action	PRIORITY 3
Purpose of Action	LEVEL 2

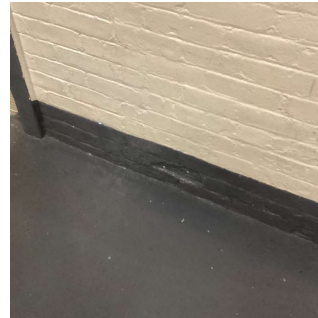
Basement corridor near Boys Toilet Room

BRICK: CRACKS/SPALLING

REPLACE

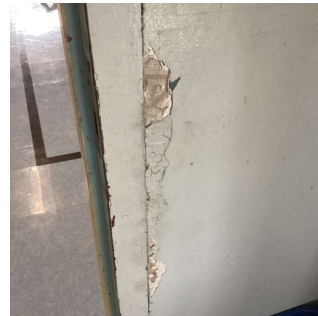
PLASTER: CRACKS/SPALLING

REPLACE

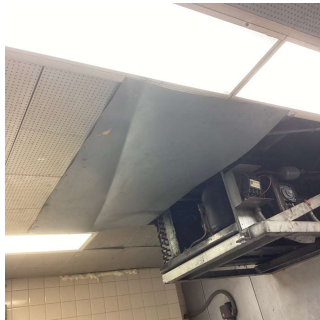
Question	Response
<b>INTERIOR</b>	
<b>GYMNASIUM</b>	Inspected
<b>Stage</b>	
<b>Stage</b>	Inspected
Deficiency	No deficiencies recorded
<b>Stage Curtain Rigging</b>	Does not Exist
Instance on 4th Floor	Does not Exist
<b>Stage Curtains</b>	Does not Exist
Instance on 4th Floor	Does not Exist
<b>Walls</b>	
Instance on 4th Floor	Inspected
Condition	2 - Between Good and Fair
Deficiency	No deficiencies recorded
<b>Window Curtains/Shades/Blinds</b>	
Instance on 4th Floor	Inspected
Condition	2 - Between Good and Fair
Deficiency	No deficiencies recorded
<b>INTERIOR DOOR HARDWARE</b>	Inspected
Condition	3 - Fair
Deficiency	No deficiencies recorded
<b>INTERIOR GUARDS</b>	Inspected
Condition	2 - Between Good and Fair
Deficiency	No deficiencies recorded
<b>KITCHEN</b>	Inspected
Instance on Basement (600 SF)	Inspected
<b>Ceiling</b>	
Instance on Basement (600 SF)	Inspected
Condition	4 - Between Fair and Poor
Deficiency	METAL PAN: DAMAGED/MISSING

Deficiency Location/Instance	Near Sink, by Small Storage Room
Deficiency Quantity	50
Quantity Uom	S.F.
Potential Action	REPLACE
Urgency of Action	PRIORITY 3
Purpose of Action	LEVEL 2
Deficiency Photo1

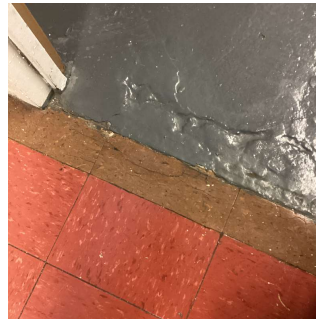
Instance on Basement (600 SF)	Inspected
Condition	3 - Fair
Deficiency	VINYL TILES: BROKEN/DETERIORATED/MISSING TILES
Deficiency Location/Instance	Kitchen Locker Room
Deficiency Quantity	10
Quantity Uom	S.F.
Potential Action	REPLACE
Urgency of Action	PRIORITY 3
Purpose of Action	LEVEL 2
Deficiency Photo1

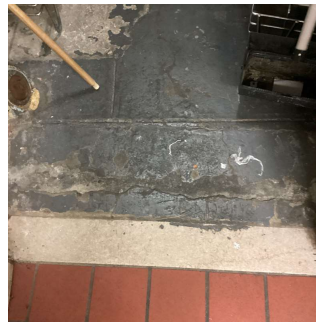
Deficiency	CONCRETE: CRACKS
Deficiency Location/Instance	Small Storage Room
Deficiency Quantity	10
Quantity Uom	S.F.
Potential Action	REPLACE
Urgency of Action	PRIORITY 3
Purpose of Action	LEVEL 2

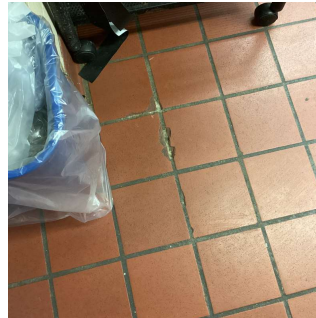
Near Main Entrance

Deficiency	QUARRY TILE: BROKEN/MISSING TILES
Deficiency Location/Instance	Near Main Entrance, by Sink
Deficiency Quantity	20
Quantity Uom	S.F.
Potential Action	REPLACE
Urgency of Action	PRIORITY 3
Purpose of Action	LEVEL 2
Deficiency Photo1

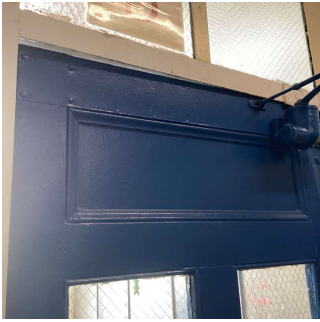
Question	Response
<b>INTERIOR</b>	
<b>LIBRARY</b>	Inspected
<b>Walls</b>	
Instance on Room 203 (800 SF)	Inspected
Condition	2 - Between Good and Fair
Deficiency	No deficiencies recorded
<b>LOCKER ROOM</b>	Does not Exist
<b>MULTI-PURPOSE ROOM</b>	Does not Exist
<b>SCIENCE DEMO ROOM</b>	Does not Exist
<b>SCIENCE LAB</b>	Inspected
Instance on Room 209	Inspected
Alternative use	No
<b>Fixed Equipment</b>	
Instance on Room 209	Inspected
Condition	2 - Between Good and Fair
Deficiency	No deficiencies recorded
<b>SCIENCE PREP ROOM</b>	Does not Exist
<b>SHOWER ROOM</b>	Does not Exist
<b>STAIRS/RAMPS: INTERIOR</b>	Inspected
Do Letter Stair Signs Exist?	Yes
<b>Ceiling</b>	Inspected
Condition	2 - Between Good and Fair
Deficiency	No deficiencies recorded
<b>Door(s)</b>	Inspected
Condition	2 - Between Good and Fair
Deficiency	METAL CLAD WOOD: DETERIORATED DOOR
Deficiency Location/Instance	Stair DB/4
Deficiency Quantity	1
Quantity Uom	EACH

Potential Action	MAINTENANCE
Urgency of Action	PRIORITY 3
Purpose of Action	LEVEL 2
Deficiency Photo1

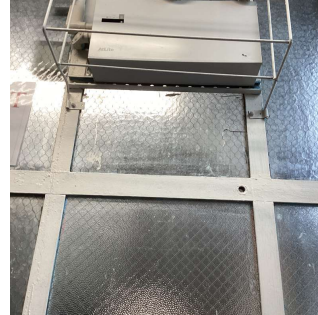
Stair DB/1

Violations	Stair DB/4 No violations recorded.
<b>Partition</b>	Inspected
Condition	3 - Fair
Deficiency	GLASS PANEL: DAMAGED/DETERIORATED
Deficiency Location/Instance	Stairs DB/1, EC/4
Deficiency Quantity	30
Quantity Uom	S.F.
Potential Action	REPLACE

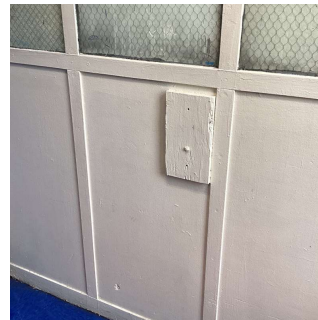
Stair EC/1

METAL PANEL: DAMAGED/DETERIORATED  
Stairs EC/Basement, 1, 2, 4  
40  
S.F.  
REPLACE  
PRIORITY 3  
LEVEL 2

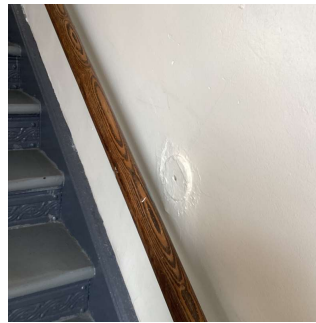
Stair DB/3

Inspected  
3 - Fair  
METAL: BROKEN BRACKET  
Stairs DB/1, 3, EC/2, 3, 4  
7  
EACH  
REPLACE  
PRIORITY 3  
LEVEL 2

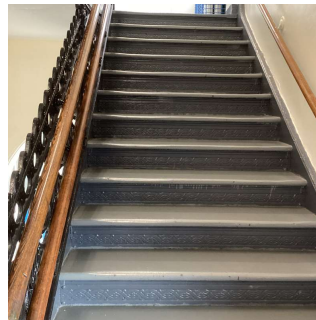
Stair DB/4

STONE: WORN-OUT TREAD/NOSINGS

REPLACE

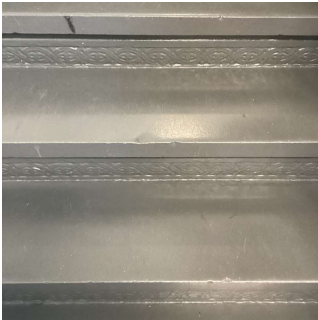
Question	Response
<b>INTERIOR</b>	
<b>STAIRS/RAMPS: INTERIOR</b>	
<b>Stairs and Landings</b>	
Violations	Stair EC/2 35671972J
Deficiency	STONE: BROKEN/MISSING
Deficiency Location/Instance	Stairs DB/2, 1, Basement
Deficiency Quantity	30
Quantity Uom	S.F.
Potential Action	REPLACE
Urgency of Action	PRIORITY 3
Purpose of Action	LEVEL 2
Deficiency Photo1

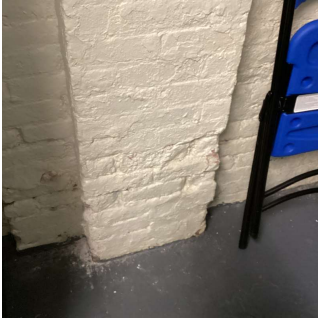
Violations	Stair DB/1 No violations recorded.
<b>Walls</b>	Inspected
Condition	2 - Between Good and Fair
Deficiency	BRICK: CRACKS/SPALLING
Deficiency Location/Instance	Stair EC/Basement
Deficiency Quantity	10
Quantity Uom	S.F.
Potential Action	REPLACE
Urgency of Action	PRIORITY 3
Purpose of Action	LEVEL 2
Deficiency Photo1

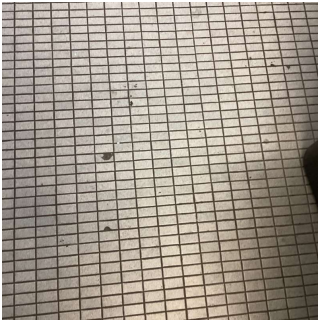
Violations	Staff Toilet Room inside Stair DB/1 No violations recorded.
<b>Floor Finish</b>	Inspected
Condition	3 - Fair
Deficiency	CERAMIC TILE: BROKEN/MISSING TILES
Deficiency Location/Instance	Staff Toilet Room inside Stair DB/1
Deficiency Quantity	10
Quantity Uom	S.F.
Potential Action	REPLACE
Urgency of Action	PRIORITY 3
Purpose of Action	LEVEL 2
Deficiency Photo1

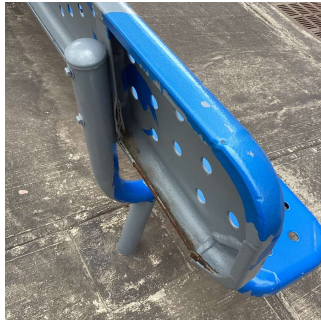
Schoolyard
Violations	No violations recorded.
<b>SEATING</b>	Inspected
<b>Benches</b>	Inspected
<b>Concrete</b>	Does not Exist
<b>Metal/Wood/Plastic</b>	Inspected
Condition	5 - Poor
Deficiency	DAMAGED/DETERIORATED
Deficiency Location/Instance	Schoolyard, near Exit 2
Deficiency Quantity	4
Quantity Uom	EACH
Potential Action	REPLACE
Urgency of Action	PRIORITY 3
Purpose of Action	LEVEL 2
Deficiency Photo1
