**NYC Department of Education**  
**Building Condition Assessment Survey 2023 - 2024**

Architectural Inspection

**Asset:**        **I.S. 117 - BROOKLYN, 300 WILLOUGHBY AVENUE, New York, 11205**

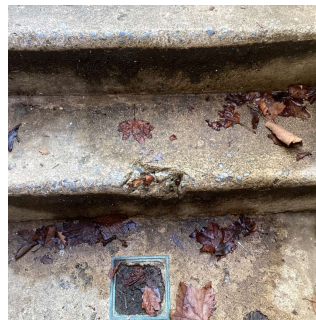
AW2

**AREAWAY STAIRS: MISSING RAILINGS**

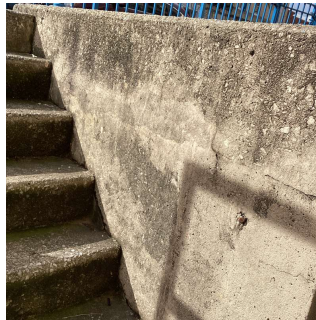
AW2

AREAWAY WALLS: CRACKS AND SPALLING

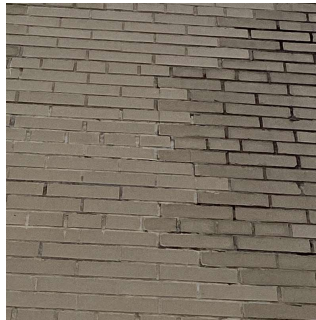
Violations	CH No violations recorded.
Deficiency	BRICK: MINOR CRACKS AND SPALLING

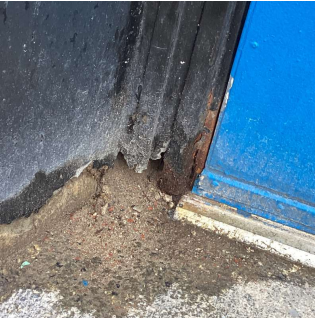
**METAL: DETERIORATED DOOR AND FRAME - MAJOR DETERIORATION**

Violations	Facade A - Main Entrance No violations recorded.
<b>DOOR HARDWARE</b>	Inspected
Condition	3 - Fair
Deficiency	No deficiencies recorded
<b>LINTELS</b>	Inspected
Condition	2 - Between Good and Fair
Deficiency	No deficiencies recorded
<b>TRANSOM/SIDE LIGHT</b>	Inspected
Condition	2 - Between Good and Fair
Deficiency	No deficiencies recorded
<b>EXTERIOR WALLS</b>	Inspected
Material Type(s)	Masonry
Replacement Quantity	32,000
Replacement Uom	S.F.
Instance on All Facades	Inspected
Instance Condition	3 - Fair
Instance Quantity	32,000
Instance Quantity Uom	S.F.
Deficiency	BRICK: DETERIORATED JOINTS

Deficiency Quantity	15
Quantity Uom	EACH
Potential Action	REPLACE
Urgency of Action	PRIORITY 4
Purpose of Action	LEVEL 2
Deficiency Photo1

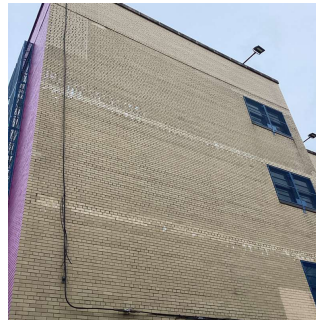
Facade B

**BRICK: EFFLORESCENCE**

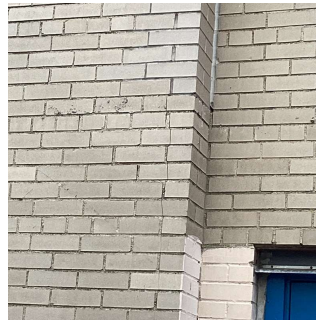
Facade H - Near Exit 10

**BRICK: CRACKS/DISPLACED/SPALLED BRICK AT BUILDING CORNERS**

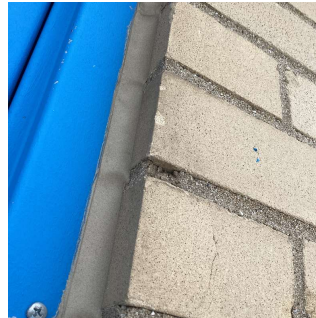
BH2

Roof 1
Instance Quantity	46,200
Instance Quantity Uom	S.F.
Does the roof have major mechanical equipment sitting on Dunnage Steel less than 18" above the Roofing?	No
Does this roof instance have a Sustainable Roof System?	Yes
Sustainable Roof Type	White Roof
Sustainable Roof Location (Roof Number)	All Roofs except Roof 3
Do solar panels exist on these roofs?	No
Is/Are the roof(s) suitable for Solar Panel installation?	Yes
Installation Year	2017
Source of Installation	Custodial Staff
Deficiency	No deficiencies recorded
<b>ROOFING DRAINS</b>	
	Inspected
Condition	2 - Between Good and Fair
Deficiency	No deficiencies recorded
<b>Specialties</b>	
	Inspected
<b>BULKHEAD/PENTHOUSE</b>	
	Inspected
Condition	3 - Fair
Deficiency	BULKHEAD/PENTHOUSE WALLS/EXTERIOR: DETERIORATED JOINTS

Deficiency Quantity	10
Quantity Uom	S.F.
Potential Action	REPOINT
Urgency of Action	PRIORITY 4
Purpose of Action	LEVEL 2

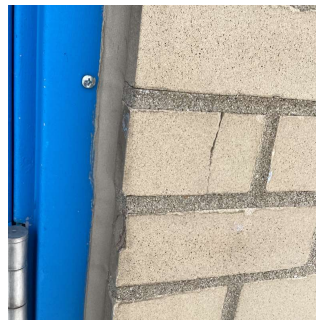
BH2

**BULKHEAD/PENTHOUSE WALLS/EXTERIOR:  
CRACKS/SPALLING - MINOR**

REPAIR

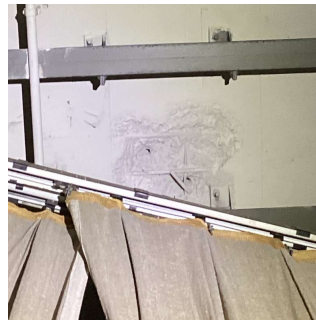
1st Floor - Auditorium Stage

CONCRETE: CRACKS/SPALLED/REINFORCEMENT EXPOSED

REPAIR

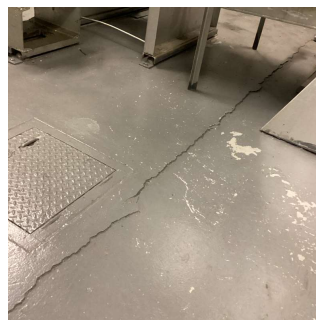
CONCRETE SLAB ON GRADE: THRU CRACKS

REPLACE

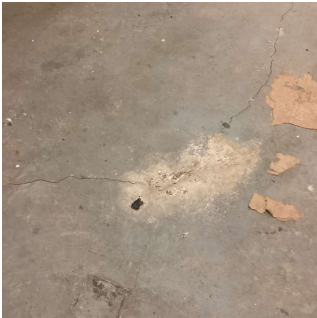
Question	Response
<b>INTERIOR</b>	
<b>STRUCTURAL</b>	
<b>FLOOR STRUCTURE</b>	
Violations	Inspected Basement - Room B26 No violations recorded.
Deficiency	CONCRETE SLAB ON GRADE: THRU CRACKS
Deficiency Location/Instance	Basement - Room B40, Boiler Room
Deficiency Quantity	50
Quantity Uom	S.F.
Potential Action	REPAIR
Urgency of Action	PRIORITY 3
Purpose of Action	LEVEL 5
Deficiency Photo1

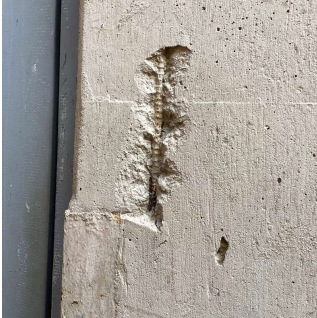
Violations	Basement - Room B40 No violations recorded.
<b>FOUNDATION WALLS</b>	
Material Type(s)	Inspected Concrete
Condition	4 - Between Fair and Poor
Deficiency	CONCRETE: CRACKED/SPALLED/REINFORCEMENT EXPOSED
Deficiency Location/Instance	Facade H - AW2
Deficiency Quantity	10
Quantity Uom	S.F.
Potential Action	REPAIR
Urgency of Action	PRIORITY 4
Purpose of Action	LEVEL 5
Deficiency Photo1

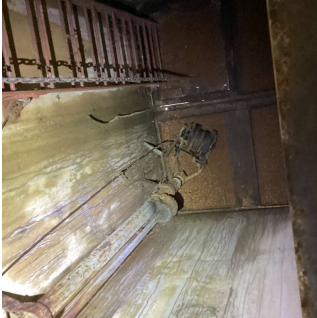
Basement - Ash Hoist Vault
Violations	No violations recorded.
Deficiency	WATER INFILTRATION
Deficiency Location/Instance	Basement - Ash Hoist Vault

Question	Response
<b>INTERIOR</b>	
<b>STRUCTURAL</b>	
<b>VAULTS-BUNKERS</b>	
<b>Vault/Ash Hoist Doors and Framing</b>	
Deficiency Quantity	10
Quantity Uom	S.F.
Potential Action	REPAIR
Urgency of Action	PRIORITY 5
Purpose of Action	LEVEL 2
Deficiency Photo1

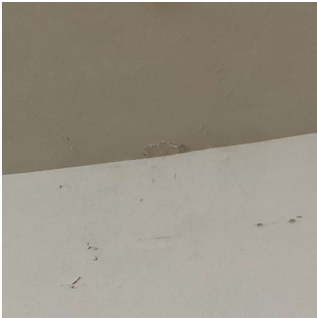
Basement - Ash Hoist Vault
Violations	No violations recorded.
<b>AUDITORIUM</b>	
	Inspected
Instance on 1st Floor (716 Seats)	Inspected
<b>Ceiling</b>	
Instance on 1st Floor (716 Seats)	Inspected
Condition	2 - Between Good and Fair
Deficiency	PLASTER: CRACKS/SPALLING
Deficiency Location/Instance	Near Entrance
Deficiency Quantity	10
Quantity Uom	S.F.
Potential Action	REPLACE
Urgency of Action	PRIORITY 3
Purpose of Action	LEVEL 2
Deficiency Photo1

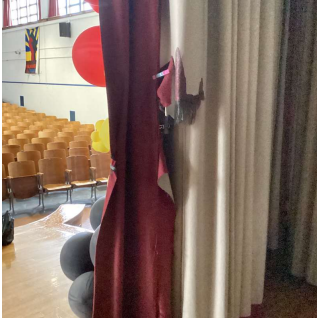
Question	Response
<b>INTERIOR</b>	
<b>AUDITORIUM</b>	
<b>Stage</b>	
<b>Stage</b>	
Deficiency Photo1	 
Violations	Stage No violations recorded.
Deficiency	DAMAGED STEPS
Deficiency Location/Instance	Left side
Deficiency Quantity	10
Quantity Uom	S.F.
Potential Action	REPLACE
Urgency of Action	PRIORITY 3
Purpose of Action	LEVEL 2
Deficiency Photo1	 
Violations	Left side No violations recorded.
<b>Stage Curtain Rigging</b>	Inspected
Instance on 1st Floor (716 Seats)	Inspected
Condition	5 - Poor
Deficiency	INOPERABLE
Deficiency Location/Instance	Main Stage Curtains
Deficiency Quantity	1
Quantity Uom	EACH
Potential Action	MAINTENANCE
Urgency of Action	PRIORITY 3
Purpose of Action	LEVEL 2
Deficiency Photo1	No photo recorded
Violations	No violations recorded.
<b>Stage Curtains</b>	Inspected
Instance on 1st Floor (716 Seats)	Inspected
Condition	4 - Between Fair and Poor
Deficiency	WORN/DETERIORATED
Deficiency Location/Instance	Right side, left side

Question	Response
<b>INTERIOR</b>	
<b>AUDITORIUM</b>	
<b>Stage</b>	
<b>Stage Curtains</b>	
Deficiency Quantity	600
Quantity Uom	S.F.
Potential Action	REPLACE
Urgency of Action	PRIORITY 3
Purpose of Action	LEVEL 2
Deficiency Photo1

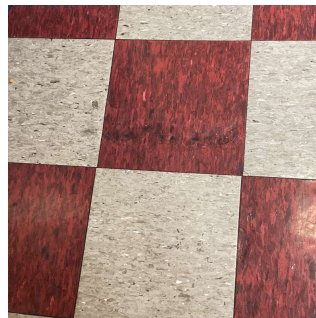
Near exit 6

VINYL TILES: DETERIORATED SUBSTRATE

REPLACE

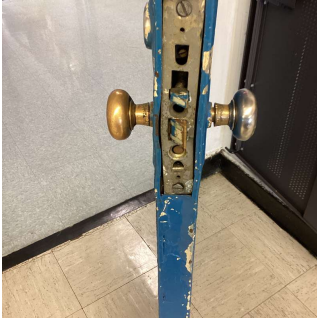
Question	Response
<b>INTERIOR</b>	
<b>CLASSROOMS/CORRIDORS/ADMIN SPACES</b>	
<b>Door(s)</b>	Inspected
Condition	5 - Poor
Deficiency	METAL: DETERIORATED DOOR
Deficiency Location/Instance	Room 307
Deficiency Quantity	1
Quantity Uom	EACH
Potential Action	MAINTENANCE
Urgency of Action	PRIORITY 3
Purpose of Action	LEVEL 2
Deficiency Photo1

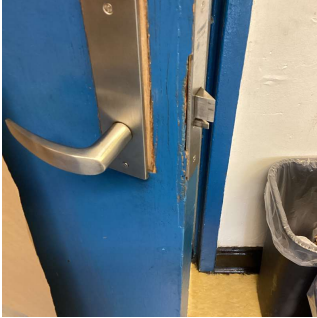
Violations	Room 307 No violations recorded.
Deficiency	WOOD: DETERIORATED DOOR
Deficiency Location/Instance	Room 320, 308, 230, 108, B1, and others
Deficiency Quantity	22
Quantity Uom	EACH
Potential Action	MAINTENANCE
Urgency of Action	PRIORITY 3
Purpose of Action	LEVEL 2
Deficiency Photo1

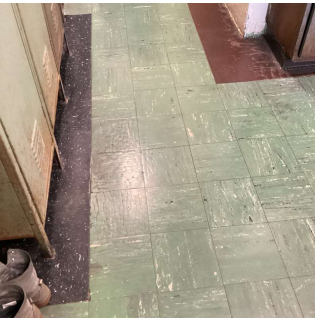
Room 313  No violations recorded.
Deficiency Deficiency Location/Instance Deficiency Quantity Quantity Uom Potential Action Urgency of Action Purpose of Action Deficiency Photo1           Violations	VINYL TILES: BROKEN/DETERIORATED/MISSING TILES Room B13, B12, Exit 6, Corridor near Room 313, 237, and others 180 S.F. REPLACE PRIORITY 3 LEVEL 2

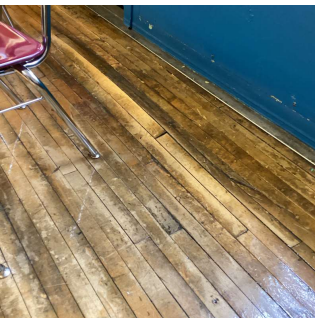
Room 112  No violations recorded.

Room B12  No violations recorded.
Deficiency Deficiency Location/Instance Deficiency Quantity Quantity Uom Potential Action Urgency of Action Purpose of Action Deficiency Photo1           Violations	WOOD: DETERIORATED SUBSTRATE Room 112 50 S.F. REPLACE PRIORITY 5 LEVEL 6

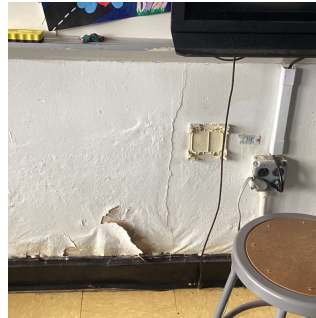
Room 303

PLASTER: CRACKS/SPALLING

REPLACE

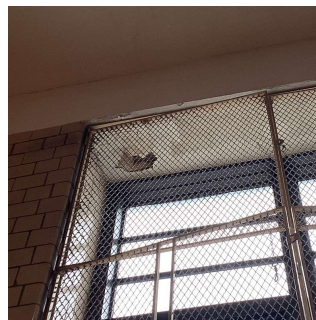
PLASTER: CRACKS/SPALLING

REPLACE

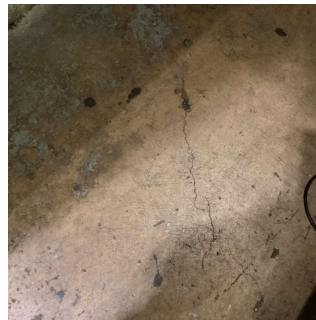
Deficiency	CONCRETE: CRACKS
Deficiency Location/Instance	Storage
Deficiency Quantity	10
Quantity Uom	S.F.
Potential Action	REPLACE
Urgency of Action	PRIORITY 3
Purpose of Action	LEVEL 2

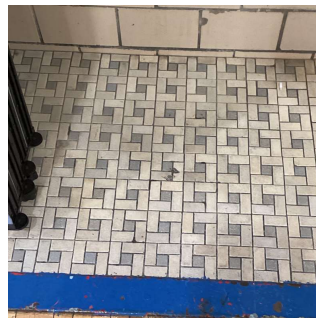
Deficiency	CERAMIC TILE: BROKEN/MISSING TILES
Deficiency Location/Instance	Water fountain area
Deficiency Quantity	10
Quantity Uom	S.F.
Potential Action	REPLACE
Urgency of Action	PRIORITY 3
Purpose of Action	LEVEL 2

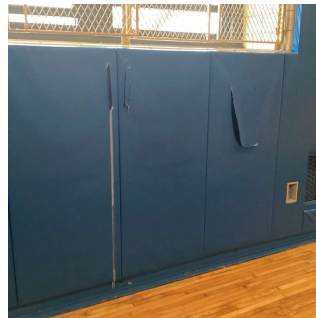
Instance on 1st Floor	Inspected
Condition	2 - Between Good and Fair
Deficiency	WALL PADDING: DETERIORATED
Deficiency Location/Instance	Near Windows
Deficiency Quantity	100
Quantity Uom	S.F.
Potential Action	REPLACE
Urgency of Action	PRIORITY 3
Purpose of Action	LEVEL 2
Deficiency Photo1

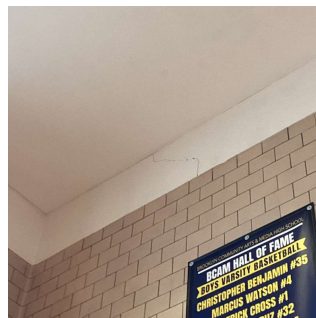
Deficiency	PLASTER: CRACKS/SPALLING
Deficiency Location/Instance	Near Windows
Deficiency Quantity	10
Quantity Uom	S.F.
Potential Action	REPLACE
Urgency of Action	PRIORITY 3
Purpose of Action	LEVEL 2
Deficiency Photo1

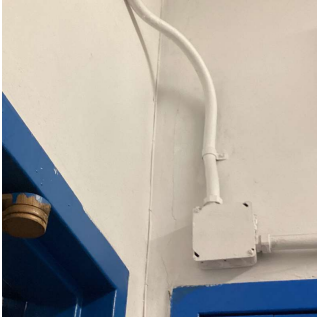
Question	Response
<b>INTERIOR</b>	
<b>KITCHEN</b>	
<b>Floor Finish</b>	
Violations	No violations recorded.
<b>Walls</b>	
Instance on Basement	Inspected
Condition	2 - Between Good and Fair
Deficiency	PLASTER: CRACKS/SPALLING
Deficiency Location/Instance	Near exit
Deficiency Quantity	10
Quantity Uom	S.F.
Potential Action	REPLACE
Urgency of Action	PRIORITY 3
Purpose of Action	LEVEL 2
Deficiency Photo1

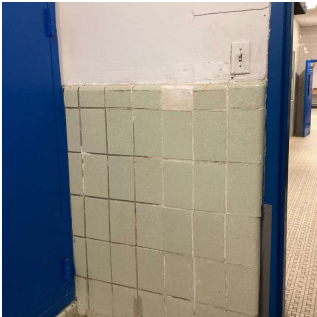
Violations	No violations recorded.
Deficiency	GLAZED BLOCK: CRACKS/SPALLING
Deficiency Location/Instance	Near storage
Deficiency Quantity	10
Quantity Uom	S.F.
Potential Action	REPLACE
Urgency of Action	PRIORITY 3
Purpose of Action	LEVEL 2
Deficiency Photo1

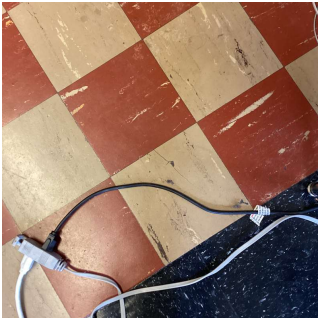
Question	Response
<b>INTERIOR</b>	
<b>KITCHEN</b>	
<b>Walls</b>	
Deficiency Photo1	 
Violations	Near servery No violations recorded.
<b>LIBRARY</b>	
Instance on Room 240	Inspected
<b>Built-in Furnishing</b>	Inspected
Instance on Room 240	Inspected
Condition	2 - Between Good and Fair
Deficiency	No deficiencies recorded
<b>Ceiling</b>	
Instance on Room 240	Inspected
Condition	2 - Between Good and Fair
Deficiency	No deficiencies recorded
<b>Door(s)</b>	
Instance on Room 240	Inspected
Condition	3 - Fair
Deficiency	WOOD: DETERIORATED DOOR
Deficiency Location/Instance	Office
Deficiency Quantity	1
Quantity Uom	EACH
Potential Action	MAINTENANCE
Urgency of Action	PRIORITY 3
Purpose of Action	LEVEL 2
Deficiency Photo1	 
Violations	Office No violations recorded.
<b>Floor Finish</b>	
Instance on Room 240	Inspected
Condition	2 - Between Good and Fair
Deficiency	VINYL TILES: BROKEN/DETERIORATED/MISSING TILES
Deficiency Location/Instance	Office

Question	Response
<b>INTERIOR</b>	
<b>LIBRARY</b>	
<b>Floor Finish</b>	
Deficiency Quantity	10
Quantity Uom	S.F.
Potential Action	REPLACE
Urgency of Action	PRIORITY 3
Purpose of Action	LEVEL 2
Deficiency Photo1

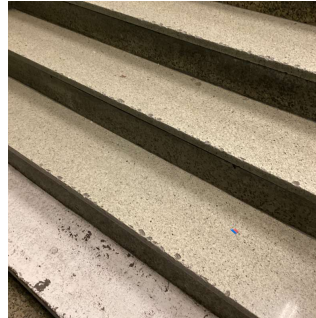
Main Entrance Vestibule

Quantity Uom	S.F.
Potential Action	REPLACE
Urgency of Action	PRIORITY 3
Purpose of Action	LEVEL 2
Deficiency Photo1

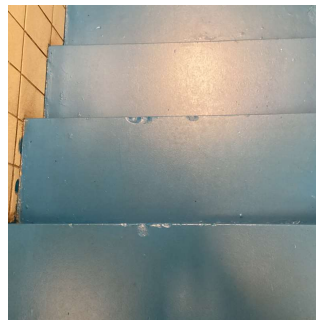
Exit 11

Deficiency	CONCRETE: CRACKS/SPALLING - MAJOR
Deficiency Location/Instance	Exit 11, Stair AB/3, 2, CD/3, 2
Deficiency Quantity	150
Quantity Uom	S.F.
Potential Action	REPLACE
Urgency of Action	PRIORITY 3
Purpose of Action	LEVEL 2
Deficiency Photo1

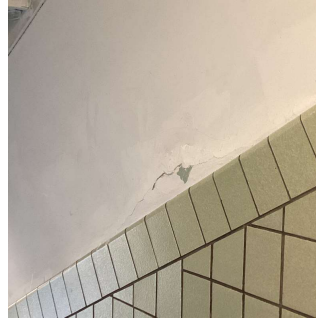
Stair AB/3

Deficiency

PLASTER: CRACKS/SPALLING

REPLACE

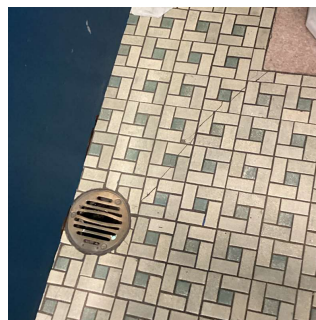
Deficiency

CERAMIC TILE: BROKEN/MISSING TILES

REPLACE

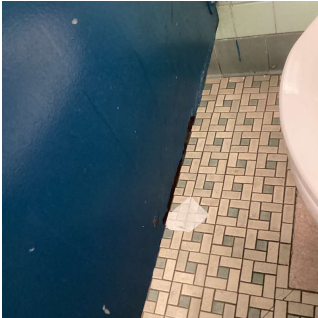
Question	Response
<b>INTERIOR</b>	
<b>TOILET ROOMS - STAFF</b>	
<b>Floor Finish</b>	Inspected
	Room 320
Violations	No violations recorded.
<b>Stalls</b>	Inspected
Condition	5 - Poor
Deficiency	RUST - MAJOR
Deficiency Location/Instance	Room 320, B12
Deficiency Quantity	2
Quantity Uom	EACH
Potential Action	REPLACE
Urgency of Action	PRIORITY 3
Purpose of Action	LEVEL 2
Deficiency Photo1

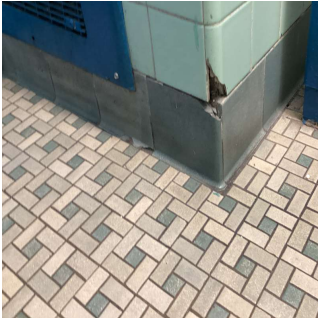
Room 320
Violations	No violations recorded.
<b>Walls</b>	Inspected
Condition	2 - Between Good and Fair
Deficiency	CERAMIC TILE: BROKEN/ MISSING
Deficiency Location/Instance	Room 320, B12, Principals Toilet, Nurses Toilet
Deficiency Quantity	35
Quantity Uom	S.F.
Potential Action	REPLACE
Urgency of Action	PRIORITY 3
Purpose of Action	LEVEL 2
Deficiency Photo1

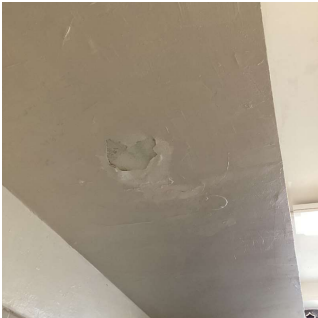
Question	Response
<b>INTERIOR</b>	
<b>TOILET ROOMS - STAFF</b>	
<b>Walls</b>	
Urgency of Action	PRIORITY 3
Purpose of Action	LEVEL 2
Deficiency Photo1	 
	Principals Toioet
Violations	No violations recorded.
<b>TOILET ROOMS - STUDENTS</b>	
	Inspected
<b>Ceiling</b>	Inspected
Condition	2 - Between Good and Fair
Deficiency	PLASTER: CRACKS/SPALLING
Deficiency Location/Instance	Room 127
Deficiency Quantity	10
Quantity Uom	S.F.
Potential Action	REPLACE
Urgency of Action	PRIORITY 3
Purpose of Action	LEVEL 2
Deficiency Photo1

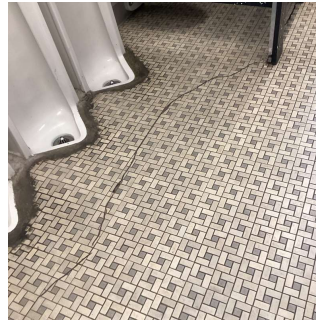
Room 327

Deficiency

CERAMIC TILE: DETERIORATED SUBSTRATE

REPLACE

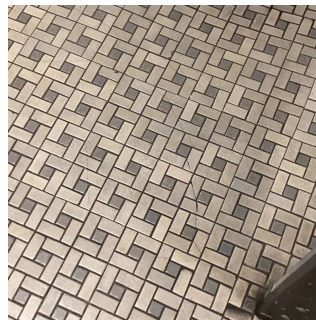
Deficiency

CERAMIC TILE: BROKEN/MISSING TILES

REPLACE

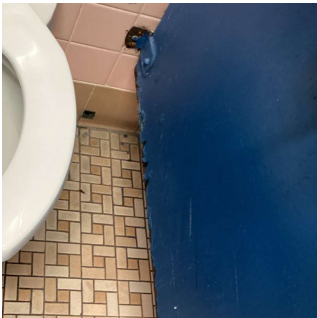
Question	Response
<b>INTERIOR</b>	
<b>TOILET ROOMS - STUDENTS</b>	
<b>Floor Finish</b>	Inspected
	Room 227
Violations	No violations recorded.
<b>Stalls</b>	Inspected
Condition	5 - Poor
Deficiency	RUST - MAJOR
Deficiency Location/Instance	Room 319, 219, 119, B19
Deficiency Quantity	16
Quantity Uom	EACH
Potential Action	REPLACE
Urgency of Action	PRIORITY 3
Purpose of Action	LEVEL 2
Deficiency Photo1

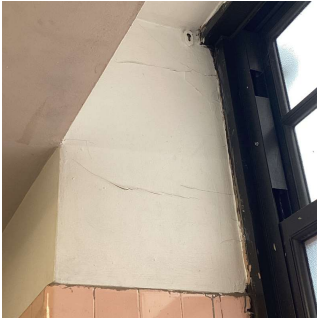
Violations	Room B19 No violations recorded.
<b>Walls</b>	Inspected
Condition	2 - Between Good and Fair
Deficiency	PLASTER: CRACKS/SPALLING
Deficiency Location/Instance	Room 119, B19
Deficiency Quantity	20
Quantity Uom	S.F.
Potential Action	REPLACE
Urgency of Action	PRIORITY 3
Purpose of Action	LEVEL 2
Deficiency Photo1

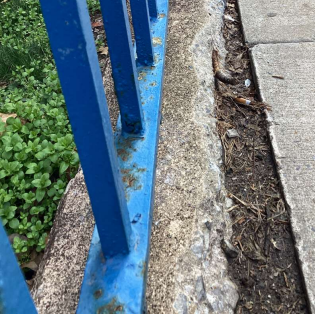
Condition	4 - Between Fair and Poor
Deficiency	CONCRETE CURB: DAMAGED/DETERIORATED
Deficiency Location/Instance	Along Kent Avenue
Deficiency Quantity	10
Quantity Uom	S.F.
Potential Action	REPLACE
Urgency of Action	PRIORITY 5
Purpose of Action	LEVEL 6

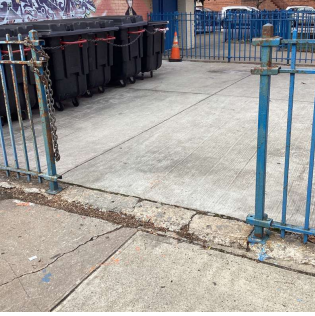
Violations	<p>Along Kent Avenue No violations recorded.</p>
Deficiency	<b>WROUGHT IRON: MISSING SECTIONS</b>
Deficiency Location/Instance	Along Franklin Avenue
Deficiency Quantity	40
Quantity Uom	S.F.
Potential Action	REPLACE
Urgency of Action	PRIORITY 3
Purpose of Action	LEVEL 2
Deficiency Photo1

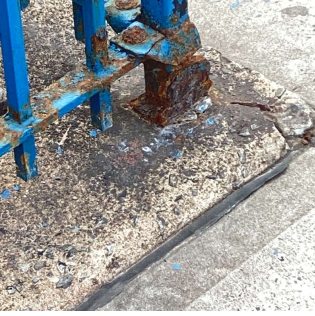
Violations	<p>Along Franklin Avenue No violations recorded.</p>
Deficiency	<b>WROUGHT IRON: RUST - MAJOR</b>
Deficiency Location/Instance	Along Willoughby Avenue, Kent Avenue
Deficiency Quantity	200
Quantity Uom	S.F.
Potential Action	REPLACE
Urgency of Action	PRIORITY 3
Purpose of Action	LEVEL 2
Deficiency Photo1

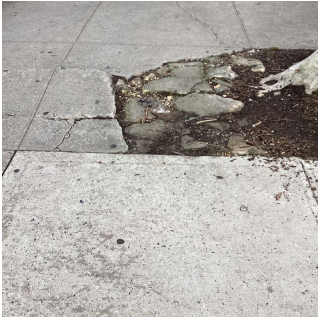
Question	Response
<b>SITE</b>	
<b>PAVING</b>	
<b>Site Sidewalks &amp; Walkways</b>	Inspected
<b>Concrete</b>	Inspected
Violations	No violations recorded.
<b>Pavers</b>	Does not Exist
<b>DOT Sidewalk</b>	Inspected
<b>Asphalt</b>	Does not Exist
<b>Concrete</b>	Inspected
Condition	4 - Between Fair and Poor
Deficiency	HEAVING
Deficiency Location/Instance	Along Franklin Avenue
Deficiency Quantity	50
Quantity Uom	S.F.
Potential Action	REPLACE
Urgency of Action	PRIORITY 5
Purpose of Action	LEVEL 6
Deficiency Photo1

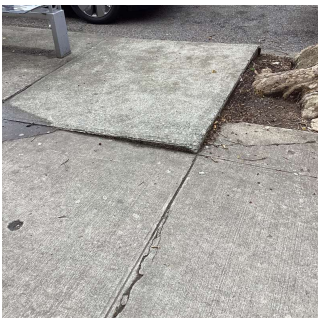
Violations	Along Franklin Avenue No violations recorded.
Deficiency	HEAVING
Deficiency Location/Instance	Along Willoughby Avenue
Deficiency Quantity	125
Quantity Uom	S.F.
Potential Action	REPLACE
Urgency of Action	PRIORITY 3
Purpose of Action	LEVEL 2
Deficiency Photo1

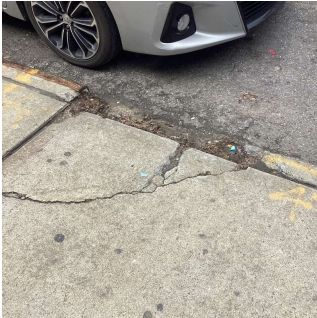
Violations	Along Willoughby Avenue No violations recorded.
Deficiency	DAMAGED CURBS
Deficiency Location/Instance	Along Willoughby Avenue, Franklin Avenue, Kent Avenue

Question	Response
<b>SITE</b>	
<b>PAVING</b>	
<b>DOT Sidewalk</b>	Inspected
<b>Concrete</b>	
Quantity Uom	L.F.
Potential Action	REPLACE
Urgency of Action	PRIORITY 3
Purpose of Action	LEVEL 2
Deficiency Photo1

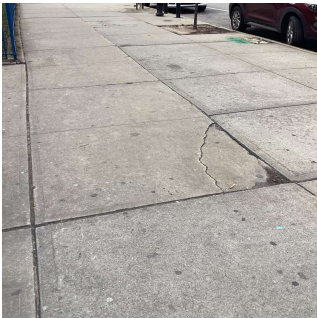
Violations	Along Willoughby Avenue No violations recorded.
Deficiency	DAMAGED/DETERIORATED/MISSING SECTIONS
Deficiency Location/Instance	Along Willoughby Avenue, Franklin Avenue, Kent Avenue
Deficiency Quantity	3,575
Quantity Uom	S.F.
Potential Action	REPLACE
Urgency of Action	PRIORITY 3
Purpose of Action	LEVEL 2
Deficiency Photo1
