**NYC Department of Education**  
**Building Condition Assessment Survey 2023 - 2024**

Architectural Inspection

**Asset:** P.S. 119 - BROOKLYN, 3829 AVENUE K, New York, 11210

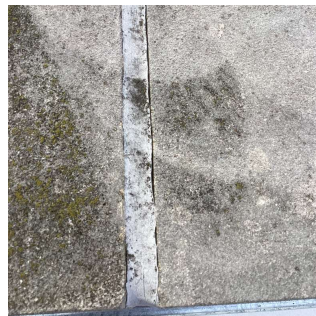
Deficiency CAST STONE: DETERIORATED TRANSVERSE JOINTS

Deficiency Quantity	10
Quantity Uom	L.F.
Potential Action	MAINTENANCE
Urgency of Action	PRIORITY 3
Purpose of Action	LEVEL 2
Deficiency Photo1

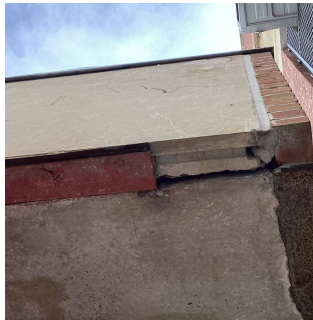
Facade C

**EXTERIOR SOFFITS**

REPLACE

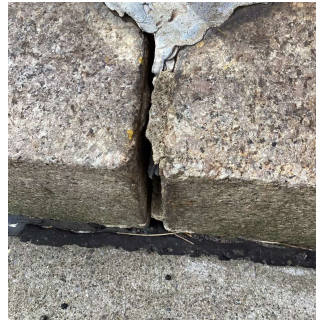
Facade A

**STONE: DETERIORATED JOINTS**

15  
 S.F.  
 REPOINT  
 PRIORITY 3  
 LEVEL 2

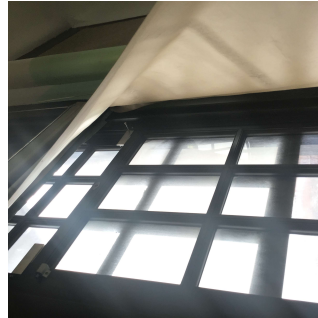
Room 200

ALUMINUM - DOUBLE HUNG: INOPERABLE BALANCE

REPLACE BALANCES

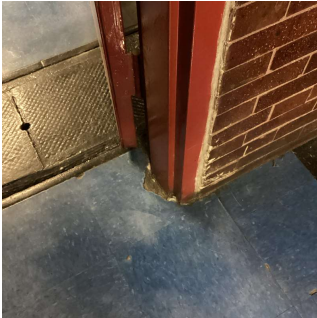
Question	Response
<b>INTERIOR</b>	
<b>CAFETERIA</b>	
<b>Fixed Equipment</b>	
Instance on Basement	Does not Exist
<b>Floor Finish</b>	
Instance on Basement	Inspected
Condition	2 - Between Good and Fair
Deficiency	VINYL TILES: BROKEN/DETERIORATED/MISSING TILES
Deficiency Location/Instance	Near Boiler Room, by Custodian Office
Deficiency Quantity	20
Quantity Uom	S.F.
Potential Action	REPLACE
Urgency of Action	PRIORITY 3
Purpose of Action	LEVEL 2
Deficiency Photo1

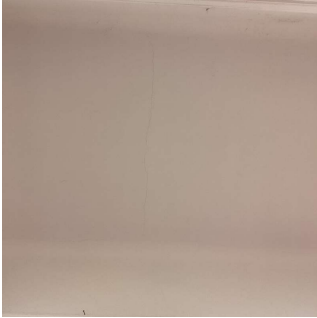
Near Room 136
Violations	No violations recorded.
<b>Window Curtains/Shades/Blinds</b>	
Instance on Basement	Does not Exist
<b>CLASSROOMS/CORRIDORS/ADMIN SPACES</b>	
<b>Ceiling</b>	Inspected
Condition	2 - Between Good and Fair
Deficiency	PLASTER: CRACKS/SPALLING
Deficiency Location/Instance	Rooms 207, 310, Corridor near Room 308
Deficiency Quantity	30
Quantity Uom	S.F.
Potential Action	REPLACE
Urgency of Action	PRIORITY 3
Purpose of Action	LEVEL 2
Deficiency Photo1

Corridor near Room 308
Violations	No violations recorded.
<b>Door(s)</b>	
Condition	Inspected
Condition	5 - Poor
Deficiency	WOOD: DETERIORATED DOOR

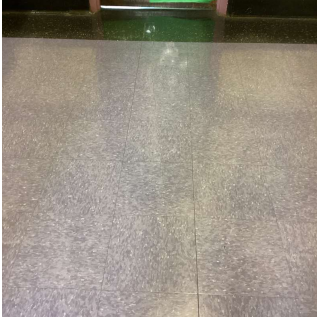
Room 103
Violations	No violations recorded.
<b>Floor Finish</b>	Inspected
Condition	3 - Fair
Deficiency	VINYL TILES: DETERIORATED SUBSTRATE
Deficiency Location/Instance	Rooms 108A, Corridor near Rooms 102, 103, 109, 308 and others
Deficiency Quantity	250
Quantity Uom	S.F.
Potential Action	REPLACE
Urgency of Action	PRIORITY 3
Purpose of Action	LEVEL 2
Deficiency Photo1

Corridor near Room 102
Violations	No violations recorded.
Deficiency	CERAMIC TILE: BROKEN/MISSING TILES
Deficiency Location/Instance	Main Entrance - Vestibule
Deficiency Quantity	20
Quantity Uom	S.F.
Potential Action	REPLACE
Urgency of Action	PRIORITY 3
Purpose of Action	LEVEL 2

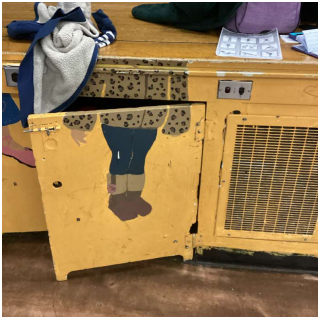
Violations	Near Room B100 No violations recorded.
<b>Seating</b>	
Instance on Basement	Does not Exist
<b>Sliding-folding Partition</b>	
Instance on Basement	Does not Exist
<b>Stage</b>	
Instance on Basement	Inspected
<b>Stage</b>	
Instance on Basement	Inspected
Condition	2 - Between Good and Fair
Deficiency	DAMAGED FASCIA
Deficiency Location/Instance	Front
Deficiency Quantity	10
Quantity Uom	S.F.
Potential Action	REPLACE
Urgency of Action	PRIORITY 3
Purpose of Action	LEVEL 2
Deficiency Photo1

Violations	Front No violations recorded.
Deficiency	DAMAGED FLOOR
Deficiency Location/Instance	Center
Deficiency Quantity	10

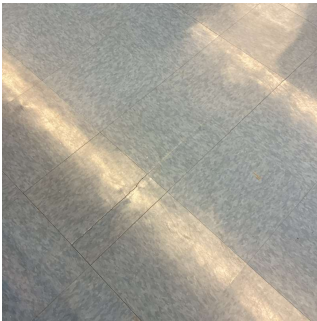
Question	Response
<b>INTERIOR</b>	
<b>LIBRARY</b>	
<b>Floor Finish</b>	
Deficiency Photo1

Violations	Near Main Entrance No violations recorded.
<b>Walls</b>	
Instance on Room 308	Inspected
Condition	2 - Between Good and Fair
Deficiency	PLASTER: CRACKS/SPALLING
Deficiency Location/Instance	Near Windows
Deficiency Quantity	10
Quantity Uom	S.F.
Potential Action	REPLACE
Urgency of Action	PRIORITY 3
Purpose of Action	LEVEL 2
Deficiency Photo1

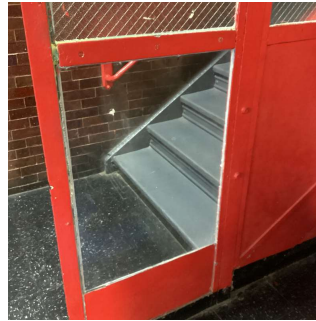
Stair B/Basement

**Partition**

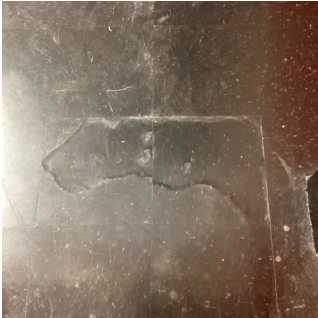
Question	Response
<b>INTERIOR</b>	
<b>STAIRS/RAMPS: INTERIOR</b>	
<b>Stairs and Landings</b>	
Deficiency	VINYL TILES: DETERIORATED SUBSTRATE
Deficiency Location/Instance	Stair B/Basement
Deficiency Quantity	10
Quantity Uom	S.F.
Potential Action	REPLACE
Urgency of Action	PRIORITY 3
Purpose of Action	LEVEL 2
Deficiency Photo1

Violations	Stair B/Basement No violations recorded.
Deficiency	STONE: WORN-OUT TREAD/NOSINGS
Deficiency Location/Instance	Stairs A/1, C/1, 2, D/1, 2 and others
Deficiency Quantity	210
Quantity Uom	S.F.
Potential Action	REPLACE
Urgency of Action	PRIORITY 3
Purpose of Action	LEVEL 2
Deficiency Photo1

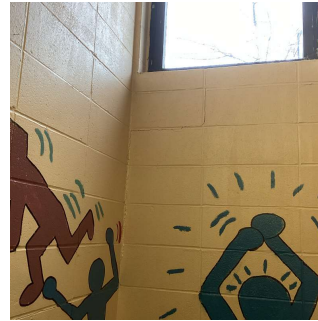
Stair F/Basement

**Walls**

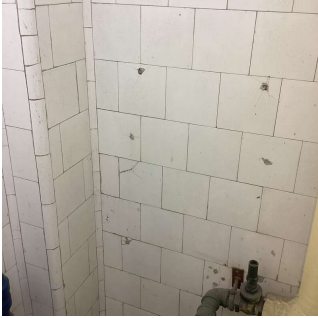
Question	Response
<b>INTERIOR</b>	
<b>TOILET ROOMS - STAFF</b>	Inspected
<b>Ceiling</b>	Inspected
Condition	2 - Between Good and Fair
Deficiency	No deficiencies recorded
<b>Door(s)</b>	Inspected
Condition	2 - Between Good and Fair
Deficiency	No deficiencies recorded
<b>Floor Finish</b>	Inspected
Condition	2 - Between Good and Fair
Deficiency	No deficiencies recorded
<b>Stalls</b>	Inspected
Condition	2 - Between Good and Fair
Deficiency	No deficiencies recorded
<b>Walls</b>	Inspected
Condition	2 - Between Good and Fair
Deficiency	CERAMIC TILE: BROKEN/ MISSING
Deficiency Location/Instance	Staff Toilet Room - 2nd Floor
Deficiency Quantity	10
Quantity Uom	S.F.
Potential Action	REPLACE
Urgency of Action	PRIORITY 3
Purpose of Action	LEVEL 2
Deficiency Photo1

Staff Toilet Room - 2nd Floor
Violations	No violations recorded.
<b>TOILET ROOMS - STUDENTS</b>	Inspected
<b>Ceiling</b>	Inspected
Condition	2 - Between Good and Fair

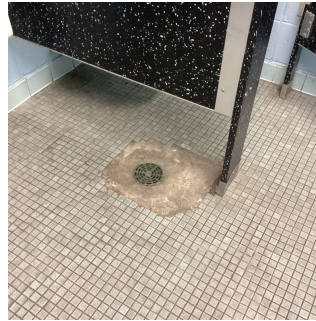
Room B102

Deficiency	No deficiencies recorded
<b>Door(s)</b>	Inspected
Condition	2 - Between Good and Fair
Deficiency	No deficiencies recorded
<b>Floor Finish</b>	Inspected
Condition	2 - Between Good and Fair
Deficiency	CERAMIC TILE: BROKEN/MISSING TILES
Deficiency Location/Instance	Rooms B102, B100, In Room 104
Deficiency Quantity	30
Quantity Uom	S.F.
Potential Action	REPLACE
Urgency of Action	PRIORITY 3
Purpose of Action	LEVEL 2

**Floor Finish**

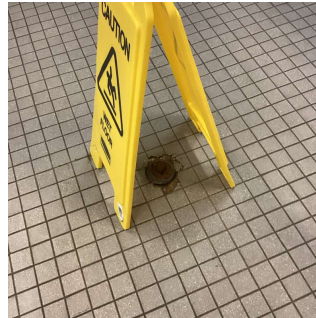
Girls Toilet Room - Basement

CERAMIC TILE: BROKEN/MISSING TILES

REPLACE

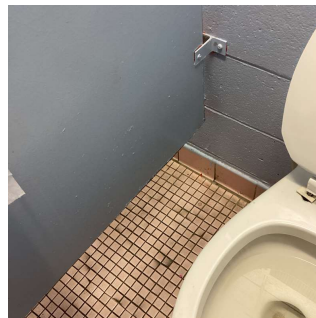
RUST - MAJOR

REPLACE

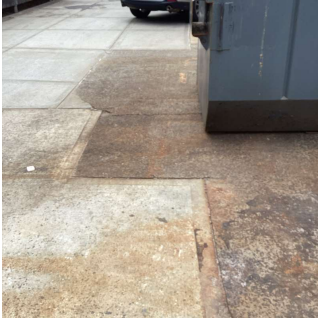
Question	Response
<b>INTERIOR</b>	
<b>TOILET ROOMS - STUDENTS</b>	
<b>Stalls</b>	Inspected
	Room B100
Violations	No violations recorded.
<b>Walls</b>	Inspected
Condition	2 - Between Good and Fair
Deficiency	No deficiencies recorded
<b>LIFE SAFETY</b>	Inspected
<b>F.D. HOLDING AREA</b>	Does not Exist
<b>STEEL STAIRS</b>	Does not Exist
<b>SITE</b>	Inspected
<b>CONTAINERIZATION</b>	Inspected
Condition	5 - Poor
Deficiency	CONCRETE PAD DAMAGED
Deficiency Location/Instance	E 39th Street
Deficiency Quantity	100
Quantity Uom	S.F.
Potential Action	REPAIR
Urgency of Action	PRIORITY 3
Purpose of Action	LEVEL 2
Deficiency Photo1

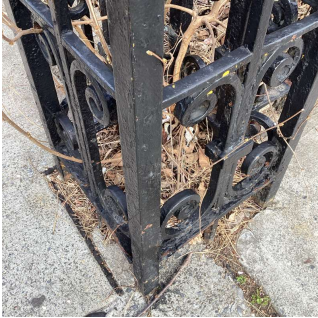
<b>Culverts - Soil Covering</b>	Does not Exist
<b>DRINKING FOUNTAINS</b>	Does not Exist
<b>FENCES</b>	Inspected
Condition	4 - Between Fair and Poor
Deficiency	WROUGHT IRON: RUST - MAJOR
Deficiency Location/Instance	E 39th Street, E 38th Street, Avenue K
Deficiency Quantity	120
Quantity Uom	S.F.
Potential Action	REPLACE
Urgency of Action	PRIORITY 3
Purpose of Action	LEVEL 2
Deficiency Photo1

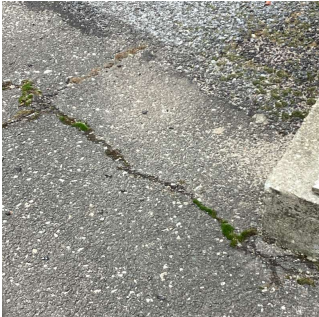
Question	Response
<b>SITE</b>	
<b>PAVING</b>	
<b>Student Non-Use</b>	
<b>Asphalt</b>	
Deficiency Photo1

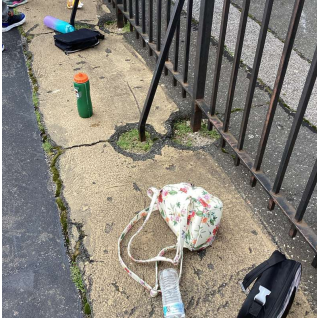
Question	Response
<b>SITE</b>	
<b>PAVING</b>	
<b>Student Use</b>	
<b>Concrete</b>	
Deficiency Photo1

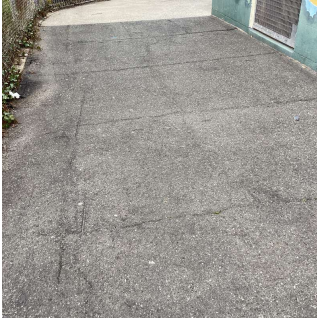
Violations	Schoolyard No violations recorded.
<b>Pavers</b>	Inspected
Condition	2 - Between Good and Fair
Deficiency	No deficiencies recorded
<b>Site Sidewalks &amp; Walkways</b>	Inspected
<b>Asphalt</b>	Inspected
Condition	3 - Fair
Deficiency	CRACKS - MAJOR
Deficiency Location/Instance	Avenue K
Deficiency Quantity	100
Quantity Uom	S.F.
Potential Action	REPLACE
Urgency of Action	PRIORITY 3
Purpose of Action	LEVEL 2
Deficiency Photo1

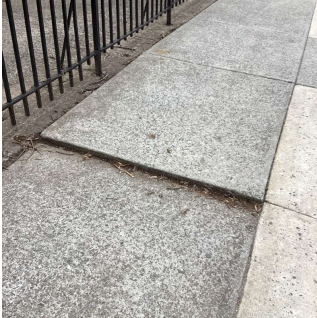
Question	Response
<b>SITE</b>	
<b>PAVING</b>	
<b>DOT Sidewalk</b>	
<b>Concrete</b>	
Deficiency Photo1

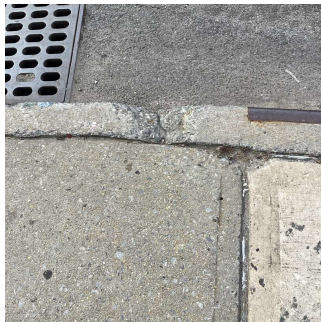
Question	Response
<b>SITE</b>	
<b>PAVING</b>	
<b>DOT Sidewalk</b>	
<b>Concrete</b>	
Violations	87738
Deficiency	DAMAGED CURBS
Deficiency Location/Instance	Avenue K, E 39th Street, E 38th Street
Deficiency Quantity	230
Quantity Uom	L.F.
Potential Action	REPLACE
Urgency of Action	PRIORITY 4
Purpose of Action	LEVEL 4
Deficiency Photo1
