**NYC Department of Education**  
**Building Condition Assessment Survey 2023 - 2024**

Architectural Inspection

**K123**

**Asset:** P.S. 123 - BROOKLYN, 100 IRVING AVENUE, New York, 11237

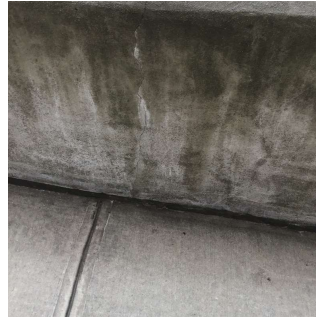
AW1

**AREAWAY WALLS: CRACKS AND SPALLING**

REPAIR

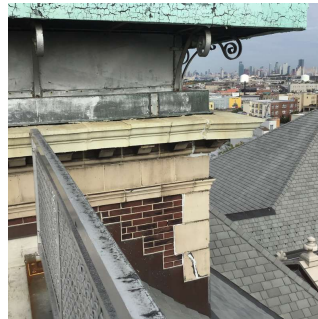
Roof 1 Cornices

**PRE-CAST CONCRETE: DETERIORATED JOINTS**

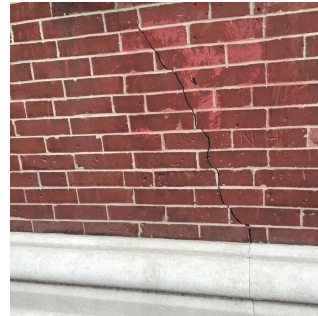
Facade B

**BRICK: MAJOR / THRU CRACKS**

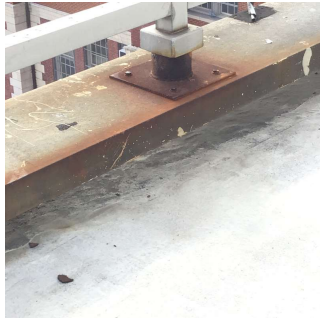
Question	Response
<b>EXTERIOR</b>	
<b>ROOF</b>	
<b>Roofing</b>	
<b>ROOF BARRIER/FENCE</b>	
Deficiency Photo1

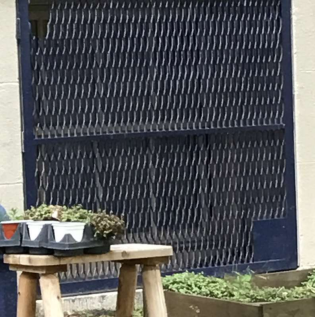
Violations	All Facades Basement Windows No violations recorded.
<b>LINTELS</b>	Inspected
Condition	2 - Between Good and Fair
Deficiency	No deficiencies recorded
<b>WINDOWS</b>	Inspected
Material Type(s)	Aluminum
Instance on Aluminum - Double Hung: All Facades	Inspected
Instance Condition	3 - Fair
Instance Quantity	10,000
Instance Quantity Uom	S.F.
Are these windows insulated	No
Installation Year	1999
Source of Installation	Custodial Staff
Deficiency	ALUMINUM - DOUBLE HUNG: INOPERABLE BALANCE

Deficiency Quantity	60
Quantity Uom	S.F.
Potential Action	REPLACE
Urgency of Action	PRIORITY 4
Purpose of Action	LEVEL 2
Deficiency Photo1

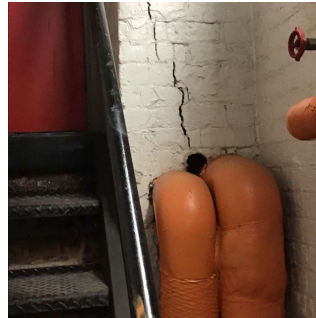
Facade E Room 306 No violations recorded.
<b>INTERIOR</b>	
<b>POOLS</b>	Does not Exist
<b>STRUCTURAL</b>	
<b>COLUMNS/BEAMS/BEARING WALLS</b>	
Condition	2 - Between Good and Fair
Deficiency  Deficiency Location/Instance Deficiency Quantity Quantity Uom Potential Action Urgency of Action	STEEL COLUMNS/BEAMS: DETERIORATED MASONRY FIREPROOFING  Vault Stair near Stair G  10 S.F. REPLACE PRIORITY 3

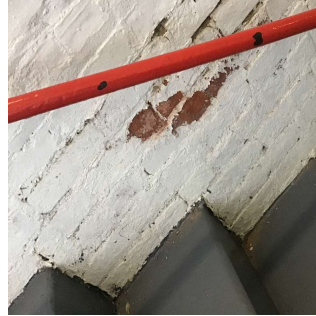
Stair 12

CINDER CONCRETE ARCH: METAL PAN DETERIORATED, SPALLED

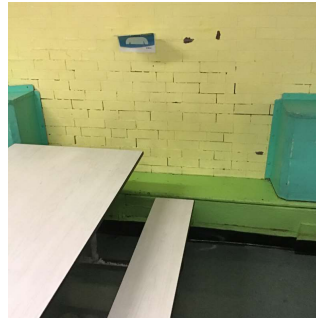
Basement cafeteria

**BRICK: DETERIORATED JOINTS**  
Basement  
500  
S.F.  
REPOINT  
PRIORITY 3  
LEVEL 5

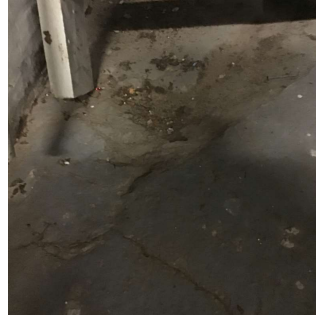
Violations	Boiler Room, Tank Room No violations recorded.
<b>Slab Structure</b>	Inspected
Condition	3 - Fair
Deficiency	CONCRETE SLAB ON GRADE: THRU CRACKS
Deficiency Location/Instance	Basement - Mechanical Equipment Room Vault
Deficiency Quantity	10
Quantity Uom	S.F.
Potential Action	REPAIR
Urgency of Action	PRIORITY 3
Purpose of Action	LEVEL 5

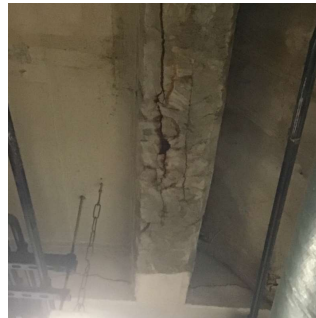
STEEL COLUMNS/BEAMS: DETERIORATED CONCRETE FIREPROOFING

Question	Response
<b>INTERIOR</b>	
<b>STRUCTURAL</b>	
<b>VAULTS-BUNKERS</b>	
<b>Slab Structure</b>	
Violations	Boiler Room Vault No violations recorded.
Deficiency	STEEL COLUMNS/BEAMS: DETERIORATED CONCRETE FIREPROOFING
Deficiency Location/Instance	Sub-Basement - Boiler Room
Deficiency Quantity	20
Quantity Uom	S.F.
Potential Action	REPAIR
Urgency of Action	PRIORITY 4
Purpose of Action	LEVEL 5
Deficiency Photo1	 
Violations	Sub-Basement - Boiler Room - East Side No violations recorded.
<b>Vault/Ash Hoist Doors and Framing</b>	Inspected
Condition	2 - Between Good and Fair
Deficiency	No deficiencies recorded
<b>AUDITORIUM</b>	
Instance on 4th Floor (404 Seats)	Inspected
<b>Ceiling</b>	
Instance on 4th Floor (404 Seats)	Inspected
Condition	2 - Between Good and Fair
Deficiency	PLASTER: CRACKS/SPALLING - ACTIVE LEAK
Deficiency Location/Instance	Center
Deficiency Quantity	20
Quantity Uom	S.F.
Potential Action	REPLACE
Urgency of Action	PRIORITY 5

REPAIR

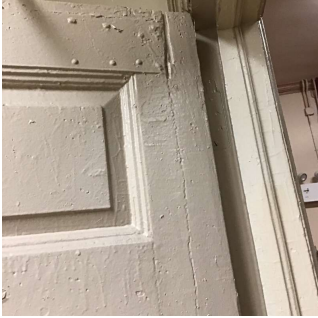
Question	Response
<b>INTERIOR</b>	
<b>AUDITORIUM</b>	
<b>Ceiling</b>	
Violations	No violations recorded.
<b>Door(s)</b>	
Instance on 4th Floor (404 Seats)	Inspected
Condition	4 - Between Fair and Poor
Deficiency	WOOD: DETERIORATED DOOR
Deficiency Location/Instance	Left Entrance at the back of stage
Deficiency Quantity	1
Quantity Uom	EACH
Potential Action	MAINTENANCE
Urgency of Action	PRIORITY 3
Purpose of Action	LEVEL 2
Deficiency Photo1

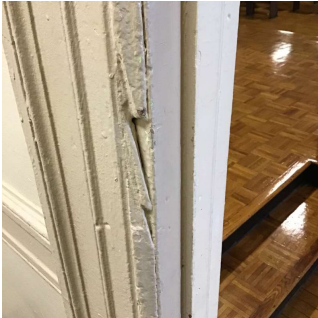
Violations	Left Entrance at the back of stage No violations recorded.
Deficiency	WOOD: DETERIORATED DOOR AND FRAME
Deficiency Location/Instance	Right Entrance at the back of stage
Deficiency Quantity	1
Quantity Uom	EACH
Potential Action	MAINTENANCE
Urgency of Action	PRIORITY 3
Purpose of Action	LEVEL 2
Deficiency Photo1

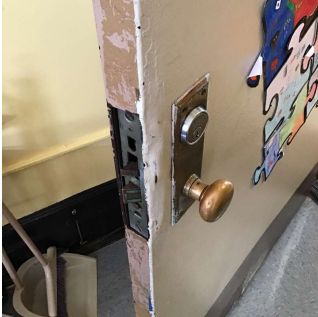
Deficiency	METAL: DETERIORATED DOOR

Question	Response
<b>INTERIOR</b>	
<b>CLASSROOMS/CORRIDORS/ADMIN SPACES</b>	
<b>Door(s)</b>	
Deficiency Location/Instance	Rooms 414, 311
Deficiency Quantity	2
Quantity Uom	EACH
Potential Action	MAINTENANCE
Urgency of Action	PRIORITY 3
Purpose of Action	LEVEL 2
Deficiency Photo1

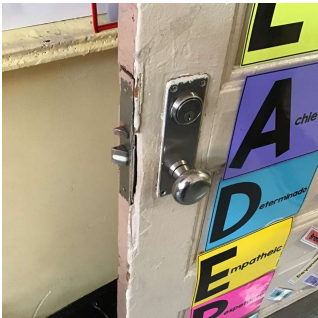
Room 414
Violations	No violations recorded.
Deficiency	WOOD: DETERIORATED DOOR
Deficiency Location/Instance	Rooms 415, 410, 408, 308, 306 and others
Deficiency Quantity	13
Quantity Uom	EACH
Potential Action	MAINTENANCE
Urgency of Action	PRIORITY 3
Purpose of Action	LEVEL 2
Deficiency Photo1

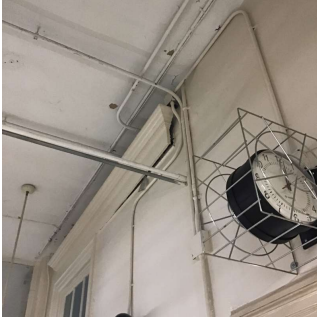
Question	Response
<b>INTERIOR</b>	
<b>CLASSROOMS/CORRIDORS/ADMIN SPACES</b>	
<b>Walls</b>	Inspected
Condition	2 - Between Good and Fair
Deficiency	WOOD PANELING: DETERIORATED
Deficiency Location/Instance	Corridor near Room 201
Deficiency Quantity	20
Quantity Uom	S.F.
Potential Action	REPLACE
Urgency of Action	PRIORITY 5
Purpose of Action	LEVEL 6
Deficiency Photo1

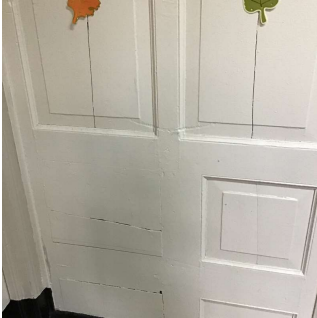
Violations	Corridor near Room 201 No violations recorded.
Deficiency	WOOD PANELING: DETERIORATED
Deficiency Location/Instance	Exit 6 Vestibule
Deficiency Quantity	60
Quantity Uom	S.F.
Potential Action	REPLACE
Urgency of Action	PRIORITY 3
Purpose of Action	LEVEL 2
Deficiency Photo1

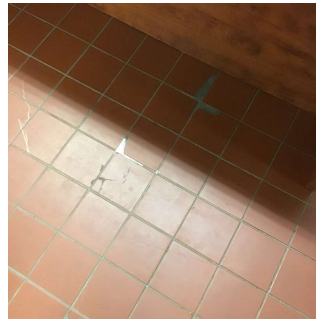
Main Entrance

QUARRY TILE: BROKEN/MISSING TILES

REPLACE

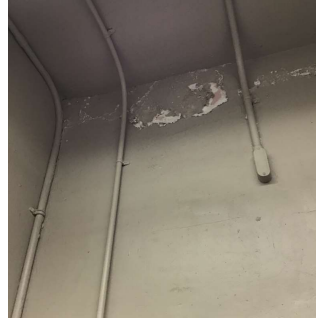
Exit 8 Vestibule

PLASTER: CRACKS/SPALLING

REPLACE

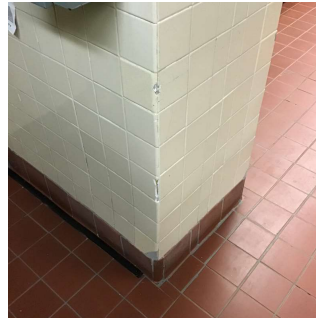
Main Entrance

CERAMIC TILE: BROKEN/ MISSING

REPLACE

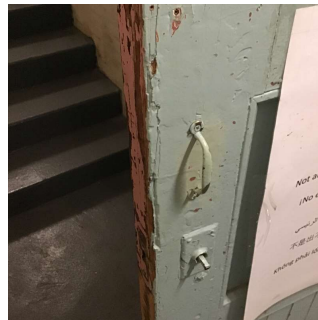
Stair CE/Basement Vestibule

WOOD: DETERIORATED DOOR

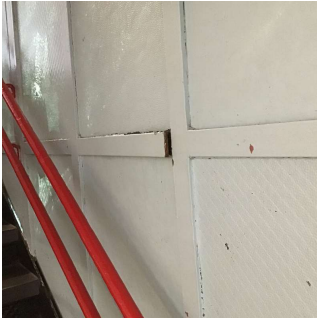
<b>Question</b>	<b>Response</b>
<b>INTERIOR</b>	
<b>STAIRS/RAMPS: INTERIOR</b>	
<b>Door(s)</b>	Inspected
	Stair F/2
Violations	No violations recorded.
<b>Partition</b>	Inspected
Condition	3 - Fair
Deficiency	METAL FRAME: DAMAGED/DETERIORATED
Deficiency Location/Instance	Stairs BD/2, 3, GI/1
Deficiency Quantity	20
Quantity Uom	L.F.
Potential Action	REPLACE
Urgency of Action	PRIORITY 3
Purpose of Action	LEVEL 2
Deficiency Photo1

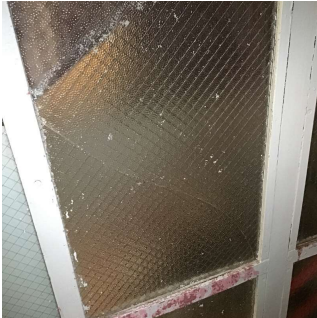
Stair BD/2
Violations	No violations recorded.
Deficiency	GLASS PANEL: DAMAGED/DETERIORATED
Deficiency Location/Instance	Stair BD/1, 3
Deficiency Quantity	10
Quantity Uom	S.F.
Potential Action	REPLACE
Urgency of Action	PRIORITY 3
Purpose of Action	LEVEL 2
Deficiency Photo1

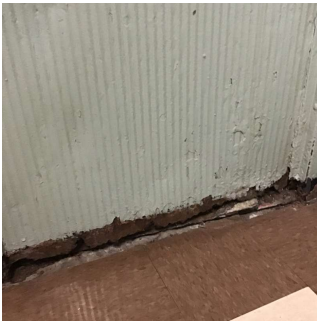
Stair BD/1
Violations	No violations recorded.
Deficiency	METAL PANEL: DAMAGED/DETERIORATED
Deficiency Location/Instance	Stairs BD/Basement, 1, 4, GI/Basement, 3 and others
Deficiency Quantity	50
Quantity Uom	S.F.
Potential Action	REPLACE

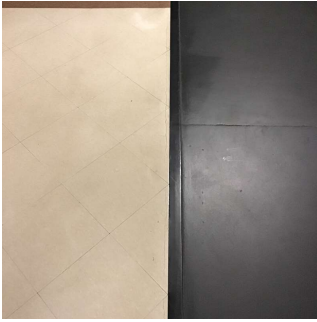
Stair BD/Basement
Violations	No violations recorded.
<b>Railings</b>	Inspected
Condition	2 - Between Good and Fair
Deficiency	No deficiencies recorded
<b>Stairs and Landings</b>	Inspected
Condition	5 - Poor
Deficiency	VINYL TILES: DETERIORATED SUBSTRATE
Deficiency Location/Instance	Stair GI/1
Deficiency Quantity	10
Quantity Uom	S.F.
Potential Action	REPLACE
Urgency of Action	PRIORITY 3
Purpose of Action	LEVEL 2
Deficiency Photo1

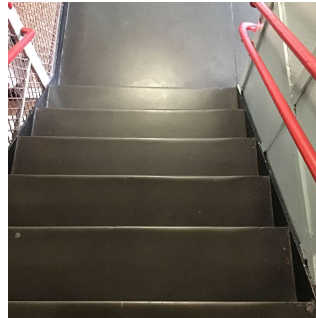
Stair Center/4

STONE: WORN-OUT TREAD/NOSINGS

REPLACE

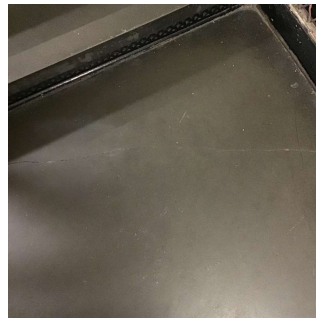
Stair BD/Basement

STONE: BROKEN/MISSING

REPLACE

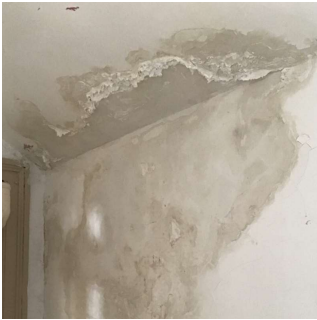
Violations	Stair BD/Basement No violations recorded.
<b>TOILET ROOMS - STAFF</b>	
<b>Ceiling</b>	Inspected
Condition	2 - Between Good and Fair
Deficiency	PLASTER: CRACKS/SPALLING - ACTIVE LEAK
Deficiency Location/Instance	Room 463
Deficiency Quantity	10
Quantity Uom	S.F.
Potential Action	REPLACE
Urgency of Action	PRIORITY 5
Purpose of Action	LEVEL 2
Deficiency Photo1

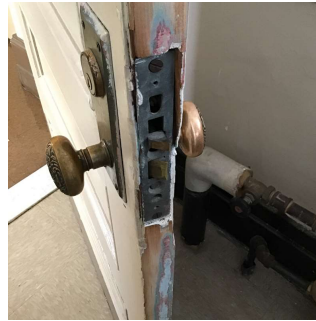
Violations	Room 463 No violations recorded.
<b>Door(s)</b>	
Condition	Inspected 5 - Poor
Deficiency	WOOD: DETERIORATED DOOR
Deficiency Location/Instance	Rooms 463, 363, 263, 163, B23, inside Room 311A
Deficiency Quantity	6
Quantity Uom	EACH
Potential Action	MAINTENANCE
Urgency of Action	PRIORITY 3
Purpose of Action	LEVEL 2

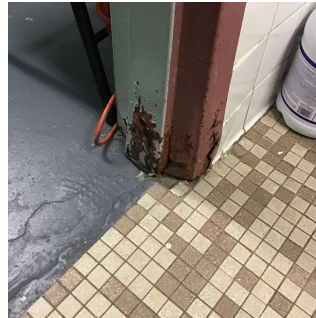
Room B23

METAL: DETERIORATED DOOR AND FRAME

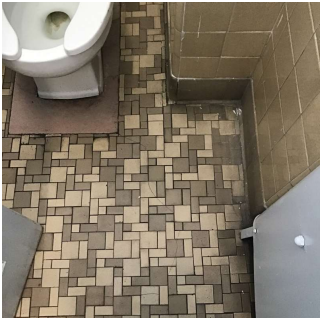
Question	Response
<b>INTERIOR</b>	
<b>TOILET ROOMS - STAFF</b>	
<b>Floor Finish</b>	
Violations	Room 363 No violations recorded.
Deficiency	CERAMIC TILE: BROKEN/MISSING TILES
Deficiency Location/Instance	Inside Room 311A
Deficiency Quantity	10
Quantity Uom	S.F.
Potential Action	REPLACE
Urgency of Action	PRIORITY 3
Purpose of Action	LEVEL 2
Deficiency Photo1

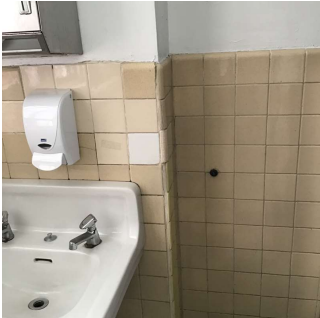
Violations	Inside Room 311A No violations recorded.
<b>Stalls</b>	Inspected
Condition	2 - Between Good and Fair
Deficiency	No deficiencies recorded
<b>Walls</b>	Inspected
Condition	2 - Between Good and Fair
Deficiency	CERAMIC TILE: BROKEN/ MISSING
Deficiency Location/Instance	Room 363
Deficiency Quantity	10
Quantity Uom	S.F.
Potential Action	REPLACE
Urgency of Action	PRIORITY 3
Purpose of Action	LEVEL 2
Deficiency Photo1

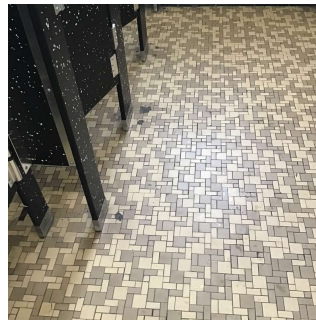
Room 411A

CERAMIC TILE: BROKEN/MISSING TILES

REPLACE

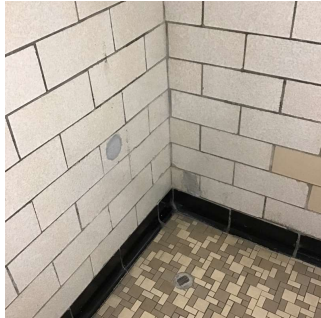
Question	Response
<b>INTERIOR</b>	
<b>TOILET ROOMS - STUDENTS</b>	
<b>Floor Finish</b>	Inspected
	Room 462
Violations	No violations recorded.
<b>Stalls</b>	Inspected
Condition	2 - Between Good and Fair
Deficiency	No deficiencies recorded
<b>Walls</b>	Inspected
Condition	2 - Between Good and Fair
Deficiency	SALT GLAZED BRICK: CRACKS/SPALLING
Deficiency Location/Instance	Rooms 462, 411A, 362, 259, B12 and others
Deficiency Quantity	60
Quantity Uom	S.F.
Potential Action	REPLACE
Urgency of Action	PRIORITY 3
Purpose of Action	LEVEL 2
Deficiency Photo1

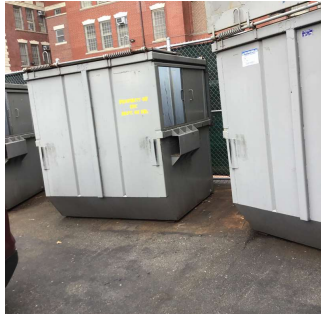
Room B12
Violations	No violations recorded.
<b>LIFE SAFETY</b>	Inspected
<b>F.D. HOLDING AREA</b>	Does not Exist
<b>STEEL STAIRS</b>	Does not Exist
<b>SITE</b>	Inspected
<b>CONTAINERIZATION</b>	Inspected
Condition	4 - Between Fair and Poor
Deficiency	CONCRETE PAD MISSING
Deficiency Location/Instance	Suydam Street
Deficiency Quantity	300
Quantity Uom	S.F.
Potential Action	INSTALL NEW

Urgency of Action	PRIORITY 3
Purpose of Action	LEVEL 2
Deficiency Photo1

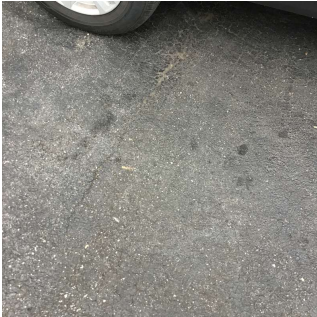
Question	Response
<b>SITE</b>	
<b>PAVING</b>	
<b>Student Non-Use</b>	
<b>Asphalt</b>	
Deficiency Photo1

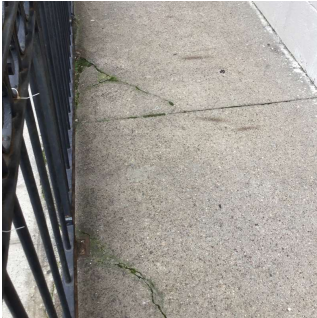
Violations	Suydam Street No violations recorded.
<b>Concrete</b>	Inspected
Condition	3 - Fair
Deficiency	CRACKS - MAJOR
Deficiency Location/Instance	Willoughby Avenue
Deficiency Quantity	150
Quantity Uom	S.F.
Potential Action	REPLACE
Urgency of Action	PRIORITY 3
Purpose of Action	LEVEL 2
Deficiency Photo1

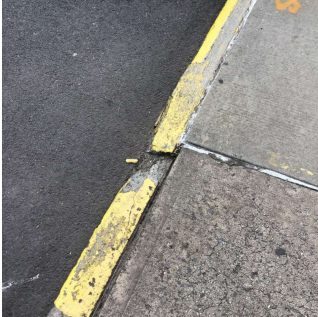
Question	Response
<b>SITE</b>	
<b>PAVING</b>	
<b>DOT Sidewalk</b>	
<b>Concrete</b>	
Deficiency Quantity	220
Quantity Uom	L.F.
Potential Action	REPLACE
Urgency of Action	PRIORITY 3
Purpose of Action	LEVEL 2
Deficiency Photo1

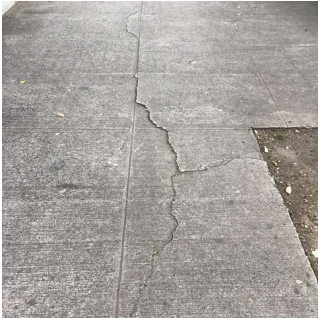
Violations	Suydam Street No violations recorded.
Deficiency	DAMAGED/DETERIORATED/MISSING SECTIONS
Deficiency Location/Instance	Suydam Street, Willoughby Avenue, Irving Avenue
Deficiency Quantity	1,100
Quantity Uom	S.F.
Potential Action	REPLACE
Urgency of Action	PRIORITY 3
Purpose of Action	LEVEL 2
Deficiency Photo1
