NYC Department of Education
Building Condition Assessment Survey 2023 - 2024

Architectural Inspection

Asset: P.S. 124 - BROOKLYN, 515 4TH AVENUE, New York, 11215

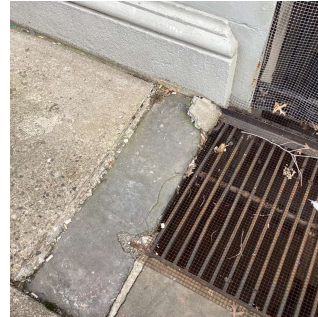
AW3

Question	Response
Architectural	
EXTERIOR	Inspected
AREAWAY	Inspected
Instance on AW1-AW6	Inspected
Instance Condition	3 - Fair
Instance Quantity	6
Instance Quantity Uom	EACH
Deficiency	AREAWAY WALLS: DETERIORATED COPING STONE
Roof Plan reference

Deficiency Quantity	30
Quantity Uom	S.F.

REPLACE
 PRIORITY 4
 LEVEL 2

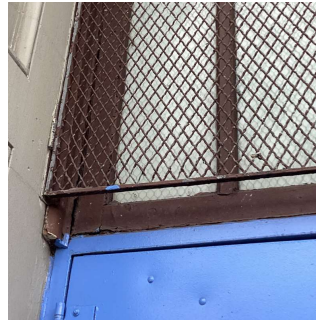
Facade A - Main Entrance

Condition	4 - Between Fair and Poor
-----------	---------------------------

Deficiency	WOOD: EXCESSIVELY WEATHERED
------------	-----------------------------

REPLACE

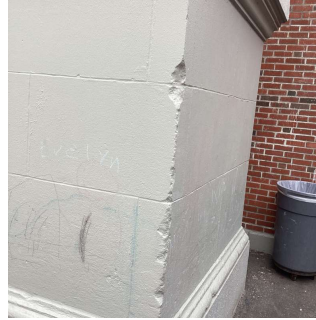
Corner of Facade D and Facade C
No violations recorded.

Violations	Facade D - Exit 4 No violations recorded.
EXTERIOR WALLS	Inspected
Material Type(s)	Concrete, Masonry
Replacement Quantity	18,000
Replacement Uom	S.F.
Instance on All All Facades	Inspected
Instance Condition	3 - Fair
Instance Quantity	18,000
Instance Quantity Uom	S.F.
Deficiency	STONE: CRACKS AT BUILDING CORNERS
Roof Plan reference	<p align="center">K124</p>

Deficiency Quantity	30
Quantity Uom	S.F.
Potential Action	REPLACE
Urgency of Action	PRIORITY 4
Purpose of Action	LEVEL 2

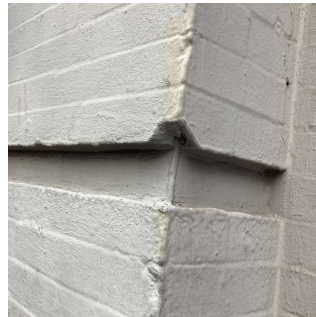
Facade D

BRICK: MINOR CRACKS AND SPALLING

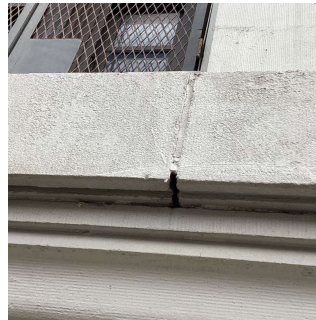
Facade A - Near Main Entrance

CAST IN PLACE / PRE-CAST CONCRETE: DETERIORATED JOINTS

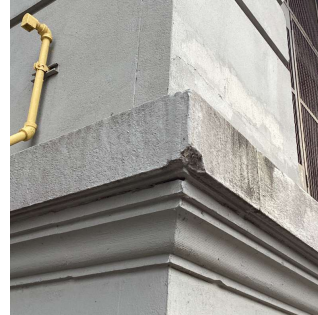
Facade A - Near Main Entrance

CAST IN PLACE / PRE-CAST CONCRETE: MAJOR
CRACKS/SPALLING

REPLACE
PRIORITY 4
LEVEL 2

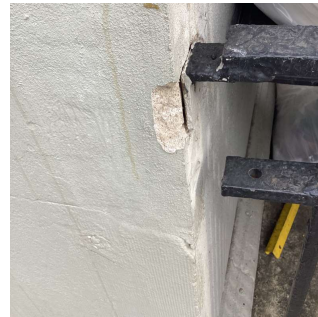
Facade A - Near Main Entrance

STONE: CHIPPED/SPALLED/BROKEN PIECES - MAJOR

REPLACE

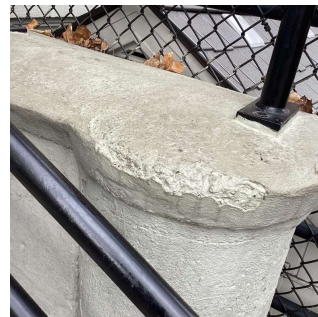
Facade D - Exit 4

STONE: CRACKS/SPALLING - MINOR

REPAIR

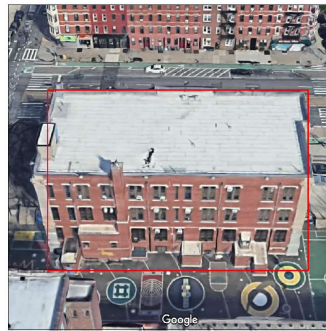
Elevation

Deficiency Quantity	20
Quantity Uom	EACH
Potential Action	MAINTENANCE
Urgency of Action	PRIORITY 3
Purpose of Action	LEVEL 2
Deficiency Photo1	No photo recorded
Violations	No violations recorded.

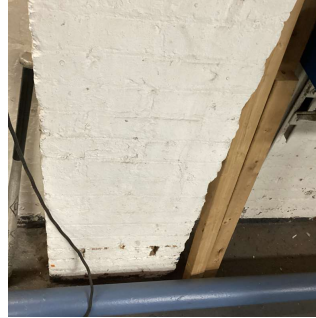
Basement - Boiler Room
No violations recorded.

Condition	Inspected 3 - Fair
Deficiency	STEEL COLUMNS/BEAMS: DETERIORATED MASONRY FIREPROOFING
Deficiency Location/Instance	Basement - Boiler Room
Deficiency Quantity	40
Quantity Uom	S.F.
Potential Action	REPLACE

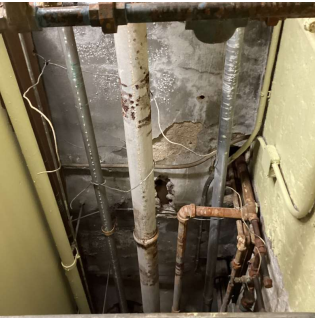
Basement - Electrical Room No violations recorded.
Deficiency Deficiency Location/Instance Deficiency Quantity Quantity Uom Potential Action Urgency of Action Purpose of Action Deficiency Photo1	CONCRETE: CRACKS/SPALLED/REINFORCEMENT EXPOSED Basement - Electrical Room 20 S.F. REPAIR PRIORITY 4 LEVEL 5
Violations

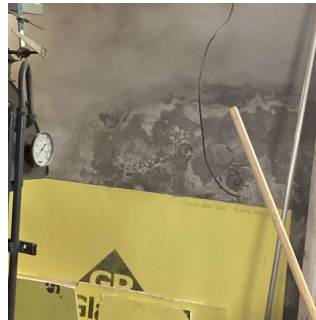
Basement - Boiler Room

CONCRETE: WATER INFILTRATION IN NON- INSTRUCTIONAL SPACE

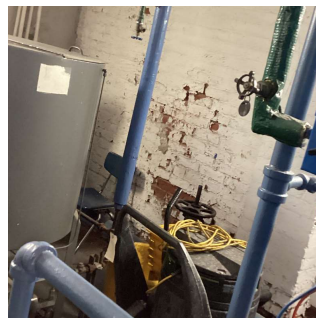
Basement - Boiler Room

BRICK: WATER INFILTRATION IN NON- INSTRUCTIONAL SPACE

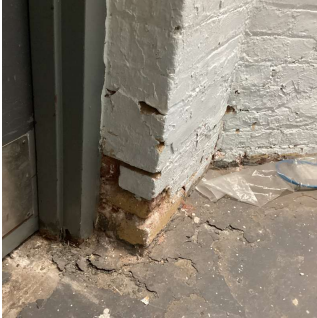
Question	Response
INTERIOR	
STRUCTURAL	
FOUNDATION WALLS	
Violations	No violations recorded.
Deficiency	BRICK: CRACKED/SPALLED
Deficiency Location/Instance	Basement - Electrical Room
Deficiency Quantity	20
Quantity Uom	S.F.
Potential Action	RESTITCH
Urgency of Action	PRIORITY 3
Purpose of Action	LEVEL 5
Deficiency Photo1

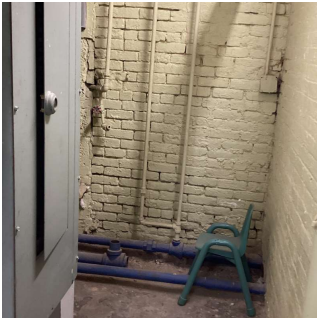
Violations	Basement - Electrical Room No violations recorded.
Deficiency	BRICK: DETERIORATED JOINTS
Deficiency Location/Instance	Basement - Electrical Room
Deficiency Quantity	50
Quantity Uom	S.F.
Potential Action	REPOINT
Urgency of Action	PRIORITY 4
Purpose of Action	LEVEL 5
Deficiency Photo1

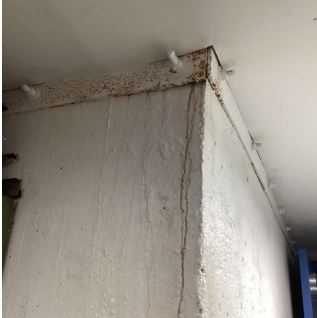
Violations	Basement - Electrical Room No violations recorded.
ROOF STRUCTURE	
Condition	Inspected 2 - Between Good and Fair
Deficiency	No deficiencies recorded
VAULTS-BUNKERS	
Condition	Inspected 4 - Between Fair and Poor
Foundation Walls	
Condition	Inspected
Deficiency	WATER INFILTRATION IN NON- INSTRUCTIONAL SPACE

Deficiency Location/Instance	Basement - Vault
Deficiency Quantity	100
Quantity Uom	S.F.

Question	Response
INTERIOR	
STRUCTURAL	
VAULTS-BUNKERS	
Foundation Walls	
Potential Action	INSTALL WATERPROOFING
Urgency of Action	PRIORITY 5
Purpose of Action	LEVEL 5
Deficiency Photo1

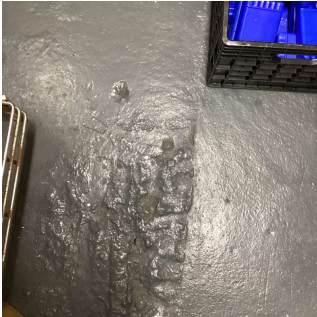
Basement - Vault
Violations	No violations recorded.
Slab Structure	Inspected
Condition	2 - Between Good and Fair
Deficiency	CONCRETE SLAB ON GRADE: THRU CRACKS
Deficiency Location/Instance	Basement - Vault
Deficiency Quantity	20
Quantity Uom	S.F.
Potential Action	REPAIR
Urgency of Action	PRIORITY 3
Purpose of Action	LEVEL 5
Deficiency Photo1

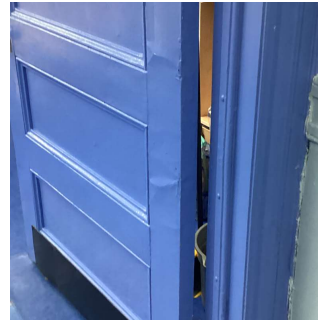
Exit 2/4 Vestibule
Violations	No violations recorded.
Door(s)	Inspected
Condition	5 - Poor
Deficiency	METAL CLAD WOOD: DETERIORATED DOOR
Deficiency Location/Instance	Room 101
Deficiency Quantity	1
Quantity Uom	EACH
Potential Action	MAINTENANCE
Urgency of Action	PRIORITY 3
Purpose of Action	LEVEL 2

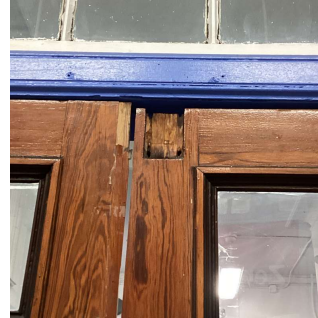
Main Entrance Vestibule

WOOD: DETERIORATED DOOR

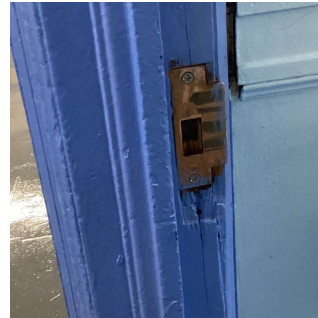
Room 307A

WOOD: DETERIORATED DOOR AND FRAME

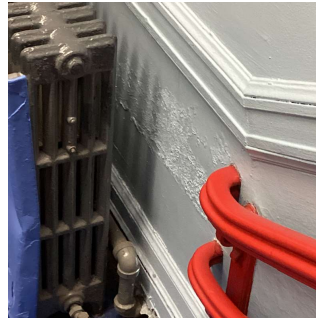
Main Entrance

PLASTER: CRACKS/SPALLING

REPLACE

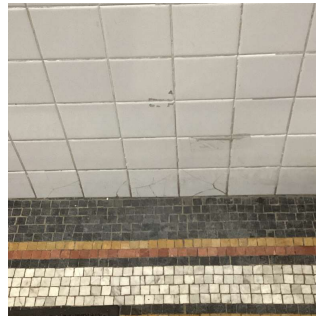
CERAMIC TILE: BROKEN/ MISSING

REPLACE

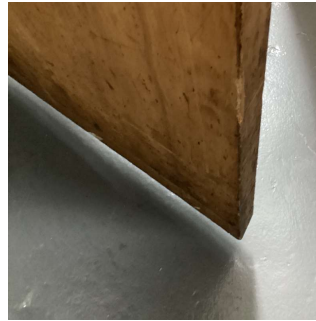
Violations	Near center No violations recorded.
Door(s)	
Instance on Basement (500 SF)	Inspected
Condition	3 - Fair
Deficiency	WOOD: DETERIORATED DOOR
Deficiency Location/Instance	Storage
Deficiency Quantity	1

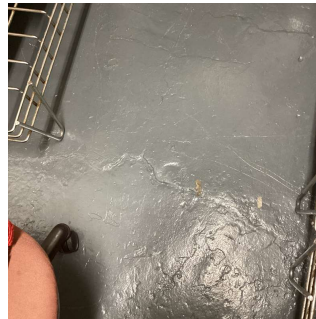
Deficiency CONCRETE: CRACKS

Deficiency Location/Instance Storage

Potential Action REPLACE

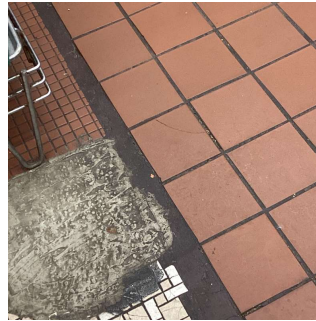
Deficiency QUARRY TILE: BROKEN/MISSING TILES

Deficiency Location/Instance Near center

Potential Action REPLACE

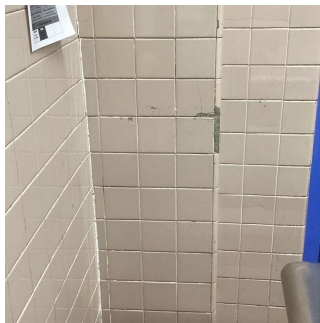
Instance on Basement (500 SF)	Inspected
Condition	2 - Between Good and Fair
Deficiency	CERAMIC TILE: BROKEN/ MISSING
Deficiency Location/Instance	Near Entrance, center
Deficiency Quantity	20
Quantity Uom	S.F.
Potential Action	REPLACE
Urgency of Action	PRIORITY 3
Purpose of Action	LEVEL 2

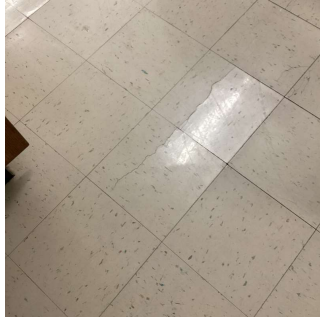
Violations	Near Entrance No violations recorded.
LIBRARY	Inspected
Instance on Room 305	Inspected
Built-in Furnishing	
Instance on Room 305	Does not Exist
Ceiling	
Instance on Room 305	Inspected
Condition	2 - Between Good and Fair
Deficiency	No deficiencies recorded
Door(s)	
Instance on Room 305	Inspected
Condition	2 - Between Good and Fair
Deficiency	No deficiencies recorded
Floor Finish	
Instance on Room 305	Inspected
Condition	3 - Fair
Deficiency	VINYL TILES: DETERIORATED SUBSTRATE
Deficiency Location/Instance	Near Entrance, center
Deficiency Quantity	50
Quantity Uom	S.F.
Potential Action	REPLACE
Urgency of Action	PRIORITY 3
Purpose of Action	LEVEL 2
Deficiency Photo1

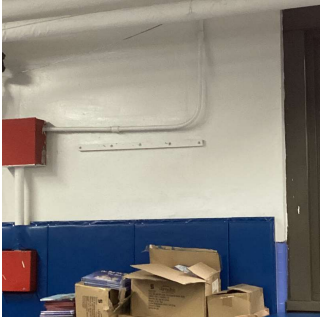
Question	Response
INTERIOR	
LIBRARY	Inspected
Walls	
Deficiency	No deficiencies recorded
LOCKER ROOM	Does not Exist
MULTI-PURPOSE ROOM	Inspected
Instance on Basement (1,600 SF)	Inspected
Ceiling	
Instance on Basement (1,600 SF)	Inspected
Condition	2 - Between Good and Fair
Deficiency	No deficiencies recorded
Door(s)	
Instance on Basement (1,600 SF)	Not Required
Fixed Equipment	
Instance on Basement (1,600 SF)	Inspected
Condition	3 - Fair
Deficiency	DAMAGED/MISSING
Deficiency Location/Instance	Near Windows
Deficiency Quantity	1
Quantity Uom	EACH
Potential Action	REPLACE
Urgency of Action	PRIORITY 3
Purpose of Action	LEVEL 2
Deficiency Photo1

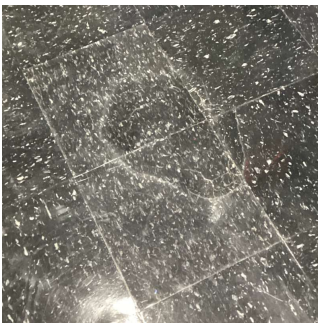
Near Windows
Violations	No violations recorded.
Floor Finish	
Instance on Basement (1,600 SF)	Inspected
Condition	2 - Between Good and Fair
Deficiency	VINYL TILES: DETERIORATED SUBSTRATE
Deficiency Location/Instance	Near Stair AB/Basement
Deficiency Quantity	20
Quantity Uom	S.F.

Potential Action	REPLACE
Urgency of Action	PRIORITY 3
Purpose of Action	LEVEL 2

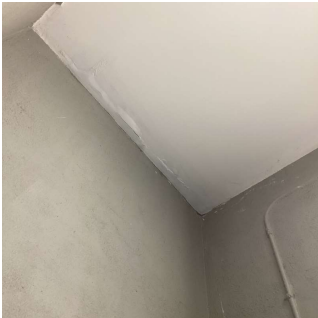
Near Stair AB/Basement
Violations	No violations recorded.
Sliding-folding Partition	
Instance on Basement (1,600 SF)	Does not Exist
Stage	
Instance on Basement (1,600 SF)	Does not Exist
Walls	
Instance on Basement (1,600 SF)	Inspected
Condition	2 - Between Good and Fair
Deficiency	No deficiencies recorded
Window Curtains/Shades/Blinds	
Instance on Basement (1,600 SF)	Does not Exist
SCIENCE DEMO ROOM	Does not Exist
SCIENCE LAB	Does not Exist
SCIENCE PREP ROOM	Does not Exist
SHOWER ROOM	Does not Exist
STAIRS/RAMPS: INTERIOR	Inspected
Do Letter Stair Signs Exist?	Yes
Ceiling	Inspected
Condition	2 - Between Good and Fair
Deficiency	PLASTER: CRACKS/SPALLING
Deficiency Location/Instance	Exit 7
Deficiency Quantity	10
Quantity Uom	S.F.
Potential Action	REPLACE
Urgency of Action	PRIORITY 3
Purpose of Action	LEVEL 2
Deficiency Photo1

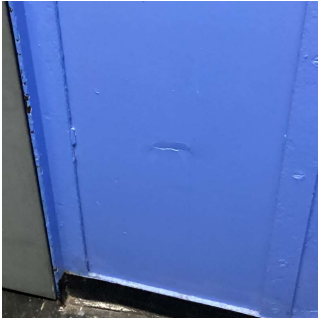
Question	Response
INTERIOR	
STAIRS/RAMPS: INTERIOR	
Ceiling	Inspected
Violations	No violations recorded.
Door(s)	Inspected
Condition	2 - Between Good and Fair
Deficiency	No deficiencies recorded
Partition	Inspected
Condition	2 - Between Good and Fair
Deficiency	METAL PANEL: DAMAGED/DETERIORATED
Deficiency Location/Instance	Stair CD/Basement
Deficiency Quantity	10
Quantity Uom	S.F.
Potential Action	REPLACE
Urgency of Action	PRIORITY 3
Purpose of Action	LEVEL 2
Deficiency Photo1

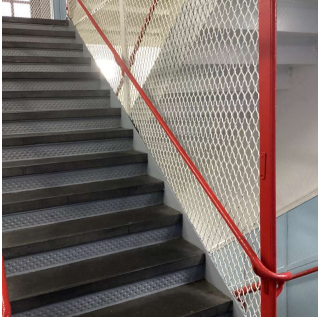
Violations	Stair CD/Basement No violations recorded.
Railings	Inspected
Condition	5 - Poor
Deficiency	METAL: MISSING
Deficiency Location/Instance	Stair AB/Basement, 1, 2, 3
Deficiency Quantity	480
Quantity Uom	L.F.
Potential Action	REPLACE
Urgency of Action	PRIORITY 5
Purpose of Action	LEVEL 6
Deficiency Photo1

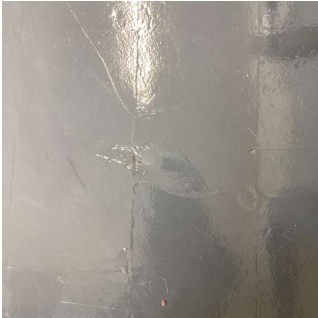
Stair CD/3

Deficiency	VINYL TILES: DETERIORATED SUBSTRATE
Deficiency Location/Instance	Stair AB/Basement, CD/3, 2
Deficiency Quantity	50
Quantity Uom	S.F.
Potential Action	REPLACE
Urgency of Action	PRIORITY 3
Purpose of Action	LEVEL 2
Deficiency Photo1

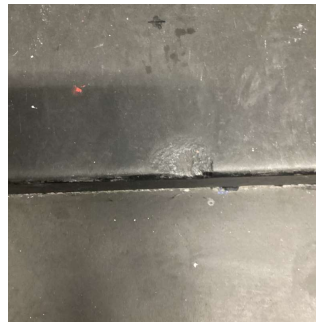
Main Entrance

Deficiency	STONE: BROKEN/MISSING
Deficiency Location/Instance	Main Entrance, Stair AB/Basement, 1, 2, 3, CD/1
Deficiency Quantity	50
Quantity Uom	S.F.
Potential Action	REPLACE
Urgency of Action	PRIORITY 3
Purpose of Action	LEVEL 2

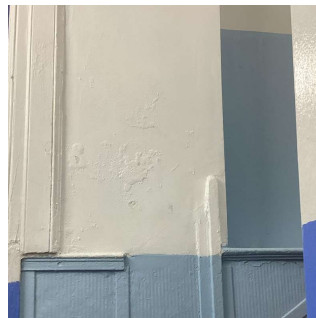
Stair AB/Basement

PLASTER: CRACKS/SPALLING - ACTIVE LEAK

REPLACE

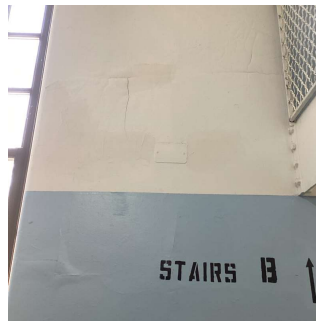
Stair AB/1

PLASTER: CRACKS/SPALLING

REPLACE

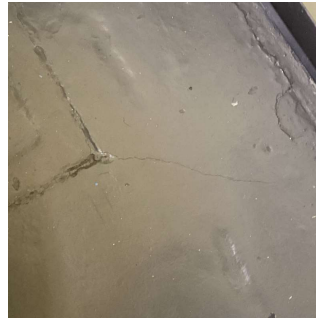
Room 306A

CONCRETE: CRACKS

REPLACE

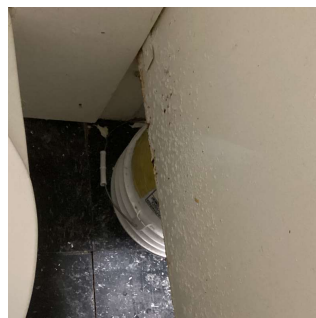
RUST - MAJOR

REPLACE

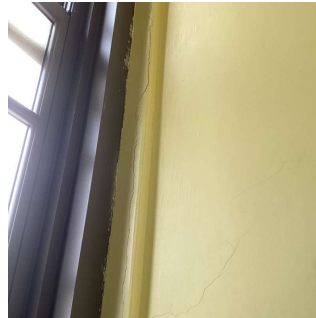
Deficiency	PLASTER: CRACKS/SPALLING
Deficiency Location/Instance	Room 306A
Deficiency Quantity	10
Quantity Uom	S.F.
Potential Action	REPLACE
Urgency of Action	PRIORITY 3
Purpose of Action	LEVEL 2
Deficiency Photo1

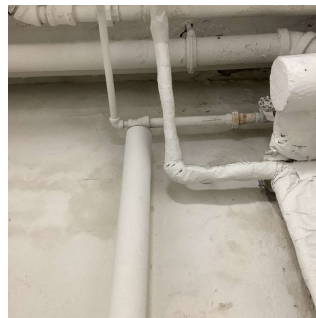
Deficiency	PLASTER: CRACKS/SPALLING - ACTIVE LEAK
Deficiency Location/Instance	Basement - Staff Toilet
Deficiency Quantity	20
Quantity Uom	S.F.
Potential Action	REPLACE
Urgency of Action	PRIORITY 5
Purpose of Action	LEVEL 2
Deficiency Photo1

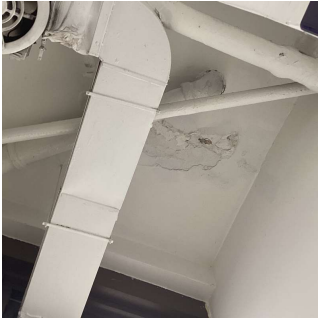
Basement - Staff Toilet
Violations	No violations recorded.
TOILET ROOMS - STUDENTS	
Ceiling	Inspected
Condition	2 - Between Good and Fair
Deficiency	PLASTER: CRACKS/SPALLING
Deficiency Location/Instance	1st Floor - Boys
Deficiency Quantity	10
Quantity Uom	S.F.
Potential Action	REPLACE
Urgency of Action	PRIORITY 3
Purpose of Action	LEVEL 2
Deficiency Photo1

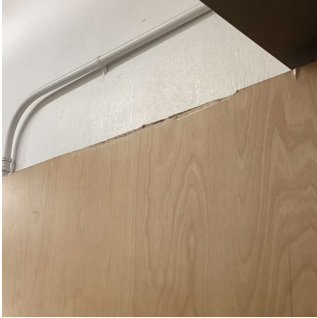
1st Floor - Boys
Violations	No violations recorded.
Door(s)	Inspected
Condition	5 - Poor
Deficiency	WOOD: DETERIORATED DOOR
Deficiency Location/Instance	2nd Floor - Boys/Girls, 1st Floor - Boys/Girls, Room 107/108

Question	Response
INTERIOR	
TOILET ROOMS - STUDENTS	
Door(s)	
Quantity Uom	EACH
Potential Action	MAINTENANCE
Urgency of Action	PRIORITY 3
Purpose of Action	LEVEL 2
Deficiency Photo1

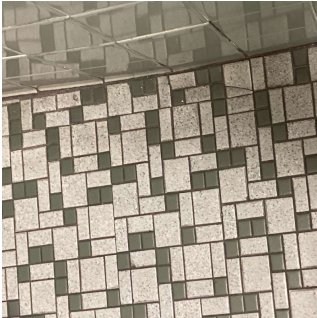
Violations	2nd Floor - Boys No violations recorded.
Floor Finish	Inspected
Condition	2 - Between Good and Fair
Deficiency	CERAMIC TILE: BROKEN/MISSING TILES
Deficiency Location/Instance	Room 107/108
Deficiency Quantity	10
Quantity Uom	S.F.
Potential Action	REPLACE
Urgency of Action	PRIORITY 3
Purpose of Action	LEVEL 2
Deficiency Photo1

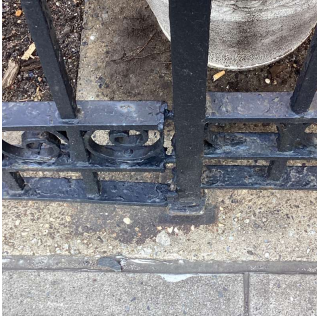
Along 14th Street

Question	Response
SITE	
FENCES	
Violations	No violations recorded.
Deficiency	CHAIN LINK: DAMAGED POST/RAIL
Deficiency Location/Instance	Along 14th Street, 13th a street, Schoolyard
Deficiency Quantity	60
Quantity Uom	L.F.
Potential Action	REPLACE
Urgency of Action	PRIORITY 3
Purpose of Action	LEVEL 2
Deficiency Photo1

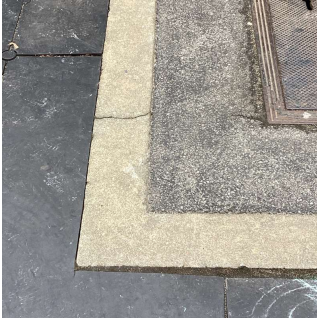
Question	Response
SITE	
PAVING	
Student Use	Inspected
Gravel Exists?	No
Asphalt	Inspected
Condition	4 - Between Fair and Poor
Deficiency	CRACKS - MAJOR
Deficiency Location/Instance	Schoolyard
Deficiency Quantity	2,000
Quantity Uom	S.F.
Potential Action	REPLACE
Urgency of Action	PRIORITY 3
Purpose of Action	LEVEL 2
Deficiency Photo1	  <p>Schoolyard</p> <p>Schoolyard</p>
Violations	No violations recorded.
Concrete	Inspected
Condition	2 - Between Good and Fair
Deficiency	DAMAGED/DETERIORATED/MISSING SECTIONS
Deficiency Location/Instance	Schoolyard
Deficiency Quantity	10
Quantity Uom	S.F.
Potential Action	REPLACE
Urgency of Action	PRIORITY 3
Purpose of Action	LEVEL 2

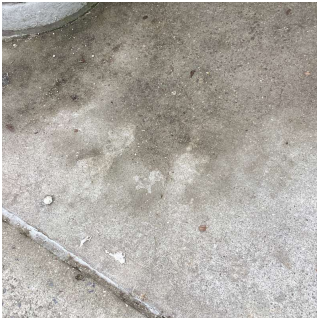
Schoolyard
Violations	No violations recorded.
Pavers	Does not Exist
Site Sidewalks & Walkways	Inspected
Asphalt	Does not Exist
Concrete	Inspected
Condition	2 - Between Good and Fair
Deficiency	DAMAGED/DETERIORATED/MISSING SECTIONS
Deficiency Location/Instance	Near exit 3/5
Deficiency Quantity	25
Quantity Uom	S.F.
Potential Action	REPLACE
Urgency of Action	PRIORITY 3
Purpose of Action	LEVEL 2
Deficiency Photo1

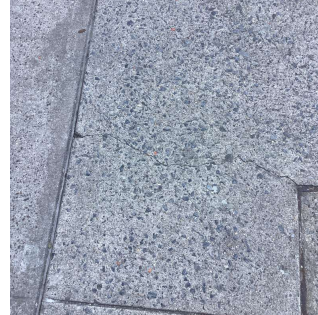
Along 4th Avenue

Near exit 3/5
Violations	No violations recorded.
Pavers	Does not Exist
DOT Sidewalk	Inspected
Asphalt	Does not Exist
Concrete	Inspected
Condition	4 - Between Fair and Poor
Deficiency	DAMAGED/DETERIORATED/MISSING SECTIONS
Deficiency Location/Instance	Along 4th Avenue, 14th Street, 13th Street
Deficiency Quantity	950
Quantity Uom	S.F.
Potential Action	REPLACE
Urgency of Action	PRIORITY 3

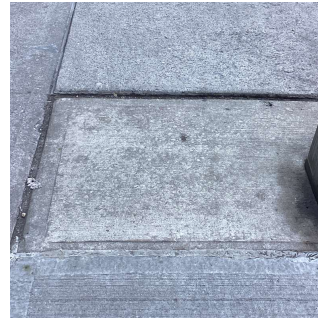
Along 4th Avenue

DAMAGED CURBS

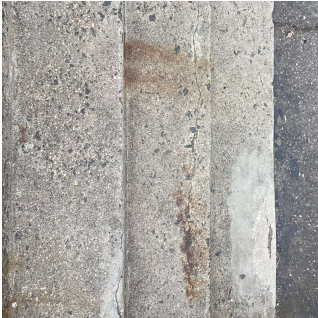
Violations	Schoolyard No violations recorded.
ARTWORK	Does not Exist

Violations	Near exit 3/5 No violations recorded.
Site Cheek/flank Walls	Inspected
Condition	2 - Between Good and Fair
Deficiency	No deficiencies recorded
Stairs/ramps	Inspected
Condition	2 - Between Good and Fair
Deficiency	CAST IN PLACE CONCRETE: CRACKS/SPALLING - MAJOR
Deficiency Location/Instance	Schoolyard
Deficiency Quantity	25
Quantity Uom	S.F.
Potential Action	REPLACE
Urgency of Action	PRIORITY 3
Purpose of Action	LEVEL 2
Deficiency Photo1
