**NYC Department of Education**  
**Building Condition Assessment Survey 2023 - 2024**

Architectural Inspection

**K126**

**Asset: J.H.S. 126 - BROOKLYN, 424 LEONARD STREET, New York, 11222**

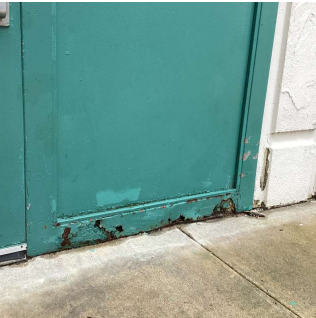
Question	Response
<b>EXTERIOR</b>	
<b>DOORS</b>	
<b>LINTELS</b>	Inspected
Deficiency	No deficiencies recorded
<b>TRANSOM/SIDE LIGHT</b>	Inspected
Condition	4 - Between Fair and Poor
Deficiency	METAL: DENTED, MAJOR RUSTING
Roof Plan reference	K126

Deficiency Quantity	20
Quantity Uom	S.F.
Potential Action	REPLACE
Urgency of Action	PRIORITY 4
Purpose of Action	LEVEL 2
Deficiency Photo1

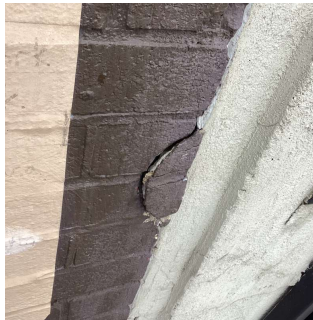
Facade B

BRICK: MAJOR / THRU CRACKS

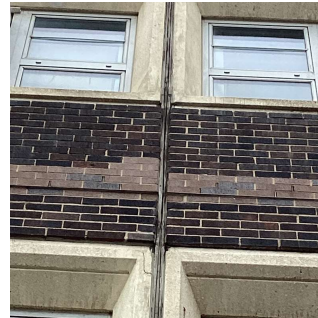
Facade A - Near Main Entrance

BRICK: DETERIORATED CONTROL/EXPANSION JOINTS

PRIORITY 3  
LEVEL 2

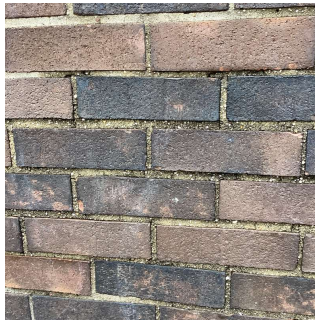
Facade H

BRICK: DETERIORATED JOINTS

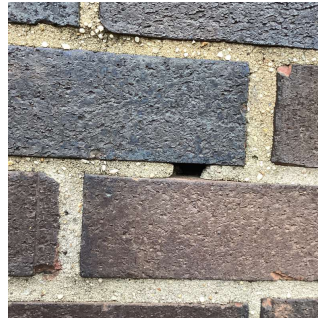
Facade H

BRICK: DETERIORATED JOINTS

PRIORITY 4  
LEVEL 2

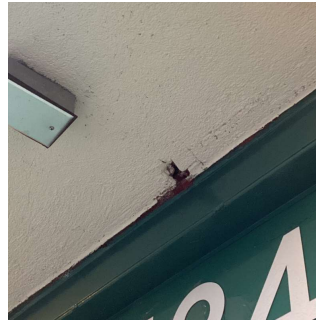
Facade A - Main Entrance

CONCRETE: MAJOR CRACKS/SPALLING

10  
S.F.  
REPLACE  
PRIORITY 4  
LEVEL 2

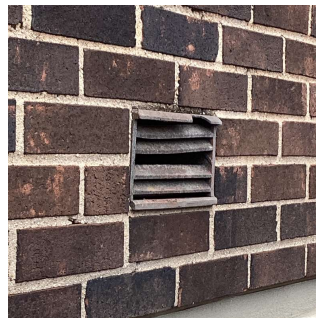
**BROKEN/ DENTED BLADES**

REPLACE

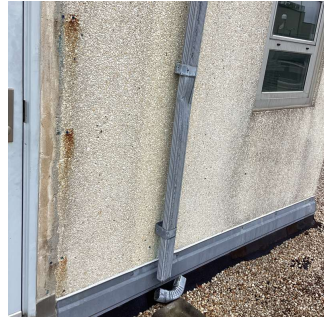
Question	Response
<b>EXTERIOR</b>	
<b>LOUVER</b>	Inspected
	Facade L
Violations	No violations recorded.
<b>PARAPETS</b>	Does not Exist
<b>PLAZA DECK</b>	Does not Exist
<b>ROOF</b>	Inspected
<b>Roofing</b>	Inspected
Replacement Quantity	58,200
Replacement Uom	S.F.
<b>ROOF HATCH/SMOKE HATCH</b>	Inspected
Condition	2 - Between Good and Fair
Deficiency	No deficiencies recorded
<b>LEADERS, GUTTERS, DOWNSPOUTS, SCUPPERS</b>	Inspected
Condition	3 - Fair
Deficiency	DAMAGED/MISSING
Roof Plan reference

Deficiency Quantity	10
Quantity Uom	L.F.
Potential Action	REPLACE
Urgency of Action	PRIORITY 4
Purpose of Action	LEVEL 2
Deficiency Photo1

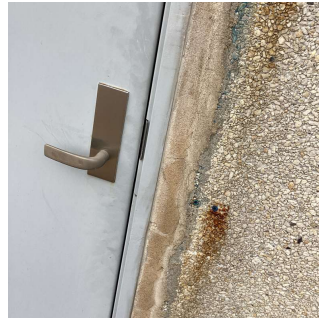
Roof 1 - BH1	Roof 1 - BH1
Violations	No violations recorded.
<hr/>	
Deficiency	BULKHEAD/PENTHOUSE WALLS/INTERIOR: PLASTER CRACKS/SPALLING
Roof Plan reference

Question	Response
<b>EXTERIOR</b>	
<b>ROOF</b>	
<b>Specialties</b>	
<b>BULKHEAD/PENTHOUSE</b>	
Deficiency	BULKHEAD/PENTHOUSE WALLS/EXTERIOR: CRACKS/SPALLING - MINOR
Roof Plan reference

Deficiency Quantity	10
Quantity Uom	S.F.
Potential Action	REPAIR
Urgency of Action	PRIORITY 3
Purpose of Action	LEVEL 2
Deficiency Photo1

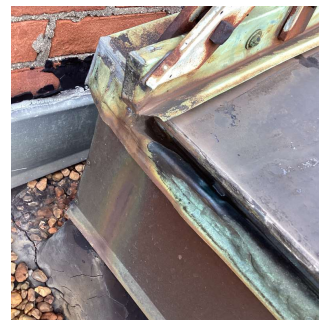
Roof 1 - SK  
 No violations recorded.

Violations	Roof 1 - BH1 No violations recorded.
<b>CUPOLA/ SPIRES/ TOWERS</b>	Does not Exist
<b>DORMER</b>	Does not Exist
<b>DUNNAGE STEEL</b>	Does not Exist
<b>SKYLIGHT/ROOF VENT</b>	Inspected
Material Type(s)	Glass
Condition	2 - Between Good and Fair
Deficiency	DAMAGED GUARDS

10  
 S.F.  
 MAINTENANCE  
 PRIORITY 3  
 LEVEL 2

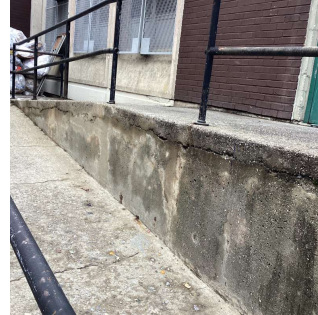
Facade M - Near Exit 11  
No violations recorded.

DAMAGED

10  
 L.F.  
 REPLACE

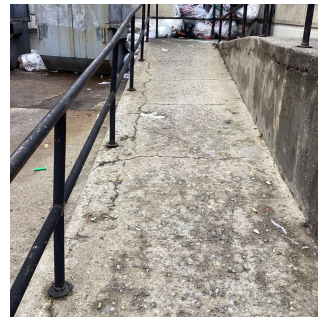
Facade M - Near Exit 11  
No violations recorded.

CONCRETE: CRACKS/SPALLING - MAJOR

100  
S.F.  
REPLACE  
PRIORITY 4  
LEVEL 2

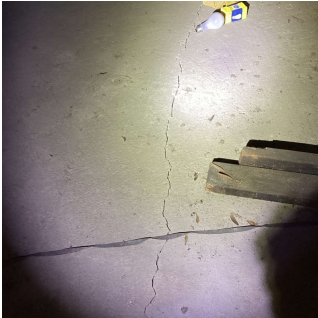
Question	Response
<b>INTERIOR</b>	
<b>STRUCTURAL</b>	Inspected
<b>COLUMNS/BEAMS/BEARING WALLS</b>	Inspected
Condition	2 - Between Good and Fair
Deficiency	No deficiencies recorded
<b>FLOOR STRUCTURE</b>	Inspected
Condition	3 - Fair
Deficiency	CONCRETE SLAB ON GRADE: THRU CRACKS
Deficiency Location/Instance	Basement - Room C13A (Ejector Room), Crawlspace
Deficiency Quantity	80
Quantity Uom	S.F.
Potential Action	REPLACE
Urgency of Action	PRIORITY 4
Purpose of Action	LEVEL 5
Deficiency Photo1

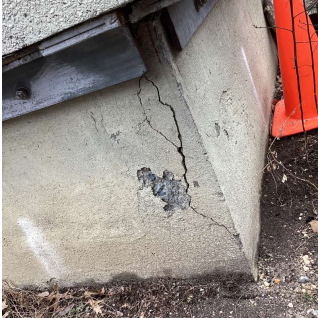
Violations	Facade H No violations recorded.
<b>ROOF STRUCTURE</b>	Inspected

Violations	Basement - Crawlspace No violations recorded.
<b>FOUNDATION WALLS</b>	Inspected
Material Type(s)	Concrete
Condition	3 - Fair
Deficiency	CONCRETE: CRACKED/SPALLED/REINFORCEMENT EXPOSED
Deficiency Location/Instance	Facade H, L
Deficiency Quantity	20
Quantity Uom	S.F.
Potential Action	REPAIR
Urgency of Action	PRIORITY 4
Purpose of Action	LEVEL 5
Deficiency Photo1

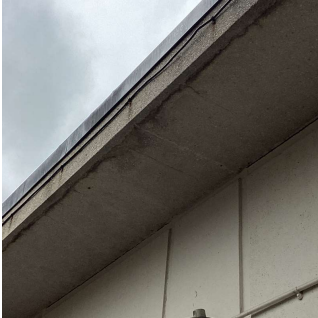
Condition	2 - Between Good and Fair
Deficiency	CONCRETE: CRACKED/SPALLED/REINFORCEMENT EXPOSED

Question	Response
<b>INTERIOR</b>	
<b>STRUCTURAL</b>	
<b>ROOF STRUCTURE</b>	
Deficiency Location/Instance	Roof 2 - Facade J
Deficiency Quantity	10
Quantity Uom	S.F.
Potential Action	REPAIR
Urgency of Action	PRIORITY 3
Purpose of Action	LEVEL 5
Deficiency Photo1

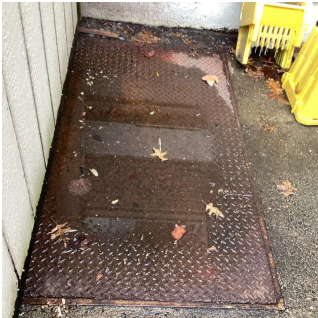
Violations	Facade M - Near AW2 No violations recorded.
<b>AUDITORIUM</b>	Inspected
Instance on 1st Floor (492 Seats)	Inspected
<b>Ceiling</b>	Inspected
Instance on 1st Floor (492 Seats)	Inspected
Condition	2 - Between Good and Fair

Violations	Roof 2 - Facade J No violations recorded.
<b>VAULTS-BUNKERS</b>	Inspected
<b>Foundation Walls</b>	Inaccessible
<b>Slab Structure</b>	Inaccessible
<b>Vault/Ash Hoist Doors and Framing</b>	Inspected
Condition	3 - Fair
Deficiency	NOT IN USE / DETERIORATED
Deficiency Location/Instance	Facade M - Near AW2
Deficiency Quantity	2
Quantity Uom	EACH
Potential Action	REMOVE AND SEAL
Urgency of Action	PRIORITY 3
Purpose of Action	LEVEL 2
Deficiency Photo1

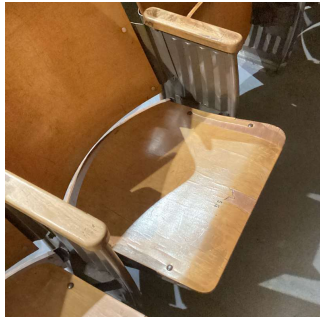
Question	Response
<b>INTERIOR</b>	
<b>AUDITORIUM</b>	
<b>Door(s)</b>	
Instance on 1st Floor (492 Seats)	Inspected
Condition	2 - Between Good and Fair
Deficiency	No deficiencies recorded
<b>Fixed H/C Lift</b>	
Instance on 1st Floor (492 Seats)	Does not Exist
<b>Fixed Seating</b>	
Instance on 1st Floor (492 Seats)	Inspected
Condition	5 - Poor
Deficiency	DAMAGED/BROKEN/INOPERABLE
Deficiency Location/Instance	Seat B/102, E/101, F/102, 107, G/101, and others
Deficiency Quantity	42
Quantity Uom	EACH
Potential Action	REPLACE
Urgency of Action	PRIORITY 3
Purpose of Action	LEVEL 2
Deficiency Photo1

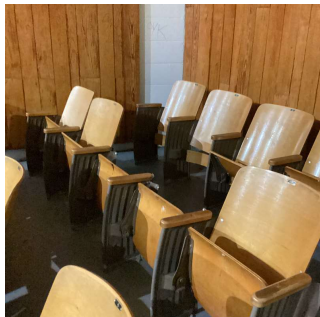
Violations	Seat R/8 No violations recorded.

Violations	Seat B/102 No violations recorded.
Deficiency	DAMAGED/BROKEN/INOPERABLE
Deficiency Location/Instance	Seat S/12, 14, 110, O/4, 8, 10, Q/6, R/11, 110, 111, L/101, A/113
Deficiency Quantity	12
Quantity Uom	EACH
Potential Action	REPLACE
Urgency of Action	PRIORITY 5
Purpose of Action	LEVEL 6
Deficiency Photo1

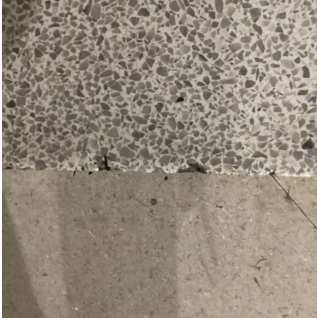
Left side
Violations	No violations recorded.
Deficiency	DAMAGED FASCIA
Deficiency Location/Instance	Center, left side
Deficiency Quantity	10
Quantity Uom	S.F.
Potential Action	REPLACE
Urgency of Action	PRIORITY 3
Purpose of Action	LEVEL 2
Deficiency Photo1

Question	Response
<b>INTERIOR</b>	
<b>AUDITORIUM</b>	
<b>Floor Finish</b>	
Deficiency	SHEET VINYL: BROKEN/DETERIORATED
Deficiency Location/Instance	Near stage
Deficiency Quantity	10
Quantity Uom	S.F.
Potential Action	REPLACE
Urgency of Action	PRIORITY 3
Purpose of Action	LEVEL 2
Deficiency Photo1	 
Violations	Near stage No violations recorded.
<b>Sliding-folding Partition</b>	
Instance on 1st Floor (492 Seats)	Does not Exist
<b>Stage</b>	
Instance on 1st Floor (492 Seats)	Inspected
<b>Stage</b>	
Instance on 1st Floor (492 Seats)	Inspected
Condition	3 - Fair
Deficiency	DAMAGED FLOOR
Deficiency Location/Instance	Center
Deficiency Quantity	10
Quantity Uom	S.F.
Potential Action	REPLACE
Urgency of Action	PRIORITY 3
Purpose of Action	LEVEL 2
Deficiency Photo1	 
Violations	Center No violations recorded.
Deficiency	DAMAGED STEPS
Deficiency Location/Instance	Left side, right side
Deficiency Quantity	25
Quantity Uom	S.F.

Question	Response
<b>INTERIOR</b>	
<b>AUDITORIUM</b>	
<b>Stage</b>	
<b>Stage</b>	
Potential Action	REPLACE
Urgency of Action	PRIORITY 3
Purpose of Action	LEVEL 2
Deficiency Photo1

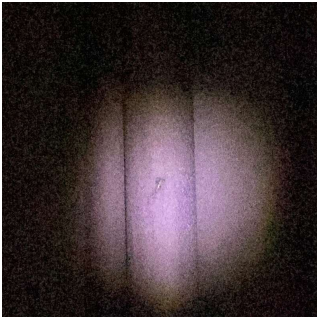
Center
Violations	No violations recorded.
<b>Stage Curtain Rigging</b>	Inspected
Instance on 1st Floor (492 Seats)	Inspected
Condition	2 - Between Good and Fair
Deficiency	No deficiencies recorded
<b>Stage Curtains</b>	Inspected
Instance on 1st Floor (492 Seats)	Inspected
Condition	3 - Fair
Deficiency	WORN/DETERIORATED
Deficiency Location/Instance	Right side
Deficiency Quantity	100
Quantity Uom	S.F.
Potential Action	REPLACE
Urgency of Action	PRIORITY 3
Purpose of Action	LEVEL 2

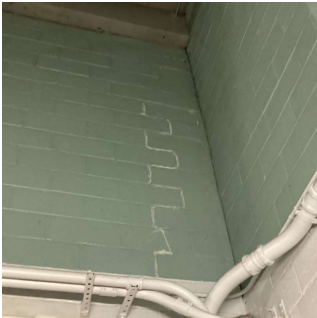
Violations	Right side No violations recorded.
<b>Walls</b>	
Instance on 1st Floor (492 Seats)	Inspected
Condition	2 - Between Good and Fair
Deficiency	MASONRY: CRACKS/SPALLING
Deficiency Location/Instance	Stage
Deficiency Quantity	10
Quantity Uom	S.F.
Potential Action	REPLACE
Urgency of Action	PRIORITY 3
Purpose of Action	LEVEL 2
Deficiency Photo1

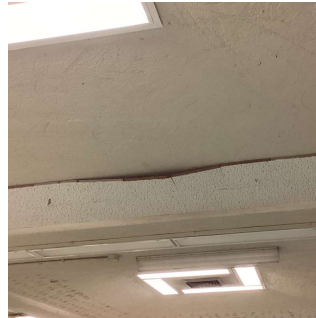
Violations	Stsge No violations recorded.
<b>Window Curtains/Shades/Blinds</b>	
Instance on 1st Floor (492 Seats)	Does not Exist
<b>CAFETERIA</b>	
Instance on 1st Floor - Students	Inspected
Instance on 1st Floor - Staff (600 SF)	Inspected
<b>Ceiling</b>	
Instance on 1st Floor - Students	Inspected
Condition	5 - Poor
Deficiency	ACOUSTIC TILES ON PLASTER: DAMAGED/MISSING
Deficiency Location/Instance	Near Windows
Deficiency Quantity	500
Quantity Uom	S.F.
Potential Action	REPLACE

Urgency of Action	PRIORITY 3

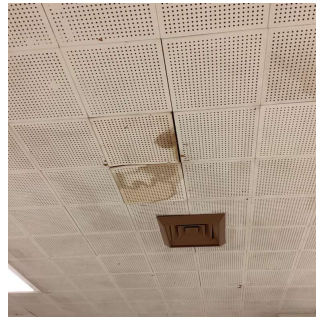
Near center

ACOUSTIC TILES ON PLASTER: DAMAGED/MISSING

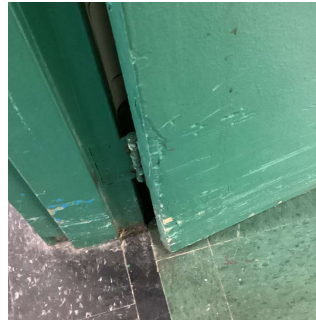
Entrance

WOOD: DETERIORATED DOOR

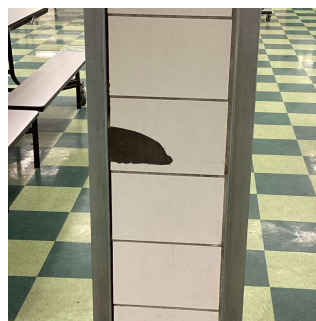
Near center

GLAZED BLOCK: CRACKS/SPALLING

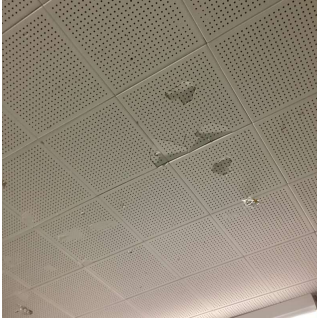
Question	Response
<b>INTERIOR</b>	
<b>CLASSROOMS/CORRIDORS/ADMIN SPACES</b>	
<b>Ceiling</b>	
Deficiency Location/Instance	Corridor near Room 401, 331, 205, 142, Exit 5, and others
Deficiency Quantity	60
Quantity Uom	S.F.
Potential Action	REPLACE
Urgency of Action	PRIORITY 3
Purpose of Action	LEVEL 2
Deficiency Photo1

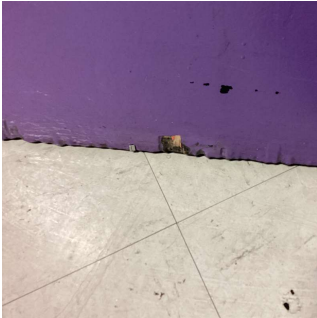
Room 402
Violations	No violations recorded.
<b>Floor Finish</b>	Inspected
Condition	2 - Between Good and Fair
Deficiency	VINYL TILES: DETERIORATED SUBSTRATE
Deficiency Location/Instance	Corridor near Room 310
Deficiency Quantity	10
Quantity Uom	S.F.
Potential Action	REPLACE

Corridor near Room 401
Violations	No violations recorded.
<b>Door(s)</b>	Inspected
Condition	5 - Poor
Deficiency	WOOD: DETERIORATED DOOR
Deficiency Location/Instance	Room 431, 408, 405, 403, 402, and others
Deficiency Quantity	12
Quantity Uom	EACH
Potential Action	MAINTENANCE
Urgency of Action	PRIORITY 3
Purpose of Action	LEVEL 2
Deficiency Photo1

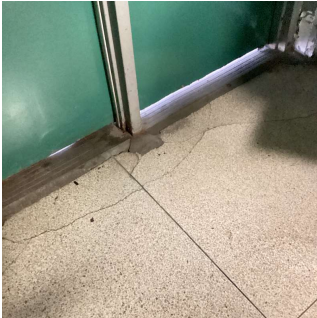
Question	Response
<b>INTERIOR</b>	
<b>CLASSROOMS/CORRIDORS/ADMIN SPACES</b>	
<b>Floor Finish</b>	
Deficiency	TERRAZZO: CRACKS
Deficiency Location/Instance	Exit 9, Exit 8, Exit 5, Exit 3, Exit 1, and others
Deficiency Quantity	60
Quantity Uom	S.F.
Potential Action	REPLACE
Urgency of Action	PRIORITY 3
Purpose of Action	LEVEL 2
Deficiency Photo1

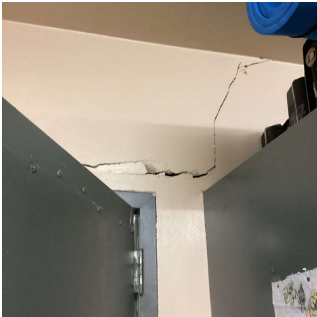
Violations	Room 142 No violations recorded.
Deficiency	GLAZED BLOCK: CRACKS/SPALLING
Deficiency Location/Instance	Near Cafeteria, Gymnasium, Room 331
Deficiency Quantity	10
Quantity Uom	S.F.
Potential Action	REPLACE
Urgency of Action	PRIORITY 3
Purpose of Action	LEVEL 2

Violations	Exit 8 No violations recorded.
<b>Walls</b>	Inspected
Condition	2 - Between Good and Fair
Deficiency	PLASTER: CRACKS/SPALLING
Deficiency Location/Instance	Room 142, Exit 8
Deficiency Quantity	20
Quantity Uom	S.F.
Potential Action	REPLACE
Urgency of Action	PRIORITY 3
Purpose of Action	LEVEL 2
Deficiency Photo1

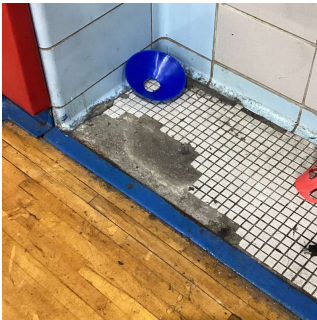
Violations	Near water fountain No violations recorded.
Deficiency	CONCRETE: CRACKS
Deficiency Location/Instance	Storage
Deficiency Quantity	20
Quantity Uom	S.F.
Potential Action	REPLACE
Urgency of Action	PRIORITY 3
Purpose of Action	LEVEL 2

Violations	Storage No violations recorded.
<b>Fixed Equipment</b>	
Instance on 1st Floor	Inspected
Condition	2 - Between Good and Fair
Deficiency	No deficiencies recorded
<b>Floor Finish</b>	
Instance on 1st Floor	Inspected
Condition	2 - Between Good and Fair
Deficiency	CERAMIC TILE: BROKEN/MISSING TILES
Deficiency Location/Instance	Near water fountain
Deficiency Quantity	10
Quantity Uom	S.F.
Potential Action	REPLACE
Urgency of Action	PRIORITY 3
Purpose of Action	LEVEL 2
Deficiency Photo1

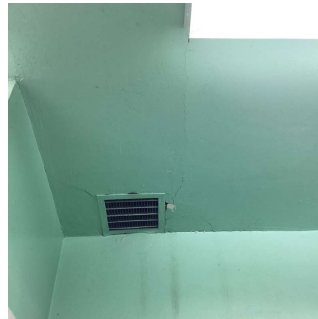
Slop sink area

Deficiency	PLASTER: CRACKS/SPALLING
Deficiency Location/Instance	Slop sink area, storage
Deficiency Quantity	15
Quantity Uom	S.F.
Potential Action	REPLACE
Urgency of Action	PRIORITY 3
Purpose of Action	LEVEL 2
Deficiency Photo1

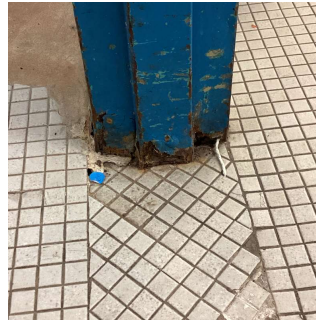
Instance on 1st Floor	Inspected
Condition	3 - Fair
Deficiency	METAL: DETERIORATED DOOR AND FRAME
Deficiency Location/Instance	Near servery
Deficiency Quantity	1
Quantity Uom	EACH
Potential Action	MAINTENANCE
Urgency of Action	PRIORITY 3
Purpose of Action	LEVEL 2

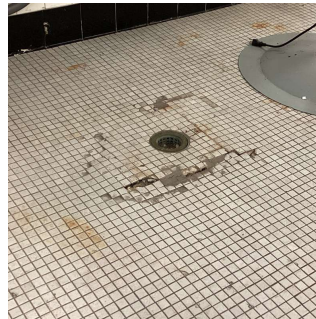
Near boiler

Deficiency CERAMIC TILE: DETERIORATED SUBSTRATE

Deficiency Location/Instance Near sink, Boiler

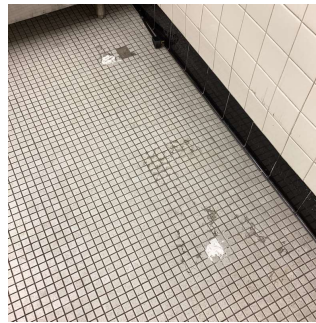
Severy

Deficiency CERAMIC TILE: BROKEN/MISSING TILES

Deficiency Location/Instance Servery, Near center, Slop sink area

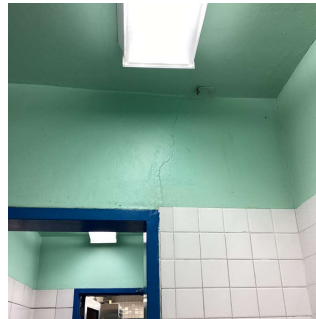
Deficiency	PLASTER: CRACKS/SPALLING
------------	--------------------------

Deficiency Location/Instance	Slop sink area, Storage Room
------------------------------	------------------------------

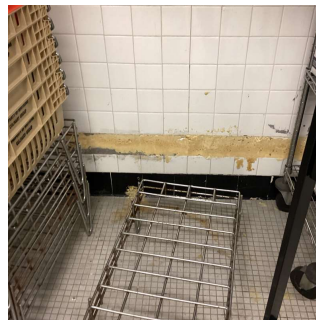
Deficiency	CERAMIC TILE: BROKEN/ MISSING
------------	-------------------------------

Deficiency Location/Instance	Near office, prep area
------------------------------	------------------------

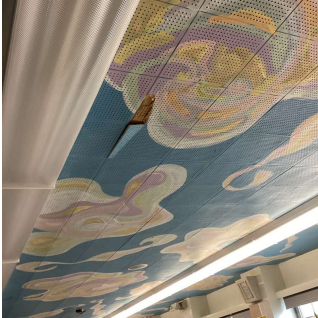
Question	Response
<b>INTERIOR</b>	
<b>KITCHEN</b>	Inspected
<b>Walls</b>	
Violations	Prep area No violations recorded.
<b>LIBRARY</b>	Inspected
Instance on Room 236	Inspected
<b>Built-in Furnishing</b>	
Instance on Room 236	Inspected
Condition	2 - Between Good and Fair
Deficiency	No deficiencies recorded
<b>Ceiling</b>	
Instance on Room 236	Inspected
Condition	2 - Between Good and Fair
Deficiency	ACOUSTIC TILES ON PLASTER: DAMAGED/MISSING
Deficiency Location/Instance	Near center, windows
Deficiency Quantity	25
Quantity Uom	S.F.
Potential Action	REPLACE
Urgency of Action	PRIORITY 3
Purpose of Action	LEVEL 2
Deficiency Photo1

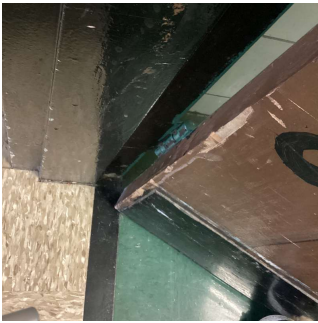
Violations	Near center No violations recorded.
<b>Door(s)</b>	
Instance on Room 236	Inspected
Condition	5 - Poor
Deficiency	WOOD: DETERIORATED DOOR
Deficiency Location/Instance	Entrance, office
Deficiency Quantity	3
Quantity Uom	EACH
Potential Action	MAINTENANCE
Urgency of Action	PRIORITY 3
Purpose of Action	LEVEL 2

Entrance
Violations	No violations recorded.
<b>Floor Finish</b>	
Instance on Room 236	Inspected
Condition	2 - Between Good and Fair
Deficiency	No deficiencies recorded
<b>Walls</b>	
Instance on Room 236	Inspected
Condition	2 - Between Good and Fair
Deficiency	PLASTER: CRACKS/SPALLING
Deficiency Location/Instance	Near Windows
Deficiency Quantity	10
Quantity Uom	S.F.
Potential Action	REPLACE
Urgency of Action	PRIORITY 3
Purpose of Action	LEVEL 2
Deficiency Photo1

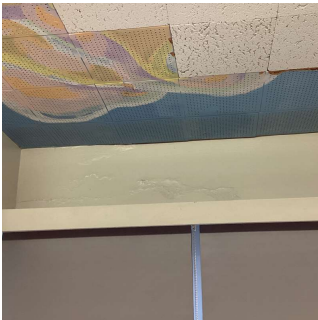
Near Windows
Violations	No violations recorded.
<b>LOCKER ROOM</b>	
Instance on 1st Floor - Boys (250 Lockers)	Inspected
Alternative use	Yes
Instance on 1st Floor - Girls (1,600 Lockers)	Inspected
Alternative use	No
<b>Ceiling</b>	
Instance on 1st Floor - Boys (250 Lockers)	Inspected
Condition	2 - Between Good and Fair
Deficiency	PLASTER: CRACKS/SPALLING - ACTIVE LEAK

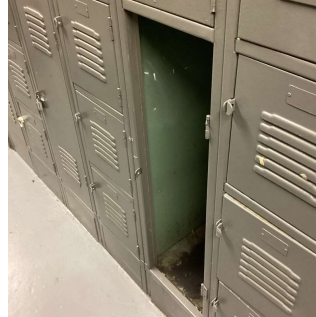
Locker 20

Condition	2 - Between Good and Fair
Deficiency	DAMAGED UNITS

Deficiency Location/Instance	Locker 1,3,15,20,24, and others
Deficiency Quantity	28
Quantity Uom	EACH
Potential Action	REPLACE
Urgency of Action	PRIORITY 3
Purpose of Action	LEVEL 2
Deficiency Photo1

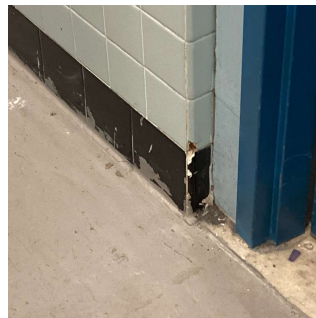
Deficiency	CERAMIC TILE: BROKEN/ MISSING
Deficiency Location/Instance	Near shower room
Deficiency Quantity	10
Quantity Uom	S.F.
Potential Action	REPLACE
Urgency of Action	PRIORITY 3
Purpose of Action	LEVEL 2
Deficiency Photo1

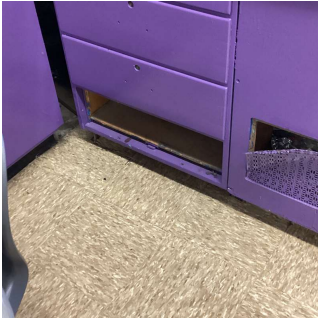
Question	Response
<b>INTERIOR</b>	
<b>LOCKER ROOM</b>	Inspected
Walls	
Violations	Near shower room No violations recorded.
<b>MULTI-PURPOSE ROOM</b>	Does not Exist
<b>SCIENCE DEMO ROOM</b>	Does not Exist
<b>SCIENCE LAB</b>	Inspected
Instance on Room 331	Inspected
Alternative use	Yes
Instance on Room 332, 333, 334, 335, 336	Inspected
Alternative use	No
<b>Fixed Equipment</b>	
Instance on Room 331	Inspected
Condition	3 - Fair
Deficiency	CABINETS: MISSING/DAMAGED
Deficiency Location/Instance	Room 331
Deficiency Quantity	10
Quantity Uom	L.F.
Potential Action	REPLACE
Urgency of Action	PRIORITY 3
Purpose of Action	LEVEL 2
Deficiency Photo1

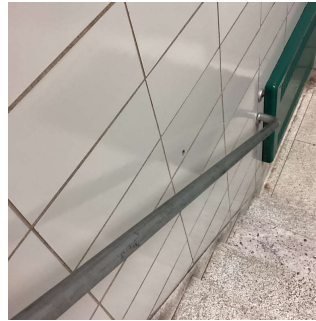
<b>Partition</b>	Does not Exist
<b>Railings</b>	Inspected
Condition	3 - Fair
Deficiency	METAL: BROKEN BRACKET
Deficiency Location/Instance	Exit 9
Deficiency Quantity	2
Quantity Uom	EACH
Potential Action	REPLACE
Urgency of Action	PRIORITY 3
Purpose of Action	LEVEL 2

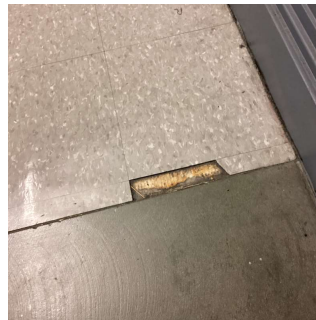
Stair C/4

VINYL TILES: BROKEN/DETERIORATED/MISSING TILES

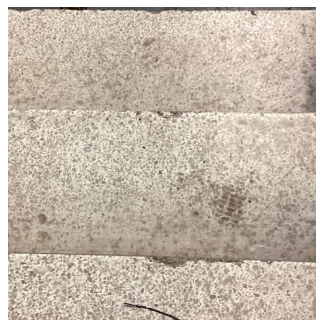
TERRAZZO: CRACKS

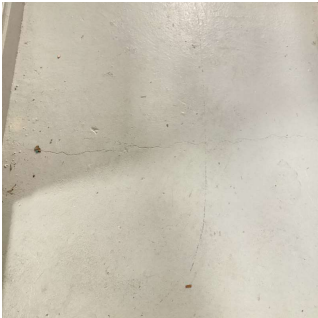
Question	Response
<b>INTERIOR</b>	
<b>STAIRS/RAMPS: INTERIOR</b>	
<b>Stairs and Landings</b>	
Violations	Exit near Gymnasium No violations recorded.
Deficiency	CONCRETE: CRACKS/SPALLING - MAJOR
Deficiency Location/Instance	Stair A/Bulkhead
Deficiency Quantity	10
Quantity Uom	S.F.
Potential Action	REPLACE
Urgency of Action	PRIORITY 3
Purpose of Action	LEVEL 2
Deficiency Photo1

Violations	Stair A/Bulkhead No violations recorded.
<b>Walls</b>	Inspected
Condition	2 - Between Good and Fair
Deficiency	GLAZED BLOCK: CRACKS/SPALLING
Deficiency Location/Instance	Stair C/4
Deficiency Quantity	10
Quantity Uom	S.F.
Potential Action	REPLACE
Urgency of Action	PRIORITY 3
Purpose of Action	LEVEL 2
Deficiency Photo1

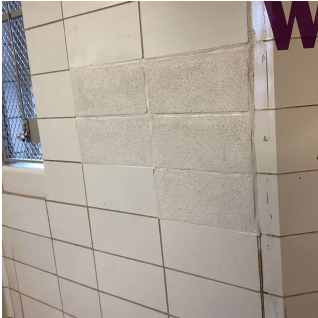
Violations	Stair C/4 No violations recorded.
<b>TOILET ROOMS - STAFF</b>	
	Inspected
<b>Ceiling</b>	Inspected
Condition	2 - Between Good and Fair
Deficiency	No deficiencies recorded
<b>Door(s)</b>	Inspected
Condition	5 - Poor

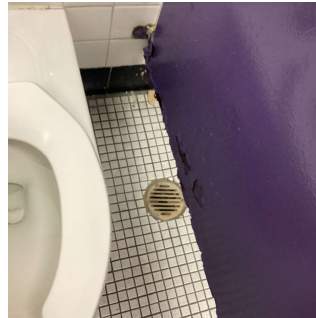
Room 420

RUST - MAJOR

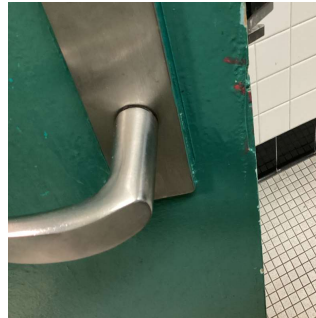
Room 310

WOOD: DETERIORATED DOOR

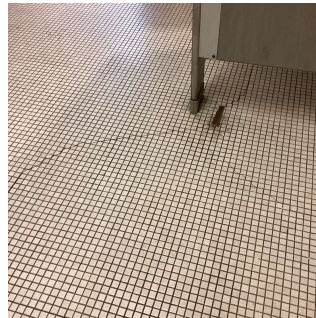
CERAMIC TILE: BROKEN/MISSING TILES

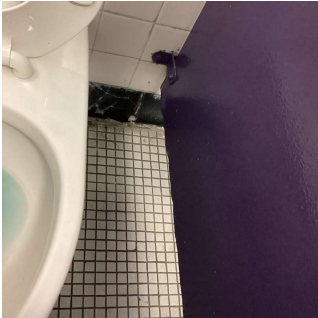
Question	Response
<b>INTERIOR</b>	
<b>TOILET ROOMS - STUDENTS</b>	
<b>Floor Finish</b>	Inspected
	Room 210
Violations	No violations recorded.
<b>Stalls</b>	Inspected
Condition	5 - Poor
Deficiency	RUST - MAJOR
Deficiency Location/Instance	Girls Locker Room, Room 416, 316, 216
Deficiency Quantity	16
Quantity Uom	EACH
Potential Action	REPLACE
Urgency of Action	PRIORITY 3
Purpose of Action	LEVEL 2
Deficiency Photo1

Violations	Room 416 No violations recorded.
<b>Walls</b>	Inspected
Condition	2 - Between Good and Fair
Deficiency	CERAMIC TILE: BROKEN/ MISSING
Deficiency Location/Instance	Girls Locker Room, Room 416, 410, 316, 310, and others
Deficiency Quantity	45
Quantity Uom	S.F.
Potential Action	REPLACE
Urgency of Action	PRIORITY 3
Purpose of Action	LEVEL 2
Deficiency Photo1

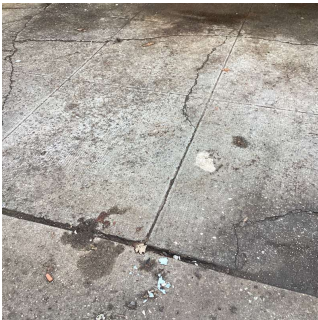
Along Manhattan Avenue
Violations	No violations recorded.
<b>IRRIGATION SYSTEM</b>	Does not Exist
<b>PAVING</b>	Inspected
<b>Student Non-Use</b>	Inspected
Gravel Exists?	No
<b>Asphalt</b>	Does not Exist
<b>Concrete</b>	Inspected
Condition	3 - Fair
Deficiency	DAMAGED/DETERIORATED/MISSING SECTIONS
Deficiency Location/Instance	Near exit 11
Deficiency Quantity	450
Quantity Uom	S.F.
Potential Action	REPLACE
Urgency of Action	PRIORITY 3
Purpose of Action	LEVEL 2
Deficiency Photo1

Near exit 11
Violations	No violations recorded.
<b>Pavers</b>	Inspected
Condition	2 - Between Good and Fair

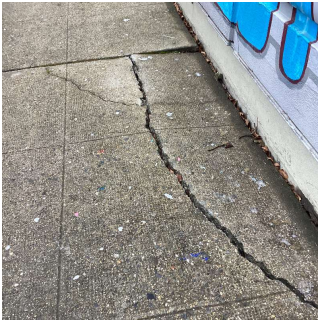
Violations	Walkway along Parks Department No violations recorded.
Deficiency	DAMAGED/DETERIORATED/MISSING SECTIONS
Deficiency Location/Instance	Walkway along Parks Department
Deficiency Quantity	25
Quantity Uom	S.F.
Potential Action	REPLACE
Urgency of Action	PRIORITY 5
Purpose of Action	LEVEL 6
Deficiency Photo1

Violations	Walkway along Park Department No violations recorded.
<b>Pavers</b>	Does not Exist
<b>DOT Sidewalk</b>	Inspected

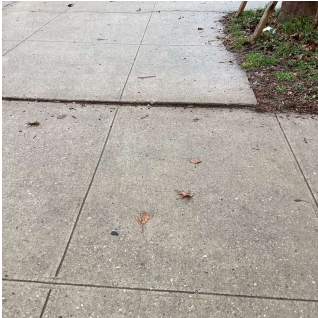
<b>Asphalt</b>	Does not Exist
<b>Concrete</b>	Inspected
Condition	4 - Between Fair and Poor
Deficiency	HEAVING

Question	Response
<b>SITE</b>	
<b>PAVING</b>	
<b>DOT Sidewalk</b>	
<b>Concrete</b>	
Deficiency Location/Instance	Along Manhattan Avenue
Deficiency Quantity	50
Quantity Uom	S.F.
Potential Action	REPLACE
Urgency of Action	PRIORITY 3
Purpose of Action	LEVEL 2
Deficiency Photo1

Violations	Along Manhattan Avenue No violations recorded.
Deficiency	DAMAGED/DETERIORATED/MISSING SECTIONS
Deficiency Location/Instance	Along Manhattan Avenue, Bayard Street, Leonard Street
Deficiency Quantity	1,200
Quantity Uom	S.F.
Potential Action	REPLACE
Urgency of Action	PRIORITY 3
Purpose of Action	LEVEL 2
Deficiency Photo1

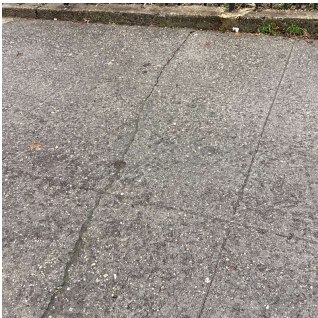
Violations	Along Manhattan Avenue No violations recorded.
Deficiency	DAMAGED CURBS
Deficiency Location/Instance	Along Manhattan Avenue, Bayard Street
Deficiency Quantity	240
Quantity Uom	L.F.
Potential Action	REPLACE
Urgency of Action	PRIORITY 3
Purpose of Action	LEVEL 2
