**NYC Department of Education**  
**Building Condition Assessment Survey 2023 - 2024**

Architectural Inspection

**K127**

**Asset: P.S. 127 - BROOKLYN, 7805 7 AVENUE, New York, 11209**

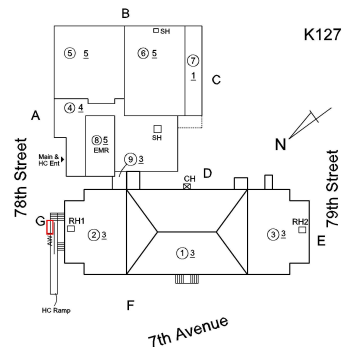
| Question | Response |
|---|---|
| Instance Condition | 3 - Fair |
| Deficiency | AREAWAY WALLS: CRACKS AND SPALLING |

Potential Action  
Urgency of Action  
Purpose of Action  
Deficiency Photo1

REPAIR  
PRIORITY 3  
LEVEL 2

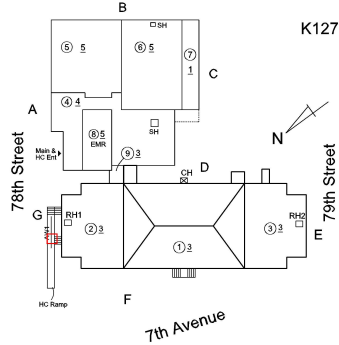
AREAWAY WALLS: CRACKS AND SPALLING

10  
S.F.  
REPLACE  
PRIORITY 4  
LEVEL 2

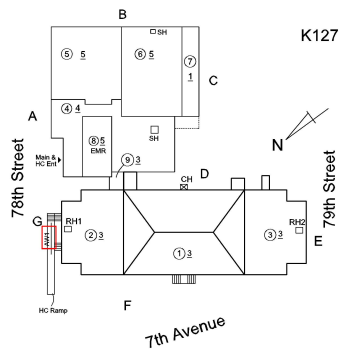
| Question | Response |
|---|--|
| Roof Plan reference | |

AREAWAY WALLS: DETERIORATED JOINTS

| Question | Response |
|---|--|
| Potential Action | REPAIR |

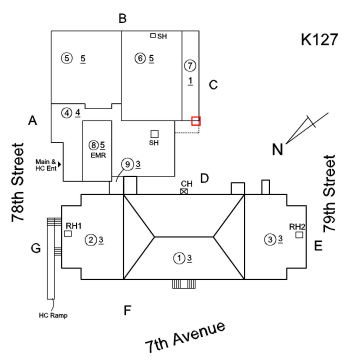
| Question | Response |
|---|--|
| Roof Plan reference | |

| Question | Response |
|---|--|
| Condition | 3 - Fair |
| Deficiency | CAST STONE: DISINTEGRATING / FREEZE THAW |

| Question | Response |
|---|--|
| Potential Action | REPLACE-IN-KIND |

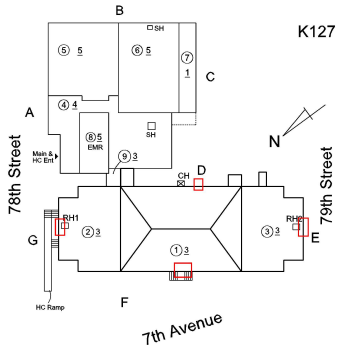
| Question | Response |
|---|--|
| Roof Plan reference | |

| Question | Response |
|---|--|
| Condition | 5 - Poor |
| Deficiency | METAL CLAD: DETERIORATED DOOR - MAJOR DETERIORATION |

| Question | Response |
|---|--|
| Potential Action | REPLACE |

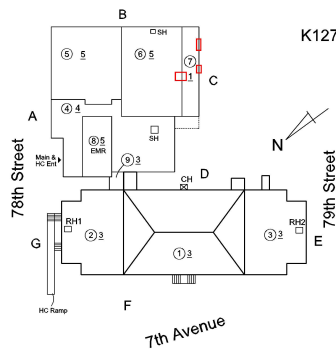
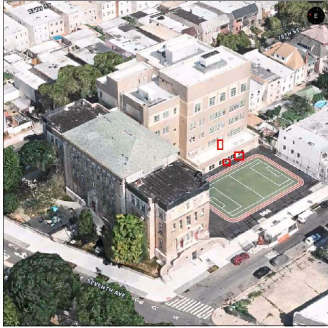
| Question | Response |
|---|--|
| Deficiency | BRICK: DETERIORATED MASONRY SILLS - MINOR |

| Question | Response |
|---|--|
| Potential Action | REPAIR |

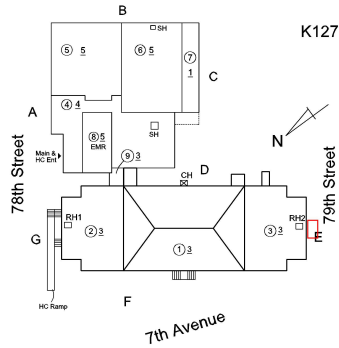
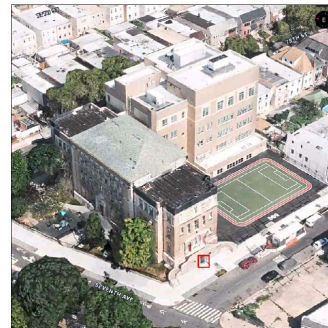
CONCRETE: WATER PENETRATION

REPLACE

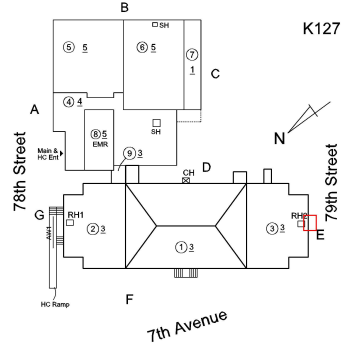
Roof Plan reference

STONE: BULGING/DISPLACED

REPLACE

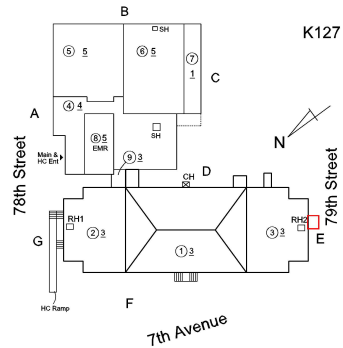
Roof Plan reference

STONE: CRACKS/SPALLING - MAJOR

REPLACE

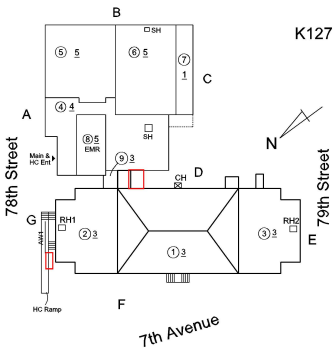
| Question | Response |
|---|--|
| Roof Plan reference | |

| Question | Response |
|---|--|
| Deficiency | CAST IN PLACE CONCRETE: CRACKS/SPALLING - MINOR |

| Question | Response |
|---|--|
| Potential Action | REPAIR |

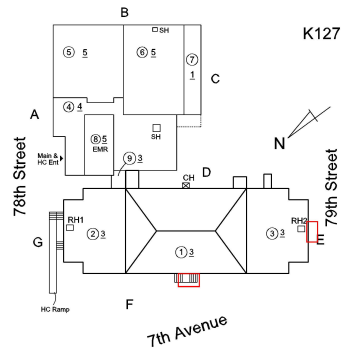
Roof Plan reference

| Question | Response |
|---|--|
| Condition | 5 - Poor |
| Deficiency | STONE: WORN-OUT TREAD/RISER/NOSING |

50  
S.F.  
REPLACE  
PRIORITY 4  
LEVEL 2

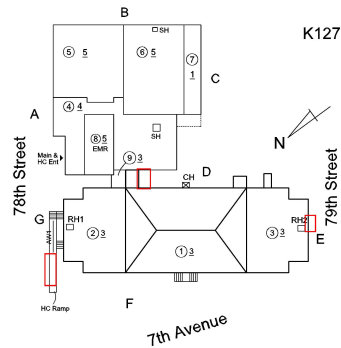
Roof Plan reference

**CONCRETE: CRACKS/SPALLING - MINOR**

85  
S.F.  
REPAIR  
PRIORITY 3  
LEVEL 2

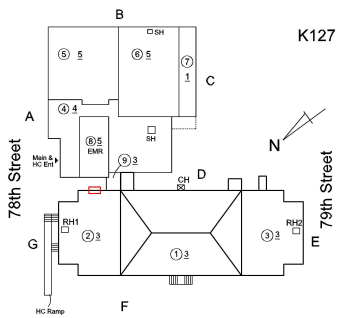
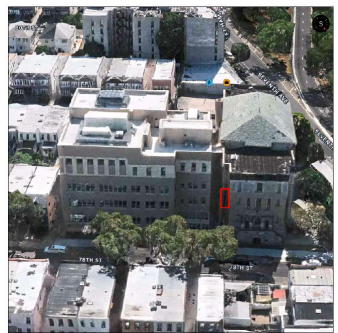
| Question | Response |
|---|--|
| Deficiency | ALUMINUM - DOUBLE HUNG: BROKEN PANE |

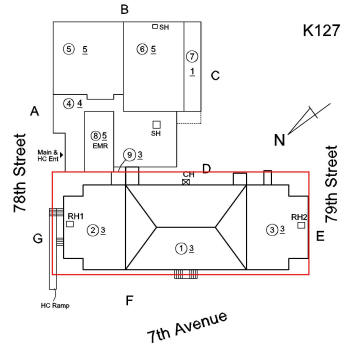
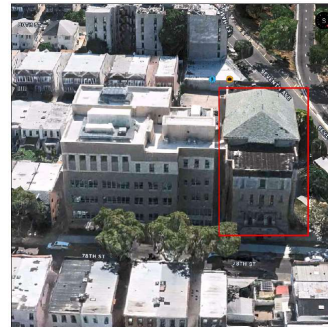
ALUMINUM - DOUBLE HUNG: INOPERABLE BALANCE

50  
EACH  
REPLACE BALANCES  
PRIORITY 3  
LEVEL 2
