NYC Department of Education
Building Condition Assessment Survey 2023 - 2024

Architectural Inspection

K131

Asset: P.S. 131 - BROOKLYN, 4305 FT HAMILTON PKWY, New York, 11219

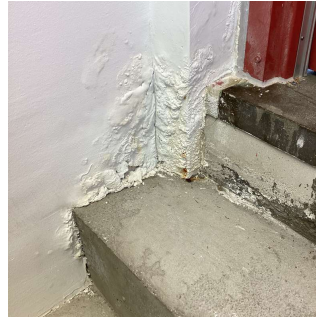
BH1

**BULKHEAD/PENTHOUSE WALLS/EXTERIOR: WATER
INFILTRATION**

Deficiency Quantity	100
Quantity Uom	S.F.
Potential Action	REPAIR
Urgency of Action	PRIORITY 5
Purpose of Action	LEVEL 2
Deficiency Photo1

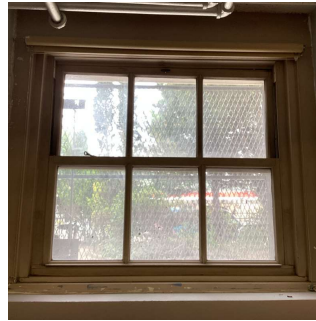
Facade A - Cafeteria

WINDOWS

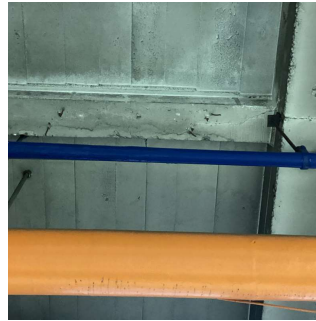
AW1
Violations	No violations recorded.
Deficiency	STEEL COLUMNS/BEAMS: DETERIORATED CONCRETE FIREPROOFING
Deficiency Location/Instance	Boiler Room
Deficiency Quantity	20
Quantity Uom	S.F.
Potential Action	REPLACE
Urgency of Action	PRIORITY 3
Purpose of Action	LEVEL 5

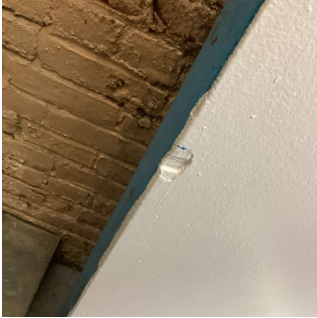
Question	Response
INTERIOR	
CAFETERIA	
Door(s)	
Instance on Basement	Inspected
Condition	3 - Fair
Deficiency	WOOD: DETERIORATED DOOR
Deficiency Location/Instance	Exit 13 Vestibule
Deficiency Quantity	1
Quantity Uom	EACH
Potential Action	MAINTENANCE
Urgency of Action	PRIORITY 3
Purpose of Action	LEVEL 2
Deficiency Photo1

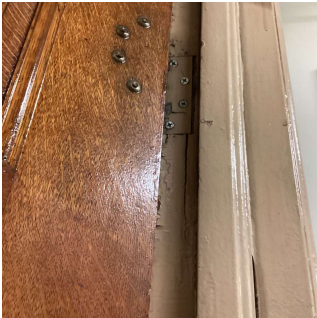
Question	Response
INTERIOR	
CLASSROOMS/CORRIDORS/ADMIN SPACES	
Door(s)	
	Room 214
Violations	No violations recorded.
Deficiency	WOOD: DETERIORATED DOOR AND FRAME
Deficiency Location/Instance	Main Entrance Vestibule, Room 110
Deficiency Quantity	3
Quantity Uom	EACH
Potential Action	MAINTENANCE
Urgency of Action	PRIORITY 3
Purpose of Action	LEVEL 2
Deficiency Photo1

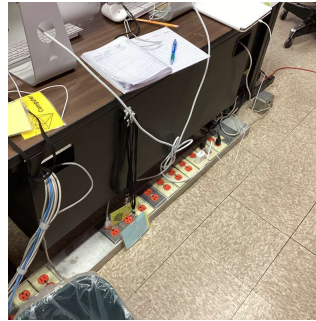
Main Entrance Vestibule
Violations	No violations recorded.
Floor Finish	Inspected
Condition	3 - Fair
Deficiency	WOOD: DAMAGED/DETERIORATED
Deficiency Location/Instance	Rooms 410, 412, 414,418
Deficiency Quantity	30
Quantity Uom	S.F.
Potential Action	REPLACE
Urgency of Action	PRIORITY 3
Purpose of Action	LEVEL 2
Deficiency Photo1	 
	Room 410
Violations	No violations recorded.
Deficiency	VINYL TILES: TRIPPING HAZARD - ELECTRICAL OUTLET
Deficiency Location/Instance	Room 202
Deficiency Quantity	10
Quantity Uom	S.F.
Potential Action	REMOVE
Urgency of Action	PRIORITY 5

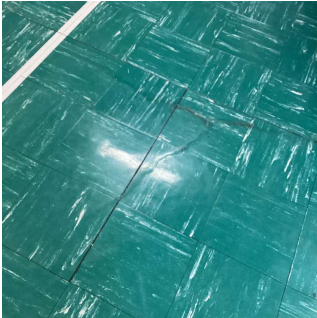
Question	Response
INTERIOR	
CLASSROOMS/CORRIDORS/ADMIN SPACES	
Floor Finish	
Deficiency	VINYL TILES: DETERIORATED SUBSTRATE
Deficiency Location/Instance	Rooms 208, 302, Corridor near Rooms 105, 204, 305, and others
Deficiency Quantity	1,300
Quantity Uom	S.F.
Potential Action	REPLACE
Urgency of Action	PRIORITY 3
Purpose of Action	LEVEL 2
Deficiency Photo1

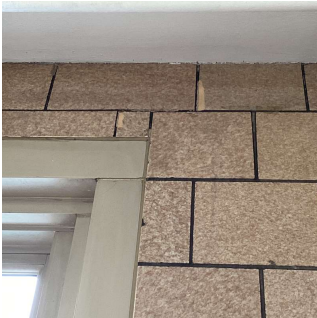
Corridor near Room 305
Violations	No violations recorded.
Walls	
Condition	Inspected
Deficiency	2 - Between Good and Fair
Deficiency Location/Instance	GLAZED BLOCK: CRACKS/SPALLING
Deficiency Quantity	1st Floor Bridge
Quantity Uom	10
Potential Action	S.F.
Urgency of Action	REPLACE
Purpose of Action	PRIORITY 3
Deficiency Photo1	LEVEL 2

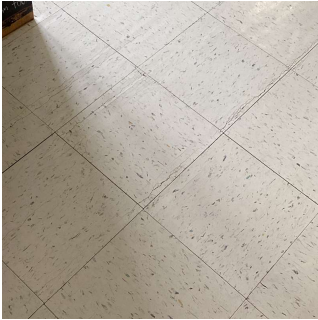
Question	Response
INTERIOR	
LIBRARY	
Floor Finish	
Instance on Room 212	Inspected
Condition	3 - Fair
Deficiency	VINYL TILES: DETERIORATED SUBSTRATE
Deficiency Location/Instance	Near center, rear
Deficiency Quantity	50
Quantity Uom	S.F.
Potential Action	REPLACE
Urgency of Action	PRIORITY 3
Purpose of Action	LEVEL 2
Deficiency Photo1

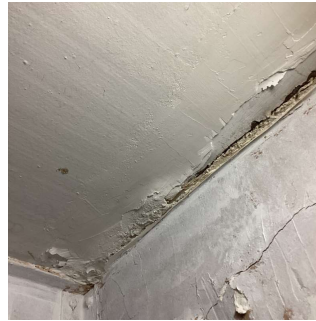
Violations	Near center No violations recorded.
Walls	
Instance on Room 212	Inspected
Condition	2 - Between Good and Fair
Deficiency	No deficiencies recorded
LOCKER ROOM	Inspected
Instance on 3rd Floor	Inaccessible
MULTI-PURPOSE ROOM	Does not Exist
SCIENCE DEMO ROOM	Does not Exist
SCIENCE LAB	Does not Exist
SCIENCE PREP ROOM	Does not Exist
SHOWER ROOM	Inspected
Instance on 3rd Floor	Inaccessible
STAIRS/RAMPS: INTERIOR	Inspected
Do Letter Stair Signs Exist?	Partially
Ceiling	
Condition	2 - Between Good and Fair
Deficiency	PLASTER: CRACKS/SPALLING
Deficiency Location/Instance	Stair C/Basement

Deficiency Quantity	10
Quantity Uom	S.F.
Potential Action	REPLACE
Urgency of Action	PRIORITY 3
Purpose of Action	LEVEL 2

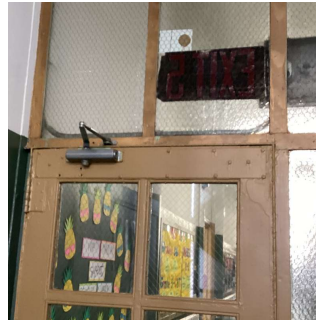
Stair C/2

METAL CLAD WOOD: DETERIORATED DOOR

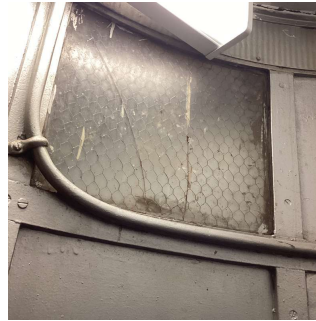
Stair D/Basement

GLASS PANEL: DAMAGED/DETERIORATED

REPLACE

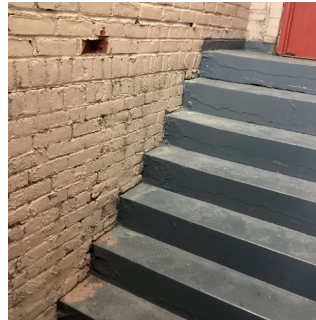
Exit 13 Vestibule

METAL: MISSING

REPLACE

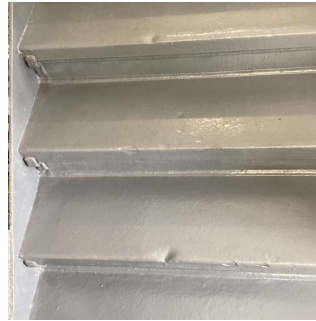
Stair D/3

STONE: BROKEN/MISSING

REPLACE

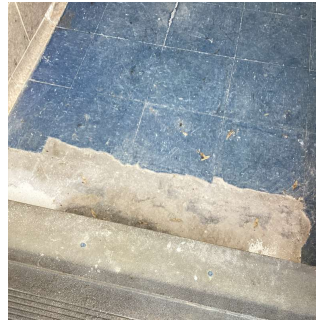
Stair bulkhead above the Gymnasium

VINYL TILES: BROKEN/DETERIORATED/MISSING TILES

REPLACE

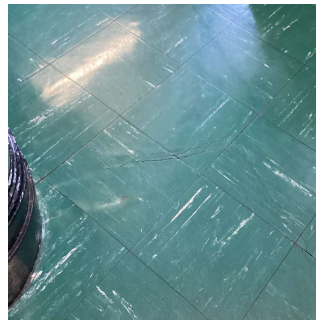
Stair C/2

VINYL TILES: DETERIORATED SUBSTRATE

REPLACE

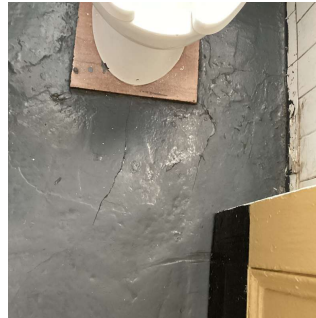
Room 307B

CONCRETE: CRACKS

REPLACE

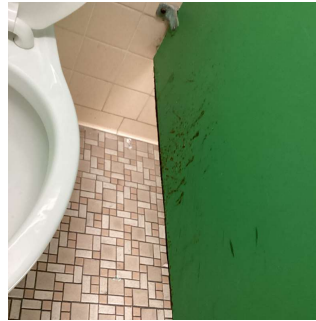
Room 326

RUST - MAJOR

REPLACE

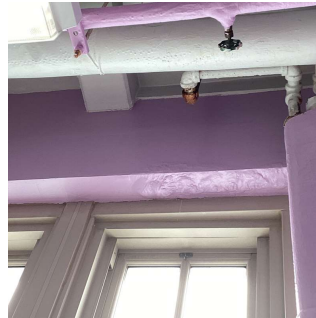
Room 326

PLASTER: CRACKS/SPALLING

REPLACE

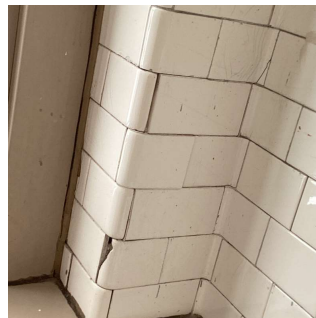
CERAMIC TILE: BROKEN/ MISSING

REPLACE

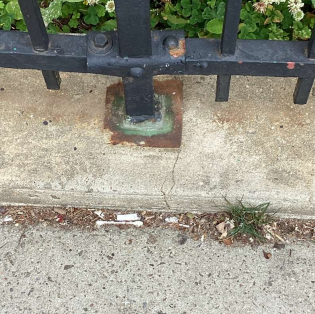
Violations	44th Street - Entrance to Exit 9/Playground side No violations recorded.
Deficiency	CONCRETE CURB: DAMAGED/DETERIORATED
Deficiency Location/Instance	44th Street, 43rd Street, Fort Hamilton Parkway
Deficiency Quantity	30
Quantity Uom	S.F.
Potential Action	REPLACE
Urgency of Action	PRIORITY 3
Purpose of Action	LEVEL 2

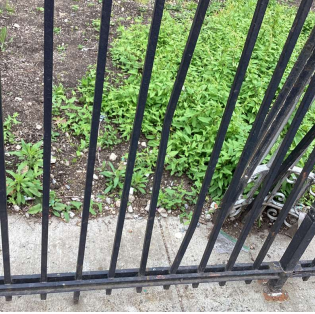
Violations	44th Street No violations recorded.
Deficiency	WROUGHT IRON: DAMAGED/DETERIORATED
Deficiency Location/Instance	44th Street
Deficiency Quantity	80
Quantity Uom	S.F.
Potential Action	REPLACE
Urgency of Action	PRIORITY 3
Purpose of Action	LEVEL 2
Deficiency Photo1

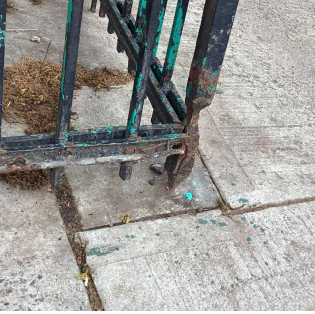
Violations	44th Street No violations recorded.
Deficiency	WROUGHT IRON: RUST - MAJOR
Deficiency Location/Instance	Fort Hamilton Parkway
Deficiency Quantity	40
Quantity Uom	S.F.
Potential Action	REPLACE
Urgency of Action	PRIORITY 3
Purpose of Action	LEVEL 2
Deficiency Photo1

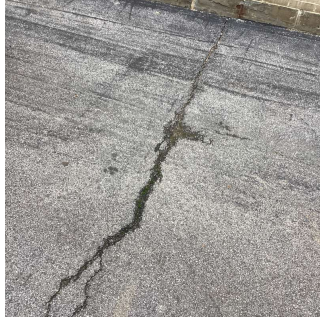
Schoolyard on 44th Street side
Violations	No violations recorded.
Concrete	Inspected
Condition	2 - Between Good and Fair
Deficiency	No deficiencies recorded
Pavers	Does not Exist
Site Sidewalks & Walkways	Inspected
Asphalt	Inspected
Condition	3 - Fair
Deficiency	CRACKS - MAJOR
Deficiency Location/Instance	44th Street - Near Exit 9 side
Deficiency Quantity	120

Quantity Uom	S.F.
Potential Action	REPLACE
Urgency of Action	PRIORITY 3
Purpose of Action	LEVEL 2

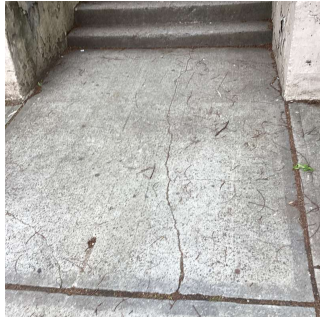
Violations	44th Street - Near Exit 9 side No violations recorded.
Concrete	Inspected
Condition	3 - Fair
Deficiency	DAMAGED/DETERIORATED/MISSING SECTIONS
Deficiency Location/Instance	44th Street, 43rd Street
Deficiency Quantity	250
Quantity Uom	S.F.
Potential Action	REPLACE
Urgency of Action	PRIORITY 3
Purpose of Action	LEVEL 2
Deficiency Photo1

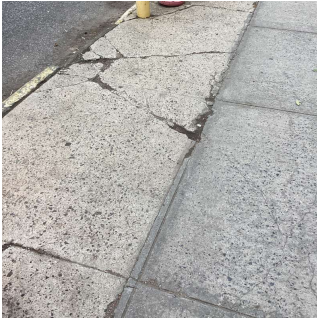
Question	Response
SITE	
PAVING	
DOT Sidewalk	
Concrete	
Violations	No violations recorded.
Deficiency	DAMAGED/DETERIORATED/MISSING SECTIONS
Deficiency Location/Instance	44th Street, 43rd Street, Fort Hamilton Parkway
Deficiency Quantity	2,350
Quantity Uom	S.F.
Potential Action	REPLACE
Urgency of Action	PRIORITY 3
Purpose of Action	LEVEL 2
Deficiency Photo1

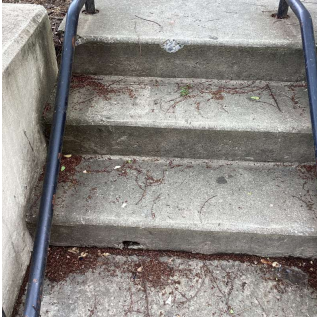
Question	Response
SITE	
STAIRS/RAMPS: EXTERIOR	
Site Cheek/flank Walls	
Potential Action	REPAIR
Urgency of Action	PRIORITY 3
Purpose of Action	LEVEL 2
Deficiency Photo1	No photo recorded
Violations	No violations recorded.
Stairs/ramps	Inspected
Condition	2 - Between Good and Fair
Deficiency	CAST IN PLACE CONCRETE: CRACKS/SPALLING - MAJOR
Deficiency Location/Instance	44th Street - Leading up to the Schoolyard
Deficiency Quantity	10
Quantity Uom	S.F.
Potential Action	REPLACE
Urgency of Action	PRIORITY 3
Purpose of Action	LEVEL 2
Deficiency Photo1
