NYC Department of Education
Building Condition Assessment Survey 2023 - 2024

Architectural Inspection

Asset: P.S. 135 - BROOKLYN, 684 LINDEN BLVD, New York, 11203

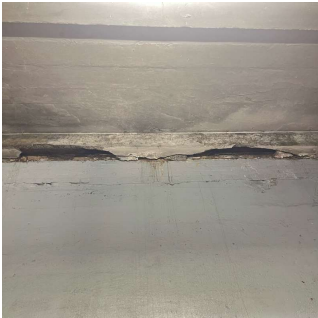
Question	Response
INTERIOR	
STRUCTURAL	
COLUMNS/BEAMS/BEARING WALLS	
Purpose of Action	LEVEL 5
Deficiency Photo1

Violations	Basement - near House Exhaust Fan No violations recorded.
FLOOR STRUCTURE	
Condition	Inspected 3 - Fair
Deficiency	CONCRETE SLAB ON GRADE: THRU CRACKS
Deficiency Location/Instance	Basement - near Oil Tank Room, near Ash Hoist Vault
Deficiency Quantity	40
Quantity Uom	S.F.
Potential Action	REPAIR
Urgency of Action	PRIORITY 3
Purpose of Action	LEVEL 5
Deficiency Photo1

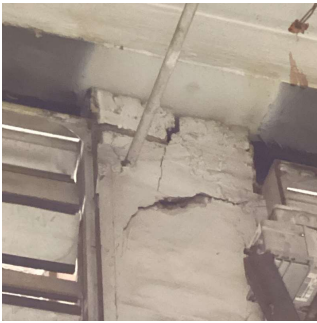
Violations	Basement - near Ash Hoist Vault No violations recorded.
FOUNDATION WALLS	
Material Type(s)	Inspected Concrete, Masonry
Condition	3 - Fair
Deficiency	BRICK: CRACKED/SPALLED
Deficiency Location/Instance	Basement - Boiler Room
Deficiency Quantity	20
Quantity Uom	S.F.
Potential Action	RESTITCH
Urgency of Action	PRIORITY 4
Purpose of Action	LEVEL 5

Violations	Basement - Boiler Room No violations recorded.
ROOF STRUCTURE	
Condition	Inspected
Deficiency	2 - Between Good and Fair
VAULTS-BUNKERS	
Condition	Inspected
Deficiency	No deficiencies recorded
Foundation Walls	
Condition	Inspected
Deficiency	2 - Between Good and Fair
Slab Structure	
Condition	Inspected
Deficiency	2 - Between Good and Fair
Vault/Ash Hoist Doors and Framing	
Condition	Inspected
Deficiency	1 - Good
AUDITORIUM	
Instance on 2nd Floor (380 Seats)	Inspected
Ceiling	
Instance on 2nd Floor (380 Seats)	Inspected
Condition	2 - Between Good and Fair
Deficiency	No deficiencies recorded
Door(s)	
Instance on 2nd Floor (380 Seats)	Inspected
Condition	2 - Between Good and Fair
Deficiency	No deficiencies recorded
Fixed H/C Lift	
Instance on 2nd Floor (380 Seats)	Does not Exist
Fixed Seating	
Instance on 2nd Floor (380 Seats)	Inspected

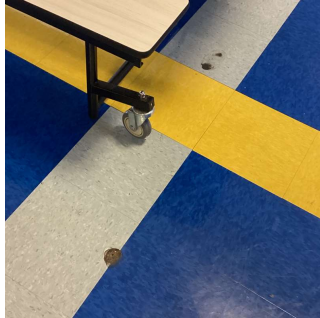
Question	Response
INTERIOR	
CAFETERIA	
Door(s)	
Instance on 1st Floor	Inspected
Condition	2 - Between Good and Fair
Deficiency	No deficiencies recorded
Fixed Equipment	
Instance on 1st Floor	Inspected
Condition	2 - Between Good and Fair
Deficiency	No deficiencies recorded
Floor Finish	
Instance on 1st Floor	Inspected
Condition	2 - Between Good and Fair
Deficiency	VINYL TILES: BROKEN/DETERIORATED/MISSING TILES
Deficiency Location/Instance	Near the center
Deficiency Quantity	10
Quantity Uom	S.F.
Potential Action	REPLACE
Urgency of Action	PRIORITY 3
Purpose of Action	LEVEL 2
Deficiency Photo1

Violations	Near the center No violations recorded.
Sliding-folding Partition	
Instance on 1st Floor	Does not Exist
Stage	
Instance on 1st Floor	Does not Exist
Walls	
Instance on 1st Floor	Inspected
Condition	2 - Between Good and Fair
Deficiency	WALL PADDING: DETERIORATED
Deficiency Location/Instance	Columns
Deficiency Quantity	100

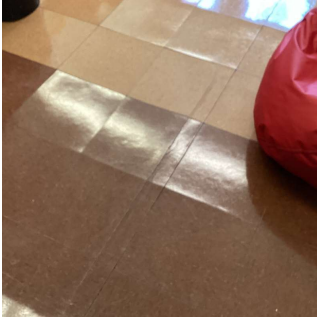
Question	Response
INTERIOR	
CLASSROOMS/CORRIDORS/ADMIN SPACES	
Floor Finish	Inspected
Condition	3 - Fair
Deficiency	VINYL TILES: DETERIORATED SUBSTRATE
Deficiency Location/Instance	Rooms 301, 403, 404, 407, 509, and others
Deficiency Quantity	1,500
Quantity Uom	S.F.
Potential Action	REPLACE
Urgency of Action	PRIORITY 3
Purpose of Action	LEVEL 2
Deficiency Photo1

Violations	Room 405 No violations recorded.
Deficiency	VINYL TILES: BROKEN/DETERIORATED/MISSING TILES
Deficiency Location/Instance	Rooms 260, 401, 402, 508, Corridor near Room 406, and others
Deficiency Quantity	500
Quantity Uom	S.F.
Potential Action	REPLACE
Urgency of Action	PRIORITY 3
Purpose of Action	LEVEL 2
Deficiency Photo1

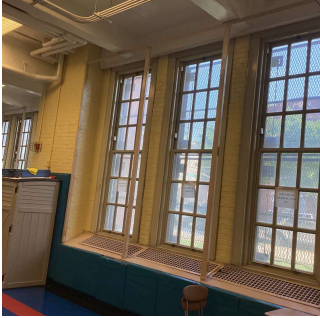
Question	Response
INTERIOR	
CLASSROOMS/CORRIDORS/ADMIN SPACES	Inspected
Walls	Inspected
Violations	Room 507 No violations recorded.
Specialties	Does not Exist
GYMNASIUM	Does not Exist
INTERIOR DOOR HARDWARE	Inspected
Condition	3 - Fair
Deficiency	No deficiencies recorded
INTERIOR GUARDS	Inspected
Condition	4 - Between Fair and Poor
Deficiency	DETERIORATED/TORN-OUT/MISSING
Deficiency Location/Instance	In the Cafeteria
Deficiency Quantity	400
Quantity Uom	S.F.
Potential Action	REPLACE
Urgency of Action	PRIORITY 3
Purpose of Action	LEVEL 2
Deficiency Photo1

Violations	In the Cafeteria No violations recorded.
KITCHEN	Inspected
Instance on 1st Floor	Inspected
Ceiling	
Instance on 1st Floor	Inspected
Condition	2 - Between Good and Fair
Deficiency	No deficiencies recorded
Door(s)	
Instance on 1st Floor	Inspected
Condition	2 - Between Good and Fair
Deficiency	No deficiencies recorded
Floor Finish	
Instance on 1st Floor	Inspected

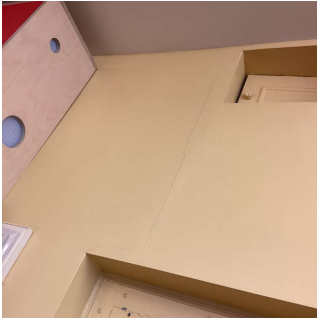
Question	Response
INTERIOR	
LIBRARY	
Floor Finish	
Deficiency	No deficiencies recorded
Walls	
Instance on 1st Floor	Inspected
Condition	2 - Between Good and Fair
Deficiency	GYPSON BOARD: DETERIORATED
Deficiency Location/Instance	Near the electrical panel/ entrance wall side, near the windows
Deficiency Quantity	30
Quantity Uom	S.F.
Potential Action	REPLACE
Urgency of Action	PRIORITY 3
Purpose of Action	LEVEL 2
Deficiency Photo1

Near the electrical panel/ entrance wall side
Violations	No violations recorded.
LOCKER ROOM	Does not Exist
MULTI-PURPOSE ROOM	Does not Exist
SCIENCE DEMO ROOM	Does not Exist
SCIENCE LAB	Does not Exist
SCIENCE PREP ROOM	Does not Exist
SHOWER ROOM	Does not Exist
STAIRS/RAMPS: INTERIOR	Inspected
Do Letter Stair Signs Exist?	Partially
Ceiling	
Condition	2 - Between Good and Fair
Deficiency	No deficiencies recorded
Door(s)	
Condition	5 - Poor
Deficiency	METAL: DETERIORATED DOOR
Deficiency Location/Instance	Stair F/1 Vestibule

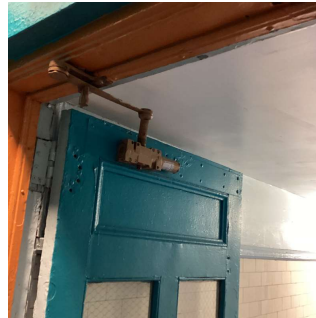
Stair G/1

METAL CLAD WOOD: DETERIORATED DOOR

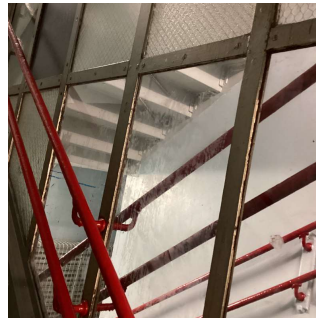
GLASS PANEL: DAMAGED/DETERIORATED

REPLACE

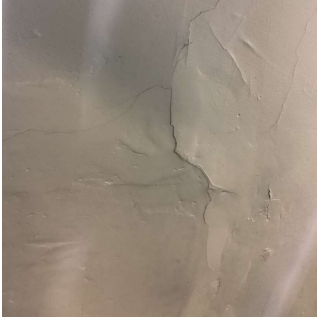
Stair G/1
Violations	No violations recorded.
Deficiency	CERAMIC TILE: BROKEN/ MISSING
Deficiency Location/Instance	Stair BC/1 Vestibule, G/1
Deficiency Quantity	60
Quantity Uom	S.F.
Potential Action	REPLACE
Urgency of Action	PRIORITY 3
Purpose of Action	LEVEL 2

Question	Response
INTERIOR	
STAIRS/RAMPS: INTERIOR	
Stairs and Landings	
Potential Action	REPLACE
Urgency of Action	PRIORITY 3
Purpose of Action	LEVEL 2
Deficiency Photo1	 
	Stair G/1
Violations	No violations recorded.
Walls	
Condition	Inspected
	2 - Between Good and Fair
Deficiency	PLASTER: CRACKS/SPALLING
Deficiency Location/Instance	Stair G/1
Deficiency Quantity	20
Quantity Uom	S.F.
Potential Action	REPLACE
Urgency of Action	PRIORITY 3
Purpose of Action	LEVEL 2
Deficiency Photo1

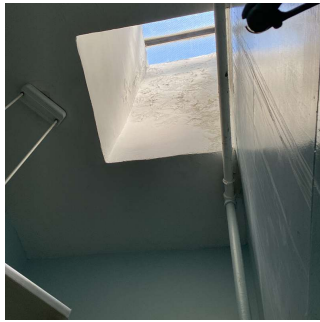
Violations	Stair BC/1 Vestibule No violations recorded.
TOILET ROOMS - STAFF	
Ceiling	Inspected
Condition	4 - Between Fair and Poor
Deficiency	PLASTER: CRACKS/SPALLING
Deficiency Location/Instance	Room 553
Deficiency Quantity	20
Quantity Uom	S.F.
Potential Action	REPLACE
Urgency of Action	PRIORITY 3
Purpose of Action	LEVEL 2
Deficiency Photo1

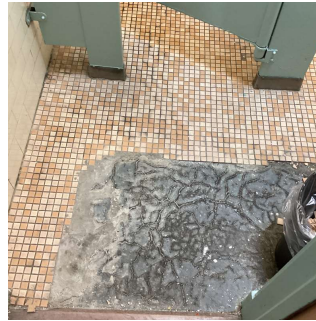
Violations	Room 553 No violations recorded.
Door(s)	
Condition	2 - Between Good and Fair
Deficiency	No deficiencies recorded
Floor Finish	
Condition	5 - Poor
Deficiency	CERAMIC TILE: BROKEN/MISSING TILES
Deficiency Location/Instance	Room 553, 4th Floor Staff
Deficiency Quantity	30
Quantity Uom	S.F.
Potential Action	REPLACE
Urgency of Action	PRIORITY 3
Purpose of Action	LEVEL 2

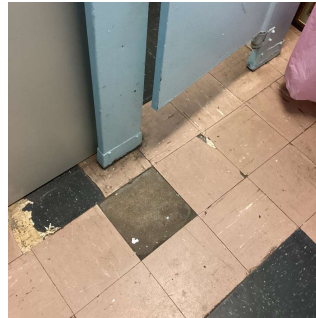
Kitchen Toilet Room

VINYL TILES: BROKEN/DETERIORATED/MISSING TILES

REPLACE

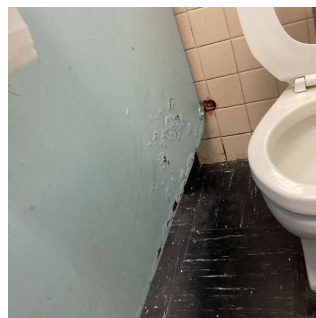
RUST - MAJOR

REPLACE

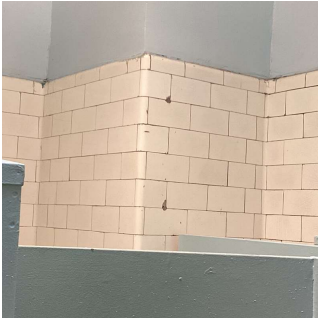
Question	Response
INTERIOR	
TOILET ROOMS - STAFF	
Stalls	Inspected
Violations	Kitchen Toilet Room No violations recorded.
Walls	Inspected
Condition	2 - Between Good and Fair
Deficiency	CERAMIC TILE: BROKEN/ MISSING
Deficiency Location/Instance	Staff 4th Floor, Room 553
Deficiency Quantity	20
Quantity Uom	S.F.
Potential Action	REPLACE
Urgency of Action	PRIORITY 3
Purpose of Action	LEVEL 2
Deficiency Photo1

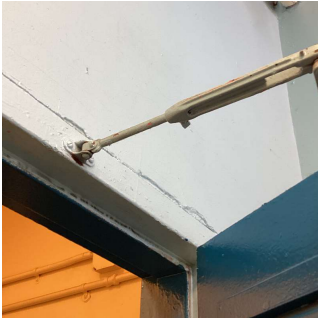
Violations	Room 553 No violations recorded.
Deficiency	PLASTER: CRACKS/SPALLING
Deficiency Location/Instance	Kitchen Toilet Room
Deficiency Quantity	10
Quantity Uom	S.F.
Potential Action	REPLACE
Urgency of Action	PRIORITY 3
Purpose of Action	LEVEL 2
Deficiency Photo1

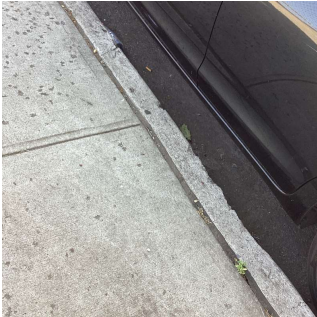
Question	Response
SITE	
PAVING	
Student Use	
Asphalt	
Deficiency Photo1	 
Violations	Schoolyard No violations recorded.
Concrete	Inspected
Condition	3 - Fair
Deficiency	CRACKS - MAJOR
Deficiency Location/Instance	Schoolyard
Deficiency Quantity	75
Quantity Uom	S.F.
Potential Action	REPLACE
Urgency of Action	PRIORITY 3
Purpose of Action	LEVEL 2
Deficiency Photo1	 
Violations	Schoolyard No violations recorded.
Pavers	Does not Exist
Site Sidewalks & Walkways	Inspected
Asphalt	Does not Exist
Concrete	Inspected
Condition	1 - Good
Deficiency	No deficiencies recorded
Pavers	Does not Exist
DOT Sidewalk	Inspected
Asphalt	Does not Exist
Concrete	Inspected
Condition	4 - Between Fair and Poor
Deficiency	DAMAGED CURBS
Deficiency Location/Instance	E.48th Street, Linden Boulevard, Schenectady Avenue
Deficiency Quantity	30

Question	Response
SITE	
PAVING	
DOT Sidewalk	
Concrete	
Quantity Uom	L.F.
Potential Action	REPLACE
Urgency of Action	PRIORITY 3
Purpose of Action	LEVEL 2
Deficiency Photo1

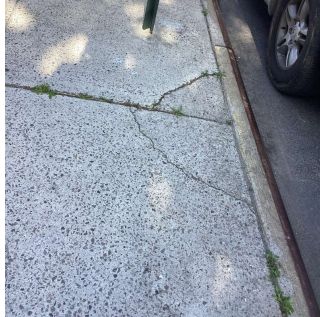
E.48th Street
Violations	No violations recorded.
Deficiency	HEAVING
Deficiency Location/Instance	E.48th Street
Deficiency Quantity	25
Quantity Uom	S.F.
Potential Action	REPLACE
Urgency of Action	PRIORITY 3
Purpose of Action	LEVEL 2
Deficiency Photo1	 
	E.48th Street
Violations	No violations recorded.
Deficiency	DAMAGED/DETERIORATED/MISSING SECTIONS
Deficiency Location/Instance	E.48th Street, Linden Boulevard, Schenectady Avenue
Deficiency Quantity	1,000
Quantity Uom	S.F.
Potential Action	REPLACE
Urgency of Action	PRIORITY 3
Purpose of Action	LEVEL 2

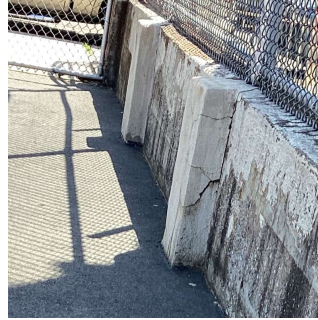
Violations	Linden Boulevard No violations recorded.
Pavers	Does not Exist
PLAYGROUNDS	Inspected
Instance on Schoolyard	Inspected
Benches	
Instance on Schoolyard	Does not Exist
Fence	
Instance on Schoolyard	Inspected
Condition	2 - Between Good and Fair
Deficiency	No deficiencies recorded
Pavement	
Instance on Schoolyard	Inspected
Condition	1 - Good
Deficiency	No deficiencies recorded
Play Equipment	
Instance on Schoolyard	Inspected
Condition	2 - Between Good and Fair
Deficiency	No deficiencies recorded
Safety Surfacing	
Instance on Schoolyard	Inspected
Condition	2 - Between Good and Fair
Deficiency	No deficiencies recorded
Unpaved Area	
Instance on Schoolyard	Does not Exist
PLAYING SURFACE	Does not Exist
RETAINING WALLS	Does not Exist
SEATING	Does not Exist
SITE WALLS (NOT RETAINING WALLS)	Inspected
Condition	3 - Fair
Deficiency	CAST IN PLACE CONCRETE: CRACKS/SPALLING - MAJOR

Deficiency Location/Instance	Schoolyard
Deficiency Quantity	25
Quantity Uom	S.F.
Potential Action	REPLACE
Urgency of Action	PRIORITY 3
Purpose of Action	LEVEL 2
