NYC Department of Education
Building Condition Assessment Survey 2023 - 2024

Architectural Inspection

K145

Asset: P.S. 145 - BROOKLYN, 100 NOLL STREET, New York, 11206

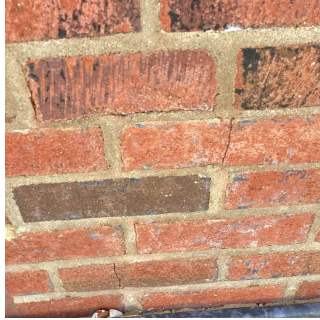
Deficiency	BRICK: MINOR CRACKS AND SPALLING
Roof Plan reference	<p>K145</p>

Deficiency Quantity	20
Quantity Uom	S.F.
Potential Action	RESTITCH
Urgency of Action	PRIORITY 3
Purpose of Action	LEVEL 2

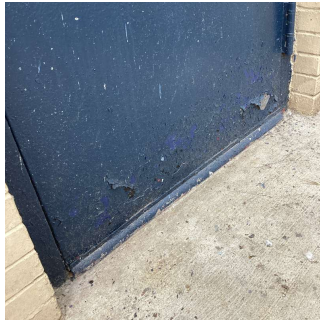
Violations	Facade D No violations recorded.
Deficiency	METAL: DETERIORATED DOOR AND FRAME - MAJOR DETERIORATION

Violations	CH No violations recorded.
COPING	
Condition	Inspected
Deficiency	2 - Between Good and Fair No deficiencies recorded
CORNICE	
Condition	Inspected
Deficiency	2 - Between Good and Fair No deficiencies recorded
DOORS	
DOORS AND FRAMES	
Condition	Inspected
Deficiency	5 - Poor
Roof Plan reference	METAL: DETERIORATED DOOR - MINOR DETERIORATION K145
Deficiency Quantity	2
Quantity Uom	EACH
Potential Action	MAINTENANCE
Urgency of Action	PRIORITY 3
Purpose of Action	LEVEL 2
Deficiency Photo1

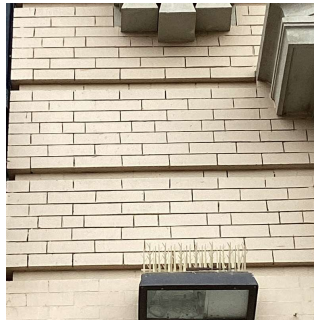
Facade A

BRICK: DETERIORATED JOINTS

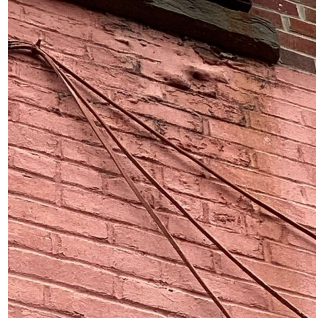
Facade D

BRICK: MINOR CRACKS AND SPALLING

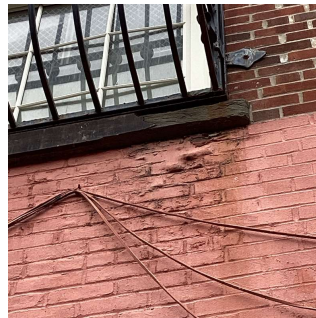
Facade C

BRICK: DETERIORATED MASONRY SILLS - MAJOR

REMOVE AND REPLACE

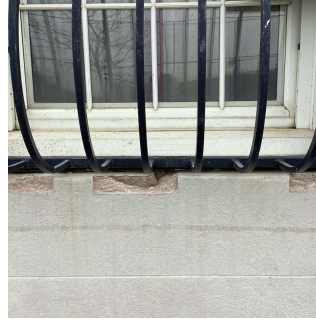
Facade A

STONE: DETERIORATED MASONRY SILLS - MAJOR

REMOVE AND REPLACE

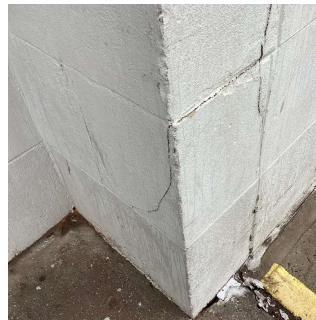
Facade A

STONE: CRACKS AT BUILDING CORNERS

REPLACE

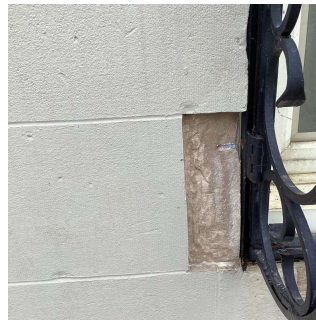
Facade A

STONE: CHIPPED/SPALLED/BROKEN PIECES - MAJOR

REPLACE

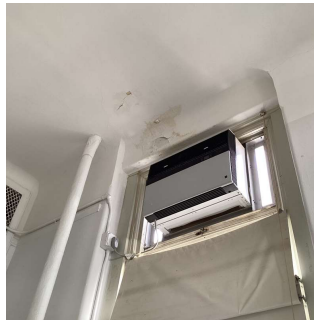
BRICK: WATER INFILTRATION IN INSTRUCTIONAL SPACE

Facade B - Room 301 (shown), Facade A - Room 110, Exit 3 Vestibule, Facade B - Room 401, Facade C - Room 409A, Stair A/3 similar

REPAIR

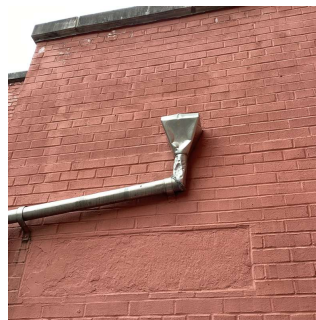
Roof 9

DETERIORATED SCUPPER

REPLACE

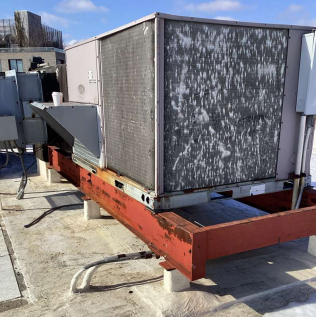
Question	Response
EXTERIOR	
ROOF	
Specialties	
BULKHEAD/PENTHOUSE	Inspected
Violations	No violations recorded.
CUPOLA/ SPIRES/ TOWERS	Does not Exist
DORMER	Does not Exist
DUNNAGE STEEL	Inspected
Condition	2 - Between Good and Fair
Deficiency	HEIGHT LESS THAN 18"
Roof Plan reference	K145

Deficiency Quantity	40
Quantity Uom	L.F.
Potential Action	REPLACE
Urgency of Action	PRIORITY 3
Purpose of Action	LEVEL 2
Deficiency Photo1

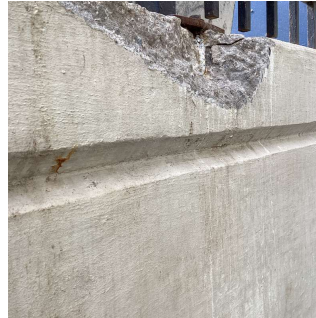
Facade D

Violations	No violations recorded.
SKYLIGHT/ROOF VENT	Inspected
Material Type(s)	Glass
Condition	2 - Between Good and Fair
Deficiency	No deficiencies recorded
ROOF/GRAVITY TANK	Does not Exist
STAIRS/RAMPS: EXTERIOR	Inspected
BUILDING CHEEK/FLANK WALLS	Inspected
Condition	4 - Between Fair and Poor
Deficiency	CAST IN PLACE CONCRETE: CRACKS/SPALLING - MAJOR
Roof Plan reference	K145

S.F.
 REPLACE
 PRIORITY 4
 LEVEL 2

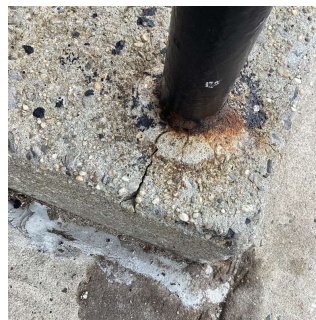
Facade A

CAST IN PLACE CONCRETE: CRACKS/SPALLING - MINOR

10
 S.F.
 REPAIR
 PRIORITY 3
 LEVEL 2

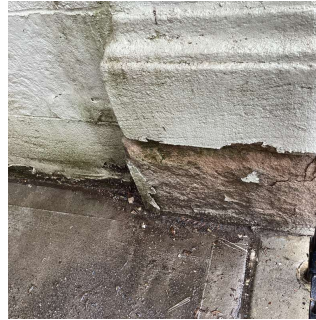
Facade A

STONE: CRACKS/SPALLING - MAJOR

Quantity Uom	S.F.
Potential Action	REPLACE
Urgency of Action	PRIORITY 4
Purpose of Action	LEVEL 2
Deficiency Photo1

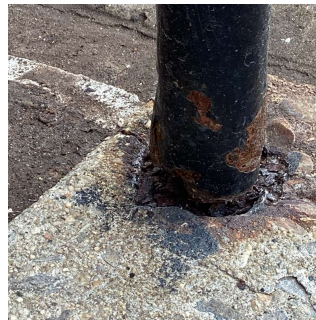
Facade A

RUST - MAJOR

REPLACE

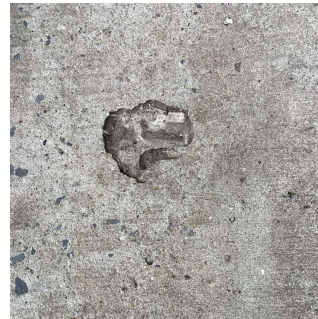
Facade D

CONCRETE: CRACKS/SPALLING - MAJOR

REPLACE

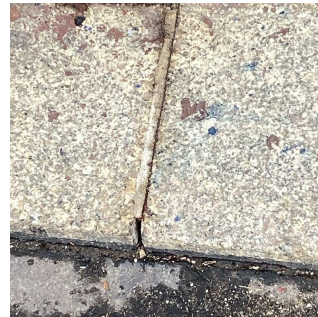
Facade E

STONE: DETERIORATED JOINTS

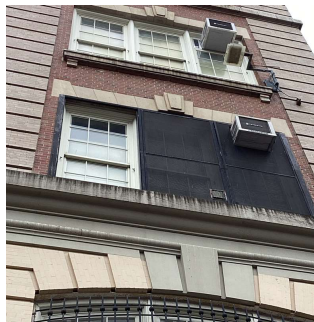
Facade D

Deficiency	DETERIORATED/TORN-OUT/MISSING
Roof Plan reference	K145

Deficiency Quantity	30
Quantity Uom	S.F.
Potential Action	REPLACE
Urgency of Action	PRIORITY 4
Purpose of Action	LEVEL 2
Deficiency Photo1

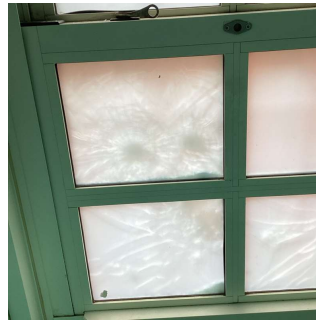
Facade C
No violations recorded.

ALUMINUM - DOUBLE HUNG: BROKEN PANE

30
S.F.
MAINTENANCE
PRIORITY 3
LEVEL 2

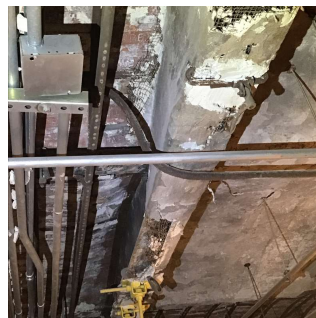
STEEL COLUMNS/BEAMS: DETERIORATED/MISSING
PLASTER FIREPROOFING

REPLACE

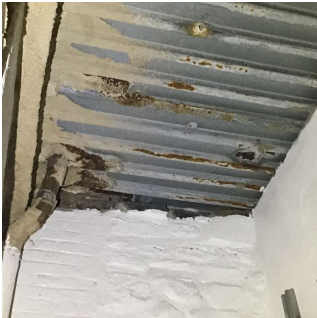
Violations	Vault No violations recorded.
Slab Structure	Inspected
Condition	3 - Fair
Deficiency	METAL DECK AND CONCRETE: DETERIORATED
Deficiency Location/Instance	Basement
Deficiency Quantity	60
Quantity Uom	S.F.
Potential Action	REPAIR
Urgency of Action	PRIORITY 4
Purpose of Action	LEVEL 5
Deficiency Photo1

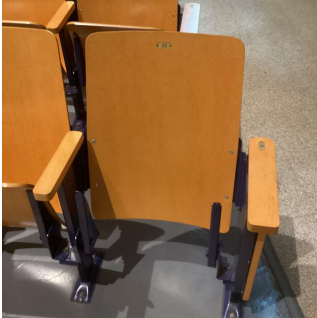
Question	Response
INTERIOR	
AUDITORIUM	
Fixed Seating	
Instance on 1st Floor (640 Seats)	Inspected
Condition	2 - Between Good and Fair
Deficiency	DAMAGED/BROKEN/INOPERABLE
Deficiency Location/Instance	Seats B/23, C/16
Deficiency Quantity	2
Quantity Uom	EACH
Potential Action	REPLACE
Urgency of Action	PRIORITY 5
Purpose of Action	LEVEL 6
Deficiency Photo1

Seat B/23
Violations	No violations recorded.
Floor Finish	
Instance on 1st Floor (640 Seats)	Inspected
Condition	2 - Between Good and Fair
Deficiency	CONCRETE: CRACKS
Deficiency Location/Instance	Near Seats B/8, 18, by Rows G, J
Deficiency Quantity	40
Quantity Uom	S.F.
Potential Action	REPLACE
Urgency of Action	PRIORITY 3
Purpose of Action	LEVEL 2
Deficiency Photo1

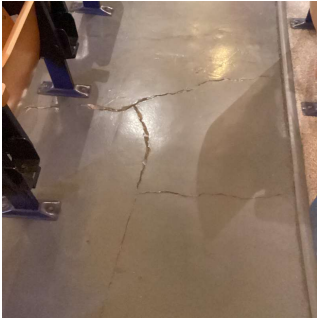
Near Seat B/8
Violations	No violations recorded.
Sliding-folding Partition	
Instance on 1st Floor (640 Seats)	Does not Exist
Stage	
Instance on 1st Floor (640 Seats)	Inspected
Stage	
Instance on 1st Floor (640 Seats)	Inspected

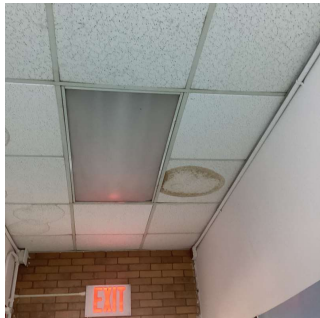
Room 419
Violations	No violations recorded.
Deficiency	ACOUSTIC TILES: DAMAGED/MISSING
Deficiency Location/Instance	Rooms 419, 417, Corridor near Stair A/4, by Rooms 426, 422 and others
Deficiency Quantity	150
Quantity Uom	S.F.
Potential Action	REPLACE
Urgency of Action	PRIORITY 3
Purpose of Action	LEVEL 2
Deficiency Photo1

Corridor near Stair A/4
Violations	No violations recorded.
Door(s)	Inspected

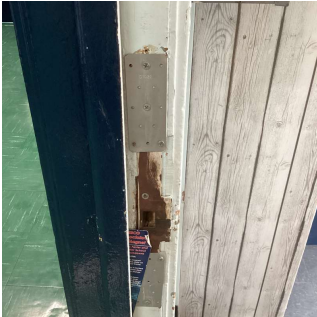
Condition	5 - Poor
Deficiency	WOOD: DETERIORATED DOOR AND FRAME
Deficiency Location/Instance	Rooms 322, 207

Question	Response
INTERIOR	
CLASSROOMS/CORRIDORS/ADMIN SPACES	Inspected
Door(s)	
Deficiency Quantity	2
Quantity Uom	EACH
Potential Action	MAINTENANCE
Urgency of Action	PRIORITY 3
Purpose of Action	LEVEL 2
Deficiency Photo1

Room 322
Violations	No violations recorded.
Deficiency	METAL CLAD WOOD: DETERIORATED DOOR
Deficiency Location/Instance	Room 409
Deficiency Quantity	1
Quantity Uom	EACH
Potential Action	MAINTENANCE
Urgency of Action	PRIORITY 3
Purpose of Action	LEVEL 2
Deficiency Photo1

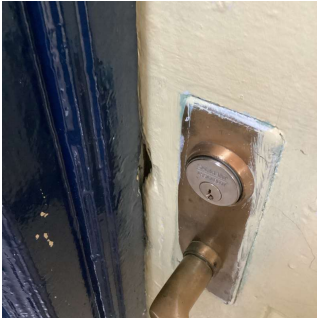
Room 409
Violations	No violations recorded.
Deficiency	WOOD: DETERIORATED DOOR
Deficiency Location/Instance	Rooms 426, 419, 417, 415, 410 and others
Deficiency Quantity	10
Quantity Uom	EACH
Potential Action	MAINTENANCE
Urgency of Action	PRIORITY 3
Purpose of Action	LEVEL 2

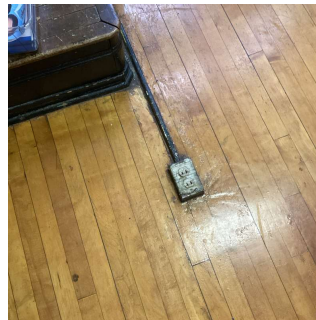
Room 106

WOOD: TRIPPING HAZARD - ELECTRICAL OUTLET

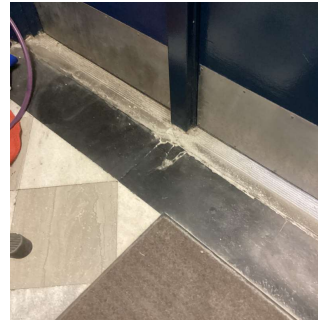
Exit 2 - Vestibule

Violations	Room 412 No violations recorded.
Deficiency	STONE: BROKEN/MISSING TILES
Deficiency Location/Instance	Exits 2, 9 - Vestibules
Deficiency Quantity	20
Quantity Uom	S.F.
Potential Action	REPLACE
Urgency of Action	PRIORITY 3
Purpose of Action	LEVEL 2

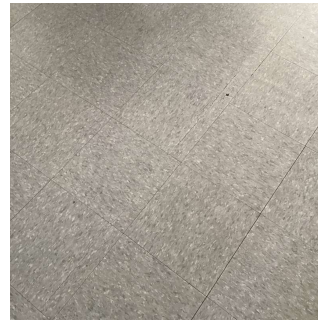
Room 415

VINYL TILES: DETERIORATED SUBSTRATE

REPLACE

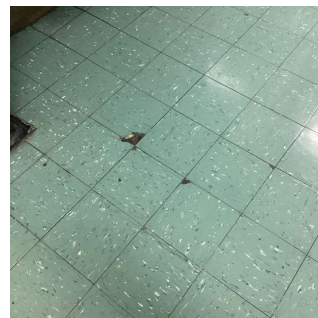
Corridor near Room 418

VINYL TILES: BROKEN/DETERIORATED/MISSING TILES

REPLACE

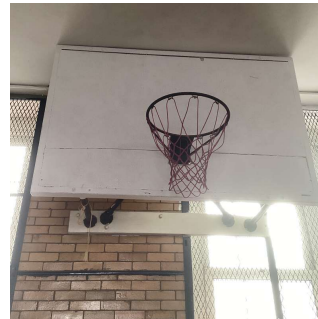
Left Side

DAMAGED/MISSING

REPLACE

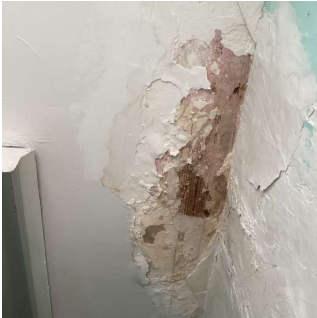
Violations	Stair A/Bulkhead No violations recorded.
KITCHEN	Inspected
Instance on Basement	Inspected
Ceiling	
Instance on Basement	Inspected
Condition	5 - Poor
Deficiency	PLASTER: CRACKS/SPALLING
Deficiency Location/Instance	Men Kitchen Locker Room
Deficiency Quantity	20
Quantity Uom	S.F.
Potential Action	REPLACE
Urgency of Action	PRIORITY 5
Purpose of Action	LEVEL 6
Deficiency Photo1

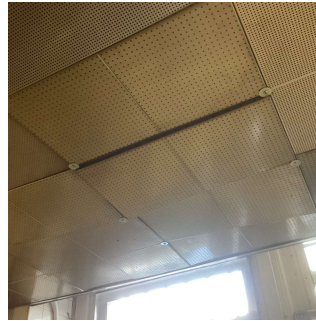
Near Windows

Violations	Men Kitchen Locker Room No violations recorded.
Deficiency	METAL PAN: DAMAGED/MISSING
Deficiency Location/Instance	Near Windows, by Preparation Area, close to Ovens, next to fridges
Deficiency Quantity	60
Quantity Uom	S.F.
Potential Action	REPLACE
Urgency of Action	PRIORITY 5
Purpose of Action	LEVEL 6

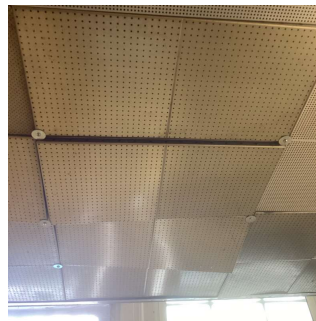
Near Sink

METAL PAN: DAMAGED/MISSING

REPLACE

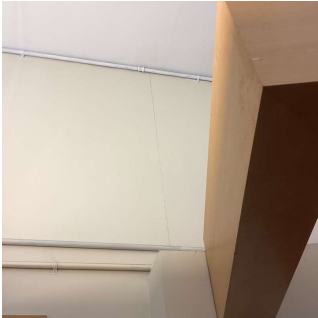
Question	Response
INTERIOR	
LIBRARY	
Walls	
Deficiency	GYP SUM BOARD: DETERIORATED
Deficiency Location/Instance	Near Main Entrance, by Windows
Deficiency Quantity	30
Quantity Uom	S.F.
Potential Action	REPLACE
Urgency of Action	PRIORITY 3
Purpose of Action	LEVEL 2
Deficiency Photo1

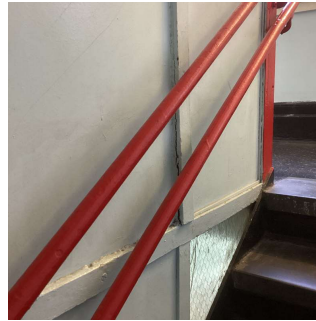
Stair FG/Basement

Deficiency	METAL FRAME: DAMAGED/DETERIORATED
Deficiency Location/Instance	Stairs FG/Basement, 2
Deficiency Quantity	20
Quantity Uom	L.F.
Potential Action	REPLACE
Urgency of Action	PRIORITY 3
Purpose of Action	LEVEL 2

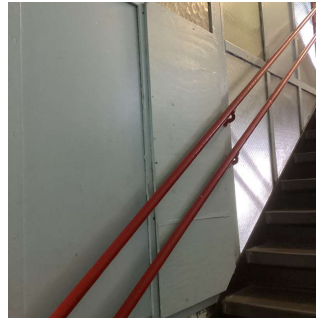
Stair FG/1

GLASS PANEL: DAMAGED/DETERIORATED

REPLACE

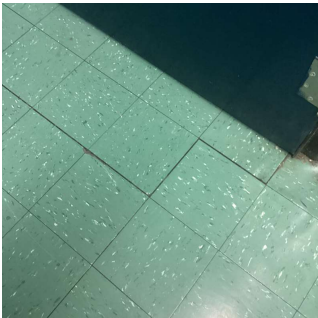
Question	Response
INTERIOR	
STAIRS/RAMPS: INTERIOR	
Railings	Inspected
	Cafeteria near Exit 8
Violations	No violations recorded.
Stairs and Landings	Inspected
Condition	3 - Fair
Deficiency	VINYL TILES: BROKEN/DETERIORATED/MISSING TILES
Deficiency Location/Instance	Stairs C/3, D/2, E/3
Deficiency Quantity	110
Quantity Uom	S.F.
Potential Action	REPLACE
Urgency of Action	PRIORITY 3
Purpose of Action	LEVEL 2
Deficiency Photo1

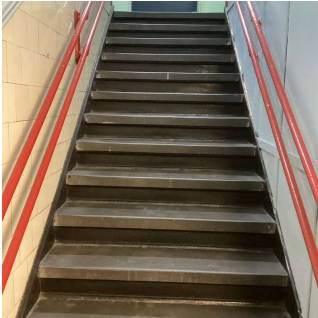
Stair C/3
Violations	No violations recorded.
Deficiency	STONE: WORN-OUT TREAD/NOSINGS
Deficiency Location/Instance	Stairs C/4, 3, 2, FG/3, 2 and others
Deficiency Quantity	220
Quantity Uom	S.F.
Potential Action	REPLACE
Urgency of Action	PRIORITY 3
Purpose of Action	LEVEL 2
Deficiency Photo1

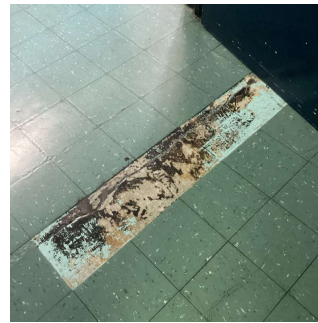
Stair C/3

Stair C/4
Violations	No violations recorded.
Deficiency	VINYL TILES: DETERIORATED SUBSTRATE
Deficiency Location/Instance	Stairs C/4, 2, 3, D/3
Deficiency Quantity	100
Quantity Uom	S.F.
Potential Action	REPLACE

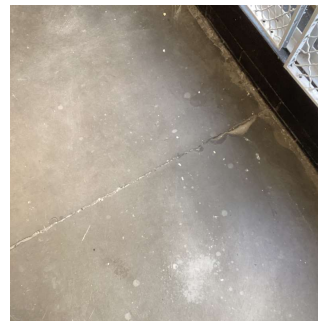
Stair D/Basement

STONE: BROKEN/MISSING

REPLACE

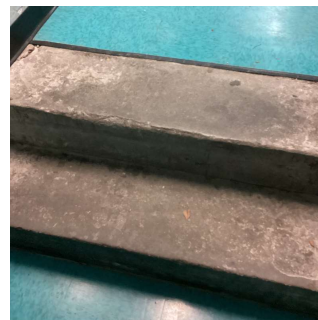
Stair F/Basement

CONCRETE: CRACKS/SPALLING - MAJOR

REPLACE

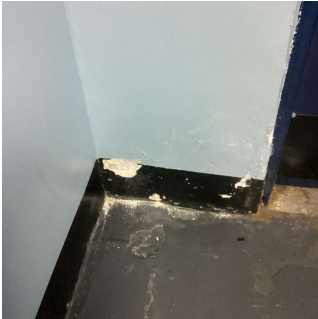
Question	Response
INTERIOR	
STAIRS/RAMPS: INTERIOR	
Stairs and Landings	Inspected
Violations	No violations recorded.
Walls	Inspected
Condition	2 - Between Good and Fair
Deficiency	PLASTER: CRACKS/SPALLING - ACTIVE LEAK
Deficiency Location/Instance	Exit 3 - Vestibule, Stair A/3
Deficiency Quantity	25
Quantity Uom	S.F.
Potential Action	REPLACE
Urgency of Action	PRIORITY 5
Purpose of Action	LEVEL 2
Deficiency Photo1

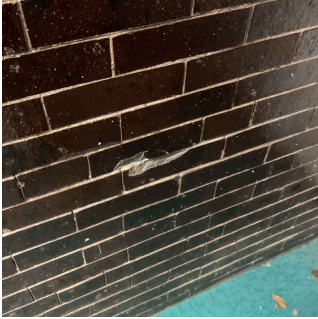
Violations	Exit 3 - Vestibule No violations recorded.
Deficiency	BRICK: CRACKS/SPALLING
Deficiency Location/Instance	Stair FG/Basement
Deficiency Quantity	10
Quantity Uom	S.F.
Potential Action	REPLACE
Urgency of Action	PRIORITY 3
Purpose of Action	LEVEL 2
Deficiency Photo1

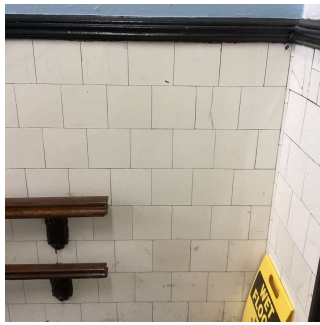
Violations	Stair FG/Basement No violations recorded.
Deficiency	CERAMIC TILE: BROKEN/ MISSING
Deficiency Location/Instance	Exit 8 - Vestibule, Stairs C/ Basement, 1, D/Basement, E/Basement, FG/1 and others
Deficiency Quantity	140

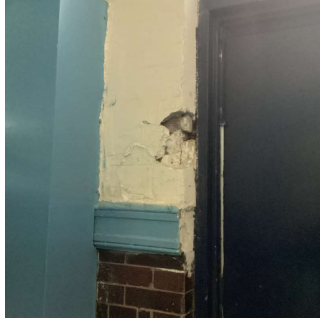
Violations	Exit 8 - Vestibule No violations recorded.
Deficiency	PLASTER: CRACKS/SPALLING
Deficiency Location/Instance	Exit 7- Vestibule, Stairs A/4, 2, C/4, FG/2 and others
Deficiency Quantity	50
Quantity Uom	S.F.
Potential Action	REPLACE
Urgency of Action	PRIORITY 3
Purpose of Action	LEVEL 2
Deficiency Photo1

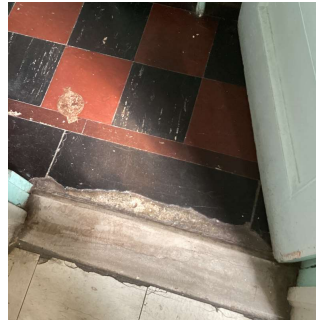
In Room 113E

Violations	In Women Kitchen Locker Room No violations recorded.
Floor Finish	Inspected
Condition	4 - Between Fair and Poor
Deficiency	VINYL TILES: BROKEN/DETERIORATED/MISSING TILES
Deficiency Location/Instance	In Room 113E, In Men Kitchen Locker Room
Deficiency Quantity	20
Quantity Uom	S.F.
Potential Action	REPLACE
Urgency of Action	PRIORITY 3
Purpose of Action	LEVEL 2

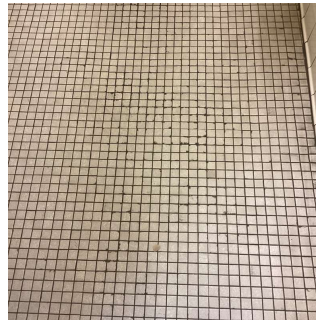
Women Toilet Room - 3rd Floor

CERAMIC TILE: BROKEN/MISSING TILES

REPLACE

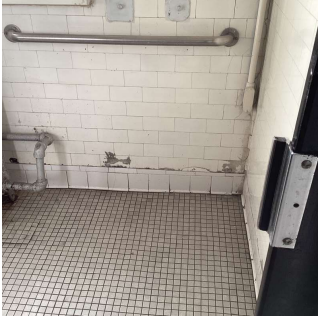
Question	Response
INTERIOR	
TOILET ROOMS - STAFF	
Stalls	Inspected
Deficiency Photo1	 
	In Men Kitchen Locker Room
Violations	No violations recorded.
Walls	Inspected
Condition	3 - Fair
Deficiency	PLASTER: CRACKS/SPALLING
Deficiency Location/Instance	In Women Kitchen Locker Room
Deficiency Quantity	20
Quantity Uom	S.F.
Potential Action	REPLACE
Urgency of Action	PRIORITY 3
Purpose of Action	LEVEL 2
Deficiency Photo1	 
	In Women Kitchen Locker Room
Violations	No violations recorded.
Deficiency	CERAMIC TILE: BROKEN/ MISSING
Deficiency Location/Instance	Women Toilet Room - 3rd, 2nd Floor, Men Toilet Room - 3rd, 2nd Floor, In Room 113E
Deficiency Quantity	50
Quantity Uom	S.F.
Potential Action	REPLACE
Urgency of Action	PRIORITY 3
Purpose of Action	LEVEL 2

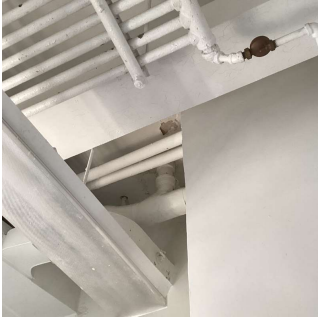
Violations	Men Toilet Room - 3rd Floor No violations recorded.
TOILET ROOMS - STUDENTS	Inspected
Ceiling	Inspected
Condition	2 - Between Good and Fair
Deficiency	PLASTER: CRACKS/SPALLING
Deficiency Location/Instance	Boys Toilet Room - 3rd Floor
Deficiency Quantity	10
Quantity Uom	S.F.
Potential Action	REPLACE
Urgency of Action	PRIORITY 3
Purpose of Action	LEVEL 2
Deficiency Photo1

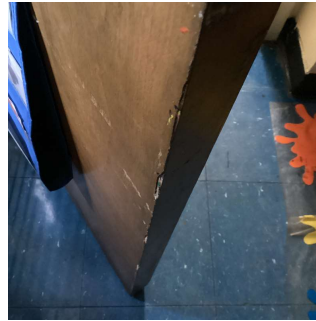
In Room 109

Violations	Boys Toilet Room - 3rd Floor No violations recorded.
Door(s)	Inspected
Condition	5 - Poor
Deficiency	WOOD: DETERIORATED DOOR
Deficiency Location/Instance	Girls Toilet Room - 4th, 2nd Floor, In Rooms 109, 105
Deficiency Quantity	4
Quantity Uom	EACH
Potential Action	MAINTENANCE
Urgency of Action	PRIORITY 3
Purpose of Action	LEVEL 2

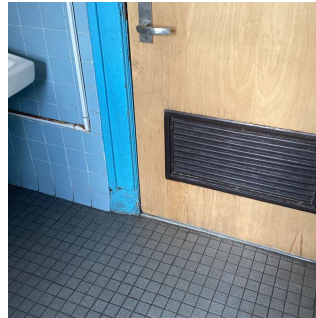
Boys Toilet Room - 4th Floor

WOOD: DETERIORATED DOOR AND FRAME

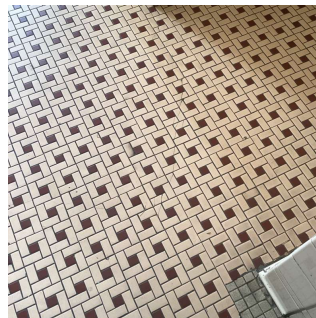
CERAMIC TILE: DETERIORATED SUBSTRATE

REPLACE

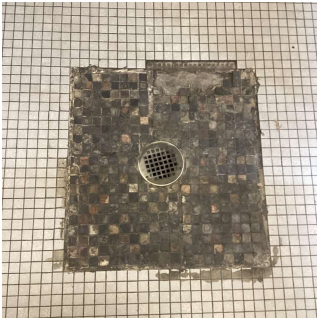
Question	Response
INTERIOR	
TOILET ROOMS - STUDENTS	
Floor Finish	
Violations	Girls Toilet Room - 3rd Floor No violations recorded.
Deficiency	CERAMIC TILE: BROKEN/MISSING TILES
Deficiency Location/Instance	Boys Toilet Room - 4th, 3rd Floor, Girls Toilet Room - 2nd Floor
Deficiency Quantity	30
Quantity Uom	S.F.
Potential Action	REPLACE
Urgency of Action	PRIORITY 3
Purpose of Action	LEVEL 2
Deficiency Photo1

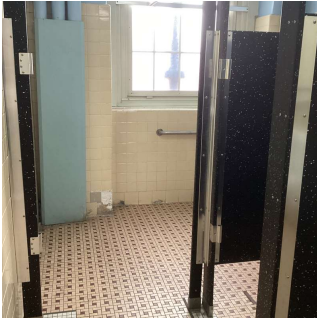
Violations	Girls Toilet Room - 2nd Floor No violations recorded.
Stalls	Inspected
Condition	3 - Fair
Deficiency	BROKEN/MISSING
Deficiency Location/Instance	Boys Toilet Room - 2nd Floor
Deficiency Quantity	2
Quantity Uom	EACH
Potential Action	REPLACE
Urgency of Action	PRIORITY 3
Purpose of Action	LEVEL 2
Deficiency Photo1

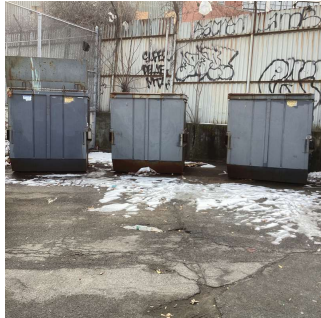
Question	Response
INTERIOR	
TOILET ROOMS - STUDENTS	
Walls	
Urgency of Action	PRIORITY 3
Purpose of Action	LEVEL 2
Deficiency Photo1	 
Violations	Girls Toilet Room - 2nd Floor No violations recorded.
LIFE SAFETY	Inspected
F.D. HOLDING AREA	Does not Exist
STEEL STAIRS	Does not Exist
SITE	Inspected
CONTAINERIZATION	
Condition	4 - Between Fair and Poor
Deficiency	CONCRETE PAD MISSING
Deficiency Location/Instance	Noll Street
Deficiency Quantity	300
Quantity Uom	S.F.
Potential Action	INSTALL NEW
Urgency of Action	PRIORITY 3
Purpose of Action	LEVEL 2
Deficiency Photo1

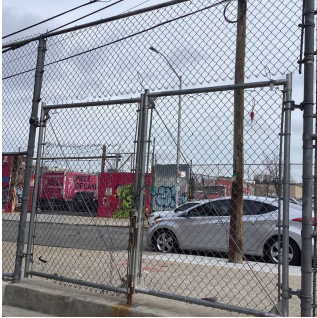
Question	Response
SITE	
Drainage System for Concrete	Inspected
Culverts - Concrete Covering	Does not Exist
Drainage System for Soil	Does not Exist
DRINKING FOUNTAINS	
Condition	1 - Good
Deficiency	No deficiencies recorded
FENCES	
Condition	3 - Fair
Deficiency	CHAIN LINK: DAMAGED/DETERIORATED
Deficiency Location/Instance	Schoolyard
Deficiency Quantity	100
Quantity Uom	S.F.
Potential Action	REPLACE
Urgency of Action	PRIORITY 3
Purpose of Action	LEVEL 2
Deficiency Photo1

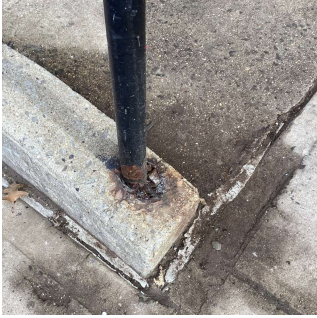
Violations	Schoolyard No violations recorded.
Deficiency	CHAIN LINK: DAMAGED POST/RAIL
Deficiency Location/Instance	Noll Street
Deficiency Quantity	10
Quantity Uom	L.F.
Potential Action	REPLACE
Urgency of Action	PRIORITY 3
Purpose of Action	LEVEL 2
Deficiency Photo1

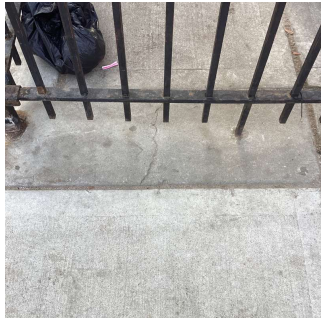
Violations	Noll Street No violations recorded.
Deficiency	CONCRETE CURB: DAMAGED/DETERIORATED
Deficiency Location/Instance	Noll Street
Deficiency Quantity	50
Quantity Uom	S.F.
Potential Action	REPLACE

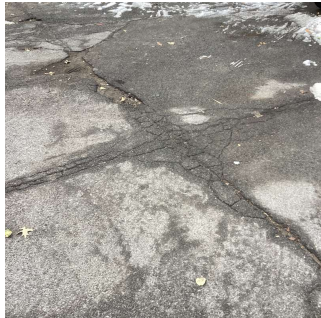
Violations	Noll Street No violations recorded.
IRRIGATION SYSTEM	
	Does not Exist
PAVING	
Student Non-Use	Inspected
Gravel Exists?	No
Asphalt	
Condition	Inspected 3 - Fair
Deficiency	CRACKS - MAJOR
Deficiency Location/Instance	Noll Street near Containers
Deficiency Quantity	300
Quantity Uom	S.F.
Potential Action	REPLACE
Urgency of Action	PRIORITY 3
Purpose of Action	LEVEL 2
Deficiency Photo1

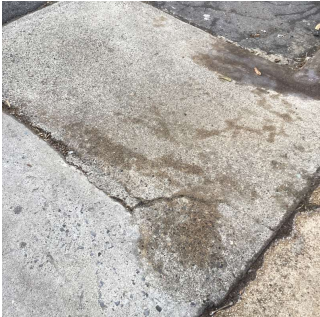
Violations	Noll Street No violations recorded.
Concrete	
	Inspected
Condition	2 - Between Good and Fair
Deficiency	DAMAGED/DETERIORATED/MISSING SECTIONS
Deficiency Location/Instance	Noll Street
Deficiency Quantity	25
Quantity Uom	S.F.
Potential Action	REPLACE
Urgency of Action	PRIORITY 3
Purpose of Action	LEVEL 2

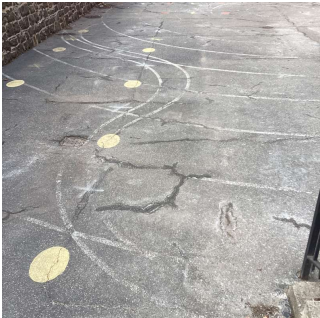
Violations	Noll Street No violations recorded.
Pavers	Does not Exist
Student Use	Inspected
Gravel Exists?	No
Asphalt	Inspected
Condition	4 - Between Fair and Poor
Deficiency	CRACKS - MAJOR
Deficiency Location/Instance	Schoolyard - East, Schoolyard - South
Deficiency Quantity	500
Quantity Uom	S.F.
Potential Action	REPLACE
Urgency of Action	PRIORITY 3
Purpose of Action	LEVEL 2
Deficiency Photo1

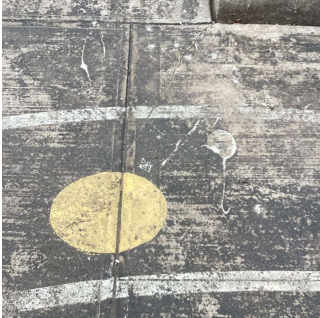
Violations	Schoolyard - East No violations recorded.
Concrete	Inspected
Condition	2 - Between Good and Fair
Deficiency	DAMAGED/DETERIORATED/MISSING SECTIONS
Deficiency Location/Instance	Near Exit 3
Deficiency Quantity	25
Quantity Uom	S.F.
Potential Action	REPLACE
Urgency of Action	PRIORITY 3
Purpose of Action	LEVEL 2

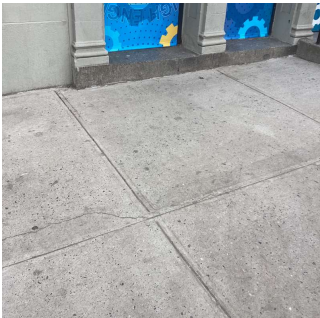
Near Exit 3
Violations	No violations recorded.
Pavers	Inspected
Condition	2 - Between Good and Fair
Deficiency	No deficiencies recorded
Site Sidewalks & Walkways	Inspected
Asphalt	Does not Exist
Concrete	Inspected
Condition	3 - Fair
Deficiency	DAMAGED/DETERIORATED/MISSING SECTIONS
Deficiency Location/Instance	Noll Street
Deficiency Quantity	50
Quantity Uom	S.F.
Potential Action	REPLACE
Urgency of Action	PRIORITY 3
Purpose of Action	LEVEL 2
Deficiency Photo1

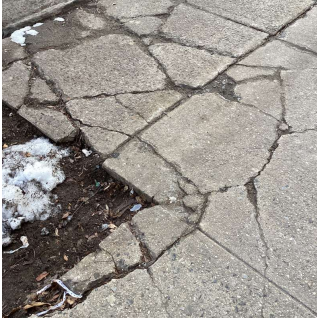
Noll Street
Violations	No violations recorded.
Pavers	Does not Exist
DOT Sidewalk	Inspected
Asphalt	Does not Exist
Concrete	Inspected
Condition	4 - Between Fair and Poor
Deficiency	DAMAGED/DETERIORATED/MISSING SECTIONS
Deficiency Location/Instance	Central Avenue, Noll Street, George Street
Deficiency Quantity	1,025
Quantity Uom	S.F.

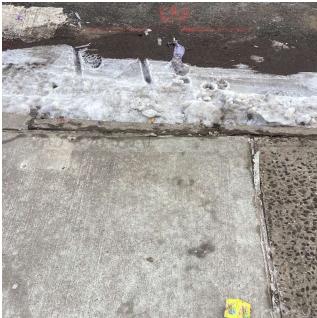
Central Avenue
Violations	No violations recorded.
Deficiency	DAMAGED CURBS
Deficiency Location/Instance	Central Avenue, Noll Street, George Street
Deficiency Quantity	230
Quantity Uom	L.F.
Potential Action	REPLACE
Urgency of Action	PRIORITY 3
Purpose of Action	LEVEL 2
Deficiency Photo1

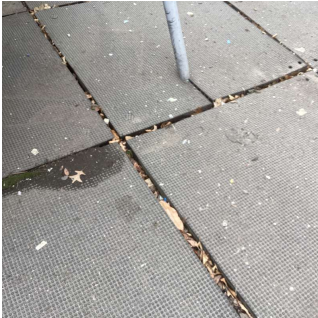
Question	Response
SITE	
PLAYGROUNDS	
Pavement	
Instance on Schoolyard East	Does not Exist
Instance on Schoolyard near Exit 2 (East)	Does not Exist
Instance on Schoolyard South	Does not Exist
Play Equipment	
Instance on Schoolyard South	Inspected
Condition	1 - Good
Deficiency	No deficiencies recorded
Instance on Schoolyard East	Inspected
Condition	2 - Between Good and Fair
Deficiency	No deficiencies recorded
Instance on Schoolyard near Exit 2 (East)	Inspected
Condition	2 - Between Good and Fair
Deficiency	No deficiencies recorded
Safety Surfacing	
Instance on Schoolyard near Exit 2 (East)	Inspected
Condition	3 - Fair
Deficiency	DETERIORATED/MISSING
Deficiency Location/Instance	Center
Deficiency Quantity	200
Quantity Uom	S.F.
Potential Action	MAINTENANCE
Urgency of Action	PRIORITY 5
Purpose of Action	LEVEL 6
Deficiency Photo1

Center
Violations	No violations recorded.
Instance on Schoolyard East	Inspected
Condition	3 - Fair

Deficiency	DETERIORATED/MISSING
Deficiency Location/Instance	Center
Deficiency Quantity	200
Quantity Uom	S.F.
Potential Action	MAINTENANCE
Urgency of Action	PRIORITY 5
Purpose of Action	LEVEL 6

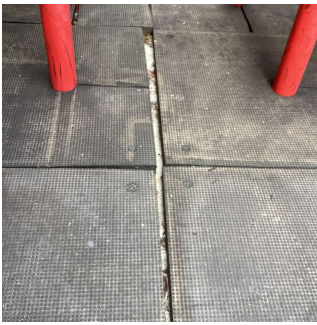
Question	Response
SITE	
PLAYGROUNDS	
Safety Surfacing	
Deficiency Photo1

Center	Center
Violations	No violations recorded.
Unpaved Area	
Instance on Schoolyard East	Does not Exist
Instance on Schoolyard near Exit 2 (East)	Does not Exist
Instance on Schoolyard South	Does not Exist
PLAYING SURFACE	Inspected
Playing Field	Inspected
Instance on Schoolyard	Inspected
Instance Condition	3 - Fair
Deficiency	ARTIFICIAL TURF: DAMAGED/WORN OUT
Deficiency Location/Instance	Schoolyard
Deficiency Quantity	60
Quantity Uom	S.F.
Potential Action	REPLACE
Urgency of Action	PRIORITY 3
Purpose of Action	LEVEL 2
Deficiency Photo1

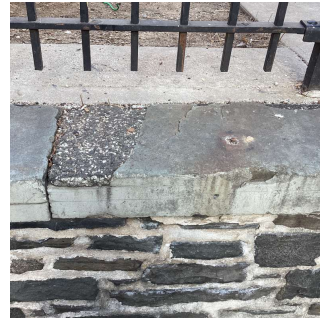
Center	Schoolyard
Violations	No violations recorded.
Running Track	Does not Exist
RETAINING WALLS	
Are there any Retaining Walls 6' OR higher facing public street/sidewalk?	Yes
Condition	4 - Between Fair and Poor
Deficiency	STONE: DETERIORATED COPING STONE
Deficiency Location/Instance	Near Exit 5
Deficiency Quantity	10

Quantity Uom	S.F.
Potential Action	REPLACE

Urgency of Action
Purpose of Action
Deficiency Photo1

PRIORITY 3
LEVEL 2

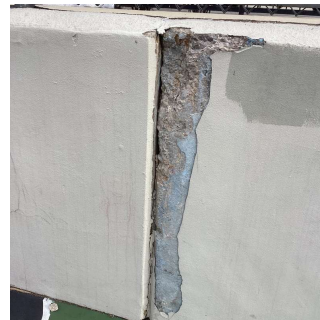
CAST IN PLACE CONCRETE: DETERIORATED CONTROL/EXPANSION JOINT

Schoolyard
10
L.F.
REPLACE
PRIORITY 3
LEVEL 2

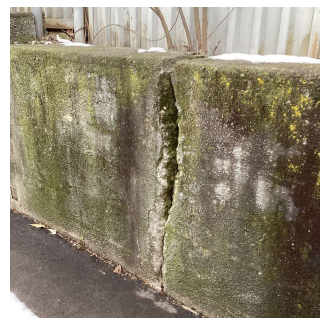
CAST IN PLACE CONCRETE: CRACKS/SPALLING - MAJOR

Container Area, Schoolyard, Central Avenue
250
S.F.
REPLACE
PRIORITY 3
LEVEL 2

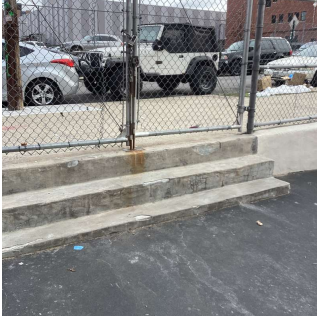
Question	Response
SITE	
RETAINING WALLS	Inspected
Violations	Container Area No violations recorded.
SEATING	Inspected
Benches	Inspected
Concrete	Inspected
Condition	1 - Good
Deficiency	No deficiencies recorded
Metal/Wood/Plastic	Inspected
Condition	1 - Good
Deficiency	No deficiencies recorded
Bleachers	Does not Exist
SITE WALLS (NOT RETAINING WALLS)	Does not Exist
STAIRS/RAMPS: EXTERIOR	Inspected
Railings	Inspected
Condition	4 - Between Fair and Poor
Deficiency	MISSING
Deficiency Location/Instance	Schoolyard
Deficiency Quantity	20
Quantity Uom	L.F.
Potential Action	REPLACE
Urgency of Action	PRIORITY 5
Purpose of Action	LEVEL 6
Deficiency Photo1

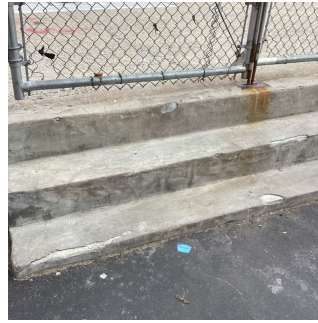
Violations	Schoolyard No violations recorded.
Site Cheek/flank Walls	Does not Exist
Stairs/ramps	Inspected
Condition	2 - Between Good and Fair
Deficiency	CAST IN PLACE CONCRETE: CRACKS/SPALLING - MAJOR
Deficiency Location/Instance	Schoolyard
Deficiency Quantity	20
Quantity Uom	S.F.

Potential Action	REPLACE
Urgency of Action	PRIORITY 3
Purpose of Action	LEVEL 2

Stairs/ramps
