**NYC Department of Education
Building Condition Assessment Survey 2023 - 2024**

Architectural Inspection

Asset: P.S. 373 (OLD P148) - BROOKLYN, 185 ELLERY STREET, New York, 11206

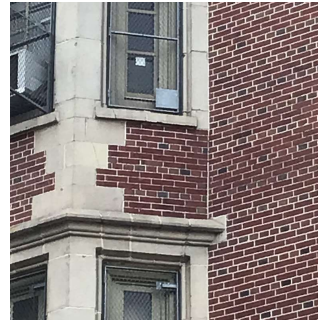
Facade F - West View

BRICK: DETERIORATED MASONRY SILLS - MINOR

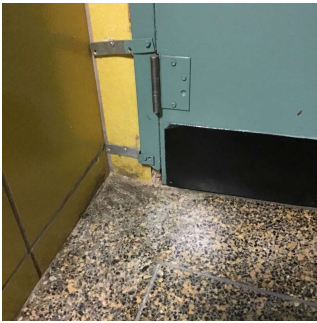
Question	Response
INTERIOR	
AUDITORIUM	
Door(s)	
Deficiency Photo1

Violations	Entrance No violations recorded.
Fixed H/C Lift	
Instance on Basement (398 Seats)	Does not Exist
Fixed Seating	
Instance on Basement (398 Seats)	Inspected
Condition	3 - Fair
Deficiency	DAMAGED/BROKEN/INOPERABLE
Deficiency Location/Instance	Seat K/103
Deficiency Quantity	1
Quantity Uom	EACH
Potential Action	REPLACE
Urgency of Action	PRIORITY 3
Purpose of Action	LEVEL 2
Deficiency Photo1

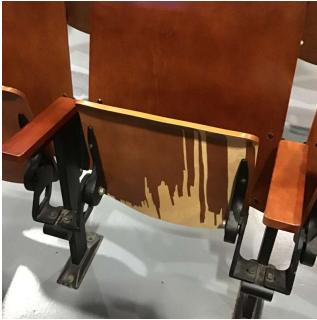
Violations	Seat K/103 No violations recorded.
Deficiency	DAMAGED/BROKEN/INOPERABLE
Deficiency Location/Instance	Seats A/2,4,6,8, D/105,109, E/101-114, F/8,10,12, G/104,105,106
Deficiency Quantity	26
Quantity Uom	EACH
Potential Action	REPLACE
Urgency of Action	PRIORITY 5
Purpose of Action	LEVEL 6

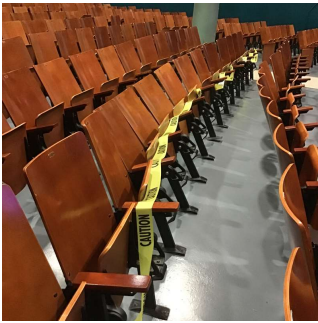
Seats E/101-114
Violations	No violations recorded.
Floor Finish	
Instance on Basement (398 Seats)	Inspected
Condition	2 - Between Good and Fair
Deficiency	SHEET VINYL: DETERIORATED SUBSTRATE
Deficiency Location/Instance	Near Entrance, Near Stage Left
Deficiency Quantity	20
Quantity Uom	S.F.
Potential Action	REPLACE
Urgency of Action	PRIORITY 3
Purpose of Action	LEVEL 2
Deficiency Photo1

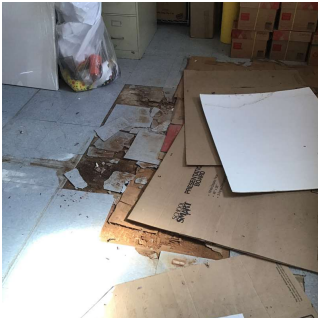
Question	Response
INTERIOR	
CLASSROOMS/CORRIDORS/ADMIN SPACES	
Floor Finish	
Violations	Room 307 No violations recorded.
Deficiency	VINYL TILES: DETERIORATED SUBSTRATE
Deficiency Location/Instance	Rooms 202, 208, 210, 217, 310
Deficiency Quantity	250
Quantity Uom	S.F.
Potential Action	REPLACE
Urgency of Action	PRIORITY 5
Purpose of Action	LEVEL 6
Deficiency Photo1

Violations	Room 310 No violations recorded.
Deficiency	VINYL TILES: DETERIORATED SUBSTRATE
Deficiency Location/Instance	Corridor near Room 406, Rooms 123, 202, 212, 321, 411, and others
Deficiency Quantity	1,700
Quantity Uom	S.F.
Potential Action	REPLACE
Urgency of Action	PRIORITY 3
Purpose of Action	LEVEL 2
Deficiency Photo1

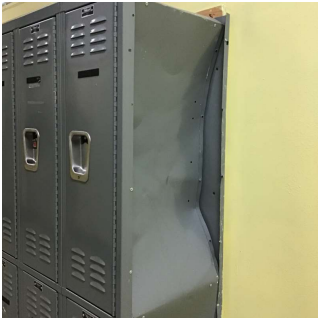
Question	Response
INTERIOR	
CLASSROOMS/CORRIDORS/ADMIN SPACES	
Specialties	Inspected
Classroom Locker(s)	Inspected
Condition	2 - Between Good and Fair
Deficiency	DAMAGED UNITS
Deficiency Location/Instance	Corridor near Room 310
Deficiency Quantity	1
Quantity Uom	EACH
Potential Action	REPLACE
Urgency of Action	PRIORITY 3
Purpose of Action	LEVEL 2
Deficiency Photo1

Corridor near Room 310
Violations	No violations recorded.
Fixed Seating	Does not Exist
GYMNASIUM	
Instance on 3rd Floor (2,500 SF)	Inspected
Ceiling	Inspected
Instance on 3rd Floor (2,500 SF)	Inspected
Condition	2 - Between Good and Fair
Deficiency	No deficiencies recorded
Door(s)	Inspected
Instance on 3rd Floor (2,500 SF)	Inspected
Condition	2 - Between Good and Fair
Deficiency	No deficiencies recorded
Fixed Equipment	Inspected
Instance on 3rd Floor (2,500 SF)	Inspected
Condition	2 - Between Good and Fair
Deficiency	No deficiencies recorded
Floor Finish	Inspected

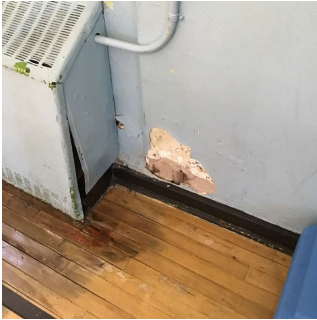
Question	Response
INTERIOR	
GYMNASIUM	
Floor Finish	
Deficiency Photo1	 
Violations	Near Windows No violations recorded.
Seating	
Instance on 3rd Floor (2,500 SF)	Does not Exist
Sliding-folding Partition	
Instance on 3rd Floor (2,500 SF)	Does not Exist
Stage	
Instance on 3rd Floor (2,500 SF)	Does not Exist
Walls	
Instance on 3rd Floor (2,500 SF)	Inspected
Condition	2 - Between Good and Fair
Deficiency	PLASTER: CRACKS/SPALLING
Deficiency Location/Instance	Near Entrance
Deficiency Quantity	25
Quantity Uom	S.F.
Potential Action	REPLACE
Urgency of Action	PRIORITY 3
Purpose of Action	LEVEL 2
Deficiency Photo1

Violations	Near Windows No violations recorded.
Deficiency	WALL PADDING: DETERIORATED
Deficiency Location/Instance	Right Side
Deficiency Quantity	40
Quantity Uom	S.F.
Potential Action	REPLACE
Urgency of Action	PRIORITY 3
Purpose of Action	LEVEL 2

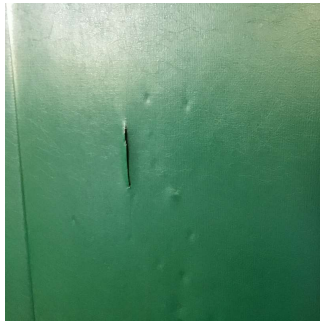
Violations	Right Side No violations recorded.
Window Curtains/Shades/Blinds	
Instance on 3rd Floor (2,500 SF)	Does not Exist
INTERIOR DOOR HARDWARE	
Condition	Inspected 3 - Fair
Deficiency	No deficiencies recorded
INTERIOR GUARDS	
Condition	Inspected 2 - Between Good and Fair
Deficiency	DETERIORATED/TORN-OUT/MISSING
Deficiency Location/Instance	Stairs AB/1, CD/3
Deficiency Quantity	20
Quantity Uom	S.F.
Potential Action	REPLACE
Urgency of Action	PRIORITY 3
Purpose of Action	LEVEL 2
Deficiency Photo1

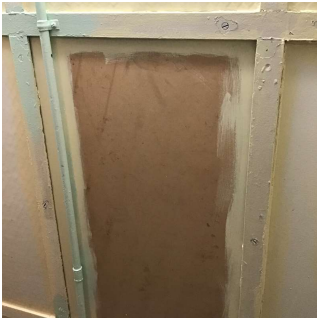
Question	Response
INTERIOR	
STAIRS/RAMPS: INTERIOR	
Partition	
Violations	Stair CD/Basement No violations recorded.
Deficiency	METAL PANEL: DAMAGED/DETERIORATED
Deficiency Location/Instance	Stairs AB/Basement,3, CD/1, GH/Basement, JK/1, and others
Deficiency Quantity	255
Quantity Uom	S.F.
Potential Action	REPLACE
Urgency of Action	PRIORITY 3
Purpose of Action	LEVEL 2
Deficiency Photo1

Violations	Stair GH/Basement No violations recorded.
Railings	
Condition	Inspected 5 - Poor
Deficiency	METAL: DAMAGED
Deficiency Location/Instance	Stair GH/1
Deficiency Quantity	32
Quantity Uom	L.F.
Potential Action	REPLACE
Urgency of Action	PRIORITY 3
Purpose of Action	LEVEL 2
Deficiency Photo1

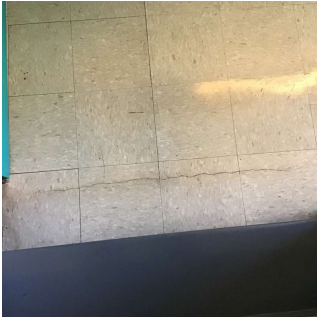
Question	Response
INTERIOR	
STAIRS/RAMPS: INTERIOR	
Stairs and Landings	
Violations	Stair F/Basement No violations recorded.
Deficiency	VINYL TILES: DETERIORATED SUBSTRATE
Deficiency Location/Instance	Stairs AB/2, CD/3
Deficiency Quantity	30
Quantity Uom	S.F.
Potential Action	REPLACE
Urgency of Action	PRIORITY 3
Purpose of Action	LEVEL 2
Deficiency Photo1

Violations	Stair AB/2 No violations recorded.
Deficiency	VINYL TILES: BROKEN/DETERIORATED/MISSING TILES
Deficiency Location/Instance	Stairs AB/2,3, GH/Basement
Deficiency Quantity	50
Quantity Uom	S.F.
Potential Action	REPLACE
Urgency of Action	PRIORITY 3
Purpose of Action	LEVEL 2
Deficiency Photo1

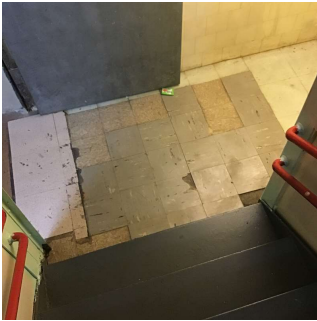
Violations	Stair GH/Basement No violations recorded.
Deficiency	STONE: BROKEN/MISSING
Deficiency Location/Instance	Stairs AB/1,4, F/Basement,1, GH/Basement, JK/2
Deficiency Quantity	165
Quantity Uom	S.F.
Potential Action	REPLACE
Urgency of Action	PRIORITY 3
Purpose of Action	LEVEL 2

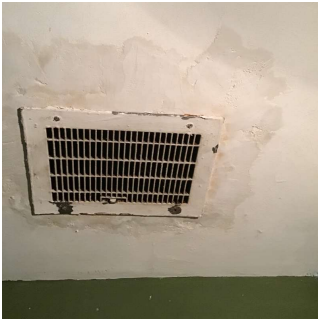
Violations	Stair E/1 No violations recorded.
TOILET ROOMS - STAFF	Inspected
Ceiling	Inspected
Condition	2 - Between Good and Fair
Deficiency	PLASTER: CRACKS/SPALLING
Deficiency Location/Instance	3rd Floor Staff
Deficiency Quantity	10
Quantity Uom	S.F.
Potential Action	REPLACE
Urgency of Action	PRIORITY 3
Purpose of Action	LEVEL 2
Deficiency Photo1

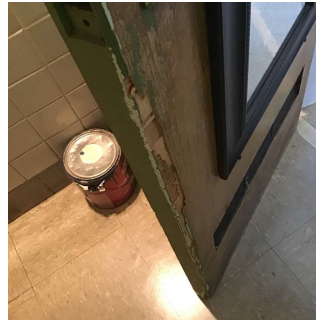
Violations	3rd Floor Staff No violations recorded.
Door(s)	Inspected
Condition	5 - Poor
Deficiency	WOOD: DETERIORATED DOOR
Deficiency Location/Instance	3rd Floor Staff, Nurse Office, Room 213D, In Room 202
Deficiency Quantity	4
Quantity Uom	EACH
Potential Action	MAINTENANCE
Urgency of Action	PRIORITY 3
Purpose of Action	LEVEL 2

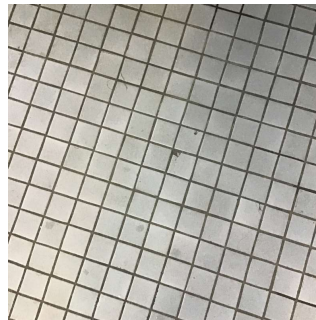
Room 209

Deficiency

CERAMIC TILE: BROKEN/MISSING TILES

REPLACE

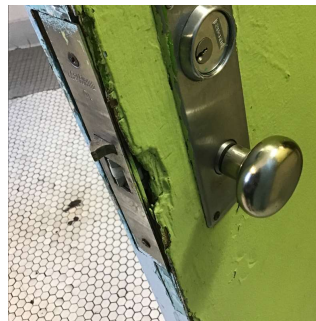
Room 309

Deficiency

WOOD: DETERIORATED DOOR

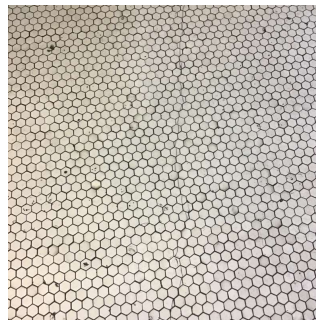
Deficiency

CERAMIC TILE: BROKEN/MISSING TILES

REPLACE

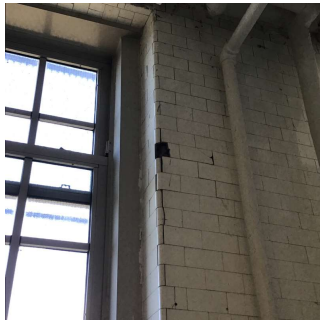
Room 309
Violations	No violations recorded.
LIFE SAFETY	Inspected
F.D. HOLDING AREA	Does not Exist
STEEL STAIRS	Does not Exist
SITE	Inspected

Question	Response
INTERIOR	
TOILET ROOMS - STUDENTS	
Floor Finish	Inspected
	Room 309
Violations	No violations recorded.
Stalls	Inspected
Condition	3 - Fair
Deficiency	BROKEN/MISSING
Deficiency Location/Instance	Room 309
Deficiency Quantity	1
Quantity Uom	EACH
Potential Action	REPLACE
Urgency of Action	PRIORITY 3
Purpose of Action	LEVEL 2
Deficiency Photo1	 
	Room 309
Violations	No violations recorded.
Walls	Inspected
Condition	2 - Between Good and Fair
Deficiency	CERAMIC TILE: BROKEN/ MISSING
Deficiency Location/Instance	Room 309
Deficiency Quantity	30
Quantity Uom	S.F.
Potential Action	REPLACE
Urgency of Action	PRIORITY 3
Purpose of Action	LEVEL 2
Deficiency Photo1

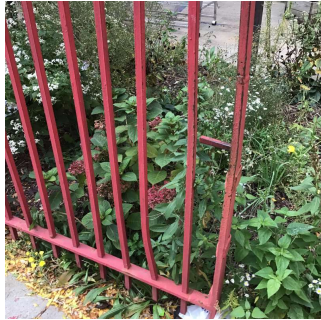
Question	Response
SITE	
CONTAINERIZATION	Does not Exist
Drainage System for Asphalt	Does not Exist
Drainage System for Concrete	Inspected
Catch Basins/Manhole - Surrounded by concrete	Inspected
Condition	2 - Between Good and Fair
Deficiency	No deficiencies recorded
Culverts - Concrete Covering	Does not Exist
Drainage System for Soil	Does not Exist
DRINKING FOUNTAINS	Does not Exist
FENCES	Inspected
Condition	3 - Fair
Deficiency	WROUGHT IRON: DAMAGED/DETERIORATED
Deficiency Location/Instance	Ellery Street
Deficiency Quantity	120
Quantity Uom	S.F.
Potential Action	REPLACE
Urgency of Action	PRIORITY 3
Purpose of Action	LEVEL 2
Deficiency Photo1

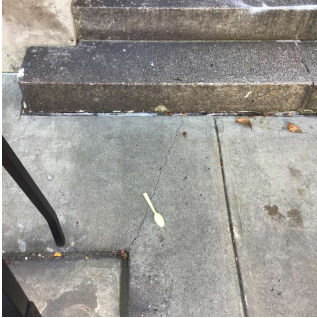
Question	Response
SITE	
PAVING	
Site Sidewalks & Walkways	
Concrete	
Condition	2 - Between Good and Fair
Deficiency	DAMAGED/DETERIORATED/MISSING SECTIONS
Deficiency Location/Instance	Hopkins Street
Deficiency Quantity	25
Quantity Uom	S.F.
Potential Action	REPLACE
Urgency of Action	PRIORITY 3
Purpose of Action	LEVEL 2
Deficiency Photo1

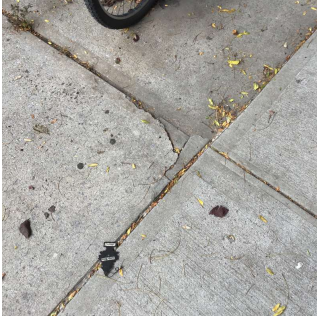
Ellery Street
Violations	No violations recorded.
Deficiency	DAMAGED/DETERIORATED/MISSING SECTIONS
Deficiency Location/Instance	Ellery Street
Deficiency Quantity	175
Quantity Uom	S.F.
Potential Action	REPLACE
Urgency of Action	PRIORITY 3
Purpose of Action	LEVEL 2

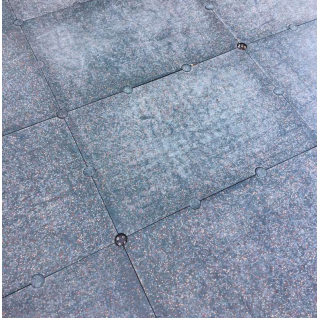
Violations	Ellery Street No violations recorded.
Pavers	Does not Exist
PLAYGROUNDS	Inspected
Instance on Plaza Deck at Hopkins Street	Inspected
Benches	
Instance on Plaza Deck at Hopkins Street	Does not Exist
Fence	
Instance on Plaza Deck at Hopkins Street	Does not Exist
Pavement	
Instance on Plaza Deck at Hopkins Street	Does not Exist
Play Equipment	
Instance on Plaza Deck at Hopkins Street	Does not Exist
Safety Surfacing	
Instance on Plaza Deck at Hopkins Street	Inspected
Condition	2 - Between Good and Fair
Deficiency	DETERIORATED/MISSING
Deficiency Location/Instance	Center
Deficiency Quantity	15
Quantity Uom	S.F.
Potential Action	MAINTENANCE
Urgency of Action	PRIORITY 3
Purpose of Action	LEVEL 2
Deficiency Photo1

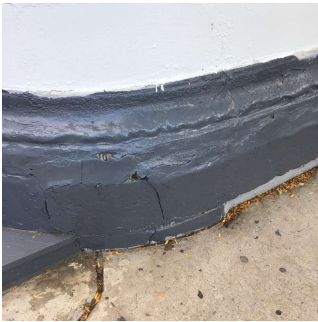
Question	Response
SITE	
PLAYING SURFACE	Does not Exist
RETAINING WALLS	Inspected
Are there any Retaining Walls 6' OR higher facing public street/sidewalk?	No
Condition	3 - Fair
Deficiency	STONE: CRACKS/SPALLING - MAJOR
Deficiency Location/Instance	Ellery Street
Deficiency Quantity	25
Quantity Uom	S.F.
Potential Action	REPLACE
Urgency of Action	PRIORITY 3
Purpose of Action	LEVEL 2
Deficiency Photo1

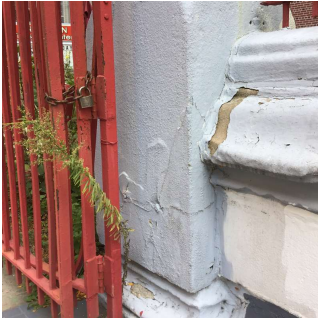
Violations	Ellery Street No violations recorded.
SEATING	Does not Exist
SITE WALLS (NOT RETAINING WALLS)	Inspected
Condition	3 - Fair
Deficiency	STONE: CRACKS/SPALLING - MAJOR
Deficiency Location/Instance	Ellery Street
Deficiency Quantity	25
Quantity Uom	S.F.
Potential Action	REPLACE
Urgency of Action	PRIORITY 3
Purpose of Action	LEVEL 2
Deficiency Photo1
